**Hendre Eirian Hydro Scheme,
Tal-y-Bont, Barmouth, Gwynedd.
April 2015
V 1.0**

Archaeological Watching Brief
Project Code: A0029.2
Report no. 0060

Archaeological Watching Brief

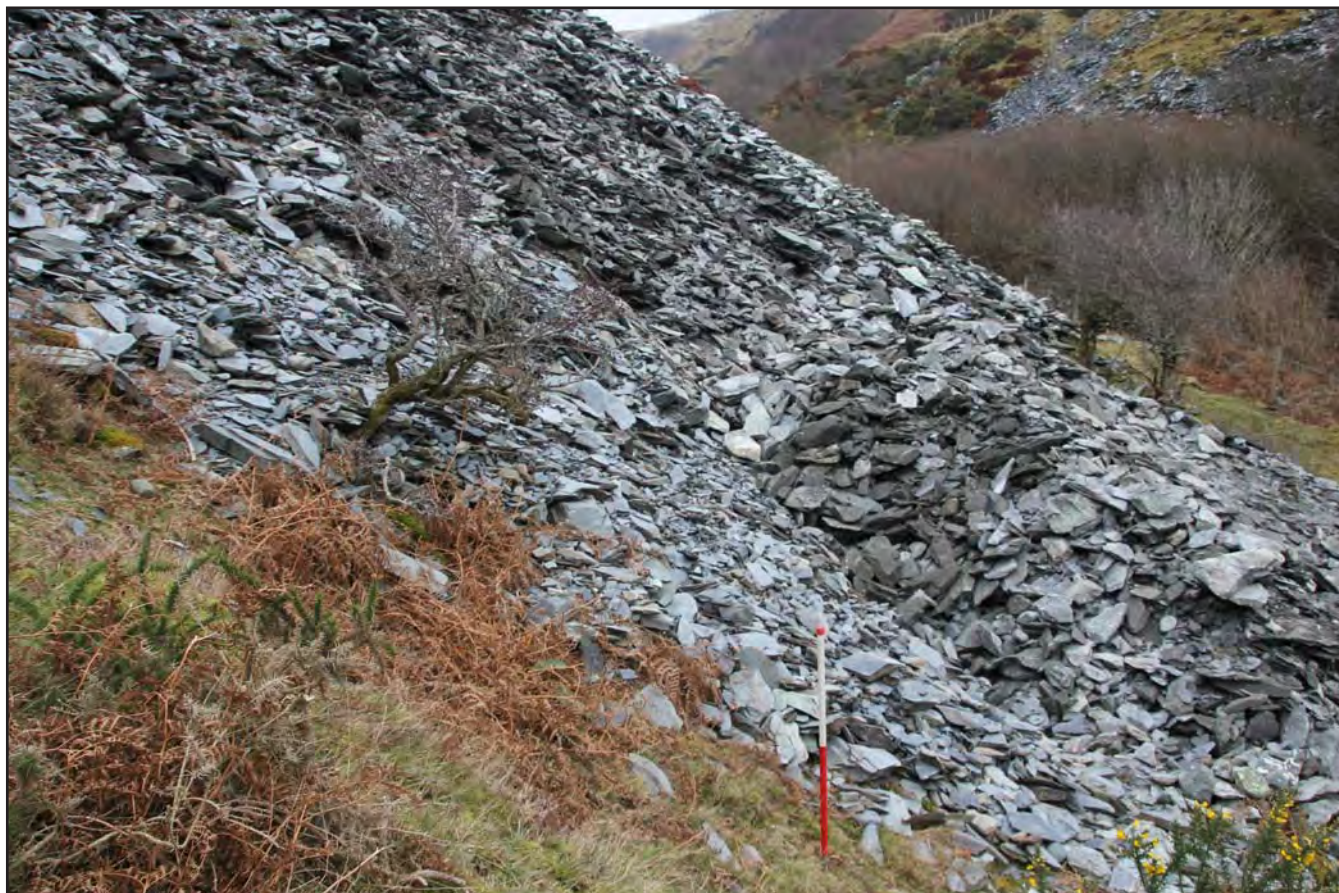
Plate 07: Cleared slate tip (feature 27), from the west. Scale 1.0m.

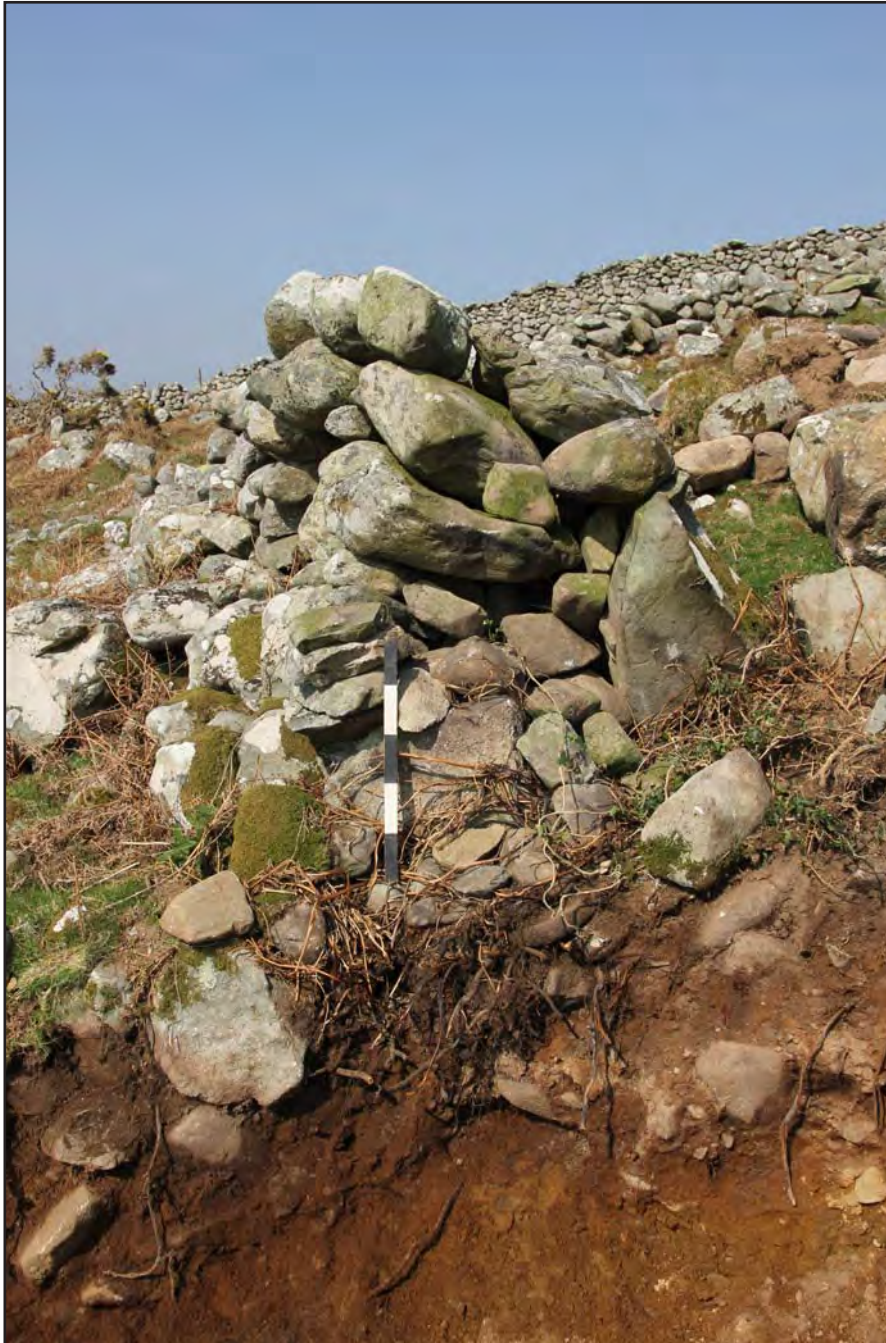
Plate 10: Breached field wall (feature 16), from the south. Scale 0.5m.

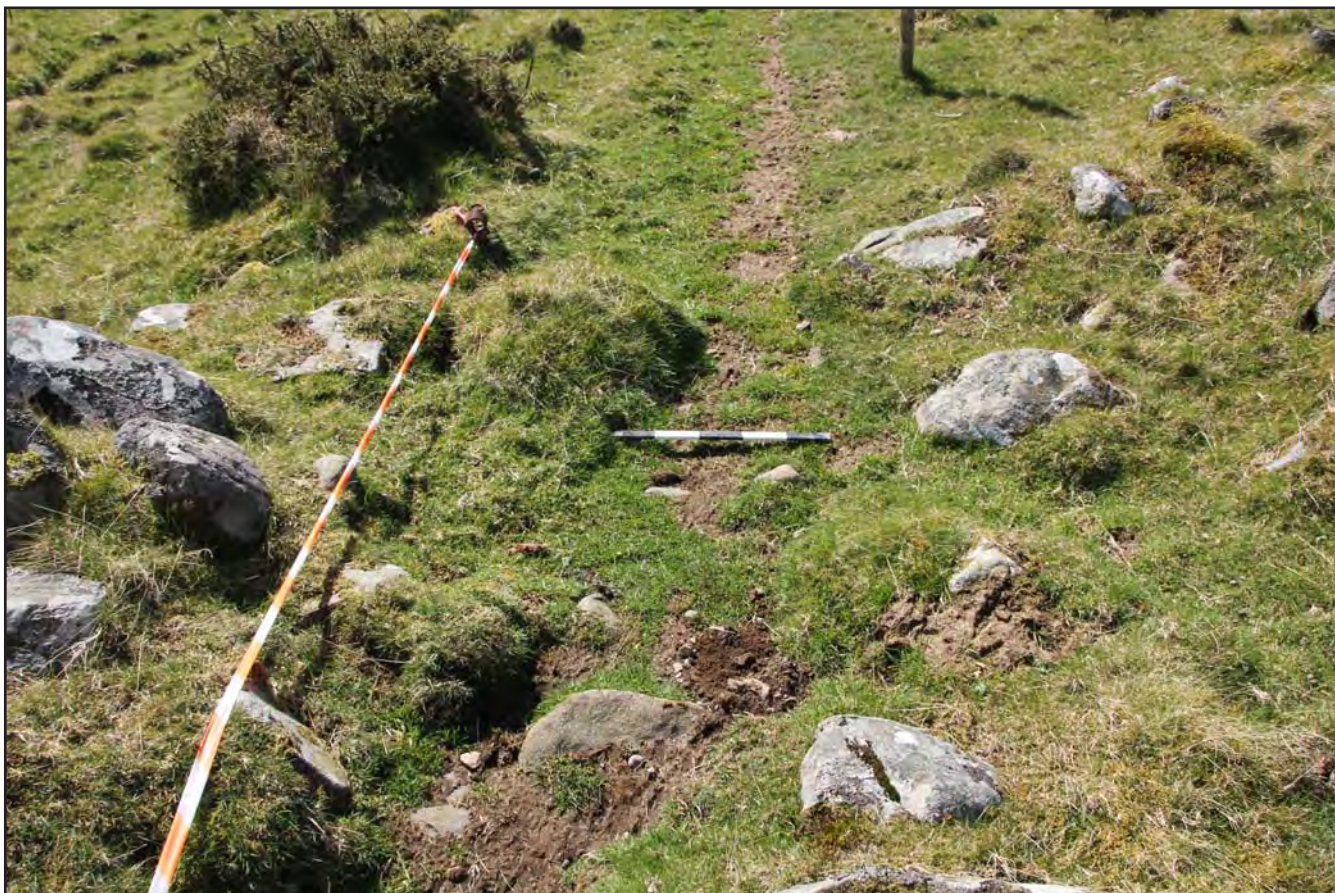
Plate 16: Relict field wall (feature 9) prior to the excavation of the penstock trench, from the east. Scale 0.5m.

These aims extended to an archaeological excavation across the suspected prehistoric relict field wall (feature 9) which was to be undertaken in advance of being breached by the penstock route at Ch703. However, upon inspection of the relict wall with the Client and site contractor it was realised that the penstock trench could be narrowed to 0.5m in width to pass through an existing gap in the wall, with plant machinery being diverted around the northern limit of the feature to ensure that no compression damage occurred. As such, the excavation across the relict field wall was not undertaken but an archaeological watching brief was maintained during the excavation of the penstock trench through the wall gap, with the exposed section cleaned by hand and photographic and descriptive records taken.

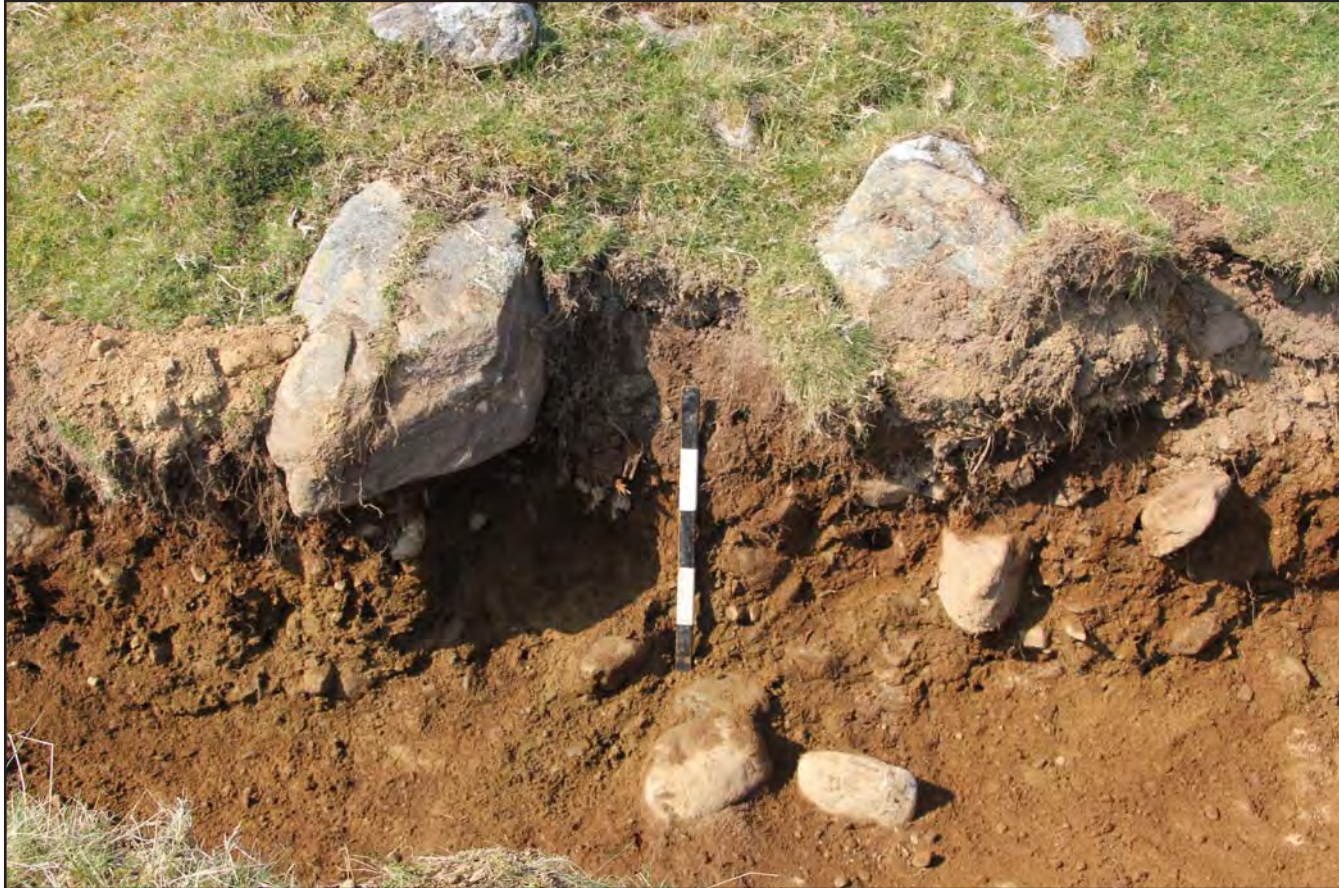
Plate 17: Penstock trench through existing gap in relict wall (feature 9), from the south. Scale 0.5m.

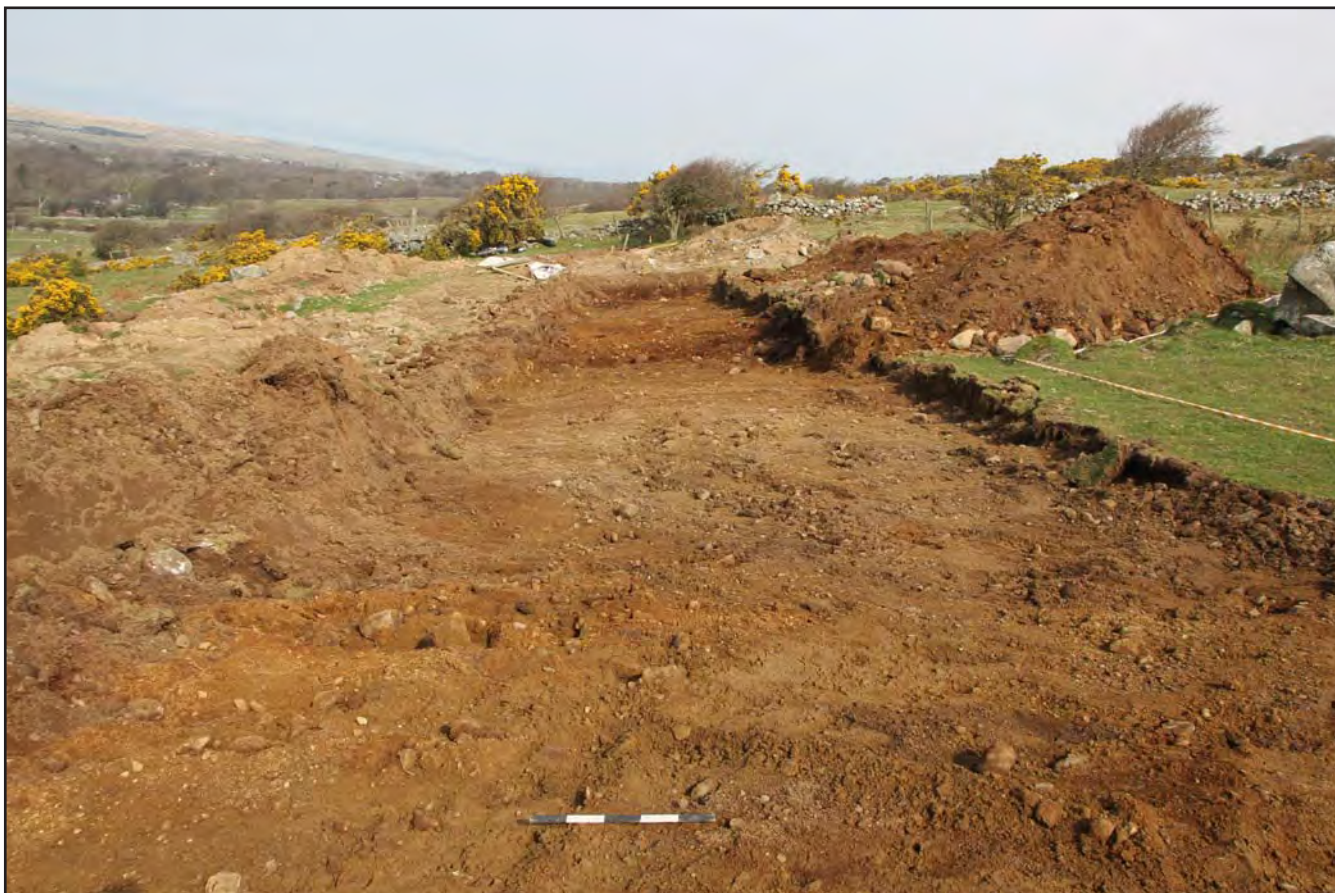
Plate 24: Stripped penstock Ch1300 - Ch1373, from the east. Scale 0.5m.

The archaeological watching brief was maintained while a tracked excavator with toothless ditching bucket excavated a 4.0m wide easement for the hydro penstock trench from Ch1300-1373 (NGR SH 60103 20742 – SH 60065 20742 – SH 60056 20770). The easement was excavated to a depth of 0.6m through a 0.2m deep reasonably soft dark grey-brown silt-clay topsoil with fairly frequent small sized sub-rounded cobble inclusions, onto a fairly loose light orange sand-clay natural glacial substrata with frequent small and medium sized sub-rounded cobble inclusions.

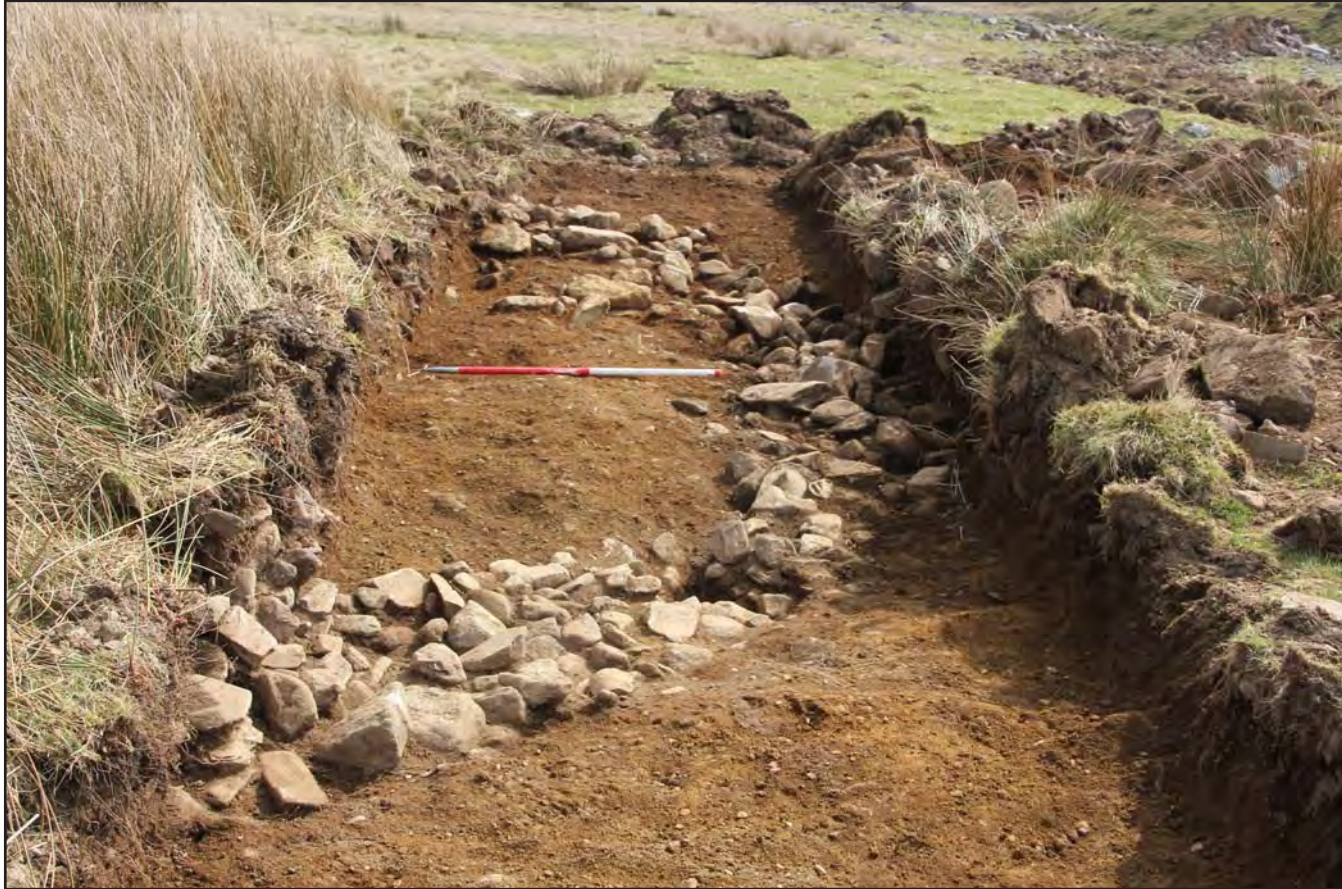
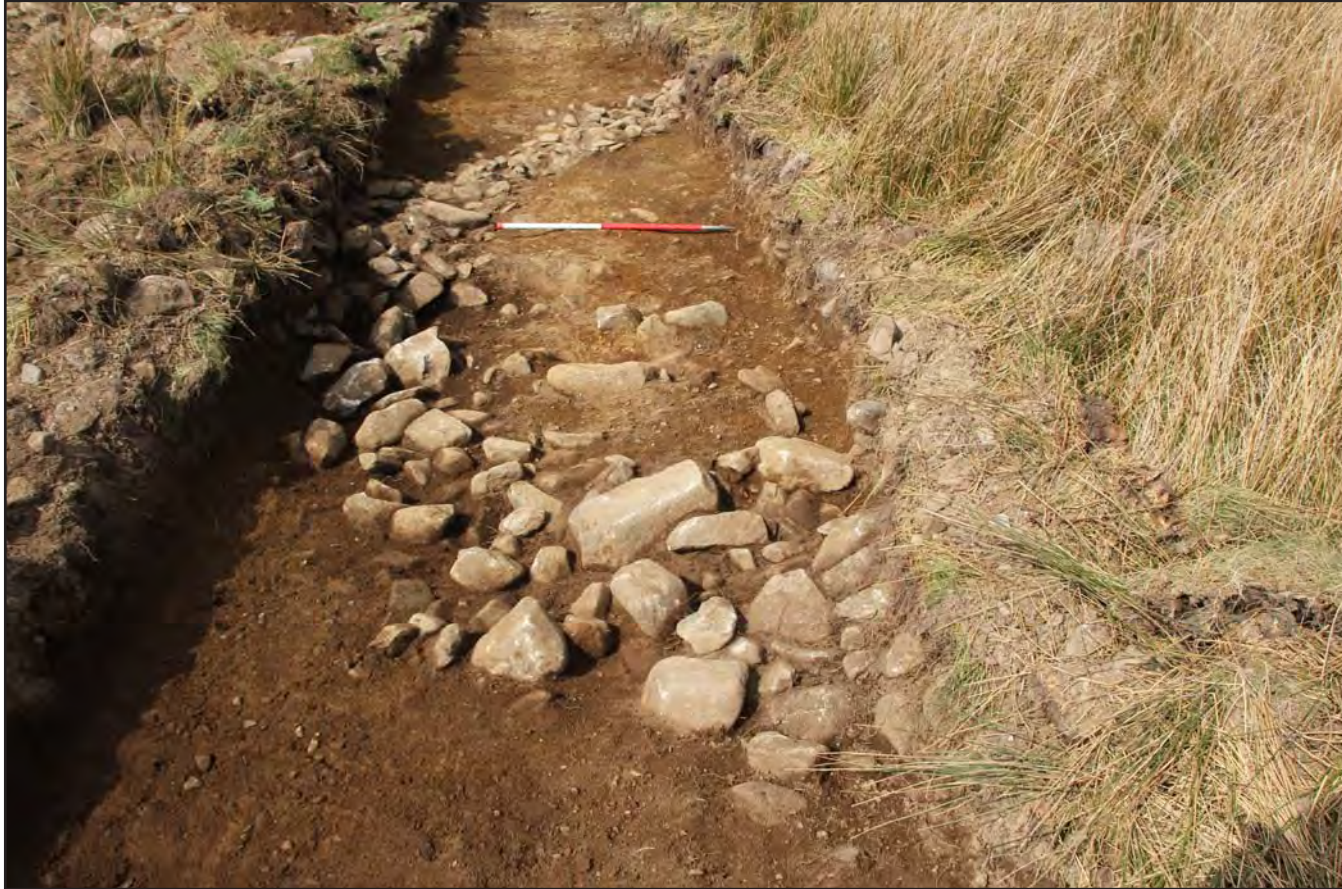
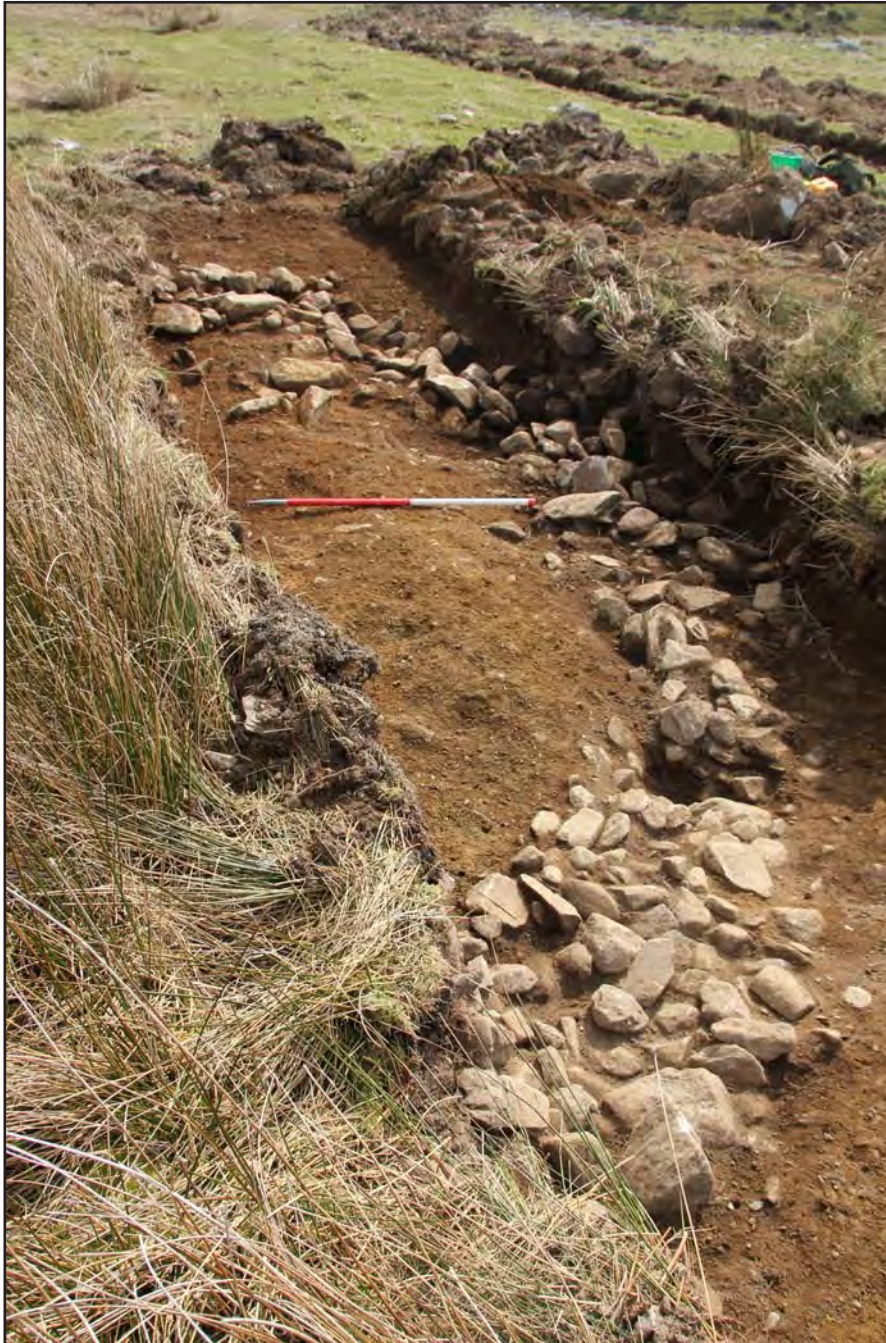
Plate 26: Round House (1001), from the northwest. Scale 1.0m.

Plate 27: Round House (1001), from the southeast. Scale 1.0m.

Plate 28: Round House (1001), from the north. Scale 1.0m.

Upon careful cleaning back with the tracked excavator utilising a toothless ditching bucket and revealing the highest surviving remains of the structure, the round house was subsequently cleaned by hand and photographed (plates 26-28) as well as being drawn in plan (figure 7). During the cleaning, a fragment of what is probably a hand-stone from a saddle quern (SF 01) (plate i) was recovered from the loose rubble within the wall structure (1003) at its south-western return. The hand-stone measured 16.0cm in length by 10.5cm in width by 3.0cm in depth, and weighed 746g. It had been carved from a mid-grey hard grit-stone with 1-3mm quartz inclusions, with a flat surface on one side and a curved edge on the opposing face forming a semi-circular profile. It appeared to have been broken at either end and on the right hand edge. This artefact is of probable prehistoric date.

The round house wall measured 0.9m in width and had a maximum surviving height of 0.42m above the natural clay at the north-eastern return. It was constructed from approximately 80% small and medium sized undressed sub-rounded cobbles averaging 0.25m in size, with a fairly soft dark red-brown silt-clay in-filling the voids (1003). This fill occasionally had lenses of lighter brown-grey silt suggesting waterlogged conditions within the wall structure, which was sampled for possible later environmental processing or Carbon 14 dating.

The wall did not appear to have any formal structure and no facing stones or integrated wall core could be identified. In fact, the wall appeared to be of fairly loose construction utilising smaller pieces of stone rubble, with the exception of the north-eastern end where the wall survived to a higher level and medium sub-rounded cobbles had been incorporated into the structure. Moreover, twelve pieces of unworked white opaque quartz were recovered within the wall structure during cleaning and the excavation of an exploratory sondage across the wall (plate ii). These pieces of quartz varied in size from a maximum of 115mm in length to a minimum of 40mm in length, and at least three pieces had clearly been fractured, although not seemingly worked. This would suggest that some of the quartz at least had been quarried from a vein rather than being a glacial erratics found at ground level.

The penstock route was diverted to the south of the round house and the trench was backfilled thus preserving the monument in-situ.

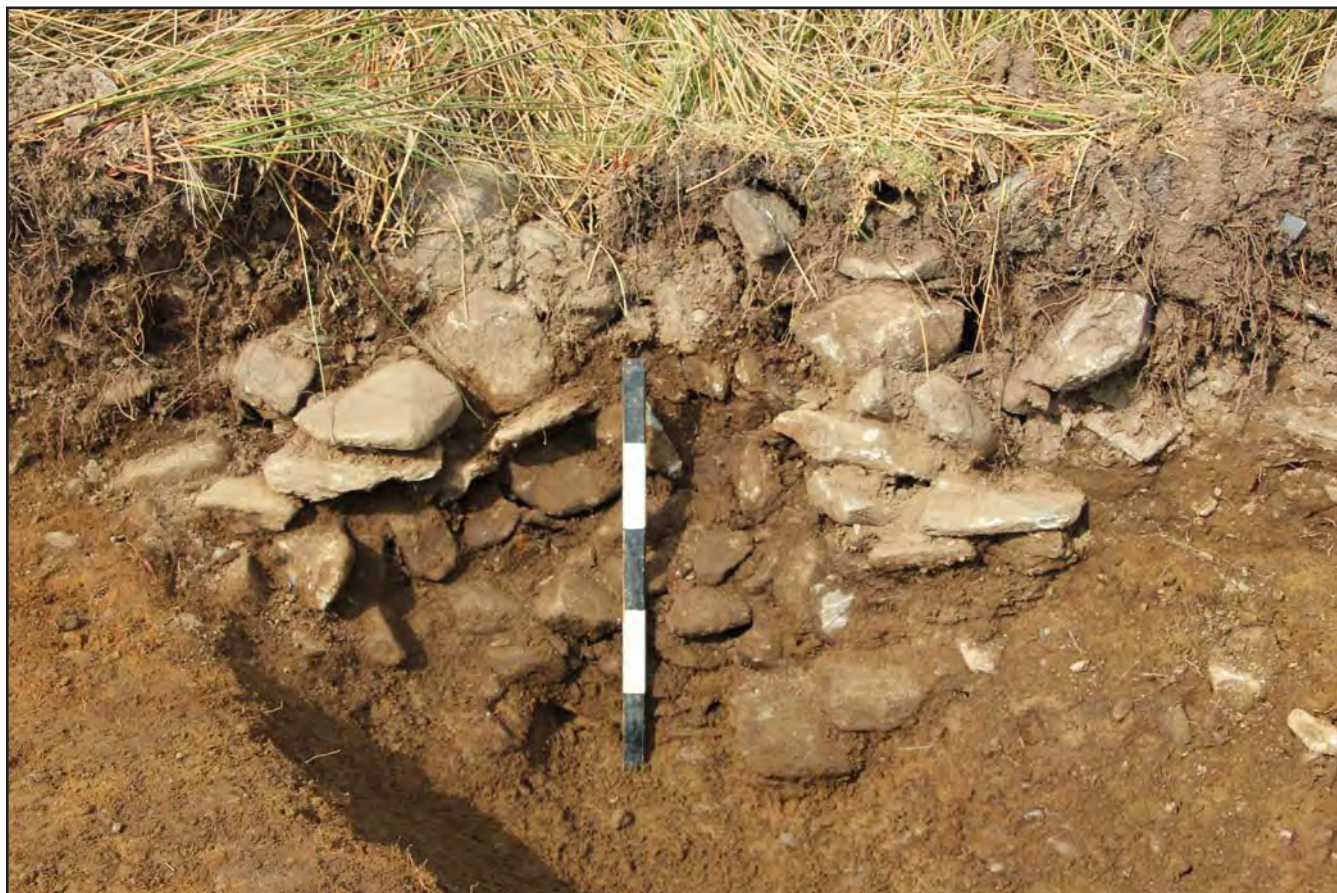
Plate 29: Sondage across Round House (1001) showing wall (1003) and foundation cut [1002], from the southeast. Scale 0.5m.

A sondage measuring 1.3m in length was placed across the south-western side of the round house wall and up against the north-western trench edge. This revealed that the wall had been constructed within a foundation trench [1002] cut into the natural glacial clay horizon (1004). The foundation trench measured 0.9m in width by 0.4m in depth, and had slightly concaved sides and a flat base. The round house wall (1003) had been placed directly into the foundation cut and extended a maximum of 0.42m above the top of the cut.

The sondage section and indeed the section of the trench edge across the round house was cleaned and recorded. This showed that after the construction of the round house wall (1003) within foundation trench [1002], a reasonably soft mid orange-brown silt-clay deposit (1005) had formed within the interior of the structure and butted up against the internal face of the round house wall, thus post-dating it. This deposit measured 0.04m in depth and although removed across half of the interior of the round house during cleaning, appeared in the trench section showing that it had occupied the whole of the revealed internal space. The deposit contained occasional small sub-rounded pebbles and occasional charcoal flecks, as such a bulk sample of the deposit was taken for the possibility of Carbon 14 dating at a later opportunity. The most likely interpretation for deposit (1005) is that it was an internal floor surface that had formed while the round house had been in use.

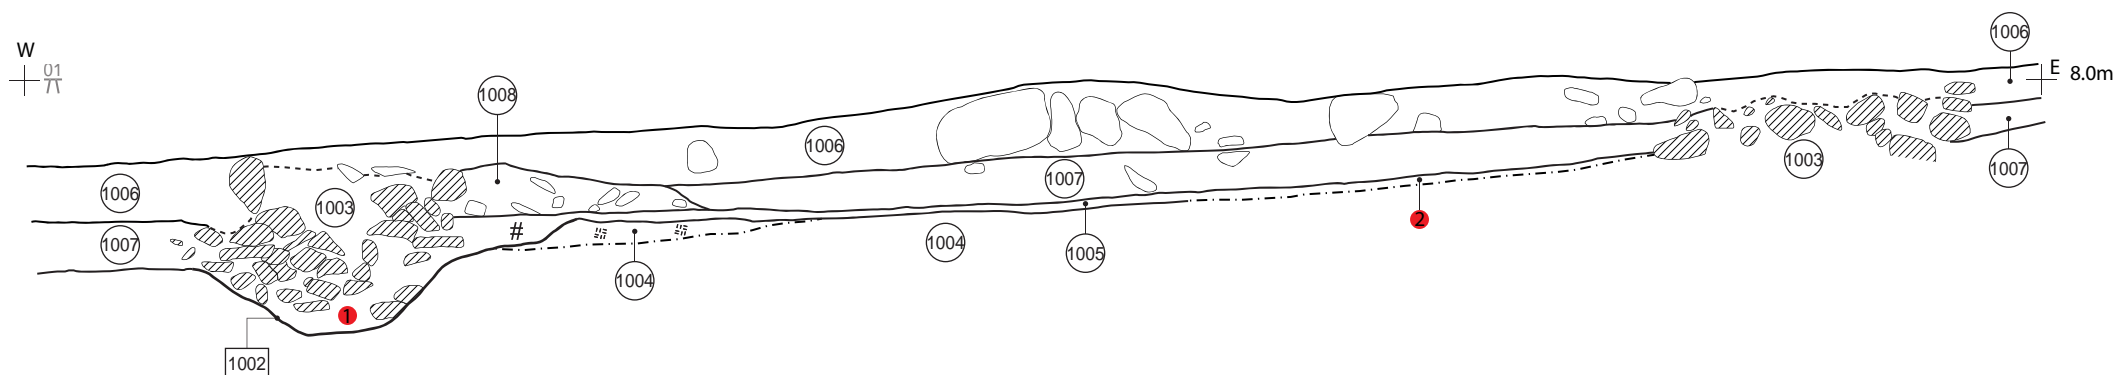
Figure 08: South facing section of Round House (1001). Scale 1:30 at A4.

1002 = Cut of foundation trench
1003 = Stone wall of Round Hut
1004 = Natural clay
1005 = Relict subsoil/surface
1006 = Topsoil
1007 = Subsoil
1008 = Demolition material

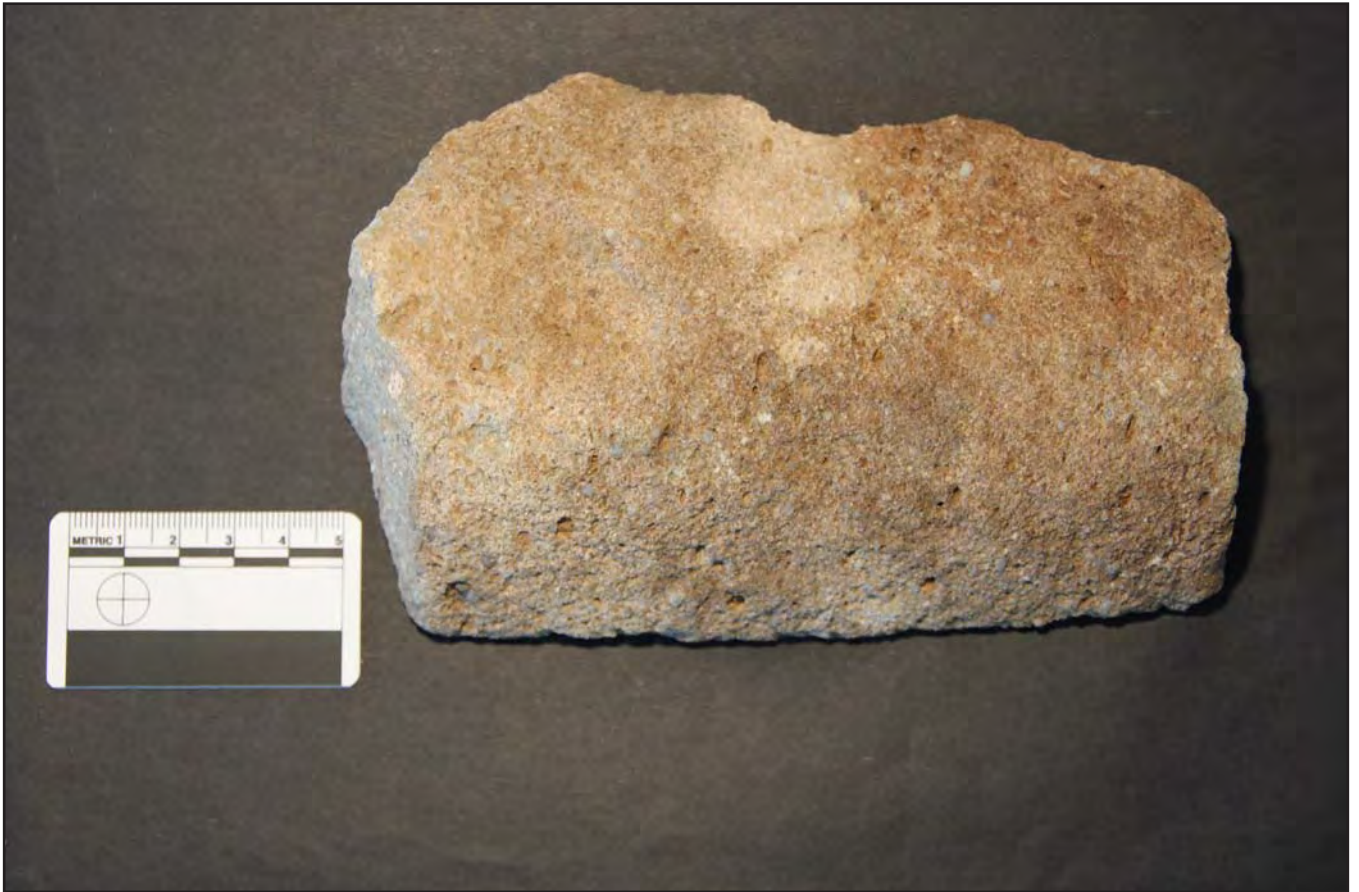
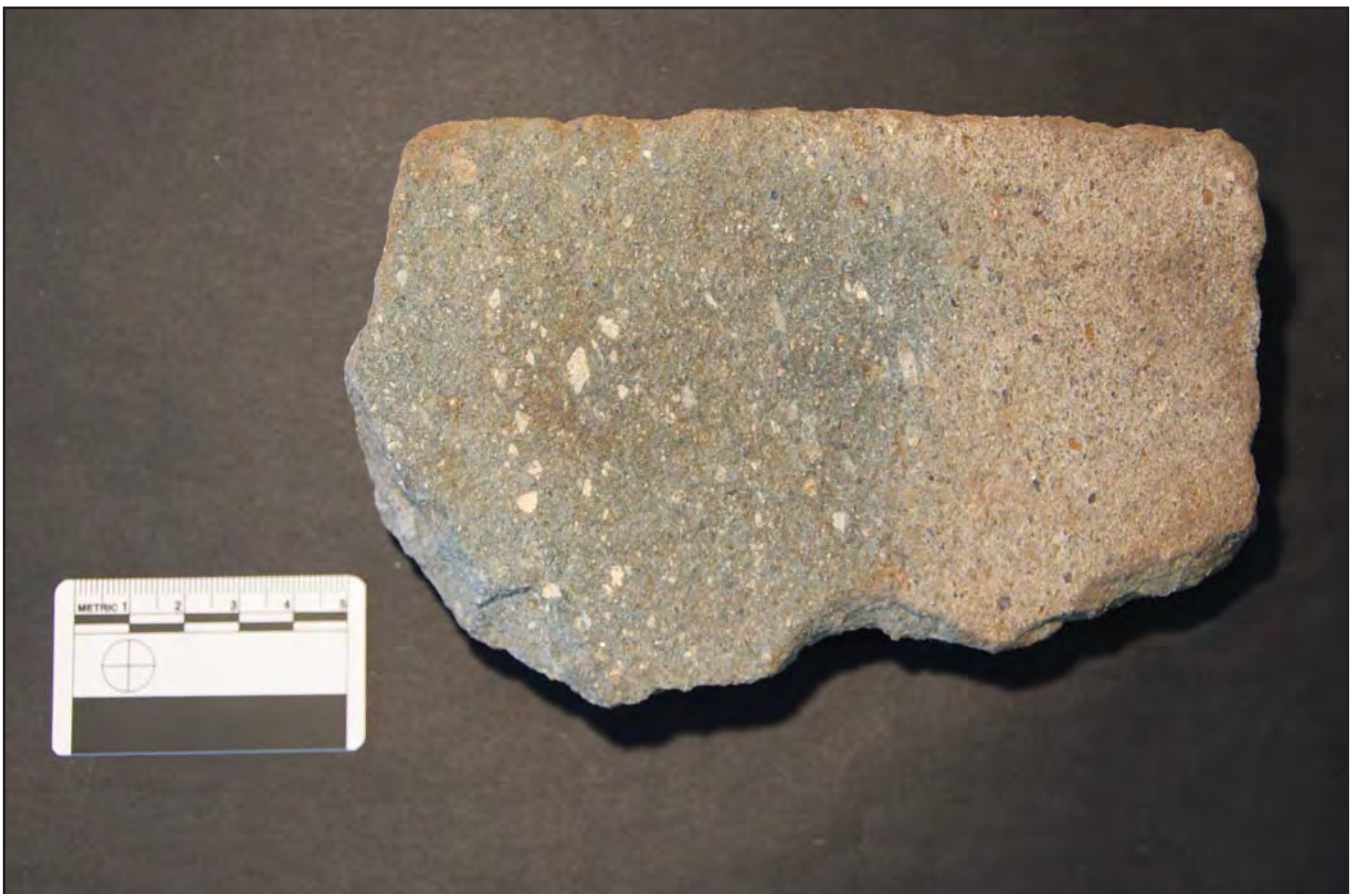
Plate i: Fragment of saddle quern hand-stone. Scale 5.0cm.

The inclusion of the probable hand-stone saddle quern fragment (SF 01) and the large quantity of unworked opaque quartz (plates i and ii respectively) into the wall structure is unlikely to be by accident, and probably represents a ritual deposition of material within the wall. The quartz, although unworked, did show that at least three pieces had been fractured, probably as a result of being quarried from a quartz vein as opposed to being found as a glacial erratic at ground level. The deposition of these fragments would classify them as *manuports*, natural items that have been moved from their original context by human agency but otherwise remain unaltered.

Find no.	Context	Form	Material	Dimensions	Description	Plate
01	1003	Hand-stone from saddle quern (prehistoric/Roman)	Stone	16.0cm long x 10.5cm wide x 3.0cm deep	Carved from a mid-grey hard grit-stone with quartz inclusions measuring 1-3mm, with a flat surface on one side and a curved edge on the opposing face forming a semi-circular profile. It appeared to have been broken at either end and on the right hand edge.	I

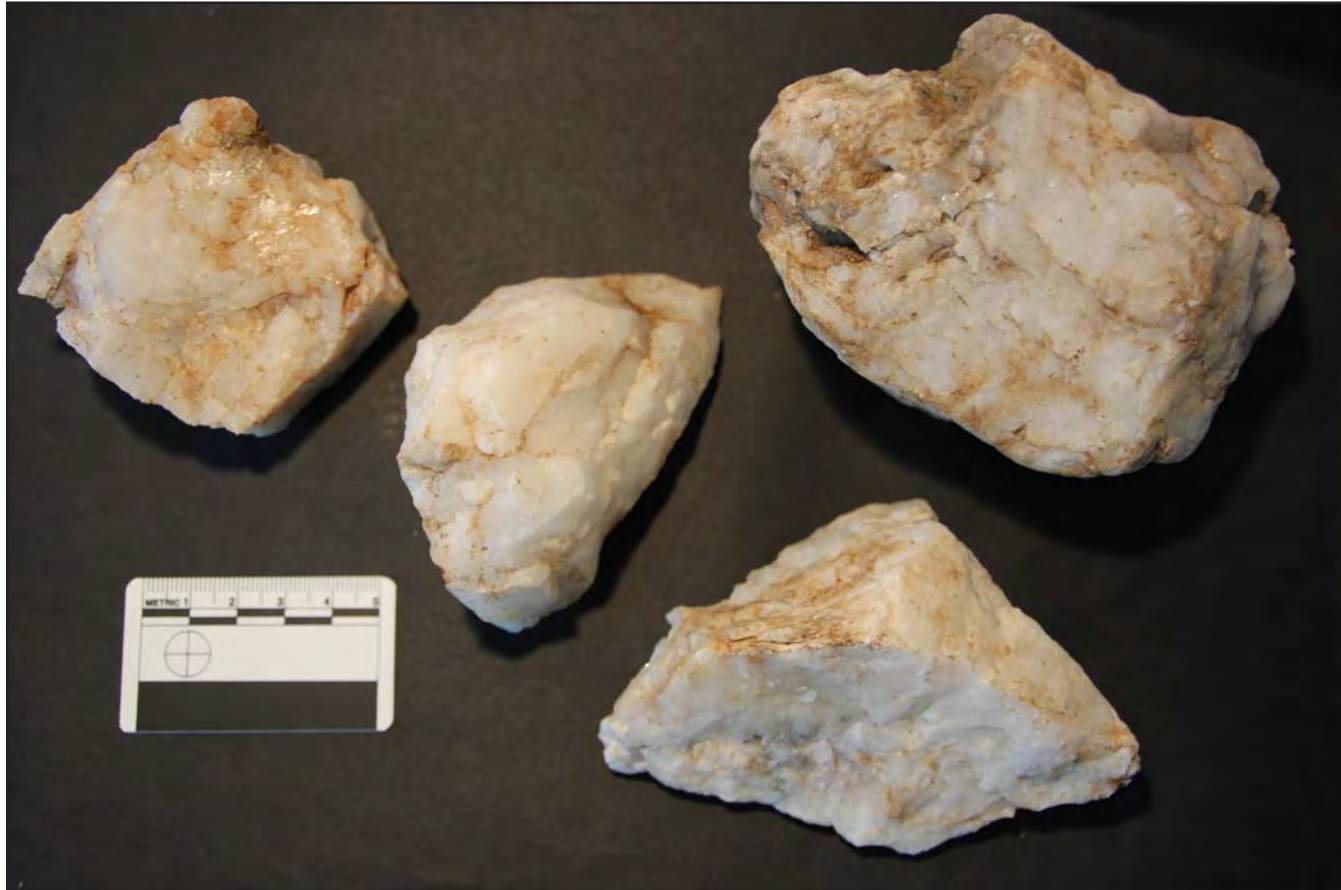
Plate ii: Quarts fragments from round house wall (1003). Scale 5.0cm.

Such deliberate depositions of quarts have been seen within the localised environment with as yet unpublished excavations of the *Mynydd Egryn Ring Cairn* ME156 approximately 480.0m to the southeast. Indeed, an alternative interpretation is that the round house (1001) is in fact a Bronze Age ring cairn, although the concentration of the stone rubble almost exclusively to the circular foundation trench and not around it would strongly suggest that the stone is in-situ rather than an accumulation within the cut. Moreover, no evidence of kerbing could be identified within the feature and the locality is not as prominent as one would expect with ring cairns making this theory less tenable.
