**Ty Coch Hydro Scheme, Nantlle,  
Gwynedd.  
August 2015  
V 1.0**

Archaeological Watching Brief and Excavation  
Project Code: A0034.2  
Report no. 0066

Report no. 0066 v1.0

Archaeological Watching Brief and Excavation

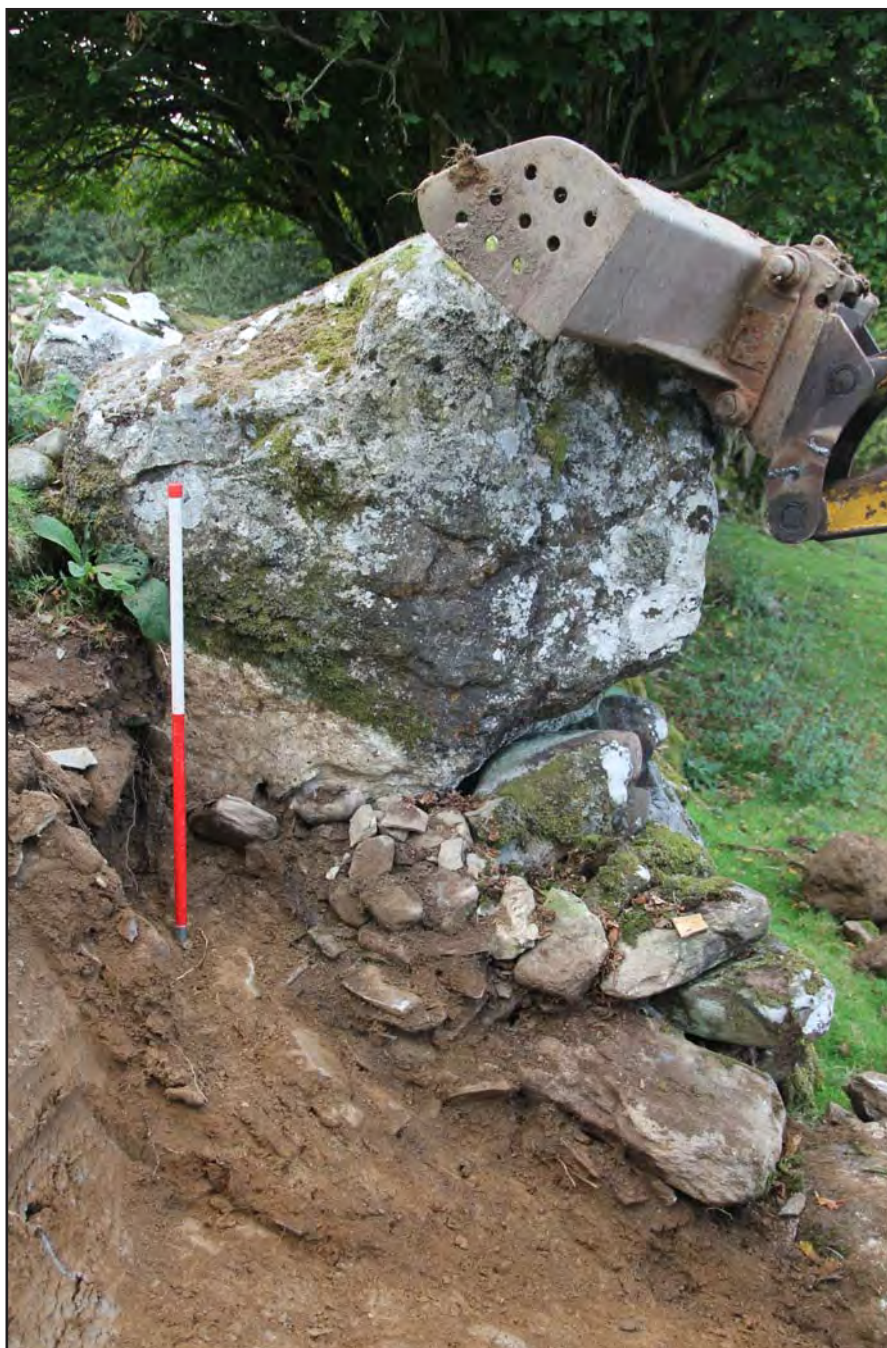
The wall measured 1.3m in height by 2.0m in width and ran from southwest to northeast. It was constructed from dry-stone bonded large sized sub-angular cobbles and boulders, and divided two fields. The wall was depicted on the first, second and third edition 25" Ordnance Survey maps of 1889, 1900 and 1916 respectively, although the use of such large stones within a revetment is often indicative of prehistoric or Roman lynchets and given the high frequency of sites from those eras within the localised landscape of Dyffryn Nantlle, it was considered a high possibility that the revetment also dated to this period.

The excavation removed all of the boulders and cobbles within the easement and excavated through a 0.1m deep mid red-brown silt-clay topsoil horizon with occasional small sub-rounded cobbles on to a reasonably firm, mid/light yellow-brown clay natural substrata. The wall revetted the natural slope and was constructed directly on to the topsoil horizon with frequent small and medium sized sub-rounded cobbles on the northern downward slope. In places the massive size of the incorporated boulders appeared to lie directly on to the natural substrata, although this was almost certainly a result of compression by the stones through the particularly thin topsoil horizon.

No clear structural element to the wall could be identified aside from a degree of sorting, with larger boulders laid on the upward slope side. Furthermore, the wall was not constructed within any foundation cut and no lenses or relict soil horizons could be identified within the wall section.

**Plate 1:** East facing section of revetment wall (feature 1), from the east. Scale 1.0m.

The lack of any structural element to the revetment wall, related relict stratigraphy, or artefactual evidence means that the origin of the wall was not identified during the excavation. Indeed, it is not unusual for prehistoric walls to exhibit very little structural form however discussions with the landowner during the excavation works revealed that the wall was in fact constructed as part of a phase of field clearance by them approximately ten years ago. This explanation does not account for the depiction of the wall on the historic Ordnance Survey maps but does explain the larger boulders on the southern upward slope of the wall.

The revetment wall may still have prehistoric or Roman origins, however the characteristics that suggested this have been shown to be modern in date. Once the large boulders are removed from the wall all that is left is a structure of dry-stone bonded small and medium sized cobbles with no clear form, which is similar to all of the other field walls within the study area. Without the identification of any prehistoric or Roman settlement activity in close proximity it would therefore appear that the revetment wall is likely to be post-medieval in date.

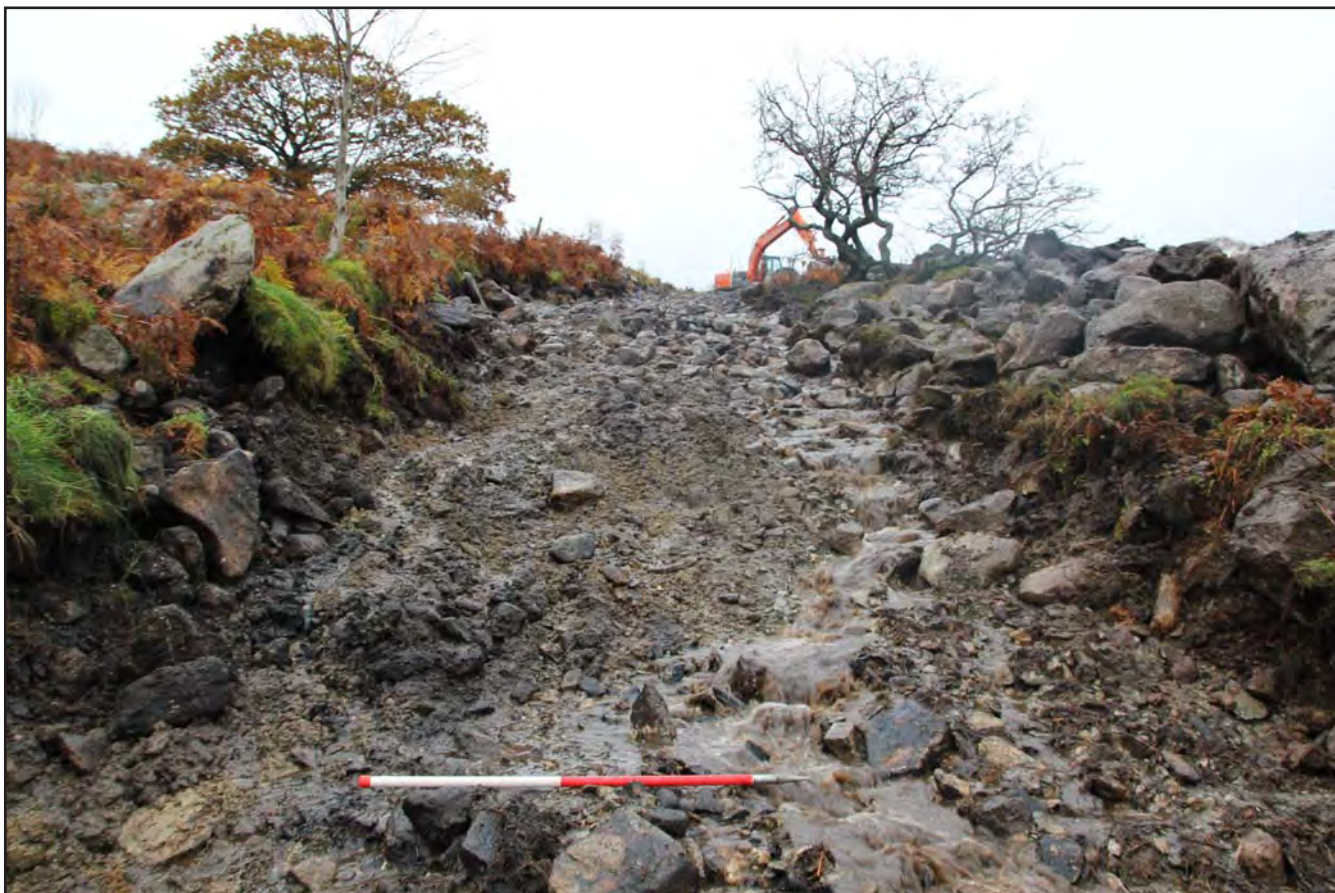
The archaeological watching brief was maintained while a tracked excavator with toothless ditching bucket excavated a 3.5m wide easement for the penstock trench between chainage 0-100m (NGR SH 50853 51889 – SH 50900 51979). The boulder field had been identified in the archaeological assessment as an area with good potential for stone-built round-houses belonging to the prehistoric or Roman periods.

The trench was excavated to a depth of 0.7m through a 0.5m deep deposit of medium and large sized rounded and sub-rounded glacial cobbles on to a firm mid grey clay with frequent shale and small cobble inclusions natural glacial substrata.

No archaeological deposits, structures or features were identified during the watching brief and no artefacts were recovered.

**Plate 02:** Location 14 (boulder field) trench, from the north. Scale 1.0m.

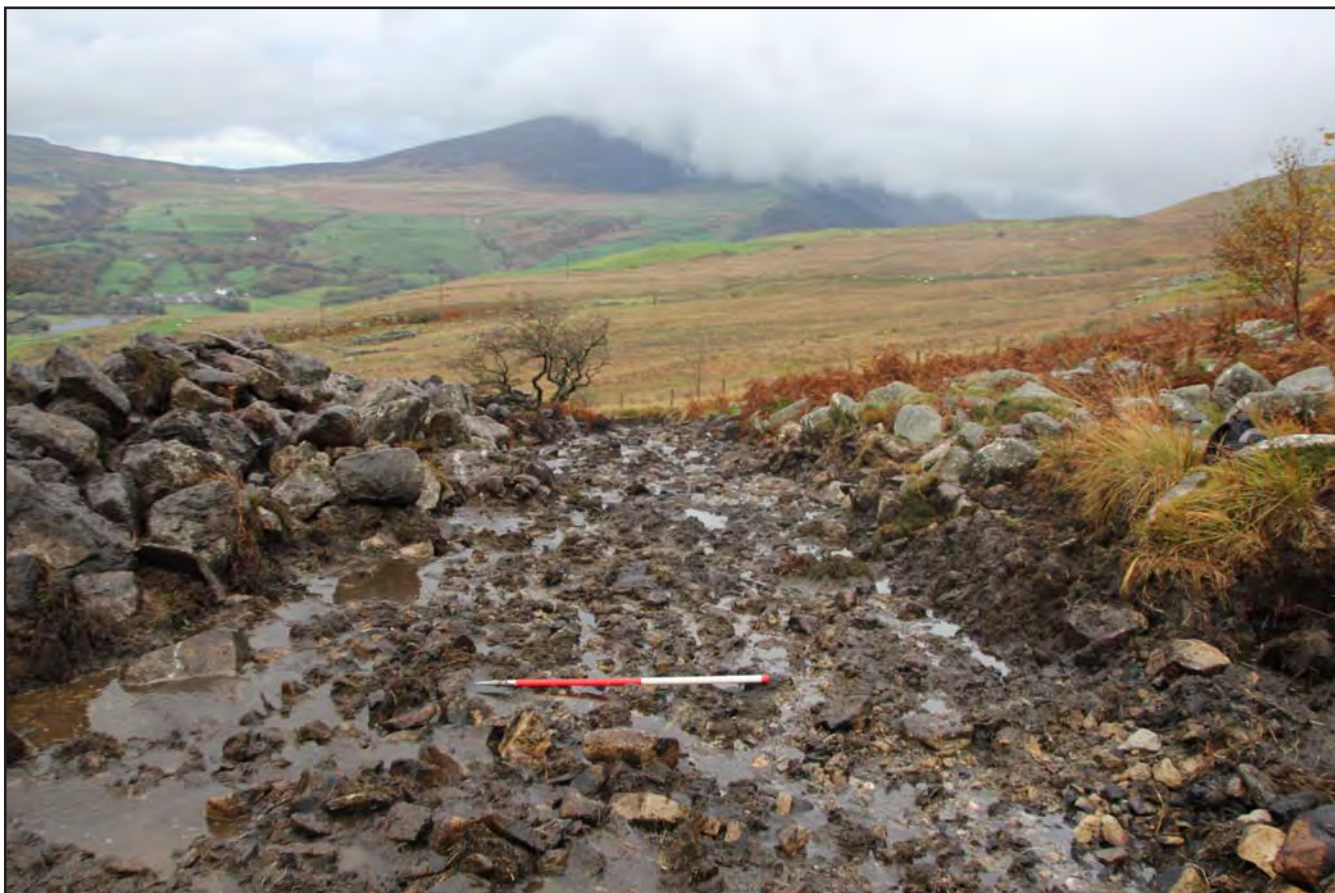
**Plate 03:** Location 14 (boulder field) trench, from the south. Scale 1.0m.

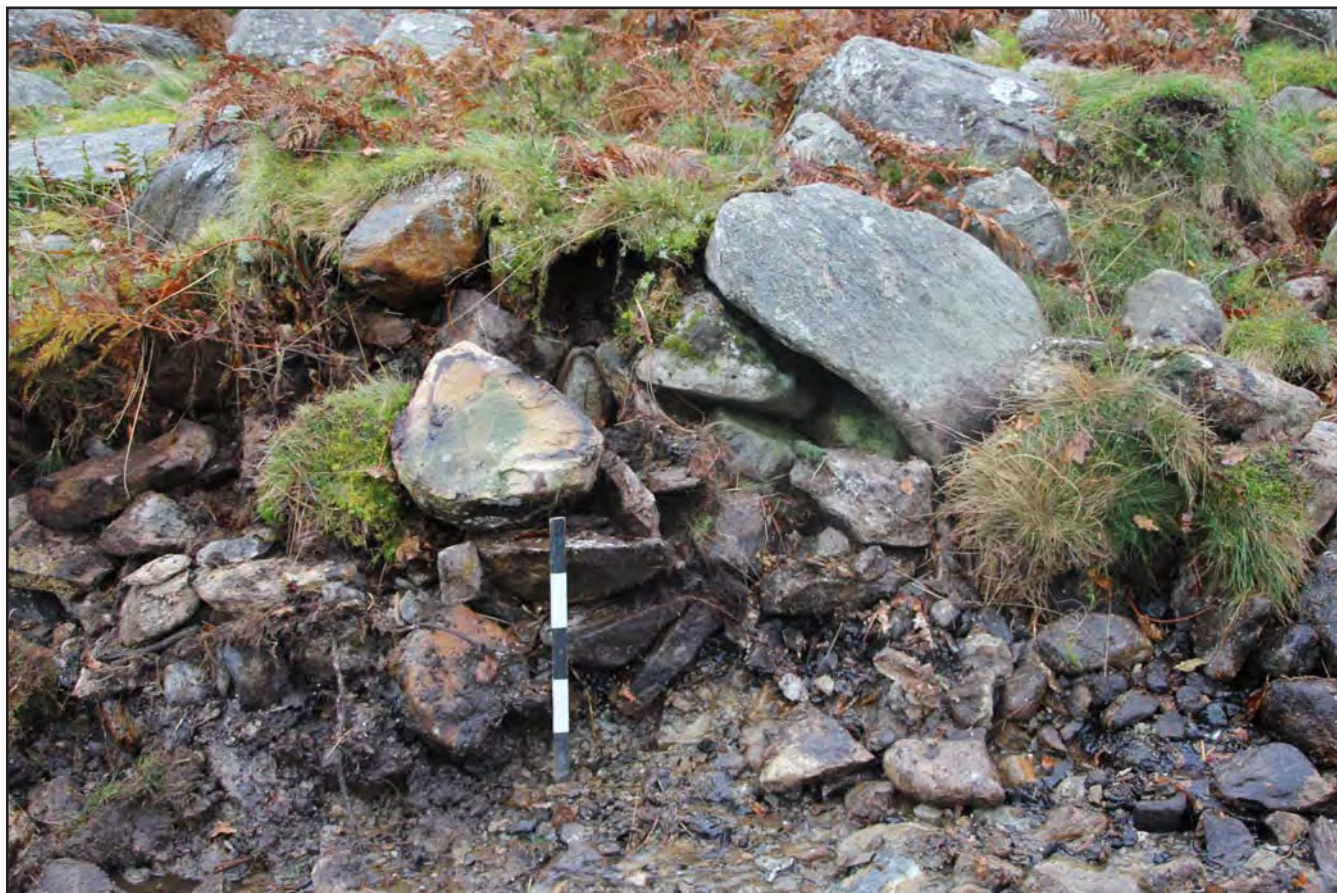
**Plate 04:** East facing section of location 14 (boulder field) trench, from the east. Scale 0.5m.

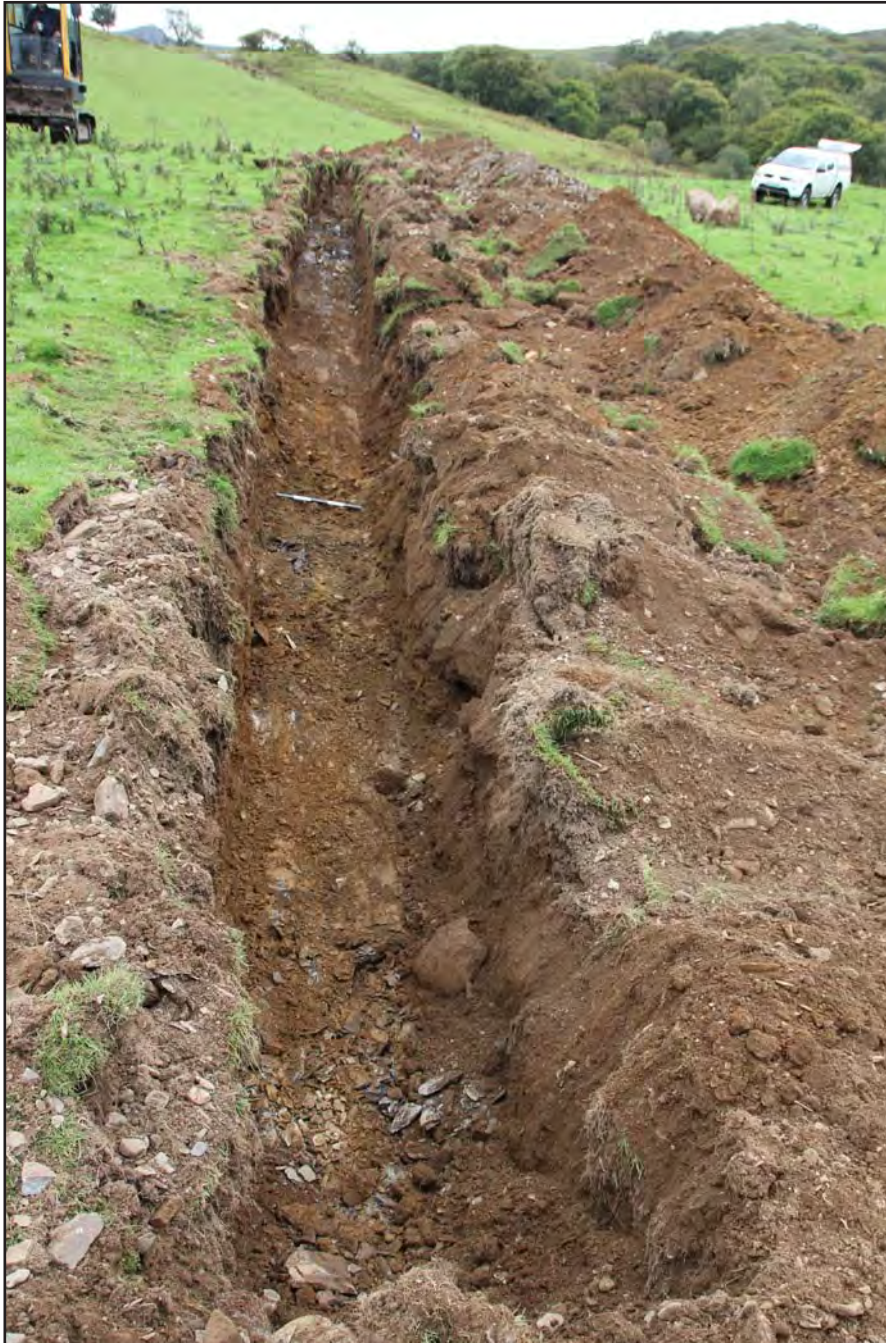
No archaeological deposits, structures or features were identified during the watching brief and no artefacts were recovered.

**Plate 05:** Location 18 (flat terrace) trench, from the northwest. Scale 0.5m.

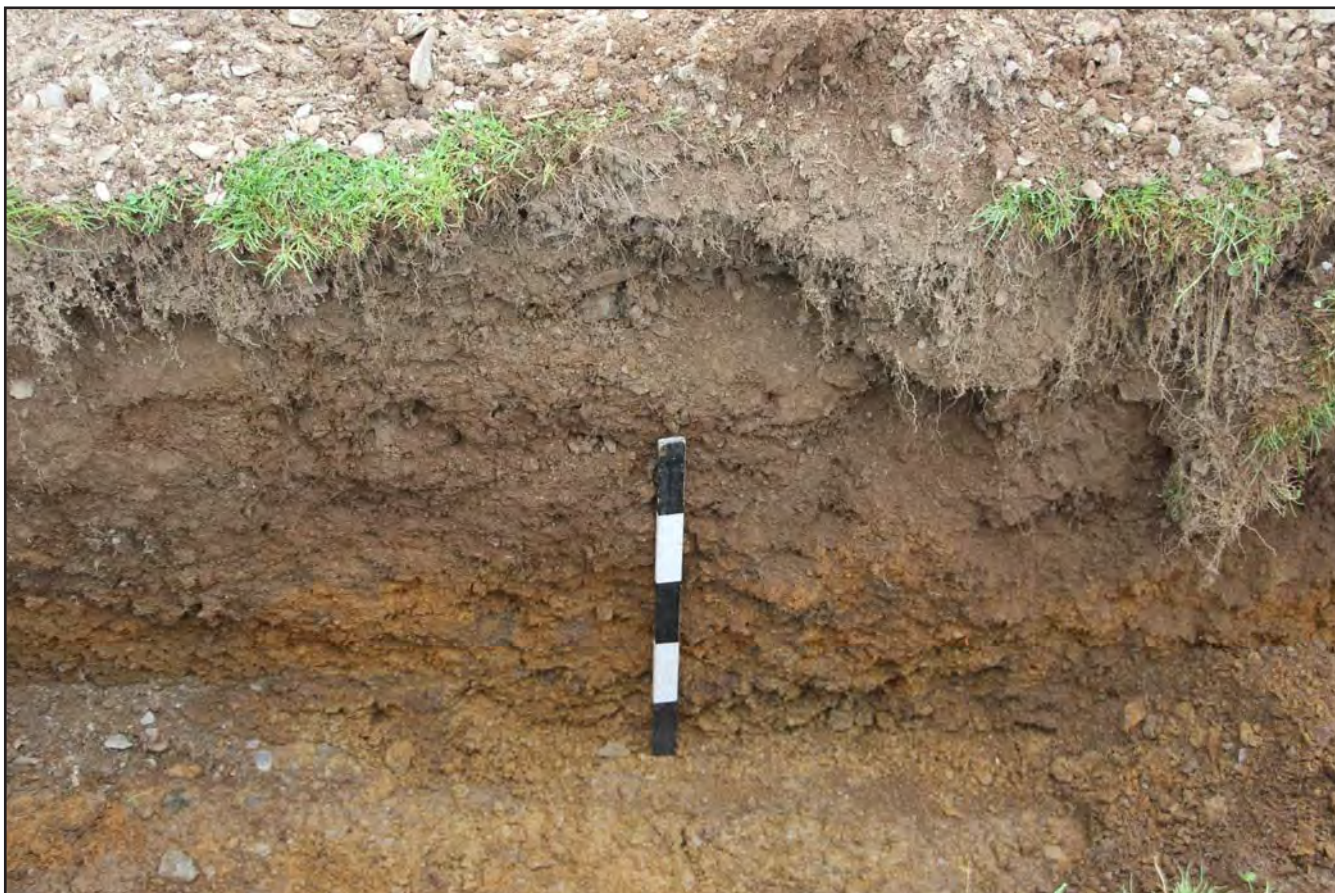
**Plate 06:** Northeast facing section of location 18 (flat terrace) trench, from the northeast. Scale 0.5m.

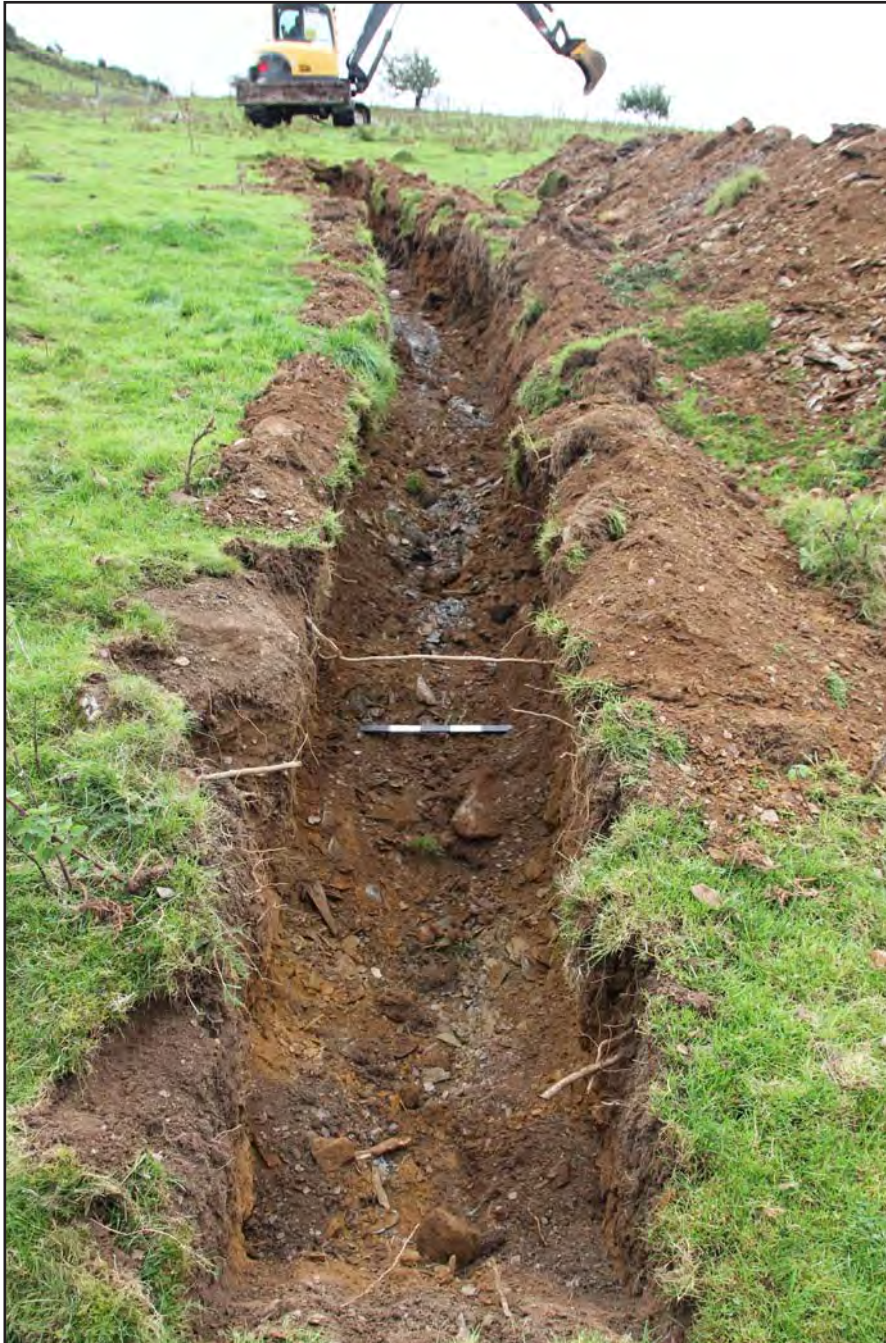
The trench was excavated to a depth of 0.7m through a 0.25m deep mid red-brown silt-clay topsoil and a >0.45m deep mid-orange silt-sand natural substrata with frequent shale inclusions.

No archaeological deposits, structures or features were identified during the watching brief and no artefacts were recovered.

**Plate 07:** Locations 19 and 20 (flat terraces) trench, from the northwest. Scale 0.5m.

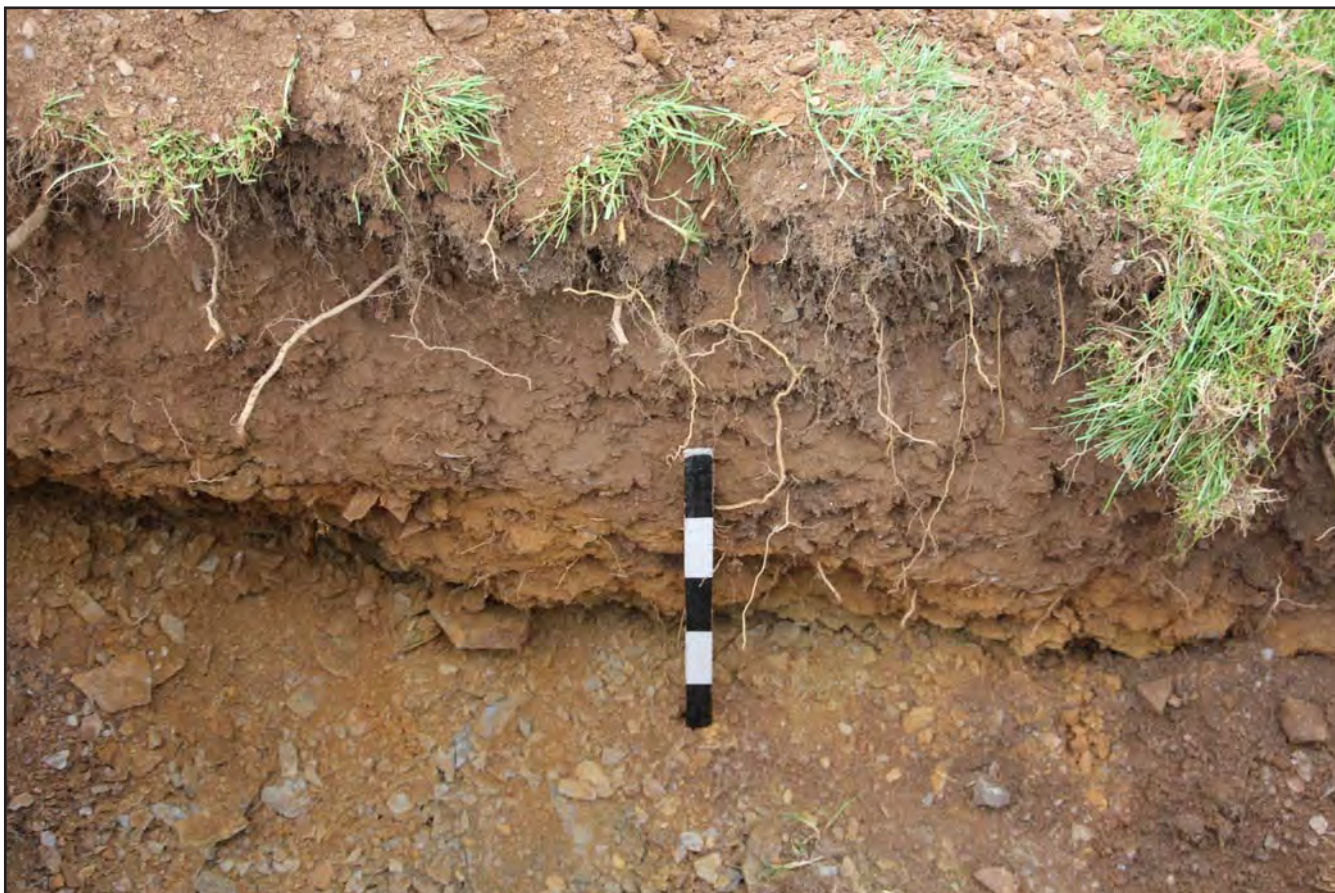
**Plate 08:** Northeast facing section of locations 19 and 20 (flat terraces) trench, from the northeast. Scale 0.5m.

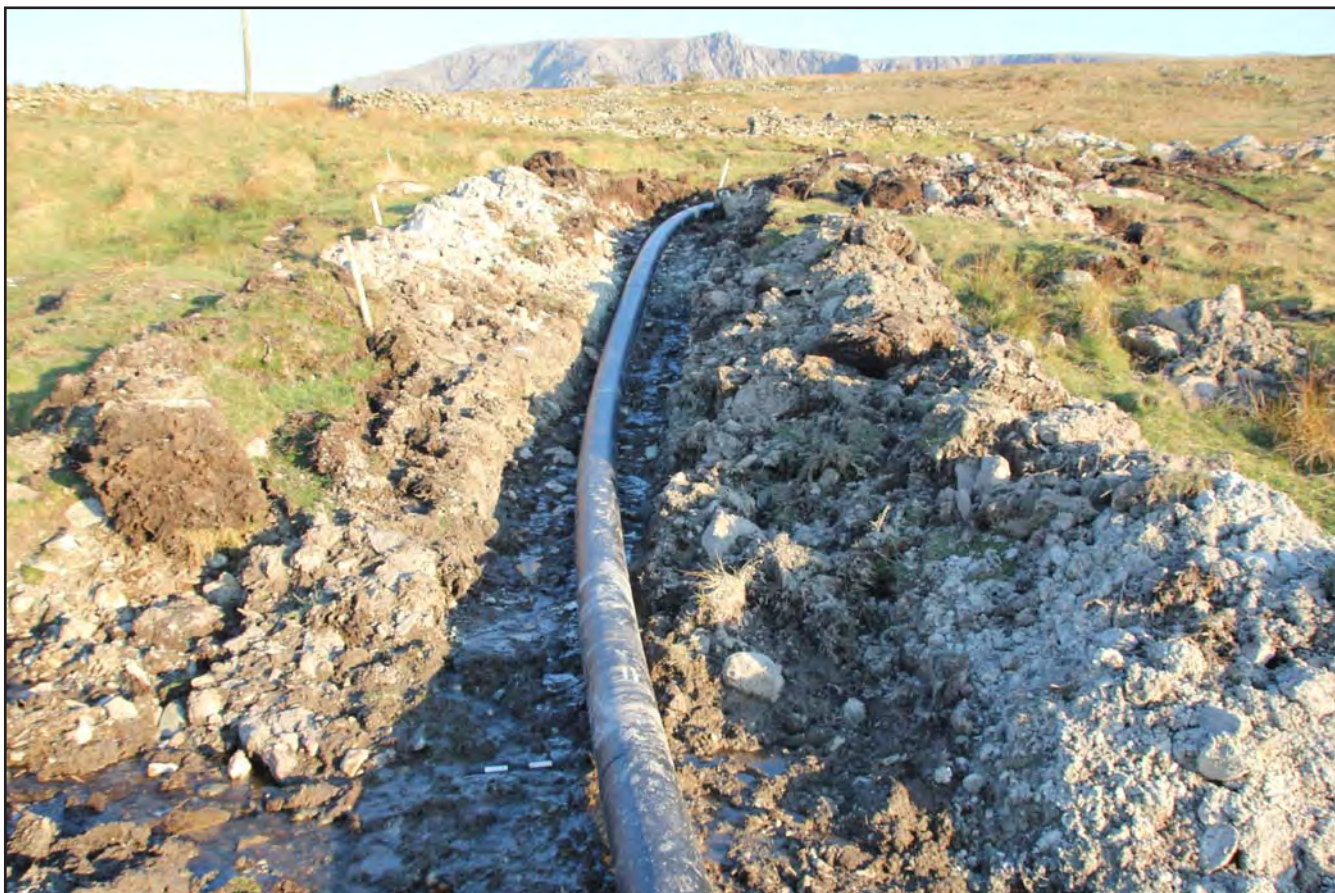
The trench was excavated to a depth of 0.7m through a 0.2m deep dark black-grey peatey silt-clay topsoil and a >0.5m deep mixed sub-angular large cobbles and light grey clay natural substrata.

No archaeological deposits, structures or features were identified during the watching brief and no artefacts were recovered.

**Plate 09:** Location 16 (stony spread) trench, from the northwest. Scale 0.5m.

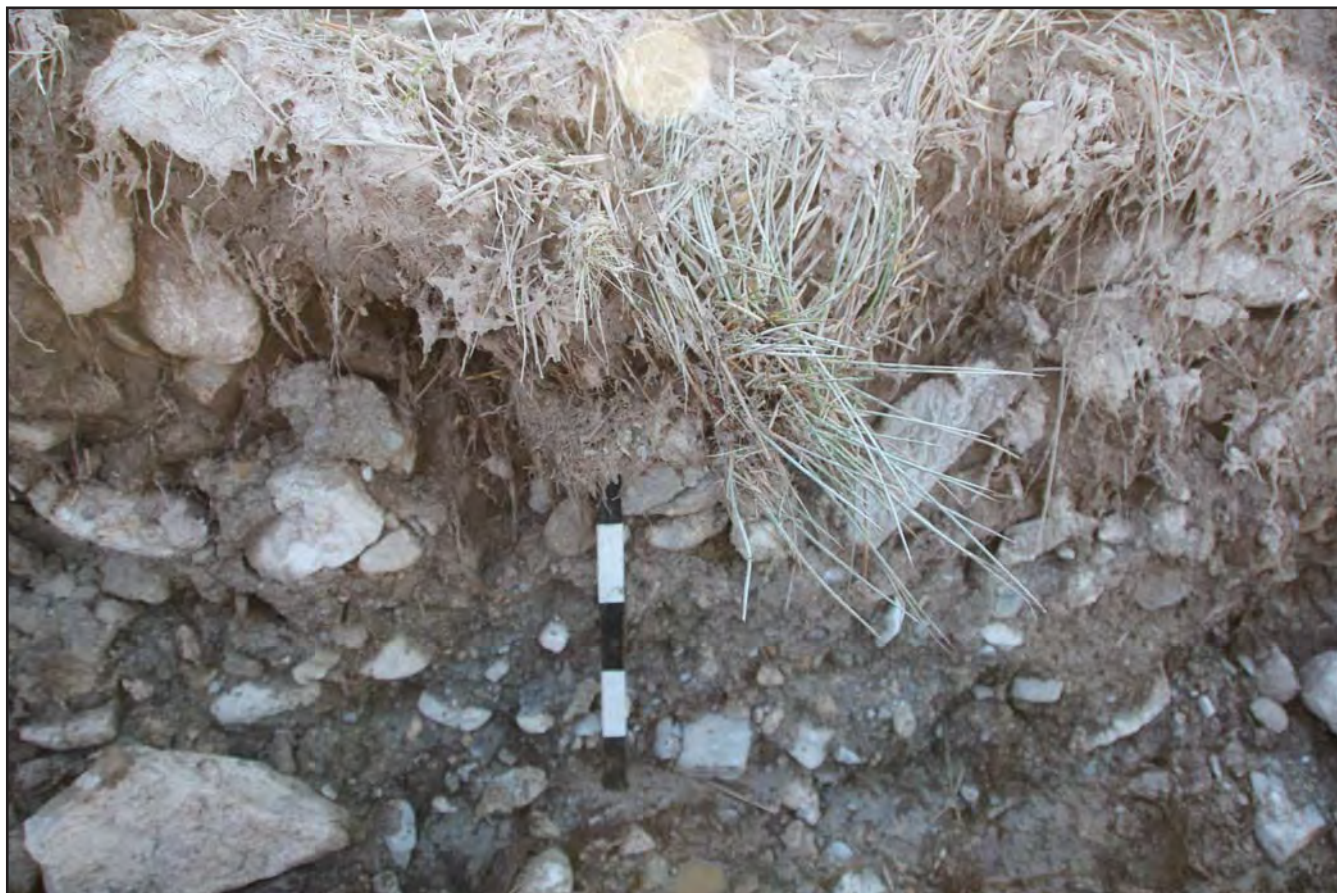
**Plate 10:** East facing section of location 16 (stony spread) trench, from the east. Scale 0.5m.
