**The Whitehouse Hotel, A499,
Abersoch, Gwynedd, LL53 7AF.
January 2016
V 1.0**

Level 2 Historic Building Record
Project Code: A0072.1
Report no. 0077

Level 2 Historic Building Record

Client: McLean Developments Ltd

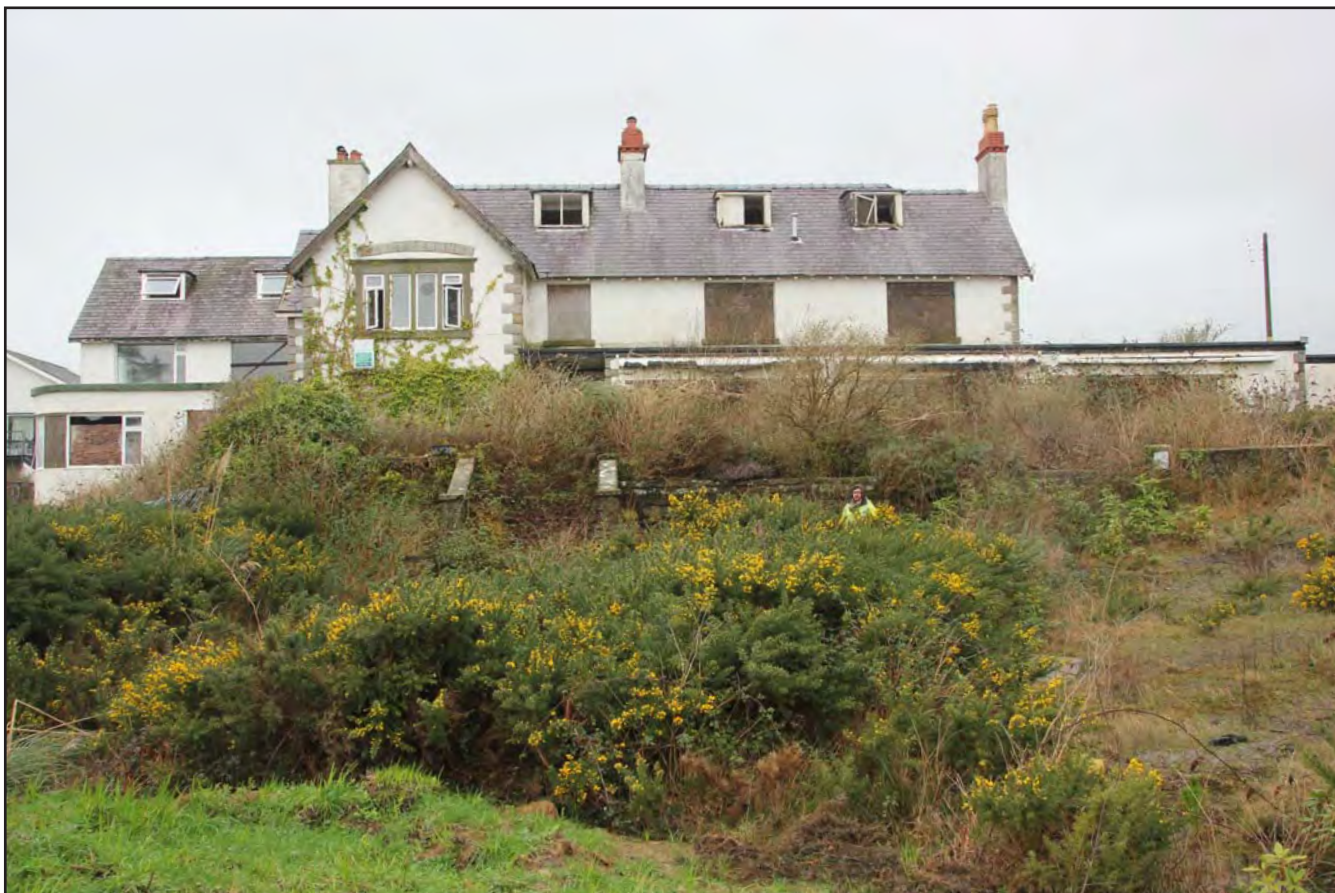
Plate 01: The Whitehouse Hotel southeast external elevation, from the southeast.

The principle elevation of the hotel faces southeast across what are now overgrown formal gardens, fronting on to the A499 main road. The principle northeast-southwest rectangular range has a double-pitched roof of grey slate with ridge tiles of the same. A rectangular chimney stack straddles the north-eastern gable with two yellow ceramic pots over a red-brick stack, the lower half of which has been rendered and painted white. A second identical chimney stack lies just to the left of centre, again straddling the roof pitch. A third stack, this time square with two red ceramic pots, straddles the south-western gable and is entirely rendered and painted white.

There are three flat-roofed dormer windows in the southeast roof pitch, the left of which is situated slightly further to the southwest, all of which have a two-pane casement window set within white-painted wooden frames, but now dilapidated and mostly missing the glass.

The south-east elevation is rendered and painted white with stone quoins on the corners. The slate roof sits above a rudimentary corbel table of white-painted wooden beams and there are three windows at first floor level all with sandstone sills, the centre and right of which are double and the left of which is single, all three are now boarded up. The ground floor is dominated by a later flat-roofed rectangular extension that projects from the principle range both to the northeast and the southeast. To the left end of the extension access into the hotel is permitted by a single arched doorway with concrete surround and dark-stained wooden board door.

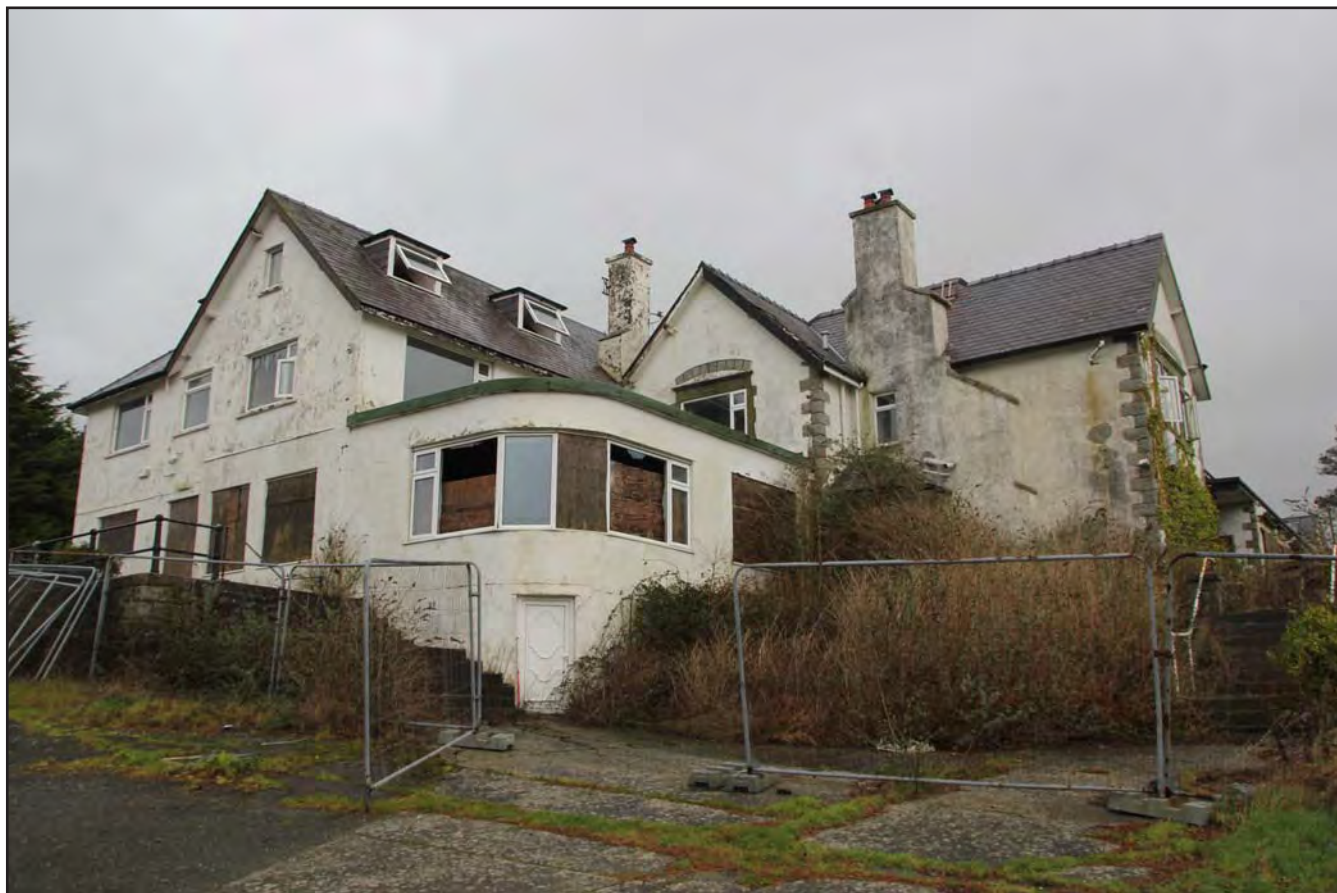
Plate 02: The Whitehouse Hotel southeast and southwest external elevations, from the south. Scale 1.0m.

At the south-western end of the property a second and smaller projecting gable is located at the left end. This has a double-pitched roof of grey slate and ridge tiles and the walls are rendered and painted white with stone quoins at the corners. The southwest facing elevation has a three pane double-glazed casement window with concrete mullions and surround at first floor level, beneath radiating stone voussoirs. This lies above a projecting flat roof extension at the right end of the southwest facing elevation, which is also rendered and painted white. The extension is dominated by a rounded corner on the southern axis with an eight pane modern double-glazed window in white PVC frames following the curve of the elevation. A second window, now boarded up lies at the right hand end. At ground floor level a single doorway of white PVC permits access into the Dining Room.

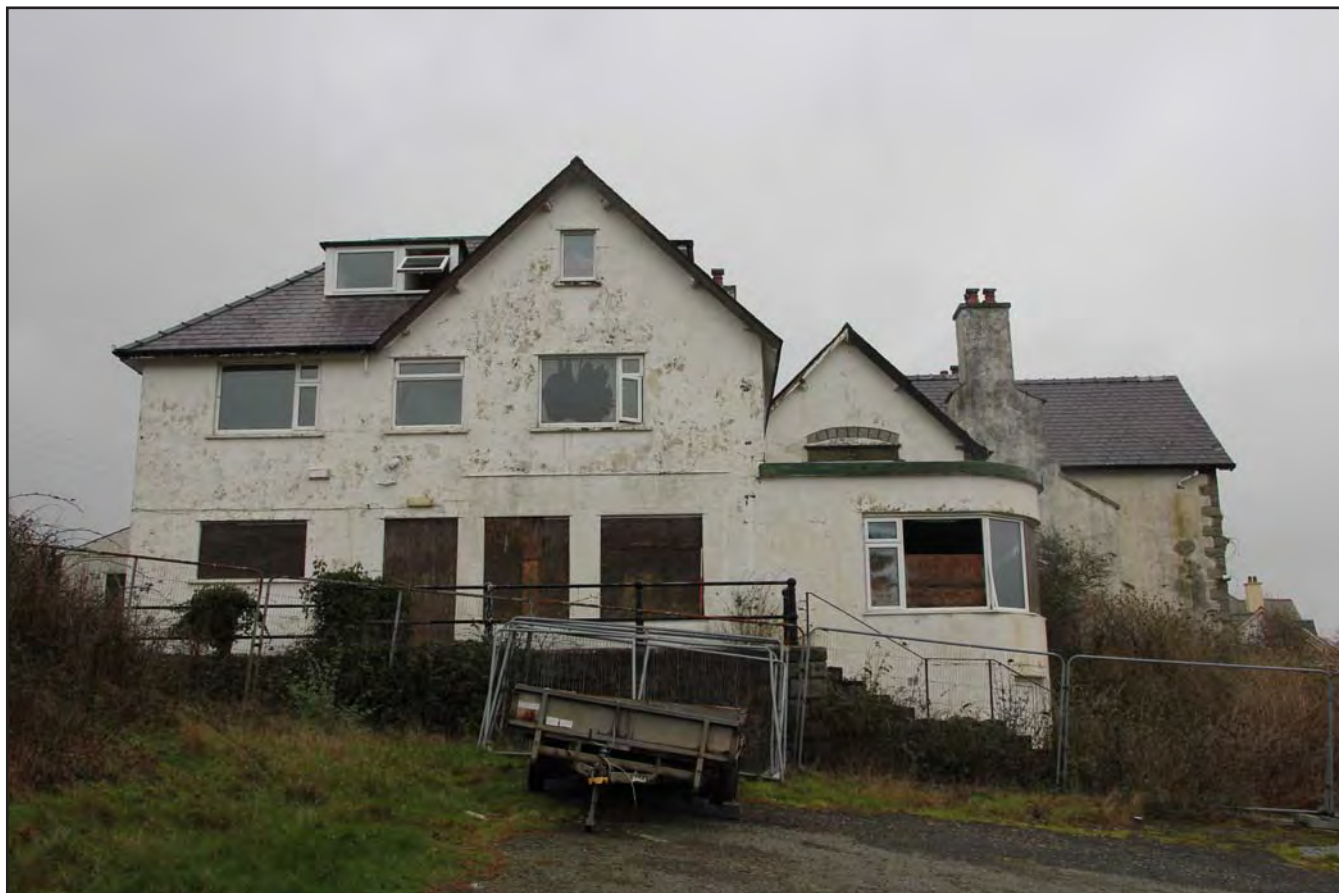
Plate 03: The Whitehouse Hotel southwest external elevation, from the southwest. Scale 1.0m.

The southwest facing gable has a single window in white PVC frame within the roof space at the right hand end and a flat-roofed dormer window in the southwest roof pitch at the left end, with a two-pane window in white PVC frame. At first floor level are three equally spaced windows, the centre of which is a two-pane casement window in white PVC frame, the left and right are of three-pane casement windows in white PVC frames. The ground floor has a doorway to the left of centre to the right of which are two windows, and to the left of which is a single window all now boarded up.

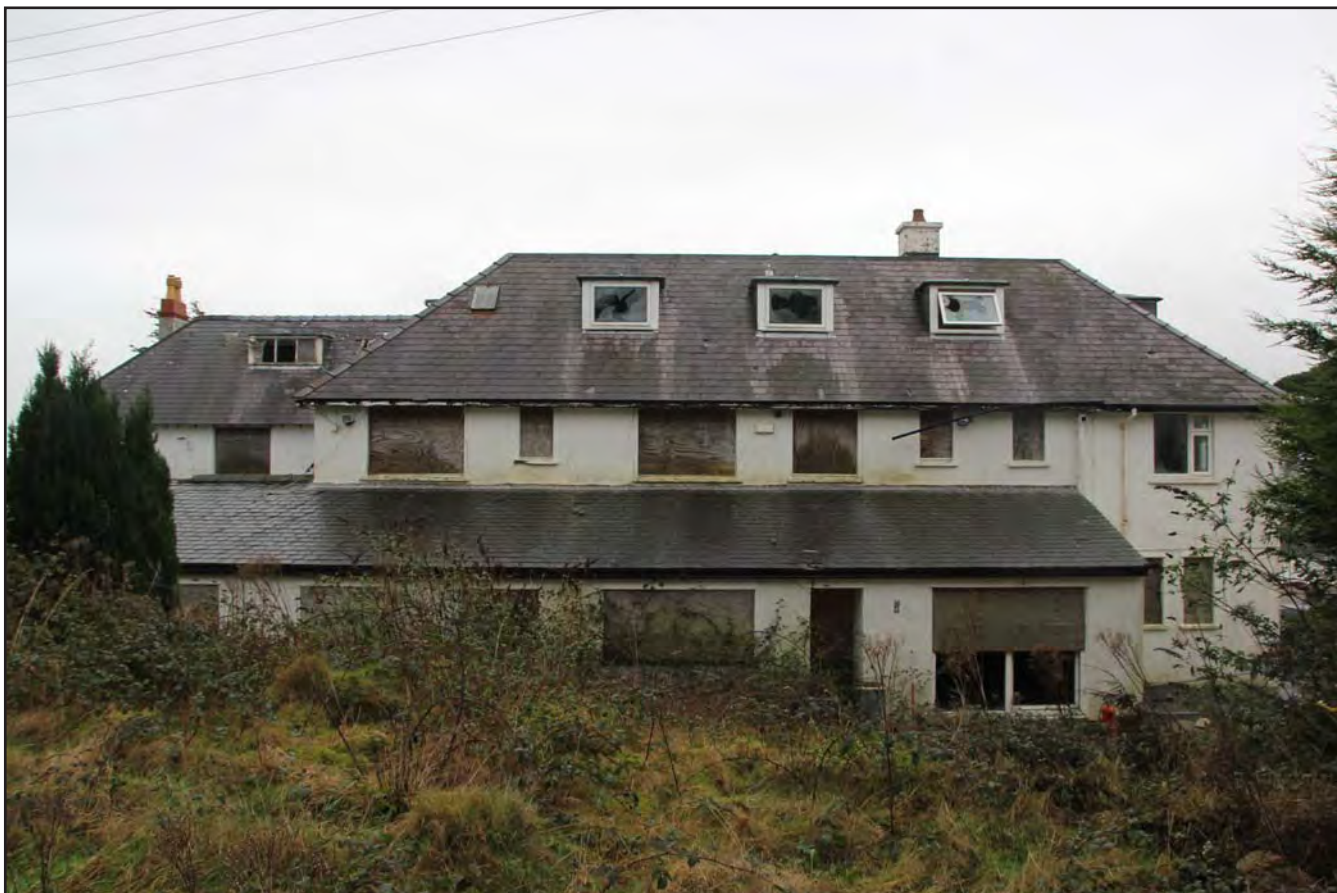
Plate 04: The Whitehouse Hotel northwest external elevation, from the northwest. Scale 1.0m.

The northwest facing elevation has a square chimney stack of white-painted red-brick with a single red ceramic pot, straddling the roof pitch to the right of centre. There are three equally spaced flat-roofed dormer windows in the northwest roof pitch, each with a single pane window in white PVC frames. The first floor level is dominated by windows with a double, a single, two doubles, two singles, and one double window from left to right, all of which are now boarded up aside from the right-hand most which is of a three-pane window in white PVC frames with white-painted concrete sill.

The ground floor has two single windows at the right hand end, now boarded up, but is otherwise dominated by a later extension that projects out from the northwest elevation at ground floor level. This extension has a monopitch roof of grey slate above modern patio doors in white PVC frames at the right end, now partially boarded but otherwise permitting access to the rear of the building. There is a further single doorway and four double windows to the left, all of which are now boarded up.

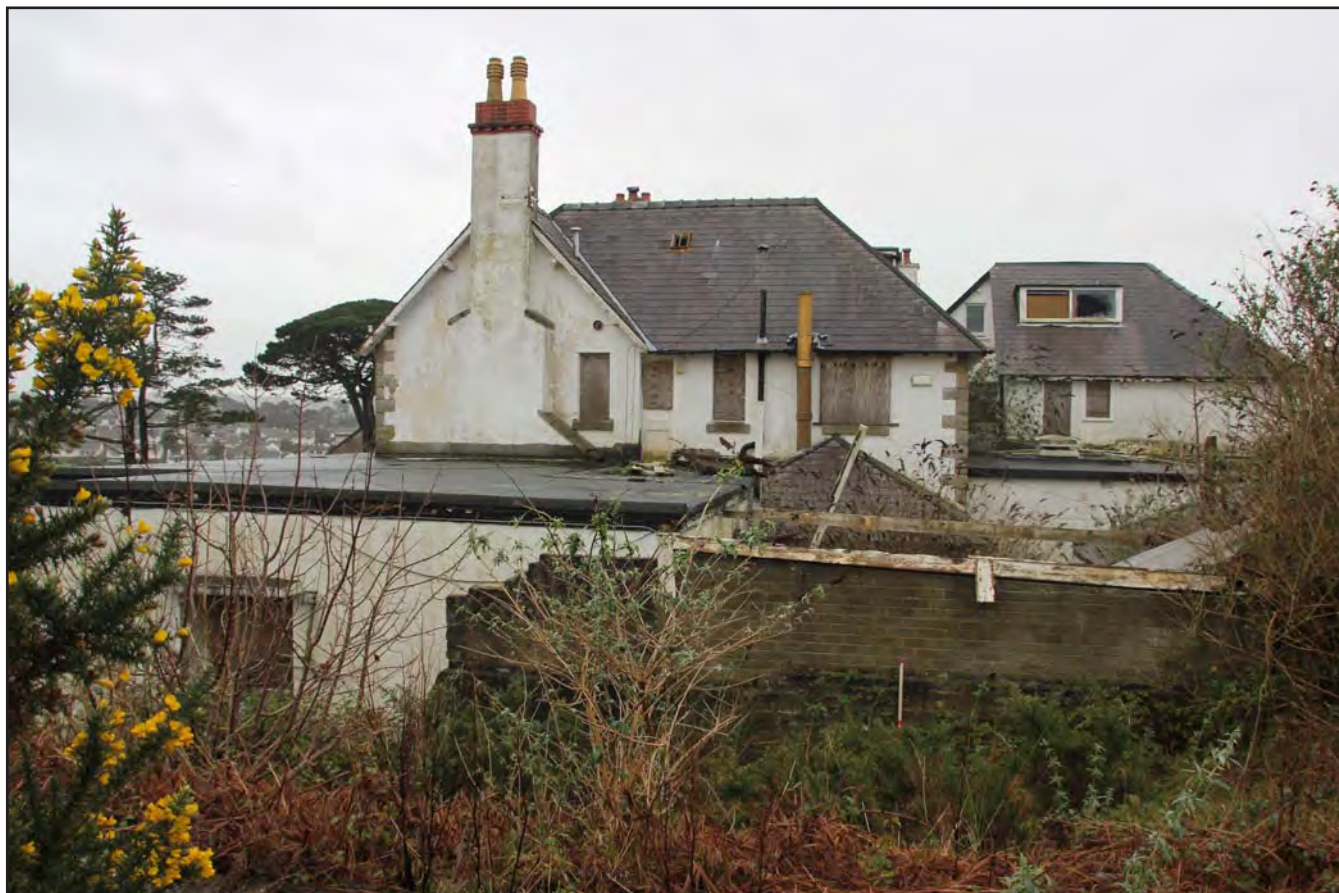
Plate 06: The Whitehouse Hotel northeast external elevation, from the northeast. Scale 1.0m.

The northeast elevation has a centralised double doorway, now boarded up, beneath an overhanging flat roofed porch. The northeast elevation is otherwise featureless.

The northeast facing elevation has a single fixed roof-light window to the right of centre. At first floor level there is a double window at the right end and two single windows at the left, all now boarded up.

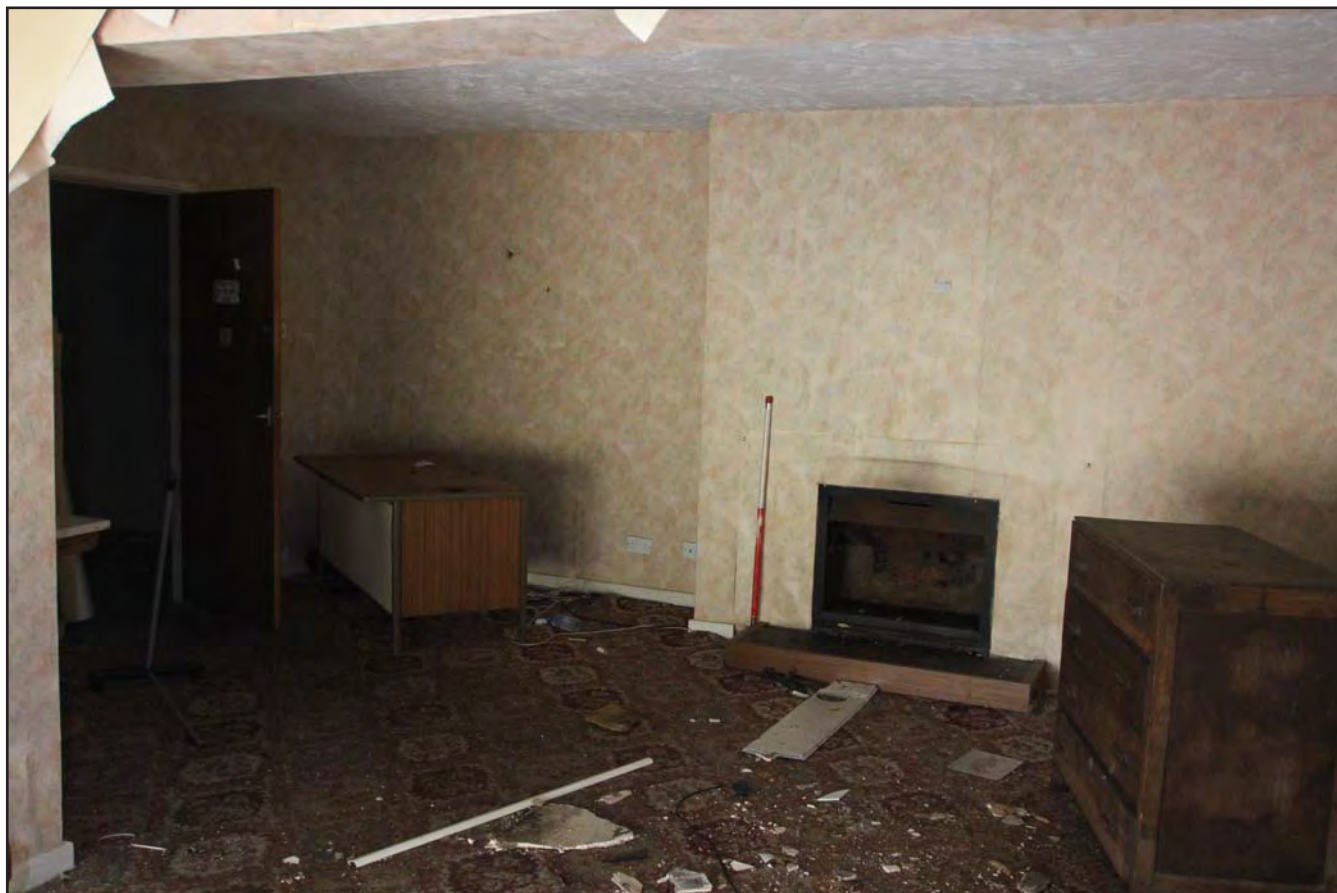
Plate 08: The Whitehouse Hotel ground floor private Living Room, from the west. Scale 1.0m.

An L-shaped room measuring 5.0m in length by 4.5m in width orientated southeast to northwest. The ceiling is of white-painted artex and the walls are papered yellow. The south-eastern elevation has the remains of a centralised square cast-iron fireplace with ceramic hearth. The south-western wall is featureless aside from a two pane casement window in white painted wooden frames to the right end.

The north-western wall is dominated by modern double-glazed patio doors in white PVC frame and there is a modern chipboard door located at the right end in the northeast elevation permitting access to the Private Kitchen. The carpet of a red floral pattern.

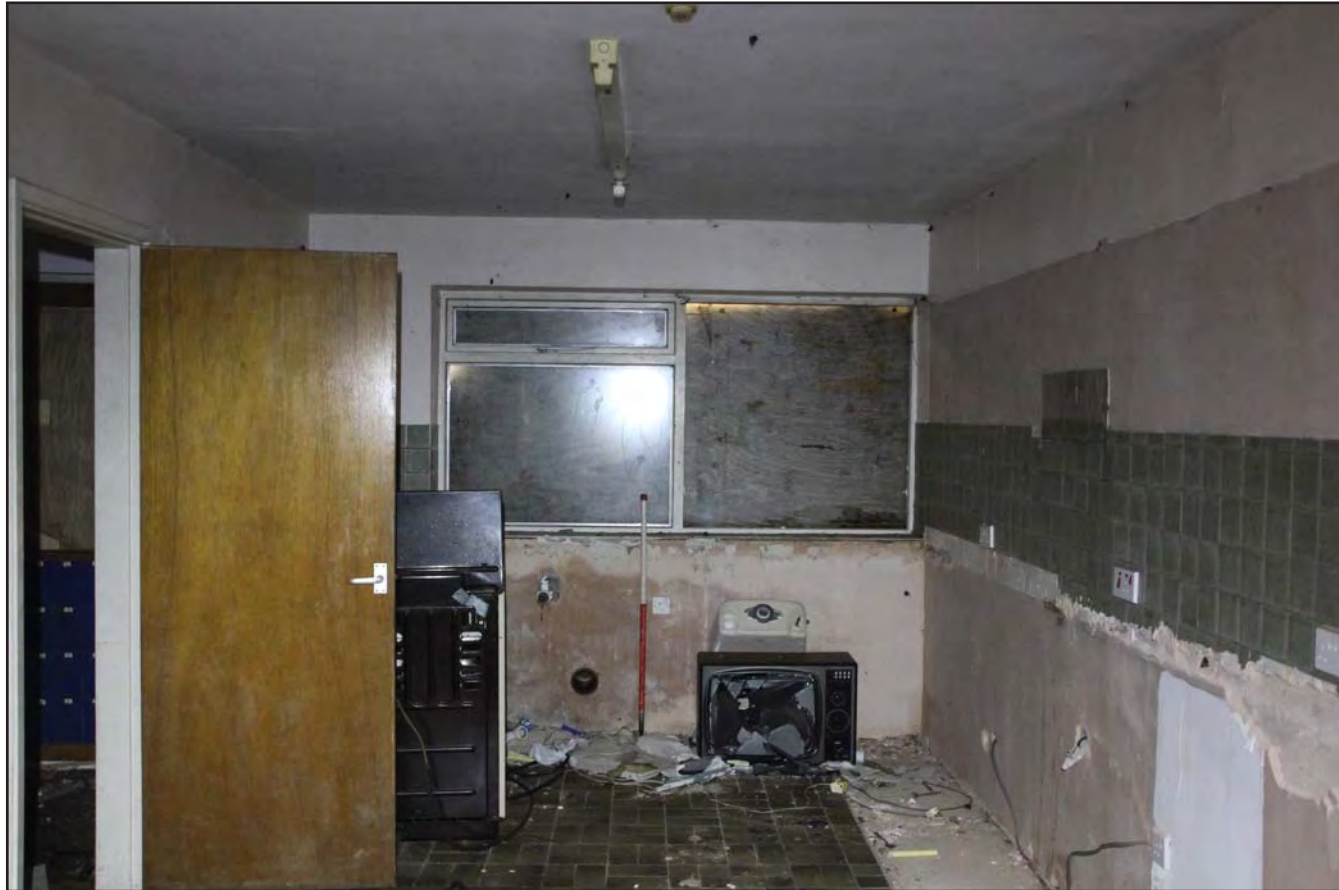
Plate 09: The Whitehouse Hotel ground floor private Kitchen, from the southeast. Scale 1.0m.

A rectangular room measuring 6.0m in length by 2.5m in width orientated northwest to southeast. The ceiling is plastered and painted white with the remains of two strip lights at the northwest and southeast ends. The walls are also plastered and painted white. The north-western elevation has a centralised three-pane casement window in white-painted wooden frames and there are the remains of grey ceramic tiles situated midway on the northwest and northeast elevations. The northeast elevation is otherwise featureless aside from a modern fire door at the right hand end, with white-painted frame.

The south-eastern elevation is featureless. The south-western elevation has two chipboard doors, the left leads into the private Living Room and the right leads into hallway 1. The floor is of grey-brown ceramic tiles.

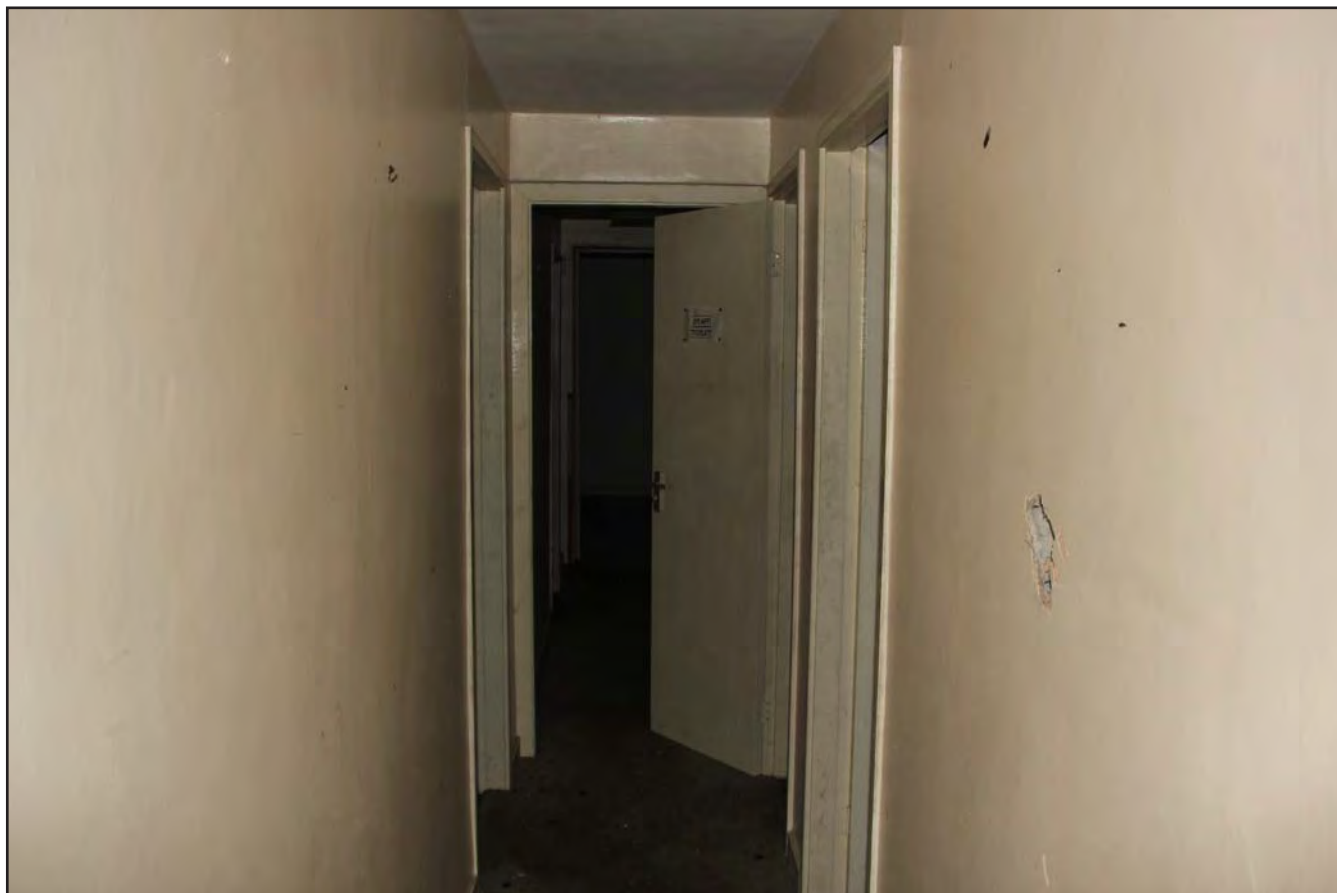
Plate 10: The Whitehouse Hotel ground floor private Hallway 1, from the southwest. Scale 1.0m.

A rectangular room measuring 7.0m in length by 1.0m in width orientated northeast to southwest. The ceiling and walls are all plastered and painted white and there is a single pendulum light at the southwest and northeast ends. The floor is of grey-brown ceramic tiles.

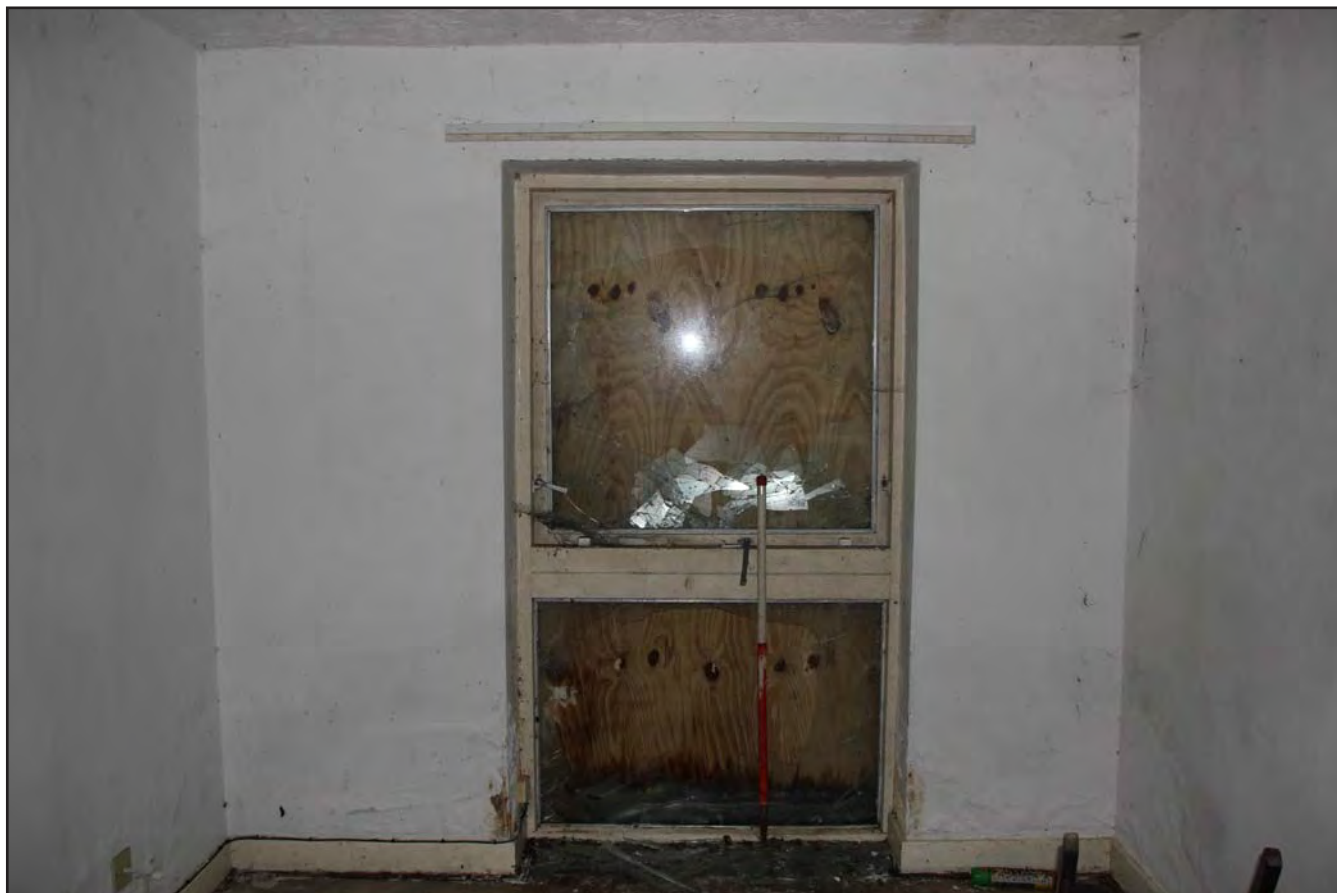
Plate 11: The Whitehouse Hotel ground floor private Bedroom 1, from the southeast. Scale 1.0m.

A rectangular room measuring 3.5m in length by 2.0m in width orientated northwest to southeast. The ceiling of white-painted artex and the walls are plastered and painted white.

The southwest elevation is featureless aside from a wall-mounted brass light fitting with tasselled shade at the left end. The northwest elevation has a centralised two-pane double-glazed window in white PVC frames. The northeast elevation is featureless aside from a wall-mounted brass light fitting with tasselled shade at the right end. The southeast elevation has a single white-painted woodchip door at the right end which permits access to hallway 2. The floor is of poured concrete.

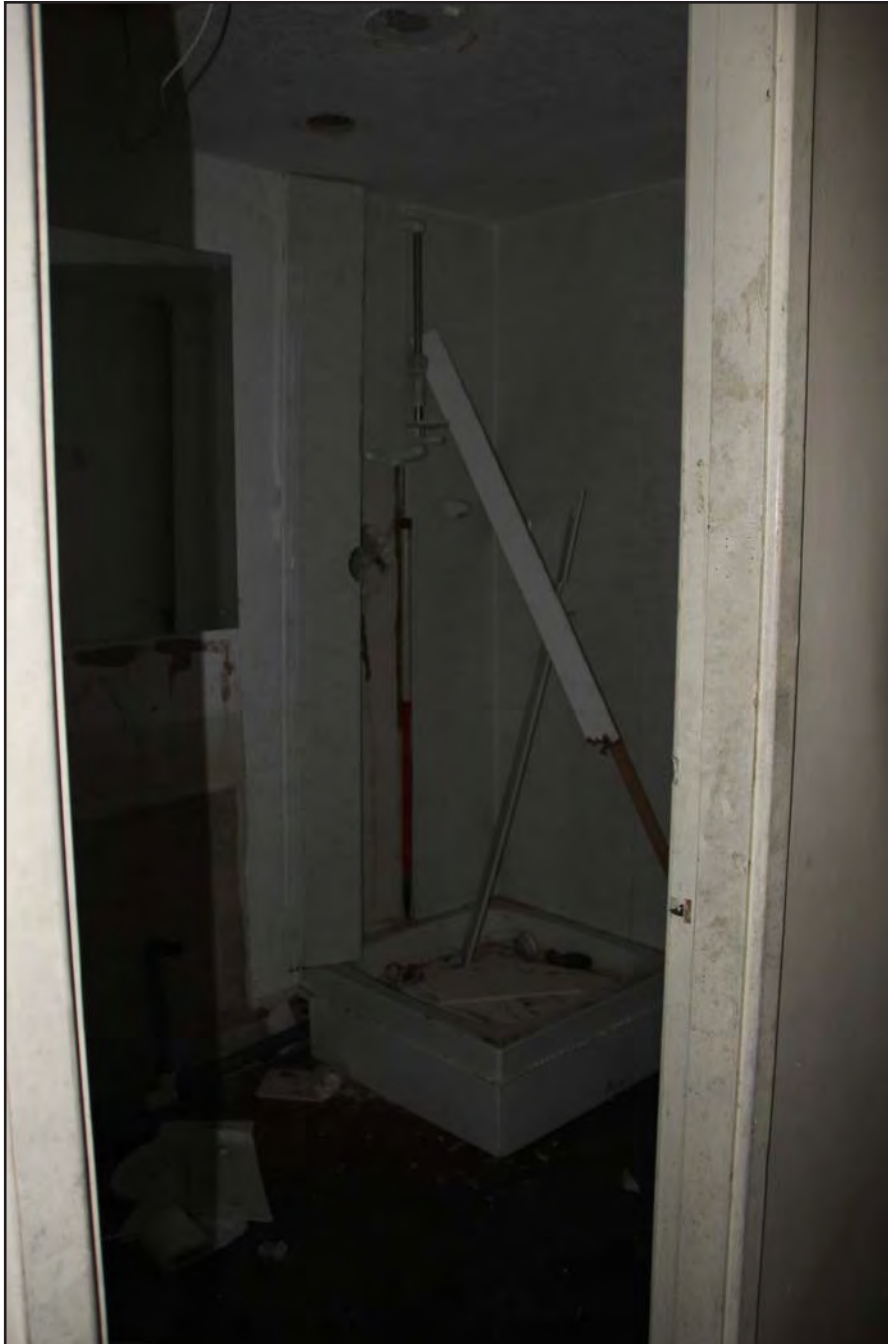
Plate 12: The Whitehouse Hotel ground floor private Bathroom 1, from the north. Scale 1.0m.

A rectangular room measuring 2.0m in length by 1.5m in width and orientated northeast to southwest. The ceiling and walls are all papered white. The southeast elevation has a centralised rectangular mirror and the remains of a single shower cubicle at the right end with white plastic base. A single ceramic white toilet is located at the left end. The northwest elevation has five brass mounted coat hooks at the left end and at the right end is a single doorway with white painted wooden frame permitting access to hallway 2. The floor is of poured concrete.

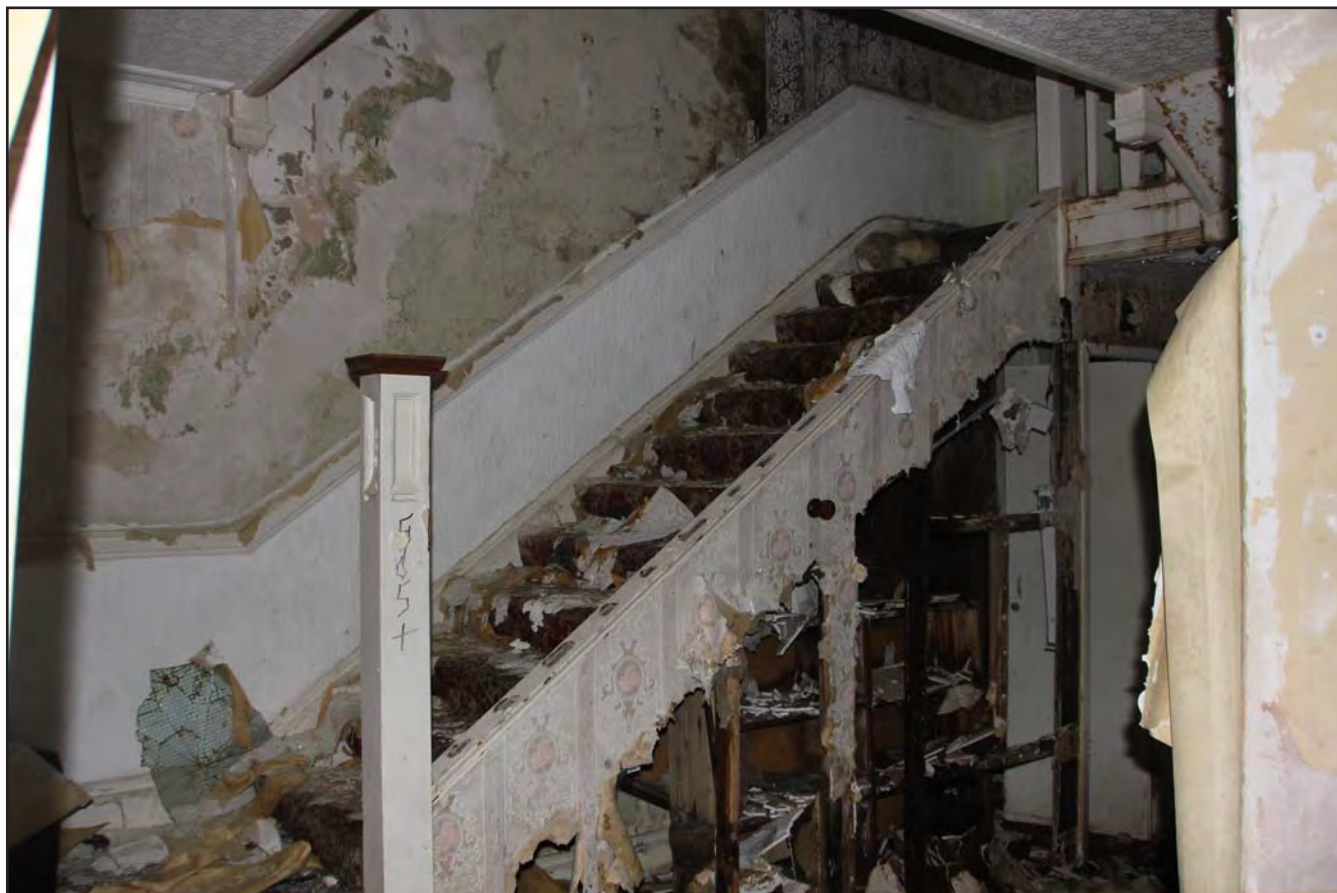
Plate 31: The Whitehouse Hotel ground floor Stairwell showing water damage, from the east.

The ground floor stairwell, cloaks/toilets, and office had been severely damaged by water making the floor boards unsafe and the rooms inaccessible. The water damage also prevented access to the first and third floors meaning the upper part of the hotel could not be recorded.

Unfortunately the hotel bedrooms on the second and third floors could not be accessed due to unsafe conditions caused by years of water ingress into the structure.

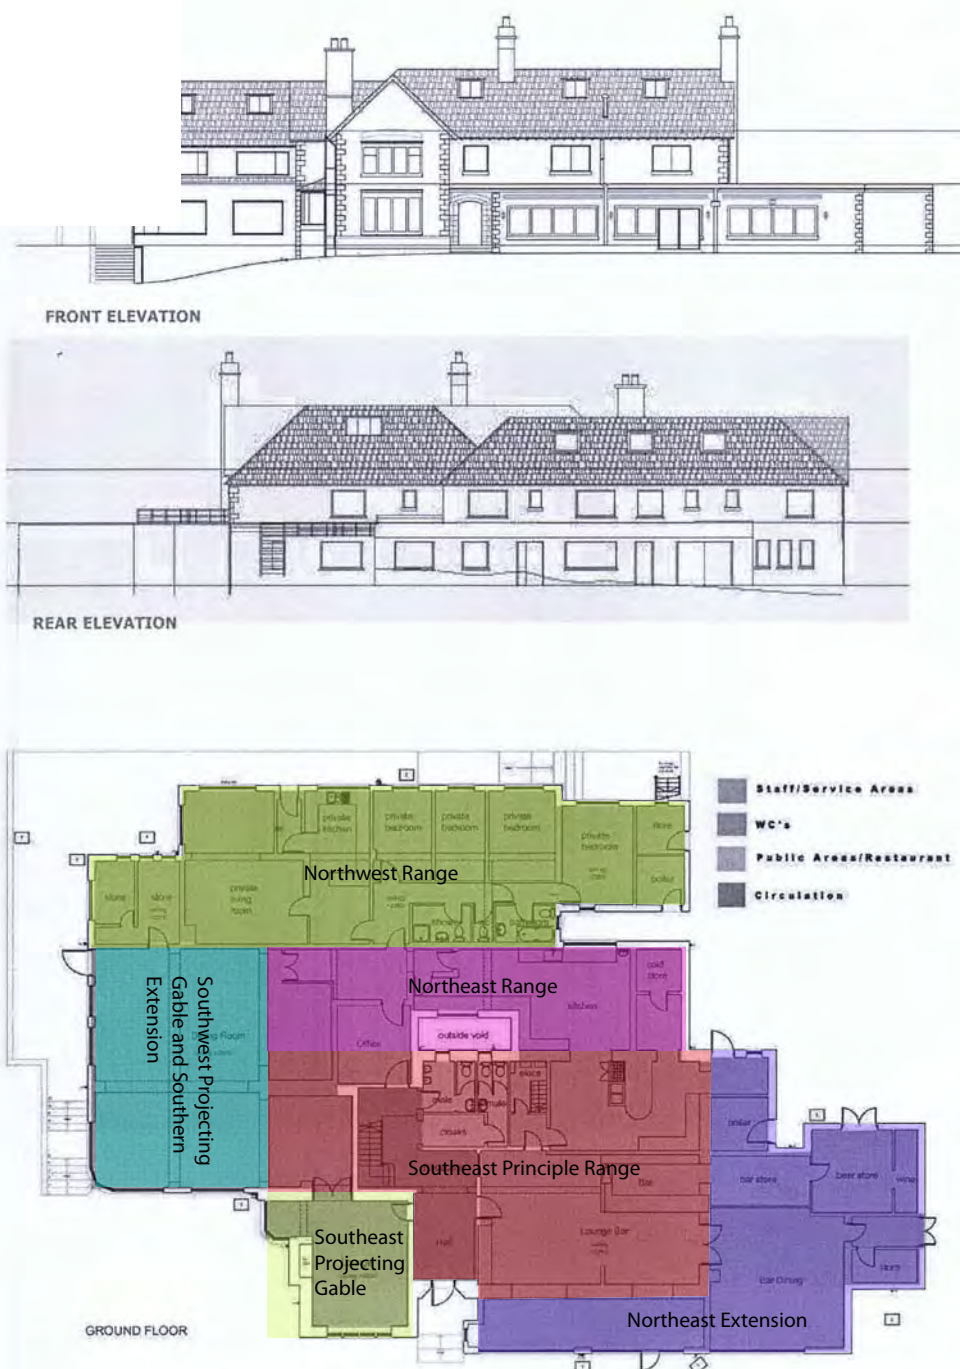
Figure 08: Development and Phasing at The Whitehouse Hotel, Abersoch.

The Whitehouse Hotel is located at NGR SH 31330 28579 north of Abersoch village centre, on the western side of the A499 main road along the southern coast of the Llŷn peninsula. The principle range is a two and a half storey rectangular structure orientated northeast to southwest but has seen numerous extensions and alterations, which are described below and depicted on figure 8.

It appears that the building remained relatively unaltered until about the mid 20th Century, when it was extended and developed to include the northeast extension, the southeast projecting gable, the southwest projecting gable and southern extension, the northeast range, and the northwest range into what is recognisable now as The Whitehouse Hotel. The building possessed clear zones or areas within its layout given over to the private dwellings and living spaces of the owners at the rear of the property; the catering facilities towards the centre; and the entertainment and dining facilities at the front of the building.
