**HISTORIC BUILDING ASSESSMENT:
BRASS SHOP
FR BOSTON LODGE WORKS
MINFFORDD
GWYNEDD**

NGR: SH 58486 37893

*on behalf of Ffestiniog & Welsh Highland Railways Heritage Ltd
and the Festiniog Railway Company*

December 2013

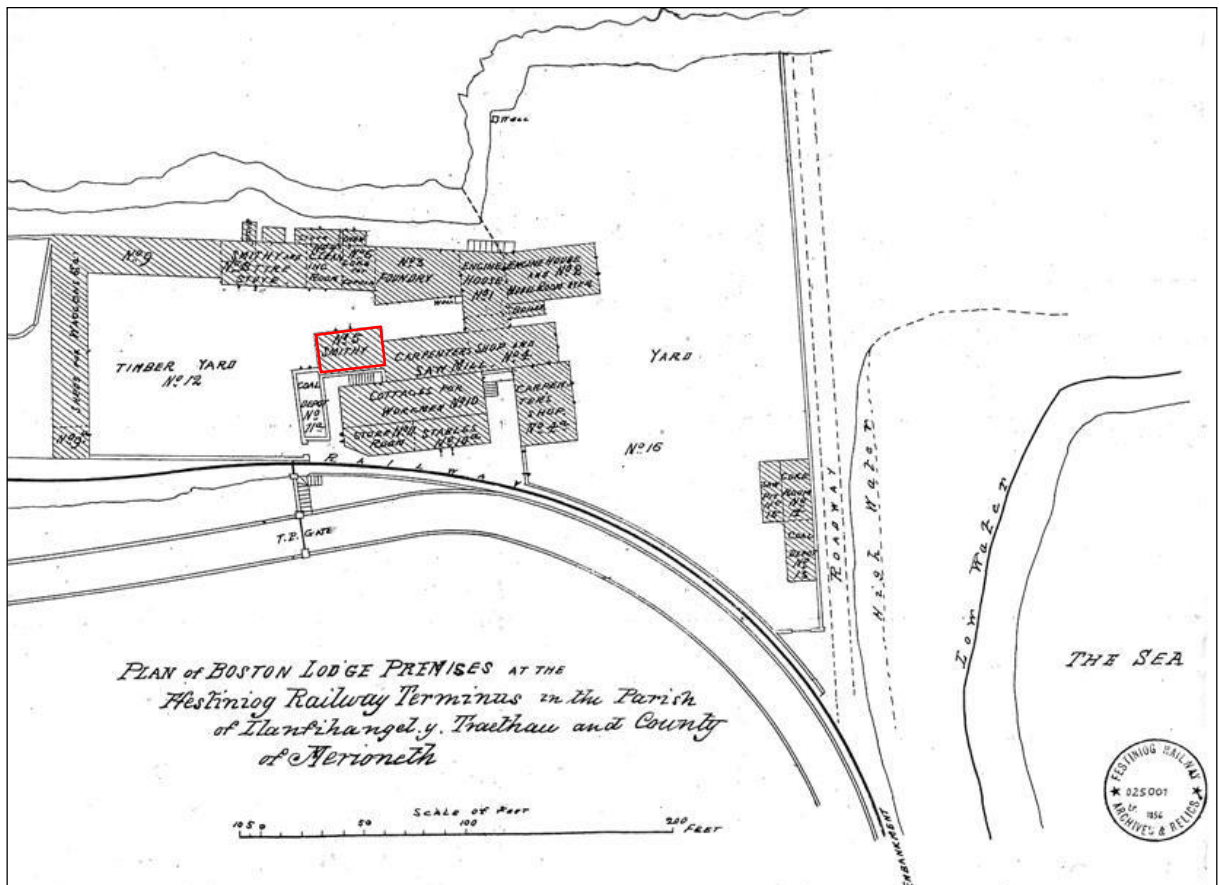
- 3.2 The Top Yard was levelled c.1836 (Lewis 1965, 32). The Brass Shop was probably constructed in 1837 or 1838 (JLA notes). Boyd (1975, 264) notes that the yard 'was completely built up as at present' in 1848. The earliest indication of the building's function appears on an insurance plan of Boston Lodge (FR Archives XD97/20010), drawn up in 1856, which labels it 'Smithy' (Fig. 3).

Figure 3: Boston Lodge insurance plan, 1856 (FR Archives XD97/20010)

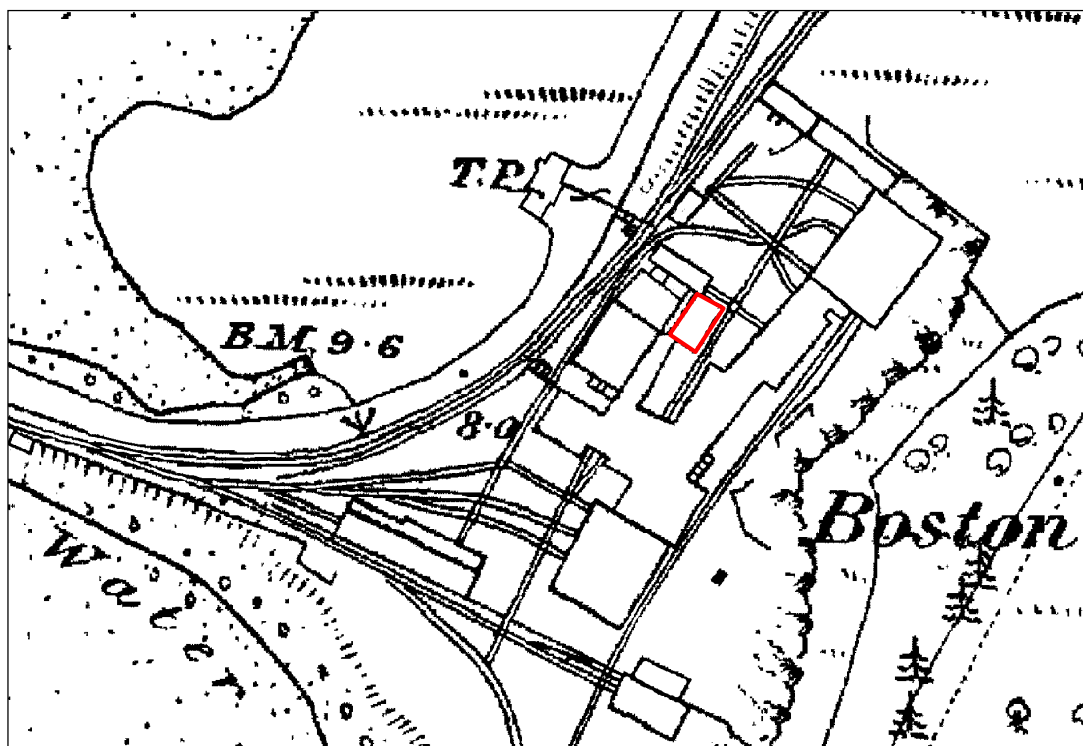
- 3.4 Subsequent plans of Boston Lodge provide little evidence of development or change to the Brass Shop. The 1889 Ordnance Survey 25" sheet (Fig. 5) shows the Works more or less at the full extent of its development during the 19th century. This layout survived, more or less unchanged, until the 1950s.

Figure 5: Boston Lodge in 1889: extract from Ordnance Survey First Edition 25" sheet
(*not to scale*)

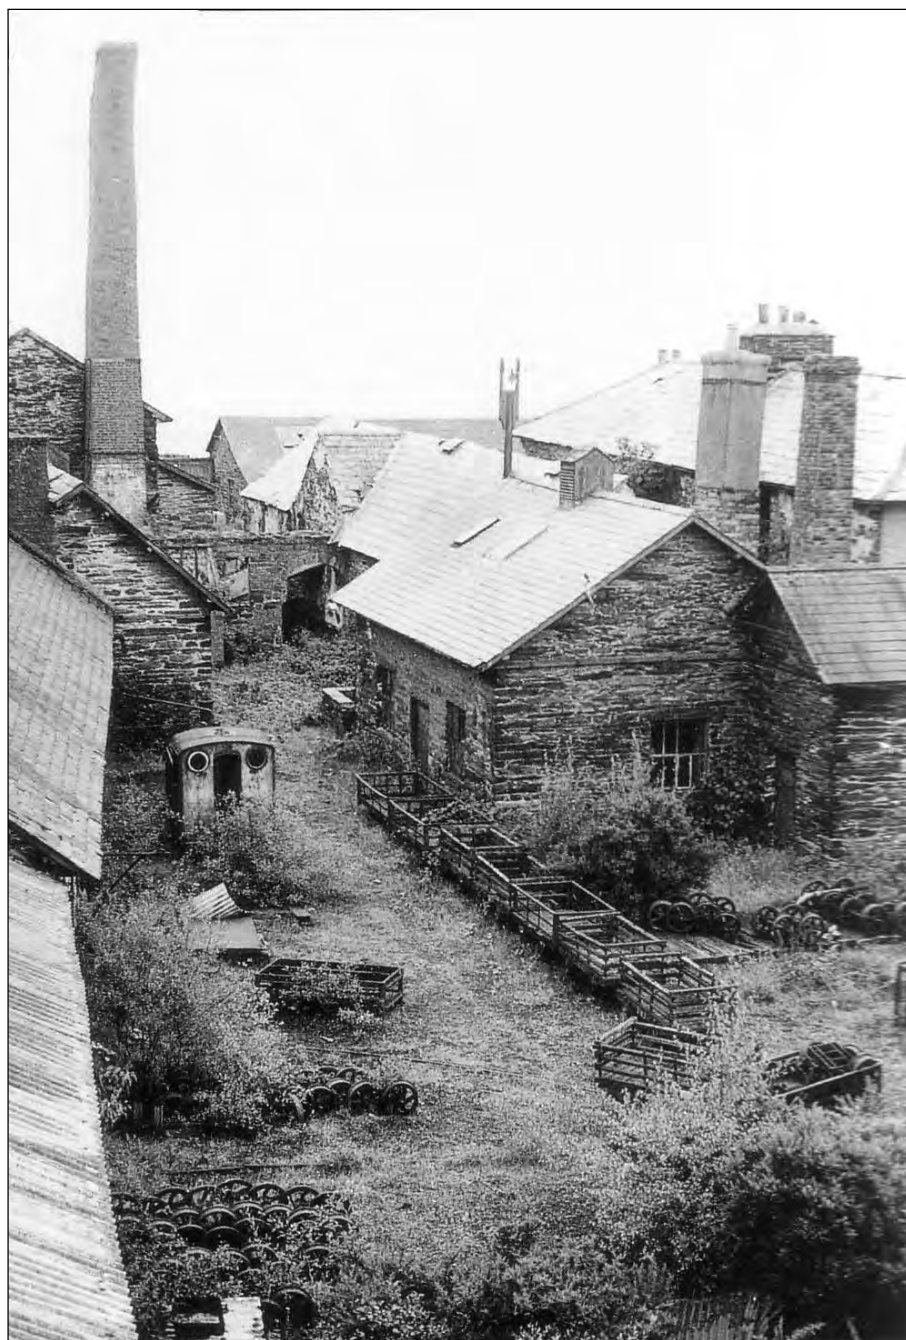
- 3.5 Two recorded features of the Brass Shop which no longer survive are the two square-section chimneys rising above the north wall of the building, shown on photographs of the site until the late 1950s / early 1960s (Fig. 6). One chimney rises from the north-east corner of the building, behind the Oil Store, and is wholly constructed in brick. The second chimney is roughly in the centre of the north wall: its lower part was built in stone, while the upper part (which leans towards No. 2 Cottage in the photograph) is shown rendered, and could be of brick construction like the first chimney. Also shown on the centre of the roof is a large 'pigeon box' ventilator: this too no longer survives. One other feature of the building worth noting on Fig. 6 is the east-facing window, which was blocked when the Telephone Exchange was constructed in the angle between the Brass Shop and Oil Store in 1970.

Figure 6: Brass Shop from the east, 1952 (*J.B. Snell*)

board, on which the rafters are carried. The slates are nailed direct to battens, without felt or boarding. There are two skylights of different sizes in the south-east face of the roof: both are shown in Fig. 6.

Neither subsequent plans of Boston Lodge nor the historic record provide much evidence of further development or change to the Brass Shop prior to 1954. From Fig. 6 the building appears to have survived in a reasonable condition into the preservation era. However, it was subject to major repairs in 1962. From the available structural evidence it is likely that these repairs were necessary because of movement in the rear wall and probably also the chimney, and that at this time the chimney was taken down, brick piers were added to the rear wall and the 'pigeon box' ventilator on the roof was removed. The structure of old rails supporting the inserted upper floor could date from this time, or later. In 1970 the east-facing window was blocked when the Telephone Exchange was built, and the doorway to the west was blocked by the time the present amenity block was constructed in 1977. The Brass Shop is now used as a store for locomotive parts.

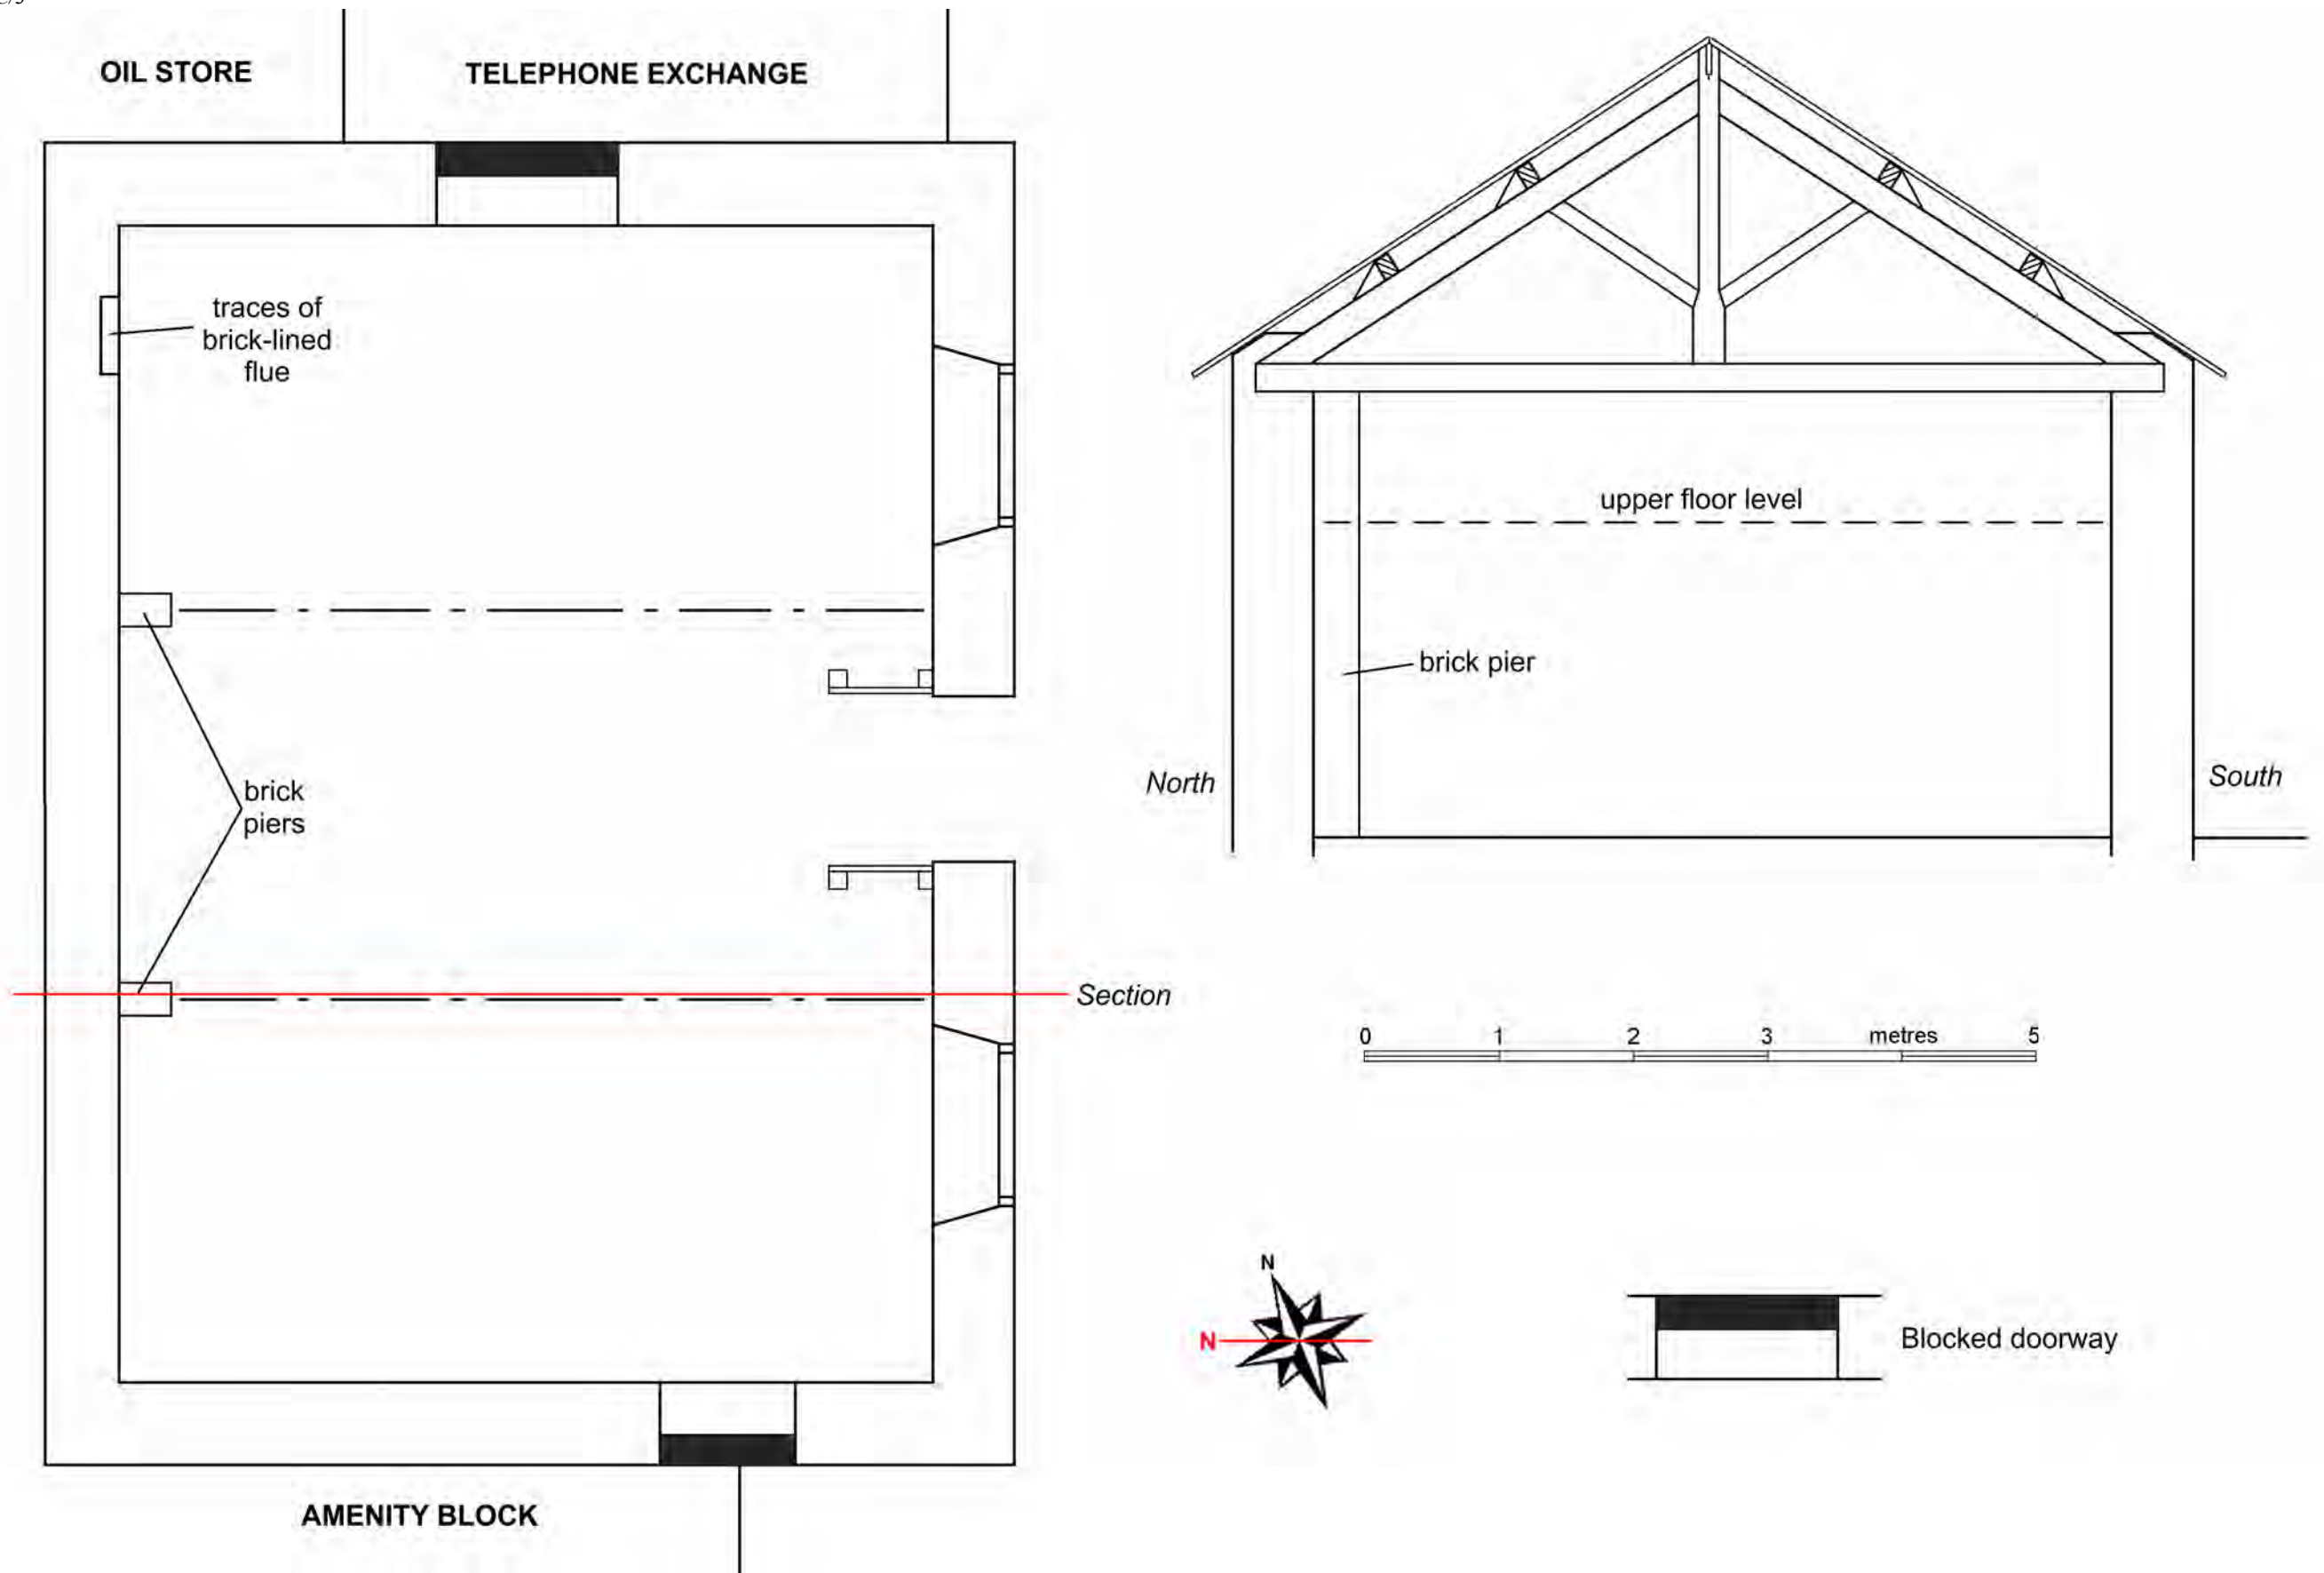
Figure 7: Brass Shop, plan and section (scale 1:50)

The Brass Shop is a rectangular structure of three bays, $9.85 \times 7.2\text{m}$ (32' 4" \times 23' 7") overall, aligned NE-SW, rising to a height of 3.7m (12' 2") at the eaves, and c.6.0m (19' 7") at the roof apex (Fig. 7). Its walls are constructed of coursed slate rubble with lime mortar bonding, c.0.6m (2') thick, with slate slab lintels and window sills.

Internally, the Brass Shop measures $8.6 \times 6.0\text{m}$ (28' 2" \times 19' 7") overall. The floor appears to be concrete, slightly lower than the external ground level at the door. The walls are stone, painted white (Figs 11, 12). The entrance to the building is flanked by timber screens, 0.75m (2' 5½") wide, rising almost to the eaves (Fig. 13). Two brick buttresses rise up the north-west wall, supporting the roof trusses. In the north-east wall is the blocked opening for the window shown in Fig. 5. A narrower bricked-up opening in the south-west wall, now containing shelving, could have been a second external doorway or window.

The other significant feature noted on the ground floor of the Brass Shop is the remains of a brick-lined flue, running up the north-west wall, close to the north corner of the building. This appears to align with the former chimney, shown on Fig. 6, and probably indicates the location of the furnace. This feature is behind shelving, and consequently could not be properly examined or recorded. Its approximate location is shown on Fig. 7.

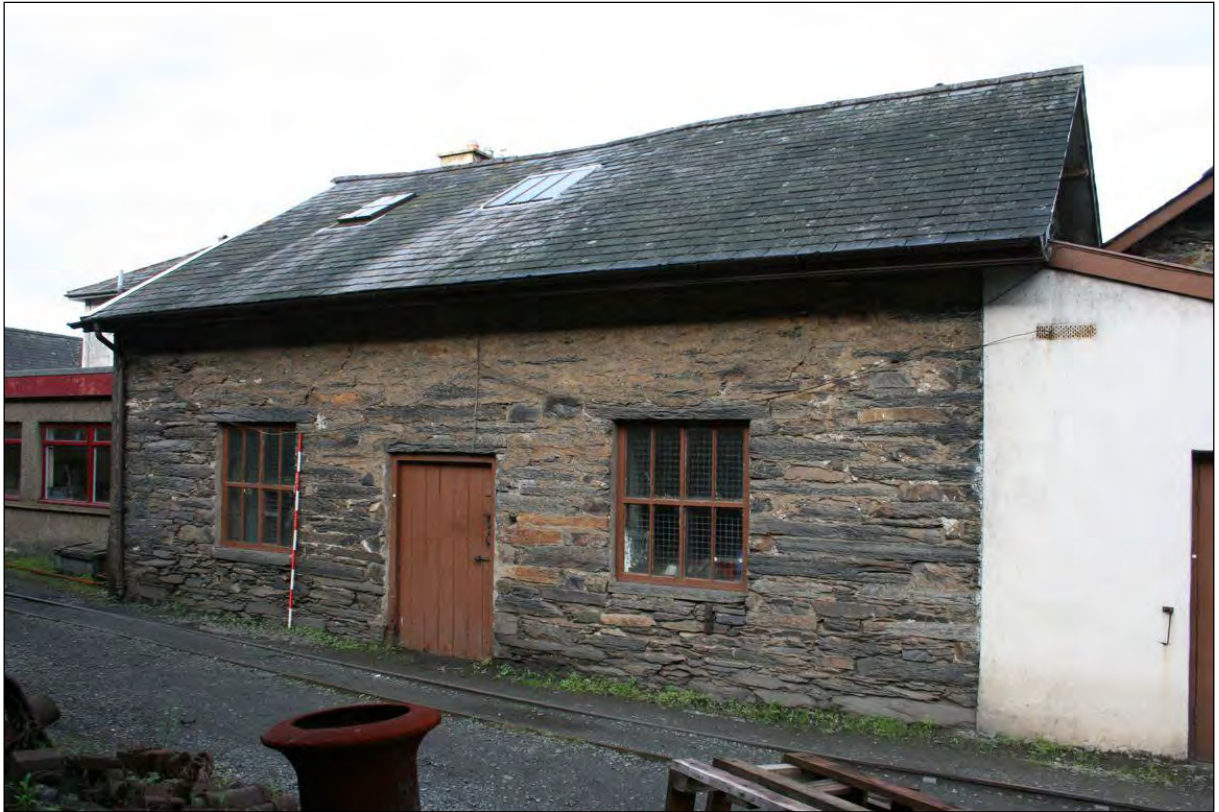
Figure 8: Brass Shop, south elevation from south-east

The south-east elevation (Fig. 8) forms the front of the building, facing onto the alley linking the East and West Yards of the Works. Entrance to the building is gained by a central plank and batten door, 1.8m (5' 11") high, flanked by identical 4 \times 2-light fixed timber-framed windows.

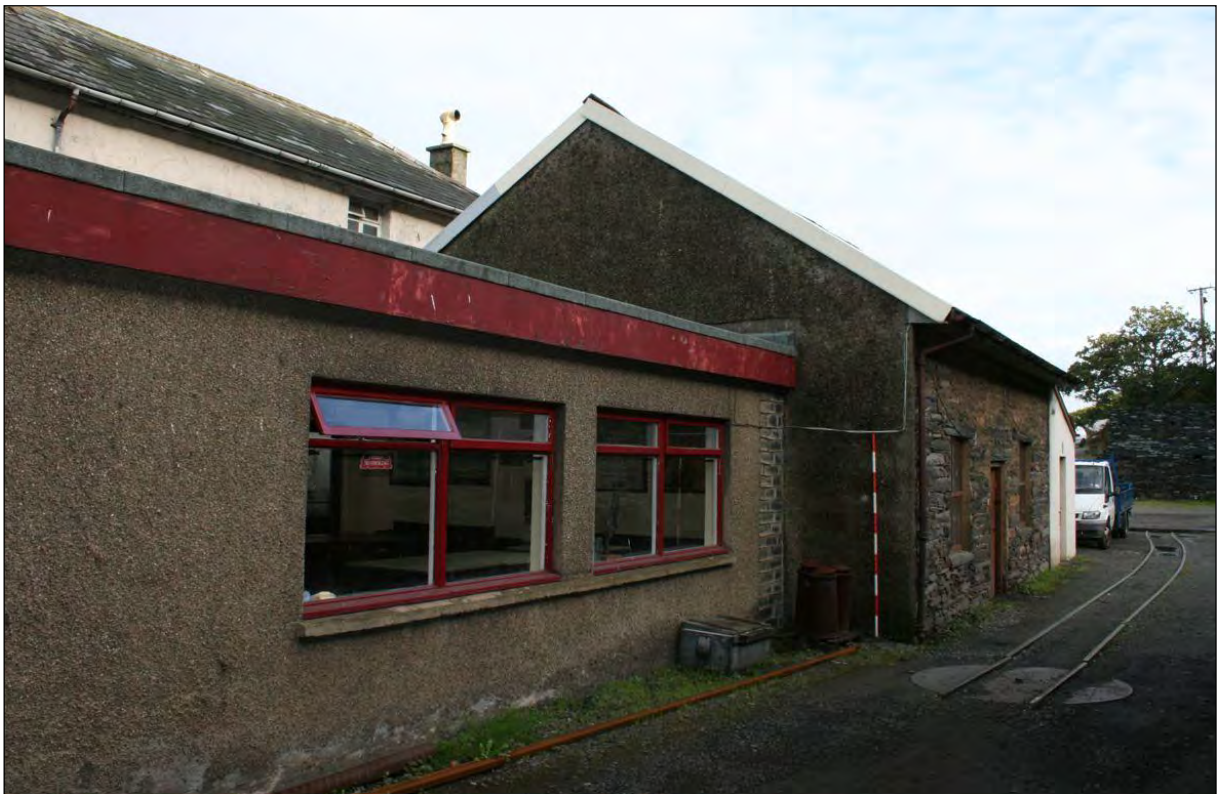
Figure 9: Brass Shop, west elevation from south-west

The south-west elevation is partly obscured by the modern amenity block: only the upper part is visible, and this is cement rendered and pebble-dashed, so no significant features are visible (Fig. 9).

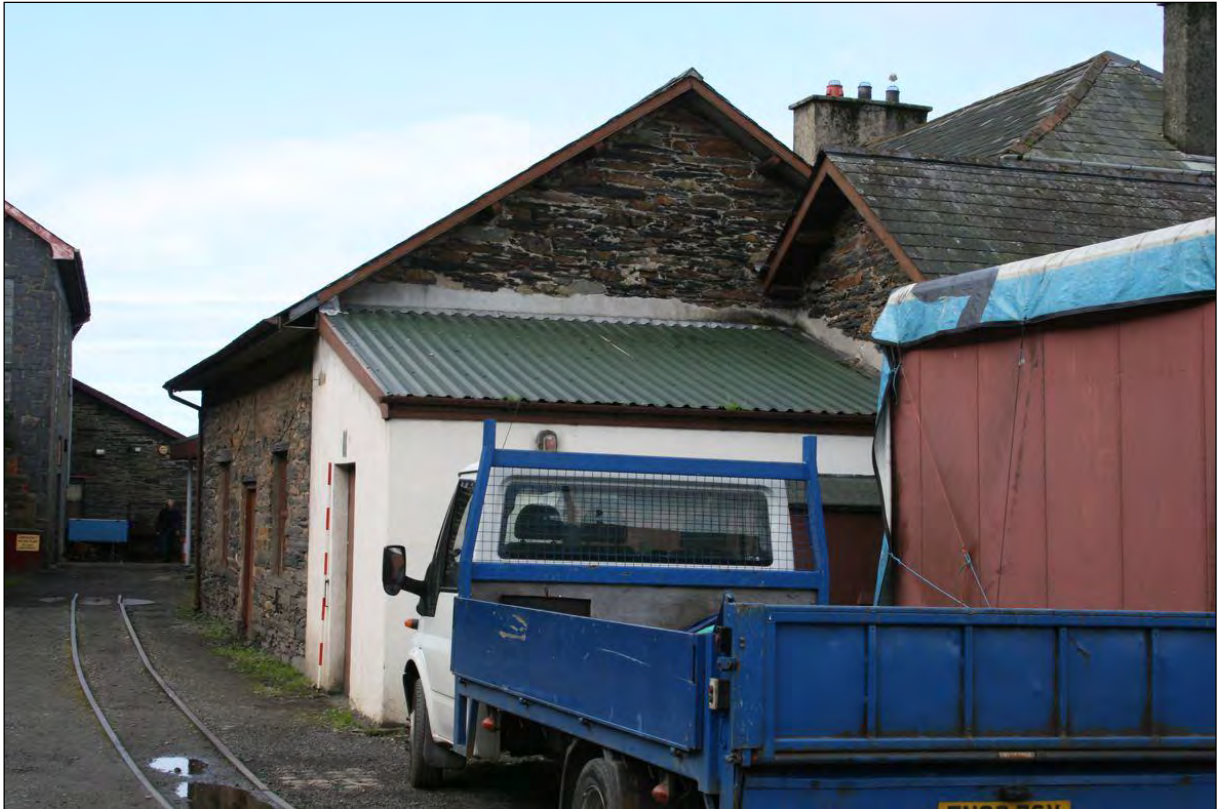
Figure 10: Brass Shop, east elevation from south-east

The north-east elevation is largely obscured by the Telephone Exchange: only the upper part of the gable is visible (Fig. 10). No significant features are visible in this area. Figure 6, which predates the construction of the Telephone Exchange, shows a window in this elevation, similar to those in the south-east elevation.

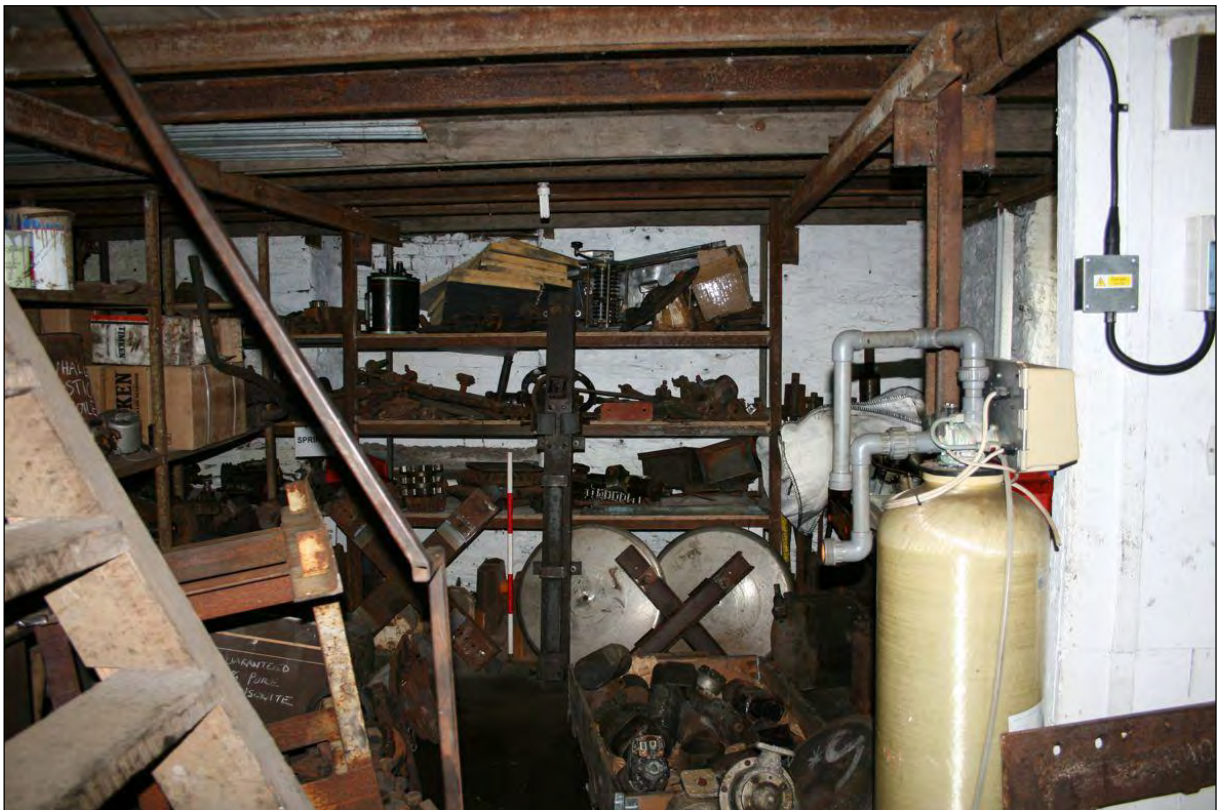
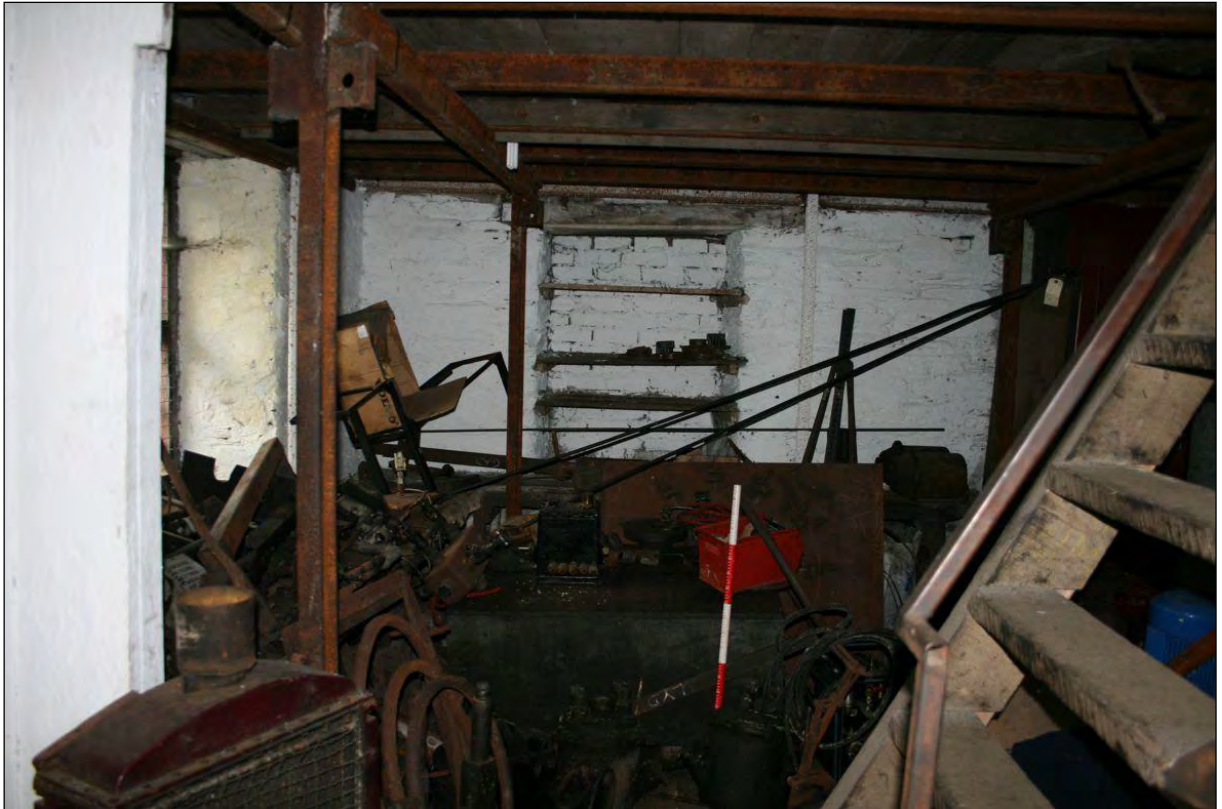
Figure 11: Brass Shop interior, looking east

Figure 12: Brass Shop interior, looking west

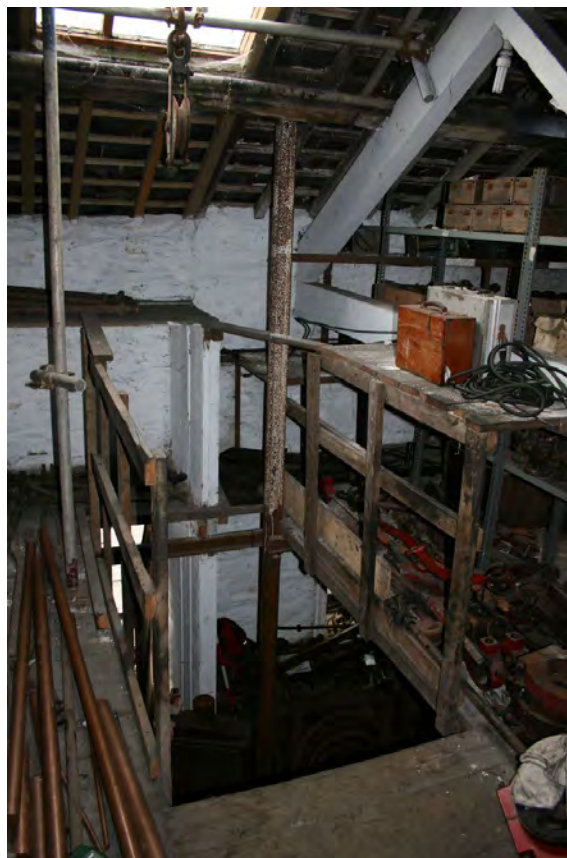
An upper floor has been inserted into the building, presumably when it became a store. The floor is supported on old double-head rails set vertically into the floor, carrying a horizontal framework of rails on which a timber floor has been laid. This floor is accessed by a steep set of stairs, rising immediately inside the door.

Figure 13: Door screen and stairs to upper floor

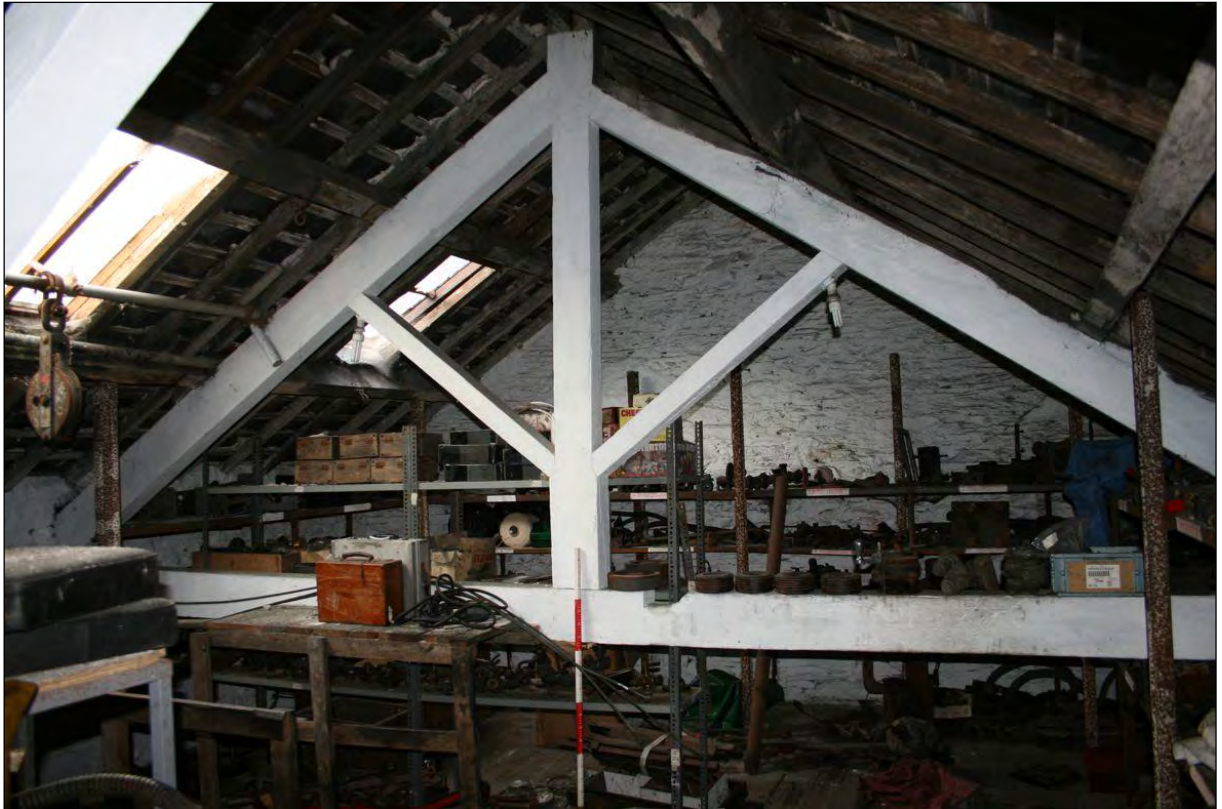
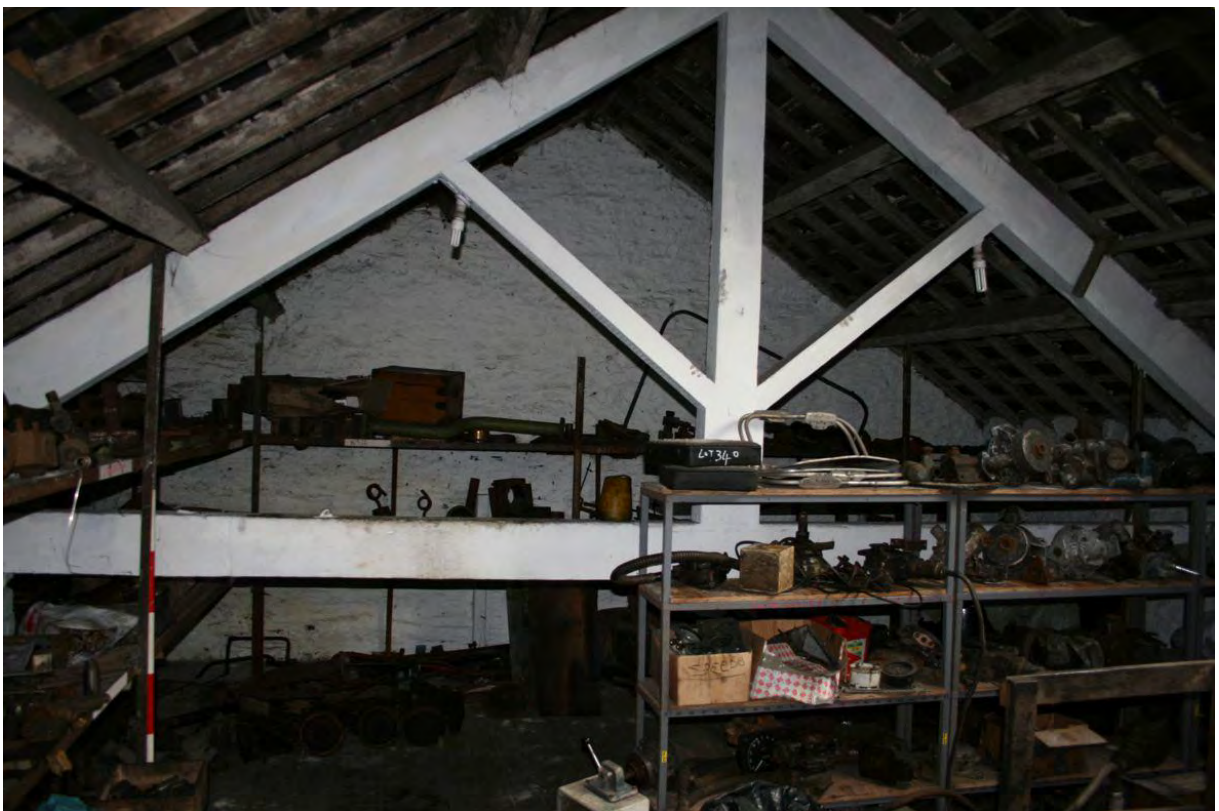
The roof structure is supported by two substantial king-post trusses (Figs 14, 15), both fitted with angled bracing struts. The trusses support purlins (2 each side) and a ridge

Figure 14: Upper floor, looking west

Figure 15: Upper floor, looking east
