Land north of Hafan Y Môr, Chwilog Pwllheli, Gwynedd

Archaeological Desk Based Assessment

Report No. 1719

Prepared For: Bourne Leisure Ltd

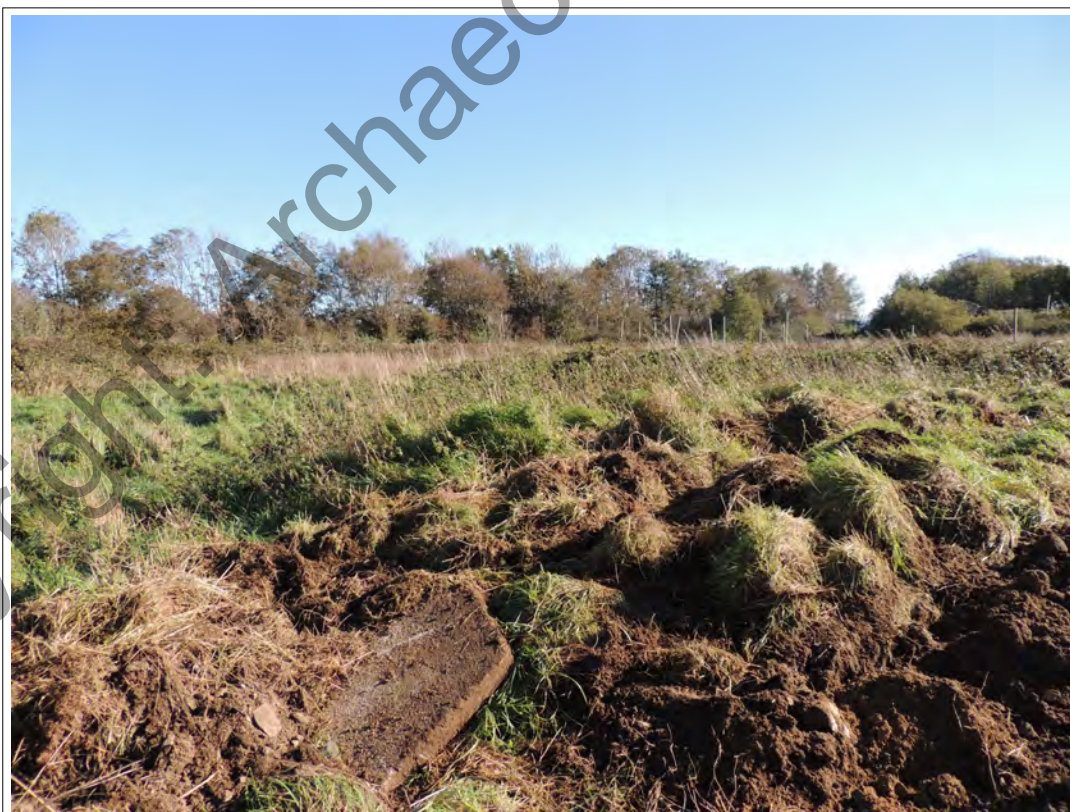
Plate 10. Northern boundary of Area A, showing evidence of deturfing and large slabs possibly associated with sewage works. Looking N.

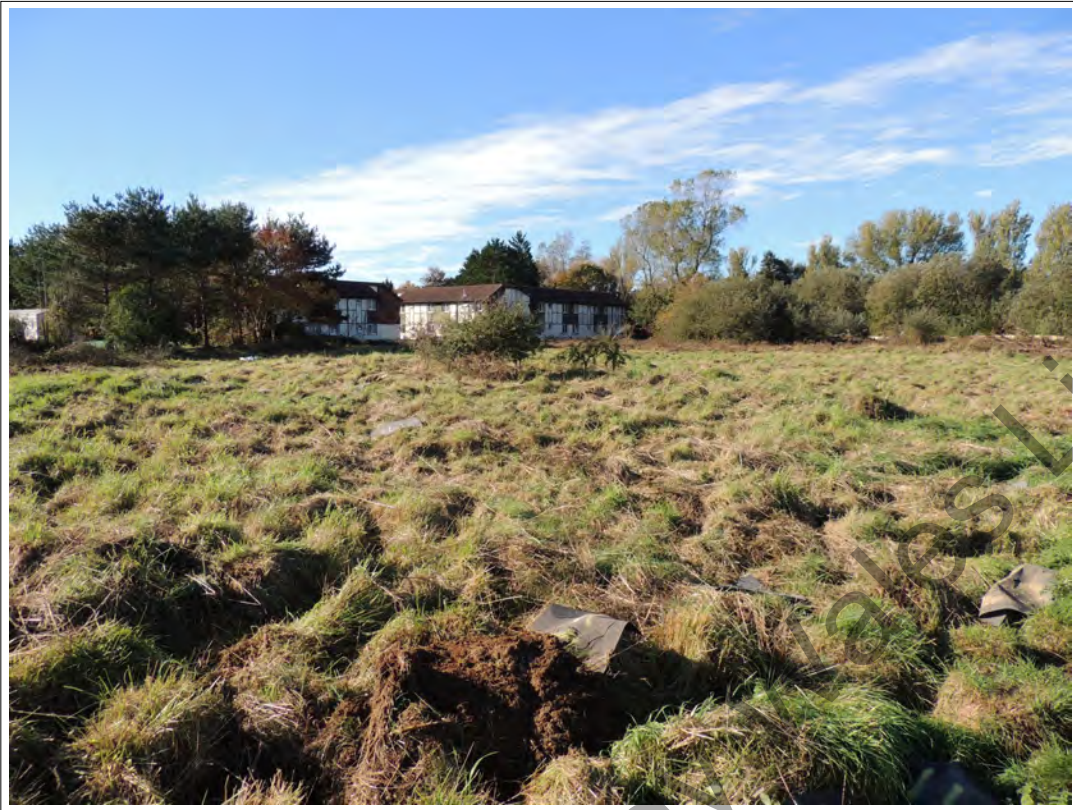
Plate 11. Area A, overgrown grasses at toward centre of the field, looking SW.

- 7.8 Both the DTM and DSM LiDAR view of the field denotes the presence of to linear features (of probable natural origin). These features are not observed on the ground as can be evidenced in Plate 11, 12 and 14. Failure to view such features might correspond to the overgrown grasses and cut bramble dominating this area.
- 7.9 The large positive feature evidenced in LiDAR imagery immediately outside the eastern boundary of the development area can be seen in Plate 13. The removal of trees in this area highlights the nature of this feature, probably man-made during the removal of structures relating to the sewage works. Works in this area also emphasise that natural deposits of gravels are deposited in this area resulting from coastal action.

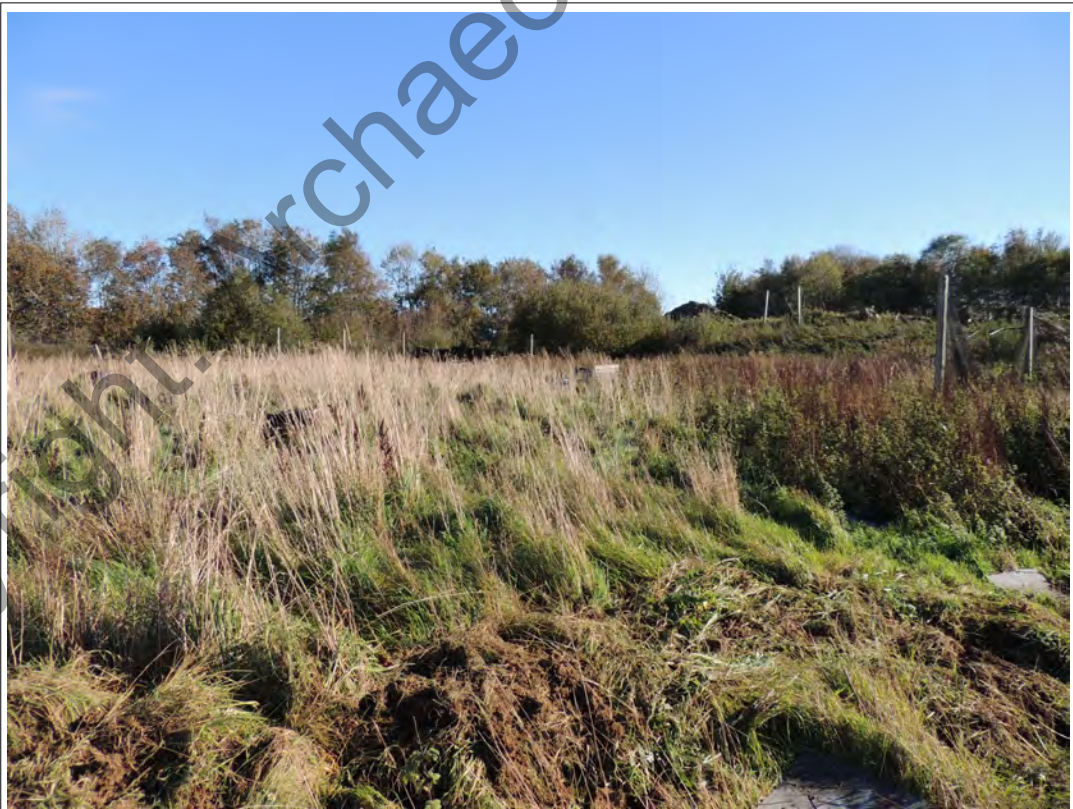
Plate 12. Area A, overgrown grasses at toward centre of the field, looking SW.

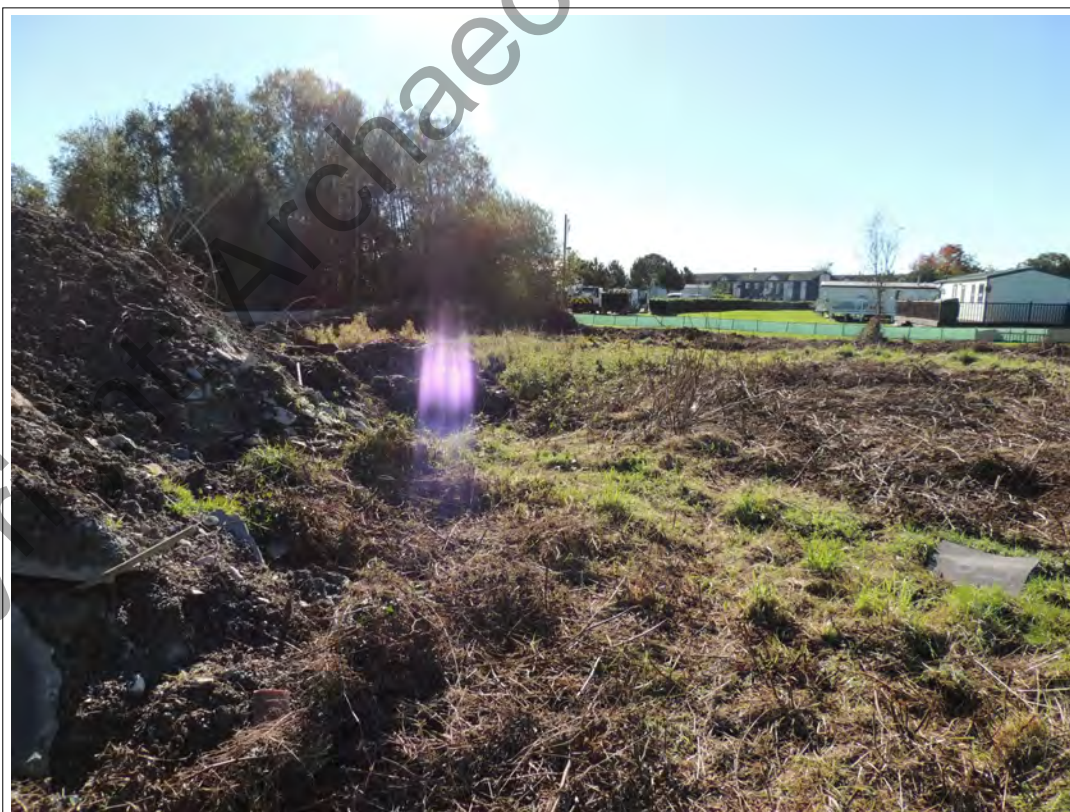
Plate 14. Area A, cut bramble toward centre of the field, looking SE.

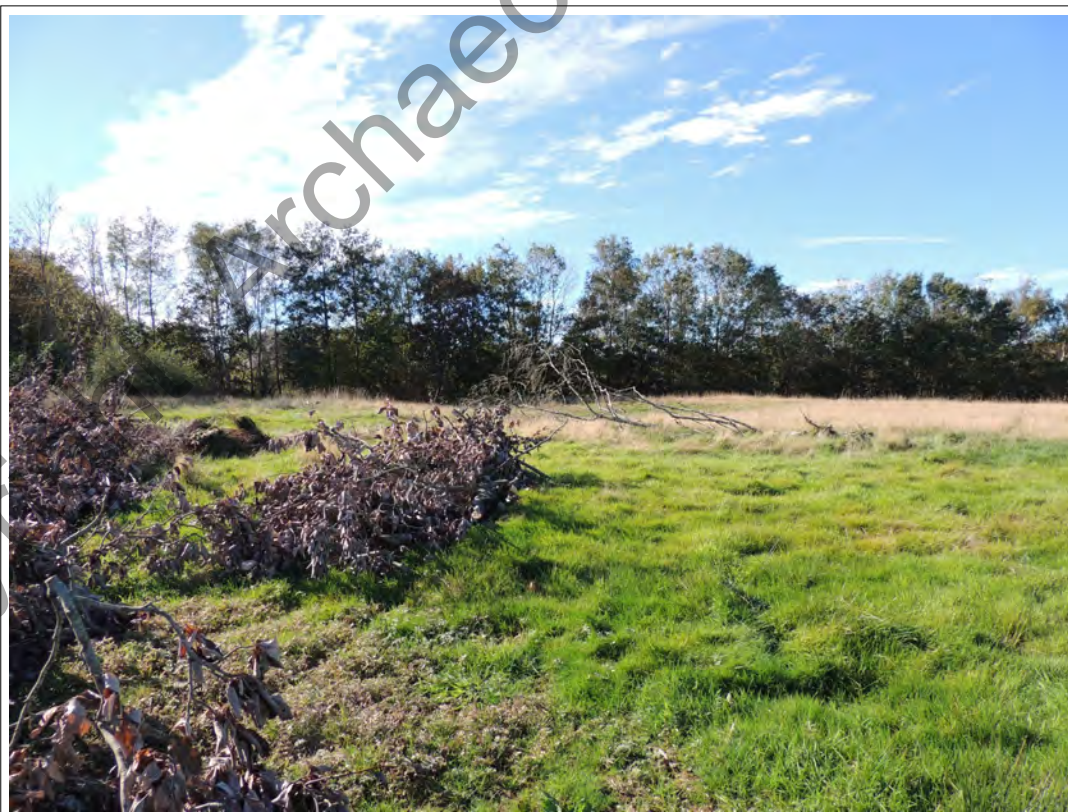
Plate 20. View of Area B towards SW end of field.

- 7.15 As already noted, the southern boundary of the field is defined by a line of trees and a stream. The former blocks views to Area A. No cropmarks or any archaeological features were observed during the inspection of the SE end of the field. The latter is characterised by unimproved grassland (Plate 20-21).

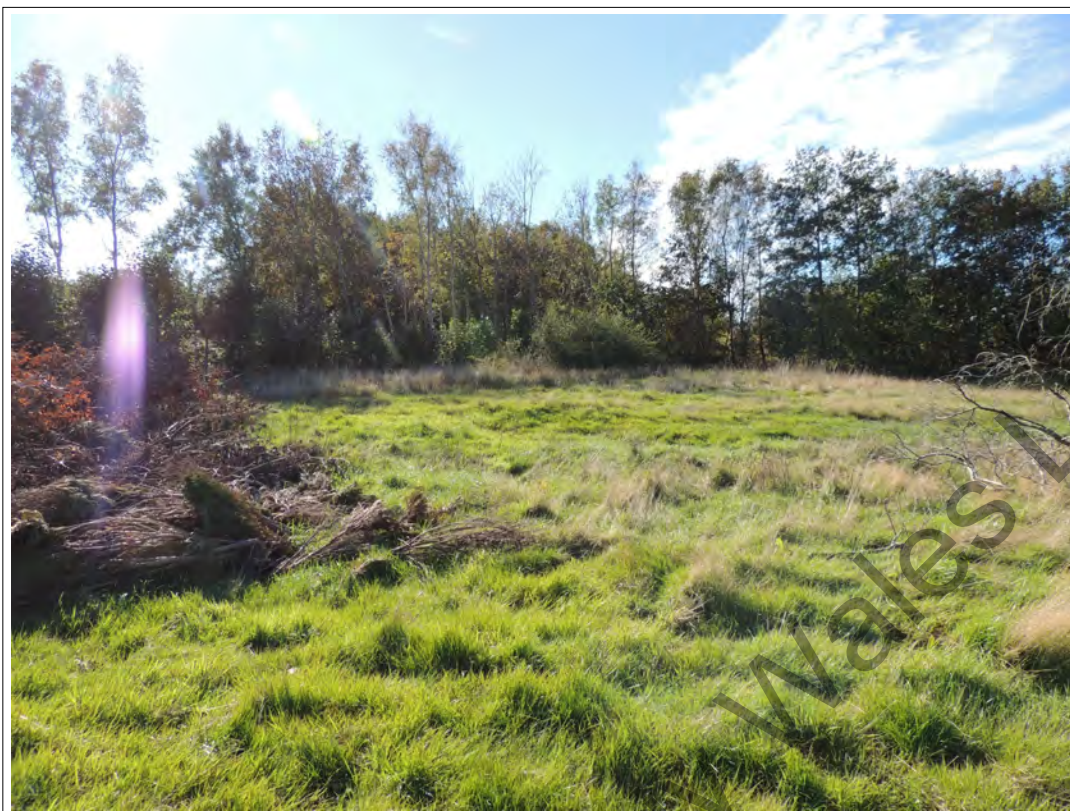
Plate 21. View of Area B towards SE end of field, close-up.

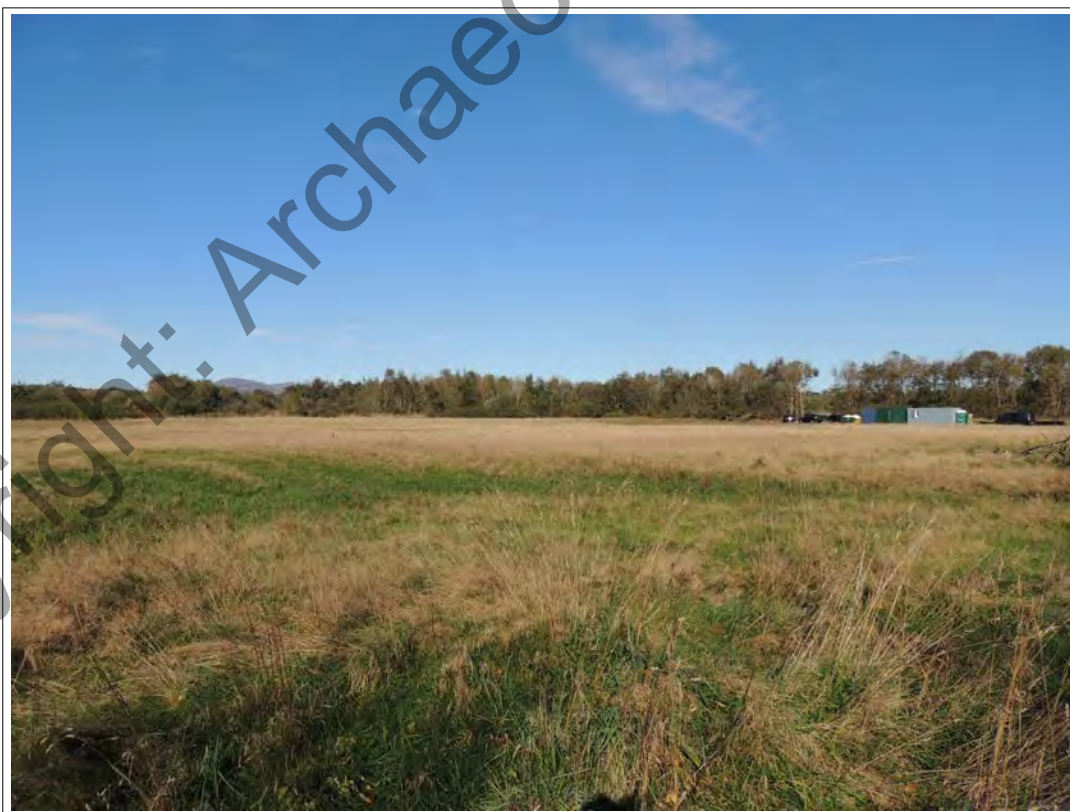
Plate 22. View toward the centre of development, looking NW.

- 7.16 Plate 22 and 23 are views toward the centre of the development. These images define the nature of the ground and evidence no views north of Area B. No archaeological finds or features were observed during the inspection of this area.

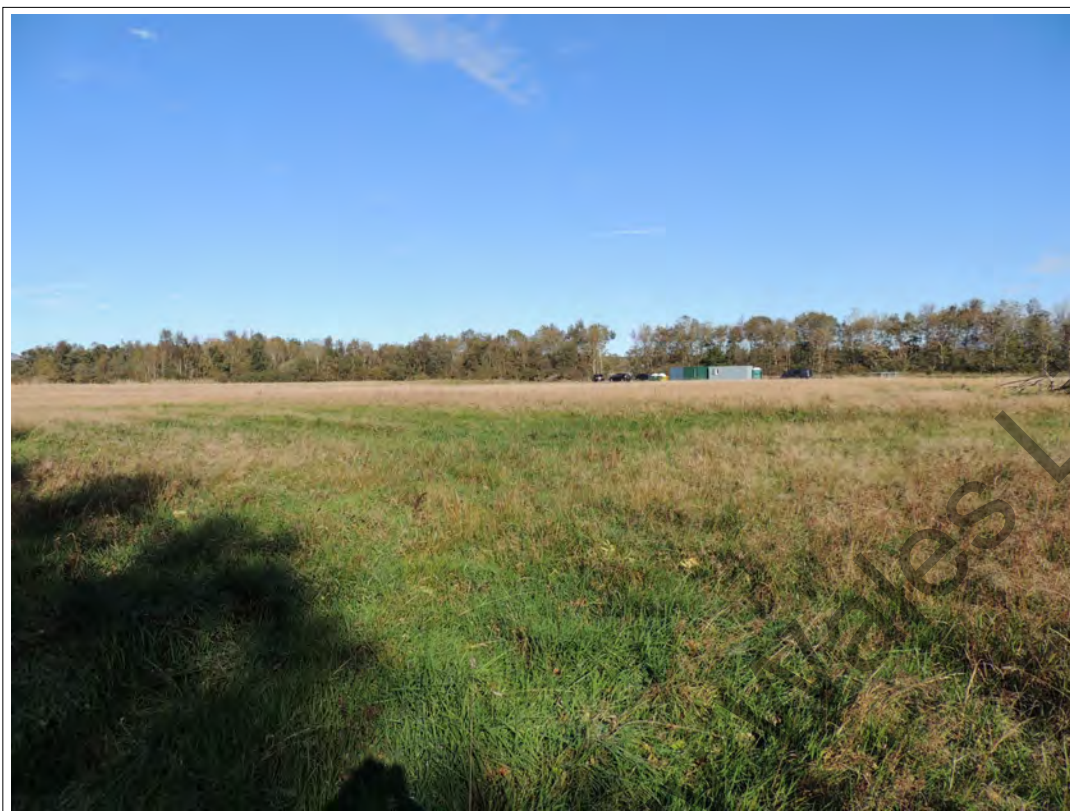
Plate 23. View toward the centre of the development, looking N.
