## **Tywyn to Brycrug Multi-User Path, Gwynedd**

Archaeological Watching Brief

## **Tywyn to Brynchrug Multi-User Path, Gwynedd**

Report No: 1015

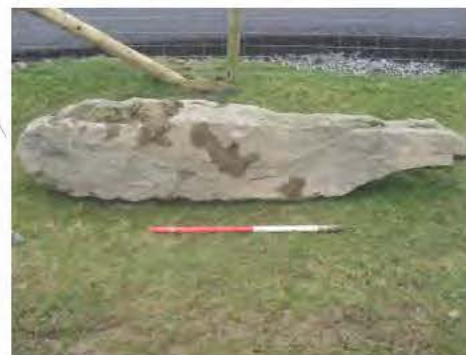
Fig. 3b  
Detail of banked field  
boundary and large stone  
identified in Section 7

This section incorporates linkages 1040m to 1240m (Photos 24-26). Here the line of the path diverged into a large field currently under pasture (fig 3b). The trench measured approximately 2.50m wide by 0.15m deep, the subsoil was reddish brown clayey silt, containing occasional small stones. A small fragment of nineteenth century pottery was recovered from the subsoil (not retained).

A constructed culvert lay at the intersection of sections 7 and 8, taking the stream underneath the present modern road (Photo 27). At this point the ground works also cut through a banked field boundary. This was orientated north-east/south-west, following the line of the road and later wall. It probably dates to the enclosure of the fields and may have comprised a hedge bank boundary that pre-dated the construction of the boundary wall in the eighteenth or nineteenth century (Photo 28).

A large long narrow, rough hewn, stone was also identified. It was found lying on its side and measured 2.43m in length by 0.42m wide at its widest point. The provenance, use or date of this stone was unknown, however it shared similarities to the Croes Faen standing stone, located at the southwestern end of the scheme.

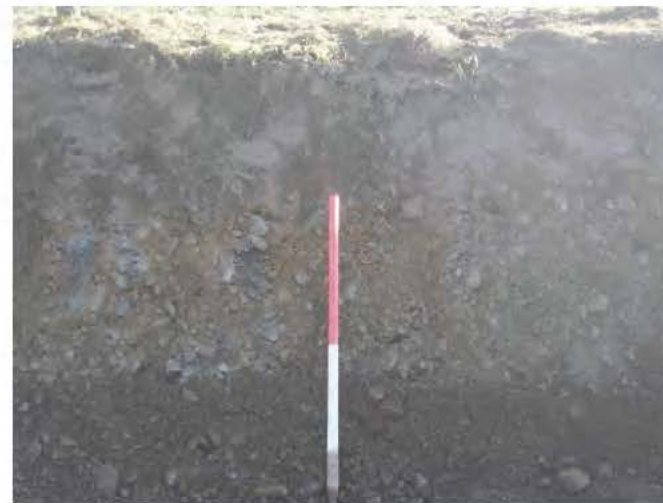
Photo 6. Section 2. Detailed shot of section showing depth of topsoil and 2 bands of natural gravel. 1m scale, Facing South.

This section incorporates linkages 180m to 310m, and corresponds to an undulating field under pasture at the time of excavation (Photos 4-7). At the north east end of the section, there was a low lying boggy area that was holding water. The excavation trench followed the line of the grass verge and measured approximately 2.50m wide by 0.15m deep, although this was variable in places. In this section the machine cut sideways into a rise in the ground surface in order to create room for the width of the path way, consequently a deeper section was seen which revealed the underlying natural gravel. The natural was composed of an orangey brown sandy gravel, containing medium to large rounded cobbles. The section which was actually cut at an angle of 45 degrees, was approximately 1.70m deep, comprising 0.70m of a clayey silt topsoil, overlying 2 bands of natural gravel which was approximately 1m thick. A fragment of pottery provisionally dated to the nineteenth century was recovered from the subsoil (not retained).

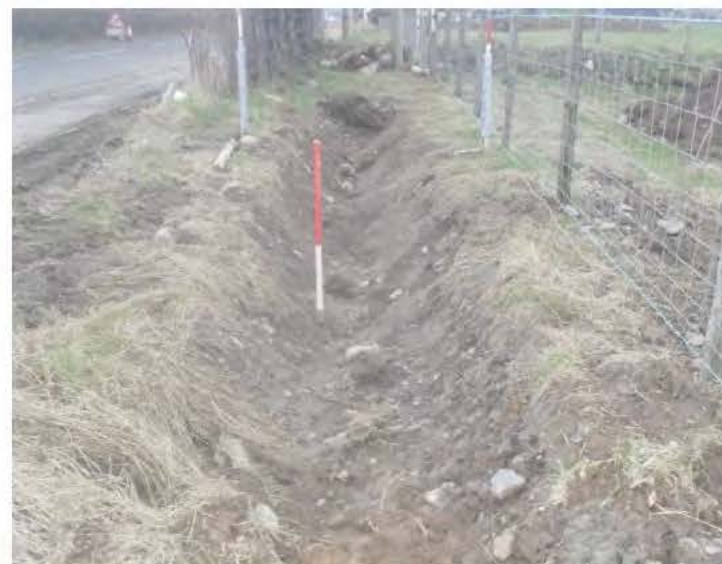
Photo 14. Section 4. Post excavation shot of services trench. 1m scale, Facing North East.

A service trench was excavated parallel to the line of the pathway at the north east end of this section (Fig 3b). This trench measured approximately 50m long by 1.20m wide by 0.50 deep, and revealed a subsoil composed of a dark brown clayey silt, with natural gravels visible towards the base (Photo 14).

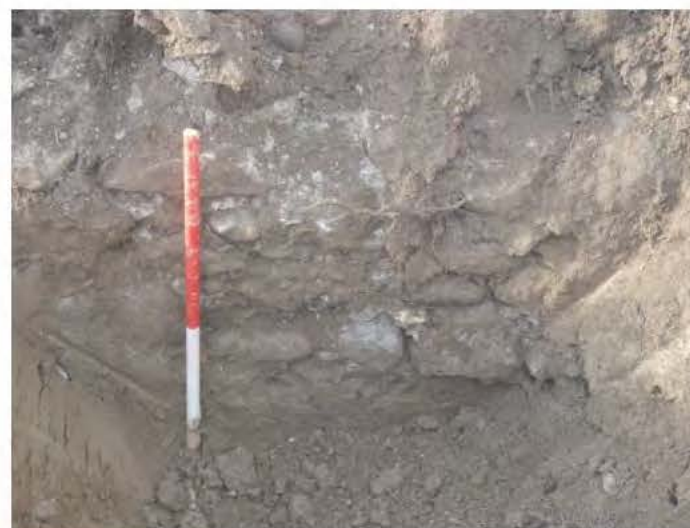
Photo 17. Section 4. Below ground remains of 19<sup>th</sup> century wall. 1m scale, Facing North West.

This section incorporates linkages 480m to 730m, and corresponds to a large relatively flat field that was under pasture at the time of excavation (Photos 11-14). At this point the trench diverged from the line of the grass verge adjacent to the modern road, and into the field (Fig 3a). The trench measured approximately 2.50m wide by 0.15m deep, and the subsoil was composed of a mid brown soft clayey silt, containing occasional small stones. At the northern end of this section an area of Japanese Knot weed which was removed by machine (Photos 15-18). To ensure that this vegetation did not return, a trench was excavated to a depth of approximately 1m by approximately 15m long. This work showed the subsoil to be approximately 0.70m thick, composed of a reddish brown clayey silt, containing occasional medium stones. Below this was a dark brown clayey silt. During the excavation of this area, a wall was revealed, running parallel with the present road. The wall was three courses high below ground level, standing to a height of 0.80m by 0.60m wide and exposed for a length of 15m. It was built of rounded blocks and cobbles which on average measured 0.30m by 0.20m, there was evidence of a light grey sandy mortar still adhering to the blocks. A foundation trench for the wall was visible, which cut through the subsoil. The cut was at least 0.80m wide and dug to a depth of 0.80m. This wall is probably of eighteenth or nineteenth century date, and may form part of a boundary associated with the Ynysmaengwyn Estate of which there upstanding remains still visible along other stretches of the road scheme (Photo 28). However, this interpretation is tentative as no dating evidence was recovered from the wall or wall cut. In addition, the wall lies on the opposite side of the road from the park boundary of the Ynysmaengwyn Estate, and so may simply be a field wall.

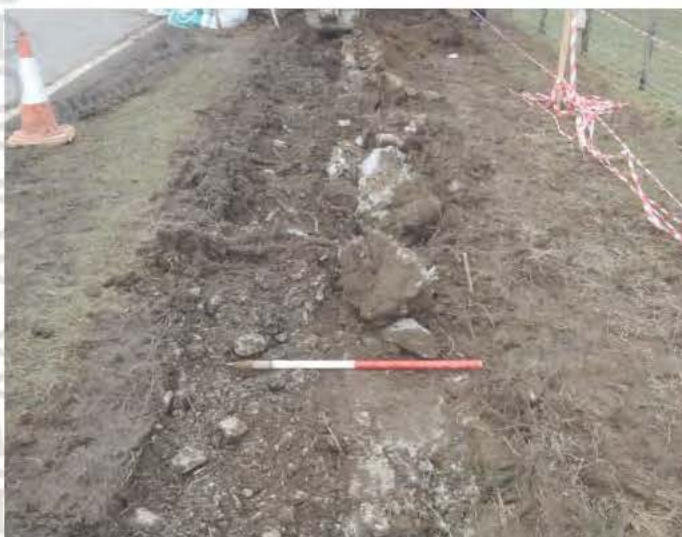
Photo 16. Section 4. Shot indicating visible line of wall at ground level. 1m scale, Facing North East

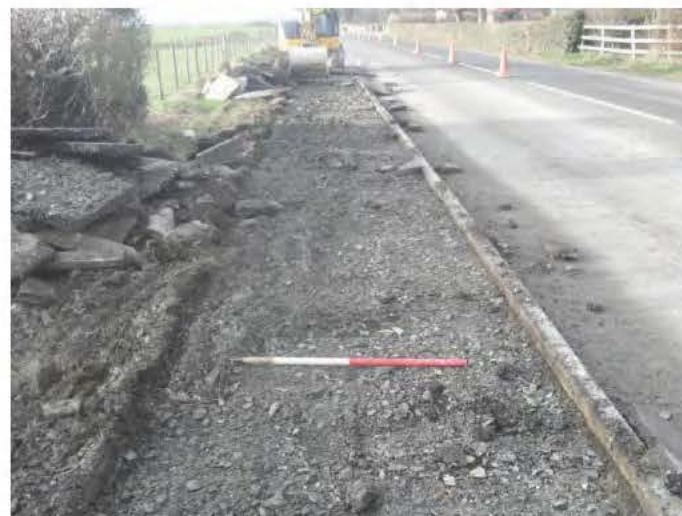
Photo 21. Underlying and pre-existing hardcore. 1m scale, Facing West.

This section incorporates linkages 730m to 920m, and corresponds to the contractors compound which was erected during the course of the road scheme (Photos 19-21). During this section, following the removal of an existing pathway running parallel to the modern road, it was decided to use the existing hardcore as a base for the new multi used path. During this phase no subsoil was disturbed.

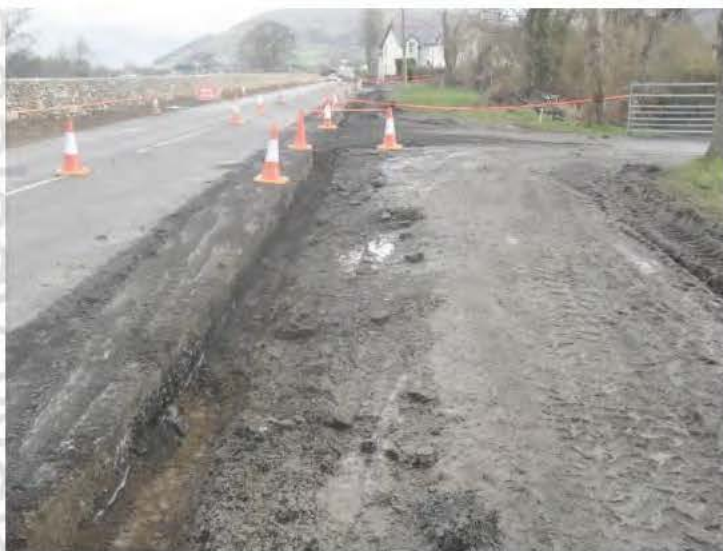
Photo 20. Section 5. Post excavation shot showing underlying and pre-existing hardcore. Facing North East.

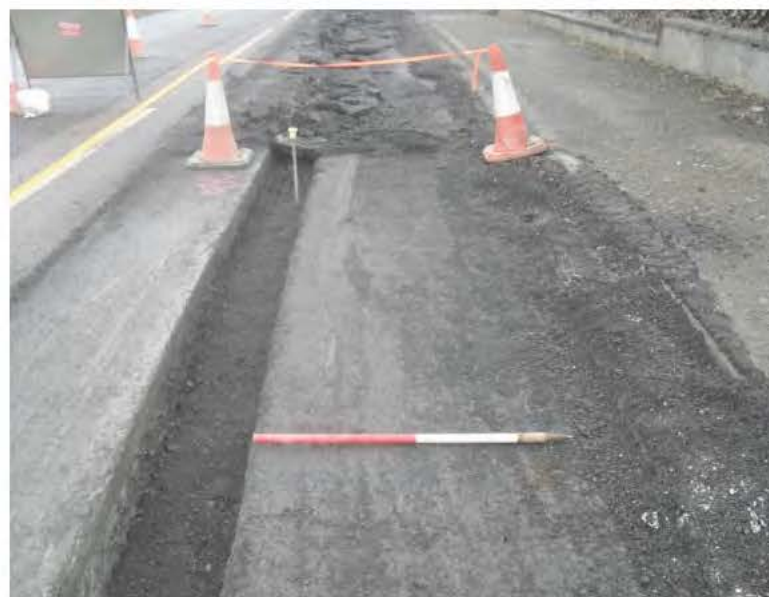
Photo 23. Section 6. Detail of pecked road surface, in advance of laying of new path surface. 1m scale. Facing North East.

This section incorporates linkages 920m to 1040m and corresponds to the Farm complex running alongside the line of the modern road (Photos 22-23). Here the present road was widened to accommodate the path along the southern edge. The road surface was pecked to a depth of 0.40m to provide the base for the path, no subsoil was removed during this section.

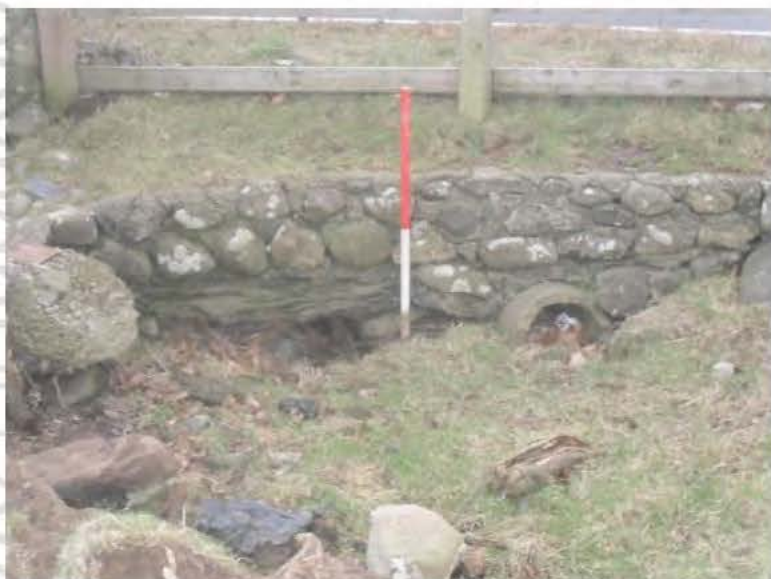
Photo 27. Section 7/8. 19<sup>th</sup> century culvert carrying stream under present modern road. 1m scale, Facing North West.

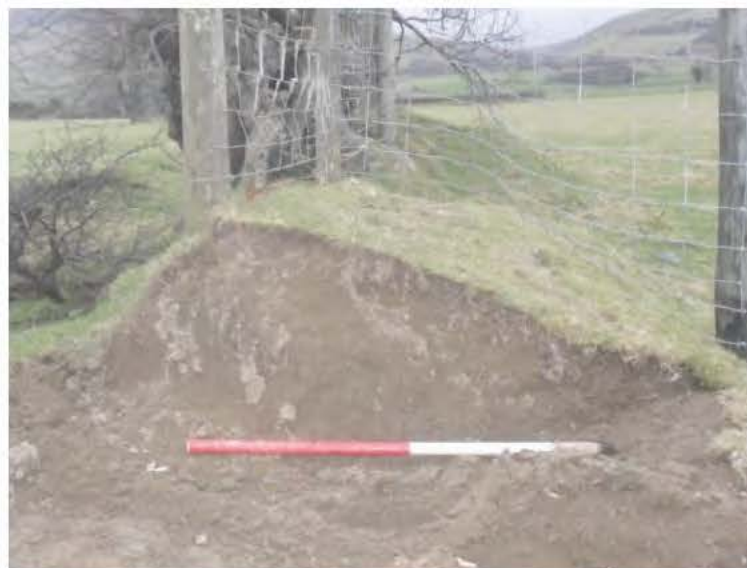
Photo 29. Section 7/8. Excavation through field boundary/bank. 1m scale, Facing East.

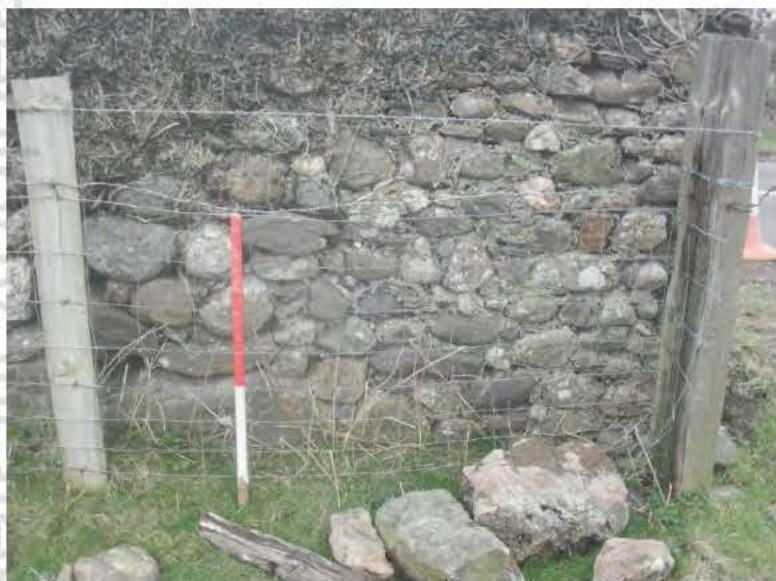
Photo 28. Extant remains of 19<sup>th</sup> century wall. Below ground remains seen in section 4. 1m scale. Facing North West.

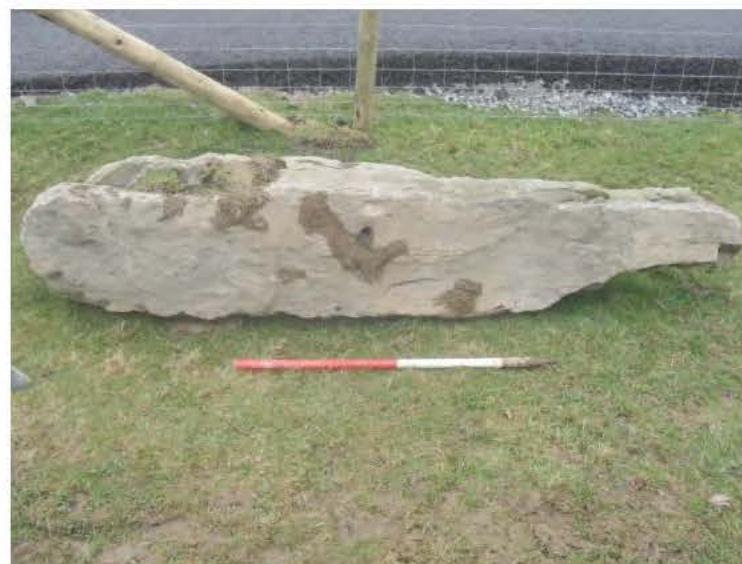
Photo 30. Section 7/8. Long stone of similar shape and size to Dragon Stone. 1m scale. Facing North West.
