## **Harlech Castle Harlech, Gwynedd**

Archaeological Field Evaluation

By  
Chris E Smith BA (Hons) MA MIFA  
Report No. 1080

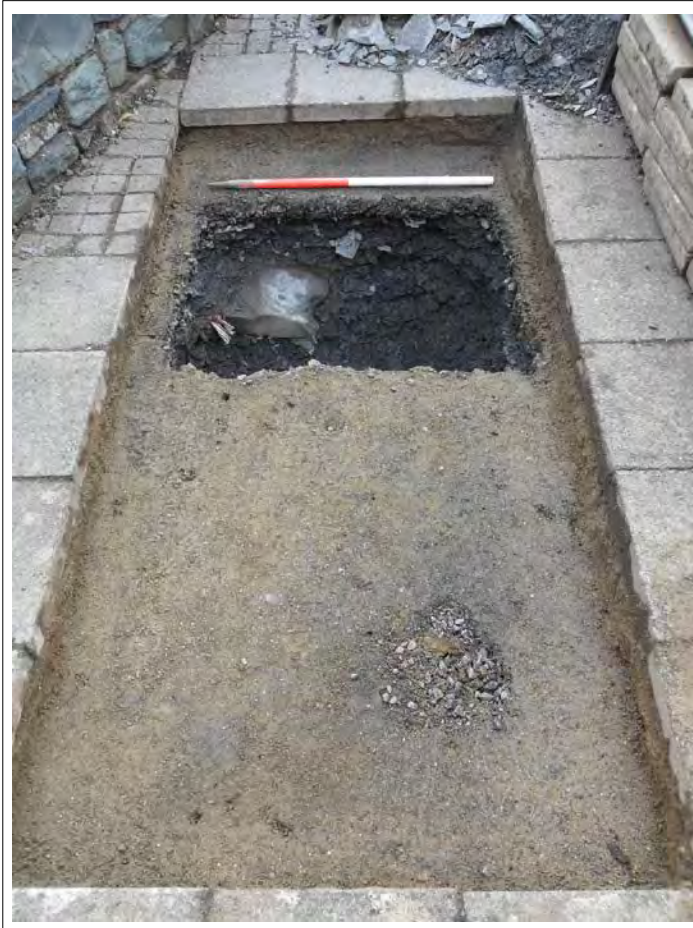
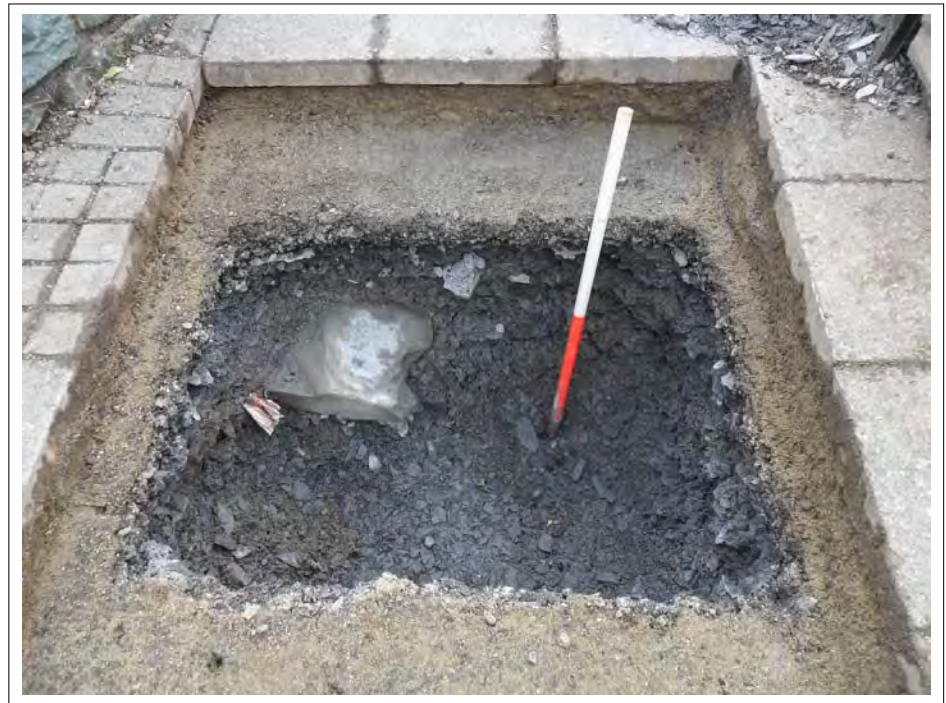
- 4.2.1 This trench measured 3m in length by 1.5m in width and was aligned on an east - west axis. The trench was located at the northern end of the castle car park in a small area of seating, overlooking a children's play area (Fig 2).
- 4.2.2 Removal of paving slabs (101) revealed a compact sand bedding (102). The sand was found to be approximately 0.15m deep and to be located above a tarmac surface (103). Excavation of a 1x1m slot through the tarmac surface (103) revealed a deposit of crushed slate fragments with occasional plastic inclusions (104). Owing to the extremely loose nature of the crushed slate deposit (104), excavation ceased at a depth of 0.9m to prevent undermining of surrounding features. No finds or features of archaeological significance were located within this trench.

Plate 1: View of Trench 1 within Car park seating area  
Looking east, Scale 1x1m

Plate 2: View of Trench 1 within Car park seating area  
Looking east, Scale 1x1m

slate deposit (104) encountered within this trench is therefore likely to represent imported levelling material. Unfortunately, owing to the extremely loose nature of the deposit, further excavation could not be undertaken without undermining surrounding features.

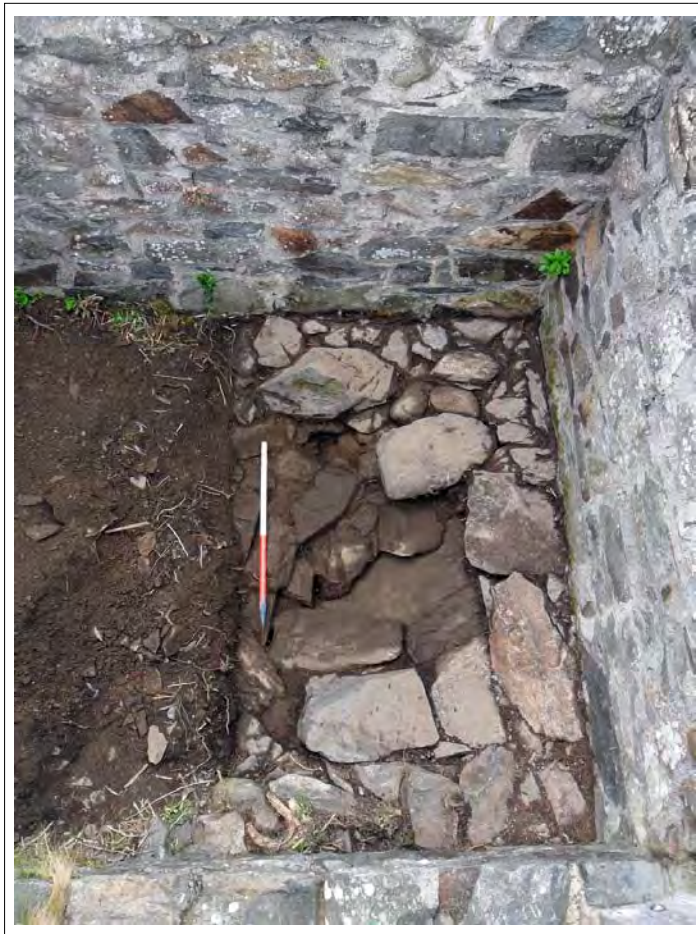
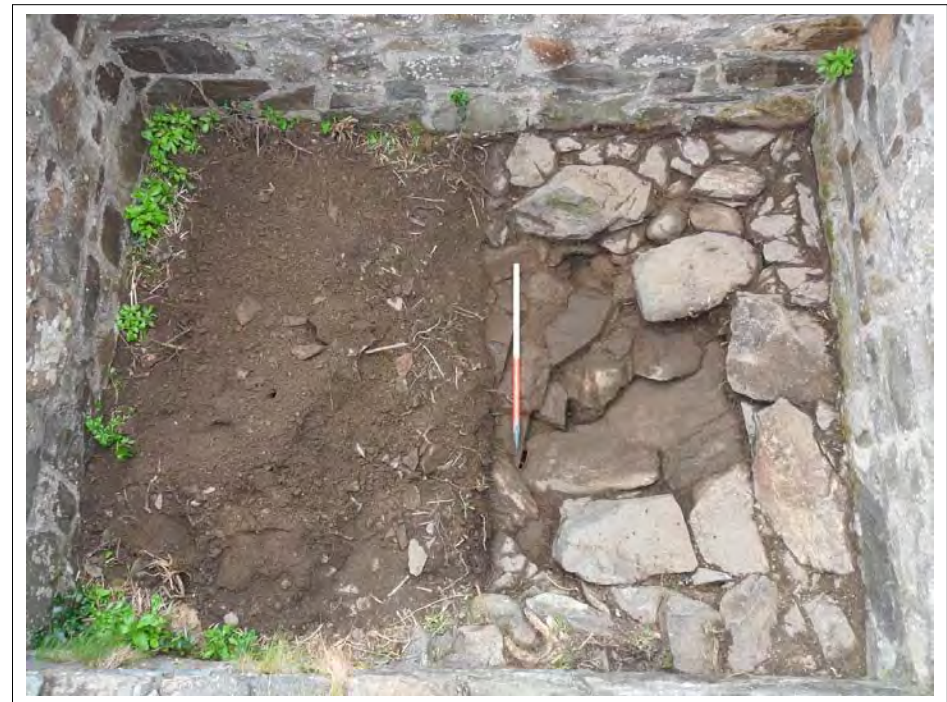
- 4.3.1 This trench measured 3m in length by 2m in width. The trench was located within one of the medieval access bridge pier bases situated within the defensive ditch surrounding the castle (Fig 2).
- 4.3.2 Removal of rotted vegetation, root material and a brown humic overburden (201) revealed a deposit of large stones (202). These stones were up to 0.5x0.5m in size and appeared to have been deposited on top of the solid bedrock natural (203) in order to provide a level platform foundation for the medieval access bridge pier. Bedrock natural was visible in places beneath the stone deposit. No finds or further archaeological features were located within this trench.

Plate 3: View of Trench 2 within base of bridge pier  
Scale 1x1m

Plate 4: View of Trench 2 within base of bridge pier  
Scale 1x1m

- 7.2.1 Trench 2 was located on the inside of one of the 15<sup>th</sup> century fortified bridge towers. The excavation showed that no floor levels survived but did show a rubble deposit piled on top of the natural bedrock, upon which the tower appears to have been built. The rubble deposit appears to have been laid down to provide a level base from which to build on. Bedrock is still visible in places beneath the rubble deposit. The lack of anything but modern finds, as well as a distinct lack of soil, would appear to suggest that this area has been previously excavated.

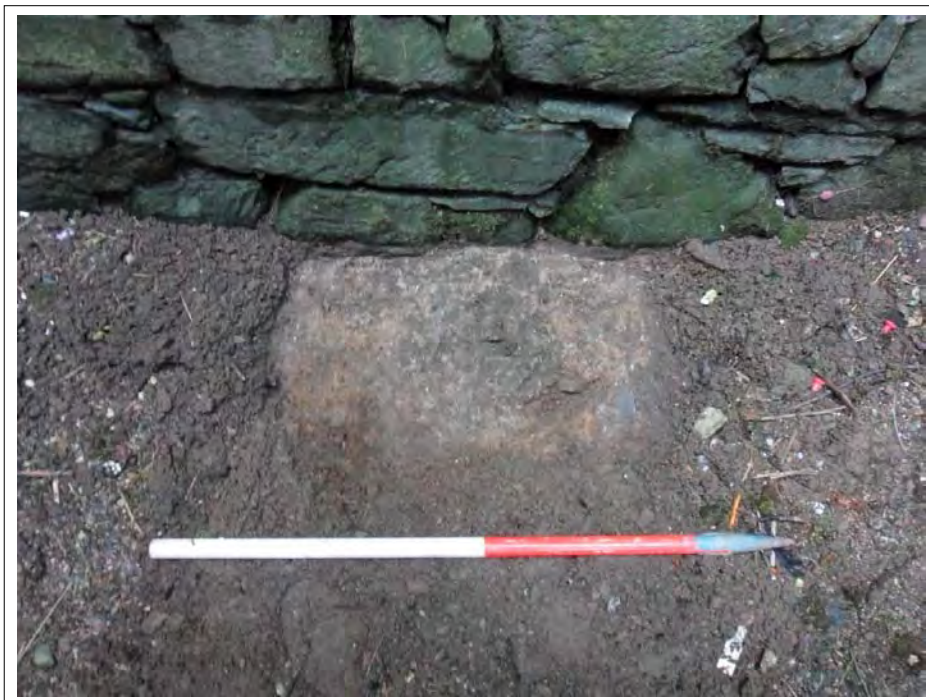
- 4.4.4 Trench 3, the westernmost trench, was located at the base of the west wall of the drawbridge pit and measured 0.5x0.3m. Removal of the sandy gravel material (301) revealed, at a depth of less than 0.1m, a compact lime mortar surface (302). It appeared to be a possible sub-floor horizon, likely bedding material for flooring since removed. Excavation ceased at this depth.

Plate 5: View of lime mortar horizon within trench 3 at base of west wall of drawbridge pit.  
Looking west, scale 1x1m

- 7.3.1 Trenches 3, 4 & 5, located within the base of the drawbridge pit, appeared to show that rather than being bare bedrock, a lime mortar and rough cobble floor was laid down here. Whilst extremely likely, the lime mortar and rough cobbling cannot be definitively ascribed to the medieval period but it would appear to predate most modern, restorative, works to the castle.

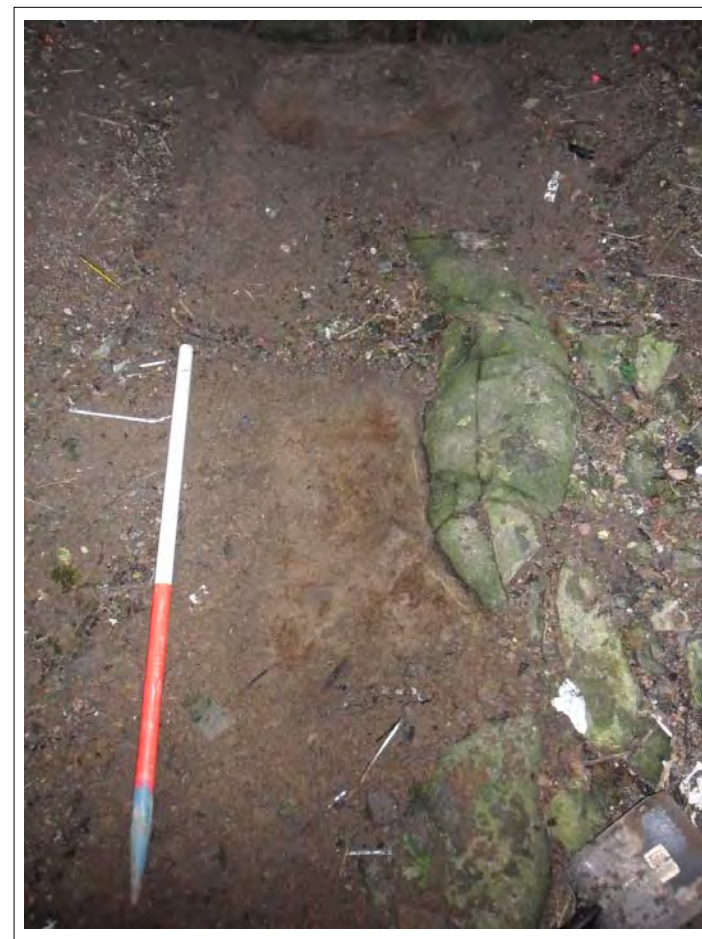
- 4.4.5 Trench 4 was located in the very middle of the base of the drawbridge pit. It again measured 0.3x0.5m and was positioned immediately adjacent to a bedrock outcrop. Removal of the sandy gravel material (401) again revealed a compact lime mortar surface within 0.1m depth. The lime mortar (402) was noted to be butting up against the edge of the natural outcrop. It again appeared to be a likely sub-floor horizon. Excavation ceased at this depth.

Plate 6: View of trench 4 in middle of drawbridge pit base immediately adjacent to natural rock outcrop.  
Note lime mortar horizon. Scale 1x1m

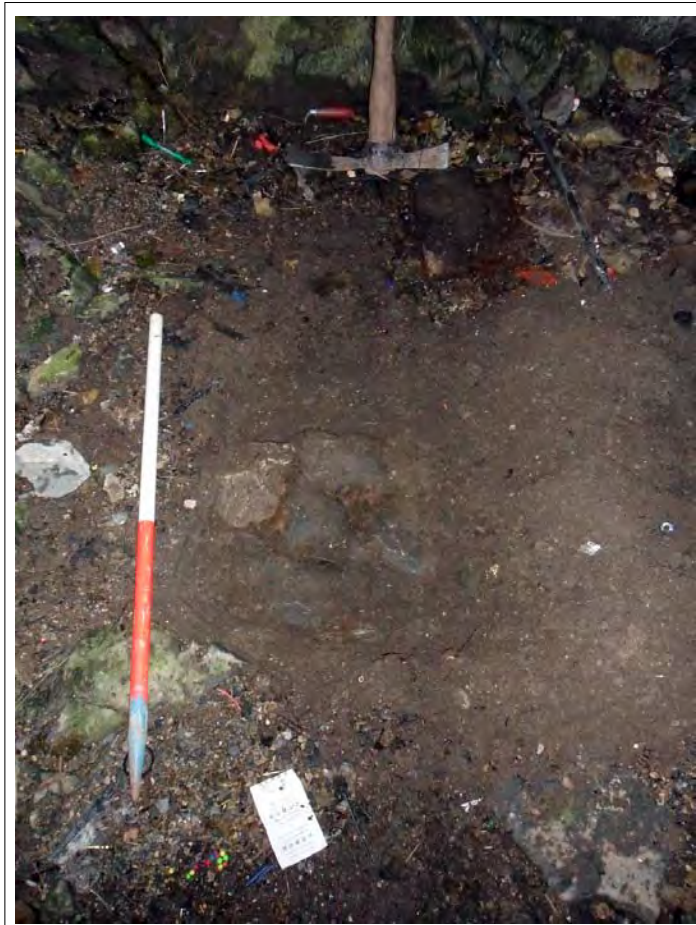
- 4.4.6 Trench 5, the easternmost trench within the drawbridge pit, was located approximately 1m away from the base of the eastern drawbridge pit wall so as to avoid an area of modern disturbance. Removal of the sandy gravel material (501) revealed an area of very rough-hewn cobbling (502) only 0.05m beneath the surface. They appeared to be set within a lime mortar horizon, likely the same horizon as seen in trenches 3 & 4. Excavation ceased at this depth.

Plate 7: View of Trench 5, note area of rough cobbling.  
Scale 1x1m

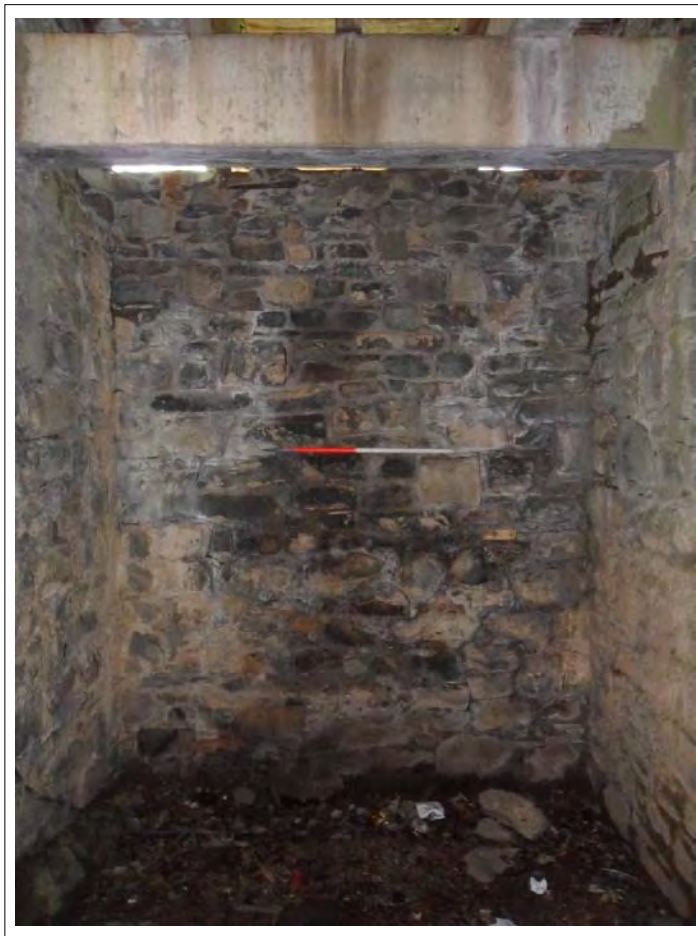
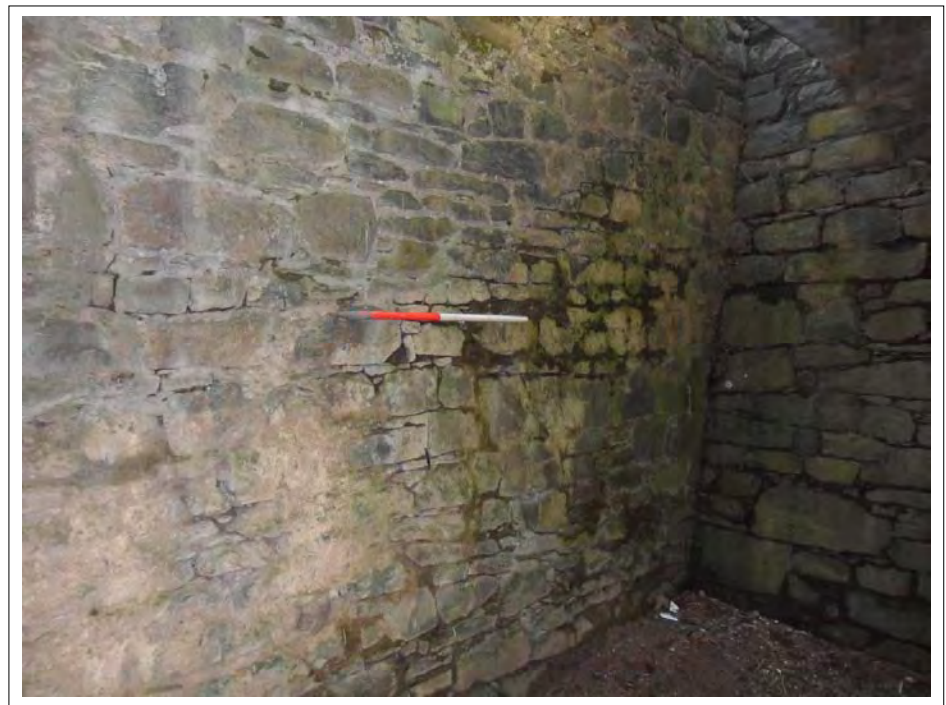
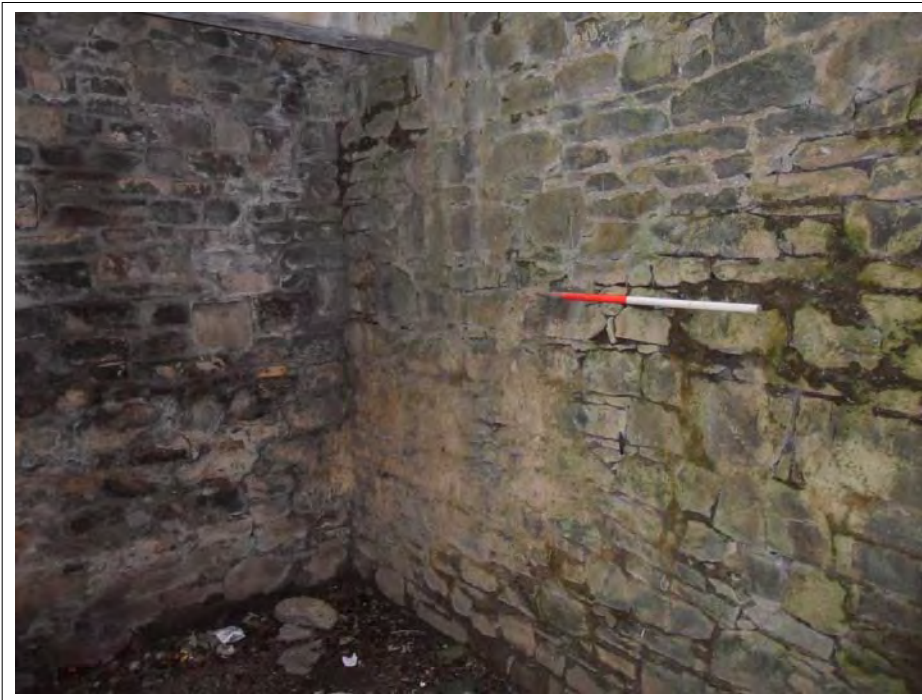
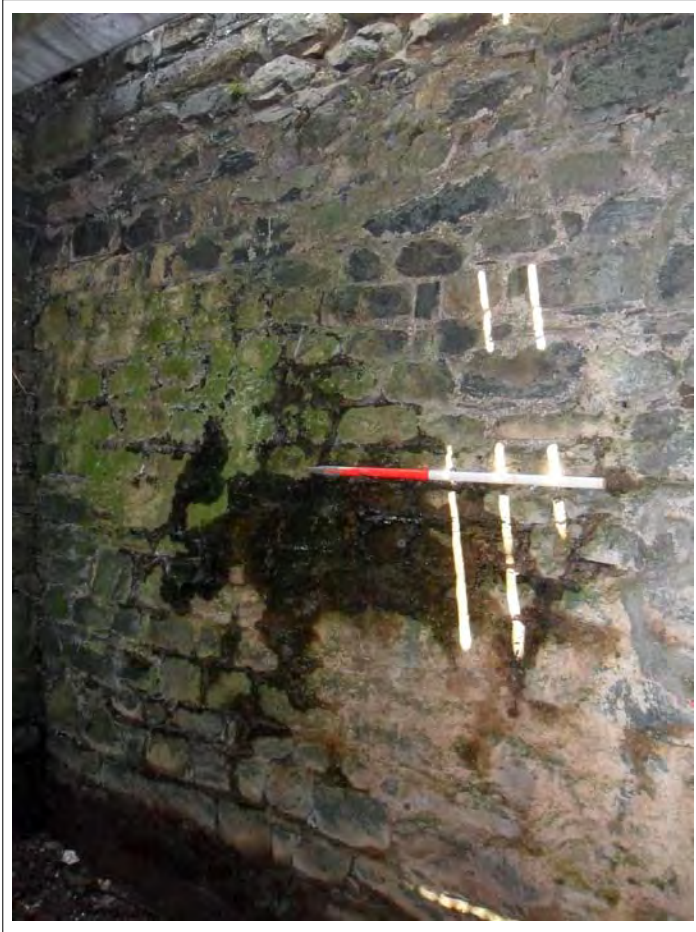
- 6.1.1 The photographs taken of the drawbridge pit walls are presented in plates 8-15. As previously mentioned, unsympathetic repair and lichen covering has made identification of original fabrics very difficult. It is worth noting, however, that the lime mortar horizon identified in trench 5 did appear to butt directly against the wall suggesting that, if indeed the horizon is medieval in date, the walls lower courses at least may be original.

Plate 8: View of west wall of drawbridge pit  
Looking west, Scale 1x1m

Plate 9: View of east wall of drawbridge pit  
Looking east, Scale 1x1m

Plate 10: Oblique view of south wall of drawbridge pit  
Looking south west, Scale 1x1m

Plate 11: Oblique view of south wall of drawbridge pit  
Looking south east, Scale 1x1m

Plate 12: Oblique view of north wall of drawbridge pit,  
looking north east, Scale 1x1m

Plate 13: Oblique view of north wall of drawbridge pit, looking north west, Scale 1x1m

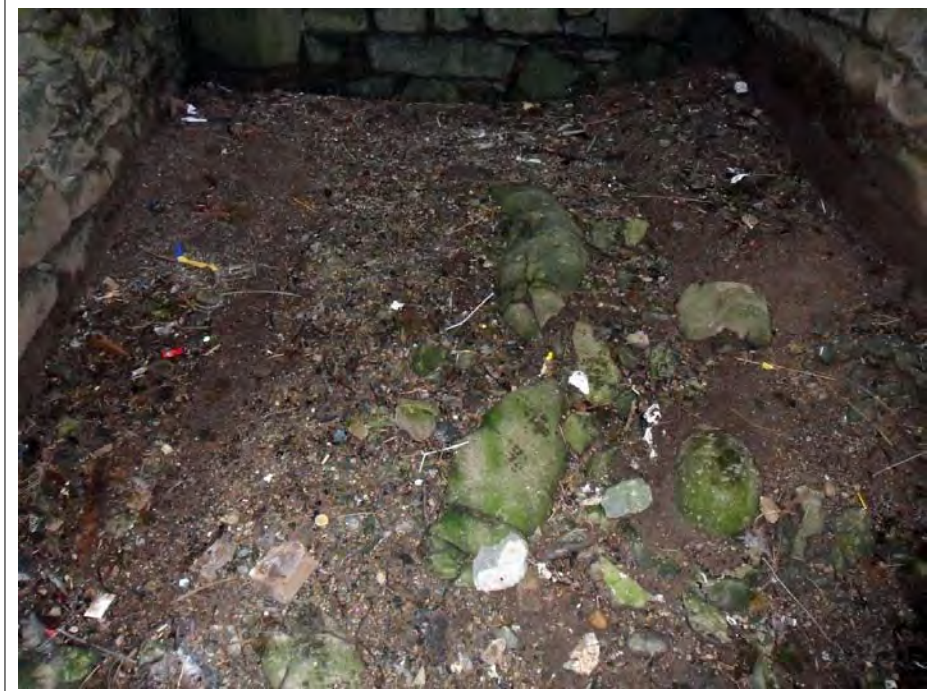
- 4.4.3 The base of the drawbridge pit is covered in a sandy gravel material though bedrock is visible jutting through the surface in places. Three trenches were excavated within the pit to ascertain the depth of material at its base.

Plate 14: View of base of drawbridge pit

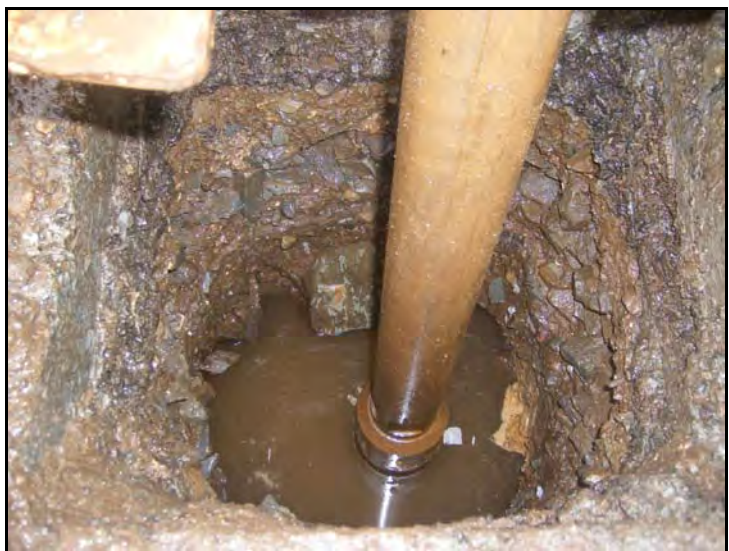
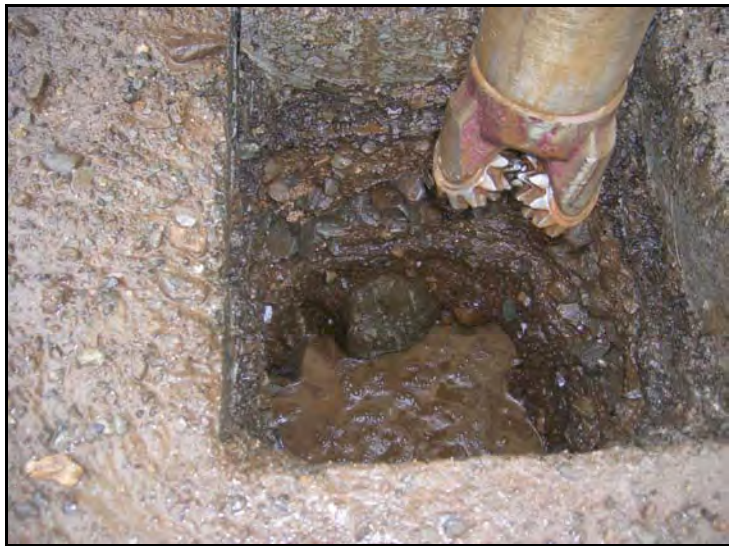
| | | | | Made Ground - Dense to medium dense dark brown and dark grey brown silty very sandy gravel with many sub angular cobbles and occasional boulders. Gravel is sub angular fine to coarse or siltstone and sandstone. | | | | |
| | | | 1.50 | large boulder at 1.30m preventing penetration | | | | |

Ground strata on inspection pit at BH2

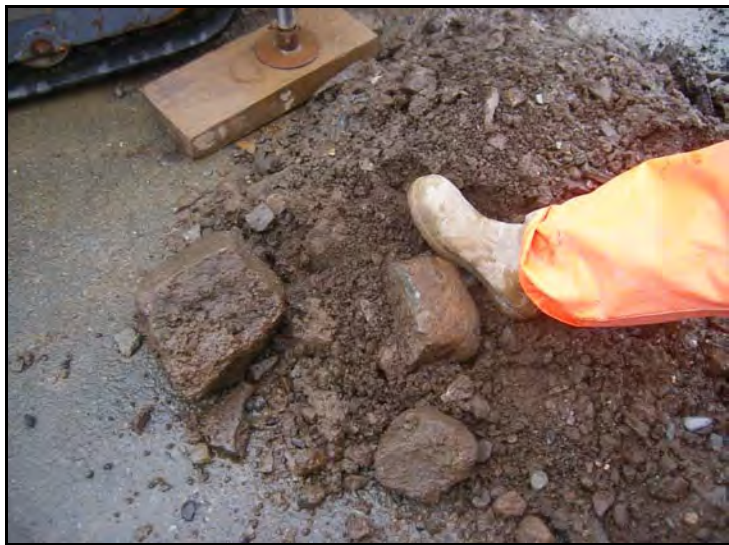
| 1.20 | U | | | Made Ground - Medium dense dark brown and dark grey brown silty very sandy gravel with many sub angular cobbles and occasional boulders. Gravel is sub angular fine to coarse or siltstone and sandstone. | | | |
| 2.20 | SPT N = R | 50 blows for 265mm | | Dense to medium dense dark brown and dark grey brown silty slightly clayey very sandy GRAVEL with many sub angular cobbles and many boulders. Gravel cobbles and boulders are sub angular and of siltstone and sandstone. (possible Made Ground) | | | |

Excavated ground from inspection pit at BH1
