## **Harlech Castle Footbridge, Harlech, Gwynedd**

Archaeological Excavation and Watching Brief

Report No. 1331

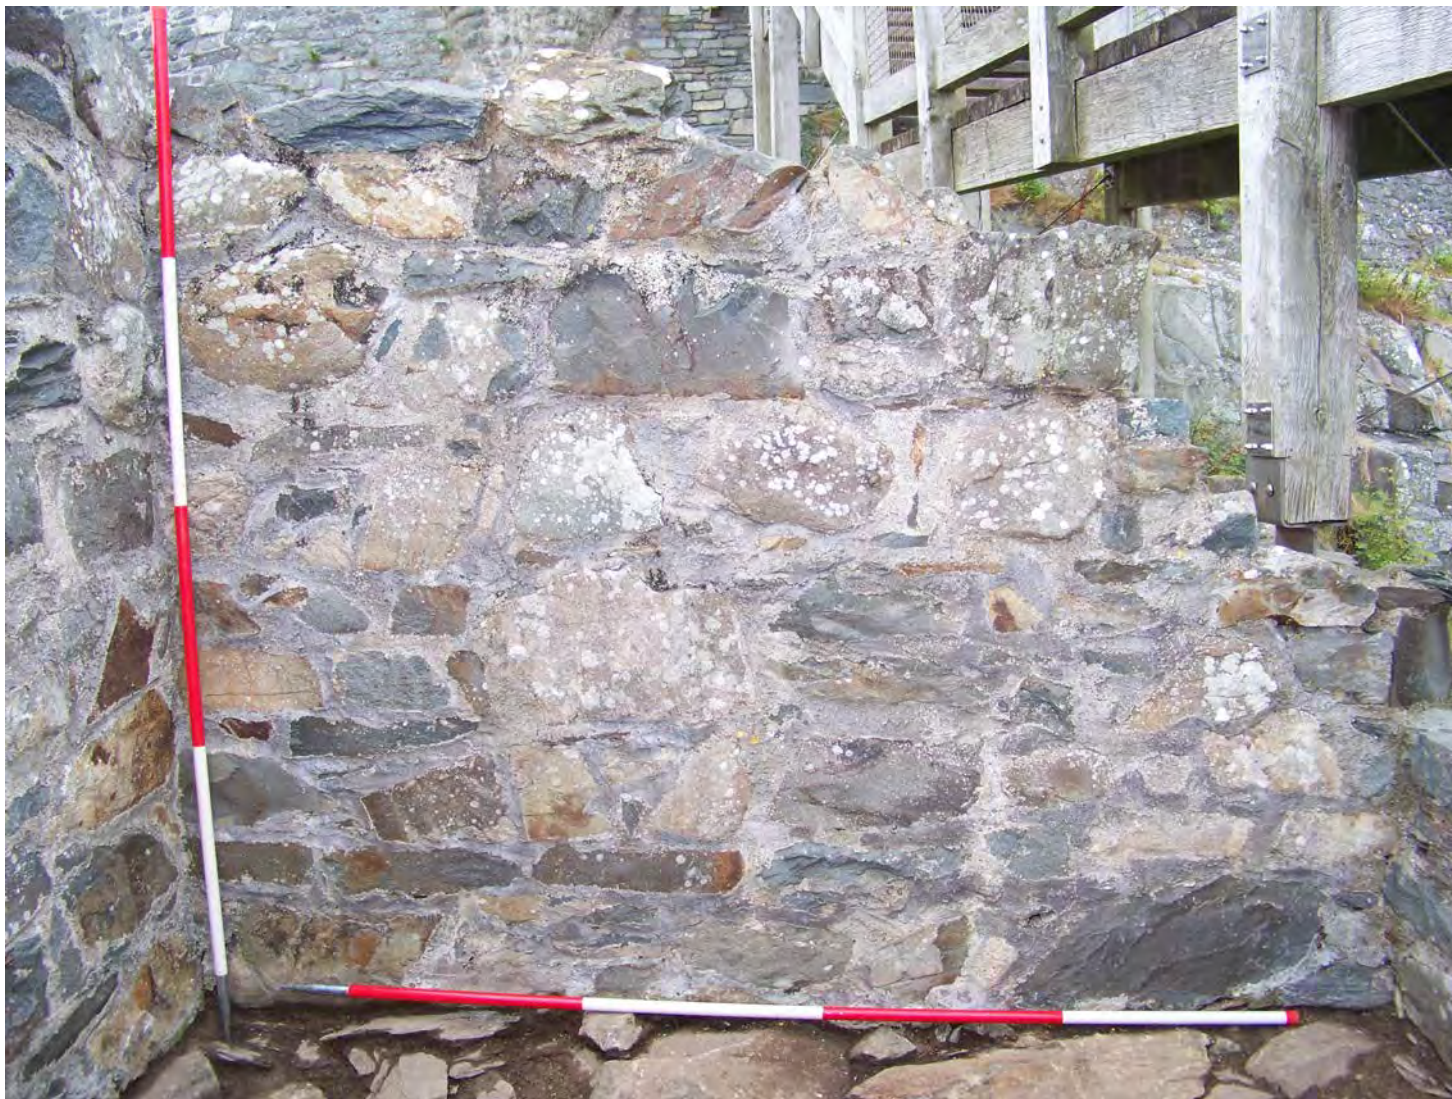
Fig.10  
Foundation 3  
walls  
(East facing)

Foundation 3: Full elevation of east facing wall of pier base

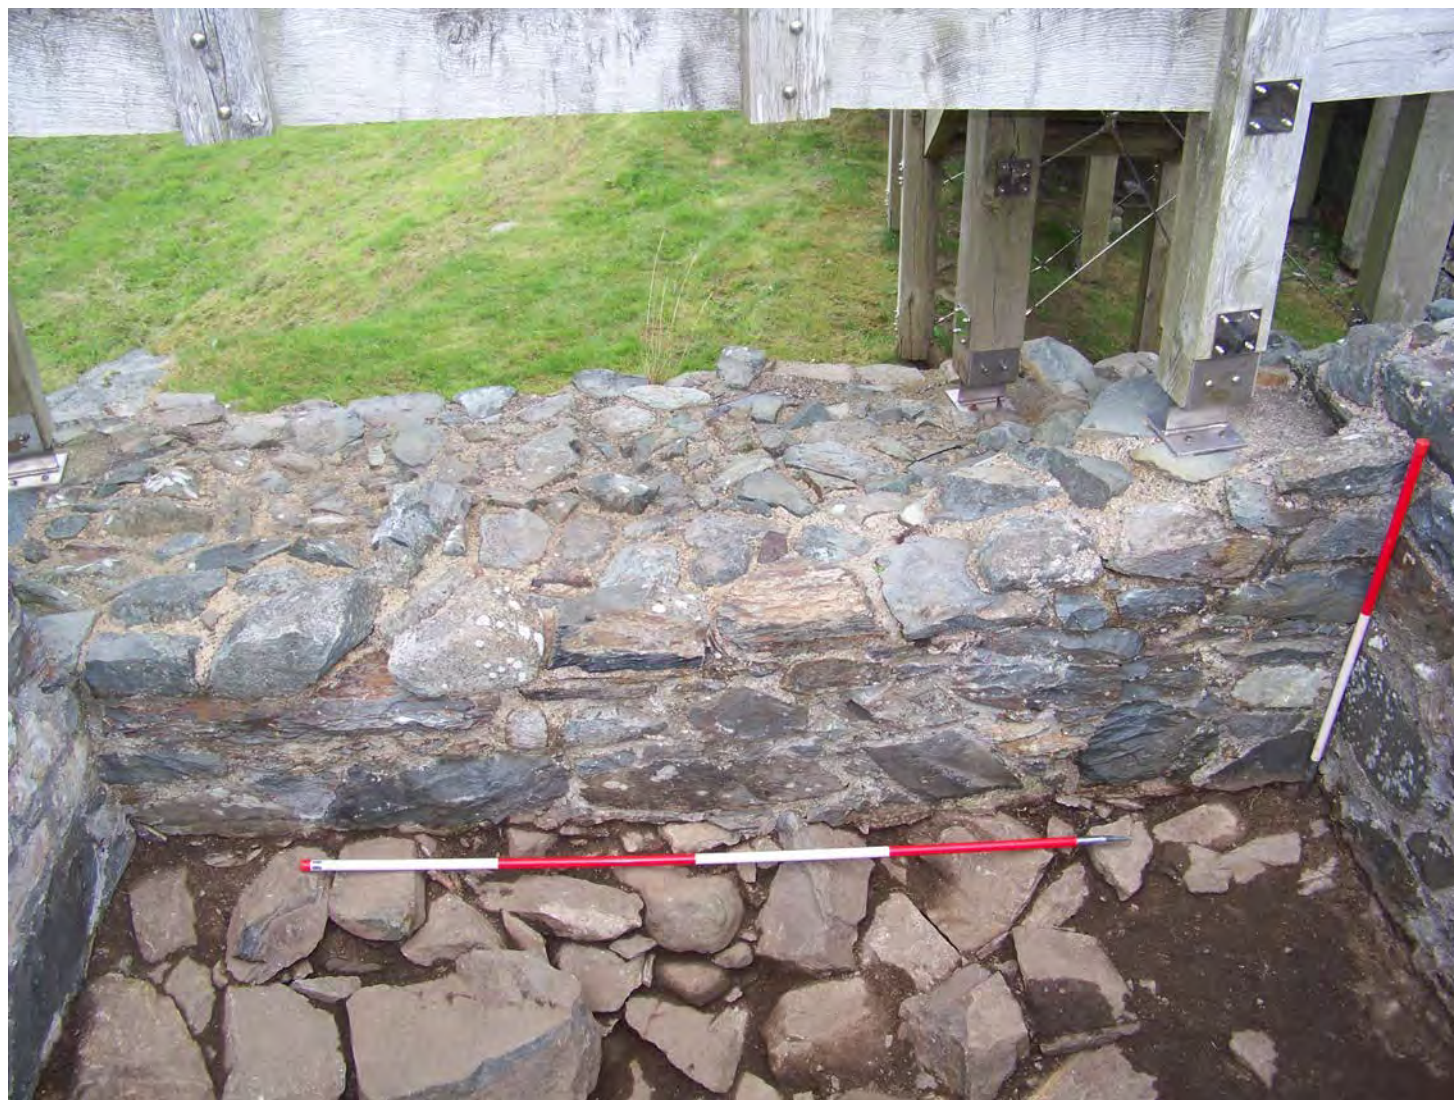
Fig. 11  
Foundation 3  
walls  
(South facing)

Foundation 3: Full elevation of south facing wall of pier base

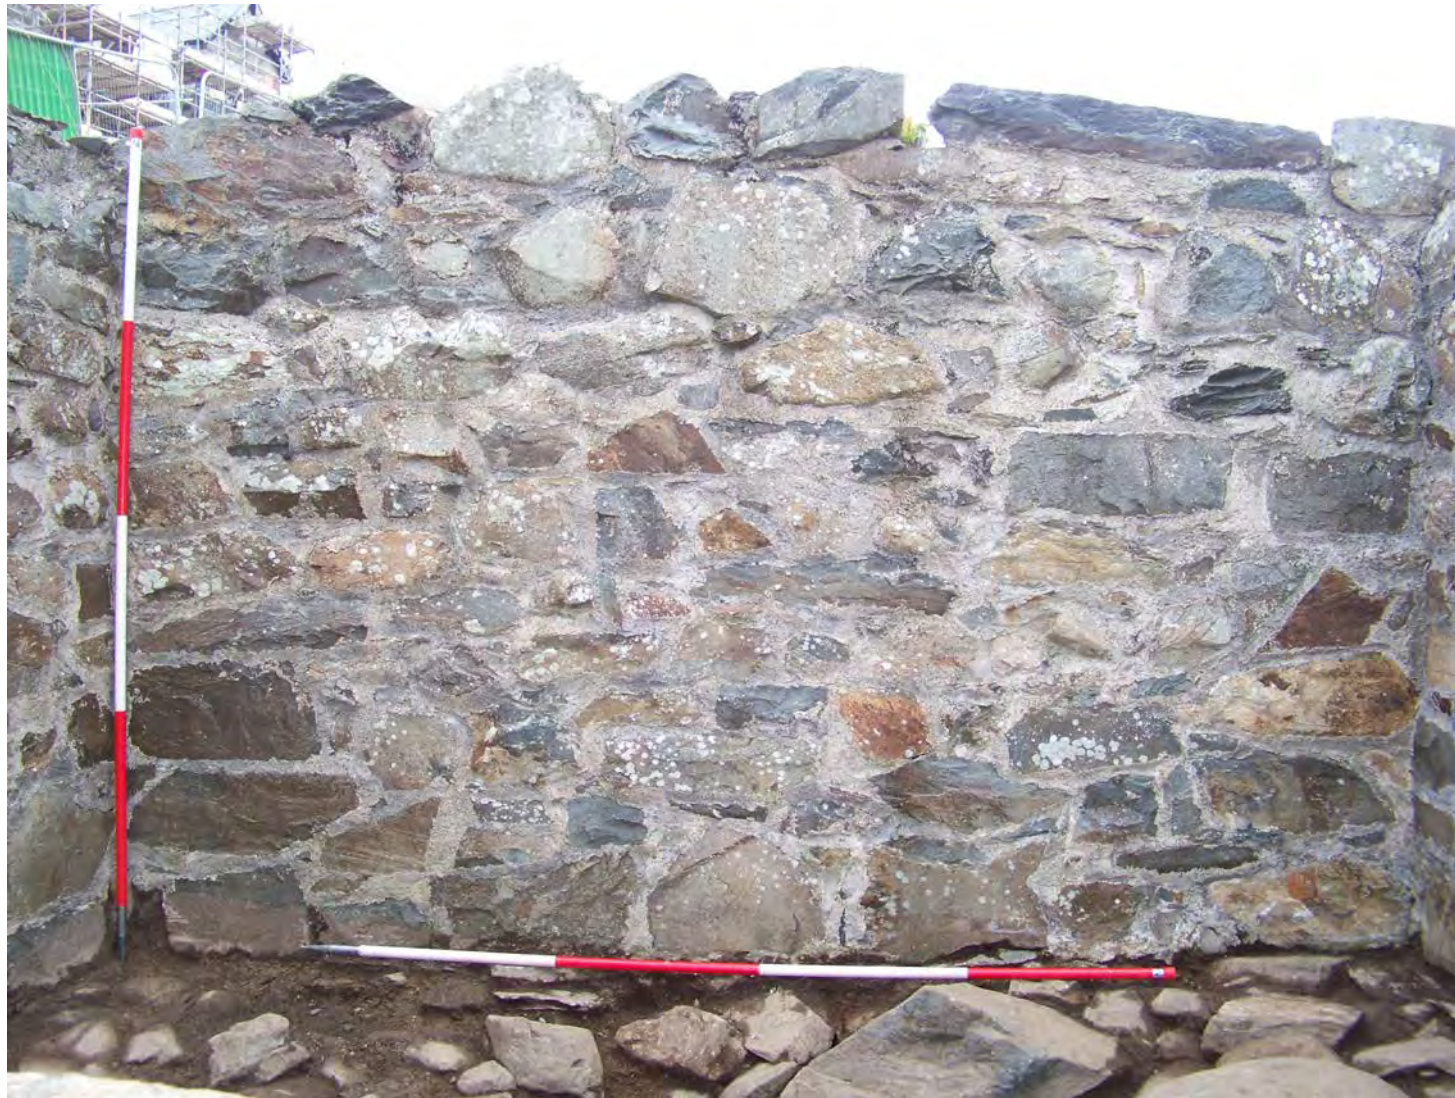
Fig. 12

Foundation 3: Full elevation of north facing wall of pier base

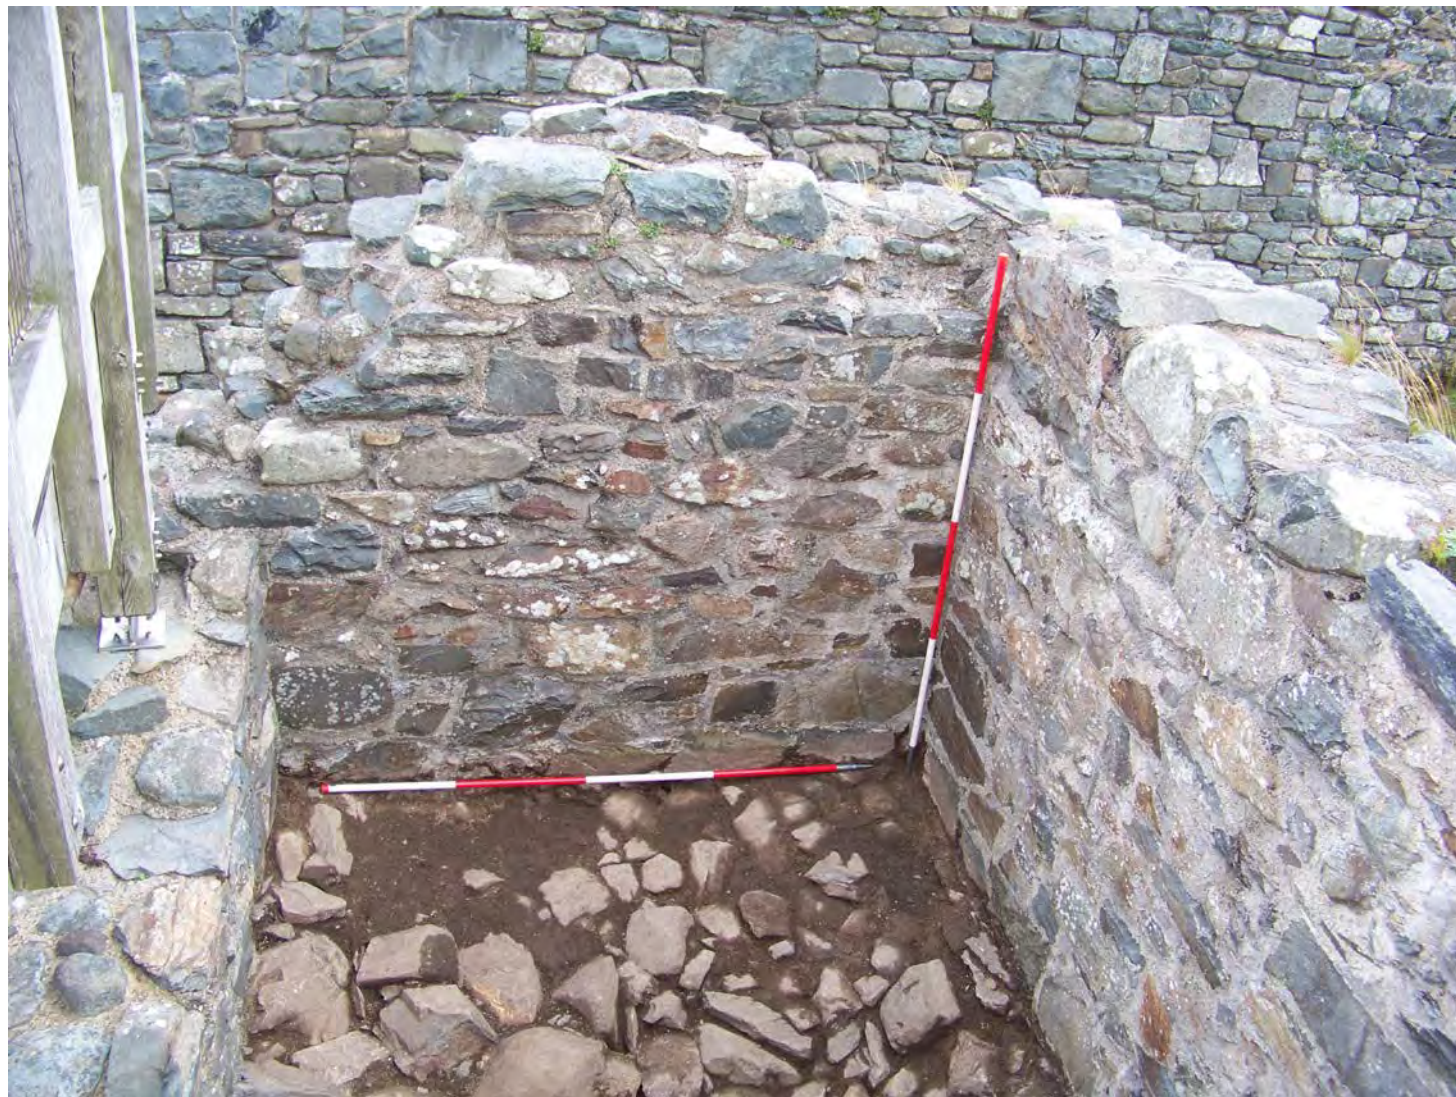
Fig. 13

Foundation 3: Full elevation of west facing wall of pier base

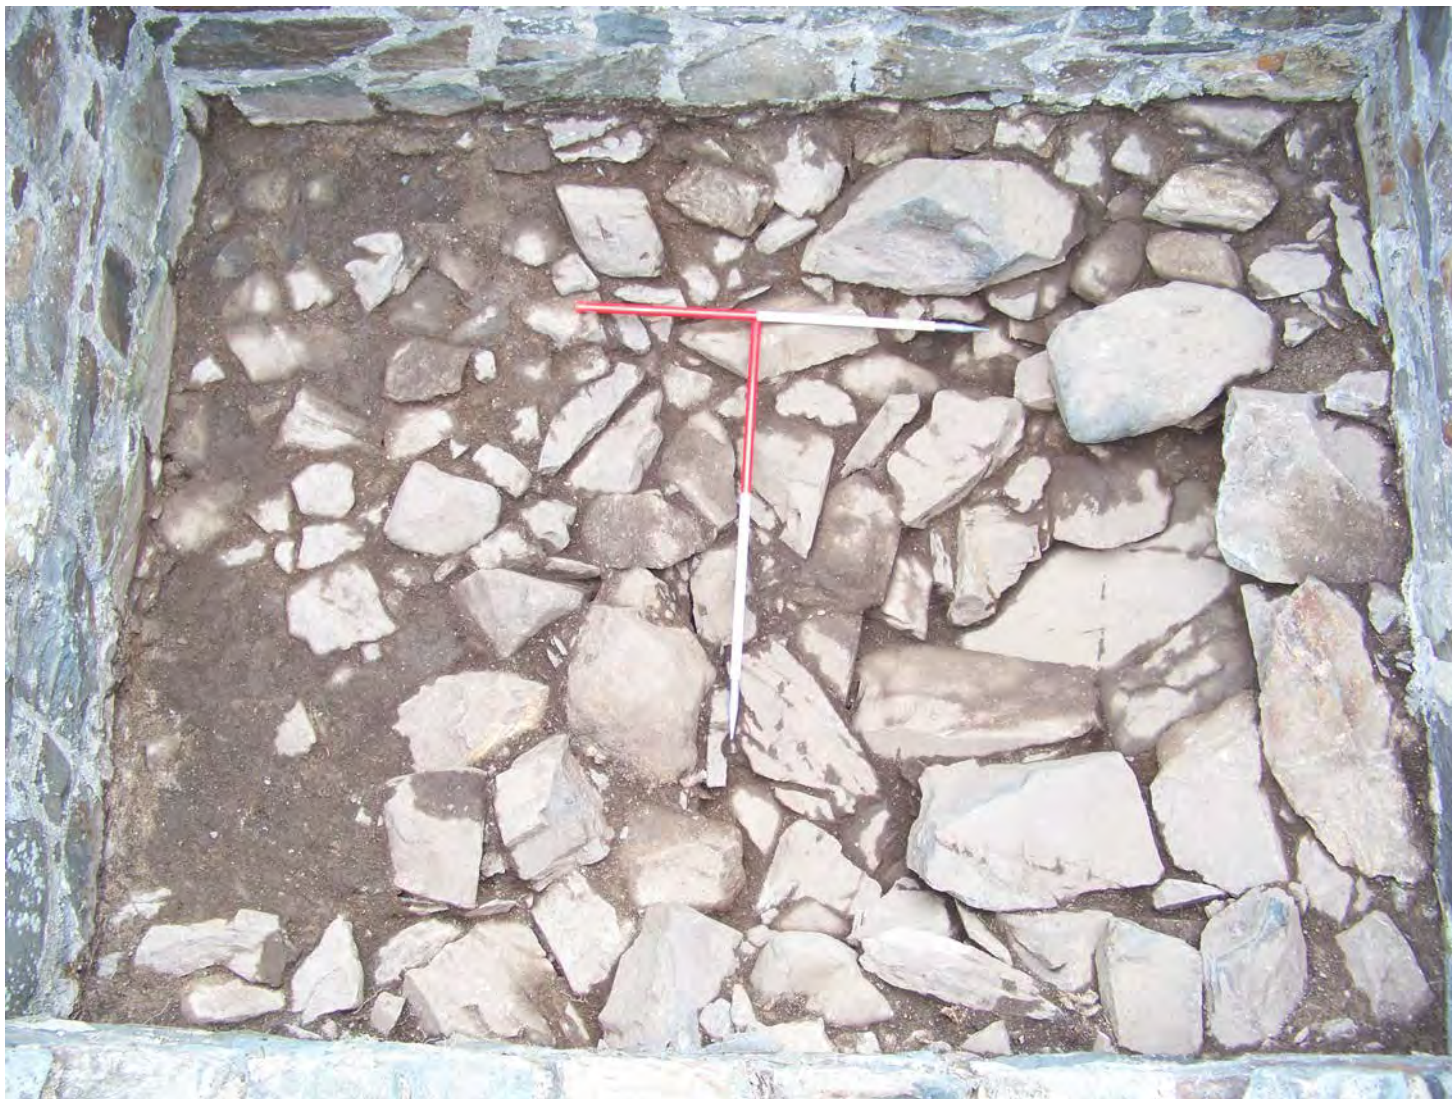
Fig. 14  
Mid-excavation  
image of  
Foundation base  
3

Foundation 3 base, mid-excavation (looking south)

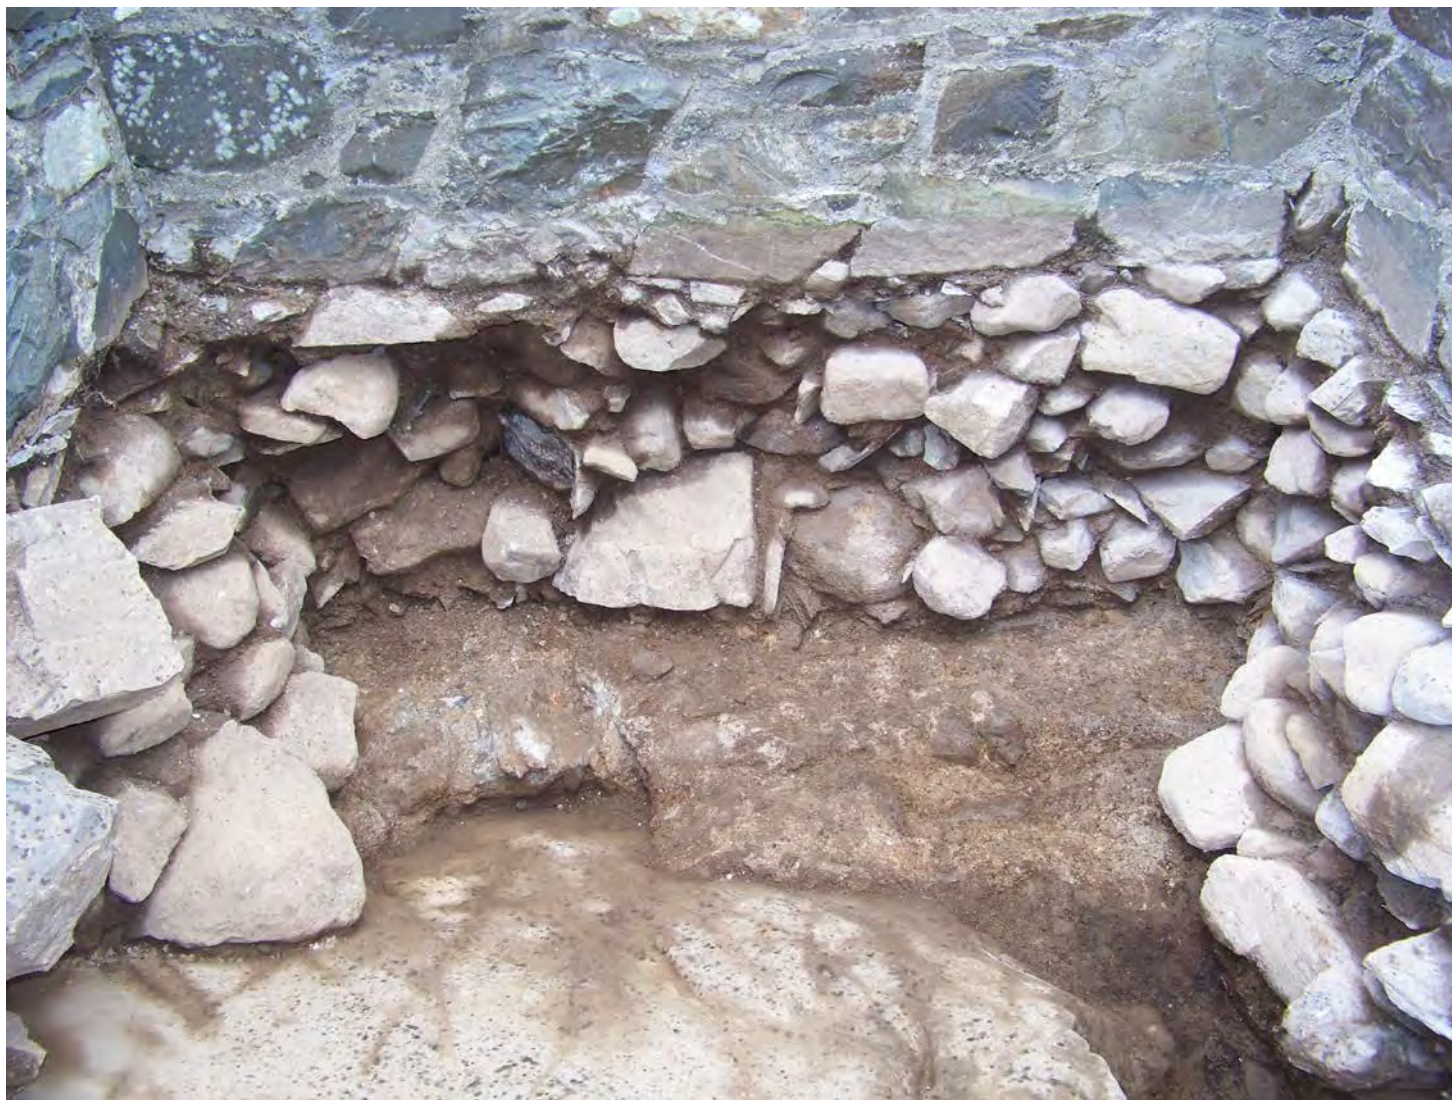
Fig. 15  
Post-excavation  
image of  
Foundation base  
3

Foundation 3 base, post-excavation with deposit 311 in background (looking east)

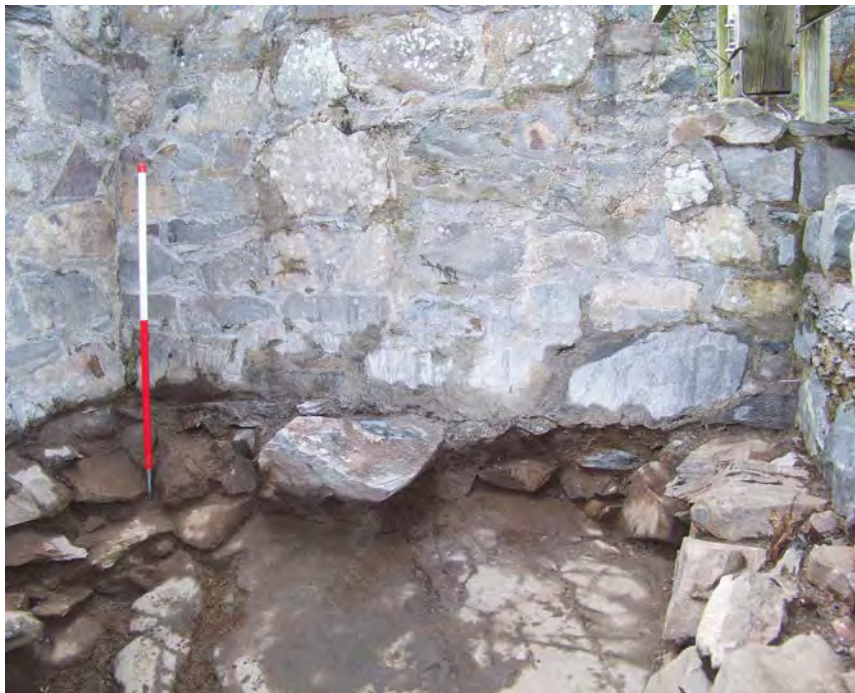
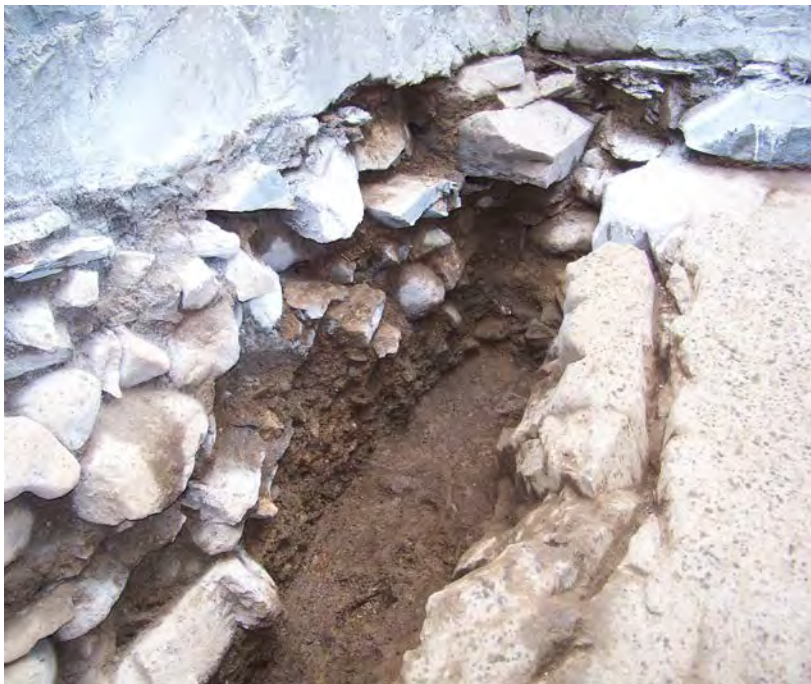
Fig. 16  
Post-excavation  
image of  
Foundation base  
3

Post-excavation image showing bedrock (009) on northern and western side of base with stones (007) above levelling deposit (008) (looking west)

Post-excavation image showing bedrock edge in south-western corner of base (looking west-southwest)

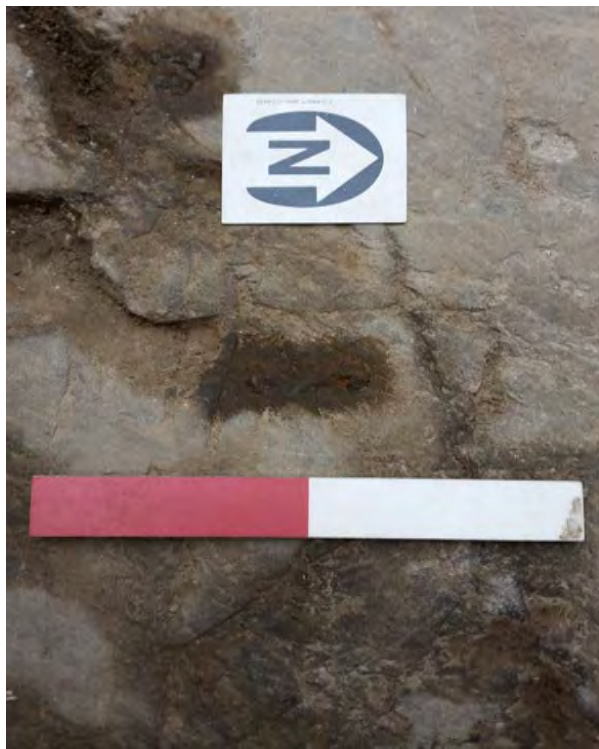
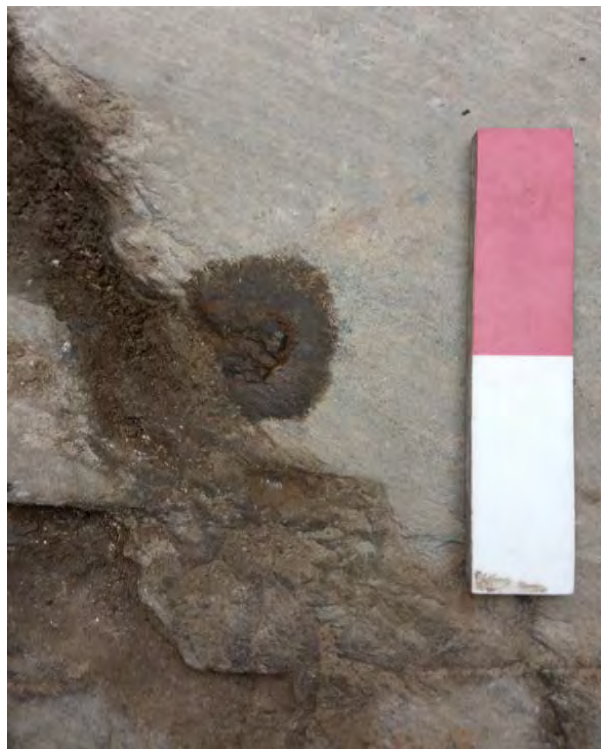
Fig. 17

Post-excavation image showing two iron stone splitter fragments in bedrock

Post-excavation image showing iron stone splitter fragment in bedrock

Post-excavation image of stone splitters in bedrock

The natural bedrock (309) was exposed and three small iron stone chisel/splitter fragments were revealed fossilised in the bedrock (Fig. 17). These appeared to follow the east-west alignment of a fissure that was 1.40m long, 0.20m deep and

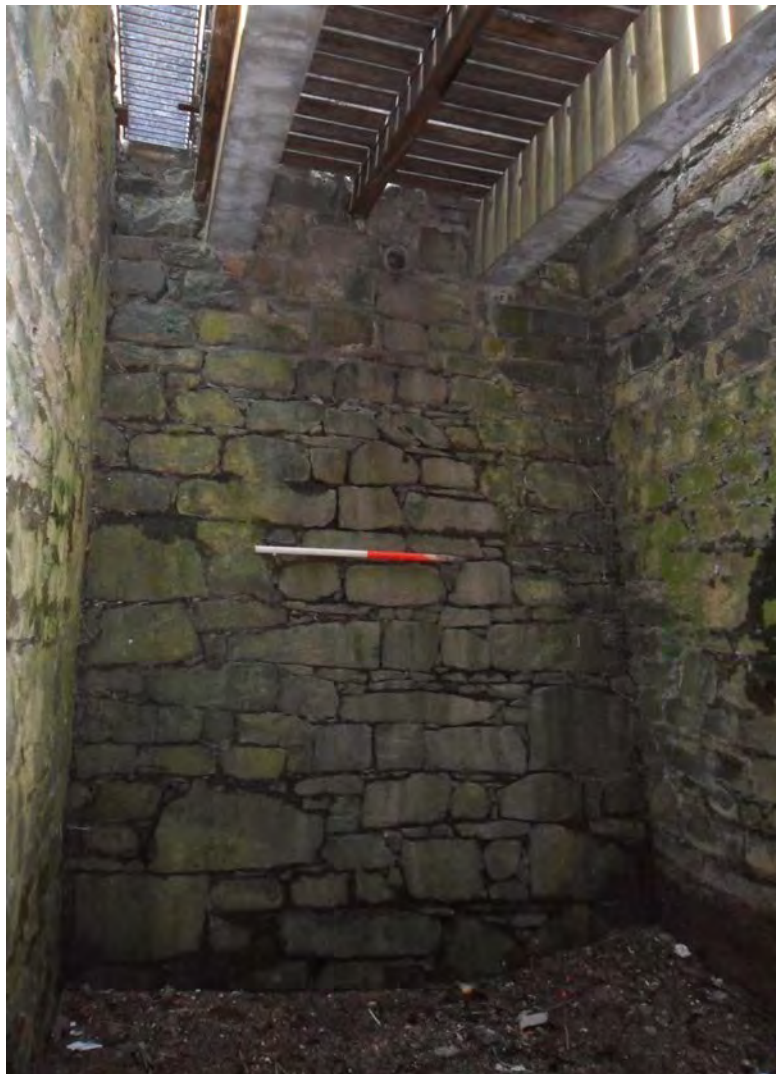
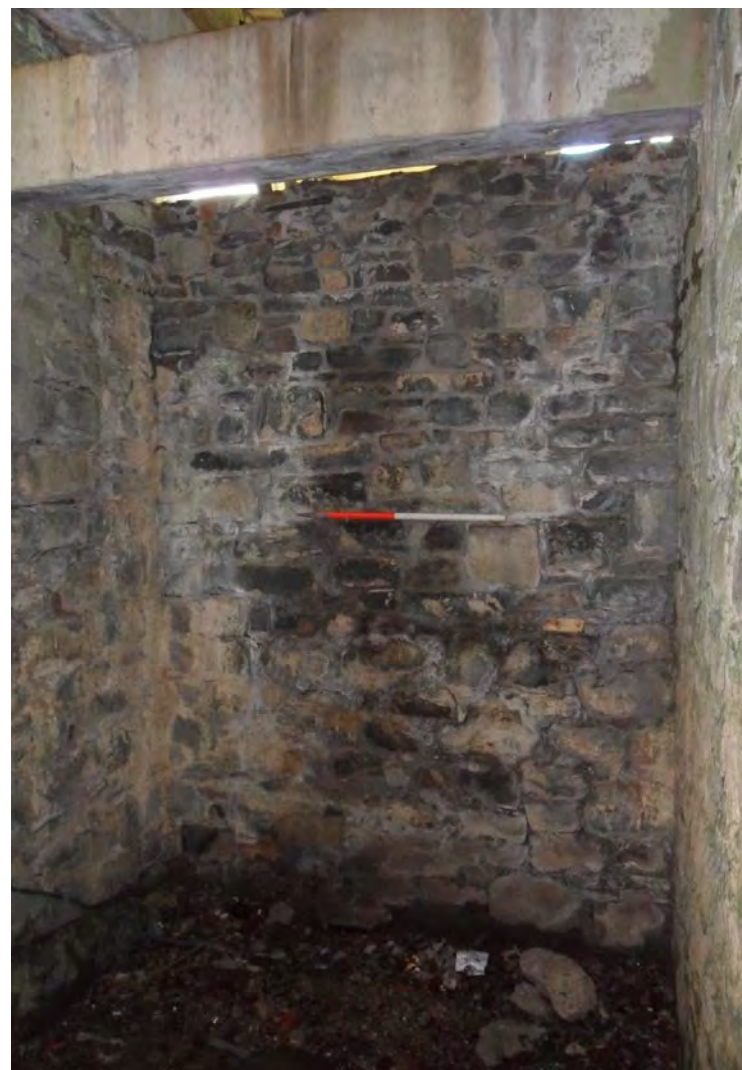
Fig. 18  
Drawbridge Pit  
elevations

East facing elevation image of drawbridge pit

West facing elevation image of drawbridge pit

Wall [401] was east facing and 2.50m long. It comprised of large to medium sub-rectangular dressed stones varying in size from 0.20m-0.35m laid in regular courses and bonded with a pale greyish white lime mortar. There appeared to be no foundation cut for this wall and it was built directly on top of natural bedrock (406). Approximately 0.50m of the uppermost part of this wall had appeared to have been reconstructed, most likely during the 1960s remodelling of the access to the castle and the placing of a concrete girder to support the modern bridge access.

Wall [403] was west facing and 2.50m long. It comprised of large to medium sub rectangular stones ranging in size from 0.20m-0.35m laid in regular courses and bonded with a pale greyish white lime mortar. There appeared to be no foundation cut for this wall and like the previous walls it was built directly on top of the natural bedrock (406). It was established during the excavation that only the first 1.50m of this wall from ground level was original construction. The upper 2m above it was a 1960s reconstruction associated with the removal of the causeway and the construction of the first wooden bridge access into the castle. Three circular tubes 0.16m-0.20m in diameter had been drilled through the wall close to the base to allow electrical cabling to be installed in the drawbridge pit and elsewhere in the castle. The culvert structure [410] passed underneath the wall to drain into the moat beyond.

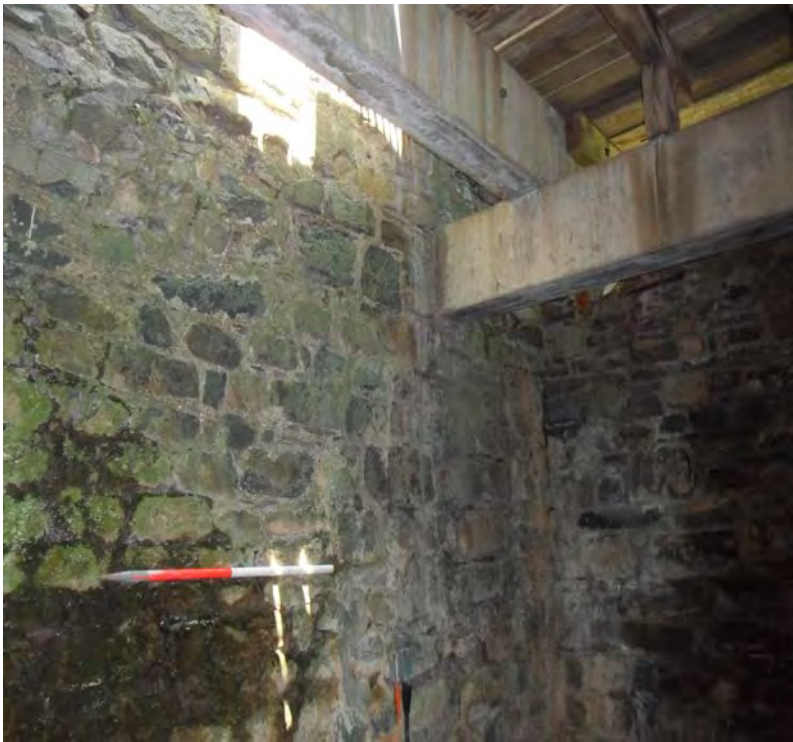
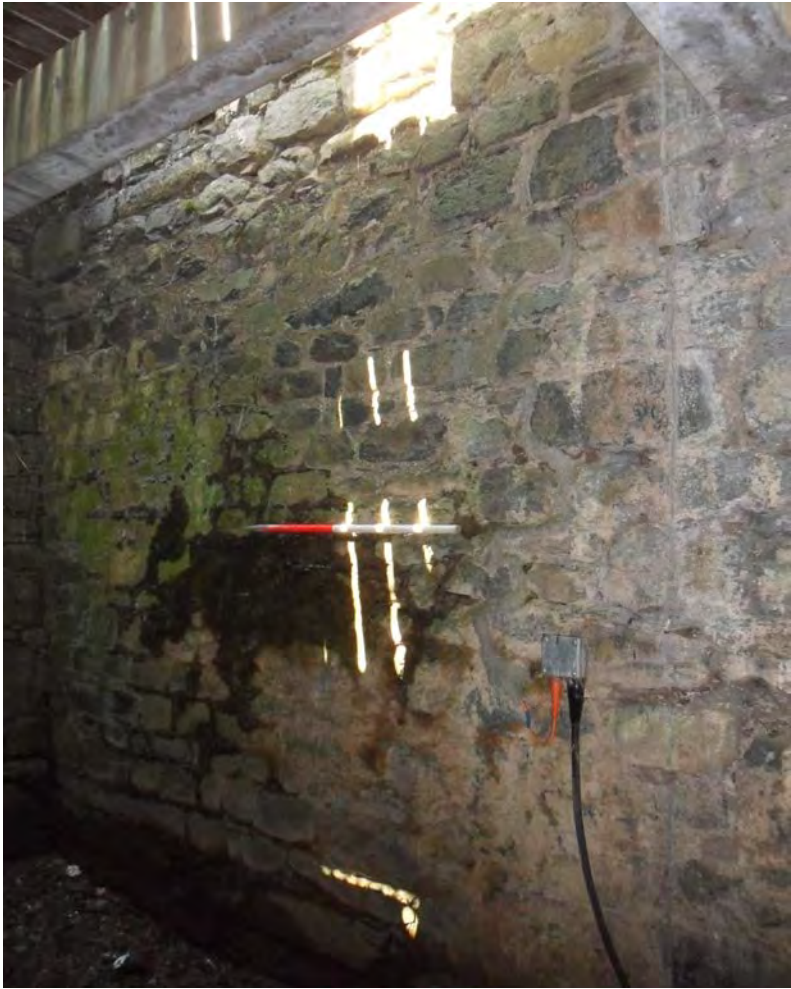
Fig. 19  
Drawbridge Pit  
elevations

Oblique images of south facing elevation of drawbridge pit

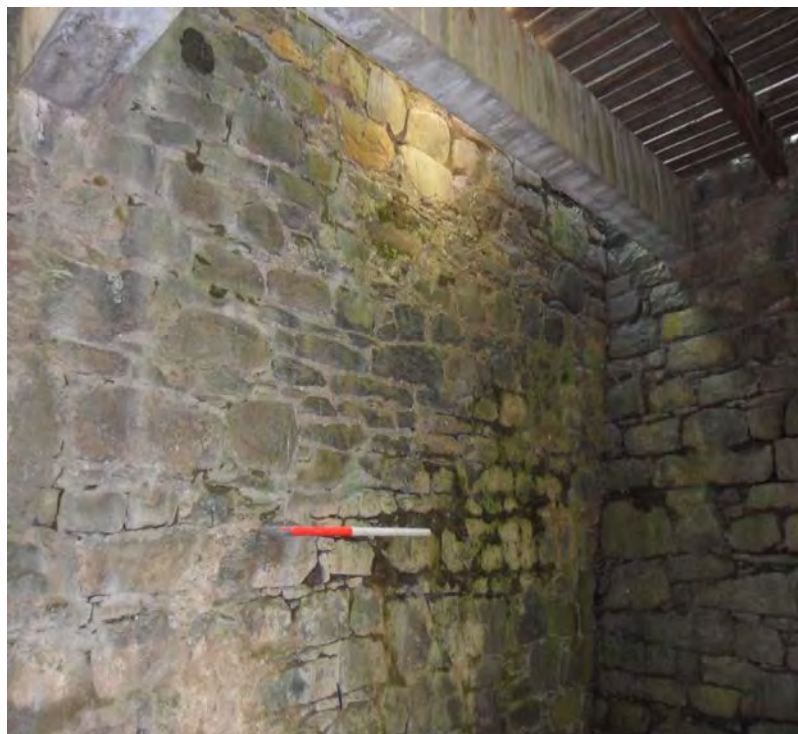
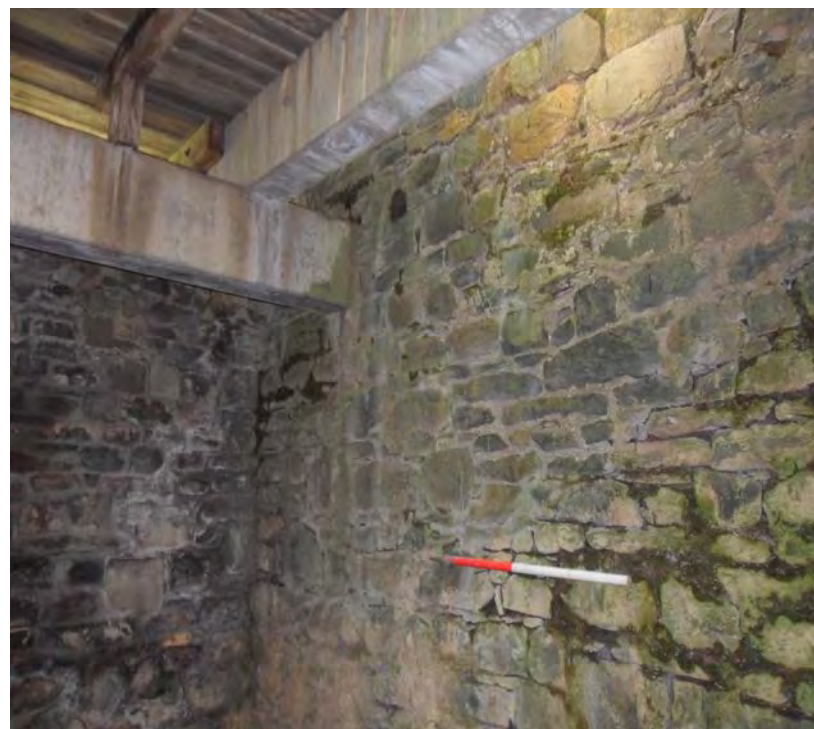
Fig. 20

Oblique images of north facing elevation of drawbridge pit

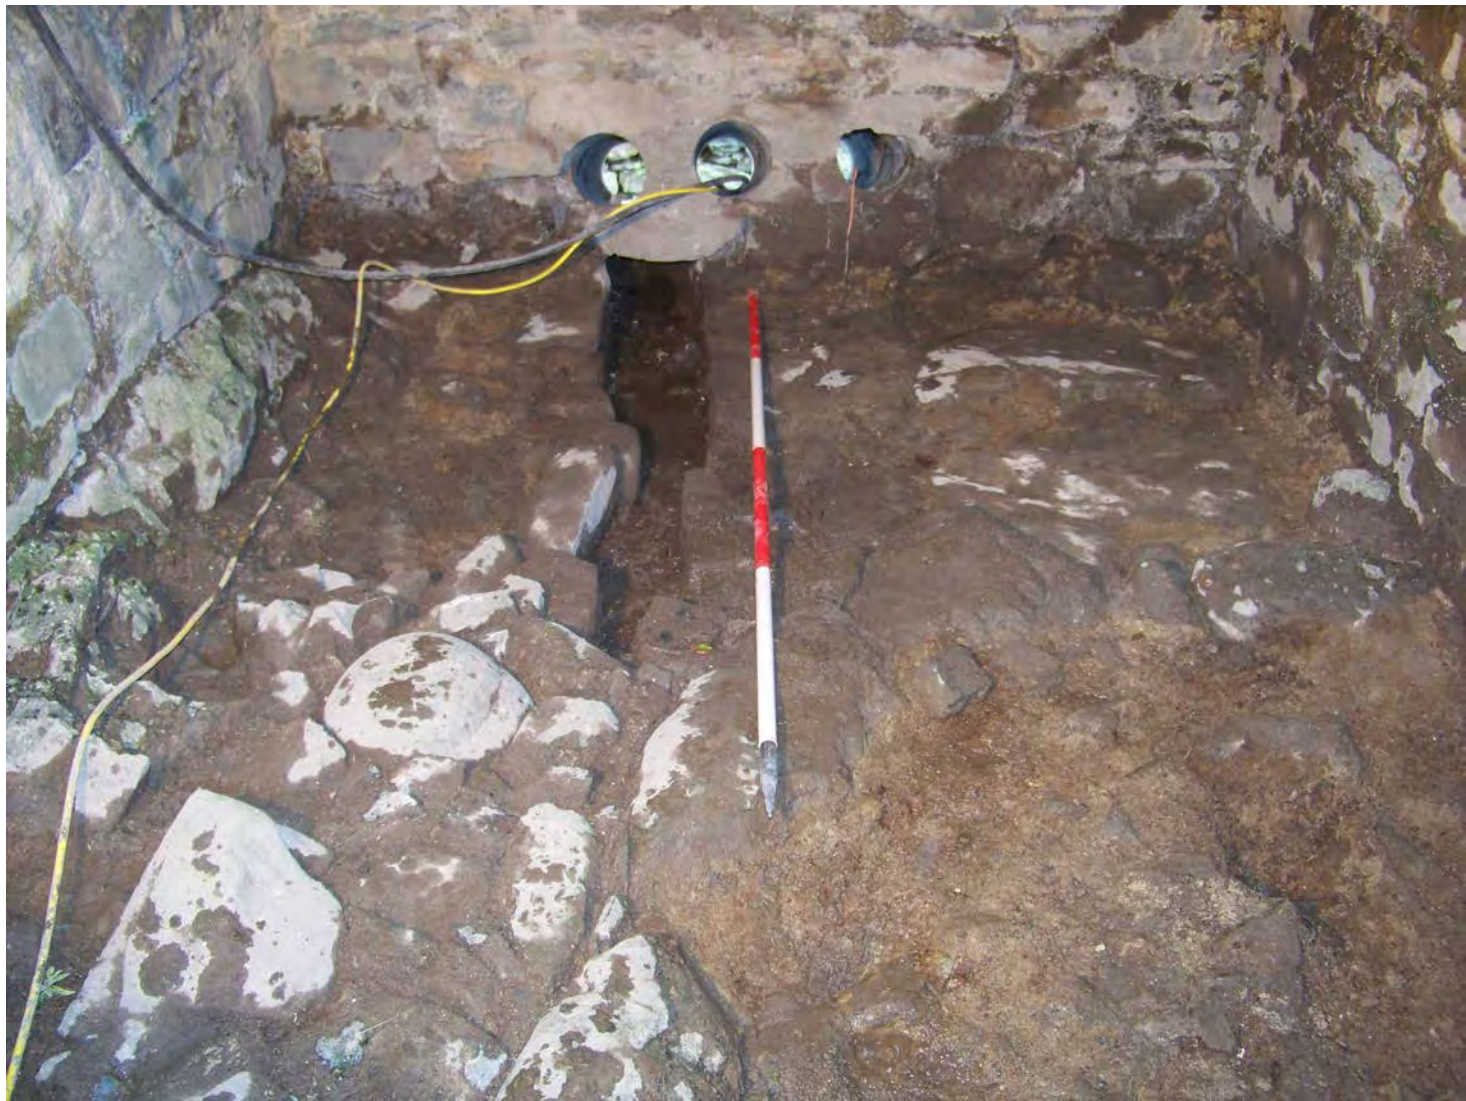
Fig. 21

Post-excitation image of Drawbridge pit culvert and base of west facing wall (looking east)

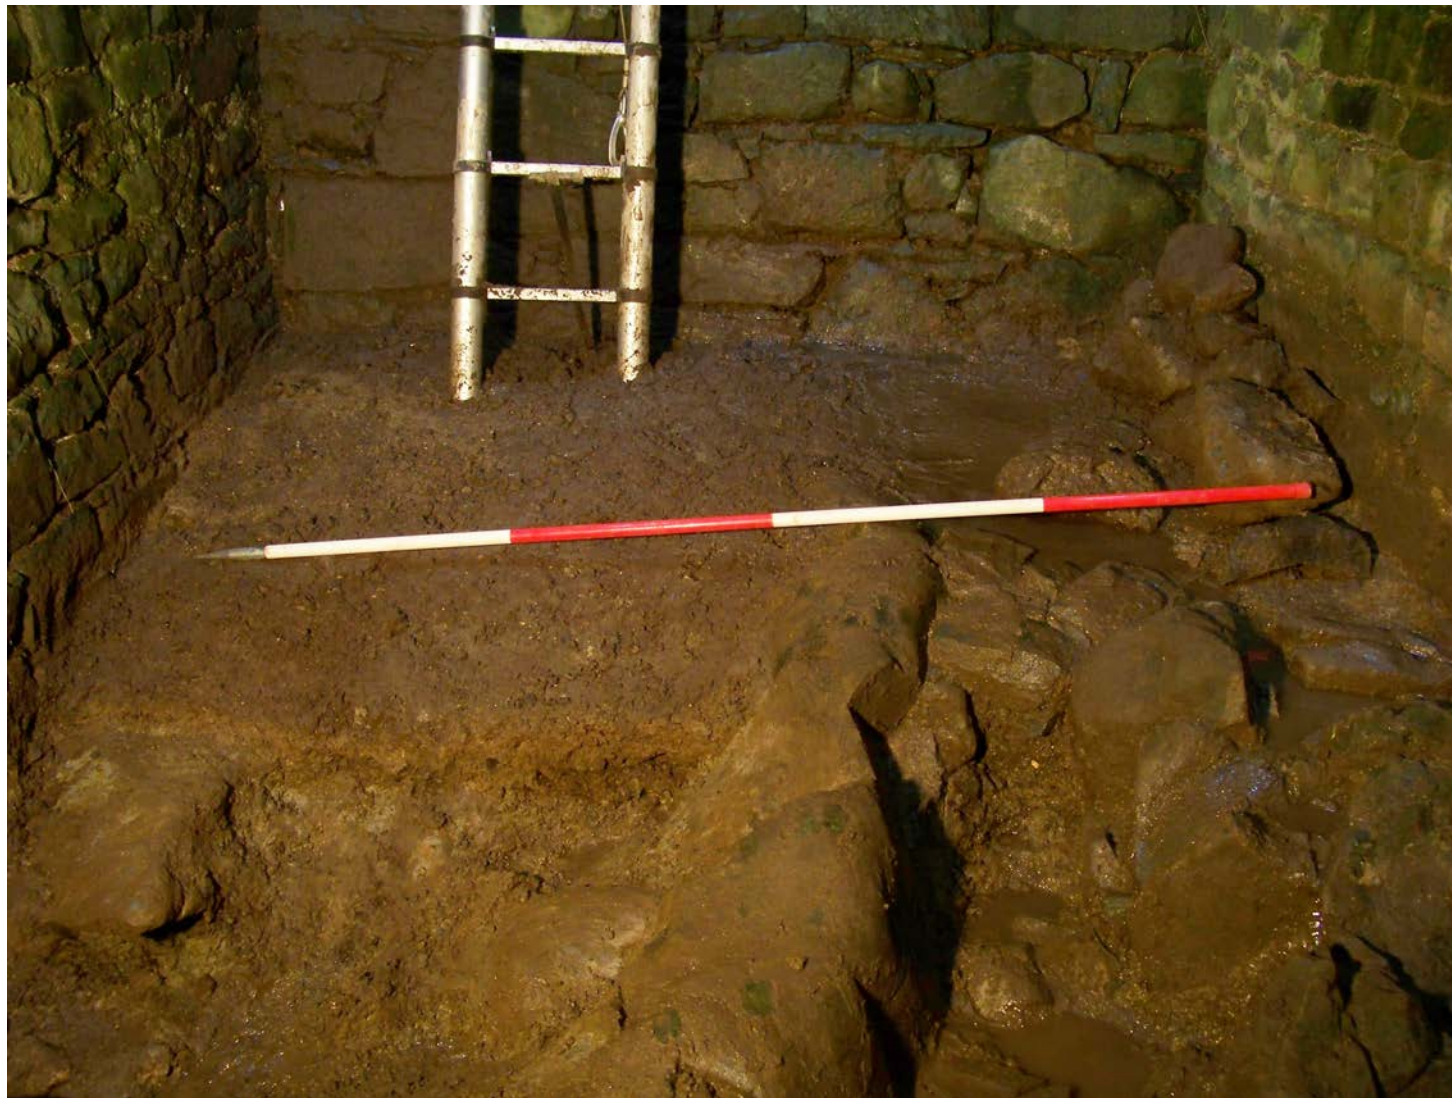
Fig. 22

Post-excavation image of east facing Drawbridge pit base section (looking west)

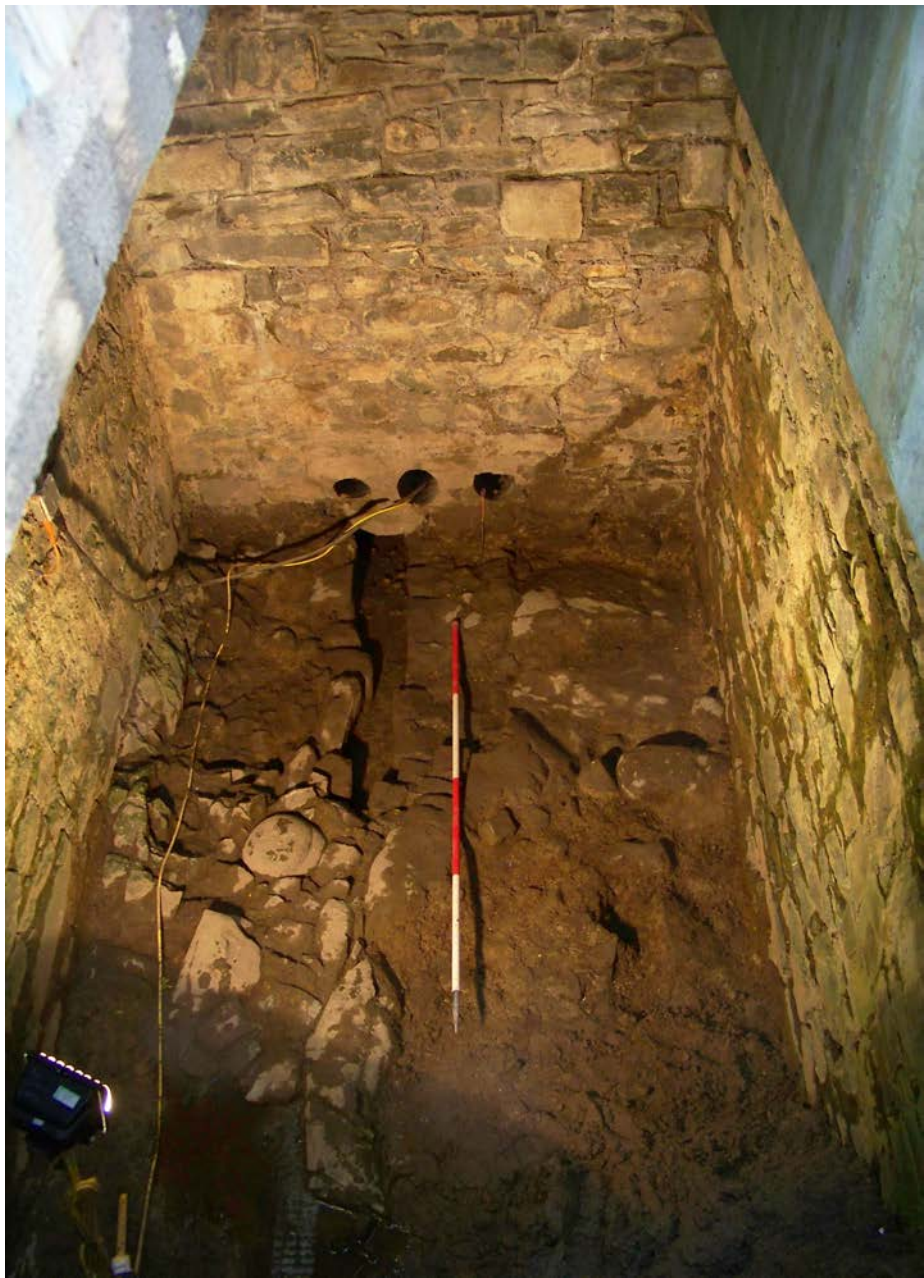
Fig.23

Post-excavation image of Drawbridge pit base (looking east)

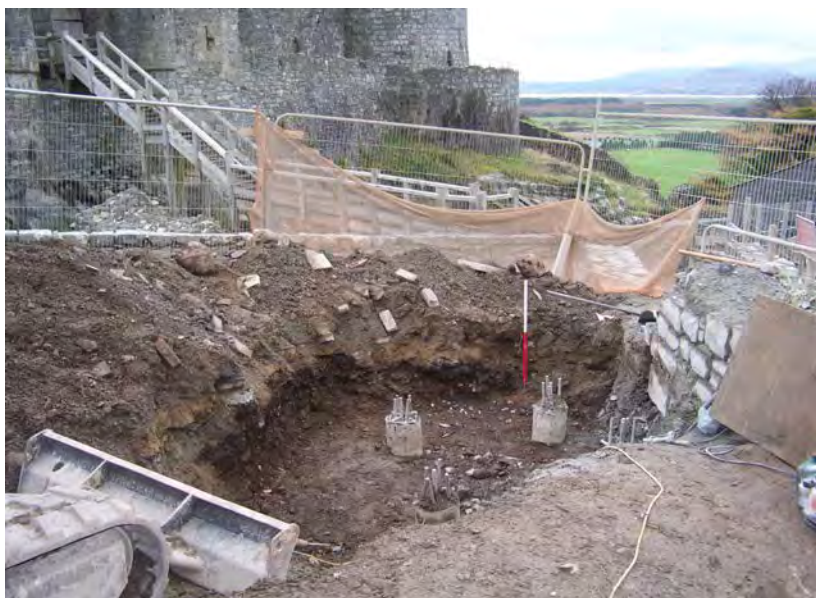
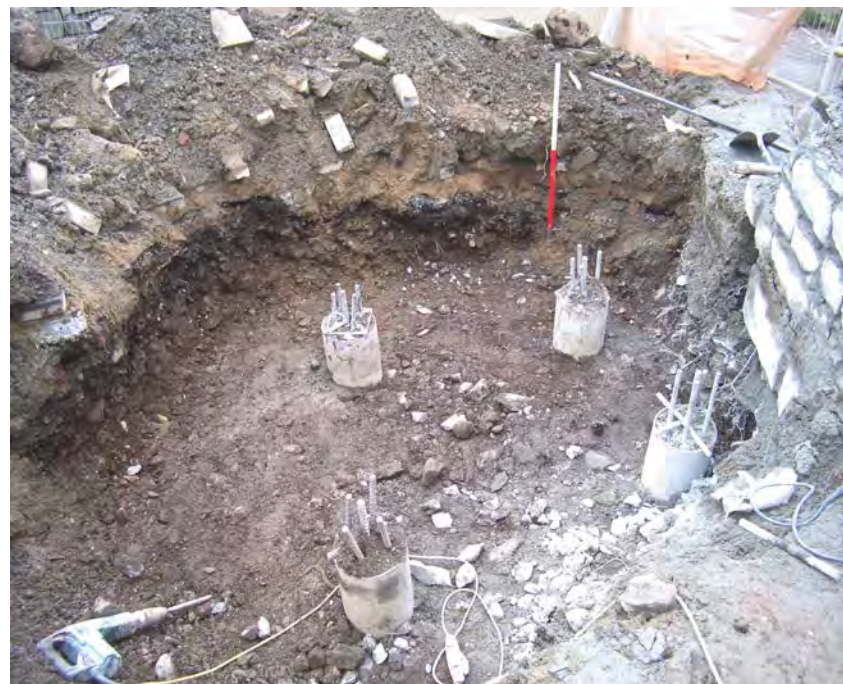
Fig. 24

Foundation 2 showing tarmac surface and modern made up ground in castle car park (looking north-west)

A watching brief was carried out during the machine excavation of Foundation Trench 2 (see Fig.24) in the Car Park area to the east of the castle entrance on the 17<sup>th</sup> November 2014.

uncovered. The deposit contained plastic sheeting fragments and appeared to be modern made ground used as a levelling deposit below the older tarmac surface. No older archaeological deposits, features or artefacts of note were recovered or observed during this work.
