## **Harlech Castle Footbridge, Harlech, Gwynedd**

Archaeological Excavation and Watching Brief

Report No. 1331

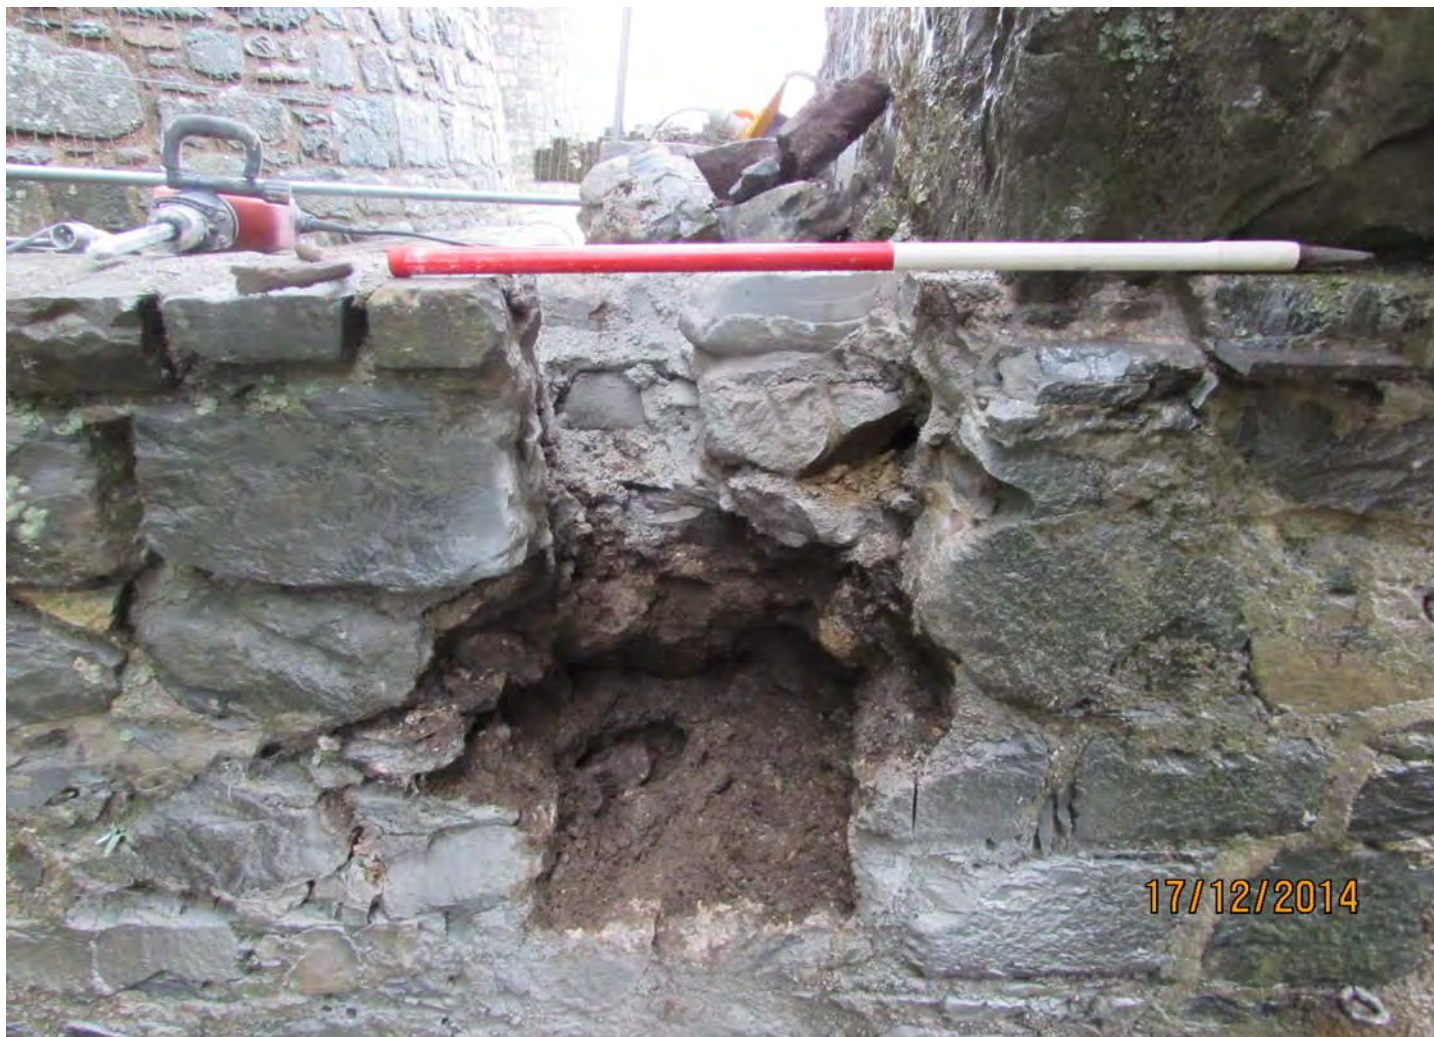
Fig. 25

Removal of stone in upper Drawbridge pit south facing wall for new bridge socket - see fig.5 for location (looking north)

Construction work  
on Drawbridge pit  
south facing wall

In the southern wall, two *in situ* stones with relatively modern cement pointing were cut to produce an L-shaped hollow, measuring 0.8m at the base and 0.5m at the upper edge, with a maximum depth of 0.5m. The stones were located between 1.4m and 0.9m from the east end of the pit. The stones and bonding material were removed, revealing that the wall facing stone was one course only. The material behind the facing stones consisted of a loosely packed stone set in a matrix of dark brown sandy silt and lime mortar (fig. 26). This was the maximum extent of the disturbance to the southern wall.

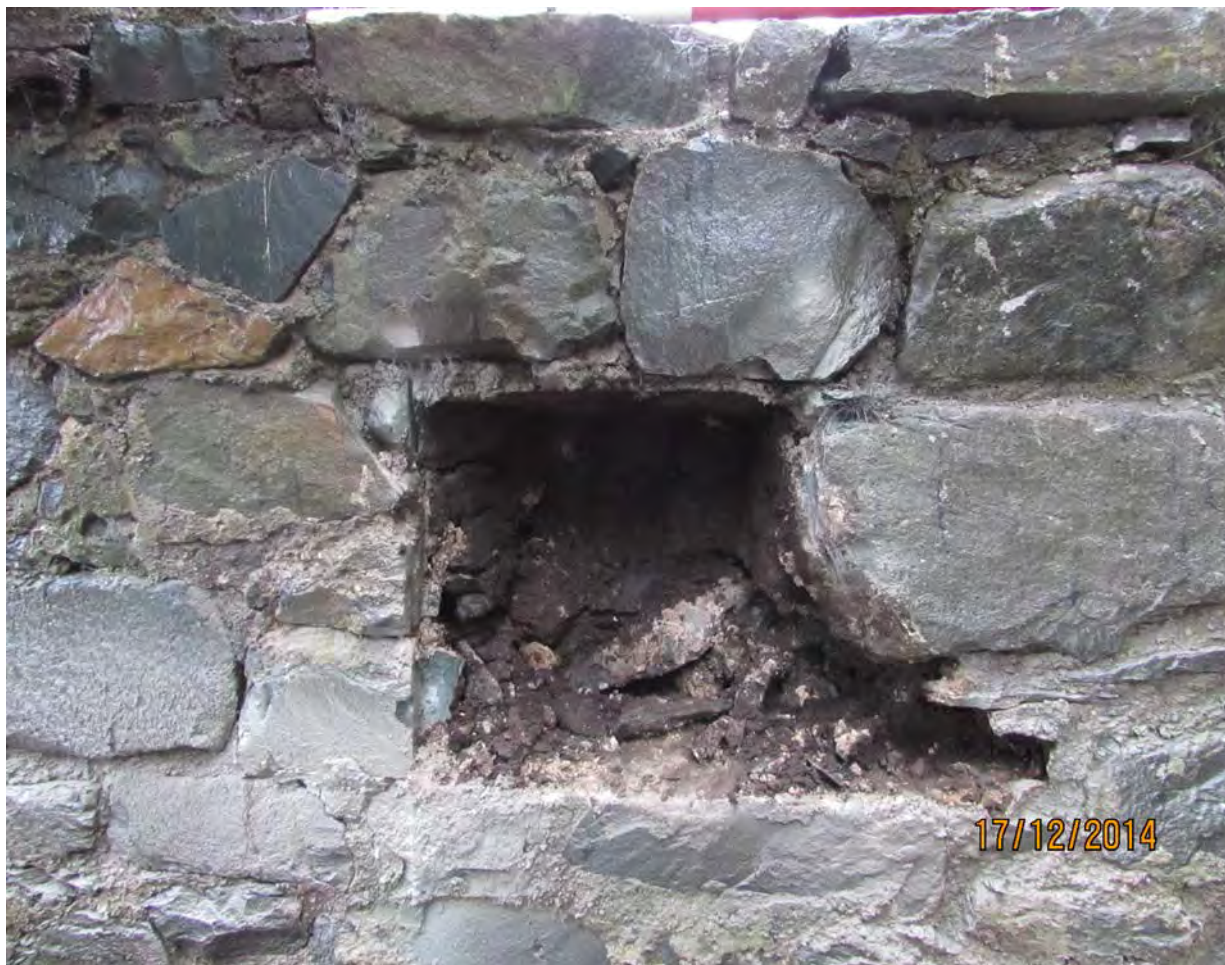
Fig. 26

Removal of stone in upper Drawbridge pit north facing wall for new bridge socket - see fig.6 for location (looking south)

Construction work  
on Drawbridge pit  
north facing wall

The modern cement-beam sockets on the upper, east-facing, elevation of the western drawbridge pit wall were cut away with no disturbance to *in situ* masonry. Two cuts were made into the top of the northern and southern walls of the drawbridge pit (see figs. 25-26). Stones and bonding material were cut from the upper, south facing, edge of the northern wall of the drawbridge pit, between 0.84m and 1.32m from the eastern edge of the drawbridge pit. The maximum depth of the resultant disturbance was 0.85m deep and 0.5m wide. The wall facing appeared to be one course deep and comprised loosely packed stones set in a mix of dark-brown sandy silt and lime mortar. This was the maximum extent of disturbance to the northern wall.

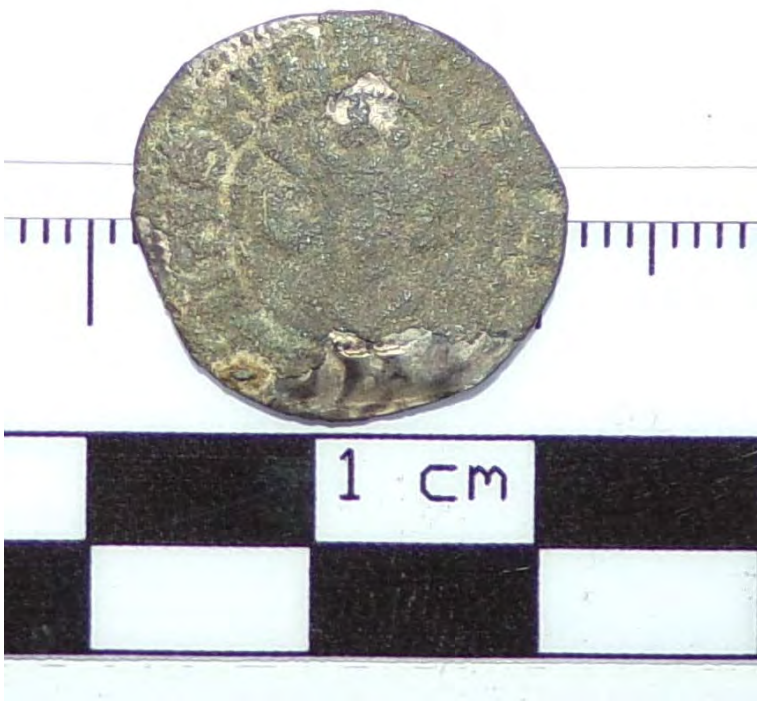
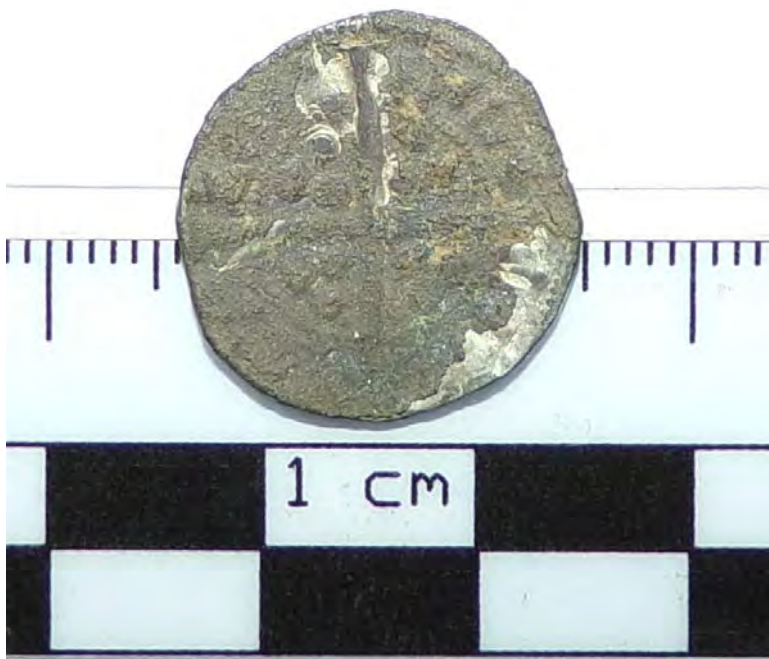
Fig. 27

Edward I or II Long Cross Silver Penny (1301-1314) - context 308

Silver penny from  
context 308  
(Foundation 3)

The coin is either Class 10/Edward I (1301-10) or Class 11/Edward II (1310-14). The latter is in effect a continuation of the former, but unfortunately corrosion has hidden the detail that would distinguish the two (North 1991, 1038-43/1060-2).
