## **Treban Farm, Bryngwran, Anglesey**

Level 3: Archaeological Building Recording

Report No. 1596

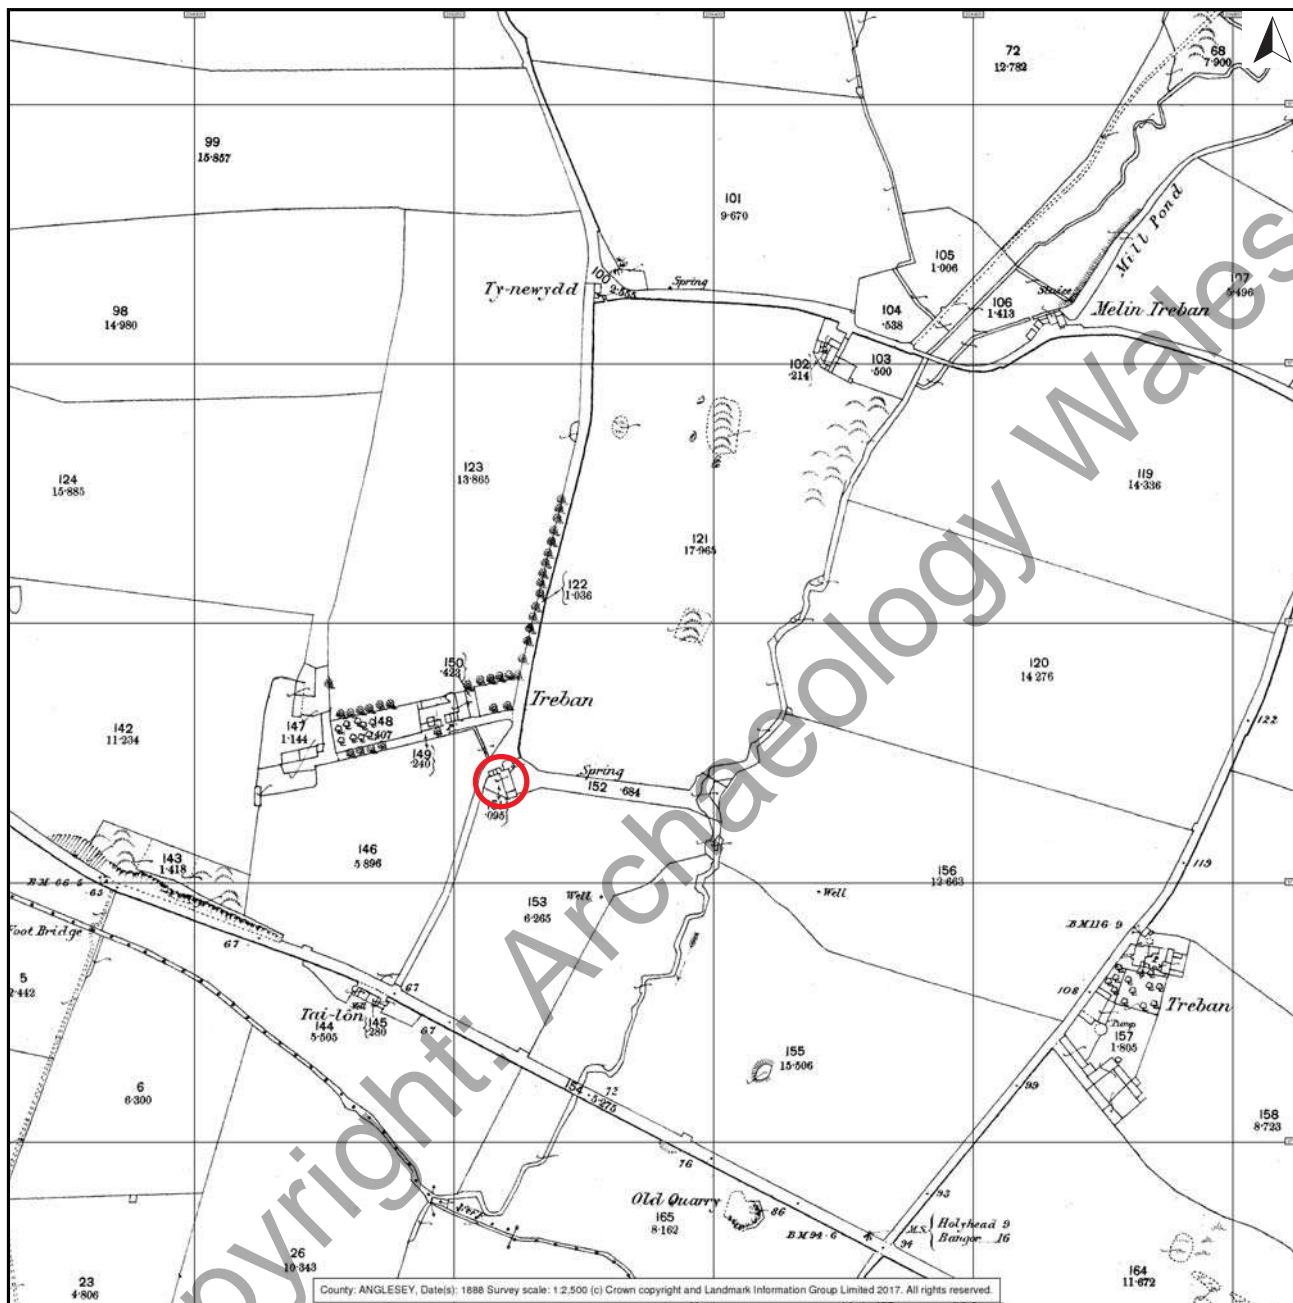
Figure 6  
Extract of the Ordnance Survey map of 1888  
(scale 1:2,500)

The Ordnance Survey (OS) Map of 1888 (Figure 6) records buildings with the same layout as today, with the Main Range (with southerly extension) and West Range. The sizes of the buildings are also unchanged. The track has been extended southwards since 1845 and the West Range added. The West Range is divided into three sections and fronts the track to the north. The site boundaries and layout are the same as modern times, except for a bounded strip of land running east from the yard to the stream. A spring and well are marked in the vicinity, which is a likely founding consideration for the location of Treban Farm. A circular feature is attached to the northern end of the main range, with access to the eastern yard, being a possible sheep fold that is extant today. To the east the Treban Farm complex is seen in detail, with numerous buildings, land units and an orchard.

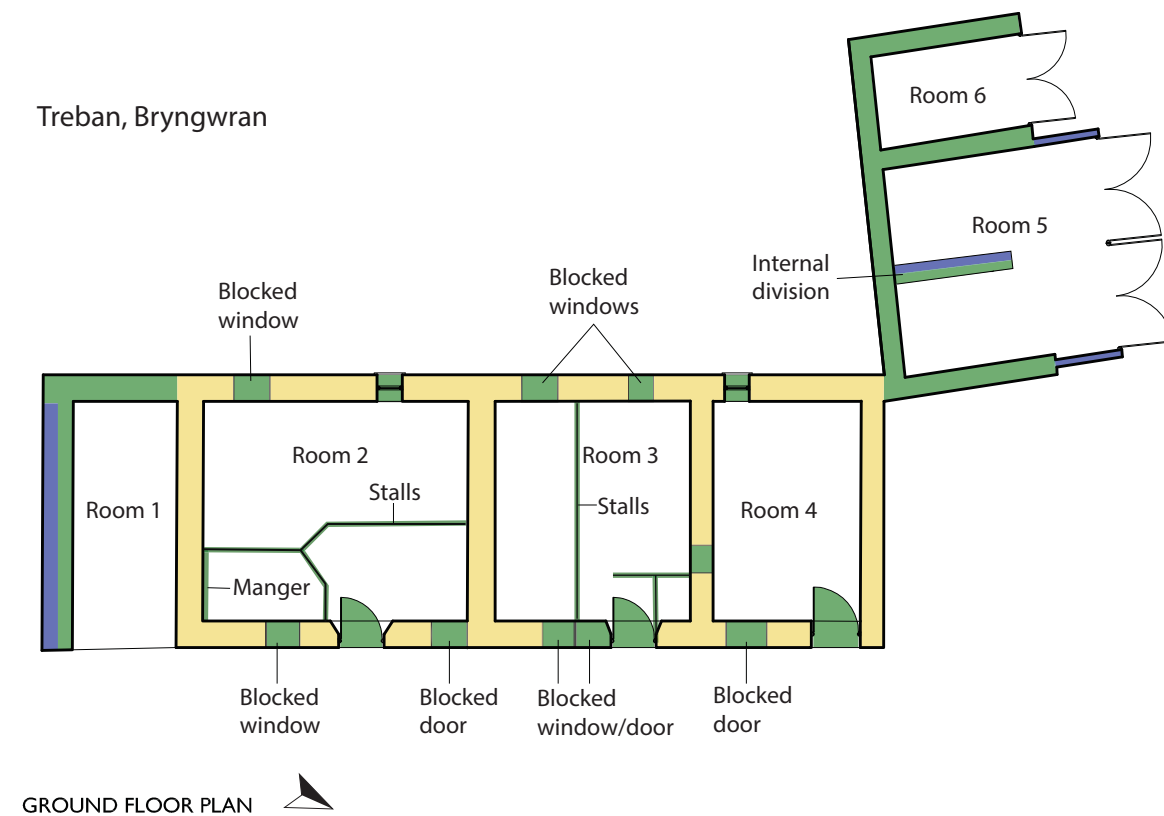
Figure 10  
Ground and first floor plans and side elevations as existing. Original drawings by Russell-Hughes Architects with adjustments by author

- Key
- Early post-medieval phase
  - 19th Century phase
  - 20th Century phase

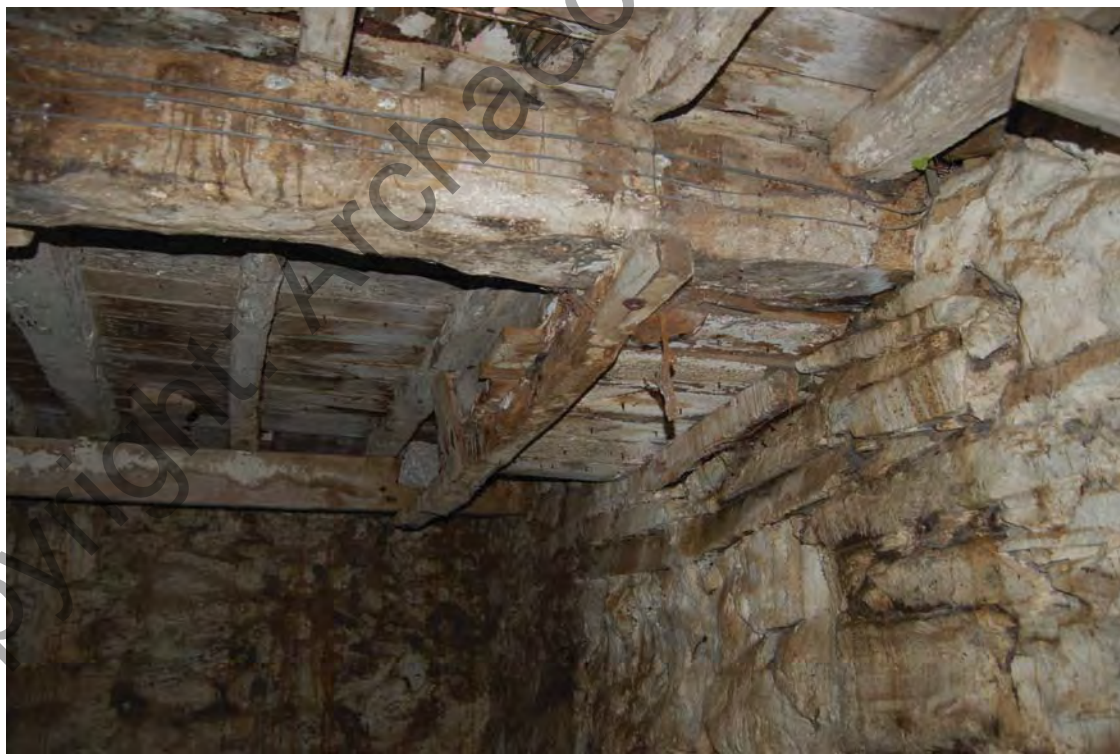
Plate 40. Interior of Room 2 of main range, stepped ceiling view S.

Two stone animal troughs remained in the corner of the pen, these were not in their original positions as were piled together. The ceiling is stepped in the south-western corner of the room to accommodate the external doorway to Room 7 above. This is a 19<sup>th</sup> century alteration linked to the roof replacement and insertion of the south-western first floor doors.

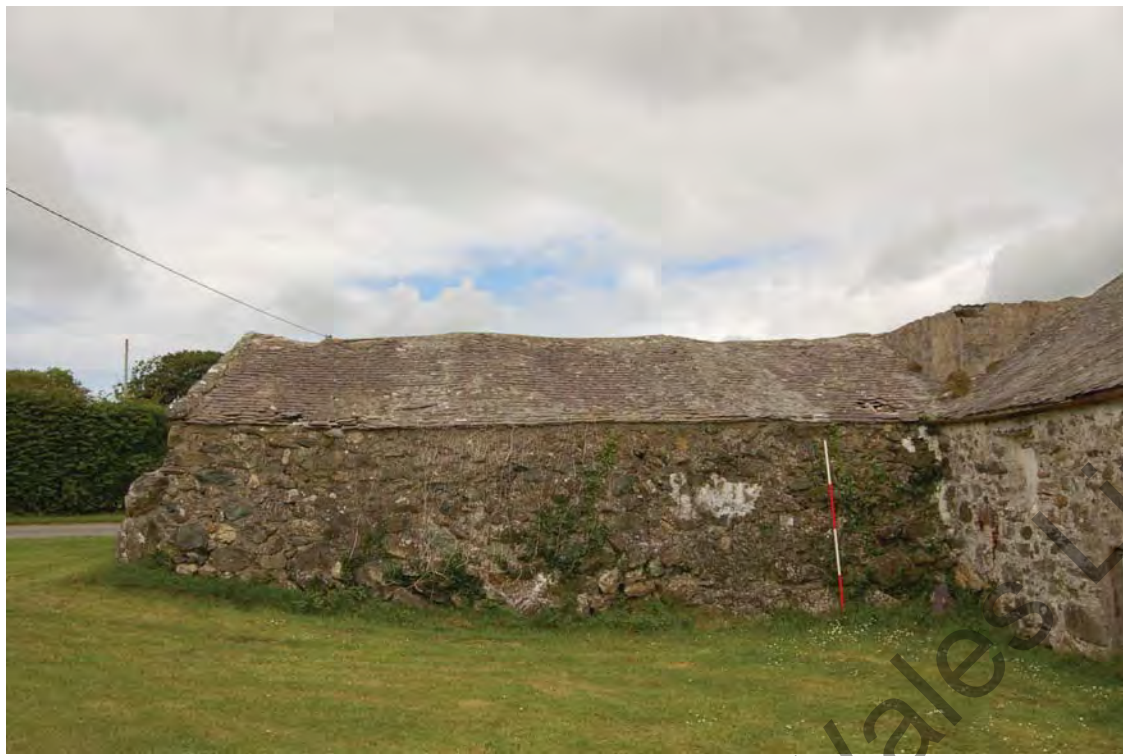
Plate 57. West Range. View NW. 2m scale

To the rear of the building is also located the West Range (Plates 57-61), built from unworked, un-coursed stone of irregular size, bonded with a sandy, lime-rich soft mortar. The walls of the West Range were not as well built as the Main Range. In similar style it also had large, sub-rounded stones at the base of the walls especially at the corners, which would have provided stability, rather than foundations, although no test pits had been excavated against this part of the building. Its roof is coved with slate, with significant bowing of the roof surface. Some small areas showing collapse of the timber below. There is an obvious, rough attempt to join both ranges with modern concrete blocks (Plate 58).
