Llangefni College Campus Site, Llangefni, Anglesey

Archaeological Watching Brief

Report No. 1703

Llandrillo Campus Extension, Llangefni (Anglesey)

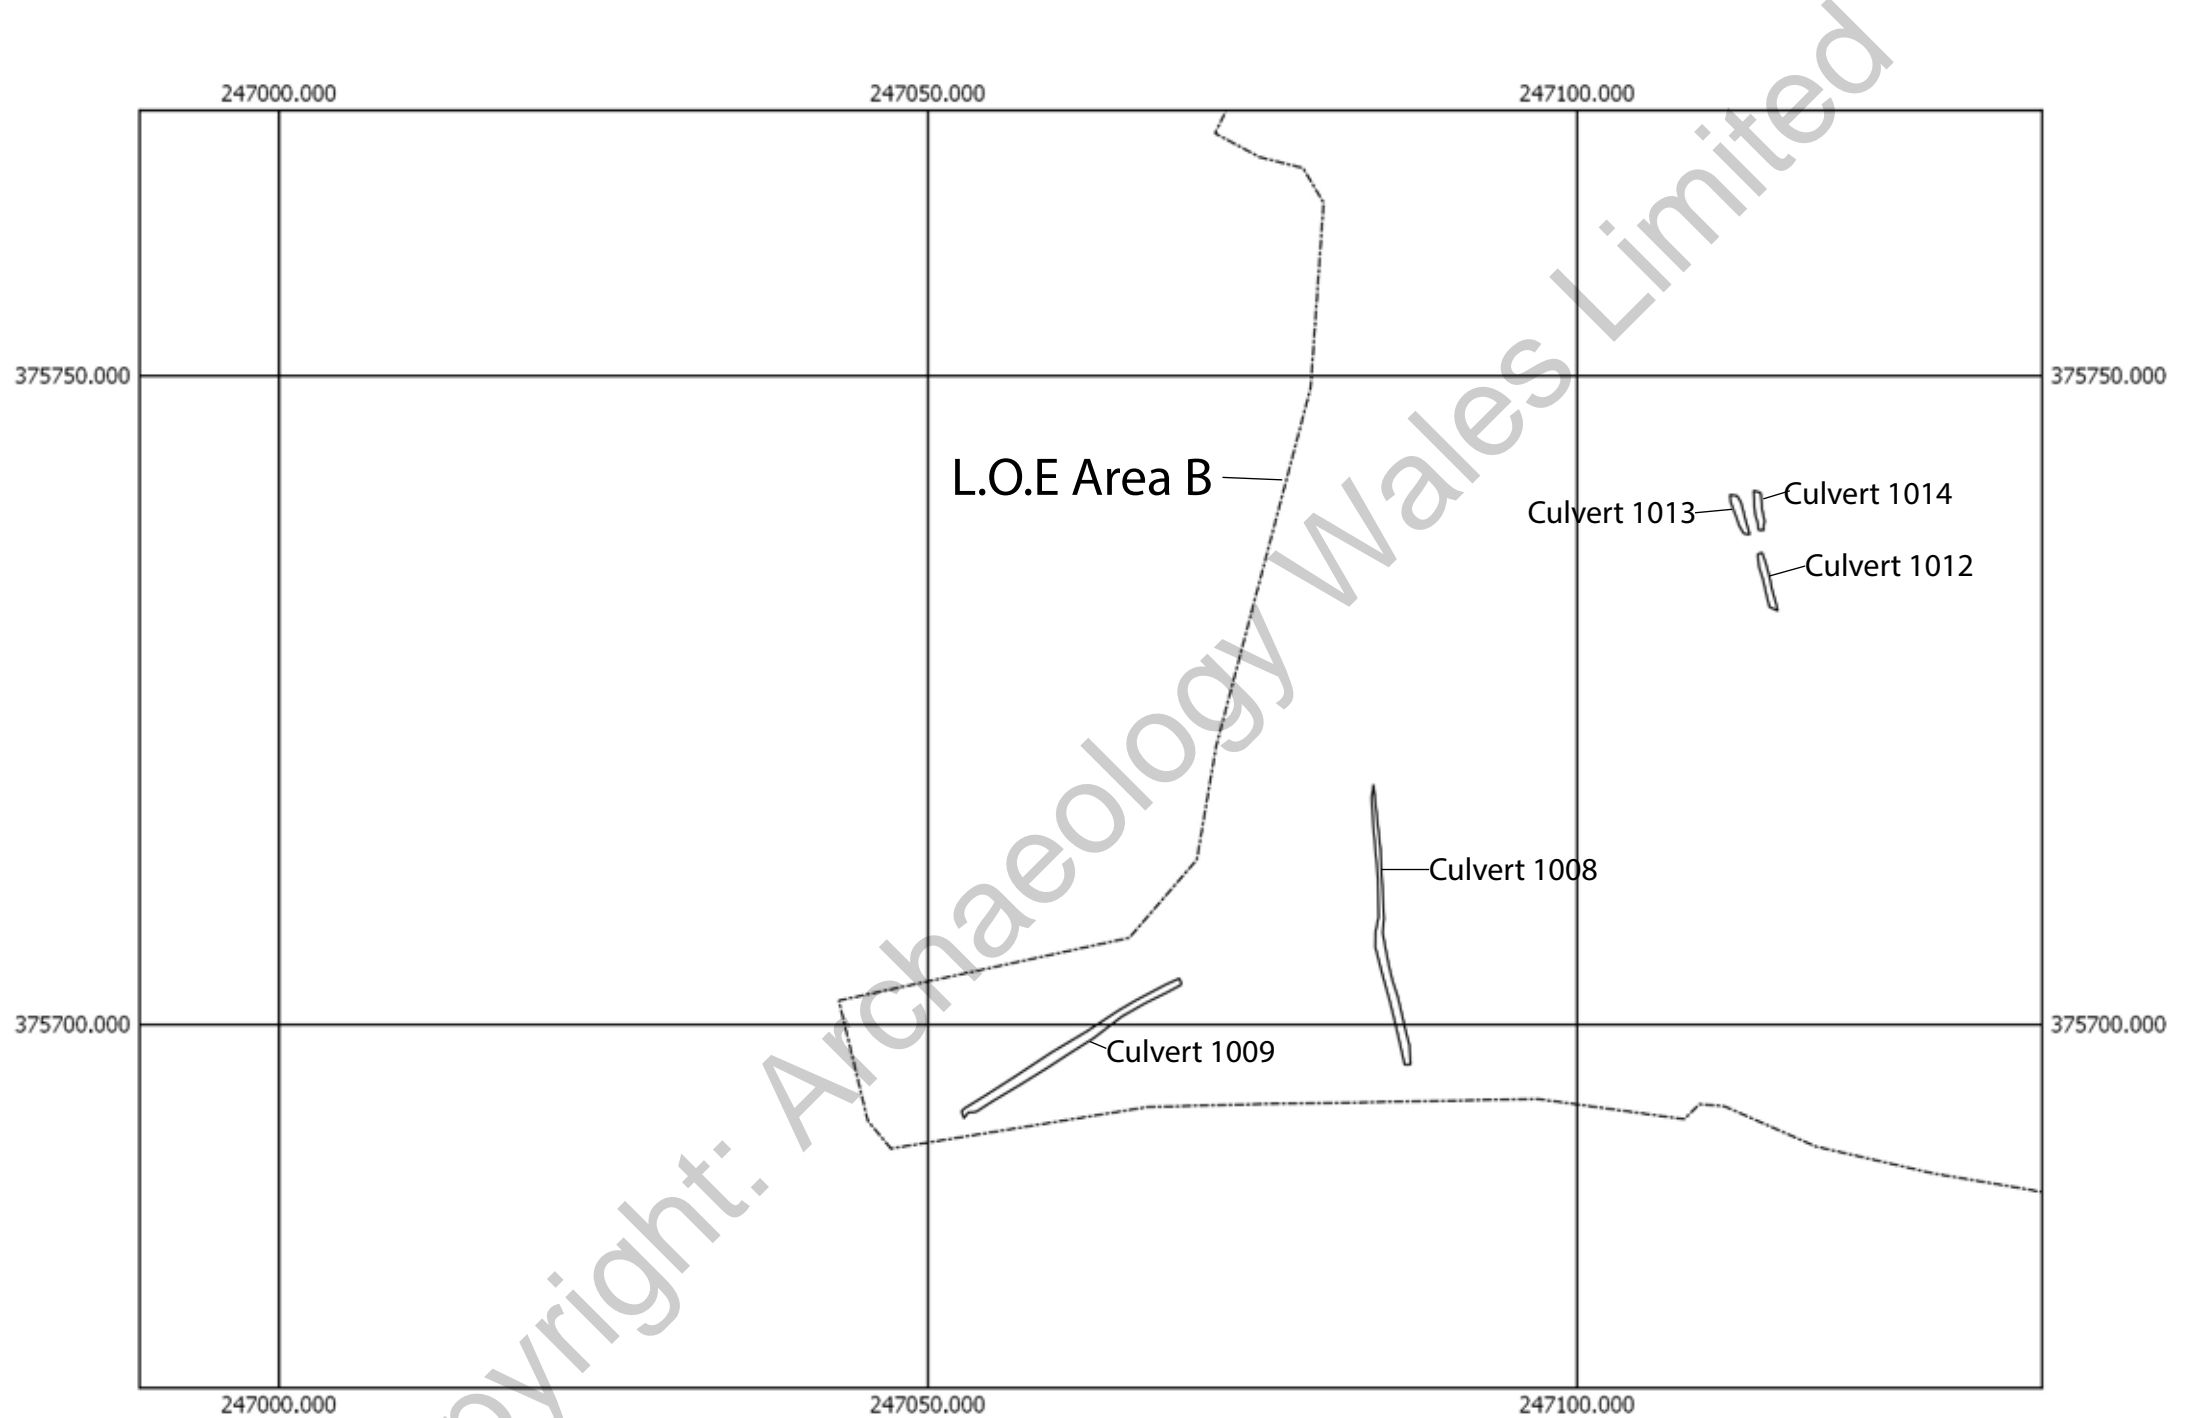
Figure 5. Location of Archaeological Features Area B

Area B was the largest area of the site, approximately 6859 m², stripped as part of the watching brief. Area B was located in the central section of the overall watching brief area. Area B was machine excavated to various depths for the construction of an access road and a bus turning circle (Plate 4).

[1008] culvert was exposed at a depth approximately 1m from the top of (1007) subsoil, and running in a NNW-SSE alignment (Plate 5-7). [1008] was constructed from local stone with loose masonry walls, with a rough-cut local stone flagged top covering an internal channel. [1008] measured 10.4m in length within the limits of the strip, however at the SSE end of the structure damage to the feature was observed, as the masonry walls and the flagged top stones were missing, leaving only the central channel and the construction cut [1043], probably caused by modern disturbance. [1008] was between 0.45m and 0.55m in width, and was one course high measuring between 0.3m and 0.4m with the dimensions of the individual stones measuring up to 0.4m, there was no evidence of a bonding material used for the construction of the culvert. The central channel of culvert [1008] measured between 0.25m and 0.3m wide and it seems more care and attention was paid to the construction of the central channel, than the rest of the culvert, as the stone used was more uniformly cut and laid flat for the smooth flow of water. [1008] had a shallow construction cut [1043] which was 0.1m deep and between 0.3m and 0.35m wide, no finds were recovered from the culvert, however culvert [1009] located to the NW of [1008] was revealed during the strip, and a possible late 19th- early 20th century clay pipe stem was recovered from within the culvert. [1008] and [1009] were very similar in appearance, and materials used for construction, so it would seem they were of a similar date, possibly late 19th-early 20th century, as the clay pipe stem was the only dateable evidence recovered, so a precise date cannot not be assigned to the structures.

[1009] was located in the NW corner of Area B running on a NNE-SSW alignment (Plate 9). [1009] was encountered at a depth of 0.3m from the top of the topsoil (1006). [1009] was 19.7m in length within the limits of the strip, however the SSW end of the culvert was badly damaged, probably due to modern disturbance, and a further stretch of the culvert was revealed after a further strip of the area. [1009] was between 0.5m and 0.6m wide and up to 0.4m in height (Plate 10) and was constructed from the same material as culvert [1008], with a central channel and a stone flagged top, housing the

[1012] culvert was located in the central section of Area B running on an NNE-SSW alignment, in close proximity to culverts [1013] and [1014] (Plate 11-13). [1012] was encountered at a depth 0.7m from the topsoil. [1012] was 4.6m in length and was up to 0.4m in height and 0.53m wide. [1012] was constructed from local stone with loose masonry walls that were two courses high in places, with a rough-cut local stone flagged top covering an internal channel that was constructed from a lighter coloured stone. [1012] was badly damaged, probably due to modern disturbance in that area, as a modern sewer and manhole cover were situated to the E, approximately 4m from [1012]. Due to the poor state of preservation of the culvert, the central channel had been badly damaged, and was very fragmentary in appearance, as the stone capping of the culvert had collapsed in on the structure, probably causing the damage to the central channel. [1012] was truncated at its NNE extremity, again probably due to modern disturbance in that area. However, it could be observed that the structure would have continued, as traces of the construction cut [1046] were visible, and there was a large amount of rough cut stones, similar in appearance to the capstones and masonry walls, within (1007) subsoil. [1046] construction cut was up to 0.6m wide and 0.12m deep, with sharp sides cut into the natural clay (1003). One piece of fragmentary animal bone and six sherds of white glazed late 19th – early 20th century pottery were recovered from within the stonework of culvert [1012], giving the structure a possible date, however further analysis of the finds is needed.

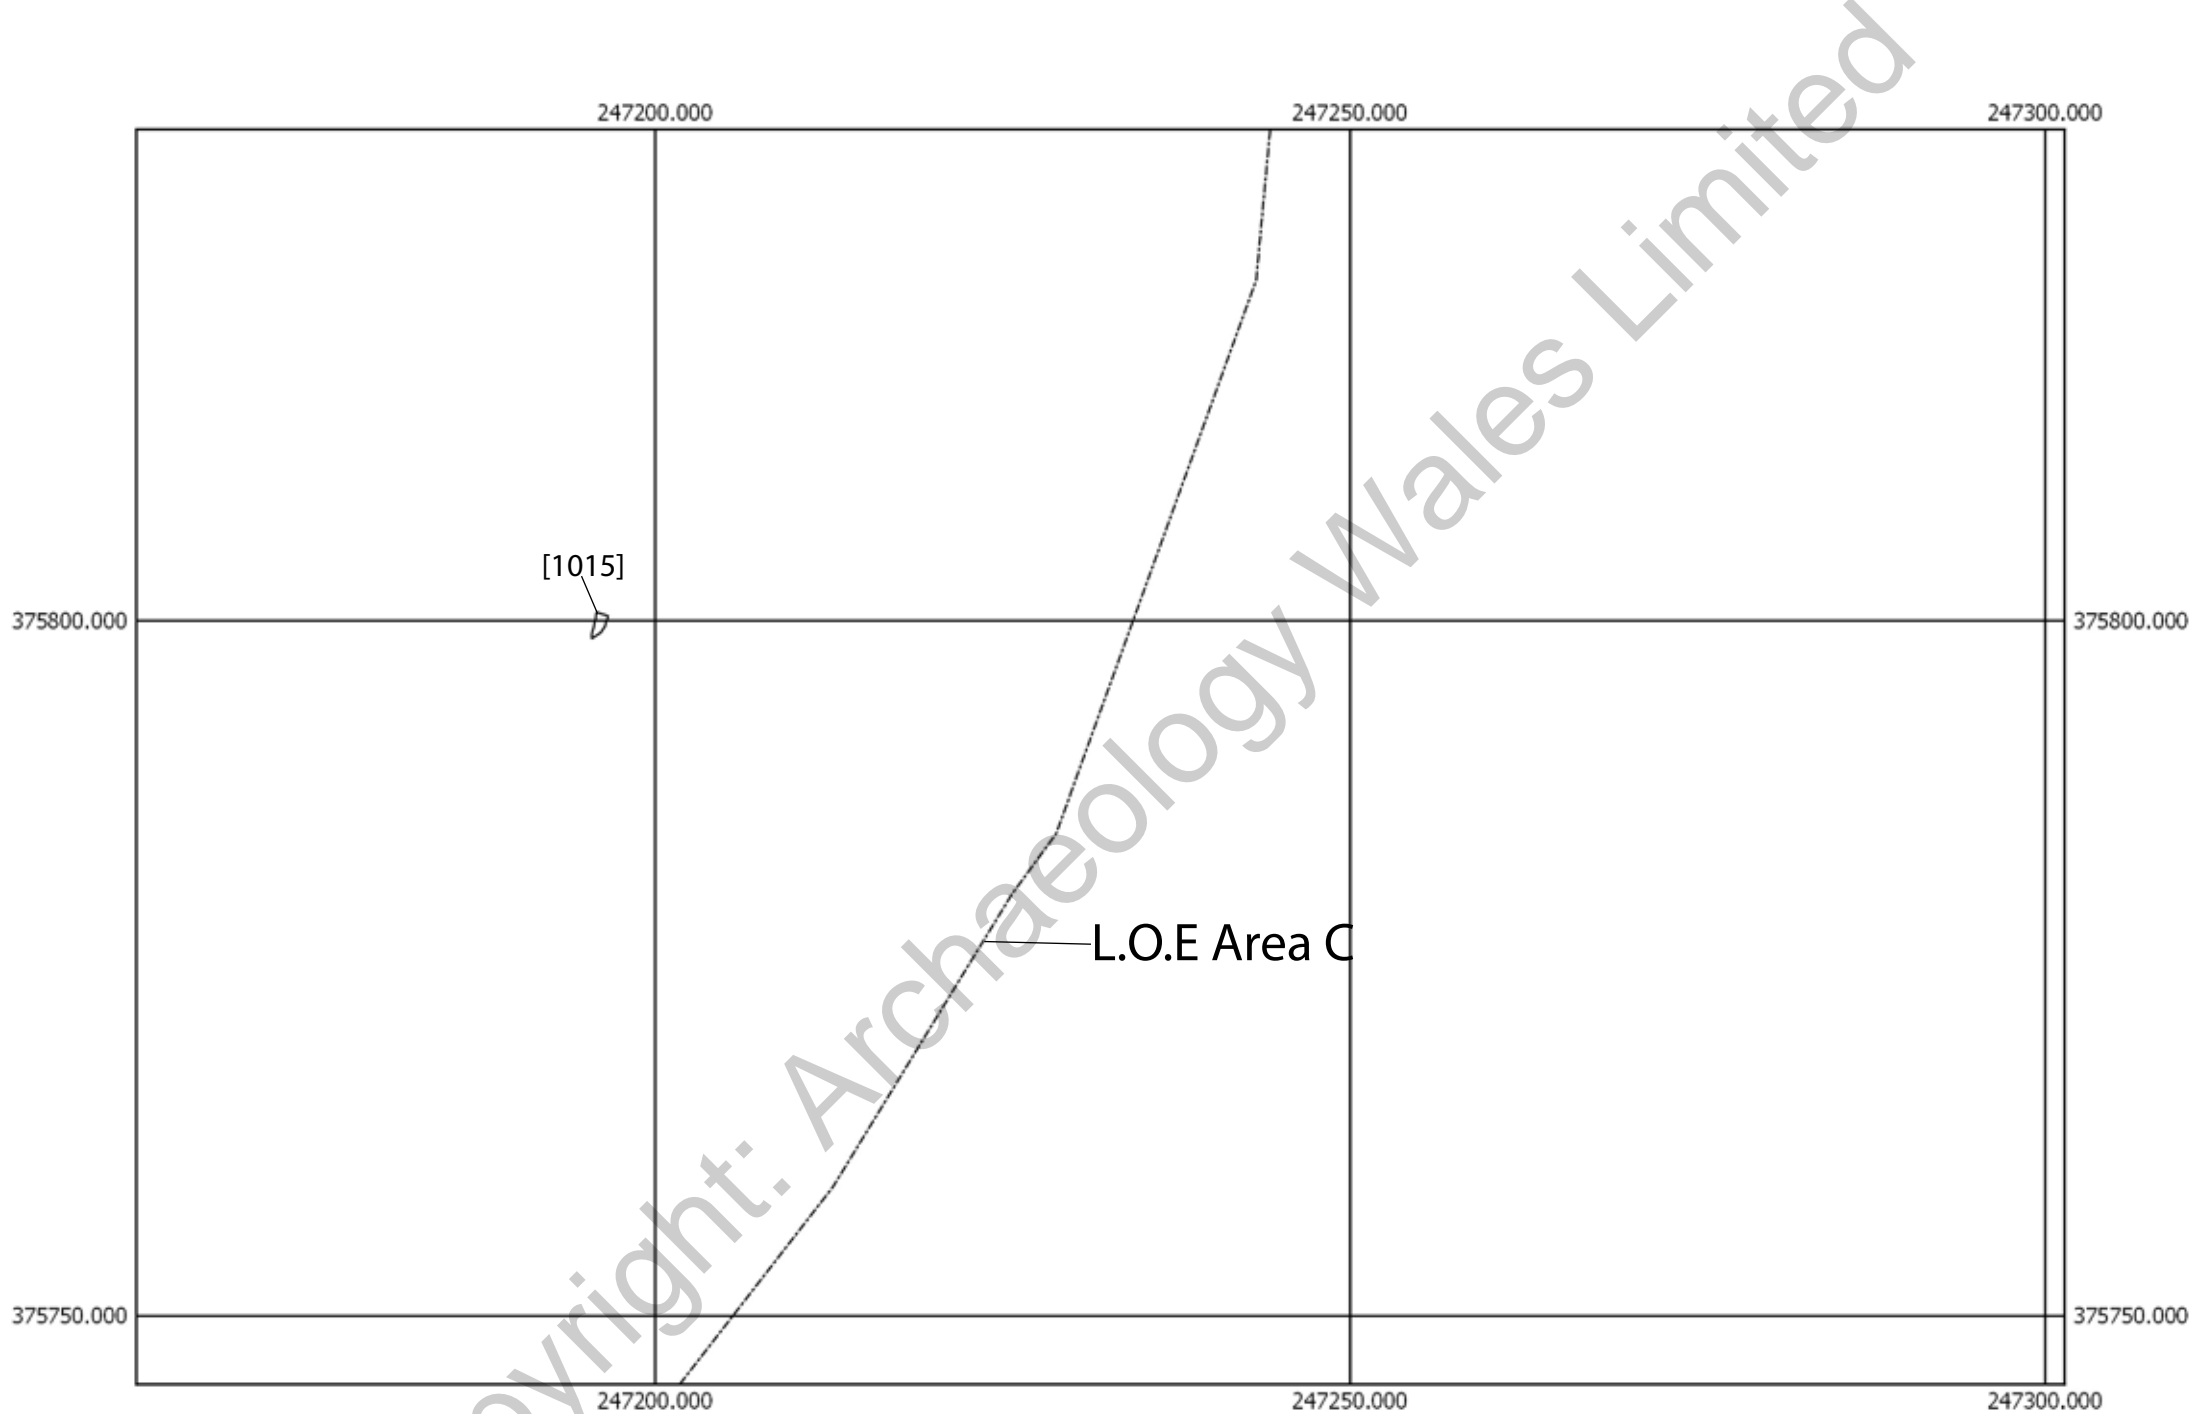
Figure 6. Location of ditch [1015], Area C

Area C was located at the eastern extremity of the watching brief area at Menai College. Area C was approximately 4436 m², and was machine excavated down through the natural substrate for the construction of a carpark and a large water drainage tank (Plate 18). Area C had previously been used for heavy plant training, so the ground in that area was heavily disturbed. The majority of the Area C was topsoil (1010) on top of natural (1003) as the subsoil (1011) was only encountered where the natural bedrock was significantly undulated. (1011) subsoil was a mid-brown grey silty clay with small – large stones up to 0.5m with an abundance of modern building waste. (1011) was between 0.1m and 0.3m thick in some parts of Area C and non-existent in other areas, due to the undulating nature of the natural (1003) (Plate 19). (1011) was overlain by (1010) topsoil that was a dark brown silty loam with inclusions of small-medium sized stones and modern building waste. (1010) was between 0.14m and 0.2m thick and was littered with modern finds, such as various sherds of 20th century pottery, CBM, wood and stone.

[1015] linear ditch was uncovered in the SE corner of Area C (Figure 13; Plate 22). [1015] was oriented on an NE-SW alignment running at a length of 1.57m, however it was observed that on its SW end [1015] ditch was truncated, most likely from modern machining. [1015] ditch was 0.82m wide with moderate sloping sides leading to a slightly pointed base (see figures 4 and 5). [1015] had two fills (1016) and (1017) within the feature. (1016) deposit was a moderate to firm silty clay that was mid-brown grey in colour, with inclusions of small sub angular stones up to 0.15m in size. (1016) was between 0.08m and 0.12m deep, no finds were recovered from (1016). (1016) appears to have formed from a natural silting process. (1017) was the upper fill of ditch [1015] that was a moderate to firmly compact silty clay. (1017) was mid-dark brown grey in colour with inclusions of sub-angular stones measuring up to 0.15m with traces of small flecks of charcoal. (1017) was between 0.12m and 0.25m deep, no finds were recovered from (1017). (1017) appears to have been formed due to a natural sedimentary process.

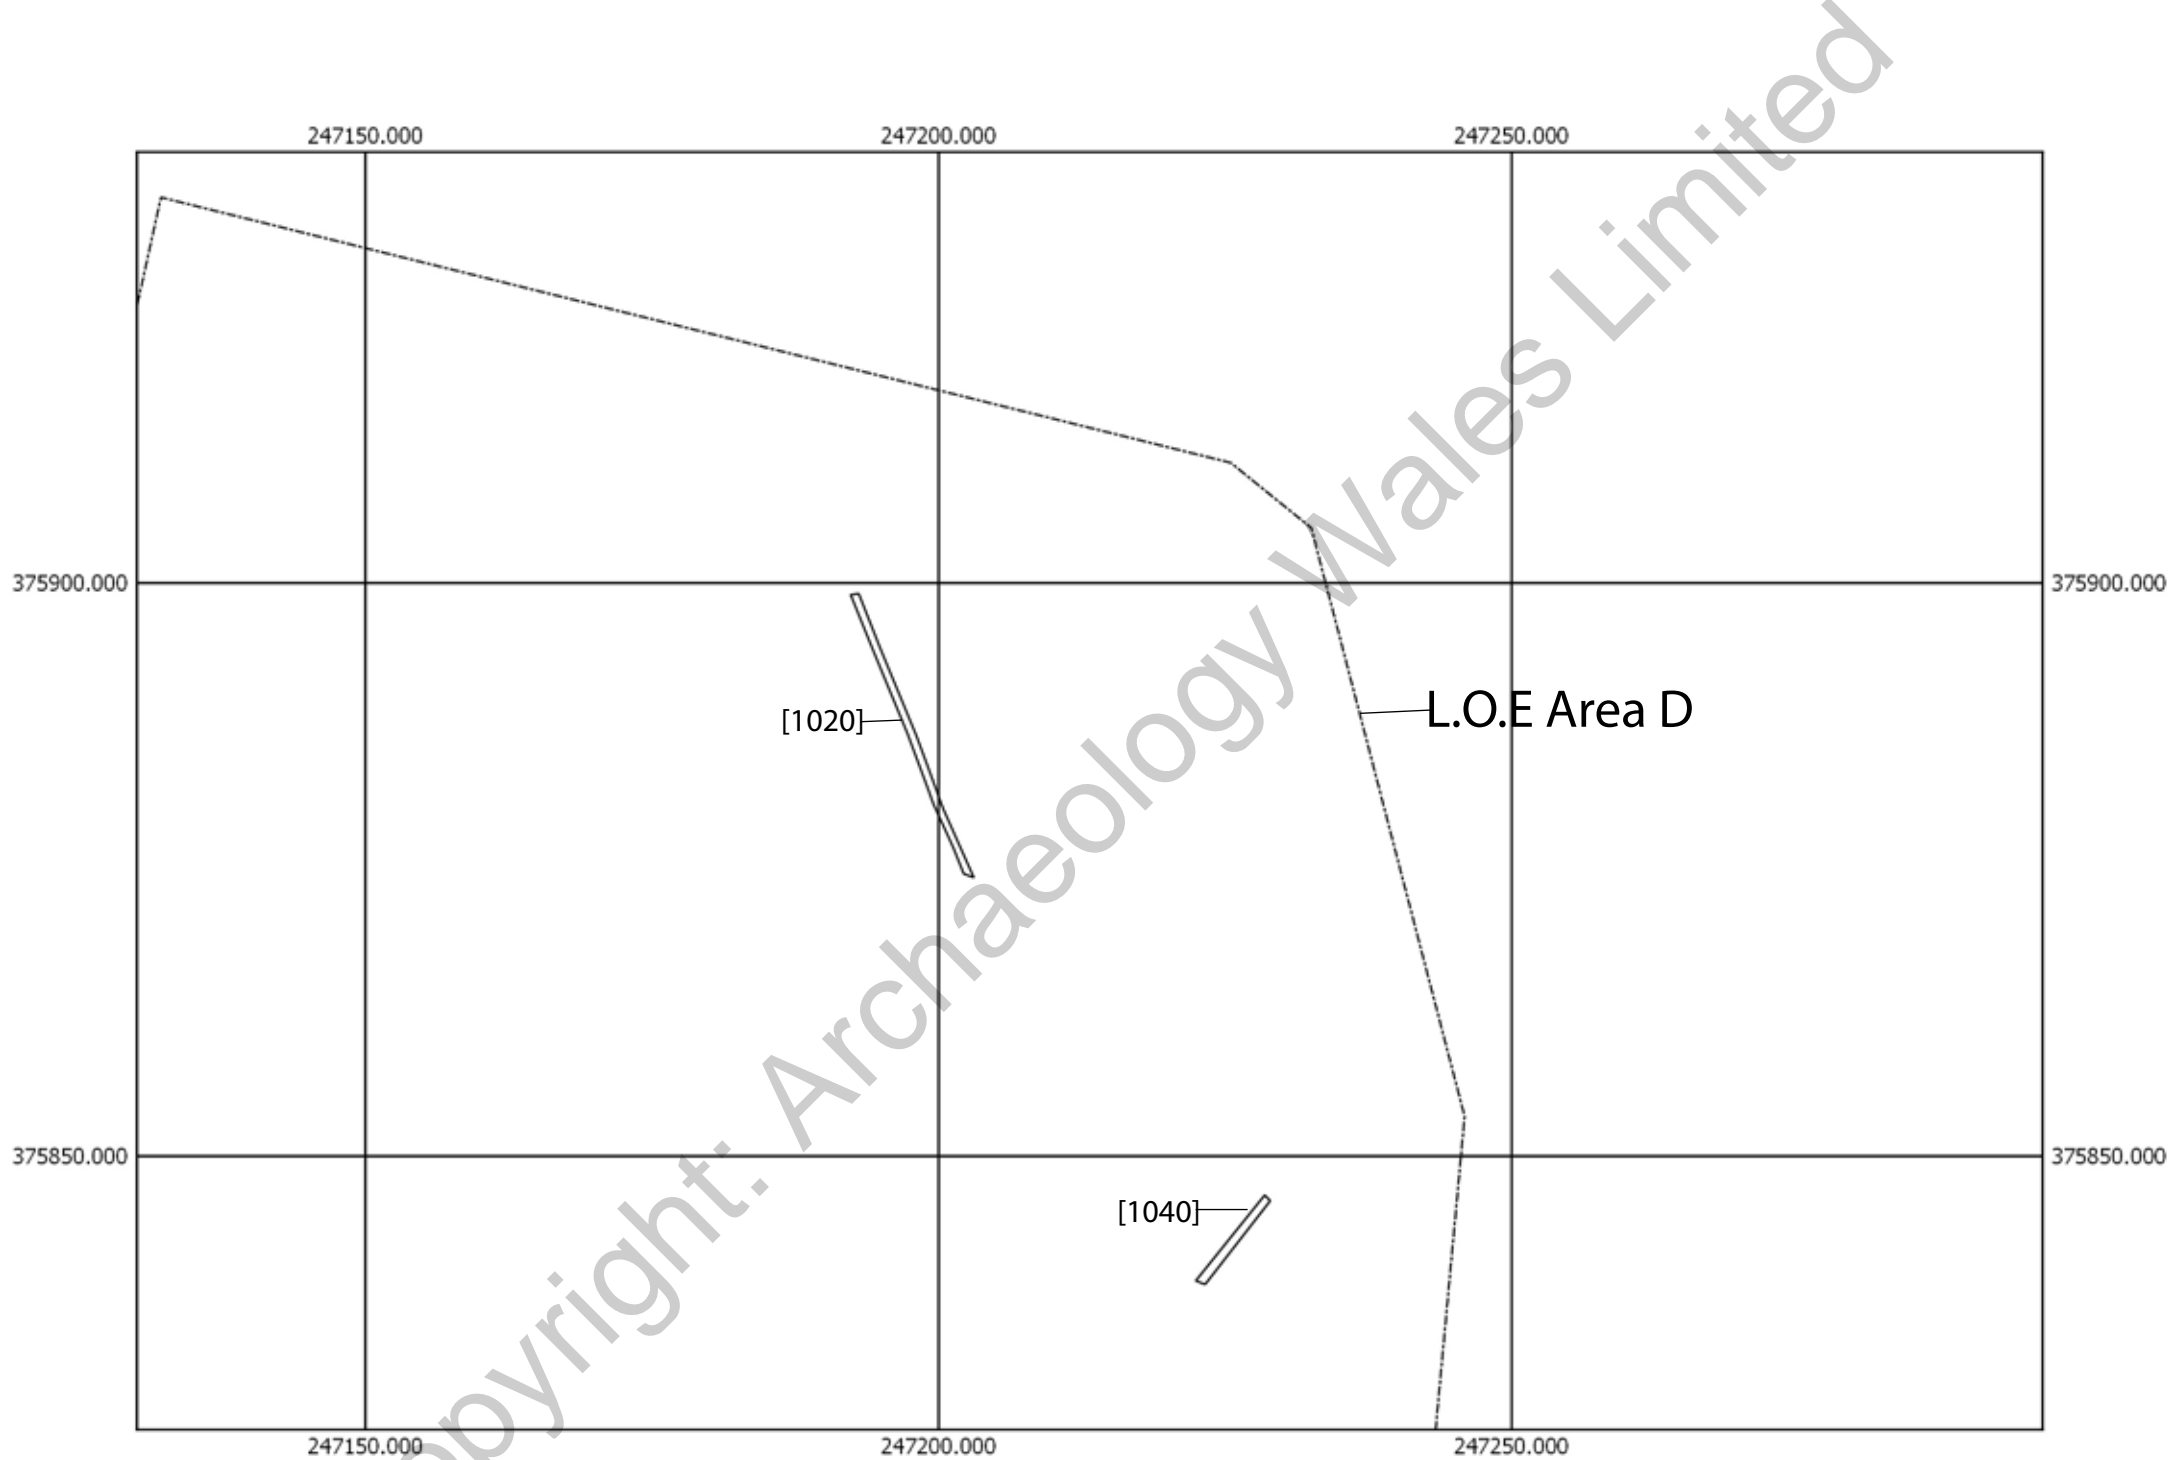
Figure 7. Archaeological features, Area D

Area D was located to the NE of the development, outside of the boundary of site 6. Area D was approximately 4439 m², and was predominantly stripped of topsoil (1023) and subsoil (1018) (Plate 20). (1018) was only visible in some areas of the site, due to the undulating nature of the natural (1019). (1019) was characterised by mid-dark brown grey silty clay, and contained infrequent small-medium sized sub-angular stones (Plate 21). (1019) was overlaid by (1018). (1018) was characterised as mid to light orange brown silty loam with inclusions of small to medium sized sub-angular stones up to 0.1m in size. (1018) varied in depth, but had an average depth of 0.5m.

[1020] was a linear feature interpreted as a stone culvert, located in the SE extremity of Area D. [1020] culvert was not fully revealed during the strip, due to the levels of excavation being reached, so the feature was recorded on the surface, covered with geosynthetic terram, then sealed in situ. [1020] was 0.45m wide, and over 5m in length and oriented on a NW-SE alignment (Plate 23). [1020] was constructed from a rough-cut local stone, with stones measuring up to 0.5m, no finds were recovered from [1020]. [1028] stone filled field drain located in the northern part of Area D, was interpreted as being part of a larger field drainage system, including [1029], [1030], [1031] and [1032] that were all oriented on a NE-SW alignment. [1028] was 3.8m long and between 0.15m and 0.18m wide with a depth of 0.1m, and filled with small pebbles and stones (Plate 24). [1028], [1029], [1030] [1031] and [1032] were not excavated, due to levels being reached in that area, the features were sealed in situ. [1029] stone filled field drain, was located 7.7m E of [1028]. [1029] was 8m in length and between 0.15m and 0.2m wide and filled with small pebbles and stones. [1030] was situated 7.7m to the west of field drain [1028]. [1030] was 7.5m long and between 0.15m and 0.2m wide and was filled with small pebbles and stones. [1031] field drain was located 7.6m to the west of [1030]. [1031] field drain was 15m in length and between 0.15m and 0.2m wide (Plate 24) and was filled with small pebbles and stones. [1032] was situated 7.6m to the east of field drain [1031]. [1032] was 15m in length and between 0.15m and 0.2m wide, and was filled with small pebbles and stones.

[1040] was a curvilinear feature located in the SW corner of Area D, W of the cemetery. [1040] was located whilst machine stripping down to levels for the construction of a large water tank. [1040] was interpreted as being a curvilinear ditch with steep sides and a concave base. [1040] was 13m in length, 0.65m wide and 0.35m deep (Figure 14-15). [1040] was aligned SW to NE and contained two fills (1041) and (1042). (1042) was the lower fill of [1040] and was characterised as a soft, pale grey brown, silty clay with occasional flat stones. (1042) was 1m in length. 0.3m wide and at a depth of 0.03m. (1042) was overlaid by (1041). (1041) was the upper fill of [1040]. (1041) was characterised as very compact, mid-red brown with black flecks, silty clay which contained frequent manganese and occasional small sub angular stones. (1040) was 13m in length, 0.65m in width and 0.3m deep (Plate 27). The function of [1040] ditch is unknown as no finds were recovered from fills (1041) and (1042), however the feature could be a continuation of [1015] ditch, located 10m SW from [1040].

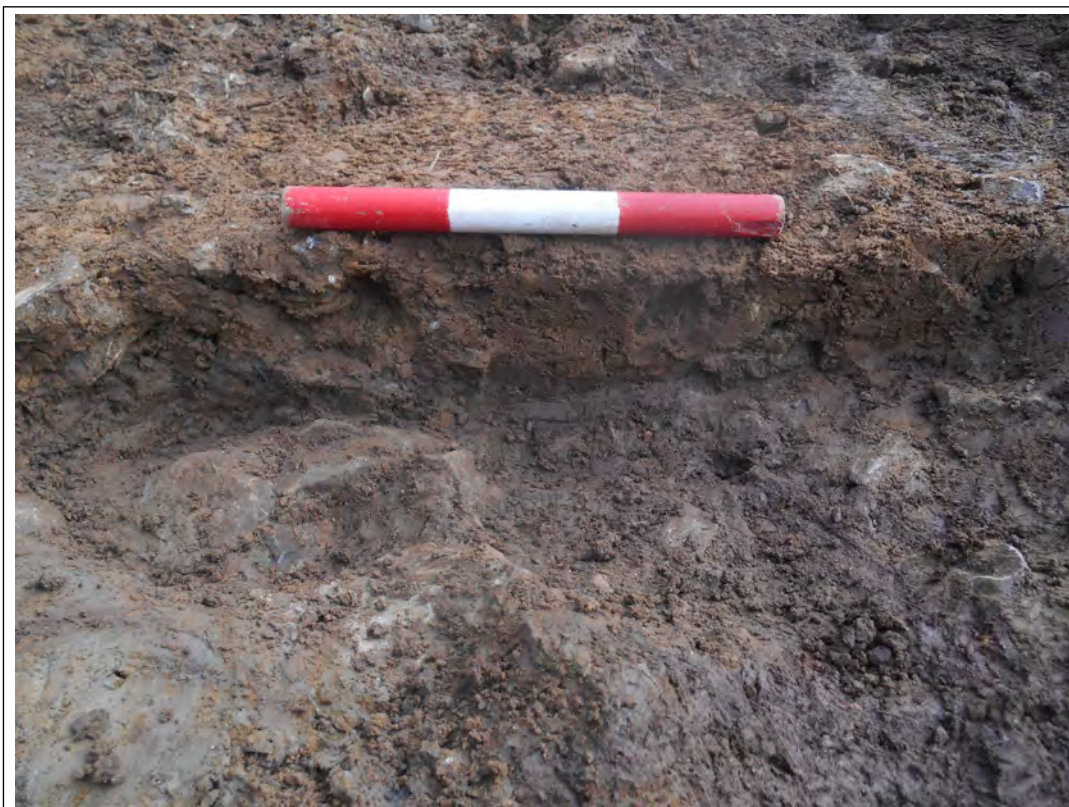
[1004] was a small sub-oval pit located in the SW corner of Area A. [1004] was 0.6m in diameter and 0.13m deep, and was cut into (1003) natural clay (Plate 3). [1004] had an irregular base due to the natural rock that was present in (1003) natural clay. [1004] had a gradual sloping side on the western side of the feature and a sharp side on the eastern side of the feature. [1004] pit had one fill (1005). (1005) was a fairly compacted light-mid brown clayey silt that had inclusions of small stones and gravel up to 0.1m and possible traces of charcoal within the fill. No finds were recovered from (1005). [1004] was located in an area of modern disturbance as there was a buried water main in close proximity on the south west side of the feature, and an open field drain to the NW of the feature.

Plate 3. SE section of [1004] and (1005) pit in Area A. Scale 0.3m

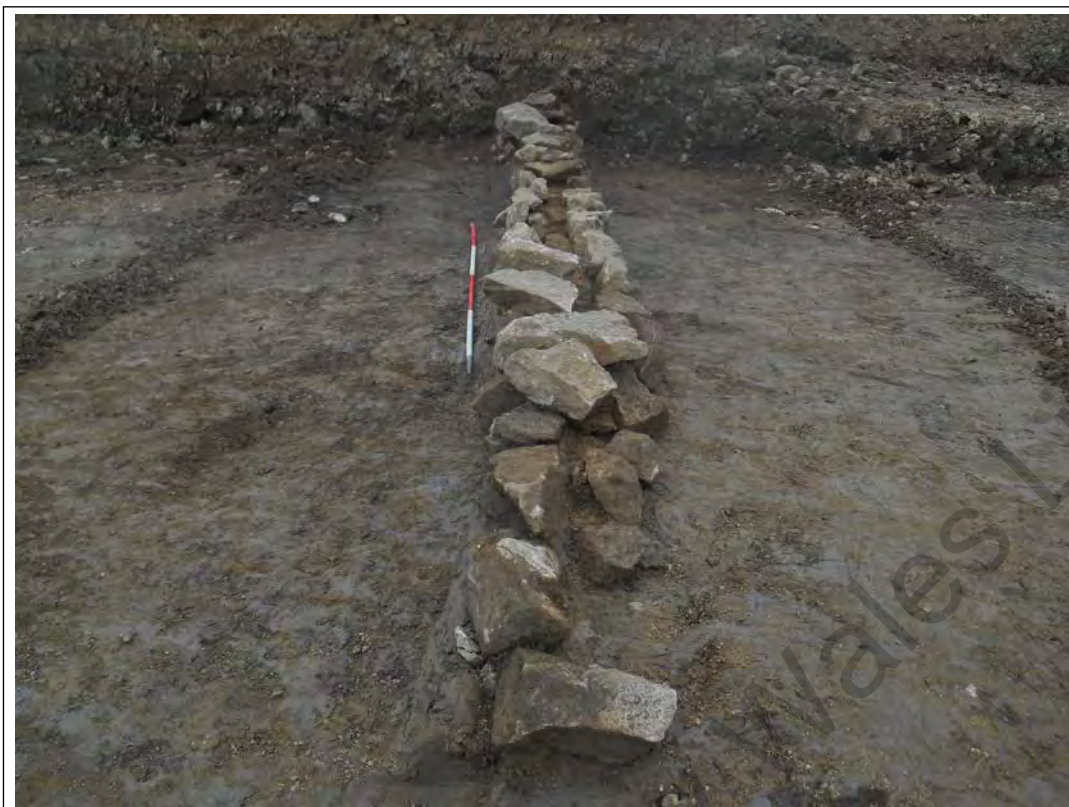
Plate 5. [1008] Culvert looking NNW. Scale 2m

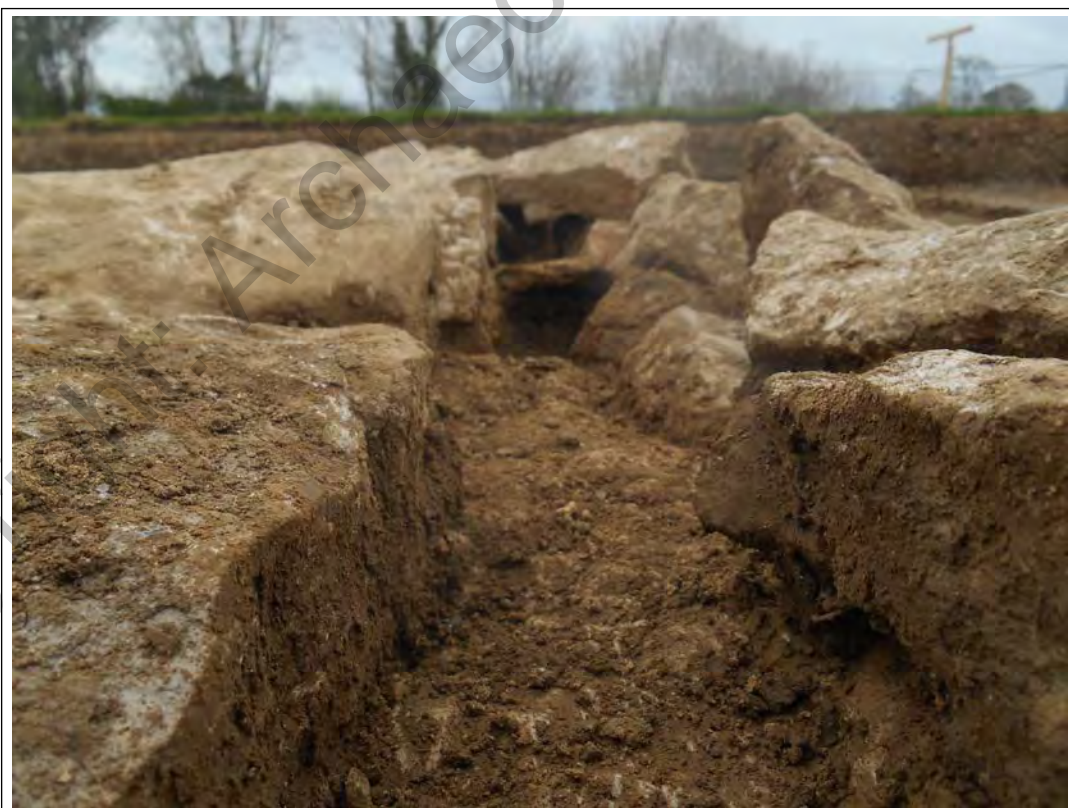
Plate 6. Shot of central channel of culvert [1008] looking SSE

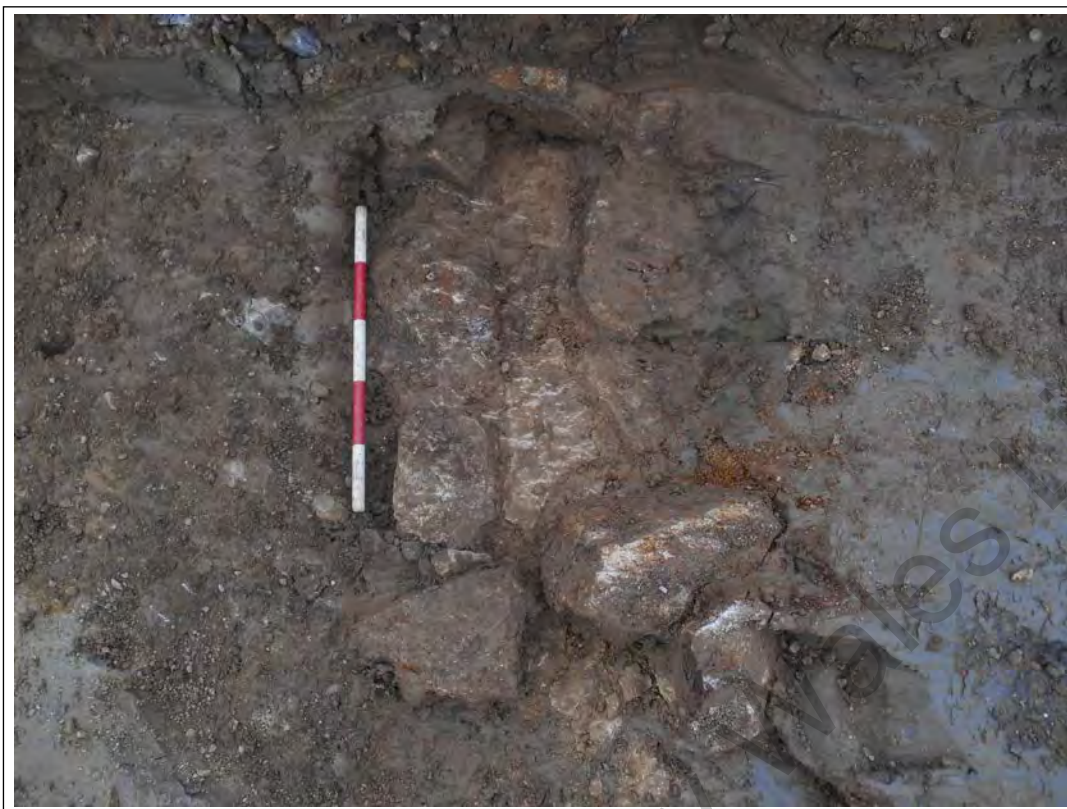
Plate 7. Shot in plan of construction cut [1043] of culvert [1008]. Scale 0.5m

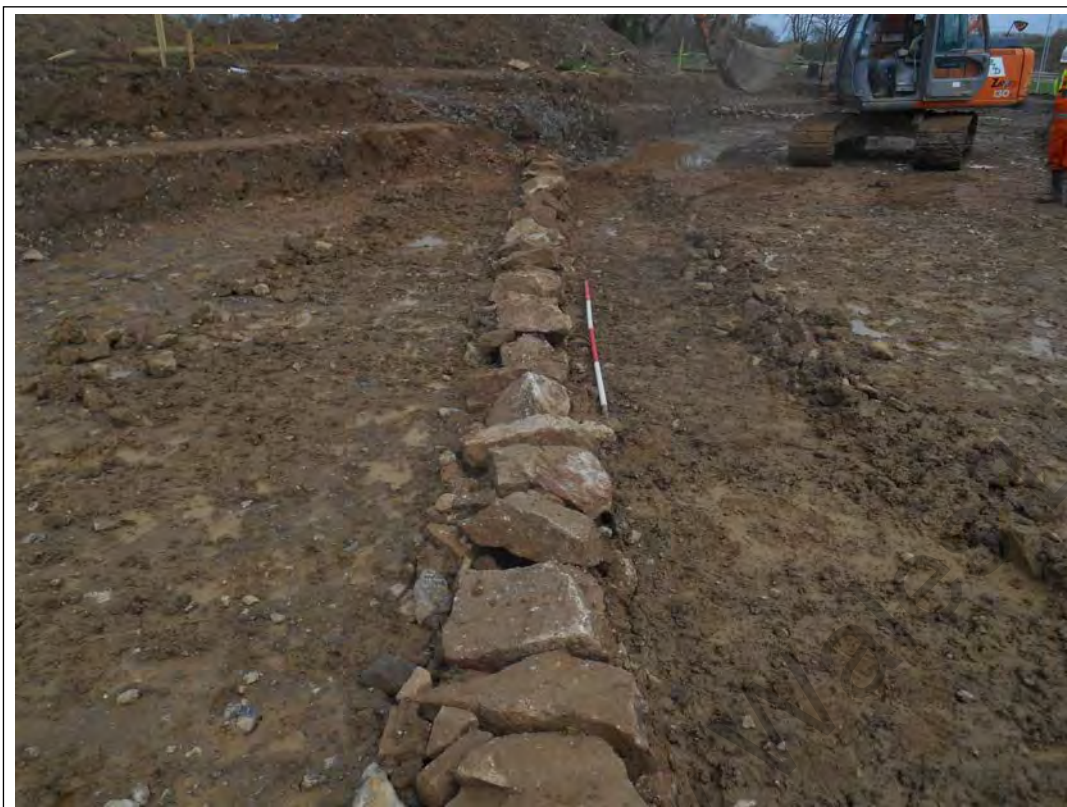
Plate 9. Culvert [1009] looking NNE. Scale 2m

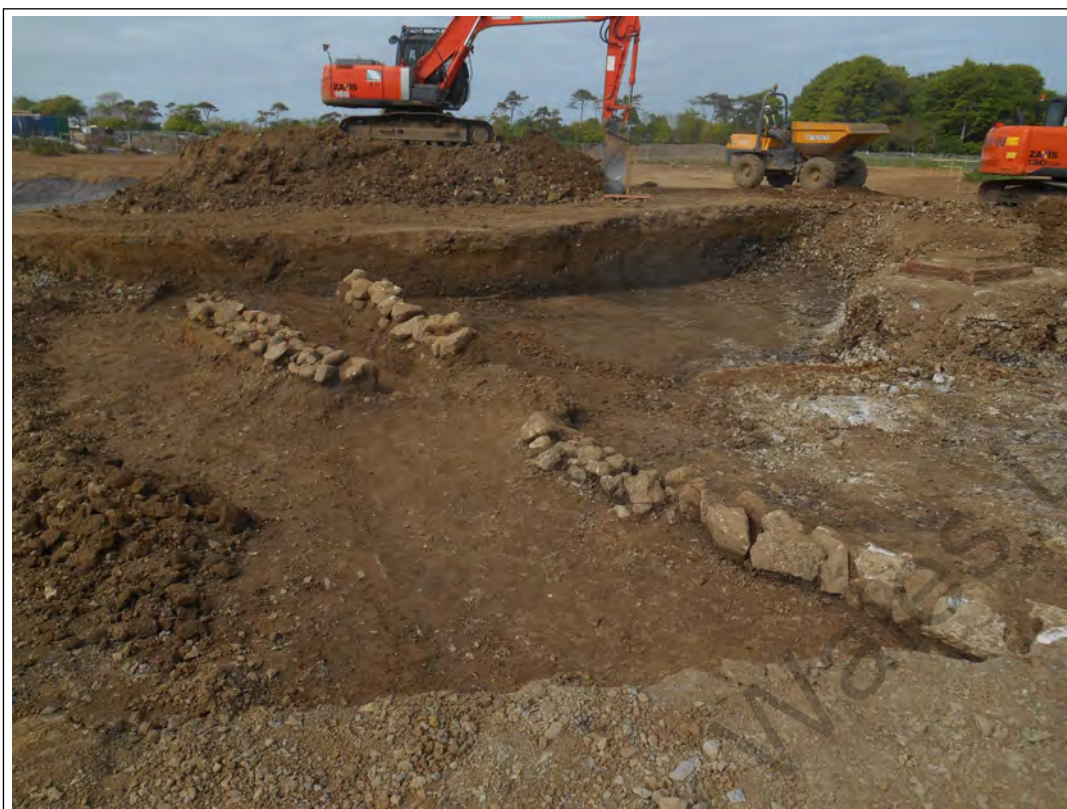
Plate 11. Oblique shot of culverts [1012], [1013], and [1014]

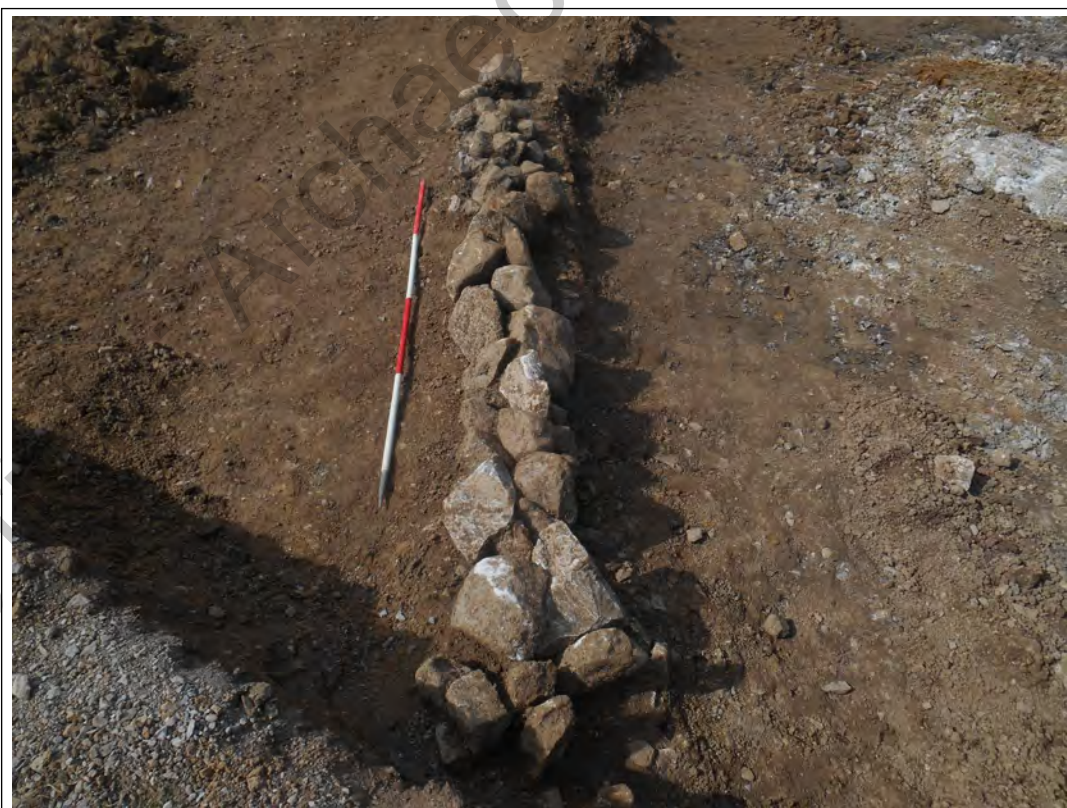
Plate 12. Plan shot of culvert [1012] looking North North East. Scale 2m

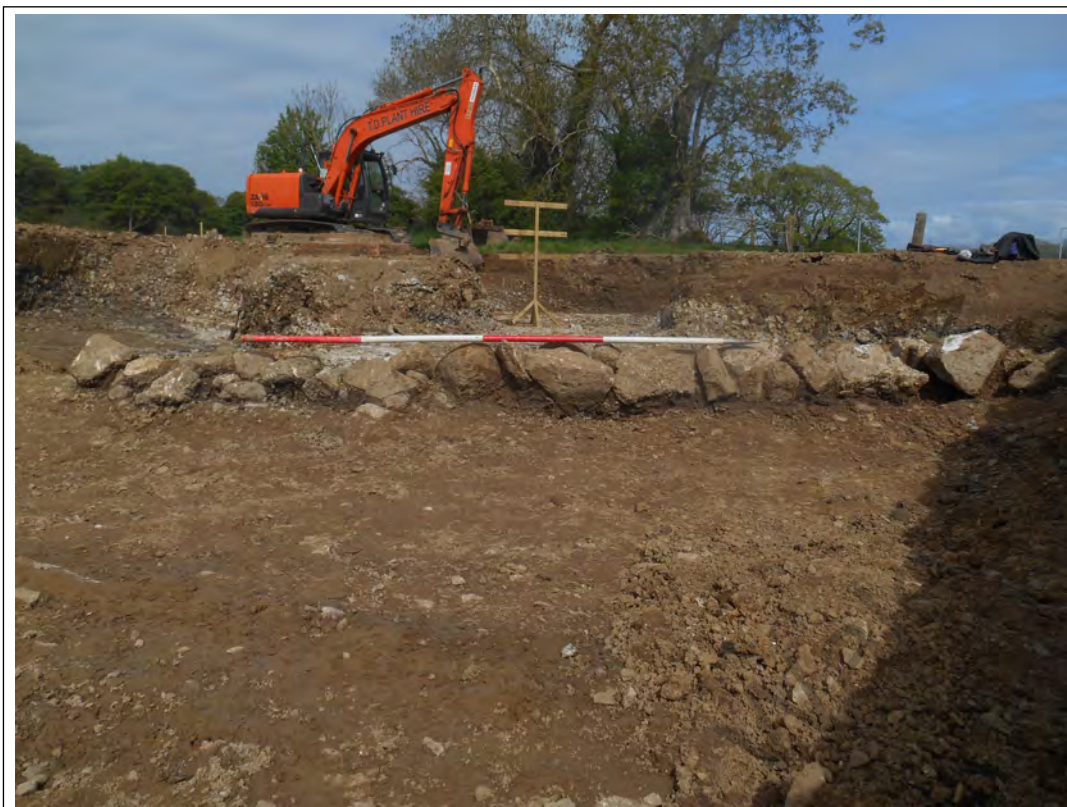
Plate 13. WSW facing elevation culvert [1012]. Scale 2m

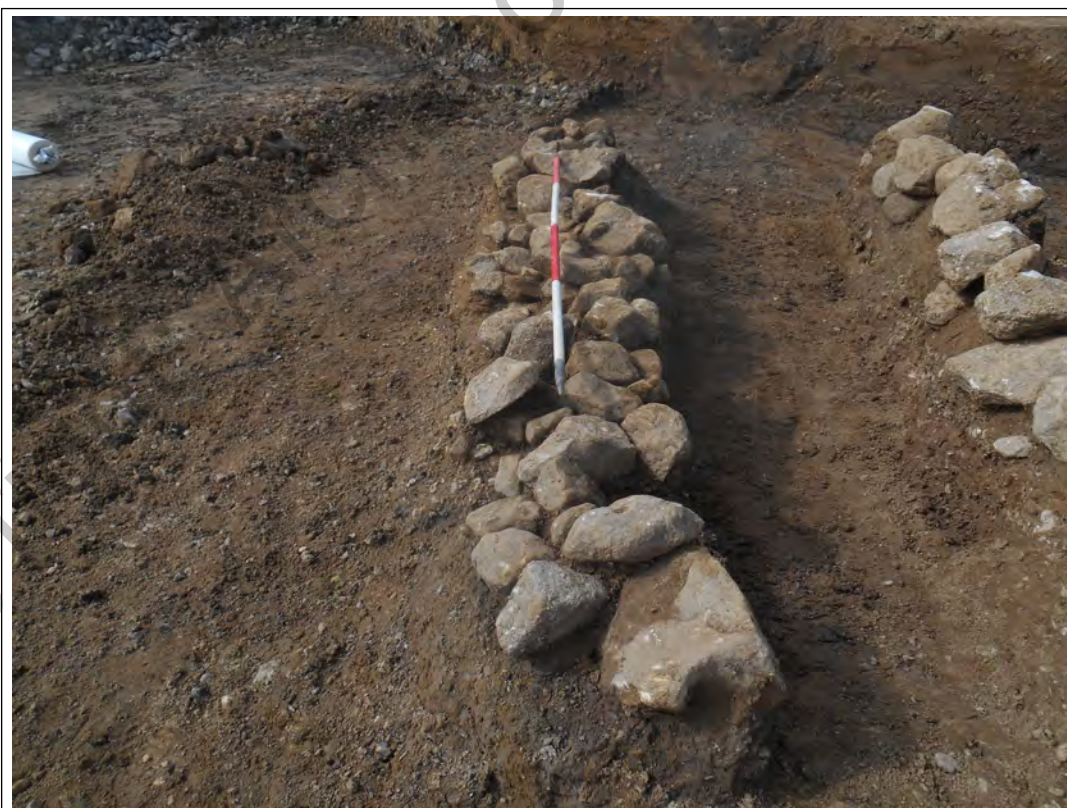
[1013] culvert (Plate 14-15) was located in the same section of Area B as [1012], lying approximately 1.5m SSE from culvert [1013] and 0.50m from culvert [1014]. [1013] was encountered at a depth of 0.4m from the topsoil (1006), whilst stripping down to levels for the construction of a bus turning circle. [1013] ran on an NNW-SSE alignment, same as [1013] and [1014] and was truncated at both ends of the structure. [1013] was 4.2m long, 0.32m high and up to 0.75m wide. [1013] was constructed of a local stone for the masonry walls, that was two courses high in sections, and a stone flagged top, same as [1008], [1009] and [1012]. [1013] had partial remains of a central channel, however due to disturbance in the area the channel was very fragmentary and the lighter coloured stone used to construct the channel had degraded significantly. One sherd of black glazed Buckley ware pottery and one small horse femur were recovered from within the stonework of culvert [1013].

Plate 14. Plan shot of culvert [1013] looking NNW. Scale 2m

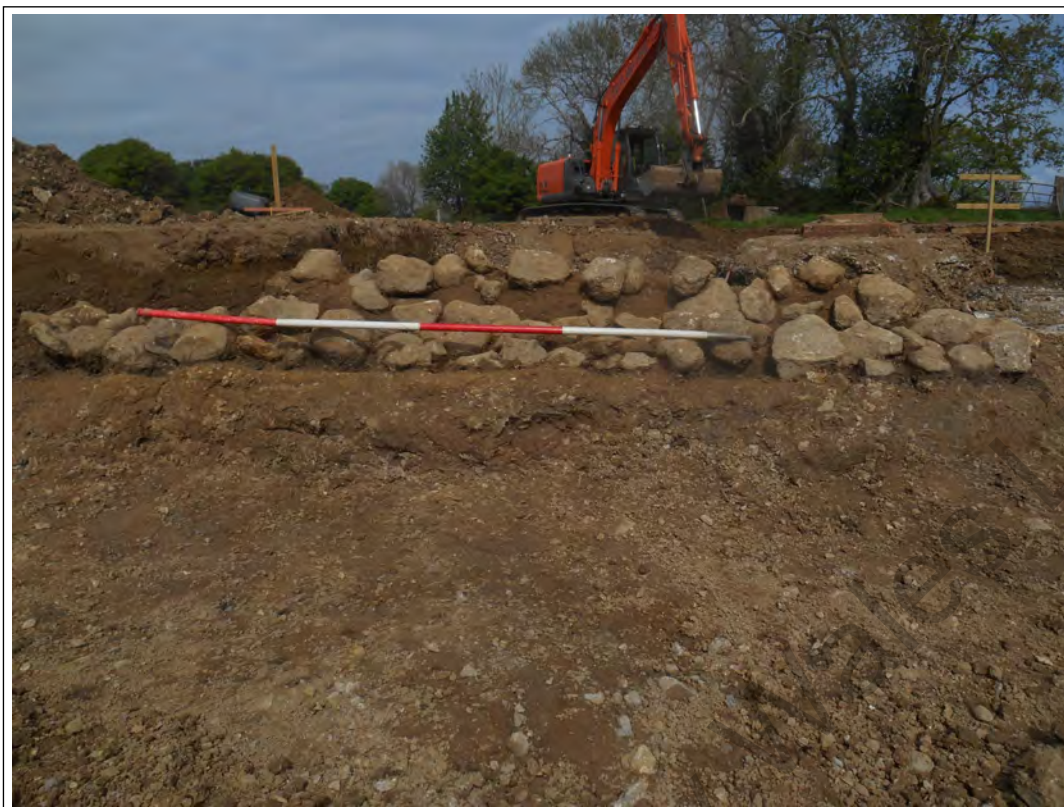
Plate 15. WSW facing elevation of culvert [1013] . Scale 2m

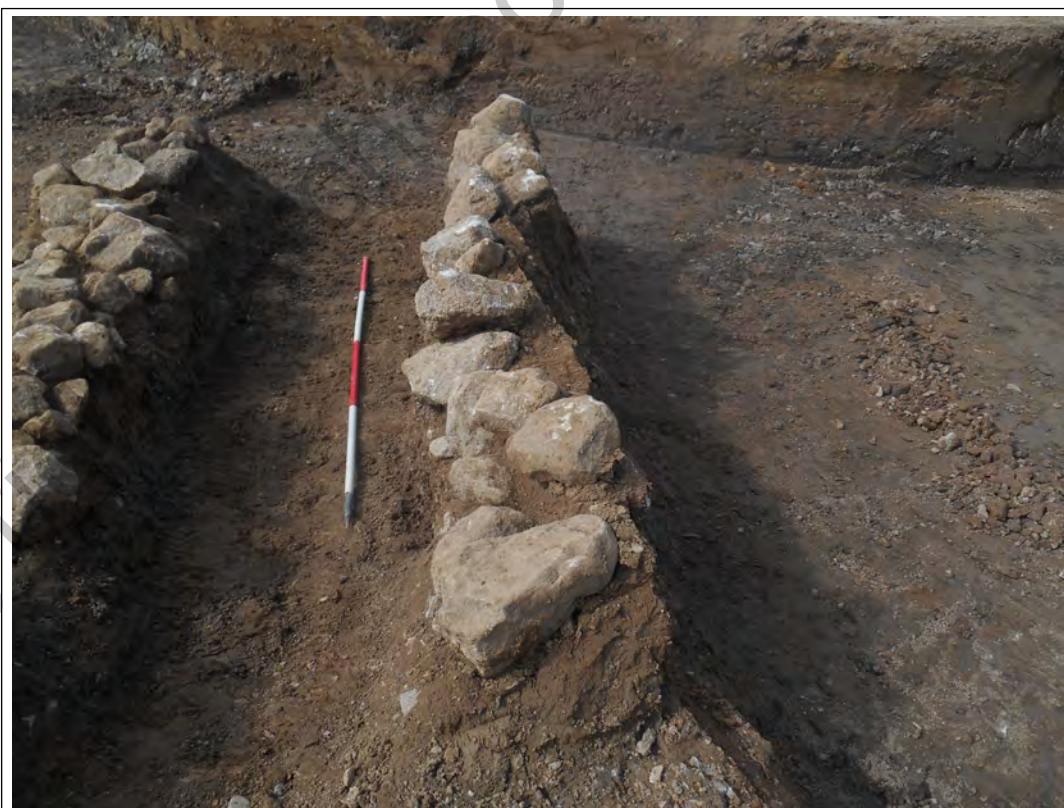
[1014] culvert was revealed at a depth of 0.35m from the top of the topsoil (1006) running on a NNW-SSE alignment (Plate 16-17), same as [1012] and [1013]. [1014] culvert was truncated at both ends of the structure, probably due to modern disturbance in the area, as there is a sewer and a man hole cover approximately 4m to the East of the structure. [1014] was 3.45m in length, up to 0.48m high and up to 0.35m wide. [1014] was in a poor state of preservation, as the structure seems to have collapsed in on its self, and the central channel was no longer visible, due to this. [1014] was constructed from local rough-cut stones, same as [1008], [1009], [1012] and [1013]. No finds were recovered from the structure, however due to its construction and materials used, [1014] is most probably the same date as the other culverts excavated during the watching brief.

Plate 16. Plan shot of culvert [1014] looking NNW. Scale 2m
