Llangefni College Campus Site, Llangefni, Anglesey

Archaeological Watching Brief

Report No. 1703

Llandrillo Campus Extension, Llangefni (Anglesey)

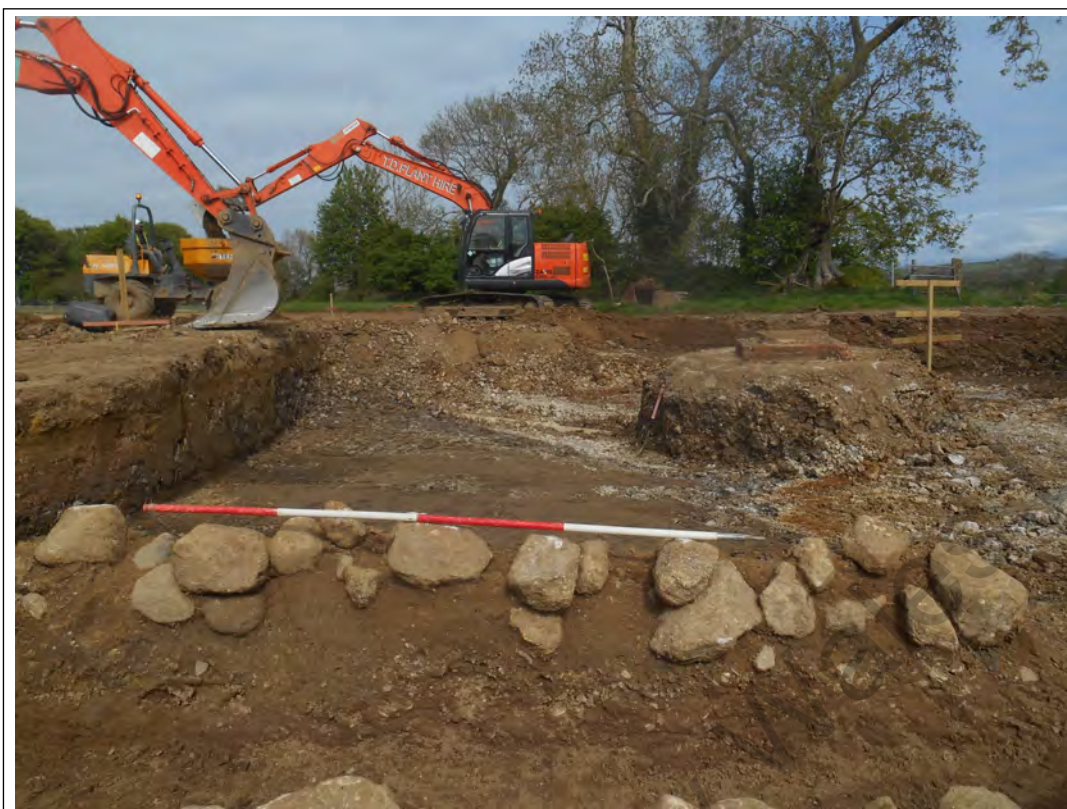
[1014] culvert was revealed at a depth of 0.35m from the top of the topsoil (1006) running on a NNW-SSE alignment (Plate 16-17), same as [1012] and [1013]. [1014] culvert was truncated at both ends of the structure, probably due to modern disturbance in the area, as there is a sewer and a man hole cover approximately 4m to the East of the structure. [1014] was 3.45m in length, up to 0.48m high and up to 0.35m wide. [1014] was in a poor state of preservation, as the structure seems to have collapsed in on its self, and the central channel was no longer visible, due to this. [1014] was constructed from local rough-cut stones, same as [1008], [1009], [1012] and [1013]. No finds were recovered from the structure, however due to its construction and materials used, [1014] is most probably the same date as the other culverts excavated during the watching brief.

Plate 17. WSW elevation of Culvert [1014]. Scale 2m

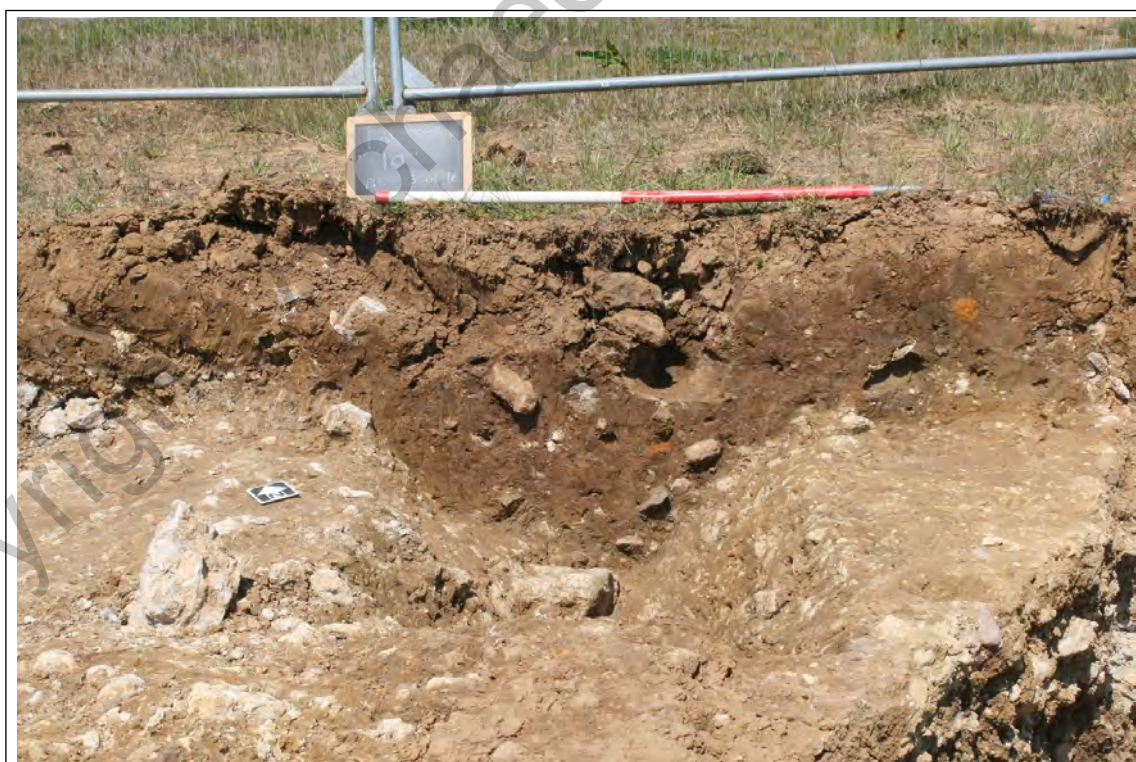
[1015] linear ditch was uncovered in the SE corner of Area C (Figure 13; Plate 22). [1015] was oriented on an NE-SW alignment running at a length of 1.57m, however it was observed that on its SW end [1015] ditch was truncated, most likely from modern machining. [1015] ditch was 0.82m wide with moderate sloping sides leading to a slightly pointed base (see figures 4 and 5). [1015] had two fills (1016) and (1017) within the feature. (1016) deposit was a moderate to firm silty clay that was mid-brown grey in colour, with inclusions of small sub angular stones up to 0.15m in size. (1016) was between 0.08m and 0.12m deep, no finds were recovered from (1016). (1016) appears to have formed from a natural silting process. (1017) was the upper fill of ditch [1015] that was a moderate to firmly compact silty clay. (1017) was mid-dark brown grey in colour with inclusions of sub-angular stones measuring up to 0.15m with traces of small flecks of charcoal. (1017) was between 0.12m and 0.25m deep, no finds were recovered from (1017). (1017) appears to have been formed due to a natural sedimentary process.

Plate 22. SW section of ditch [1015], (1016) and (1017). Scale 1m

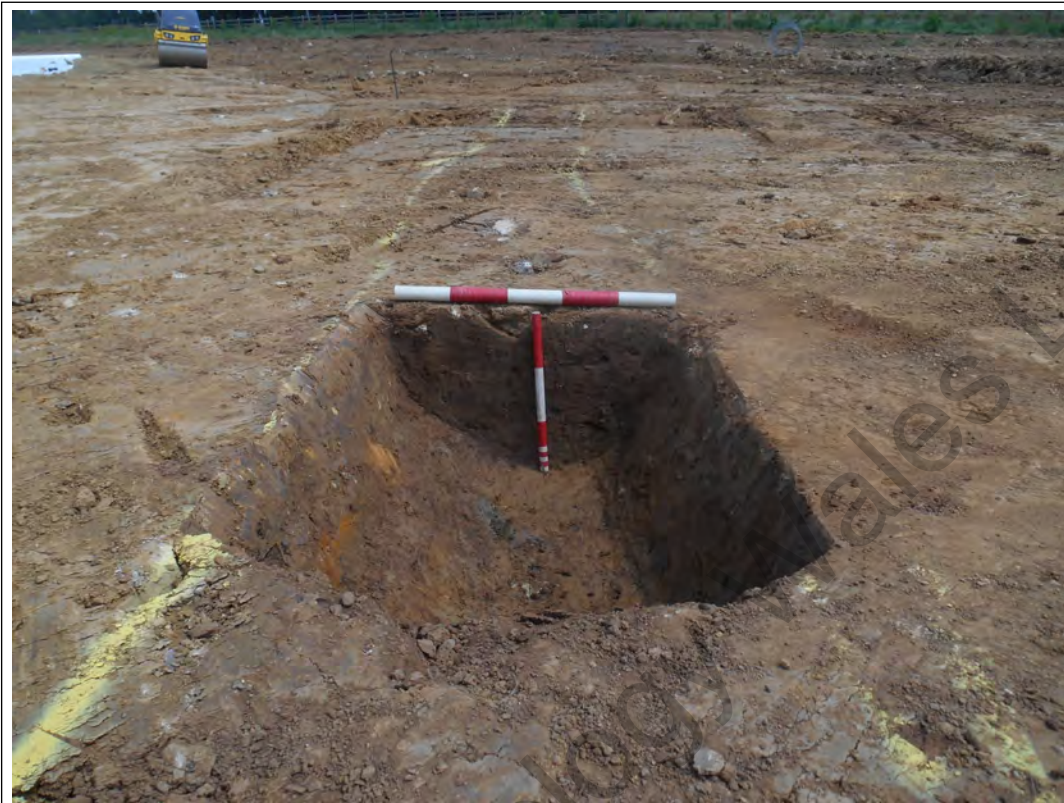
[1040] was a curvilinear feature located in the SW corner of Area D, W of the cemetery. [1040] was located whilst machine stripping down to levels for the construction of a large water tank. [1040] was interpreted as being a curvilinear ditch with steep sides and a concave base. [1040] was 13m in length, 0.65m wide and 0.35m deep (Figure 14-15). [1040] was aligned SW to NE and contained two fills (1041) and (1042). (1042) was the lower fill of [1040] and was characterised as a soft, pale grey brown, silty clay with occasional flat stones. (1042) was 1m in length. 0.3m wide and at a depth of 0.03m. (1042) was overlaid by (1041). (1041) was the upper fill of [1040]. (1041) was characterised as very compact, mid-red brown with black flecks, silty clay which contained frequent manganese and occasional small sub angular stones. (1040) was 13m in length, 0.65m in width and 0.3m deep (Plate 27). The function of [1040] ditch is unknown as no finds were recovered from fills (1041) and (1042), however the feature could be a continuation of [1015] ditch, located 10m SW from [1040].

Plate 27. WSW facing section of curvilinear ditch [1040], (1041) and (1042). Scales 0.3m & 0.5m
