CAERGEILIOG, ANGLESEY

Desk Based Assessment and Site Visit

Report No. 1910

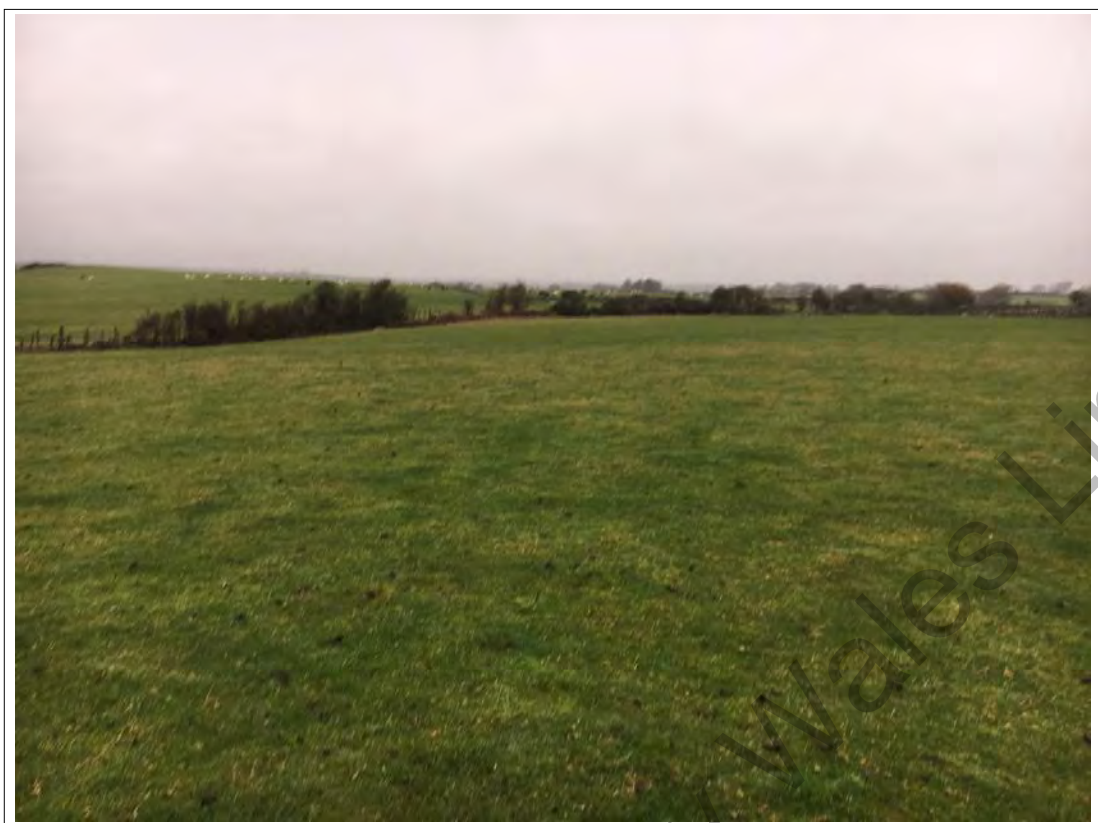
Plate 3.5 View from westernmost region of Area 3, looking NNW

- 8.5. Castellor Hut Group (AN088; PRN 2520) is the closest SAM to Area 3. The scheduled monument is located immediately north of Area 3. While views are partly masked by existing vegetation, and by the topography, it could be possible that the remains of this site extend into Area 3. Visual impacts were also assessed (see Plates 3.1, 3.3, 3.5, 3.16 and 3.37), noting that while for the most part the SAM is obscured by a line of trees, the fields in which is found are visible from certain regions of Area 3 (e.g. 3.5).

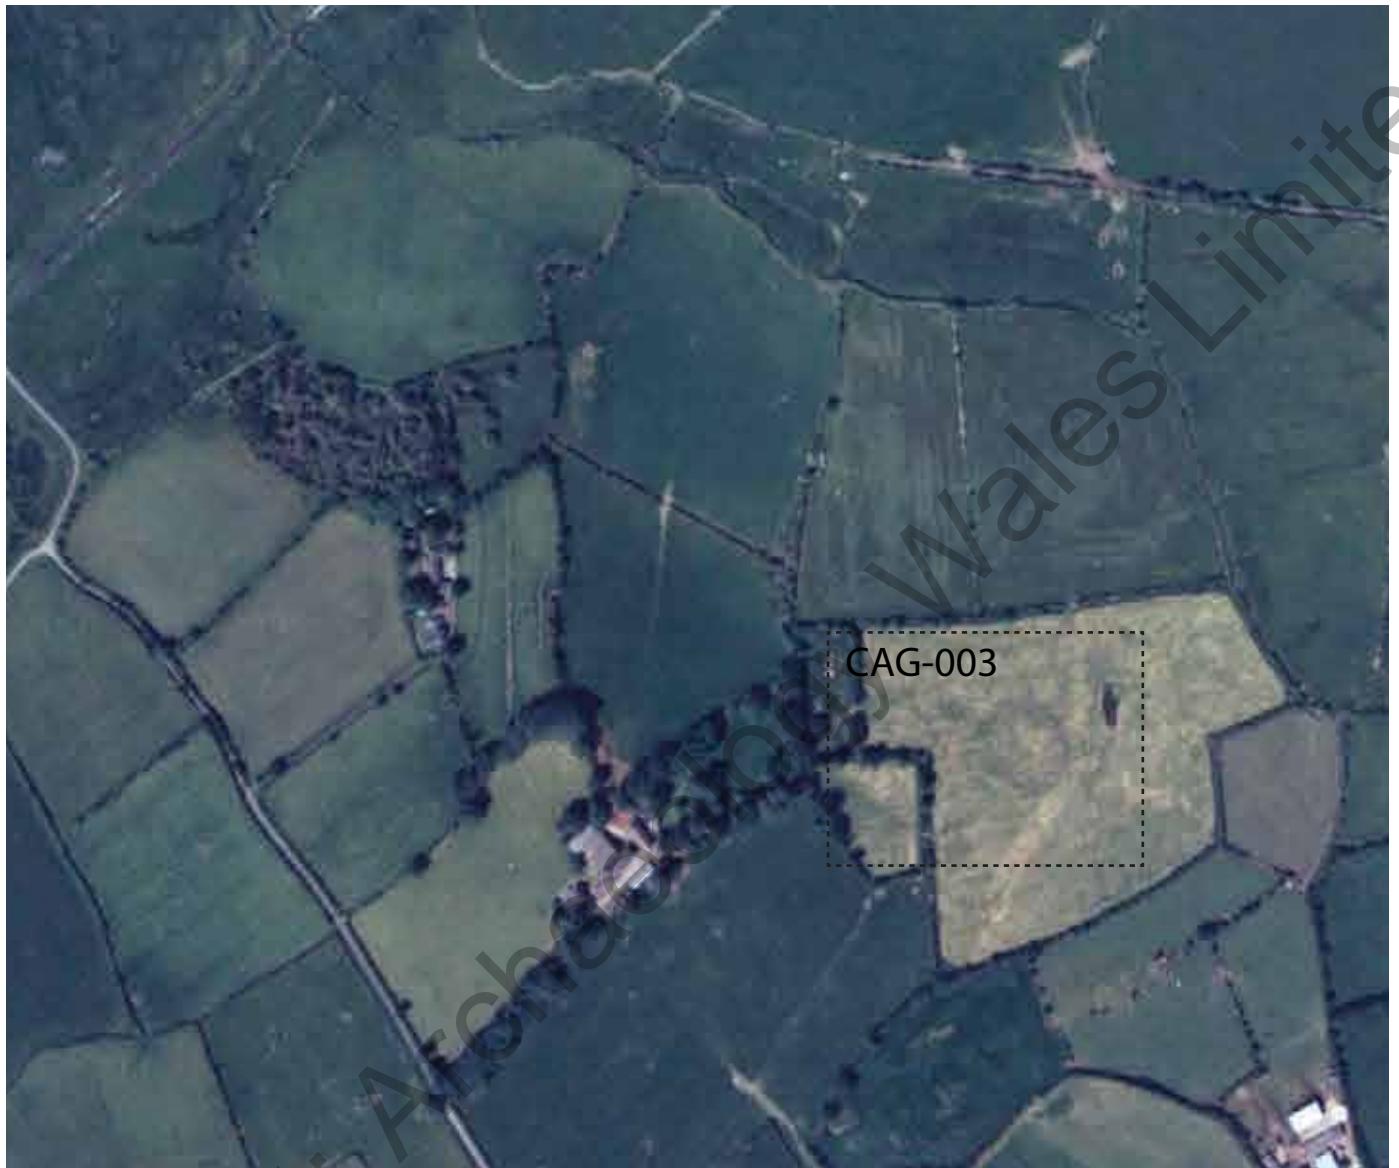
Plate 3.42. RAF Valley 1985-93 (9205 ADAS 555). Area 3 - CAG-003.

- 6.5. Photograph 8512 074 documents Area 3. No changes are visible in Area 2. CAG-003 is observed within Area 3, although as a very faint cropmark.
- 6.6. Photograph 9205 ADAS 555 194 documents Area 3. This is a colour vertical photograph shot at high altitude. An examination of Area 3 clearly evidences CAG-003 (Plate 3.42).

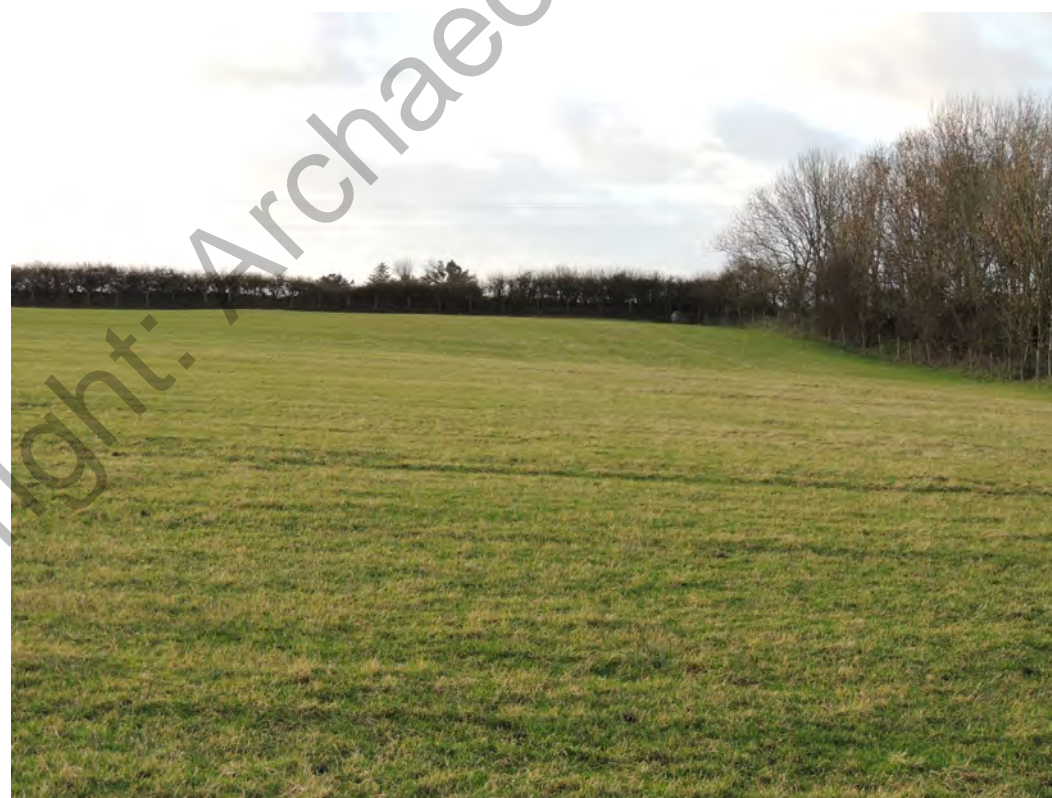
Plate 4.7 Views from Area 4 to Pond Cymunod

- 8.7. The closest listed building is Pont and Factory Cymunod (LB 5278, 20510). Plate 4.7 demonstrated views from the building to the site.
- 8.8. Three sites recorded on the HER are either located within Area 4 or immediately outside of it. A well (PRN28943), and a sheepfold (PRN28944) are located at the westernmost region of Area 4. These sites were not directly observed during the site visit, though their location is currently marked by an area of marshland.

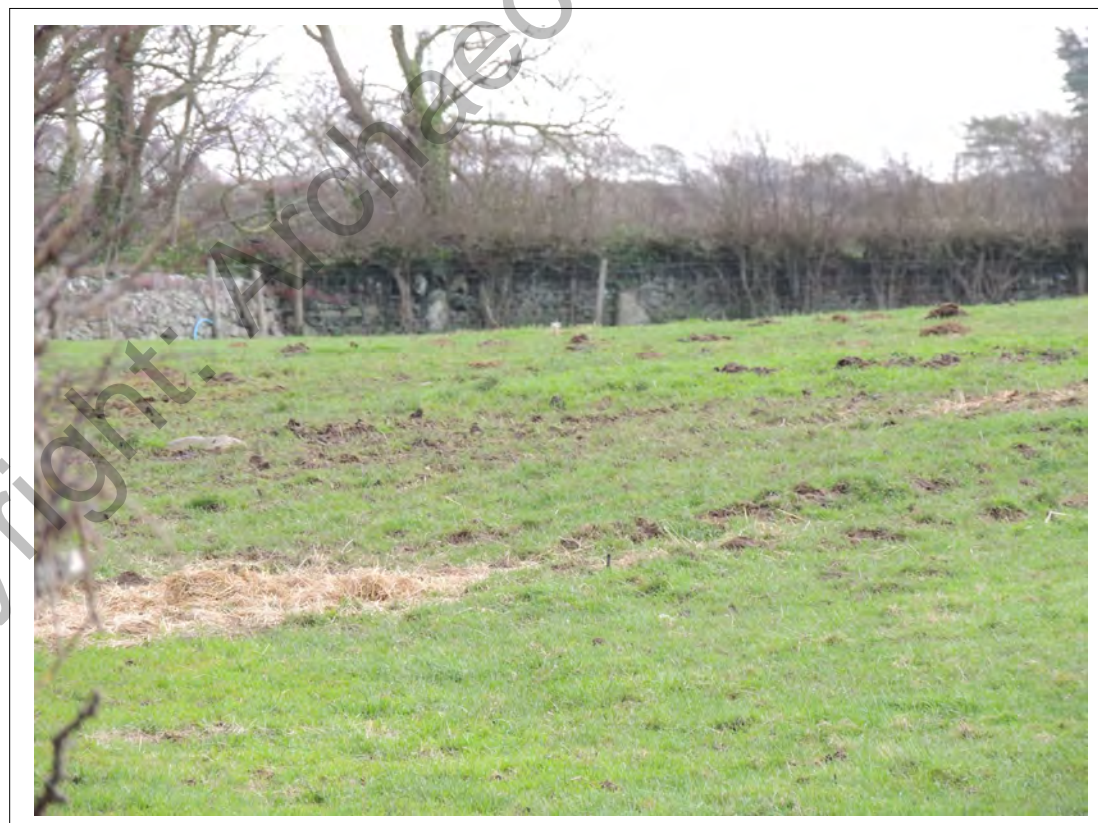
Plate 4.32 View of northern boundary Area 4

- 8.4. A pair of gate piers are observed in Plate 4.32. These would have possibly demarcated the way into Cae'r Ddôl, documented in maps from the 1880s to date.
