Desk-based Assessment:

National Slate Museum, Gilfach Ddu, Gwynedd

Report No. 2293

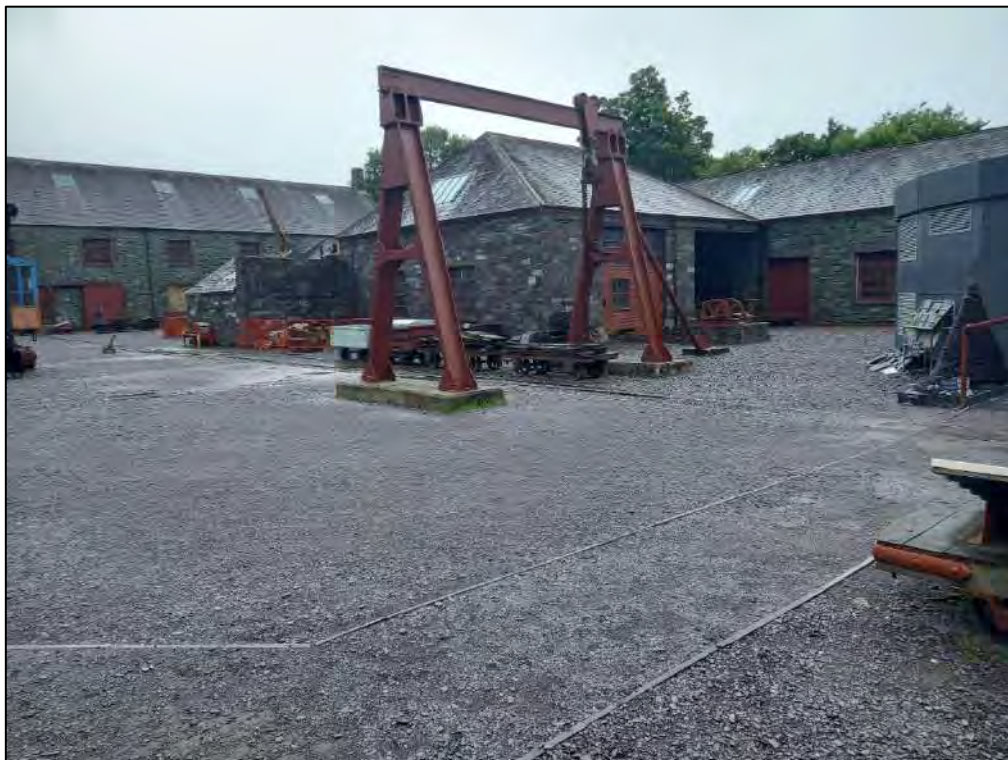
Plate 4. Inner yard, with crane NSM03. View southwest.

New Site	Description
NSM01	Coal Storage area original to the Gilfach Ddu site and in its original location
NMS02	Crane used to unload oil drums in Gilfach Ddu courtyard
NMS03	Gantry crane located within the yard built upon concrete foundations. Not in original location

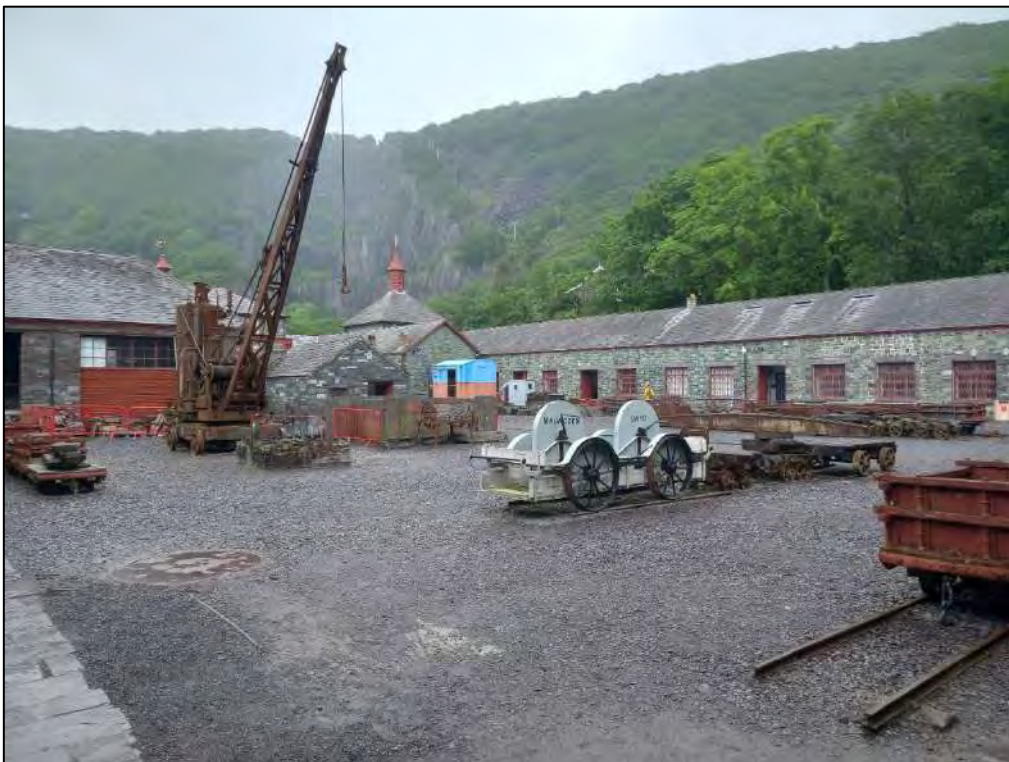
Plate 6. Inner yard, coal storage NSM01 on background. View northeast.

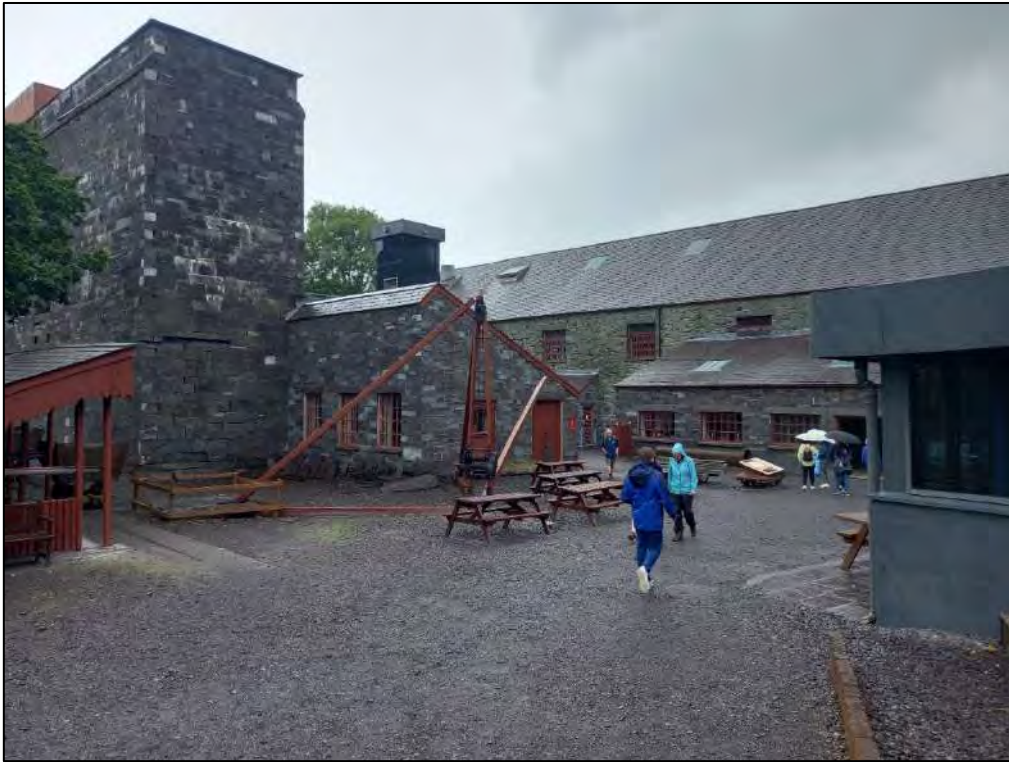
Plate 9. Rear yard, wheel pit (CN163) to the left of the image. View north-northwest.

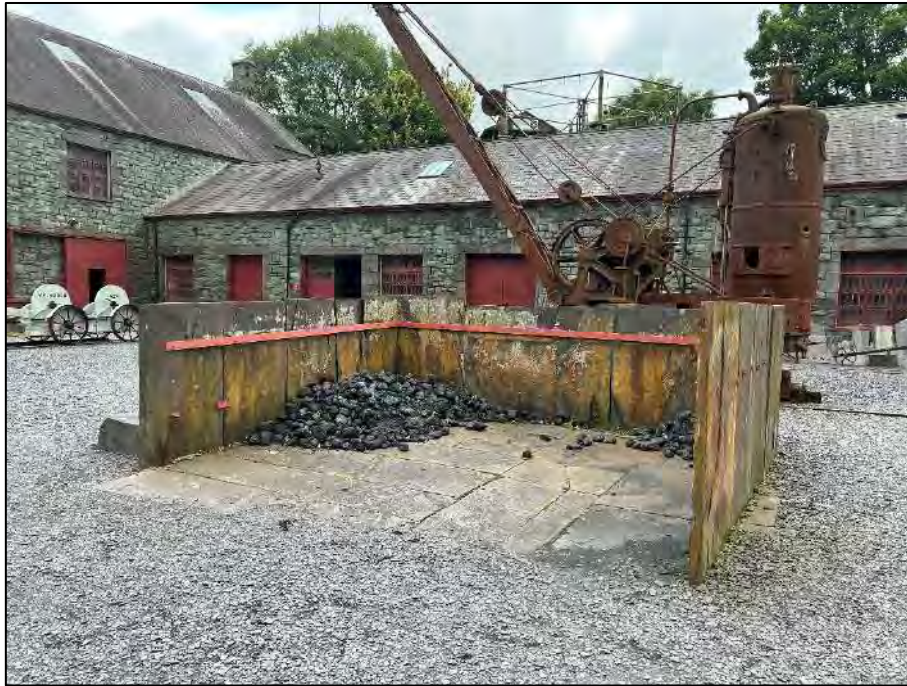
Plate 11. Coal store – NSM01. View west.

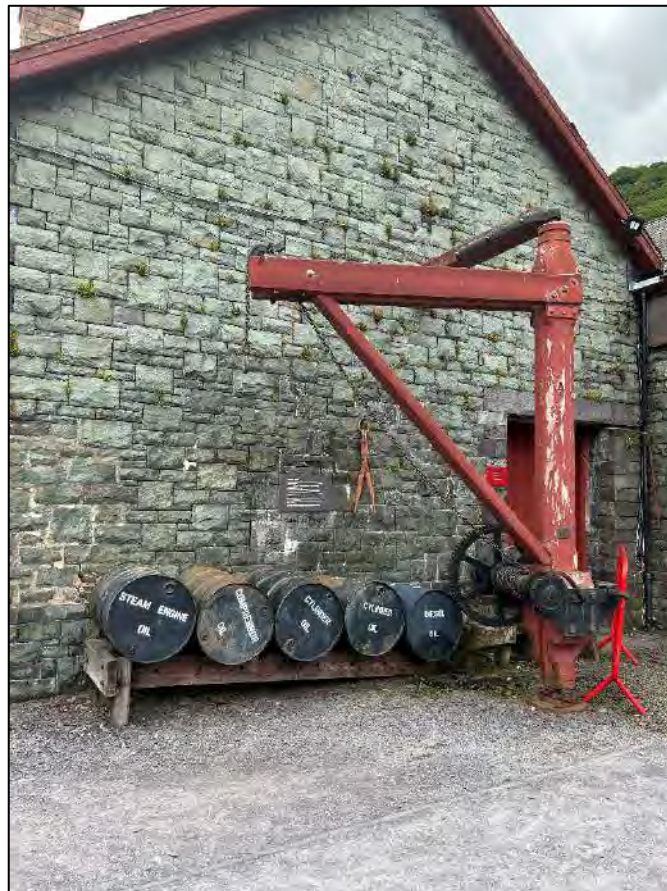
Plate 12. Oil crane – NSM02. View north-northeast.

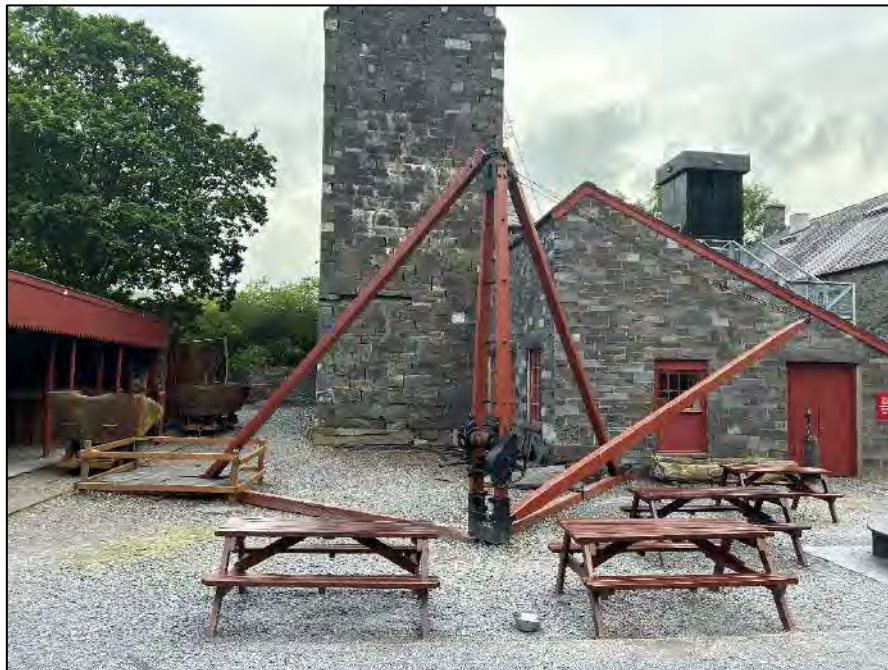
Plate 14. Crane – NSM07. View west.

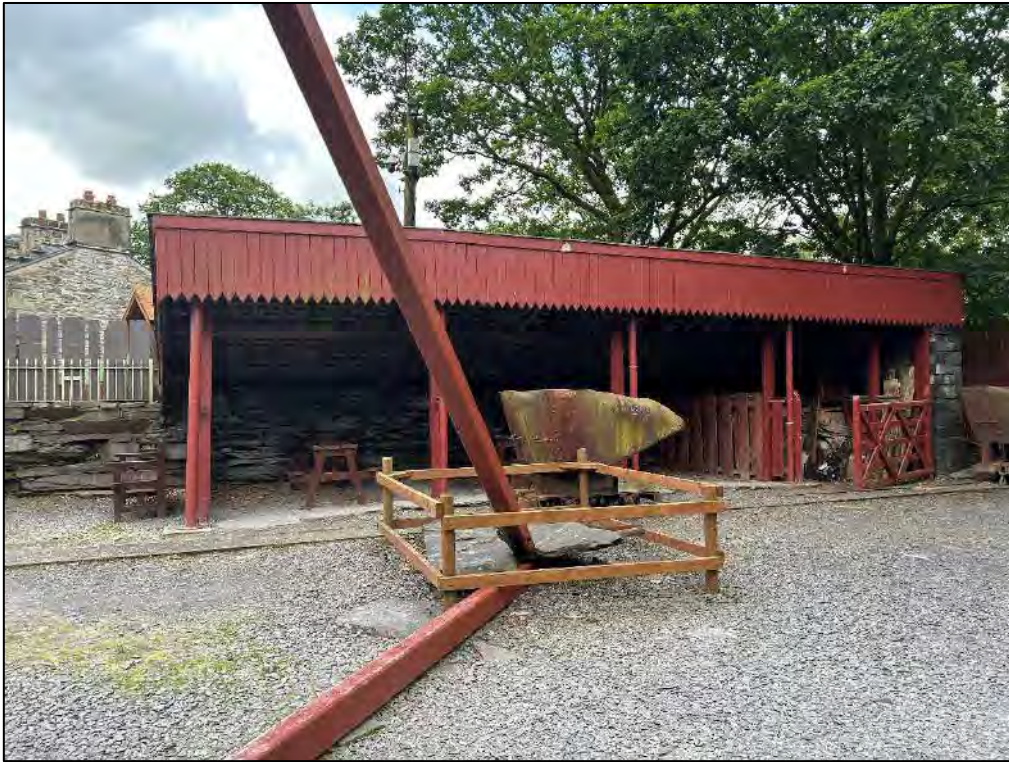
Plate 15. Drying shed – NSM08. View south.

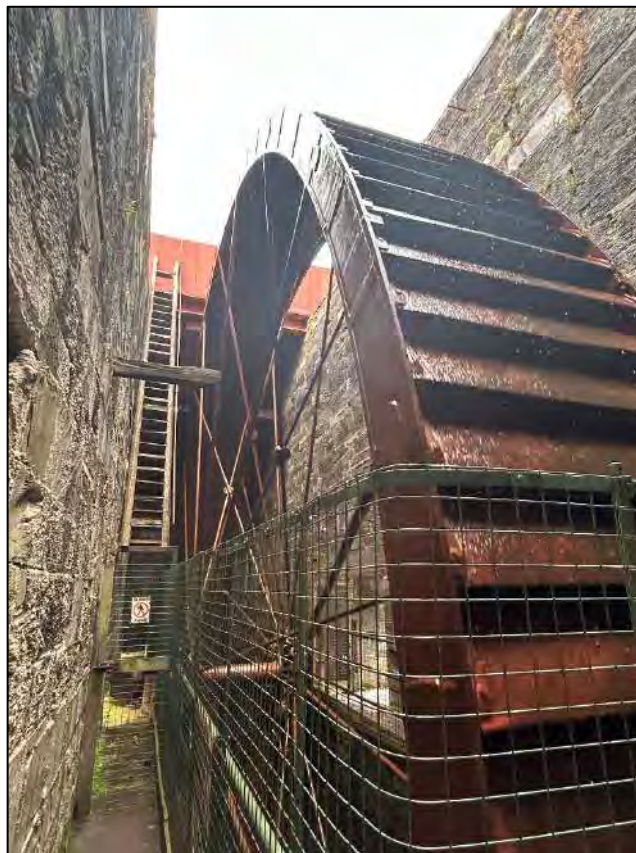
Plate 16. Waterwheel (CN163). View west.

- 4.3.3. Dinorwic Quarry: Hafod Owen Winding Engine, Locomotive Shed, Main Waterwheel and Housing (CN163) is comprised of three elements, which all formed part of the slate quarry prior to its closure. The first is the waterwheel and its housing, which are located to the south of the museum buildings. The waterwheel is an iron suspension wheel and was erected in 1870 to power the machinery within the quarry. It remained in use until 1926 when it was replaced by a Pelton wheel (Cadw, 2001).

SUMMARY A waterwheel fully enclosed within the wheelpit and originally served by a header tank that in turn was supplied by a gravity-fed rising main. Reaching an impressive height of 55ft 5 in, it is the largest surviving waterwheel on mainland Britain and was fabricated in sections by De Winton's Ironworks of Canerfon. The wheel has undergone intermittent repair since its original construction in 1870 and is now in need of complete refurbishment.

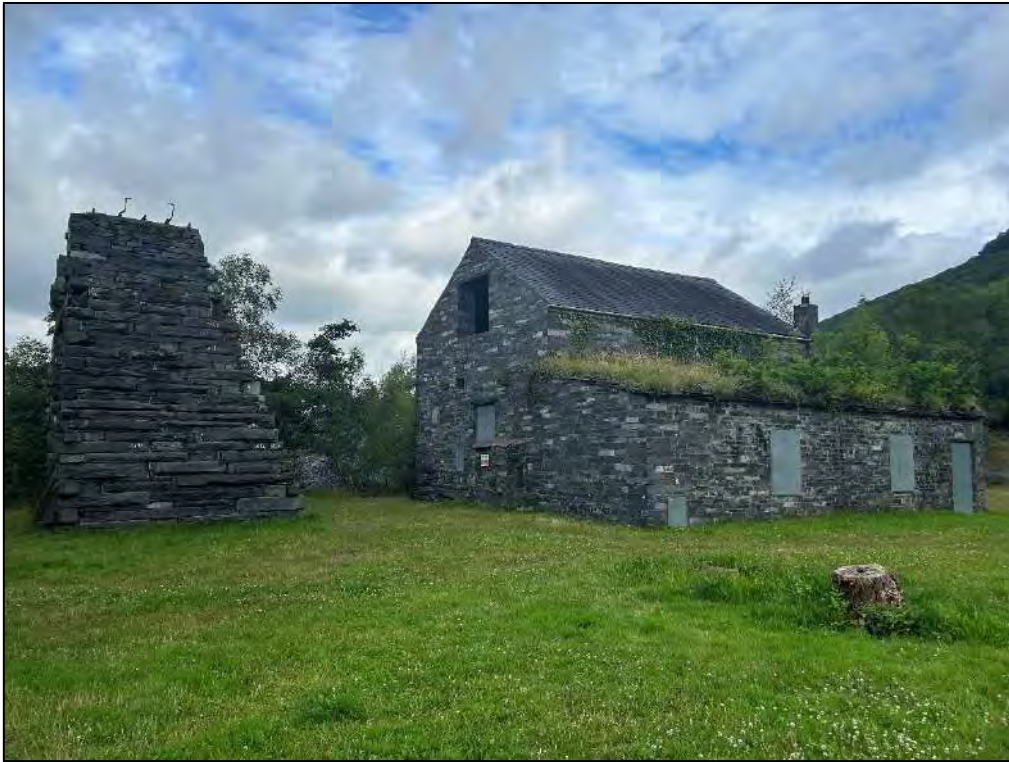
Plate 17. Hafod Owen Winding Engine (CN163). View west-northwest.

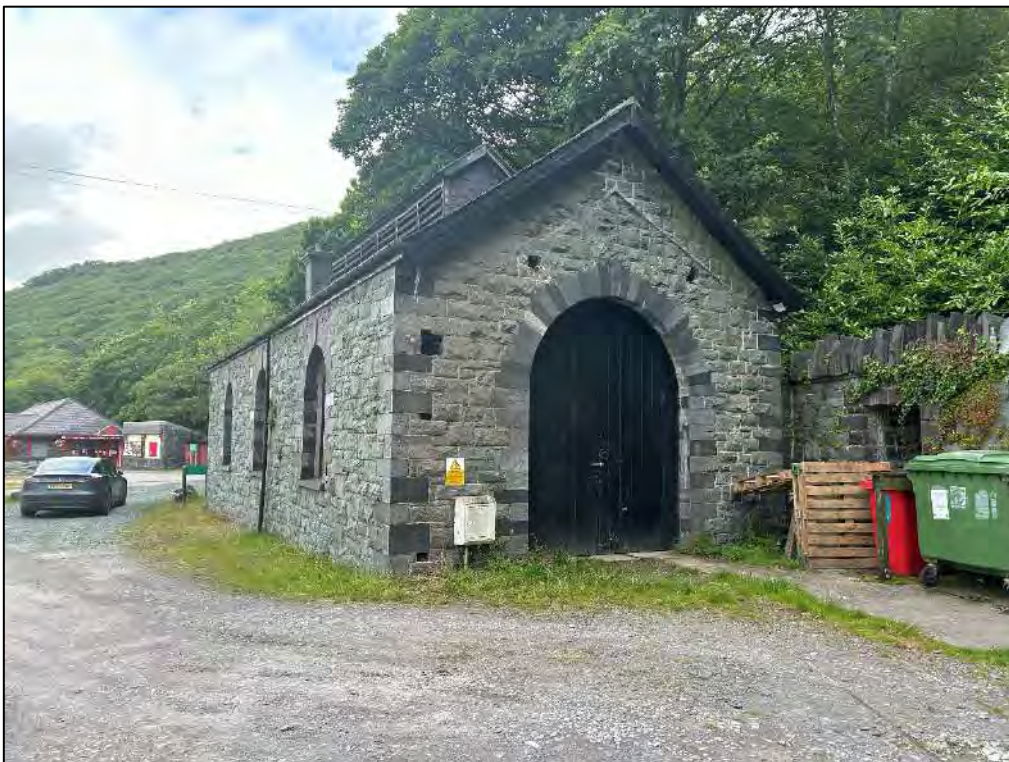
Plate 18. Locomotive shed (CN163). View north-northwest.
