Field evaluation:

National Slate Museum, Gilfach Ddu, Gwynedd

Report No. 2312

Field Evaluation: National Slate Museum, Gilfach Ddu, Gwynedd

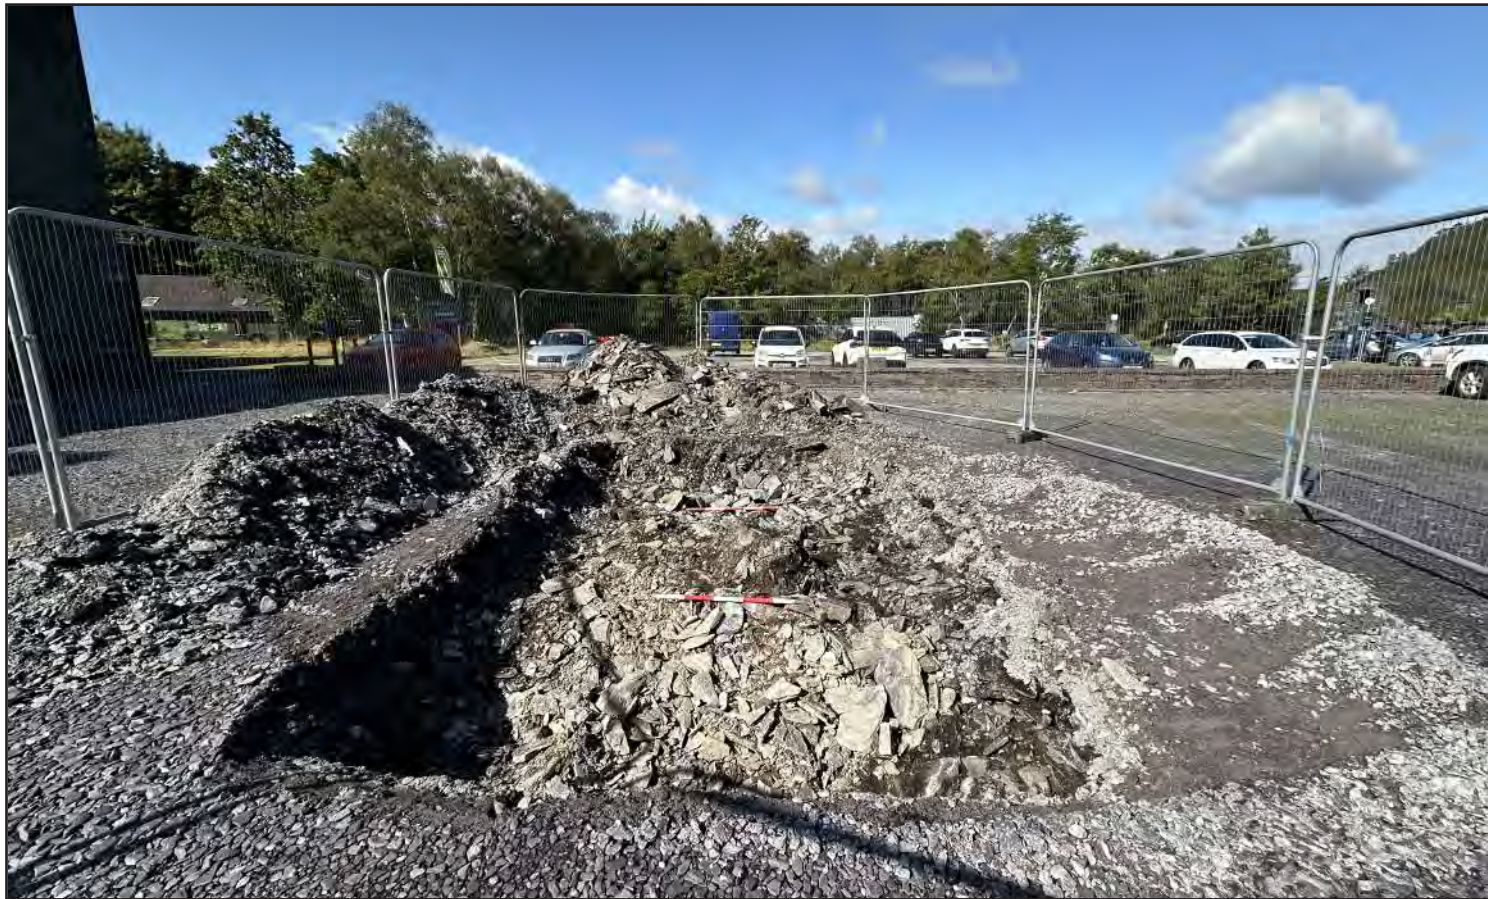
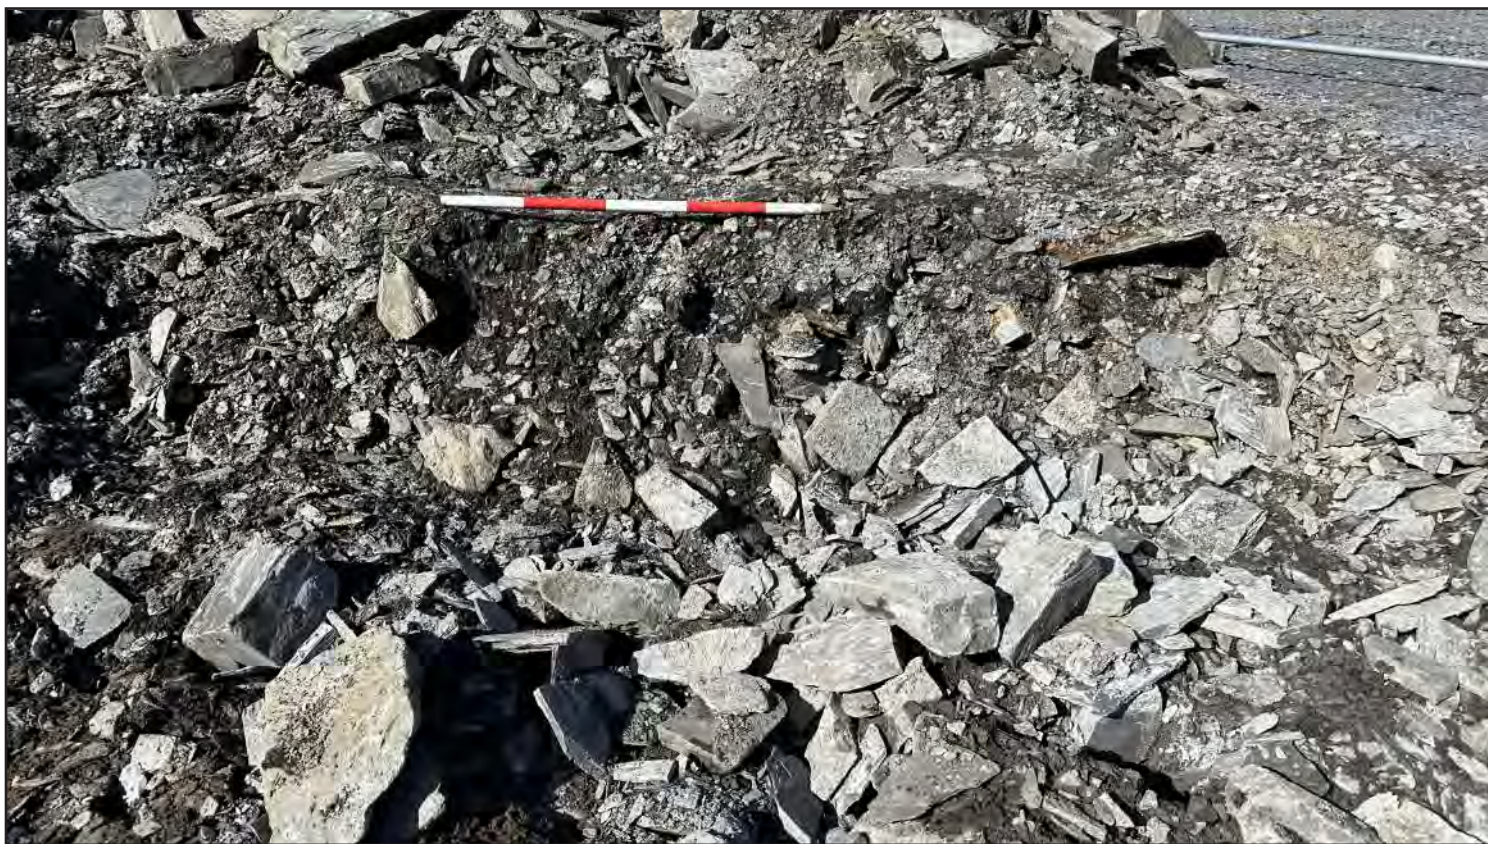
Figure 3. Trench 1 plates

Trench 1, looking west. 2x 1m scale.

East facing section Trench 1. 1m scale.

- 5.2.1. The basal deposit encountered within Trench 1 was slate waste (101), which had a minimum thickness of 0.55m (Figure 3). The deposit was comprised of loose large to medium sized slate fragments. Occasional lenses of dark greyish-black silt were evident within the deposit.
- 5.2.2. This was overlain by deposit (100), which was a dark greyish-black silt with frequent small angular slate fragment inclusions. The deposit had a maximum thickness of 0.2m.

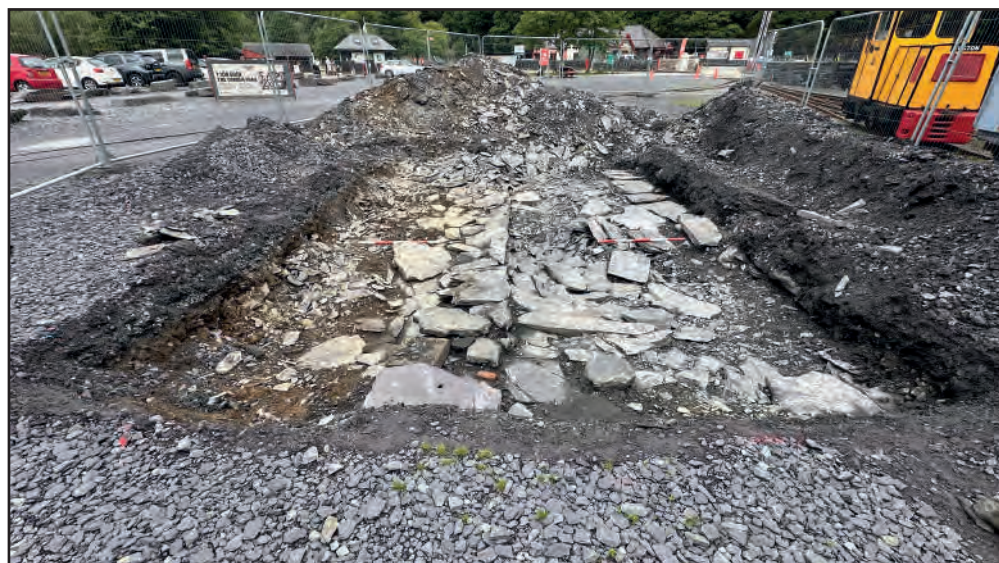
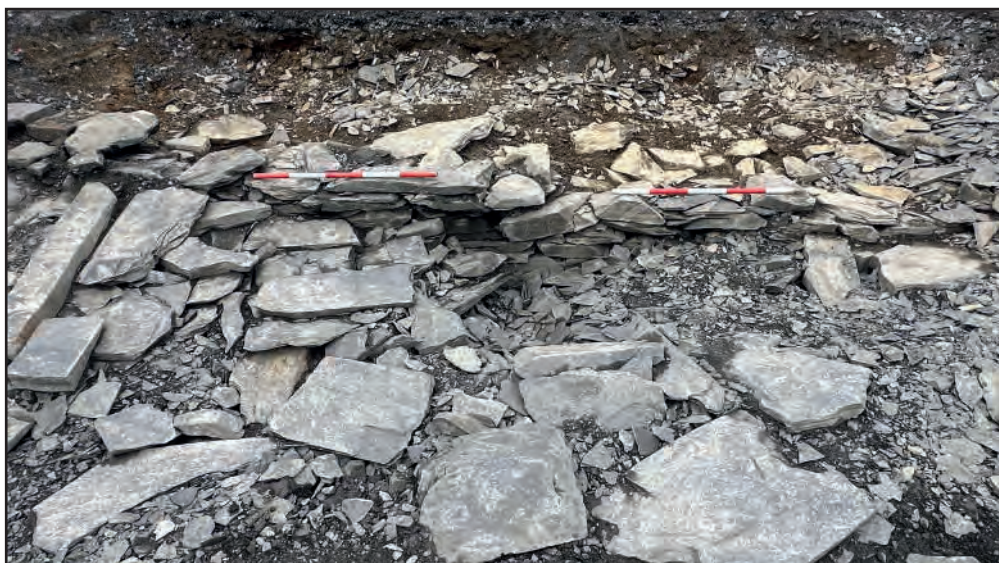
Figure 4. Plan and plates of Trench 2

Trench 2 looking north. 2x 1m scale.

Wall (204), looking west. 2x 1m scale.

- 5.3.1. Trench 2 was excavated to a maximum depth of 0.55m (Figure 4). The earliest deposit encountered within the trench was slate waste (203), which was recorded along the western half of the trench. The deposit was the same as (101) and measured 7m in length by 1.7m in width and had a thickness of 0.1m. The deposit abutted wall (204), which was oriented north to south and measured 7m in length by 0.6m in width and had a minimum depth of 0.5m. The wall had been constructed of large slate slabs with no obvious bonding material (Figure 4). It was likely constructed in order to retain deposit (203).
- 5.3.2. The wall was overlain by slate waste deposit (208), which had been deposited along the eastern half of the trench. The deposit measured 7m in length by

2.45m in width and had a minimum thickness of 0.5m. The deposit was similar in nature to (203) and (101), however, no lenses of silt were present within it.

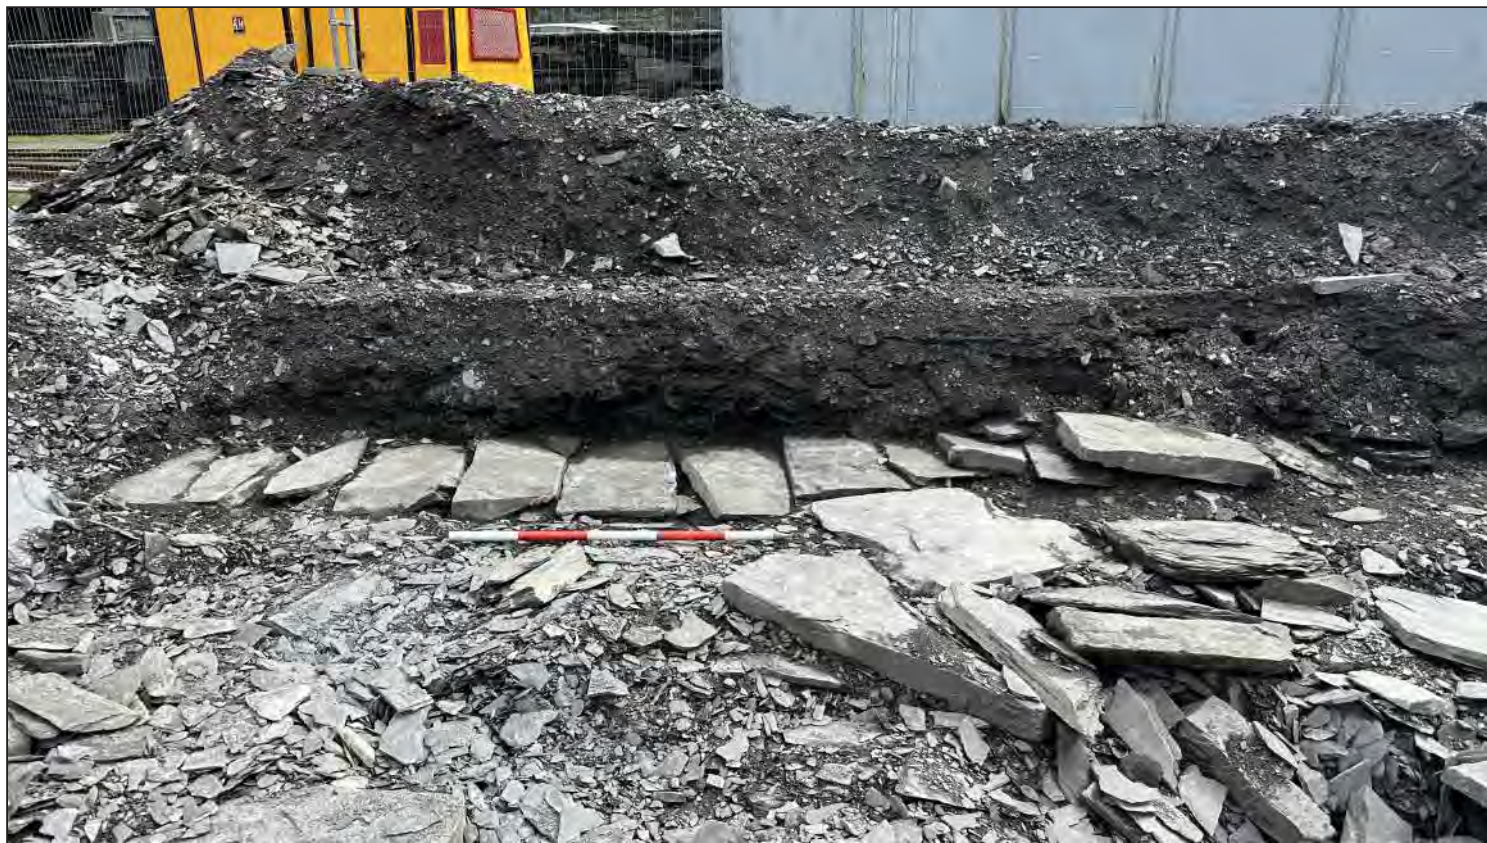
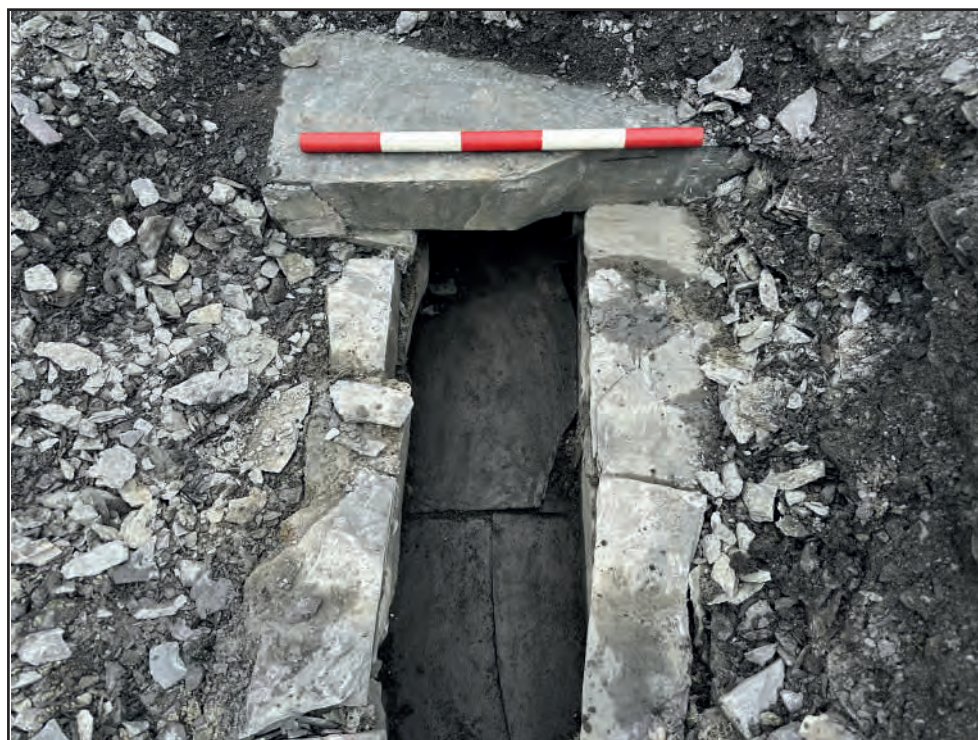
Figure 5. Trench 2 plates

Drain (205), looking east. 1m scale.

Drain (205). 0.5m scale.

- 5.3.3. The deposit had been cut by [206] which was a construction cut for stone lined drain (205). The drain was orientated north-north-west to south-south-east and measured 5m in length by 0.6m in width and had a depth of 0.3m (Figure 5). The drain was constructed from slate with the base of the drain having been lined with thin slabs, the sides consisted of small rectangular blocks, which supported the large cap stones. The drain contained fill (207), which was a dark greyish-black silt, with moderate small slate inclusions. The fill had a maximum thickness of 0.03m.

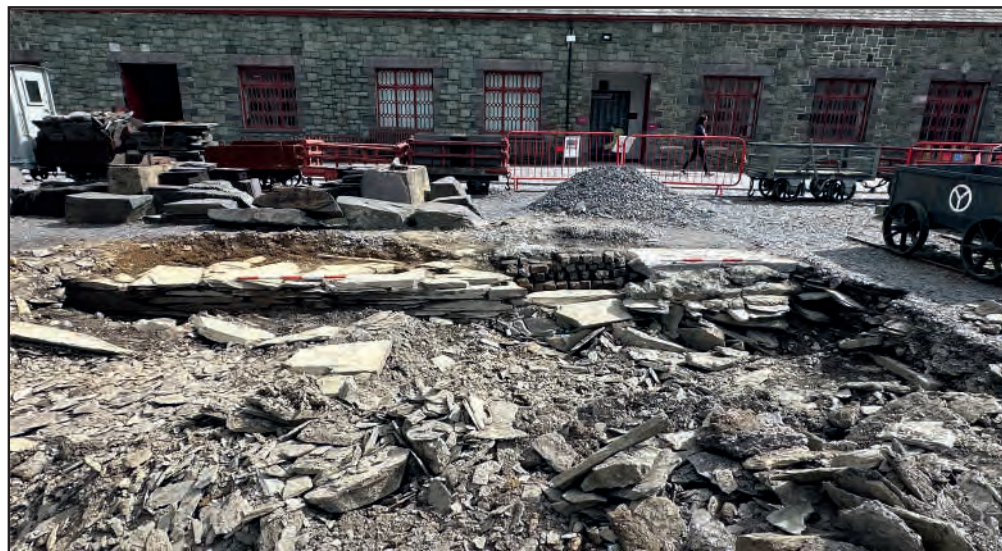
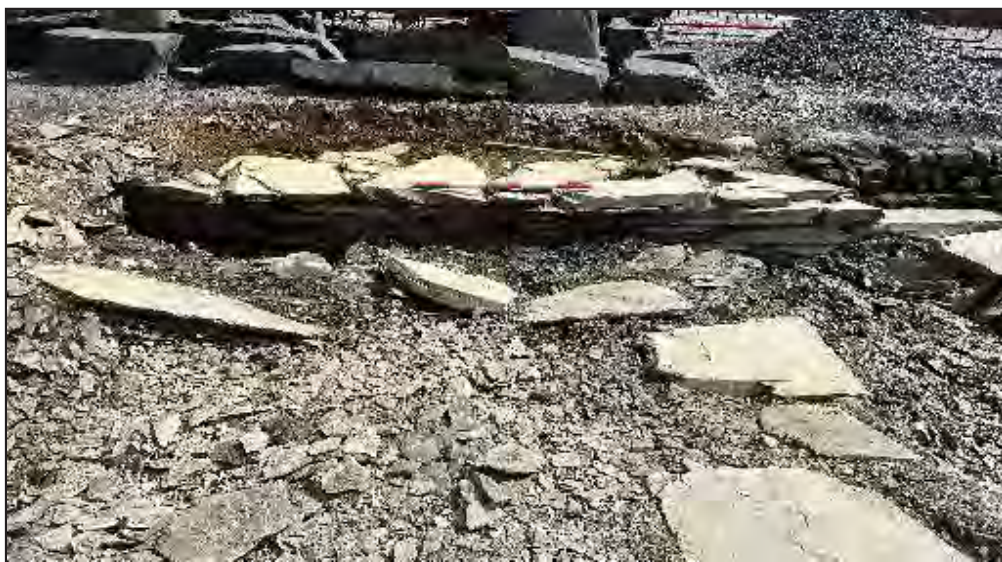
Figure 6. Plan and plates of Trench 3

Trench 3 plan.

North facing section of Trench 3.

Trench 3 looking east. 2x 1m scale.

Wall (304), looking east. 1m scale.

- 5.4.1. The trench was excavated to a maximum depth of 0.8m, with the basal deposit (303) being encountered at a depth of 0.2m (Figure 6). The deposit was formed of slate waste, the same as (101) and had a minimum thickness of 0.4m.
- 5.4.2. The deposit had been cut by wall (304), which measured 5.4m in length by 0.6m in width and had a minimum depth of 0.8m (Figure 6). The wall was broadly orientated north to south and was constructed in the same manner as wall (204). It is possible that these walls formed part of the same, larger feature.
- 5.4.3. Flagstones (308) had been laid over the northern section of the wall and

continued to the east beyond the limit of excavation. These likely formed part of the inner courtyard surface and were contemporary with the construction of the Gilfach Ddu workshops.

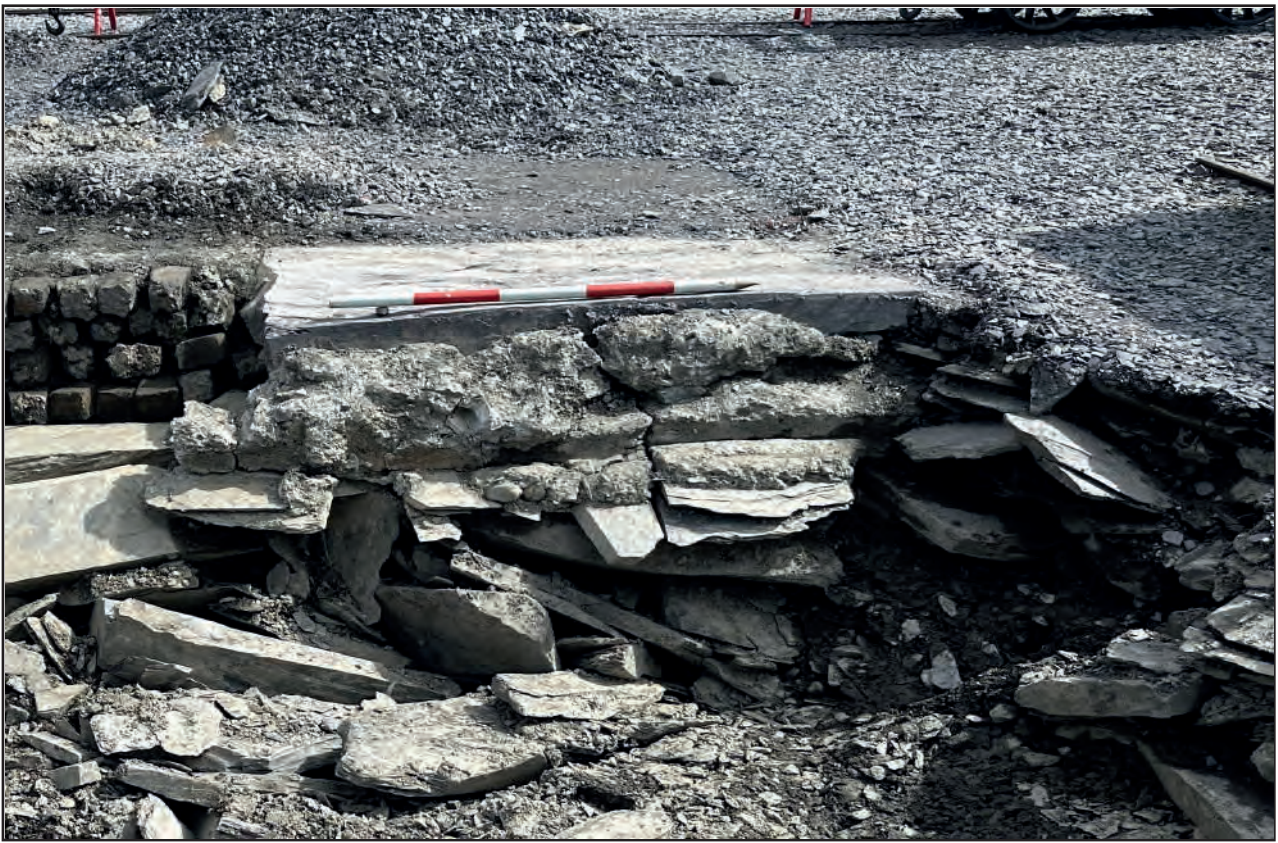
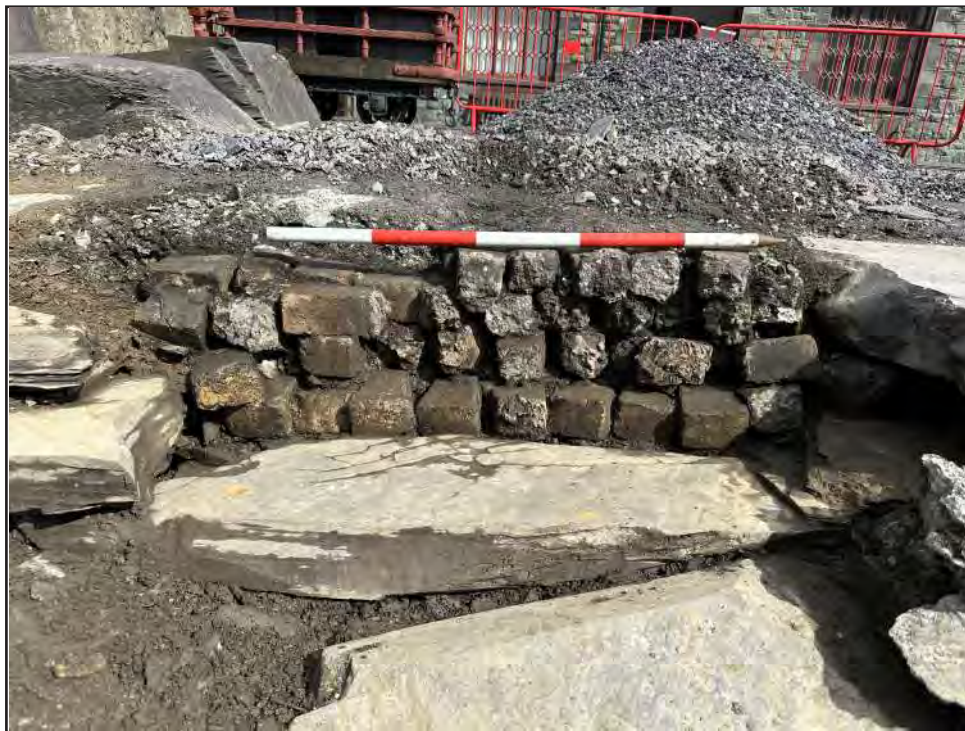
Figure 7. Trench 3 plates

Slab (302) and concrete deposit (301), looking east. 1m scale.

Brick structure (305), looking east. 1m scale.

- 5.4.4. Dark greyish-black silt deposit (310) was recorded in the south-eastern corner of the trench and appeared to overlay wall (304). The relationship was slightly uncertain due to later truncations and disturbance. The deposit had been cut through by brick structure (305). The structure measured 1.4m in length by 0.3m in width and 0.35m in height. The bricks were key shaped refractory bricks and had likely come from a chimney, possibly one located within the site, although this is impossible to confirm. The narrower inside faces of the bricks were vitrified and so it is likely they were originally part of the foundry chimney. The purpose of the brick structure was unclear (Figure 7).

- 5.4.5. The bricks were overlain by large slate slab (302), which is likely modern in date and was placed to form part of the modern surface of the museum courtyard. The slab measured in excess of 1.5m in length by 0.64m in width and had a thickness of 0.09m.

- 5.4.6. Along the western side of the slab was concrete deposit (301), which measured 1.7m in length by 0.35m in width and 0.36m in thickness (Figure 7). It contained the remains of a linear impression, likely from an iron bar possibly part of a rail line. The relationship of the concrete to slab (302) is not certain. The eastern side of the concrete was flat, suggesting it had been poured up against a solid structure, however, that is unlikely to have been slab (302) as the slab was not as thick as the concrete and the two did not abut. It is then likely that concrete (301) is earlier than the slab and may have been poured against wall (304), but it is not possible to be certain.

- 9.1.2. The brick structure in Trench 3 was formed of refractory bricks, which based on their shape would likely have come from a chimney. The foundry within the Gilfach Ddu workshops was located in the south-western corner of the workshop shop range, with a chimney still standing within this. It is possible the bricks originated from this chimney, with them being reused after the chimney had been repaired. However, as discussed above it is not possible to be certain of this. If it were the case however, then it is evidence of repair and maintenance taking place to the Gilfach Ddu workshops. The workshops operated for just over 100 years and must have been repaired and maintained over the course of their lifespan.

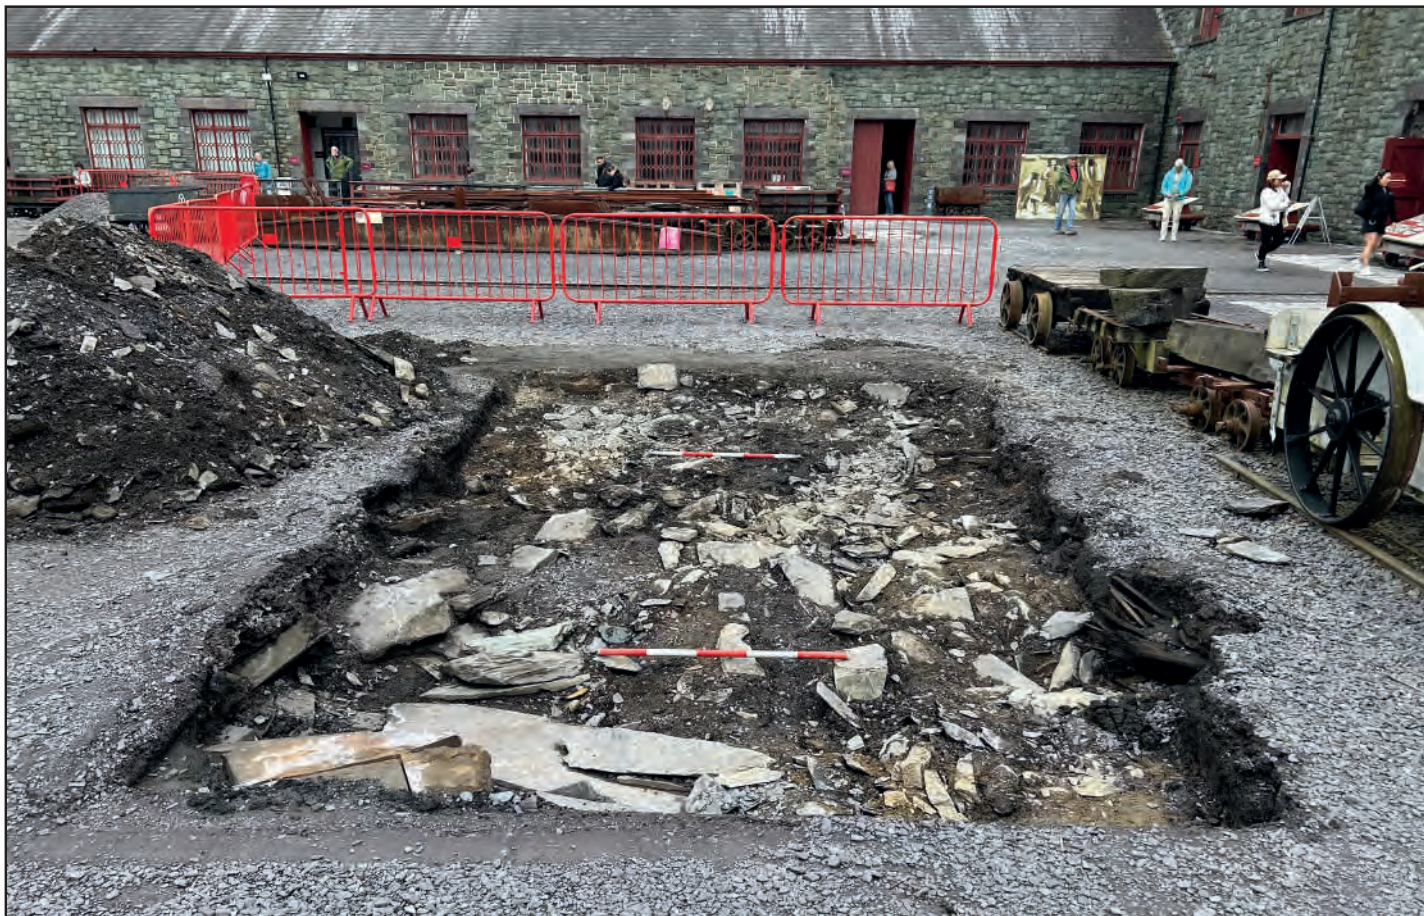
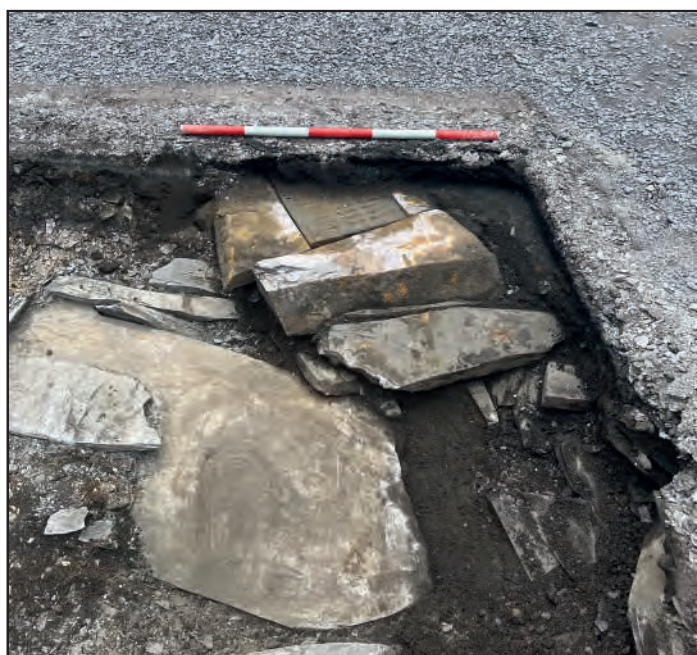
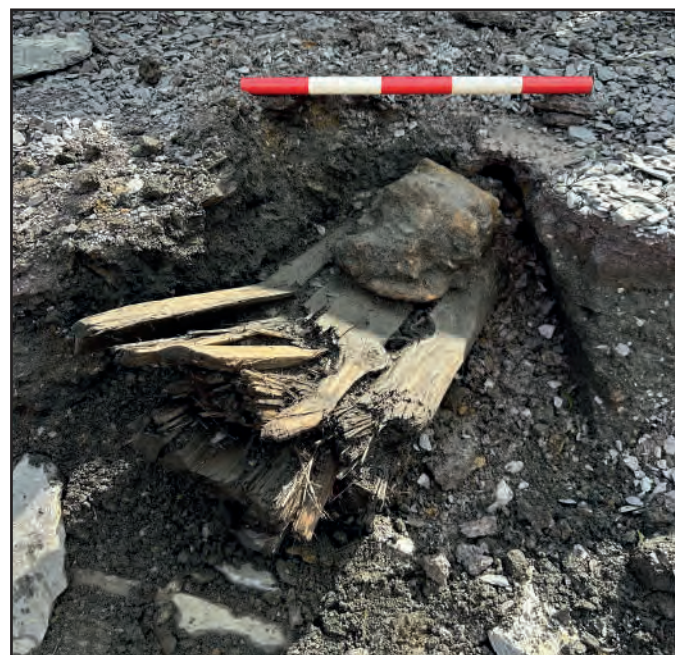
Figure 8. Trench 4 plates

Trench 4, looking east. 2x 1m scale.

Drain (403), looking west. 1m scale.

Rail sleeper with chair, looking south. 0.5m scale.

- 5.5.1. Trench 4 was excavated to a maximum depth of 0.4m, with basal deposit (402) encountered at a depth of 0.33m (Figure 8). The deposit was formed of slate waste, the same as evidenced in Trenches 1 to 3.
- 5.5.2. The deposit was overlain by (401) which was a dark greyish black silt with lenses of yellowish brown sand and slate. The deposit appears to have been a mixed dumped layer potentially used to level this area of the inner courtyard. There were two rail sleepers recorded within this deposit in the southern limit of excavation, one of which still had the chair preserved. The deposit had a thickness of 0.31m.
- 5.5.3. Drain (403), which was located in the north-west corner and had been cut into (401). The drain had been constructed from brick and the iron grill was still in situ.
- 5.5.4. The drain was overlain by modern slate gravel (400), which had a thickness of 0.02m.

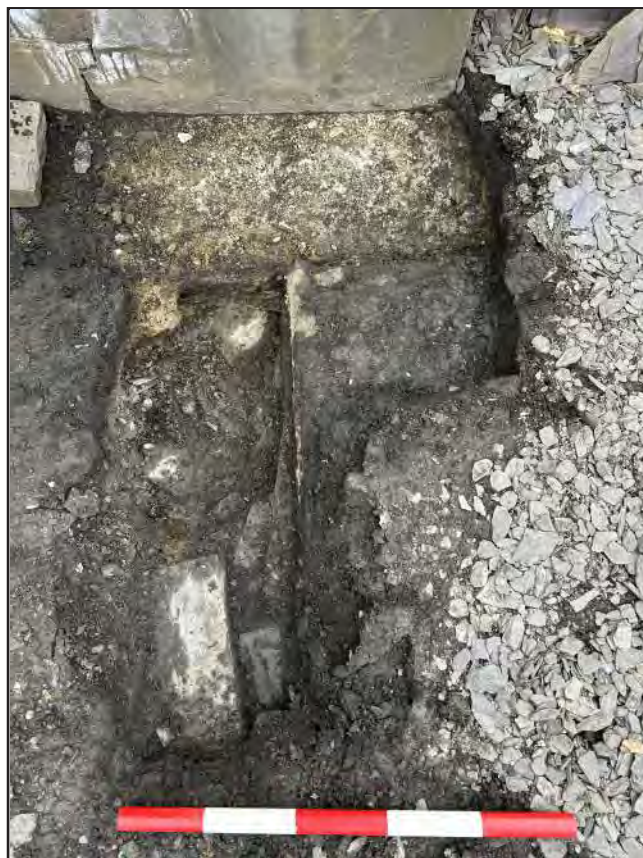
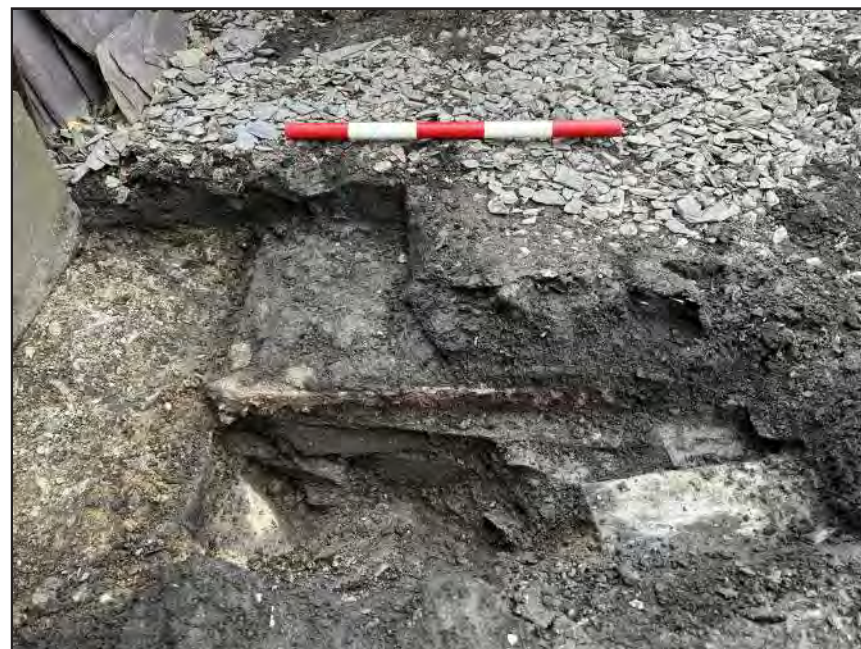
Figure 9. Plan and plates of Test Pit 5

Test Pit 5 plan.

Test Pit 5, 0.5m scale.

South facing section of Test Pit 5. 0.5m scale.

- 5.6.1. The test pit had a maximum depth of 0.29m. The basal deposit was (506), which was the same slate waste evident across the site. The deposit had a thickness of 0.12m (Figure 9).
- 5.6.2. It had been cut through by [502], which was the construction cut for foundations (503). The cut measured in excess of 0.5m in length by 0.25m in width with a depth of 0.2m. The foundations were formed of a light brownish-yellow mortar with small to medium slate inclusions. The foundations supported wall (504), against which the test pit had been excavated.
- 5.6.3. Abutting the foundations was iron plate (505) which was not fully revealed but had a thickness of 0.07m. It is possible that the slab related to a drain.

- 5.6.4. This was overlain by dark grey black silt deposit (501), same as (401), which had a thickness of 0.15m. This was in turn overlain by modern slate gravel (500), which had a thickness of 0.02m.

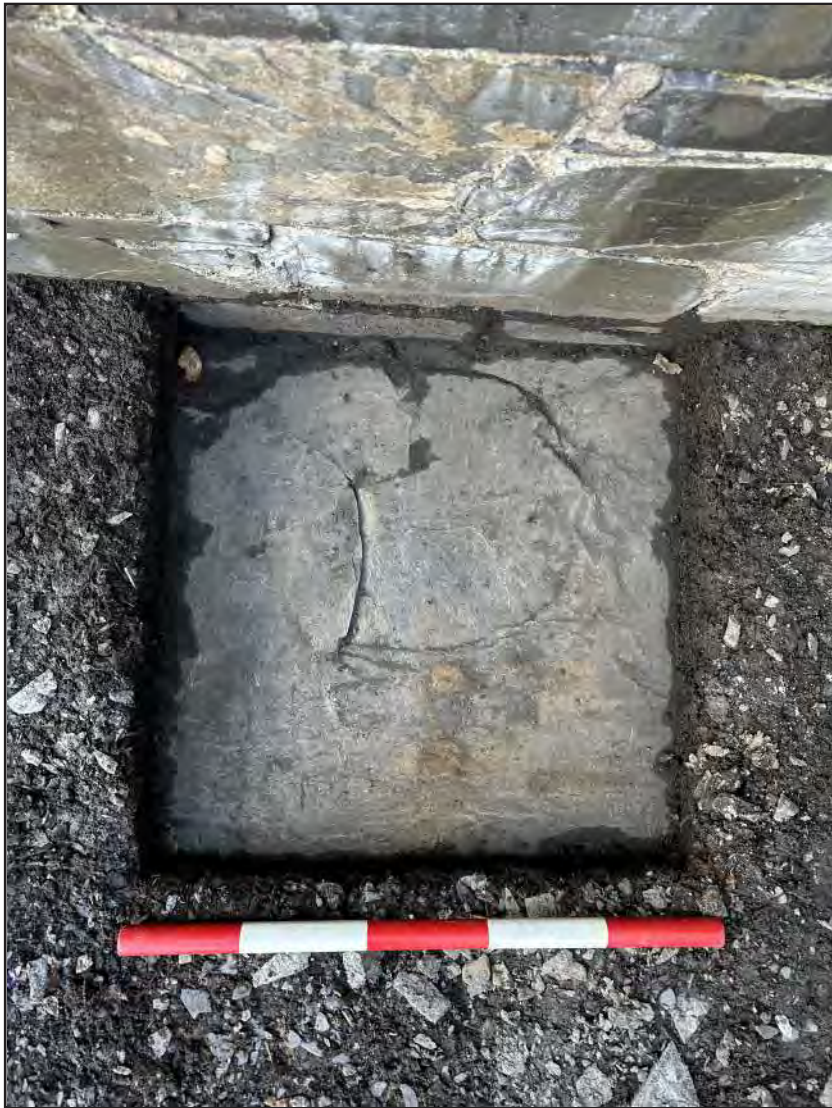
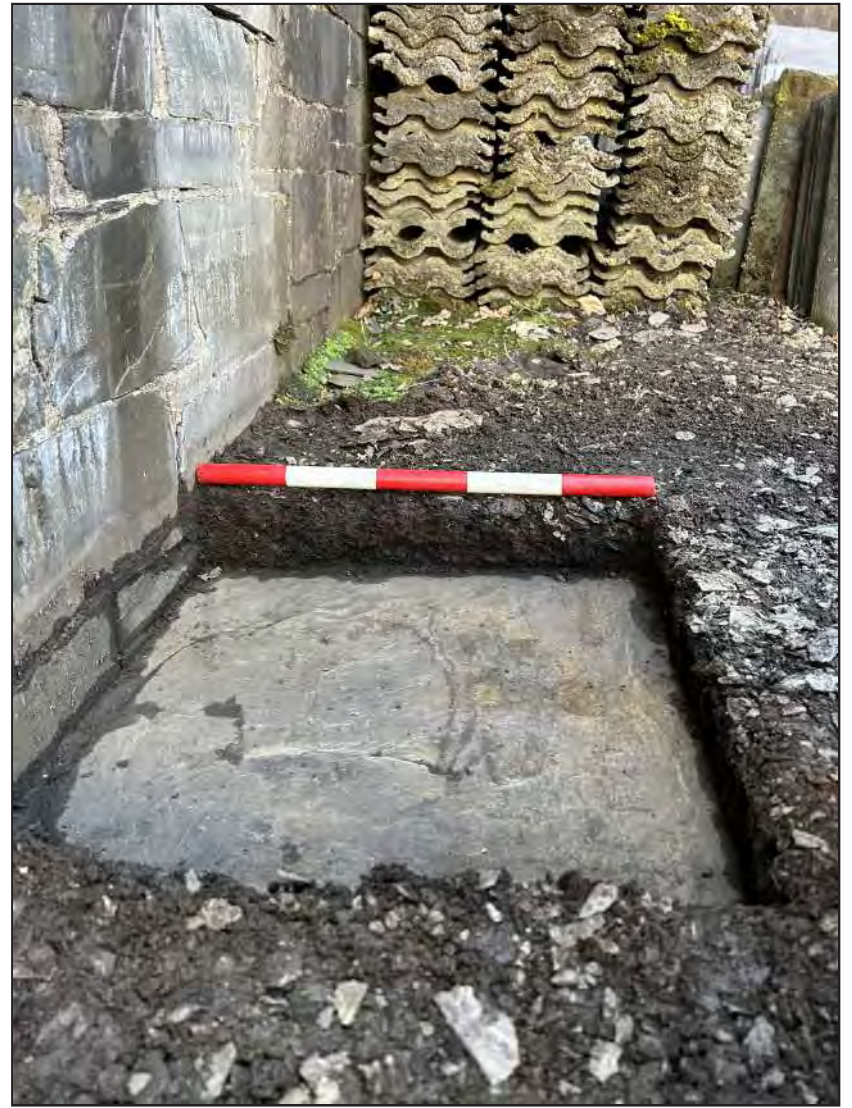
Figure 10. Plates of Test Pit 6

Test Pit 6, 0.5m scale.

South facing section of Test Pit 6. 0.5m scale.

- 5.7.1. Test Pit 6 had a maximum depth of 0.06m. The basal deposit encountered within the test pit was flagstone (602), which likely formed part of the original courtyard surface (Figure 10). This was overlain by (601), which was the same dark greyish-black silt as seen in both Test Pit 5 and Trench 4. It had a thickness of 0.05m.
- 5.7.2. The silt deposit was overlain by slate gravel (600), which had a thickness of 0.01m

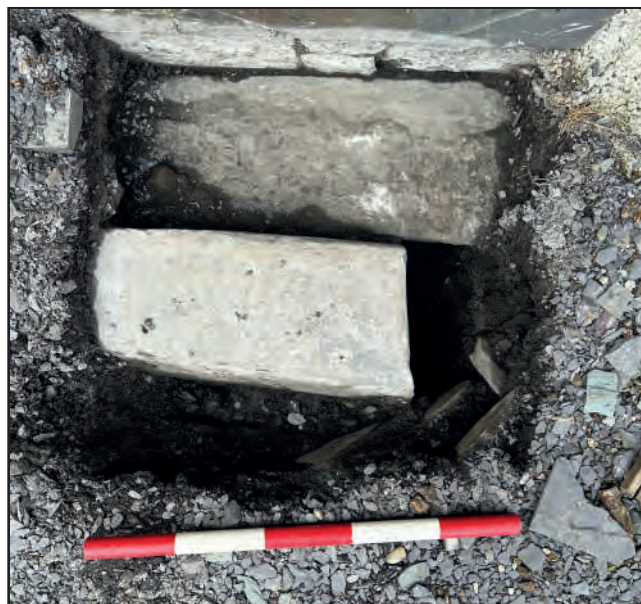
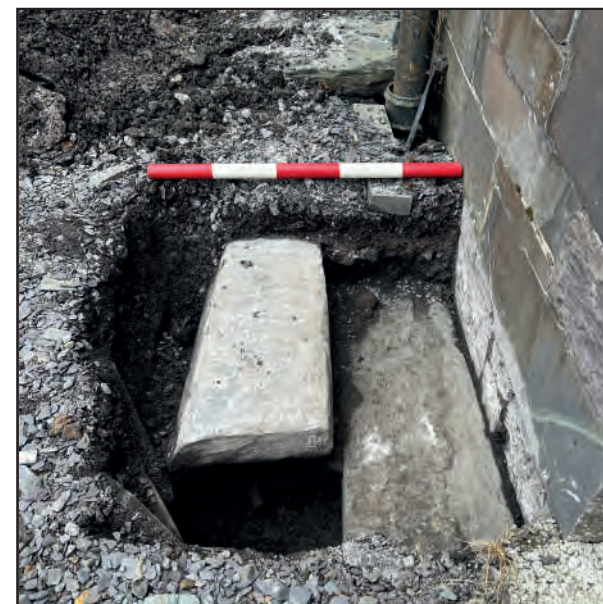
Figure 11. Plan and plates of Test Pit 7

Test Pit 7 plan.

Test Pit 7, 0.5m scale.

East facing section of Test Pit 7. 0.5m scale.

- 5.8.1. Test Pit 7 had a maximum depth of 0.25 (Figure 11). The basal deposit within the test pit was dark greyish-black silt (704), which was the same silt deposit evident across Test Pits 5 and 6 and Trench 4. The silt had a thickness of 0.15m.
- 5.8.2. The silt had been cut by [703], which was the cut for a slate lined gully (702) that ran along the southern outside face of the wall against which the test pit had been located. The gully had a slate base and side and had been constructed flush with the wall probably to collect rain water. A downpipe was noted just to the west of the test pit.
- 5.8.3. The gully had become backfilled with deposit (701), which was a mid brownish-grey silt with frequent small slate inclusions. The backfill had a thickness of 0.06m. It was overlain by (700), which was the modern gravel deposit evident across the site that had a thickness of 0.07m.

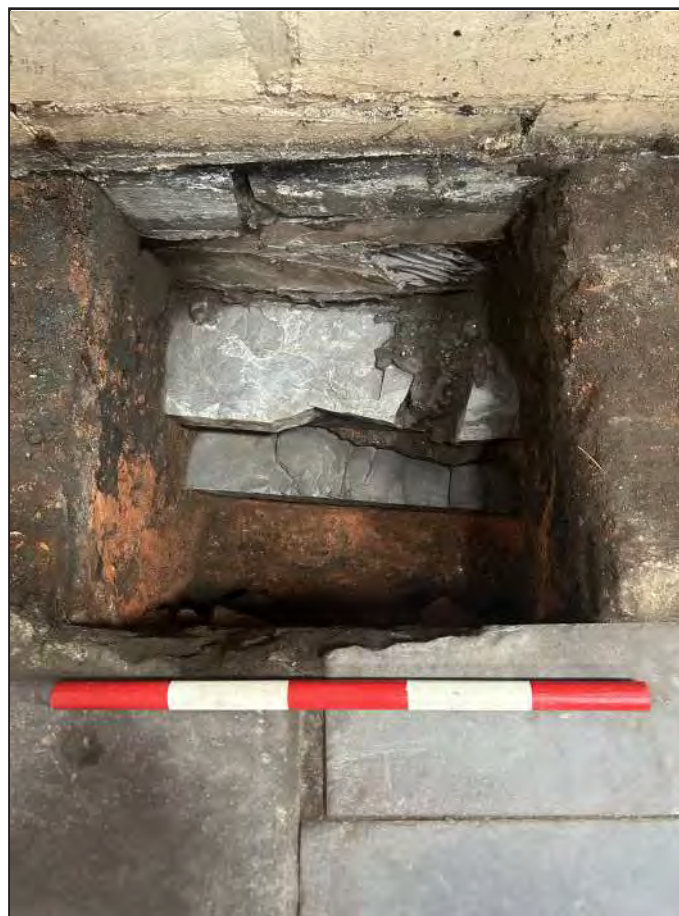
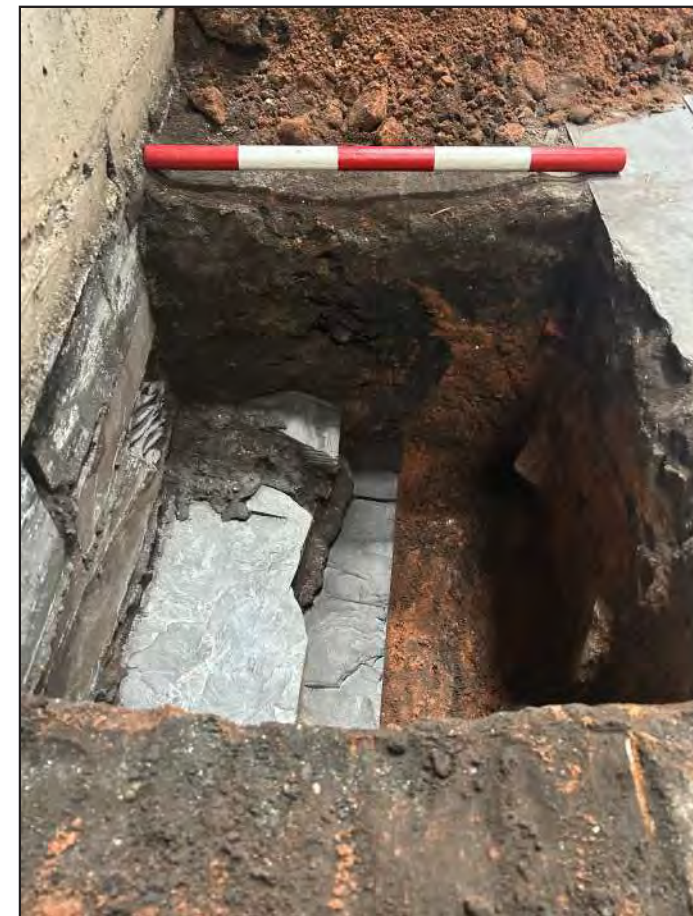
Figure 12. Plan and plates of Test Pit 8

Test Pit 8, 0.5m scale.

North facing section of Test Pit 8. 0.5m scale.

- 5.9.1. The test pit was located inside one of the workshops along the southern range of the building and was dug alongside an internal wall.

- 5.9.2. The test pit had a maximum thickness of 0.5m (Figure 12). The basal deposit was mid brownish-red sand (803), which had a thickness of 0.39m. The sand had been cut by [806], which was the construction cut for the internal wall. The cut measured 0.5m in length by 0.31m in width and had a depth of 0.39m. The cut contained a stepped slate foundation (805). The foundation supported internal wall (804).
- 5.9.3. The construction had been backfilled by (802), which was a dark brownish-black sand. This was overlain by an ash deposit, which had a thickness of 0.09m. The ash was in turn overlain by (800), which was a dark brownish-black sand that measured 0.02m in thickness. The sand formed part of the modern floor level within the workshop, with flagstones also evident within the room.

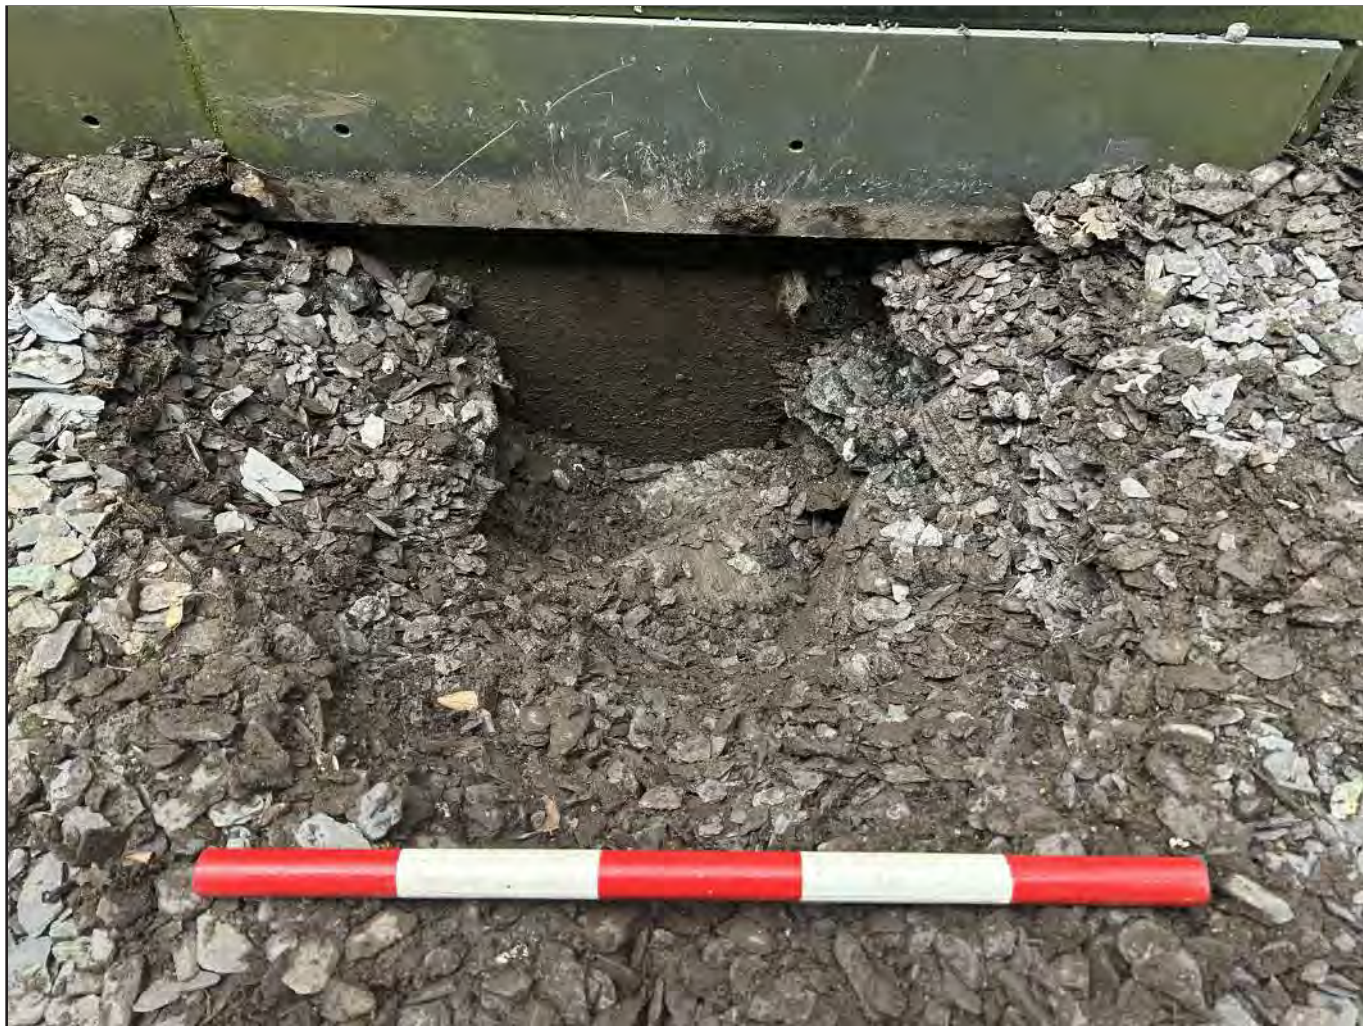
Figure 13. Test Pit 9 plate

Test Pit 9, looking east. 0.5. sacle.

- 5.10.1. Test Pit 9 had a maximum depth of 0.47m with the basal deposit (903) being encountered at a depth of 0.42m. The deposit consisted of slate waste, evident across the rest of the site (Figure 13).
- 5.10.2. This had been cut by [901], which was the construction cut for the lift, which accesses the wheel pit above. The cut contained concrete foundation (902), which measured in excess of 0.8m in length and 0.45m in thickness. The foundation was not fully exposed due to its continuing depth.
- 5.10.3. Overlying this was deposit (900) which was the modern late gravel seen across the site. It had a thickness of 0.42m.
