Field evaluation:

National Slate Museum, Gilfach Ddu, Gwynedd

Report No. 2312

Field Evaluation: National Slate Museum, Gilfach Ddu, Gwynedd

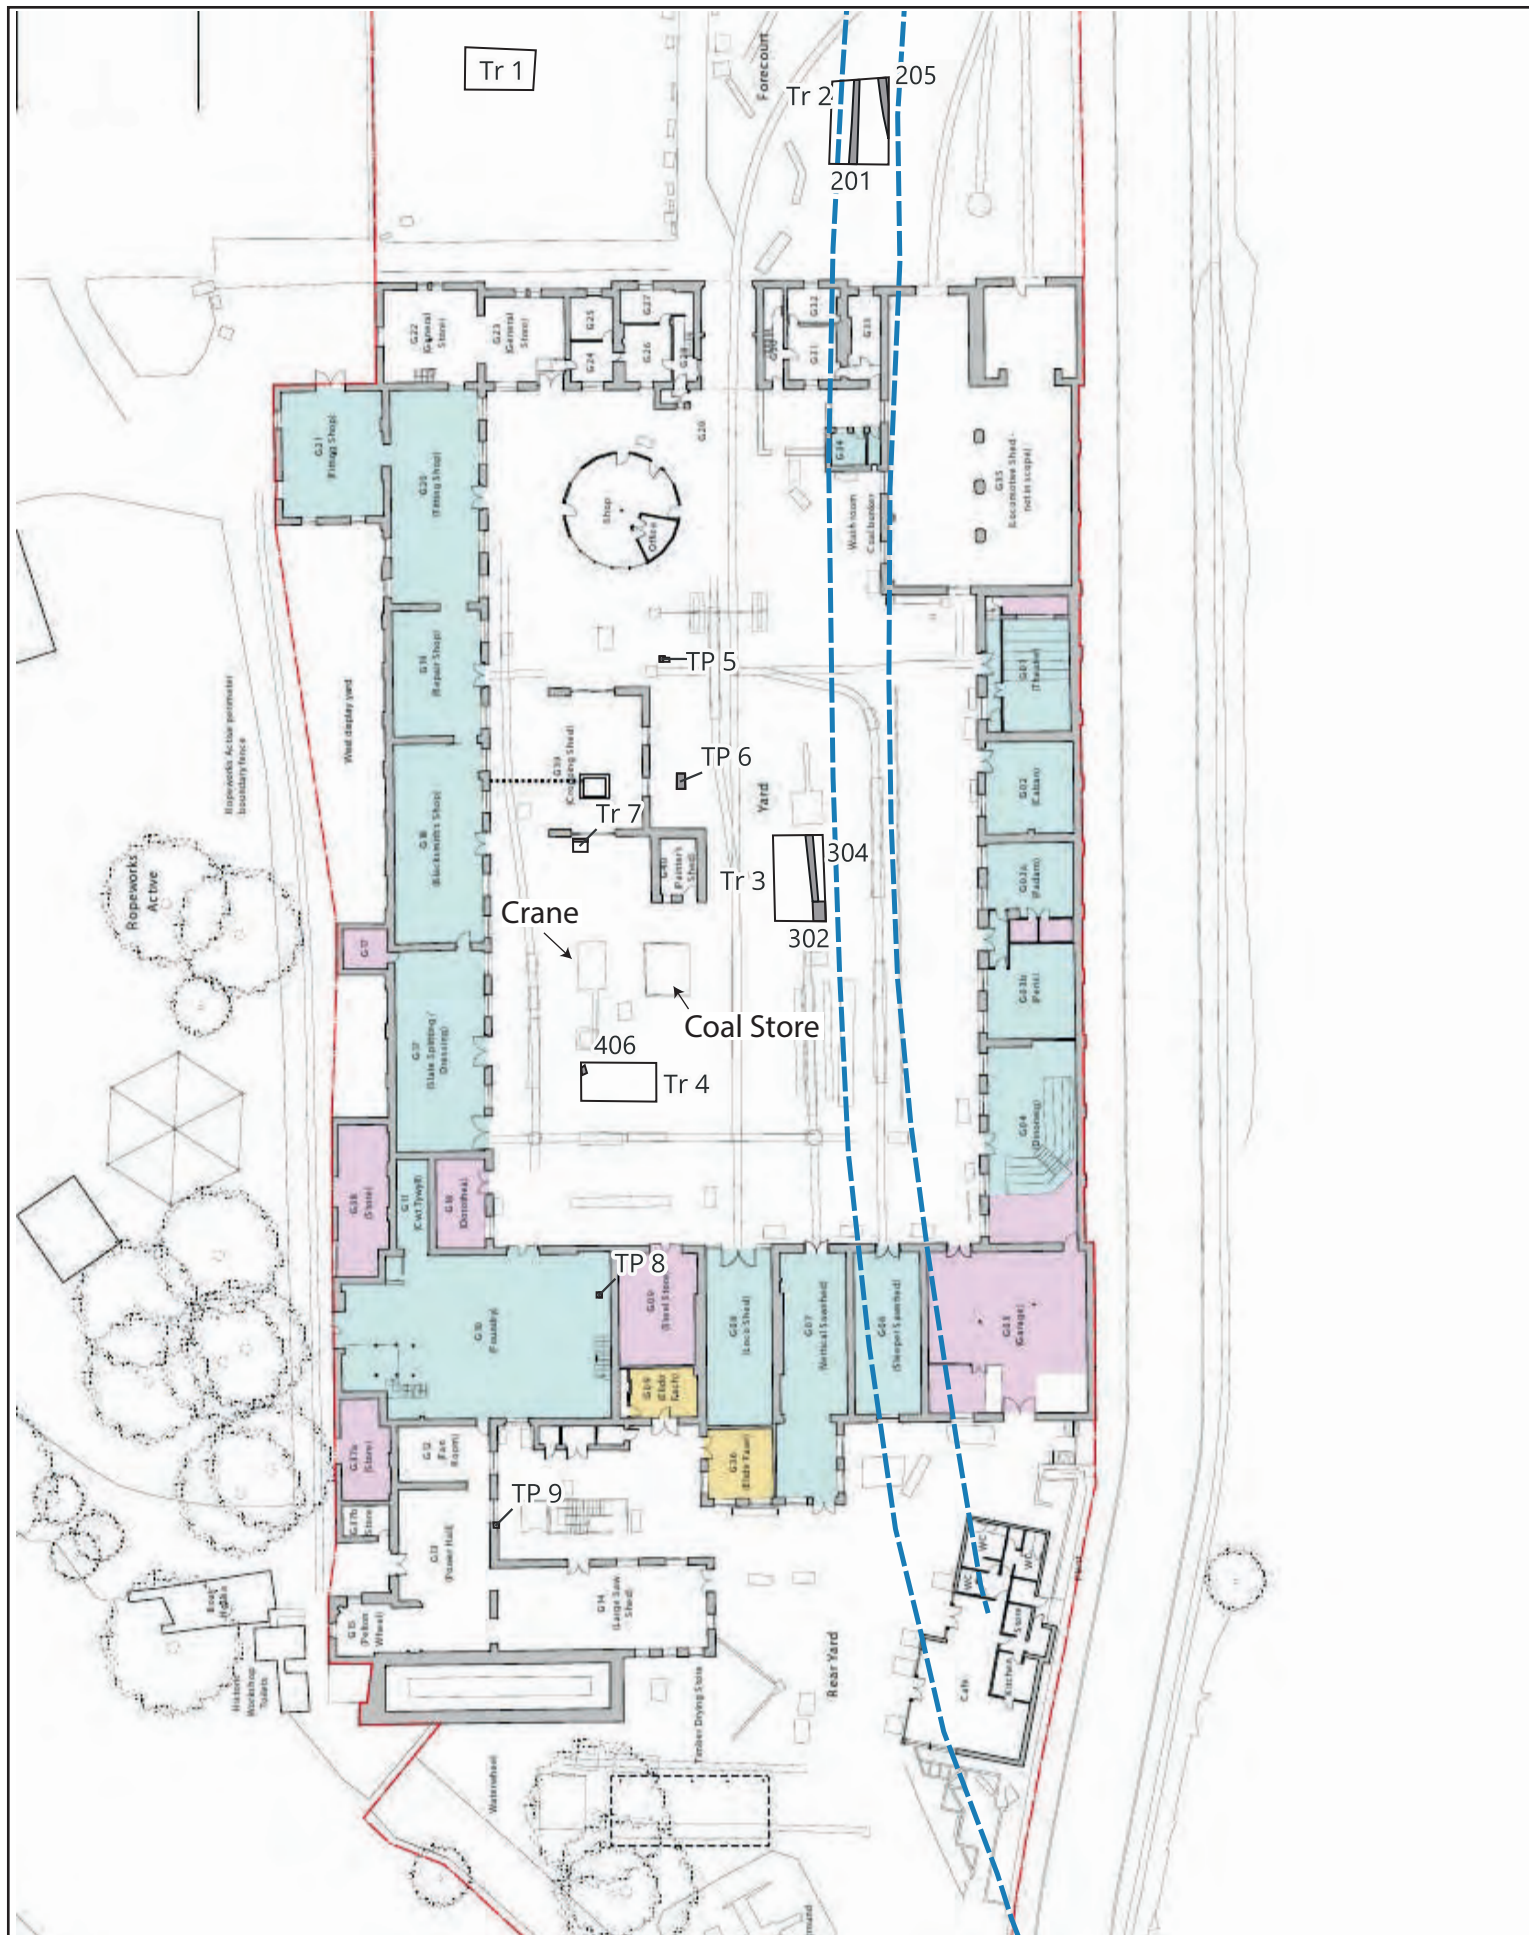
Figure 15: Plan showing the location of the historic railway, with the trenches, features, coal store and crane.
