Archaeological Evaluation Trenching Report
A496 Llanbedr Airfield Access Improvements
Document Number B1508.05.02

A496 Llanbedr Airfield Access Improvements

Archaeological Evaluation Treching Report

November 2016

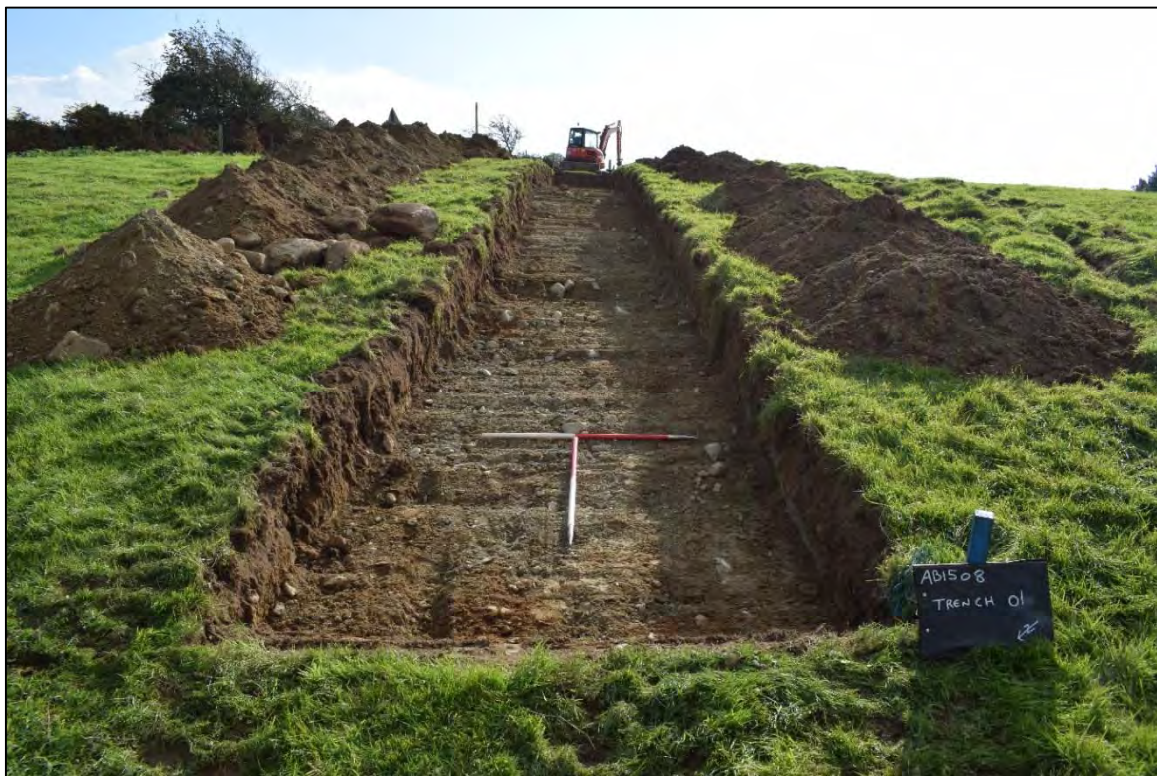
Plate 01 – Trench 01. Post-ex shot of trench, testing the steep incline with the level area at the top. View from the NW with 2x1m scales.

- Trenches were opened by mechanical excavator fitted with a flat, toothless ditching bucket under constant guidance of the archaeologist.
- Mechanical excavation continued until archaeological deposits or the natural glacial subsoil/bedrock was reached (Plate 01).

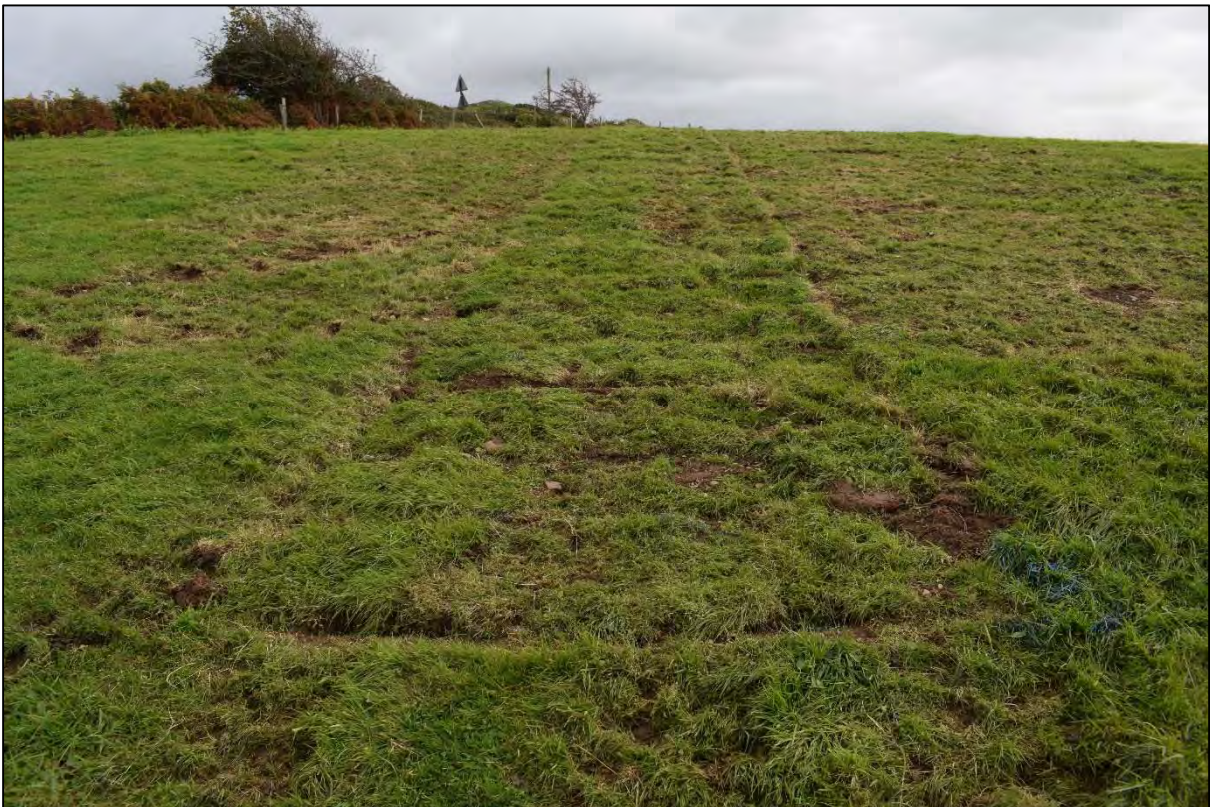
Plate 02 – Trench 01. Photo after re-instatement of the trench, all trenches were re-turfed after completion. Viewed from the NW.

- All trenches were backfilled and carefully re-turfed by the mechanical excavator, preferably on the same working day (Plate 02). Trenches which could not be backfilled and re-turfed on the same working day were fenced off with barrier fencing.

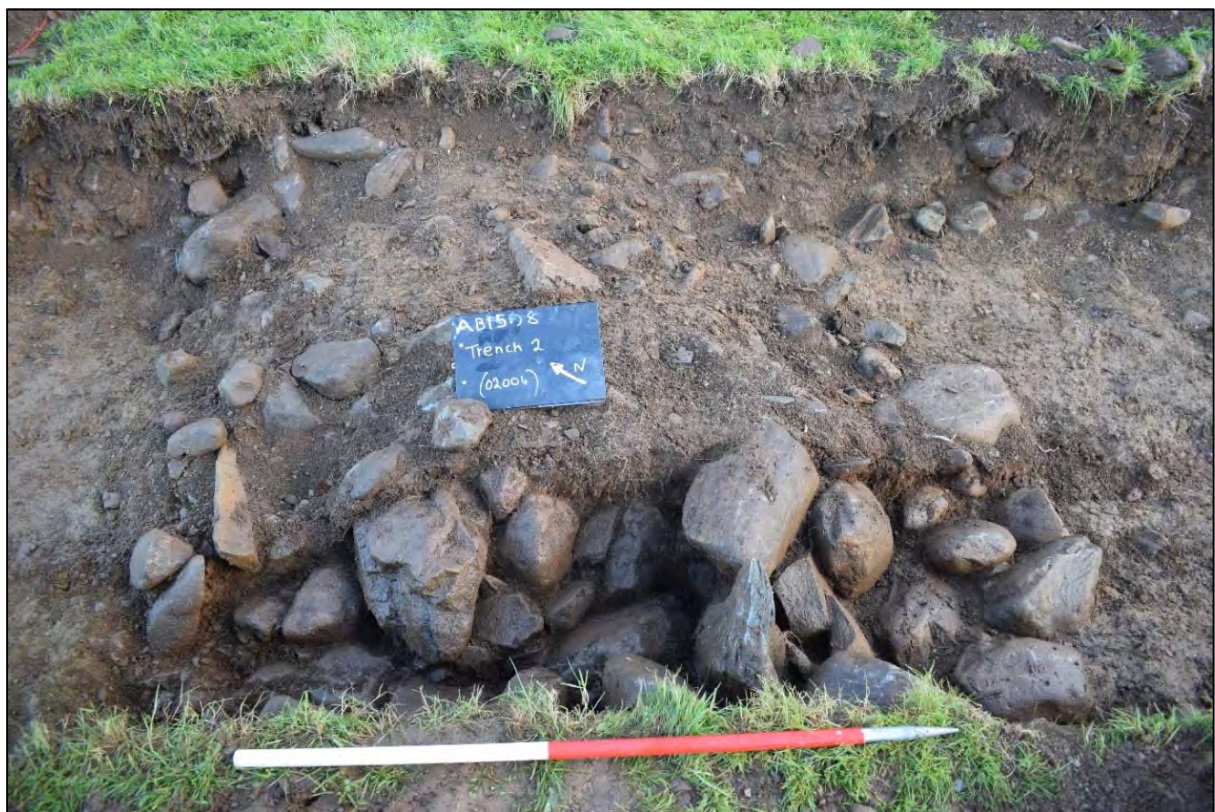
Plate 03 – Trench 02. Photo of excavated section of field boundary, stone core built over with earth. View from the SW with 1x1m scale.

On excavation 3 possible linear banks of stone were found, all with roughly NE-SW orientations. During archaeological examination 2 of the features were seen to be collections of loose stone or dumps of possible recent date. The central feature (02.004) was almost certainly a former field boundary constructed of earth and stone which was archaeologically recorded (Plate 03). The boundary had a width of 2.77m and height of 0.55m, had a SSW-NNE orientation.

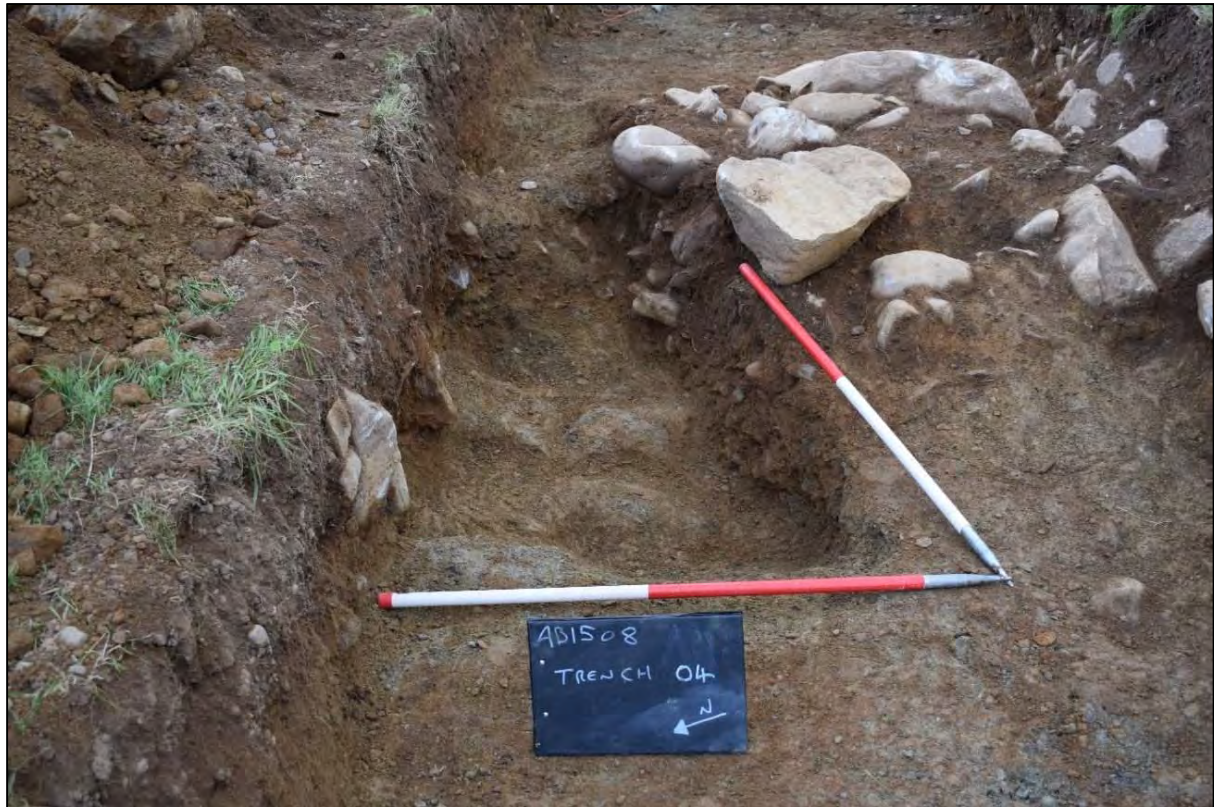
Plate 04 – Trench 04. Showing section through post-Medieval field boundary (04.004). View from the NW with 2x1m scales.

The excavation found a possible field boundary (04.004) composed of earth and stone towards the eastern end of the trench with a NW-SE orientation, the width of the boundary was 3.1m and current height of 0.6m.

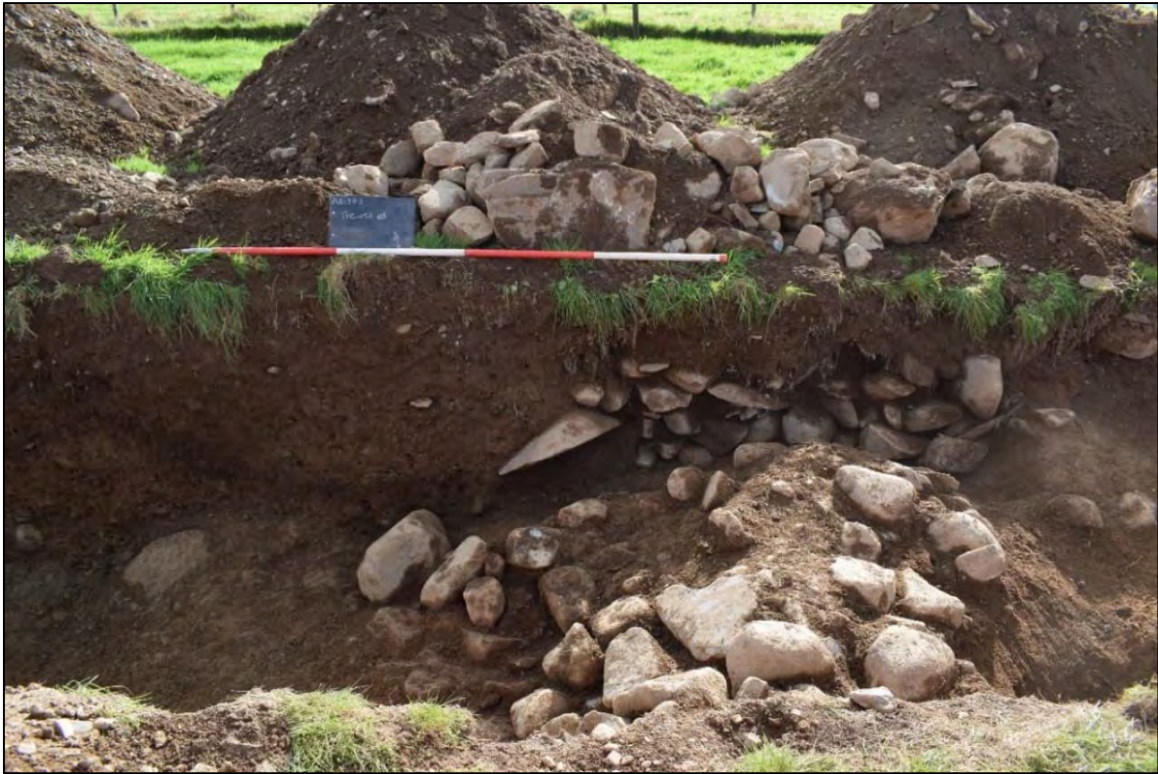
Plate 05 – Trench 05. Earth core field boundary (05.007) with a ditch [05.008] on the eastern side, excavated slightly oblique. View from the NNE with a 1x2m scale.

Two field boundaries were found within the trench confines, one running SE-NW (05.006) and a larger boundary (05.007) and associated ditch [05.008] with a SW-NE orientation (Plate 05). The smaller field boundary (05.006) was over 2.25m wide with a height of 0.4m, and was composed of a clay silt and mainly cobble sized stones, no ditch was associated with this boundary (Plate 06). The larger boundary (05.007) was also composed of earth and stone in equal quantities with a width of 2.2m and height of 0.5m, and a ditch at the eastern side with a width of 2.4m and depth of 0.5m. This boundary was also located in Trench 07 roughly 45m to the NE, although the ditch was not located in this section.

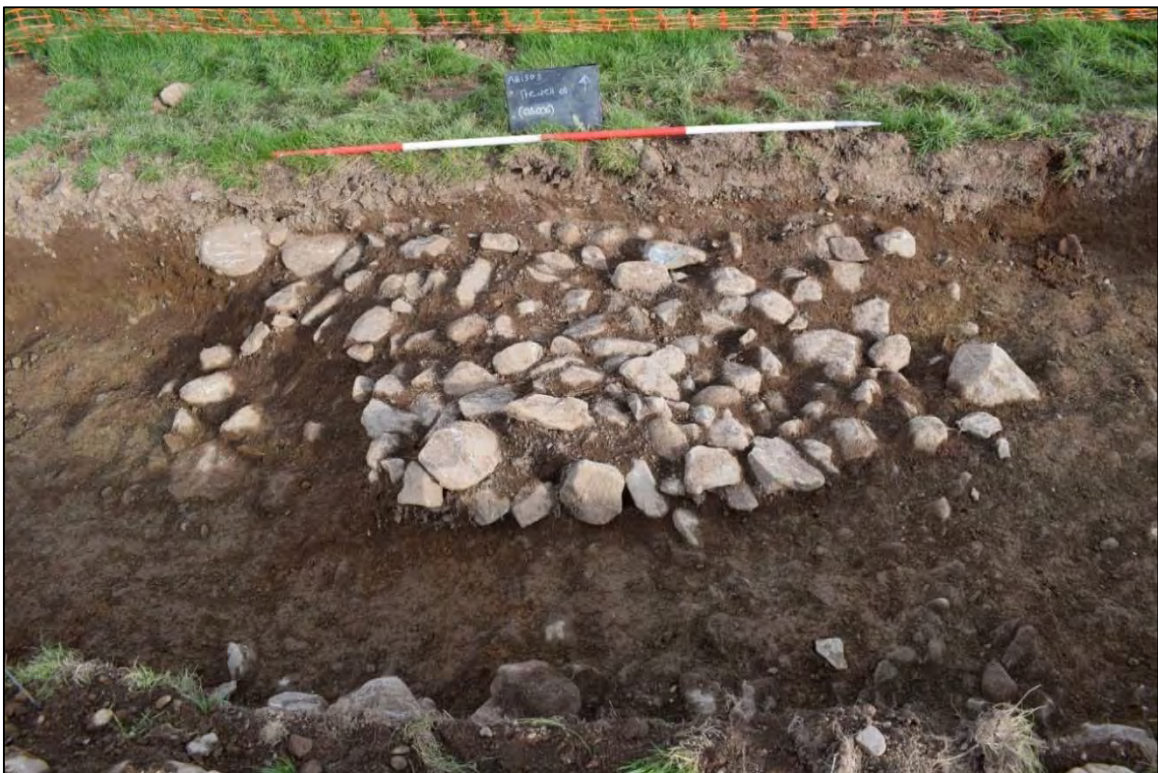
Plate 06 – Trench 05. Field boundary (05.006) with SE-NW orientation. Excavated section with no associated ditches. View from the SSE with 1x2.0m scale.

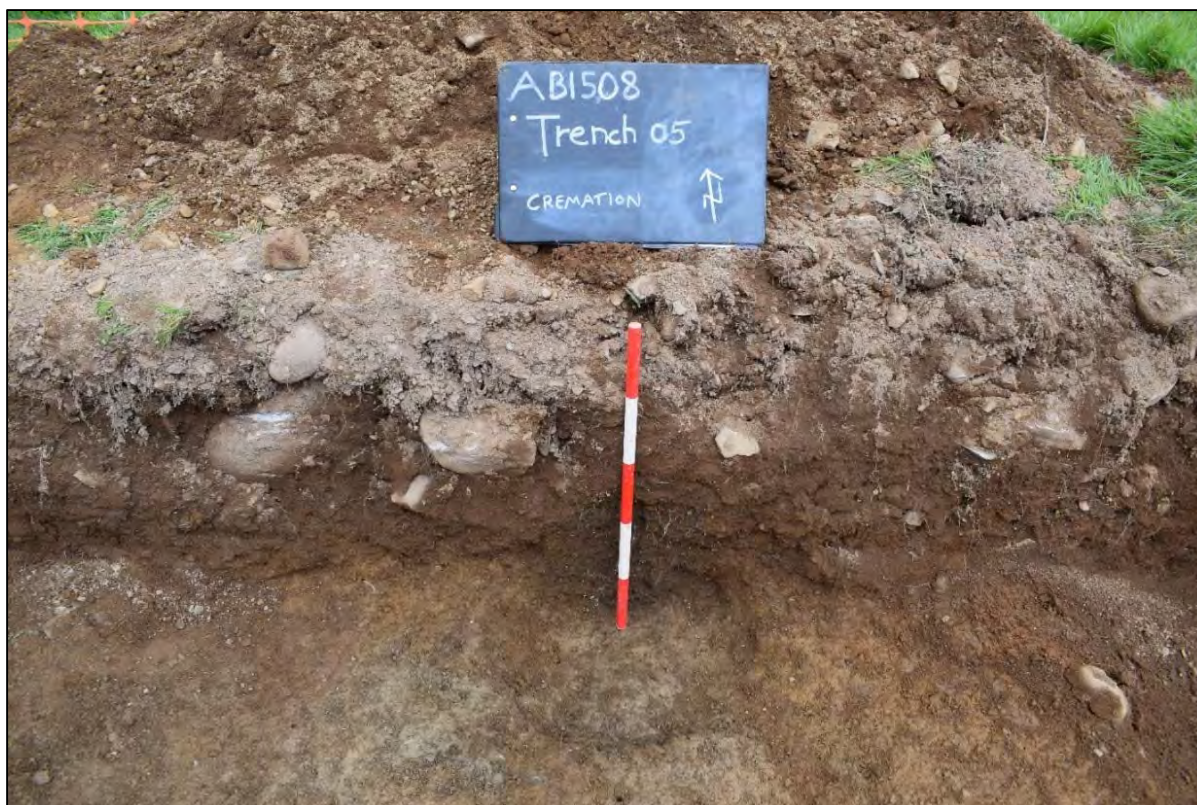
Plate 07 – Trench 05 showing the excavated possible cremation pit with a small part within the baulk section, later removed. View from the SSW with 1x0.5m scale.

A small possible cremation [05.004] was found a few metres to the west of the larger boundary (05.007) (Plate 07), which was recorded archaeologically, photographed with scale section drawings and a plan made. An environmental sample of this feature was also taken to try and establish a function and date. The pit had a diameter of 0.4m and depth of 0.1m, 100% of the fill was removed as an environmental sample.

It is recommended that the bulk soil sample collected from the possible cremation deposit in Trench 05 is processed by floatation and residue sorting to recover burnt bone and have all charred plant remains palaeoenvironmentally analysed. It is recommended that the recovered material is analysed by a specialist and suitable material selected for radiocarbon dating to assess the likely palaeoenvironmental potential of the deposits present within the development area. The information gathered from the environmental analysis of the bulk sample will be used to inform an appropriate mitigation if the scheme is to proceed.

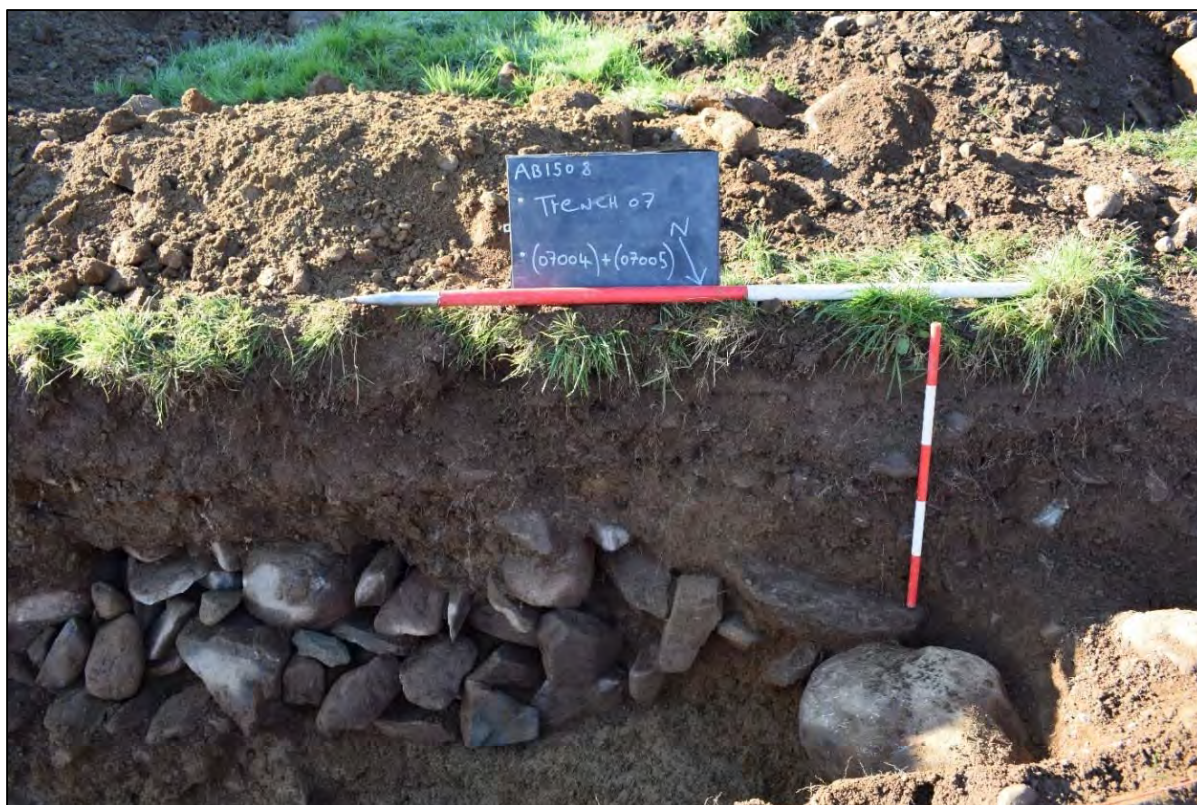
Plate 08 – Trench 07. Section showing the field boundary (07.004) (east) with the stone land drain (07.005) (west – boulder stones) joined into the boundary, and possibly contemporary. View from the NNE with 1x1m and 1x0.5m scales.

L-shaped trench to target two features seen on lidar, the NW-SE section was 20m x 2m, and NE-SW section 10m x 2m. There was a 1.0m wide sewer drain running along the NE-SW section, therefore this section could not be excavated further. The NW-SE section was excavated to a maximum depth of 0.6m and located the field boundary (07.005) also seen in Trench 05 (05.007), and a stone filled field drain (07.004) running within the southern baulk of the trench from the field boundary towards the east (Plate 08).

The field boundary had a width of 2.4m and height of 0.4m in this area and was composed of earth and cobble sized stone as the boundaries seen in Trench 05, but no associated ditch in this section. The E-W stone filled field drain seems to have been built into the boundary and would therefore explain the need not to have a separate boundary ditch in this area as water would be diverted along the drain. The width of the drain could not be established as was largely within the baulk, but had a depth of 0.45m. The eastern end of this trench was only approximately 5m from Trench 06, but there was no evidence the drain continued into Trench 06.

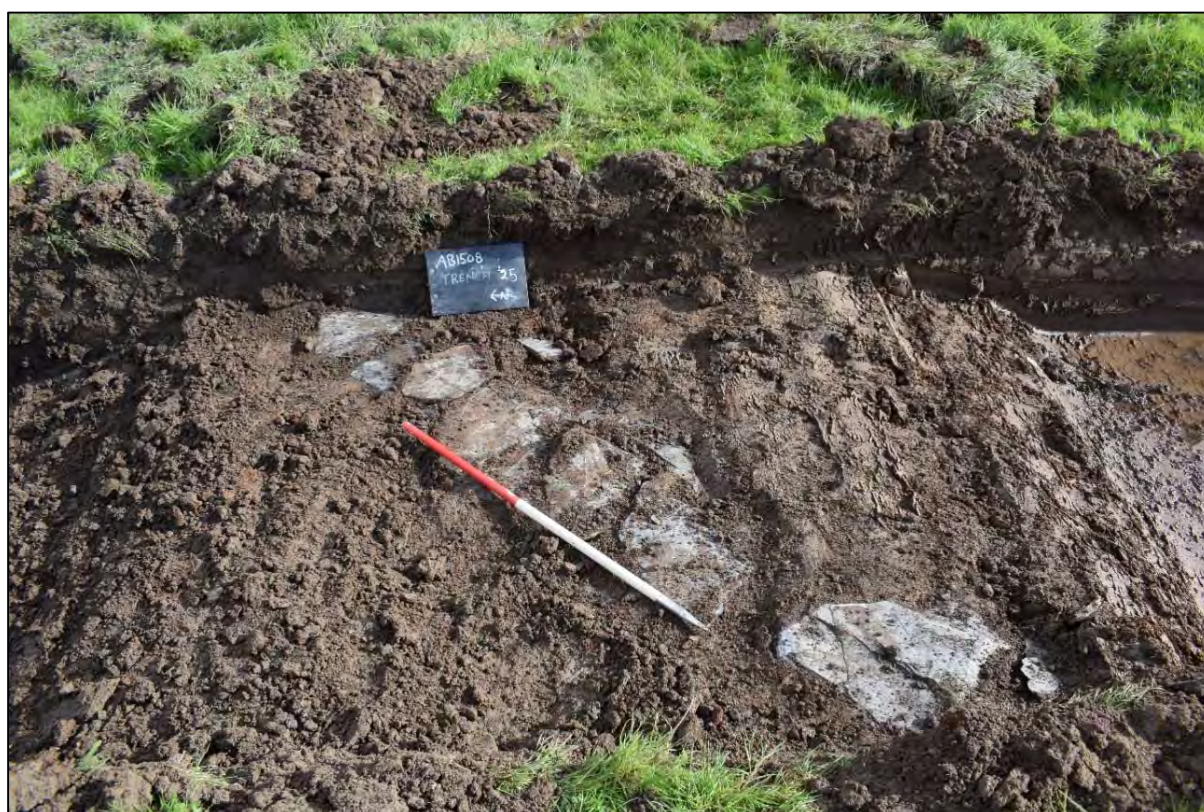
Plate 09 – Trench 25. Showing stone lined field drain with NE-SW orientation. View from the W with 1x1m scale.

A stone capped field drain was found roughly 11 m from the northern end of the trench with an WNW-ENE orientation (Plate 09). A 0.5m slot was excavated into the drain and photographs taken, with the stones carefully replaced into their original locations prior to backfilling. No further archaeology or finds were found in the trench.

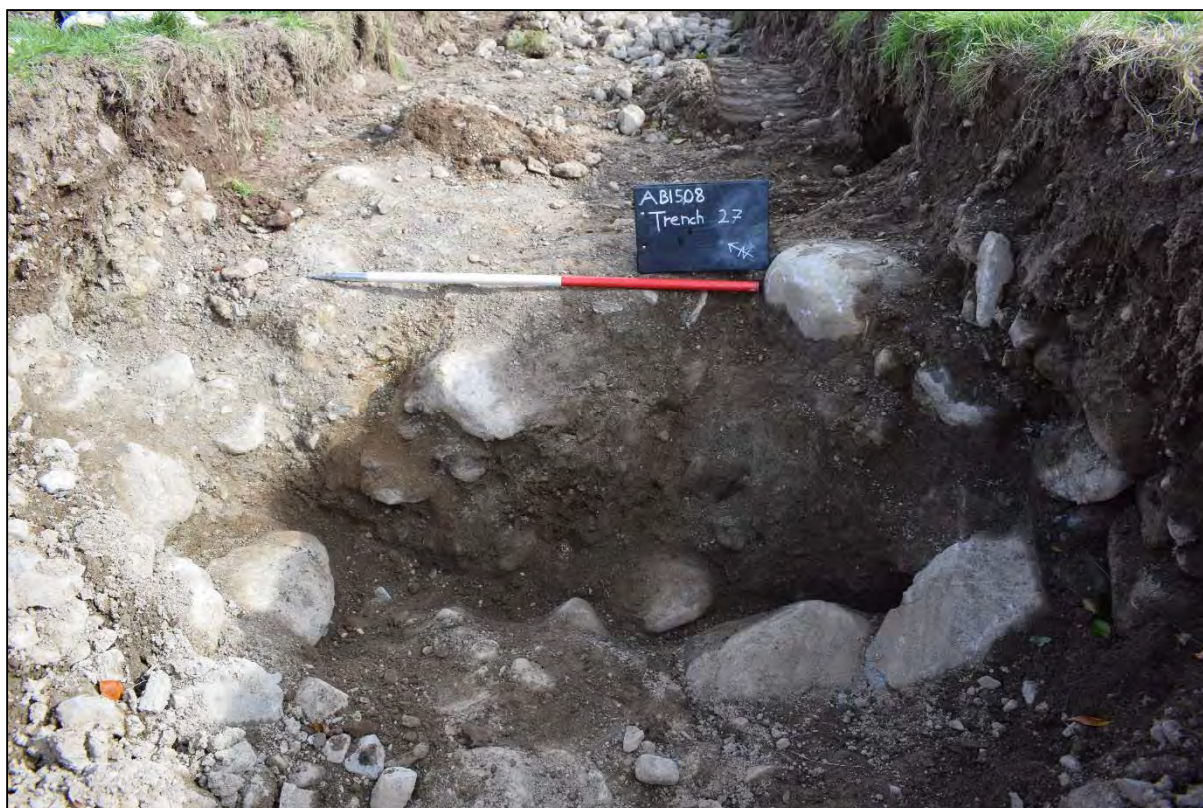
Plate 10 – Trench 27. General shot of large hollow area, backfilled filled with a large amount of stones. Post medieval pottery and iron farming implements were found within the fill. View from the SW using a 1x1m scale.

During excavation a large cavity was encountered and filled with large volumes of cobble and small boulder sized stone, initially thought to be a large ditch running in a NNW-SSE direction (Plate 10). The extent of the feature could not be determined as it was very deep with the trench edges getting increasingly unstable due to the volume of loose stones. The edge of the feature at the eastern side was very irregular, with the western edge slumped over the edge of feature. After limited excavation the feature is most likely to be a natural occurrence, either a large tree bole or a hollow that has been filled in with accumulated stone for field improvement. Within the excavated areas of the feature numerous late 19th century to early 20th century pottery and some iron farming implements were found.

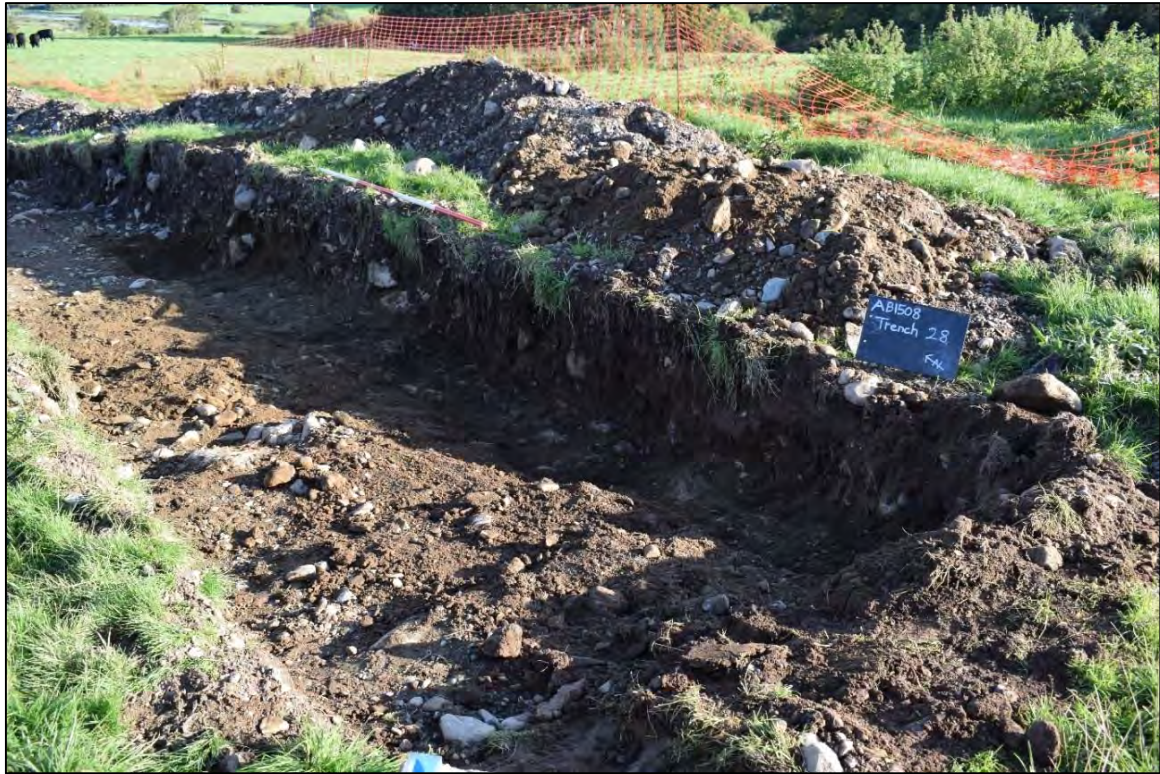
Plate 12. Trench 28 showing upper/inner bank (28.014) with possible retaining wall (28.016) also visible. View from the SW with 1x2.0m scale.

The maximum depth of the trench was 0.57m and the expected ditches were not seen, two more sections of the trench were cleaned with the mechanical digger to eliminate the possibility that the ditches had been overlooked below hill wash/overburden. Both the upper/inner bank (28.014) and lower/outer bank (28.015) were diffuse with the subsoil (28.002) and was defined by their shape and stone placement. Both banks were seen in section however no associated ditches were visible. Bank (28.014) (Plate 12) had a very simply built retaining wall (28.016) (Plate 13) creating a possible level/terrace on its inner/north side and possible stone revetment on its outer/south side, this looked less structural than (28.016).

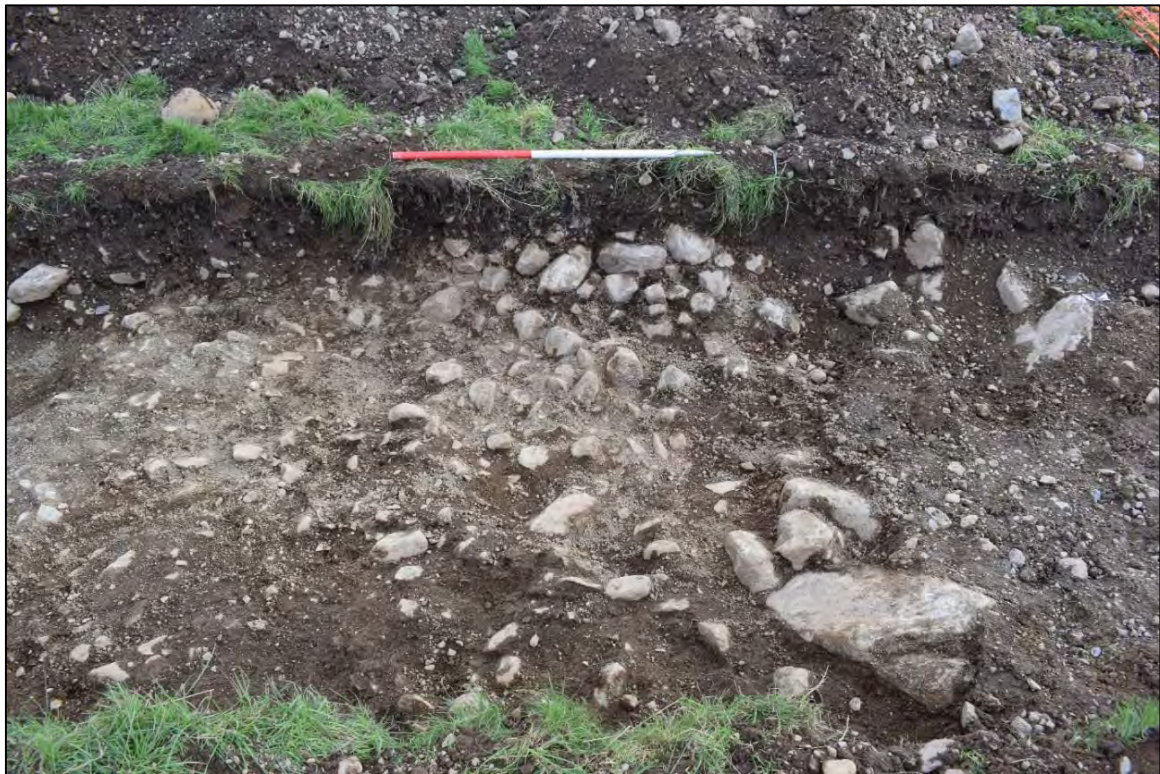
Plate 13 – Trench 28. Possible bank/wall/revetment (28.016) at the upper end of the trench associated with bank (28.014). View from the W with 1x1.0m scale.

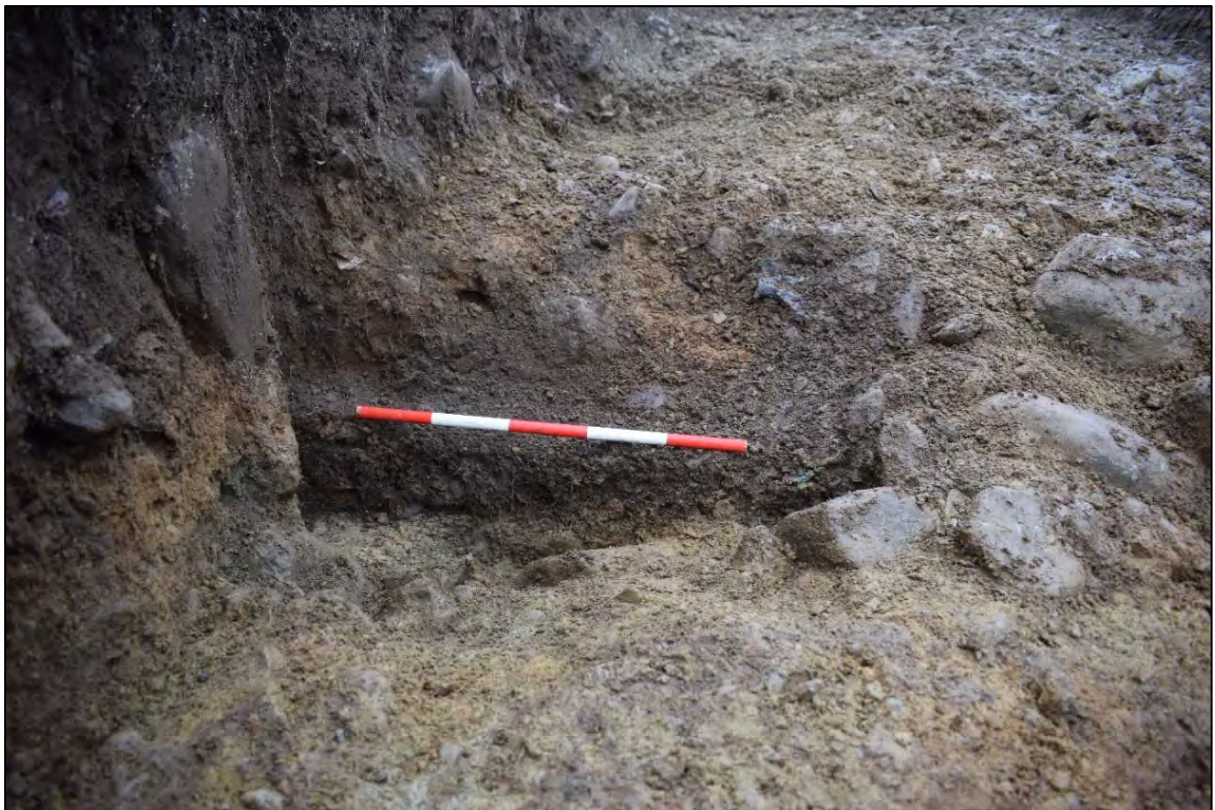
Plate 13 – Trench 28. Section through a possible post hole [28.006]. View from the W with 1x0.5m scale.

The lower/outer bank (28.015) had no definite stone revetment but did have a possible posthole [28.006] with a large stone visible in the section on the inner/north side of the lower/outer bank the which could be post packing for a possible retaining structure. The banks, although no ditch was seen between the areas between and either side of them were very level and looked like the remnants of possible terracing.

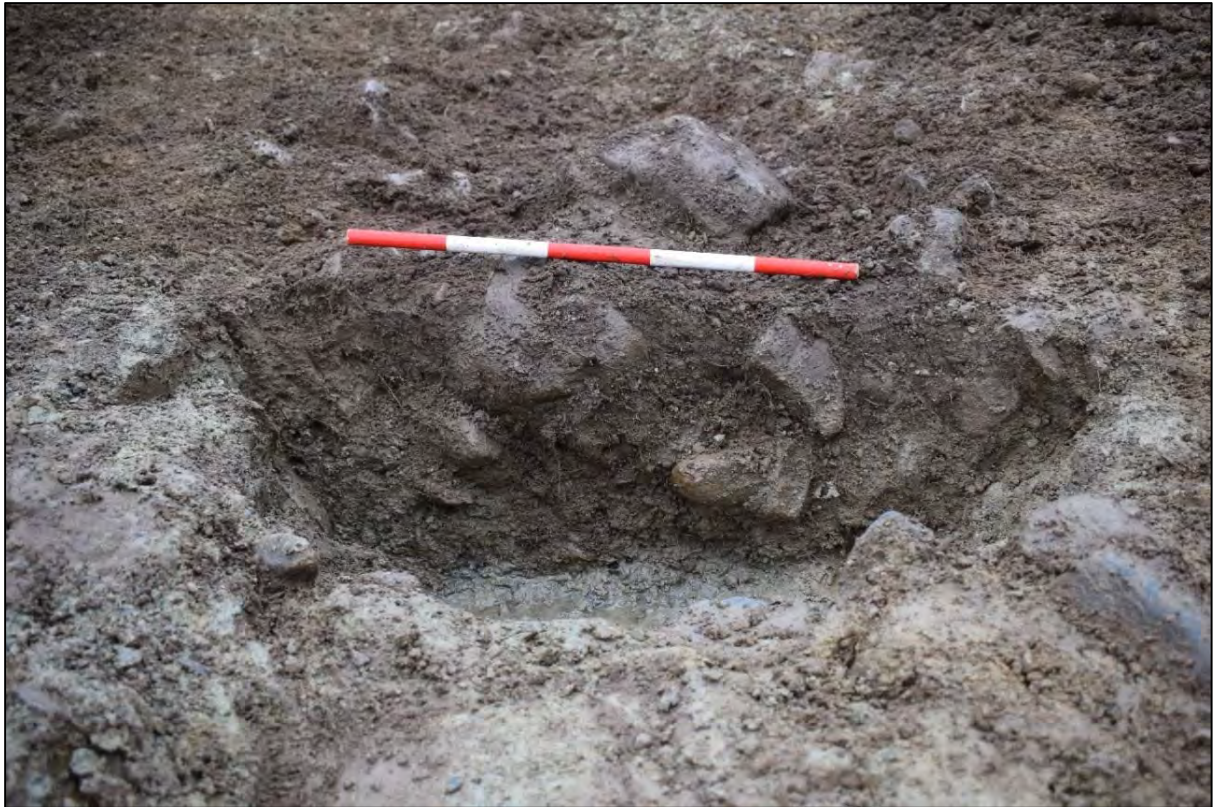
Plate 14 – Trench 28. Section of possible pit or small post hole [28.008]. View from the N, with 1x0.5m scale.

Also within this trench were four possible postholes (Plates 14 and 15) and evidence of burning, including heat fractured stones which can be indicative of settlement. The other four features may have been small pits or post holes, they formed no obvious structure. The features were recorded and drawn to scale, as well as having a written and photographic record.
