Archaeological Fieldwork Report
Nanner Road Improvements, Cemlyn
Document Number B1609.02

Nanner Road Improvements Cemlyn

Archaeological Fieldwork Report

B1609.02

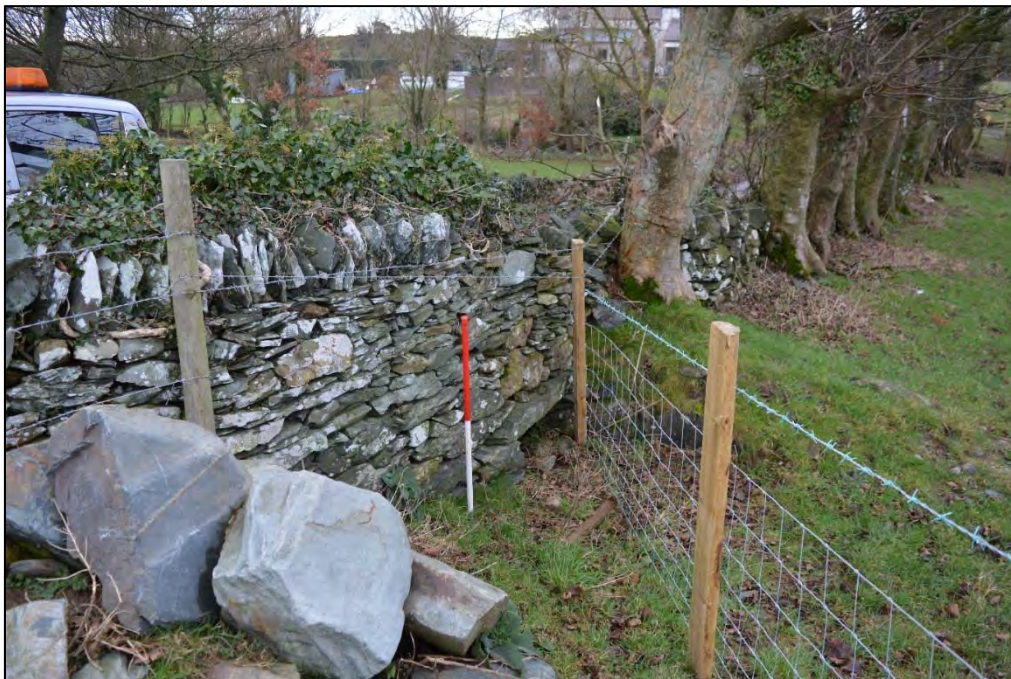
Approximately 23m of boundary wall was demolished for the construction of passing point 1C which was near the Mill Race associated with Melin Cefn Goch (DBA Feature 03). The work in the area did not affect the Mill Race, being approximately 5m west of the culvert through which it passes under the road (Plate 1). The dry stone, free standing wall was interrupted by a 2.5m wide entrance, the gate having been previously removed (Plate 2). Two large stone gateposts flanked the entrance. The eastern stone measured 1.40m in height, 0.58m in width, and 0.23m in depth. The western stone measured 1.24m in height, 0.91m in width, and 0.19m in depth. Only 2m of boundary wall east of the gap was demolished. This section of the wall was of dry stone construction, roughly coursed with vertical coping stones and measured 1.20m in height and 0.50m in depth. 18m of boundary wall to the west of the entrance was demolished. This section was un-coursed and had no coping stones. It had a maximum height of 0.72m and a depth of 0.50m.

Plate 1. View of culvert associated with Mill Race. View from South-West, Scale: 1m

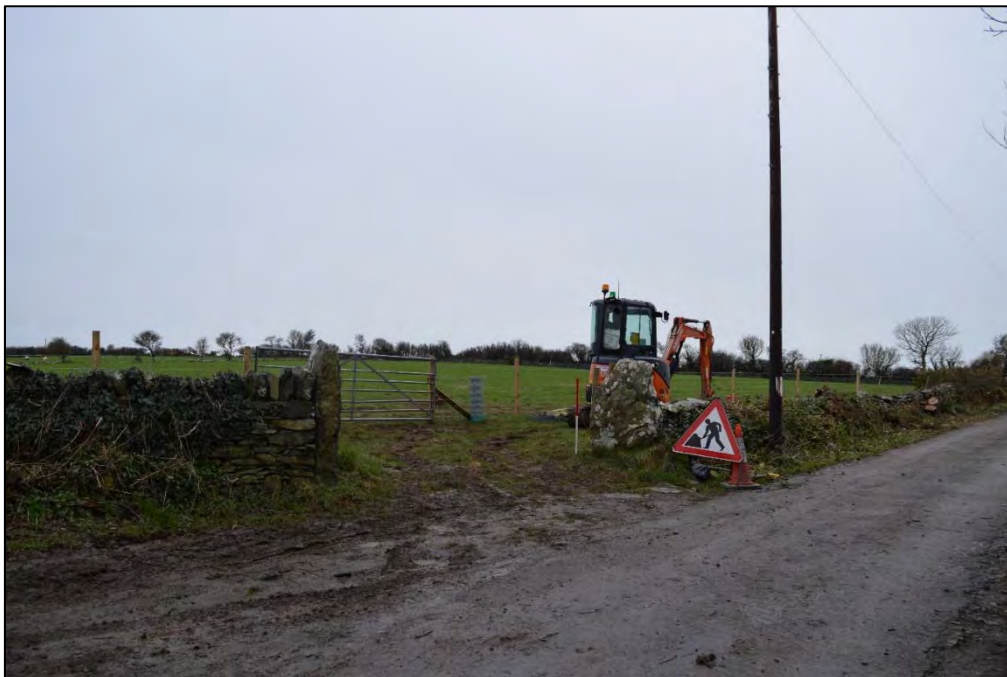
Plate 2. View of boundary wall in passing point 1C. View from North, Scale: 1m

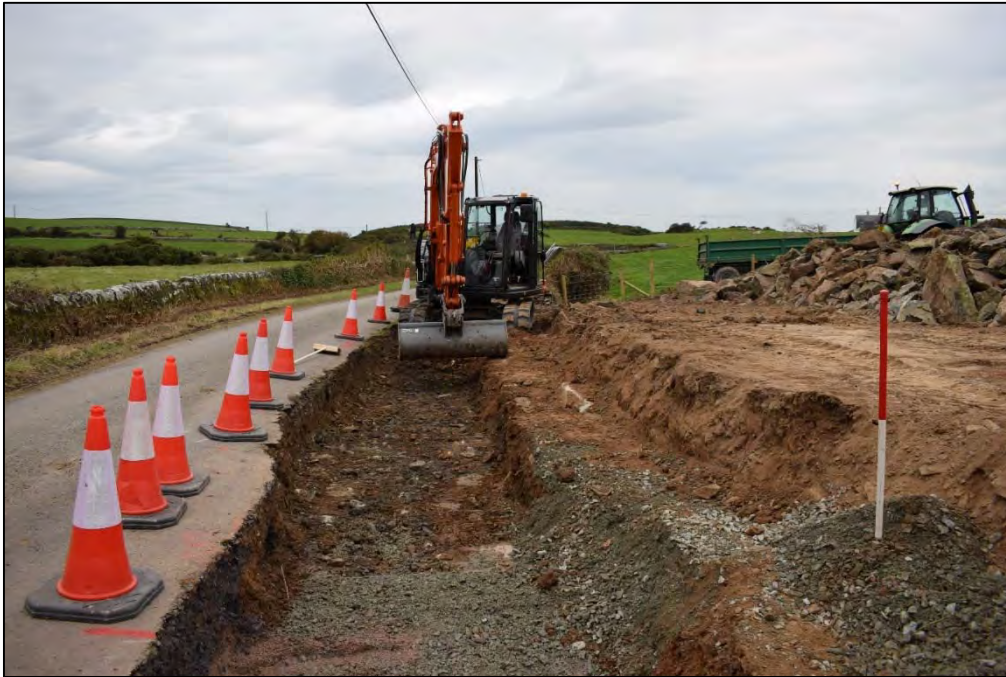
The topsoil was stripped from the edge of the eastern side of the boundary wall which was a free standing, un-coursed, dry stone construction with vertical coping stones and had a maximum height of 0.8m. After the demolition of the boundary wall, the ground was reduced to a depth of 0.55m from the top of the road surface (Plate 3). The topsoil consisted of dark brown silt clay. The subsoil was made up of medium brown silt sand (0.15m) while the natural consisted of mixed patches of light to medium grey-yellow silt sand with abundant sub-angular, medium limestone inclusions. No archaeology was identified during the work in this area.

Plate 3. Working shot at passing point 19. View from South, Scale: 1m

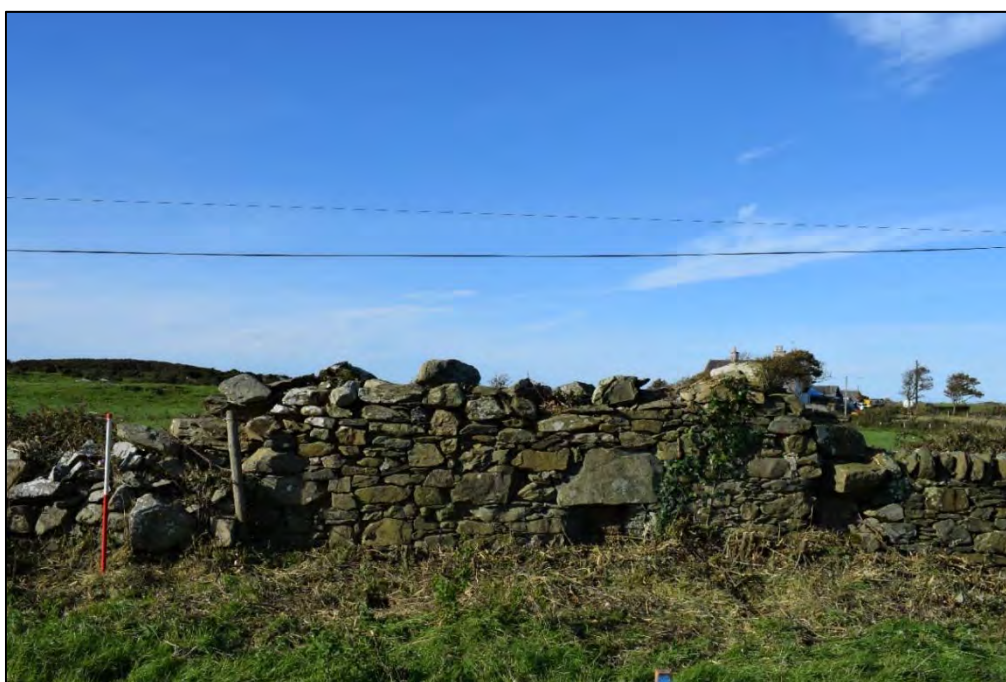
The remains of Tŷ Sarah (Plate 4) consisted of the gable of a former dwelling which had been incorporated into a dry stone boundary wall. The lime mortared, un-coursed rubble construction measured 5.3m in length, 1.7m in height (on the exterior north-facing side), and 0.6m in width. Some of the mortared pointing remained. On the interior south-facing side of the gable, the remnants of the western and eastern returns were still visible. The internal width of the gable measured 4.2m. The ground level on the south-facing side was higher than on the road-facing north side. Turf and brambles partially obscured a fireplace located slightly east of centre in the gable. The height of the exposed fireplace measured 0.61m in width, and 0.77m in height including a 0.78m wide lintel.

The dry stone boundary wall to the east of Tŷ Sarah was about 1.10m in height, was un-coursed and had vertical coping stones. The boundary wall west of Tŷ Sarah was of un-coursed dry stone, its height varied from 0.1m to 0.7m, wire and post stock fencing was present in areas on its southern side.

Plate 4. Tŷ Sarah gable (interior/south facing) and boundary wall. Scale: 1m

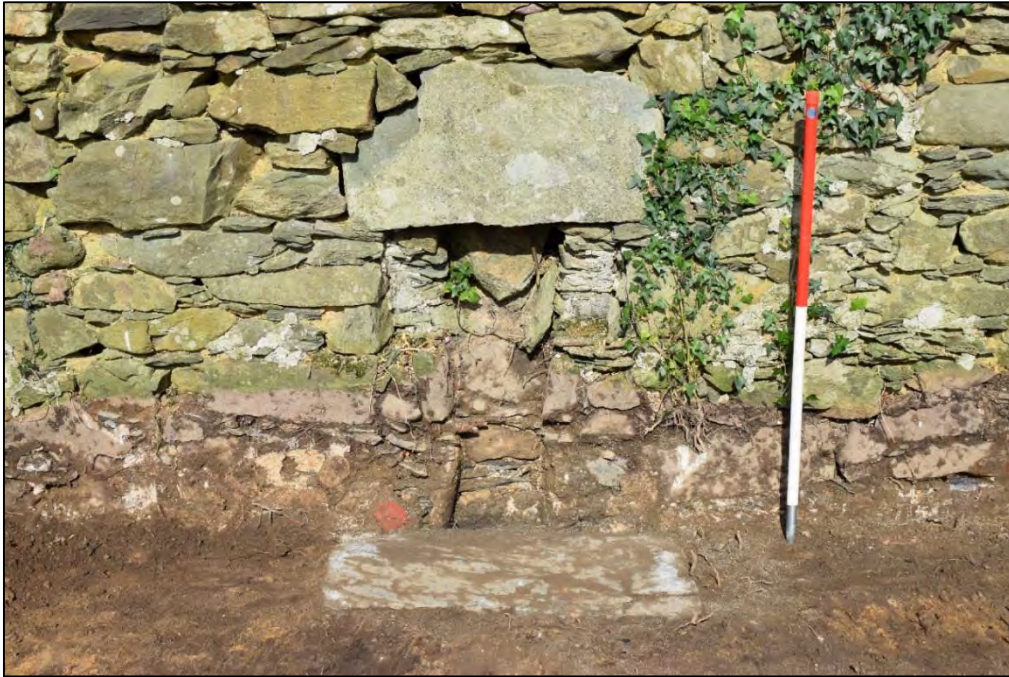
The watching brief during topsoil removal in the interior of Tŷ Sarah revealed an in-situ hearth measuring 0.84m x 0.55m (Plate 5).

Plate 5. Fireplace in northern gable of Tŷ Sarah following stripping of topsoil. View from South, Scale: 1m

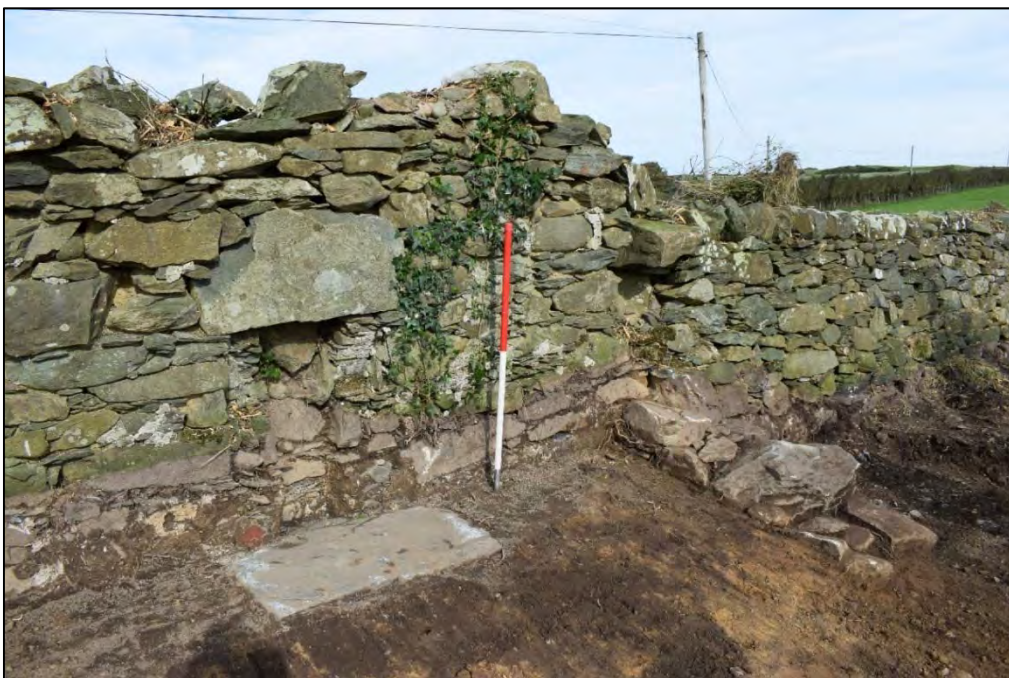
During the hand excavation of the hearth, the remains of the iron grates and tray were identified. The remnants of the eastern return (Plate 6) measuring 1.23m from the northern gable, 0.66m wide, and 0.61m at its highest point were hand cleaned and recorded. No further evidence of the western wall was present within the affected area. The height of the gable within the interior was 1.68m from the former floor level. Several fragments of post medieval ceramics and glass bottles (both blue and green) were identified but not retained.

Plate 6. Tŷ Sarah fireplace and eastern return. View from South-West, Scale: 1m
