AB1705 Coed Helen  
Summer House  
Archaeological Investigation Report

Document Number B1705.02.01

Prepared for Clarke Telecom Ltd

August 2019

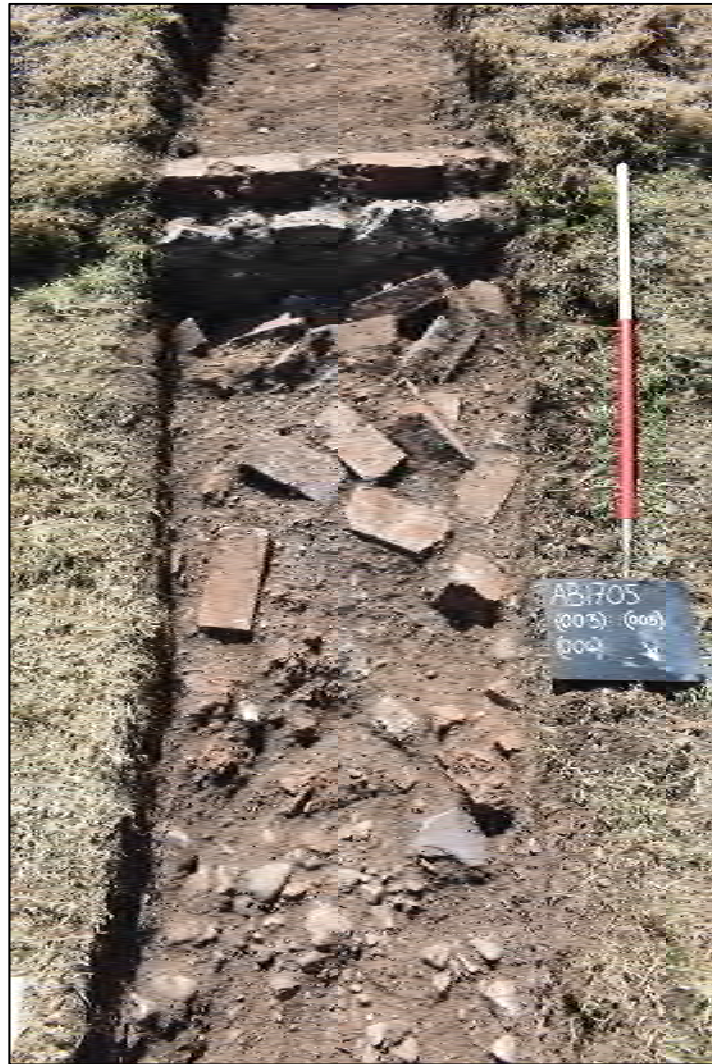
Plate 1: The upper brick and stone constructed revetment [004]. View from the north east. 1x1m scale.

The section of revetment wall [004] within the trench, which forms part of the octagonal terrace, was constructed in two phases both of which are believed to be contemporary. A lower course of, relatively large, mortared limestone blocks [003] formed a foundation on which a single course of red, unfrogged, bricks [004] were laid. The bricks in [004] were laid in a Flemish Bond with alternate stretchers and half brick headers, their arrangement, form and size is consistent with a late 18<sup>th</sup> century date (Brunskill & Clifton-Taylor, 1977). Downslope of [003]/[004] was a layer of tumbled material (005) which suggests that the structure may have formally been higher than what remains *in situ* below ground. This tumble overlayed a dumped deposit (007) which formed a hard, compacted platform between the upper [003/004] and lower (006) revetments.

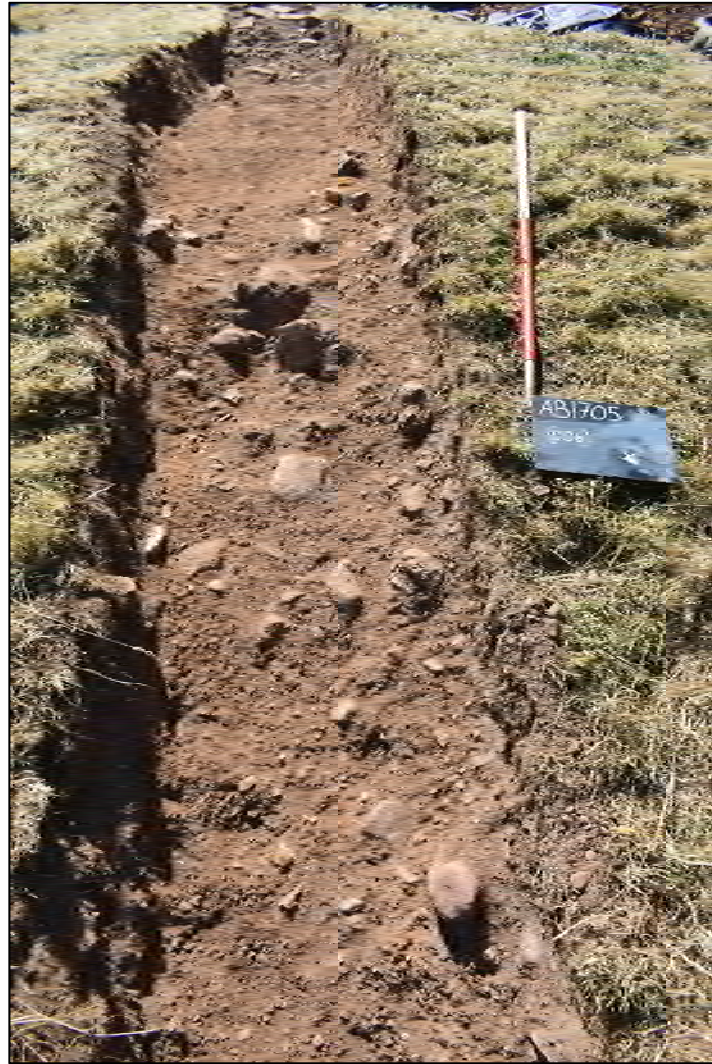
Plate 2: the lower revetment consisted of a distinctive stony deposit (006). View from the north east. 1x1m scale.

The revetment for the lower terrace was less formal and not as substantial as the upper. A distinctive stony deposit which also contained some brick (006) corresponds to the bank seen on LiDAR and is likely to be what remains of a second revetment wall. The nature of the deposit encountered in the trench could suggest that this lower revetment consisted of a stone and earth bank rather than a mortared wall.

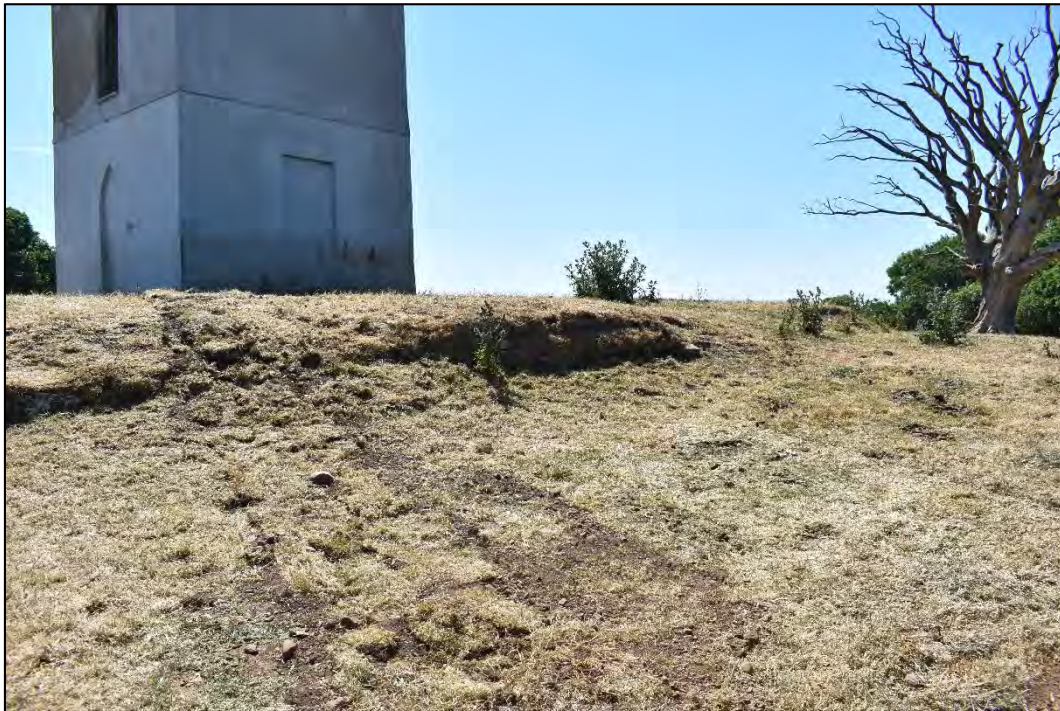
Plate 3: After reinstatement of the hand dug trench. View from the east.

The hand excavated trench was opened, recorded and reinstated (Plate 3) within a day, decreasing the risk of any further impact to the monument and reducing potential visual impact from Caernarfon Castle.
