## St Cadfan's Church Tywyn 2014

Archaeological Watching Brief

Report No. 686

Date: 17 June 2014

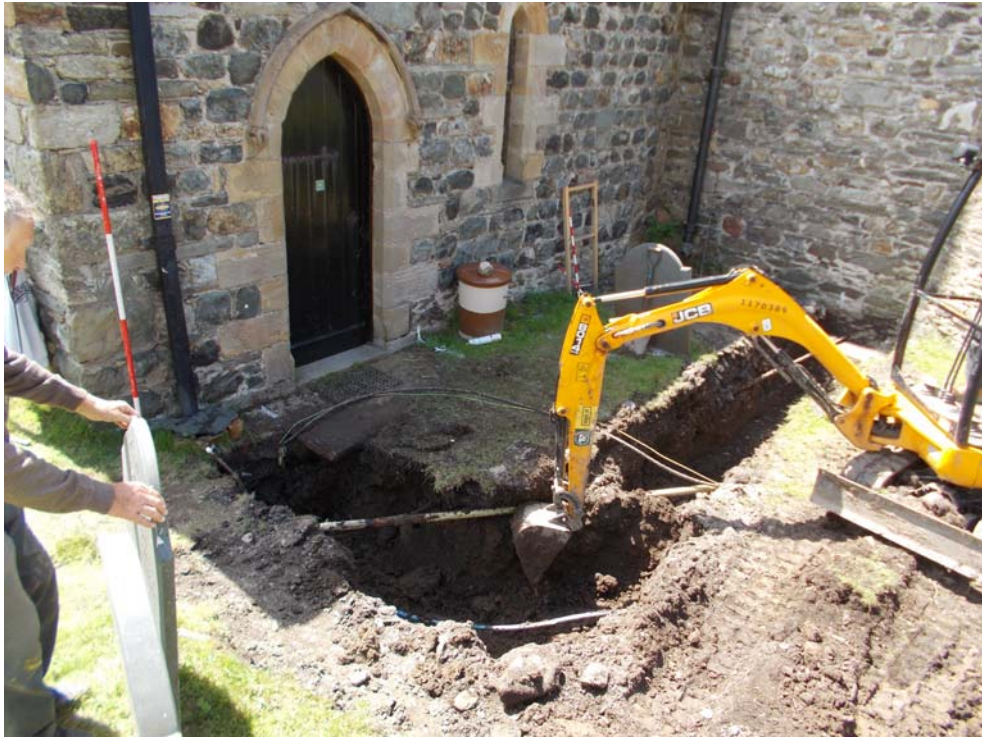
Plate 1: General view of work in progress on foundations, looking south-east. Scale 2m

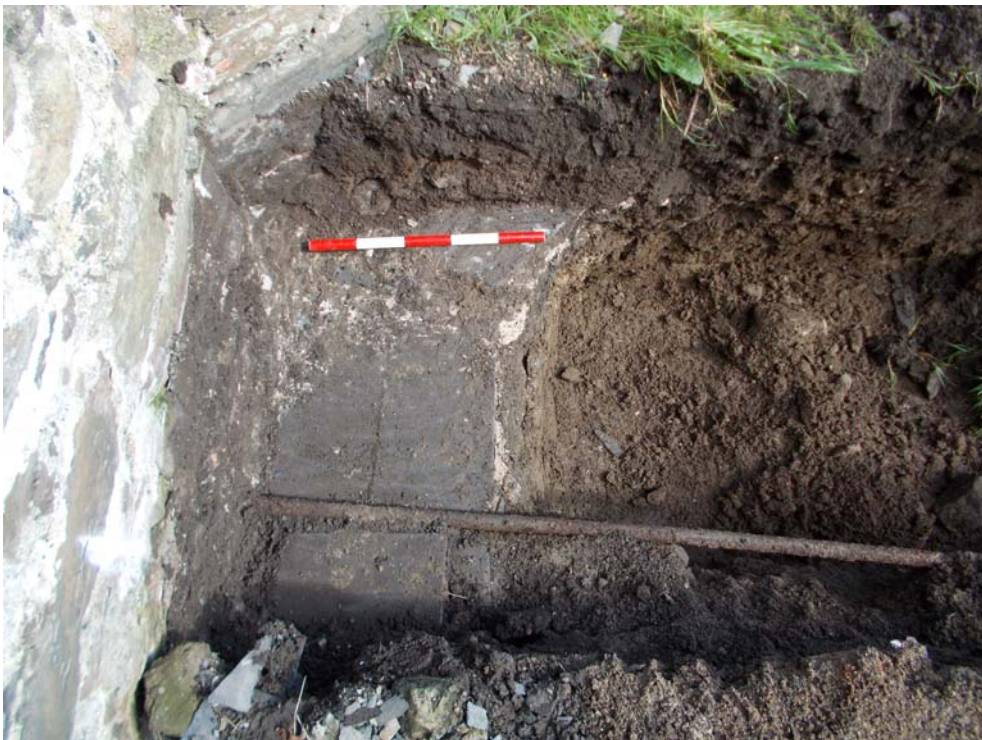
Plate 2: Detail of stone and slate foundation (3) for north transept, looking north. Scale 0.5m

excavation cut down onto the stone and slate foundation (3) for the late medieval north transept. Towards the east end of the trench a skull and right shoulder were visible from an intact skeleton (7), which was not investigated further. More bones (perhaps for a second skeleton) were seen in the base of the trench close to the junction of the two trenches, but again left in-situ. Modern features comprised a 19<sup>th</sup> century ceramic drain (10) and an iron pipe (4) and recent services comprising electric (11), gas (9), earth cable (12), copper water pipe (13) and plastic water pipe (8).

- 5.2.1 The earliest feature recorded was the stone foundation for the late medieval north transept. The two skeletons noted are likely to be 19<sup>th</sup> century in date since they were both located 0.9m below ground and in good condition. Deposits of slate and mortar rubble found in both the foundation trench on forming part of a raised area are thought to have been from the 1884 re-building of the church.

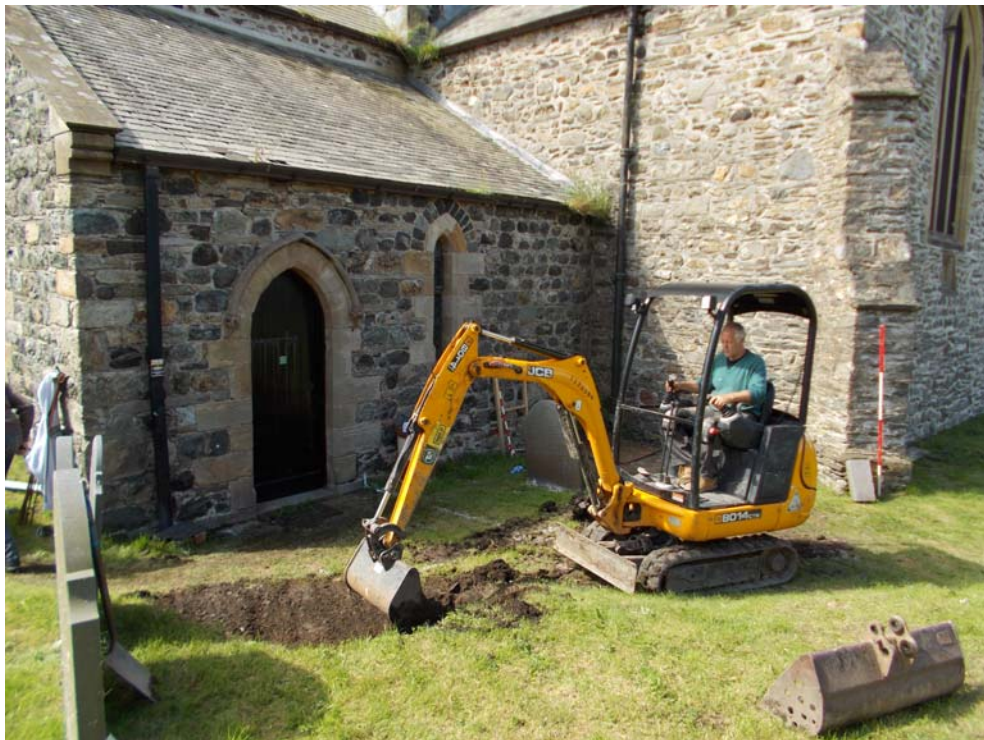
Plate 3: General view of machine work on cutting into raised area, looking south-east. Scale 2m

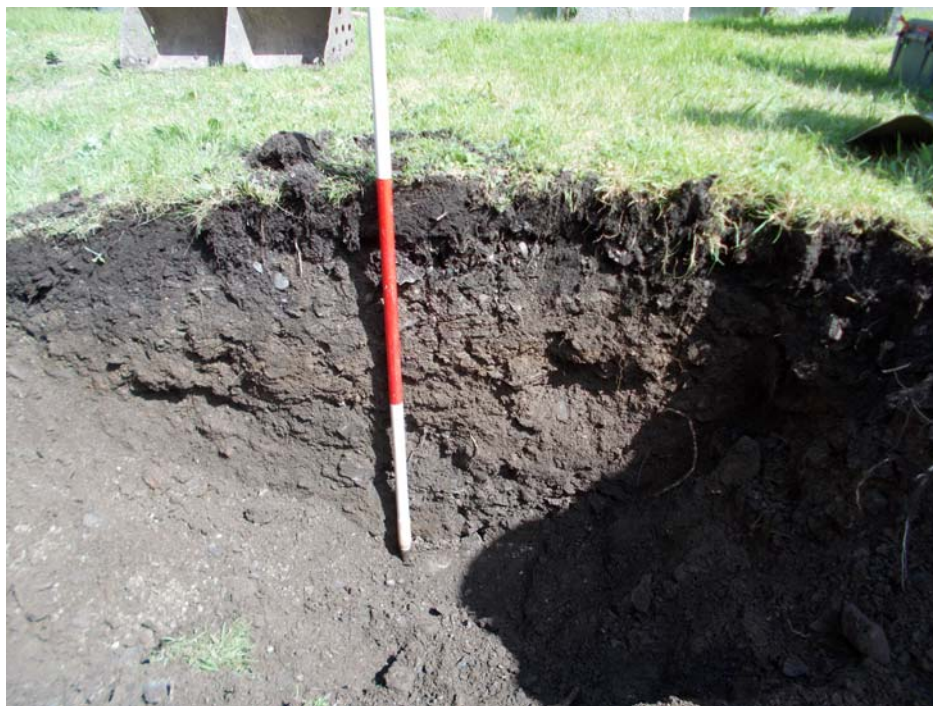
Plate 4: Section of cutting into raised area, looking north. Scale in 0.5m divisions

- 4.2.4 The excavation into the raised area north-west of the vestry revealed the following sequence of deposits: topsoil 0.3m thick (1), over mid-brown sandy gravel (5) which was a re-deposited natural, over a thick layer of slate and mortar rubble (6) presumably material left over from the 1884 restoration work.

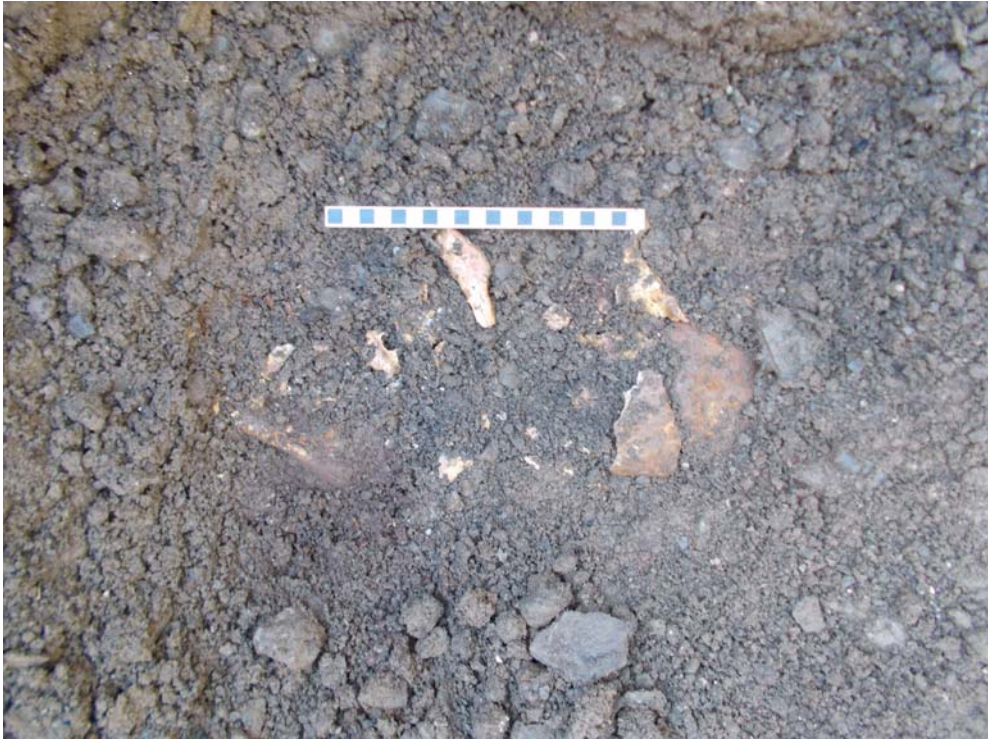
Plate 5: Part of skeleton (7) uncovered. Note skull and left shoulder, looking north. Scale 0.2m
