CPAT Report No 1210

Dolgarrog to Pentir overhead powerline, Gwynedd Excavations adjacent to tower AD13

Client name: Iberdrola Engineering and Construction
CPAT Project No: 1865
Project Name: AD Line Revision II
Grid Reference: SH 74819 70132
County/LPA: Gwynedd

Report Title: Dolgarrog to Pentir Overhead Powerline, Gwynedd. Excavations adjacent to tower AD13
CPAT Report No: 1210
Report status: Final
Confidential: No

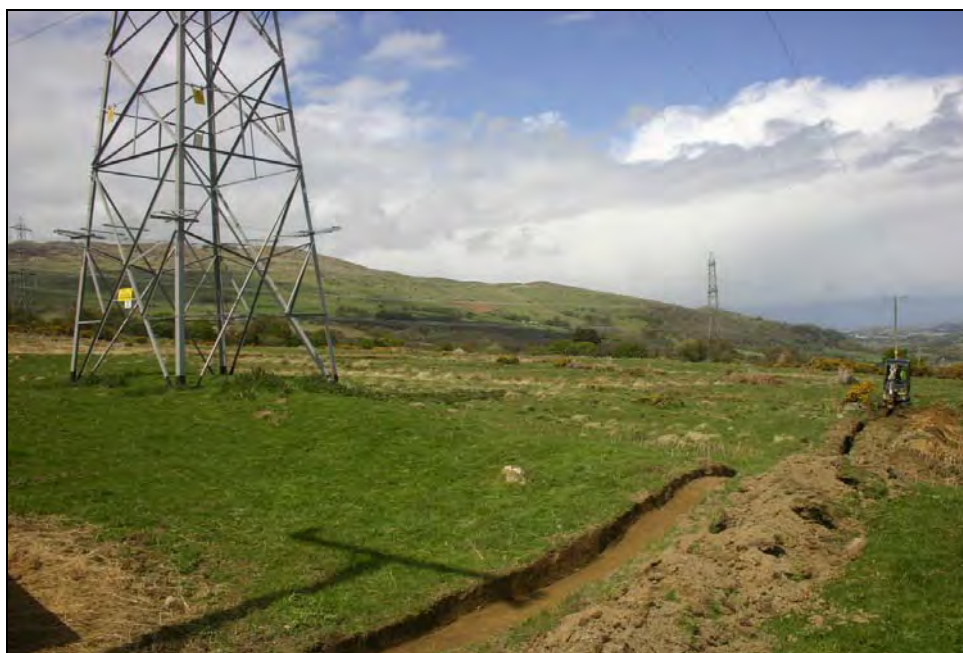
Fig. 3 View of the excavation across the embankment with tower AD13 located to the left of the trench. Photo CPAT 3634-0001

- 2.3 The trench, which was aligned north-north-east to south-south-west, provided a complete section through the bank and allowed an investigation of deposits to either side.
- 2.4 A number of deposits (02, 03 and 10) which post-dated the bank were removed by hand to reveal its surface. This had been constructed directly on top of natural subsoil (13), which varied from pale, iron-stained, yellow stony clay to pale grey sand and grey silty clay. Thin deposits of mottled grey silt (12) to the south of the bank and a silty clay (4) to the north, both around 80mm thick, may represent remnants of an old ground surface, though this was not evident beneath the bank.

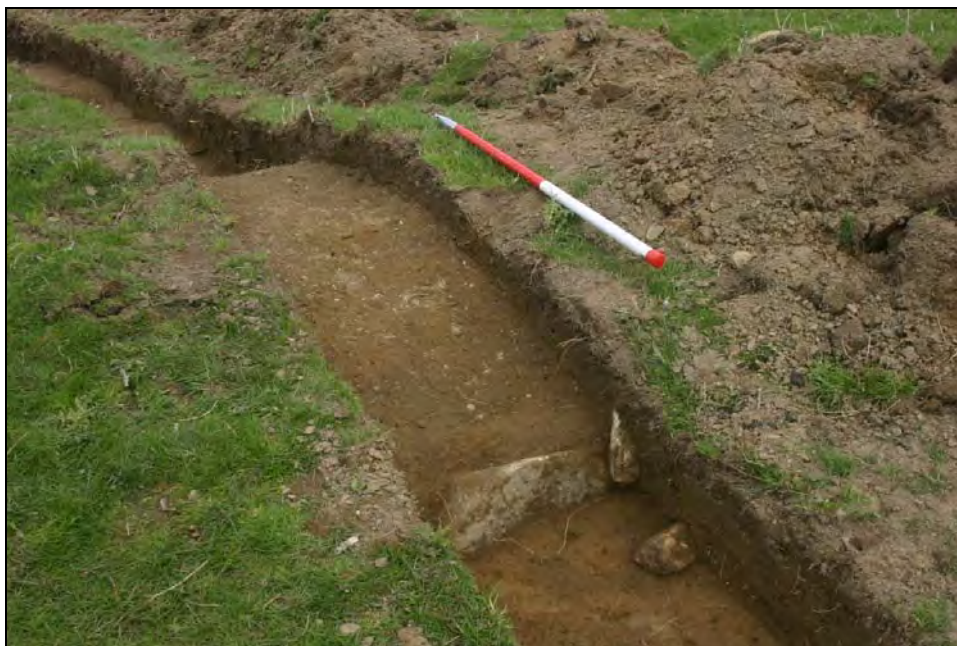
Fig. 4 The bank with its in-situ revetment wall along the south-eastern face.
Photo CPAT 3634-0013

- 2.5 The bank was around 4.6m wide and survived to a height of 0.5m, having been constructed from four dumps of soil (5, 6, 7 and 8) deposited against a roughly built stone revetment wall (9). The basal construction deposit (8), an orange brown silty sand, was 0.3m thick, into which the revetment wall had been set along the south-east edge of the bank. There was evidence to suggest that the rear of the wall had been packed with individual blocks of turf (7) (Figs 4-6), from which several fragments of charcoal were recovered.

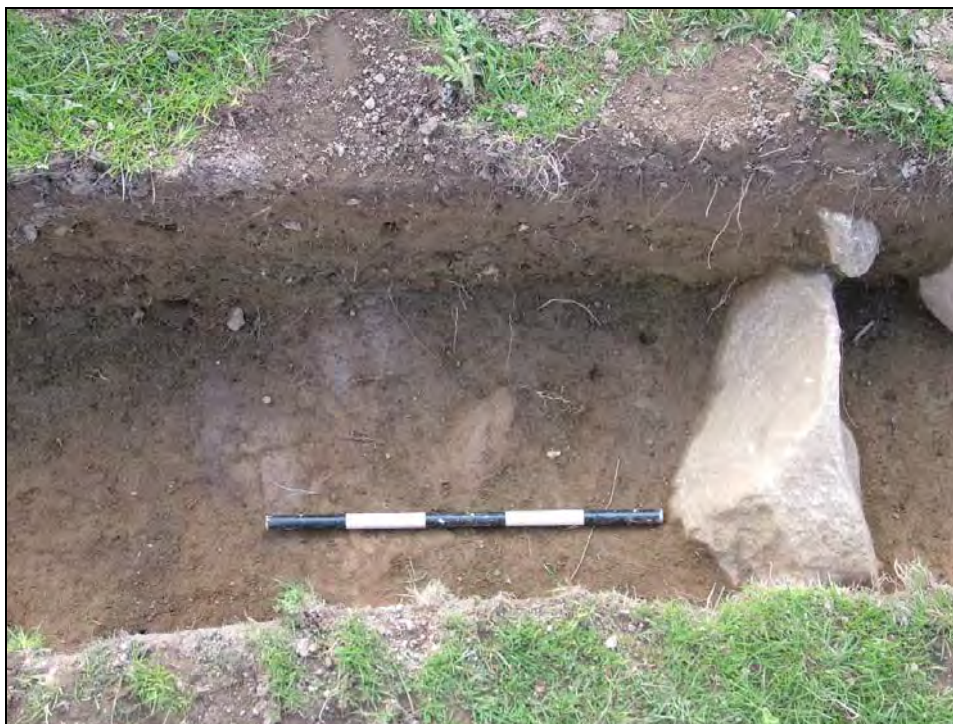
Fig. 5 View of the turf packing (7) behind the revetment wall (9).
Photo CPAT 3634-0036

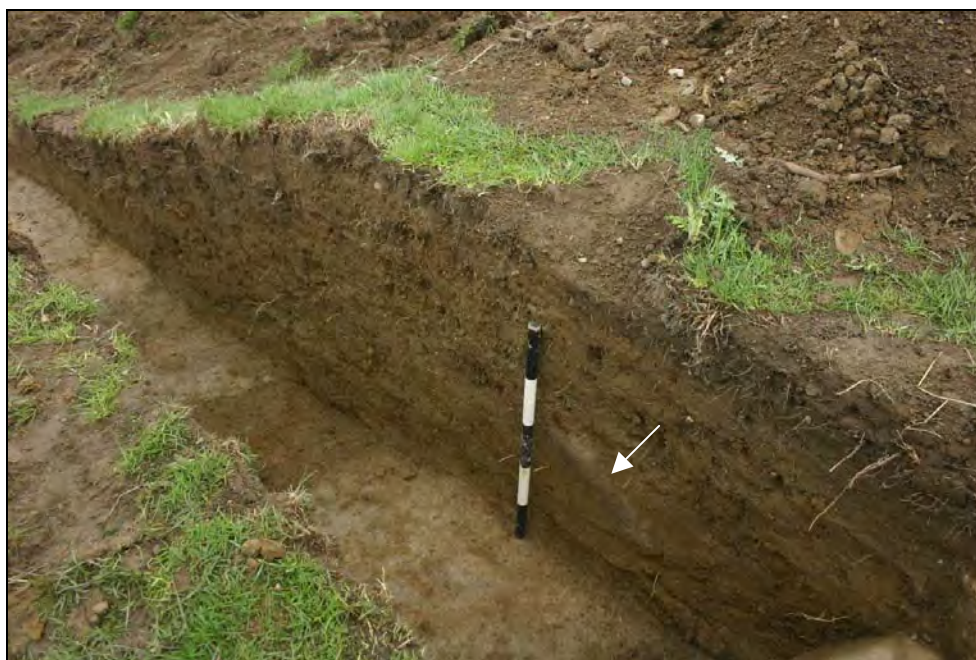
Fig. 6 The west-north-west facing section through the bank with a block of turf (arrowed) visible to the right of the scale. Photo CPAT 3634-0074

- 2.6 The main bank material (8), together with the turf packing (7), was sealed beneath a 80mm-thick deposit of greenish-grey gritty sand (6), with an uppermost layer of firm, orange brown, sandy silt (5), up to 0.16m thick and containing a significant quantity of small stones. A deposit, 0.24m-thick, of orange grey gritty silt (11) had accumulated against, and partly overlay the revetment wall (9), possibly material eroded from the bank.

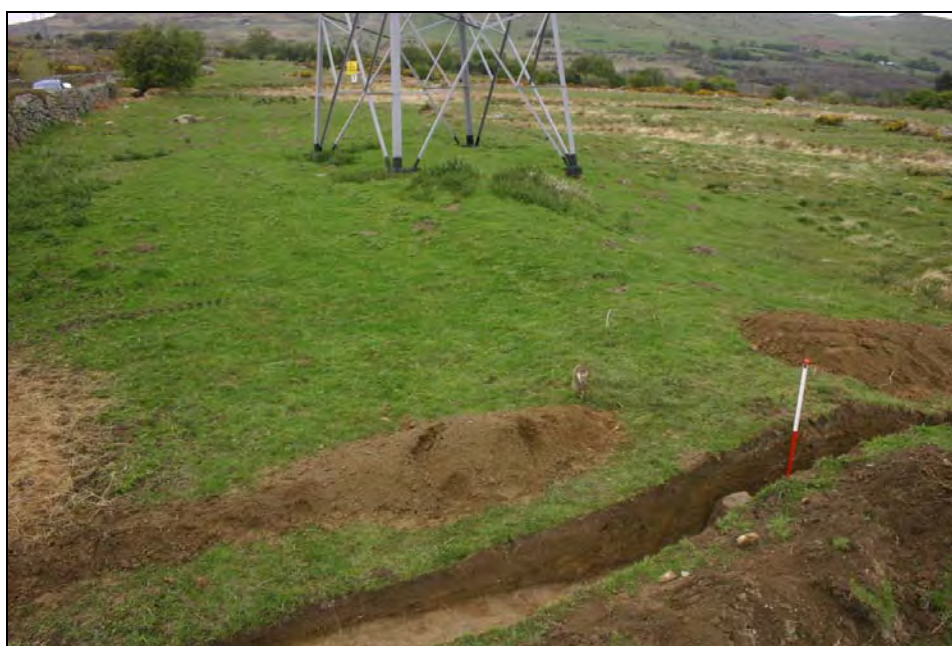
Fig. 7 The excavated trench view from the south-east, showing the bank and tower AD13. Photo CPAT 3634-0063
