CPAT Report No. 1409

Maentwrog to Trawsfynydd 33kV Powerline

Archaeological Watching Brief

Client name: Iberdrola
 CPAT Project No: 2094
 Project Name: Maentwrog to Trawsfynydd Powerline
 Grid Reference: SH 67638 39343
 County/LPA: Gwynedd/Snowdonia National Park
 CPAT Report No: 1409
 Issue No:
 Report status: Final
 Confidential: No

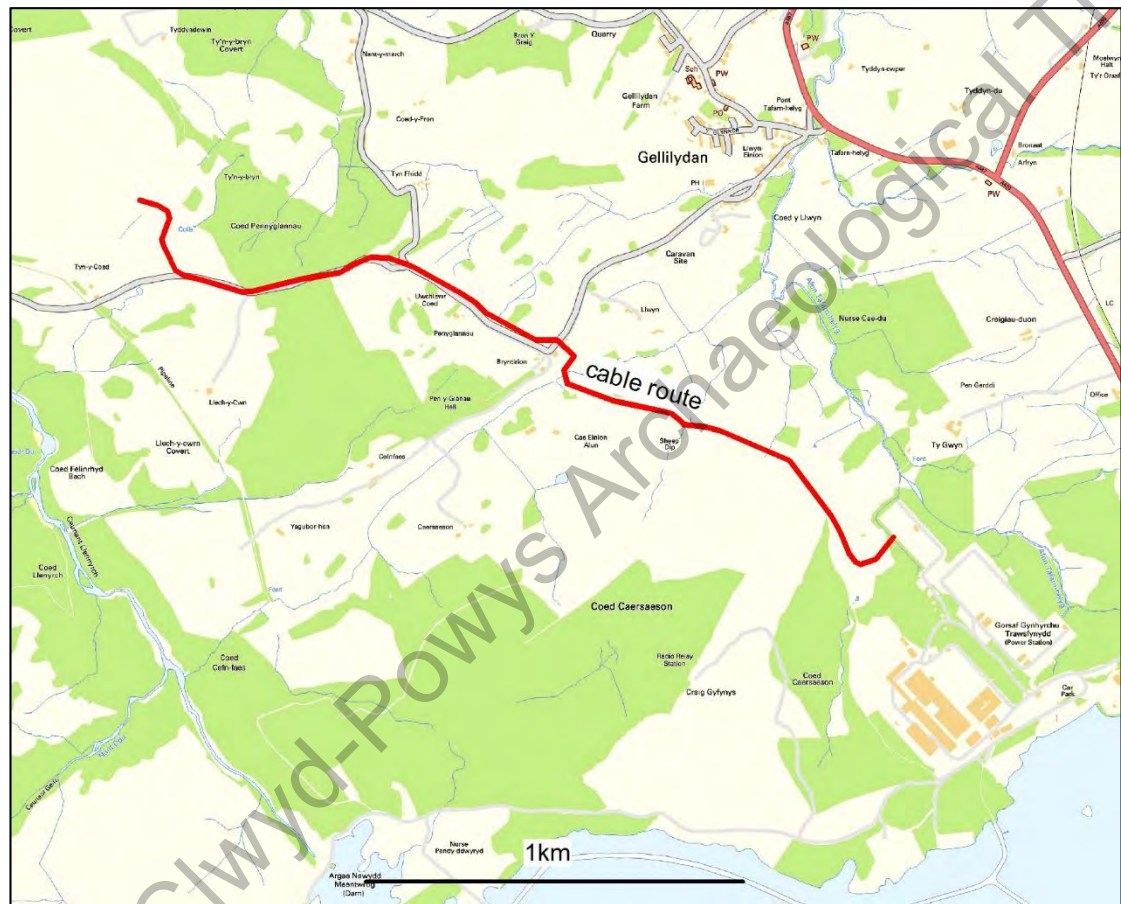
Fig. 1. Plan showing powerline route (marked in red)

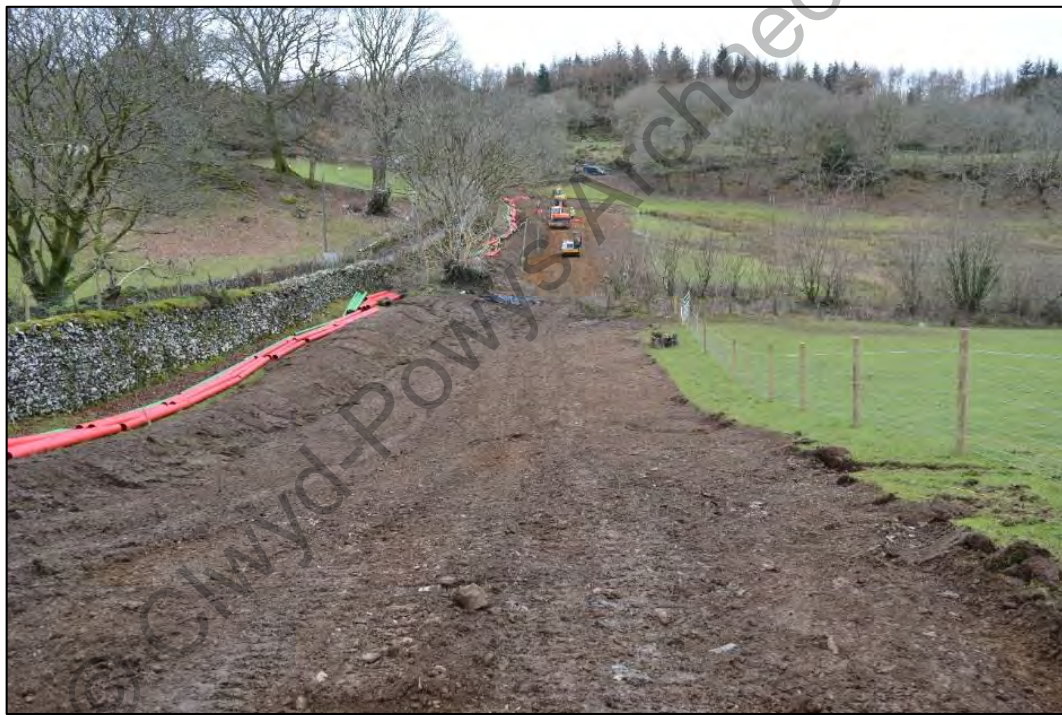
- 3.3. The fields immediately to the north-west and north-east of Penyglannau (SH 67790 38070) contained the predicted line of a Roman road running broadly east-west, although previous geophysical survey (Fry 2014) had failed to identify any such feature. The watching brief also produced no evidence for a Roman road and identified no finds earlier in date than approximately 1850 within this area.

Fig. 2. General view from the west of powerline route northwest of Penyglannau
CPAT 4155-0001

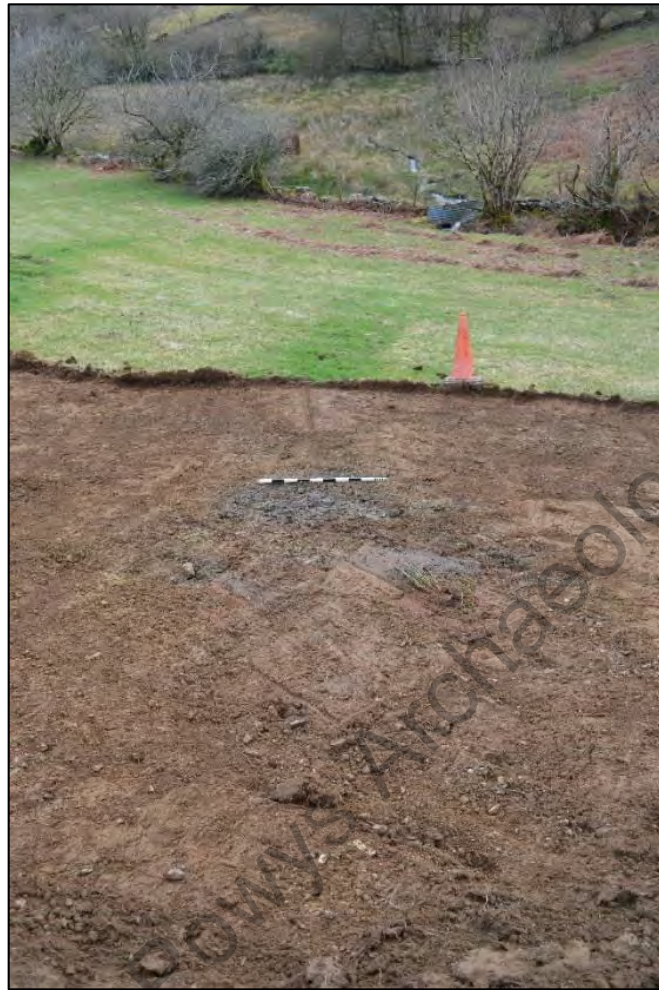
- 3.4. The powerline route crossed a lane opposite Beudy Bach (SH 68030 339098) and traversed a field immediately to the east in a southerly direction, then turned to the east to follow the general line of a trackway. Two linear features revealed during topsoil stripping to the south of Beudy Bach (SH 68760 39000) were interpreted as gullies or open drains, recently backfilled. A small quantity of 18th- or 19th-century pottery was identified within the topsoil in this area.

Fig. 3. View from the north-west of drain or gully in the field to the south of Beudy Bach CPAT 4155-0008

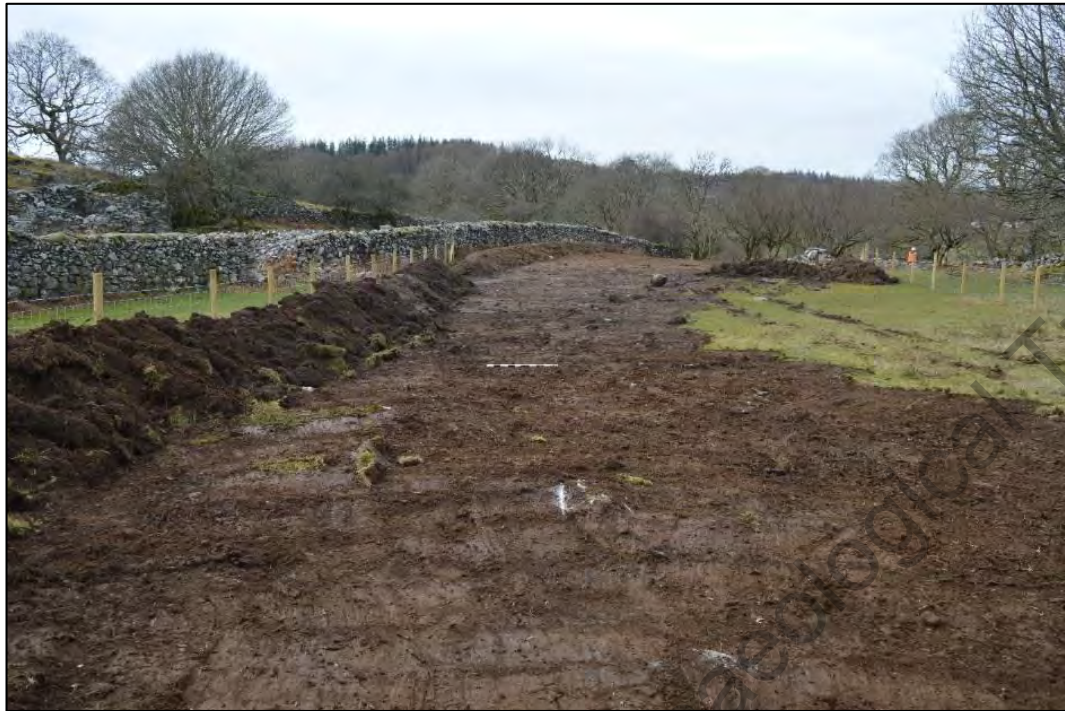
- 3.5. To the east of Beudy Bach the pipeline route was modified slightly to the south of a trackway running broadly east-west between the lane and the northern side of Llyn Trawsfynydd. The easement ran through two small fields to the north of a derelict building (SH 68212 38929), marked on the 1889 Ordnance Survey mapping as Pant-yr-orien, probably a smallholding. The topsoil yielded a few sherds of 19th-century pottery but no earlier finds or features were revealed.

Fig. 4 View from the east of easement to the north of Pant-yr-orien (visible in the background) CPAT 4155-0013
