**Results of Archaeological Assessment at**

**Gorswen, Plas Road, Holyhead**

**Project Number CR142-2017**

**Results of Archaeological Works at:  
Gorswen, Plas Road, Holyhead**

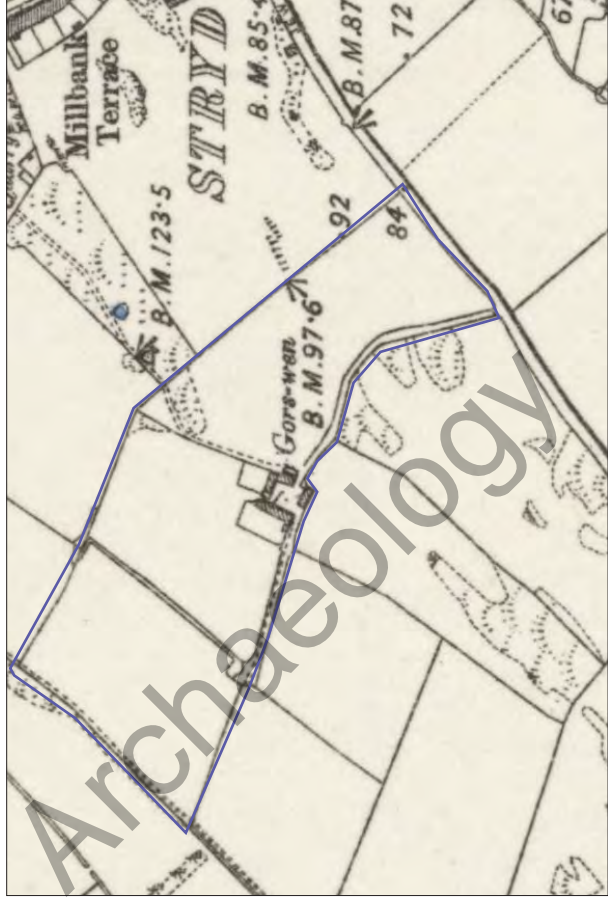
**Figure 8.** First Edition Ordnance Survey Map Surveyed 1887, Published 1889

**5.3.1.4** The First Edition Ordnance Survey map, surveyed 1887 (figure 8), shows that the divisions between fields 232 and 233 which appear on the tithe map have been removed, as has the boundary between fields 227 and 228. The building complex has been enlarged and additional buildings including the north-eastern wing of the current farmhouse have been added.

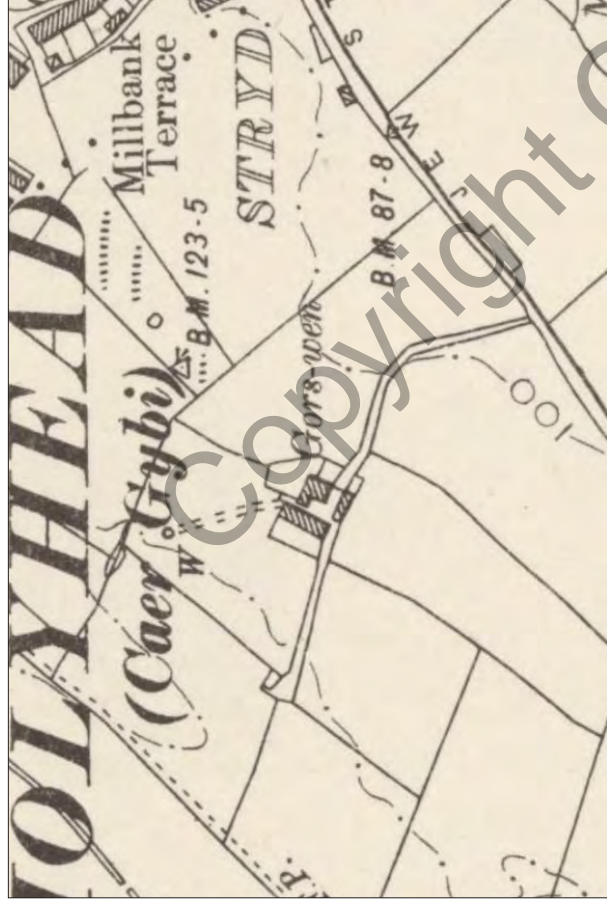
**Figure 9.** Ordnance Survey Map  
Revised 1899, Published 1901

**5.3.1.5** The main block of the current farmhouse has been constructed by the time of the 1899 survey (figure 9). There have been further pens/enclosures added around the farmyard, which are again added to in the 1920 edition (figure 10). A small structure along the entrance into the farmyard first appears on this map edition. There are no changes shown on the 1938 and 1949 editions (figure 11 & 12). The division between the north-western fields (228 and 229 on the Tithe map) has been removed at some point following the 1949 survey of the land. The large pond in field 2b is a modern construction and was excavated by the present owner.

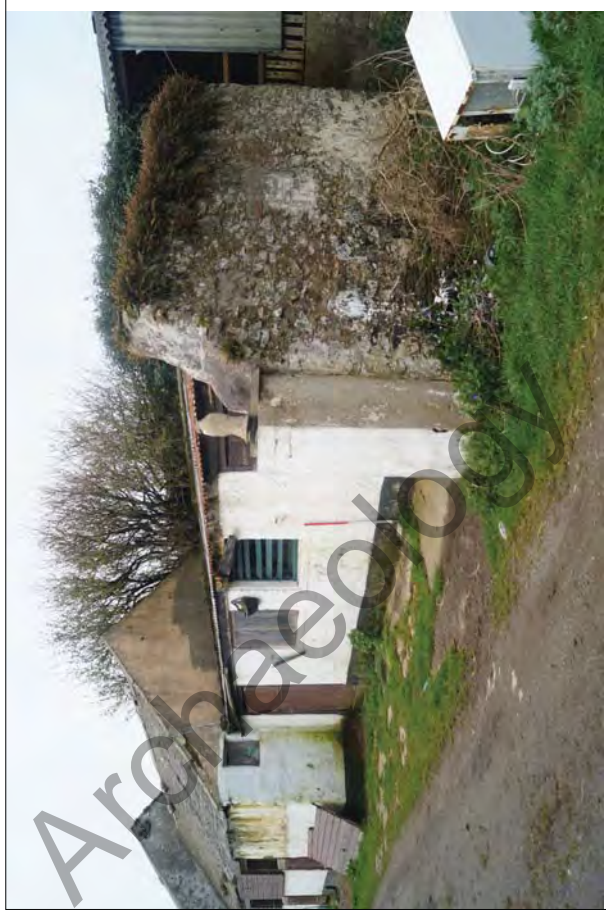
**Plate 16.** Building 7 - Small Stable Block with Earlier Gable Wall

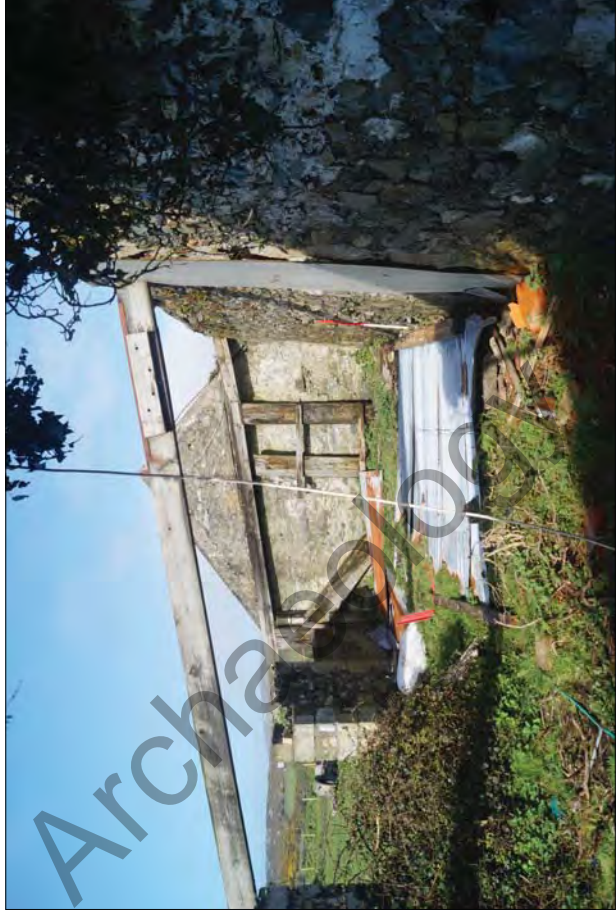
**Plate 20.** Building 8 - Built Against Earlier Boundary Wall

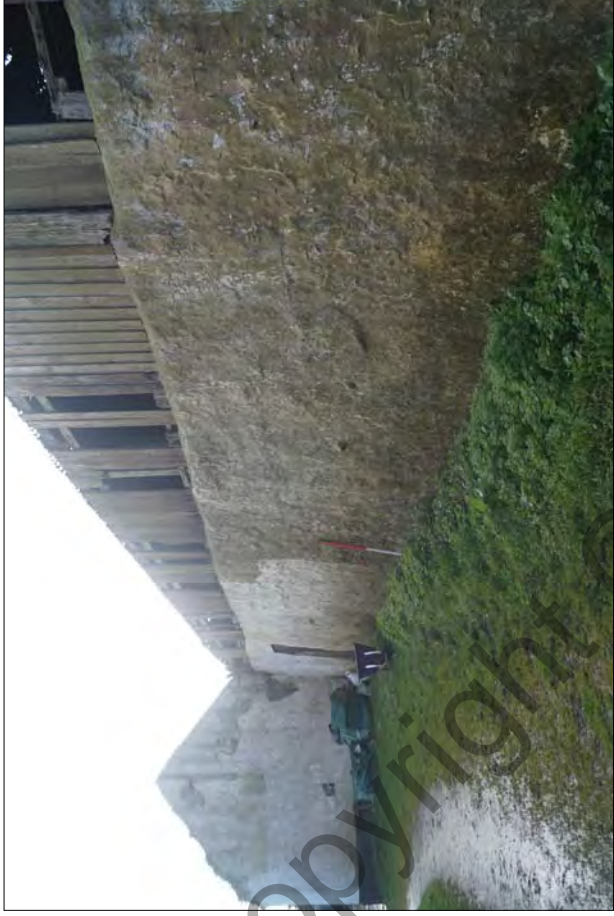
**Plate 26.** Gable End of Building 4 and Elevation  
Of Barn 5 Utilising Earlier Boundary Wall

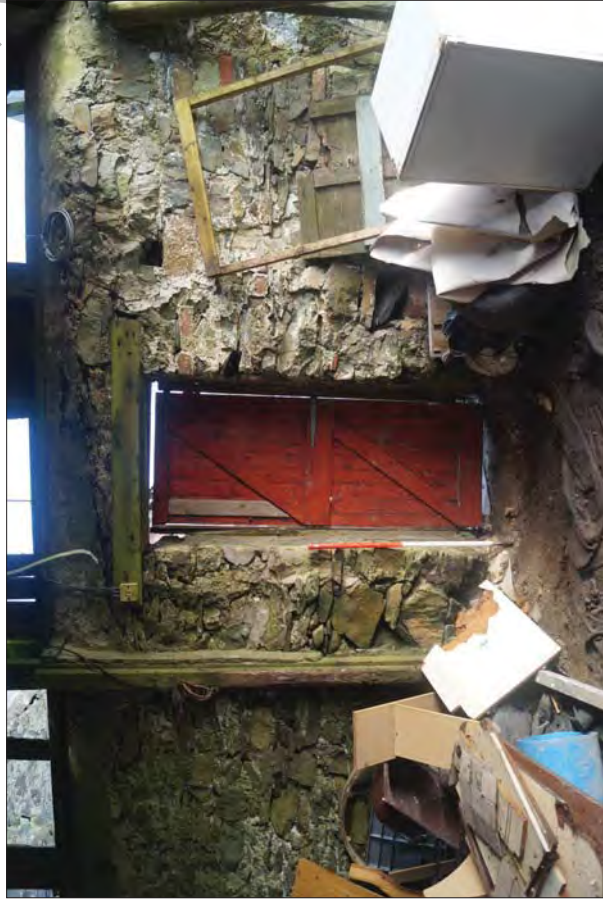
Building 5 is a barn which utilises an earlier boundary wall as its northern elevation. This wall has a slight slope to it and is stone built and white washed. The remaining elements of the building consisted of a wooden frame and corrugated iron roof and walls. There is a large wooden door on its western gable and an entrance way to the eastern gable. The interior had a heavily disturbed mud floor. The building postdates the 1949 Ordnance Survey map.

**Figure 38.** Interior of Building 5 - Barn. Showing Earlier Boundary Wall Incorporated into Structure

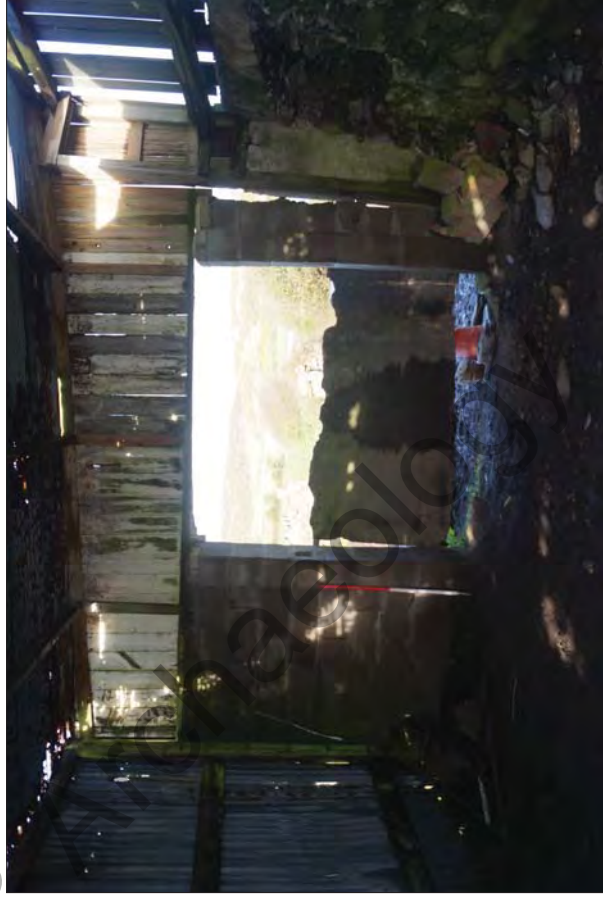
**Figure 39.** Interior of Building 5 - Barn. Showing Differing Construction Materials

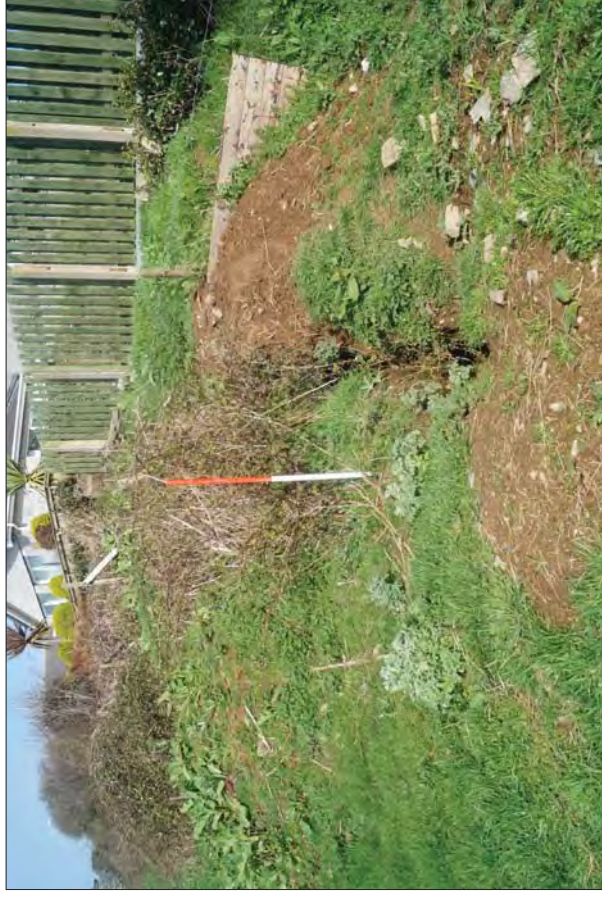
**Plate 49.** Badger Set in Boundary Bank of Field 1

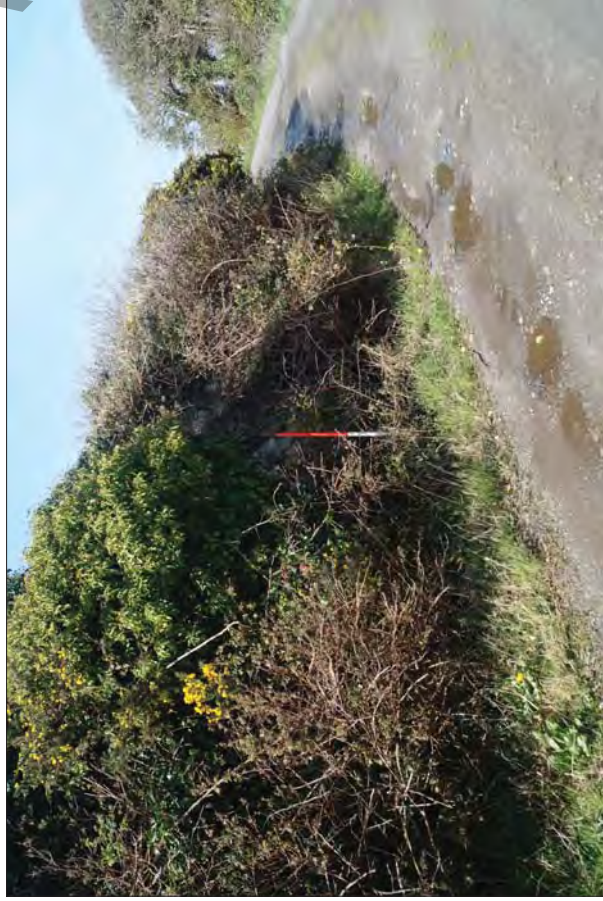
**Plate 54.** Field Boundary Road With Rock Outcropping

**6.3.3.5** Groundcover was found to be shallow in certain areas with the bedrock just below or protruding from beneath the turf area in places. This will have had a negative impact on any buried remains which may have previously survived on the site and the level of survival of features on site is unknown. It is however considered unlikely that the disturbance in certain areas will have resulted in the total destruction of features across the entire site. The material which was removed during the excavation of the pond is evidence that there are parts of the site where the bedrock is much deeper than in others.

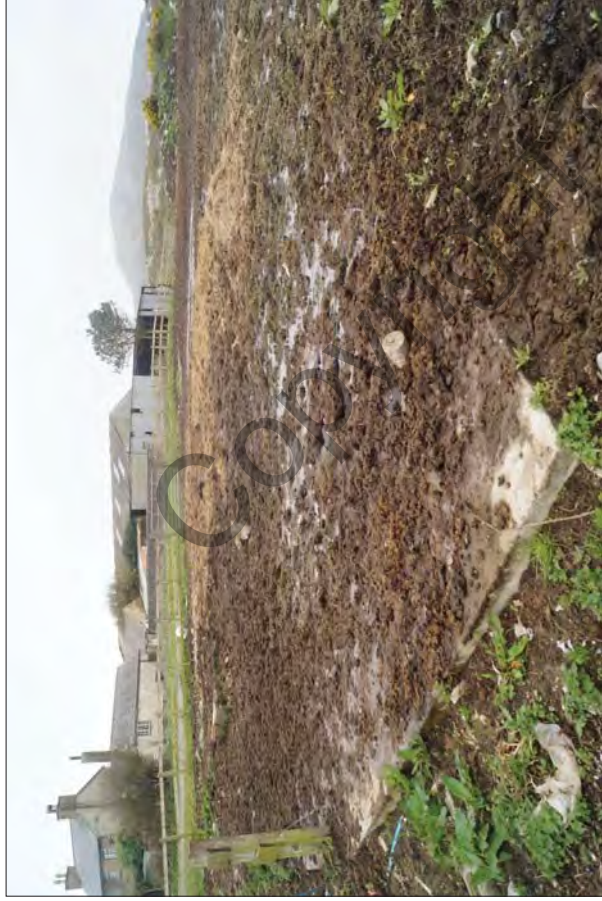
Field 2a is located to the north-east of main farm complex. This area has been heavily disturbed and held a large quantity of standing water. To the south and west there is a wood and wire boundary fence. To the east and north there is a slight raise due to an outcrop of bedrock which had been quarried flat in line with the fencing. It is unclear as to how far this originally extended into the field. To the north-west there are large piles of rubble, rubbish and soil, predominantly the result of the excavation of the large pond in field 2b. There is a large concrete foundation slab in the southern end of the field (see plates 56-57). It is unclear as to how far this hardstanding extends into the field but it appears to have disturbed a minimum of 10 – 15m<sup>2</sup>. There were no observable archaeological features, earthworks or cropmarks recorded within this area. The field was in use by the riding stables.

**Plate 56.** Concrete Hard-standing in Field 2a

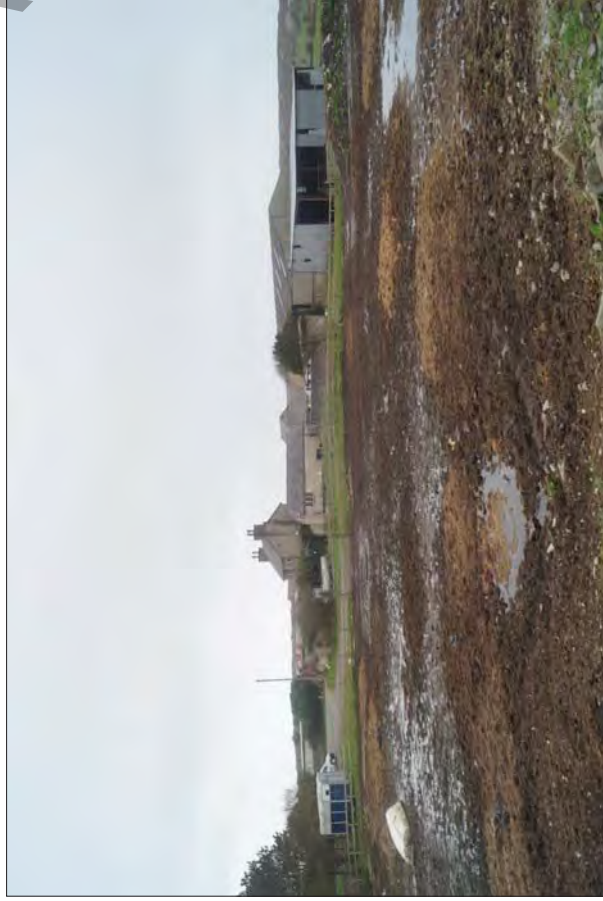
**Plate 58.** Field 2a Showing Disturbed Ground and Rubble Piles

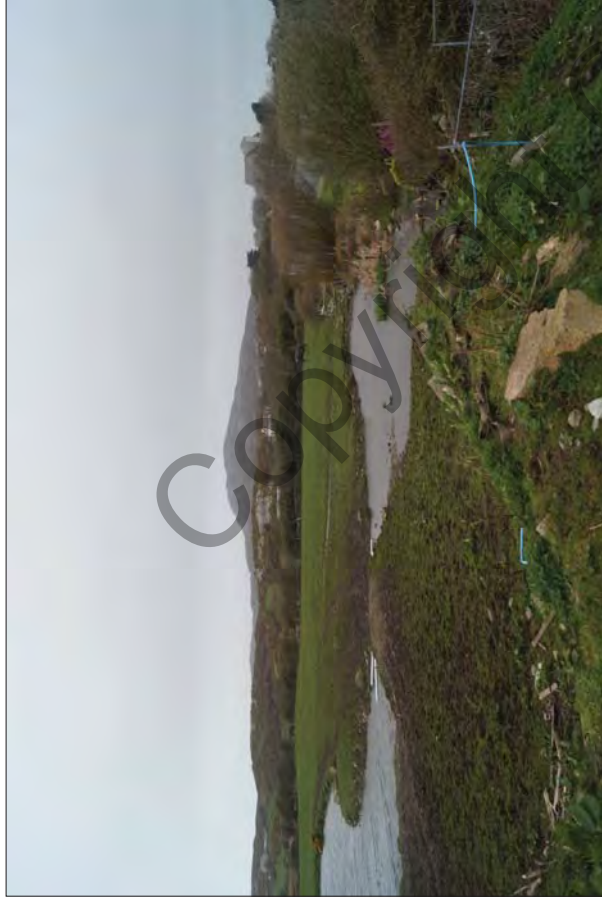
**Plate 60.** Modern Artificial Pond in Field 2b.  
Note Rock Outcrop in Background

**6.3.3.4** The desk-based element of this report has indicated that the potential for encountering archaeological remains, particularly of Prehistoric and Romano-British/Roman date within the proposed development area is high, and that the significance of these remains would also be considered to be high. This potential must however be weighed against the results of the walkover survey which has shown that large areas of the site are heavily disturbed by modern activity such as the excavation of the pond in field 2b, the concrete hardstanding in field 2a and damage by livestock.
