# **Results of Archaeological Works at Wern Wen, Llangwstenin**

**Report Number CR165-2018**

<b>Planning Application Number:</b>	0/44770
<b>National Grid Reference:</b>	281423 378180
<b>Client:</b>	Mr & Mrs Martin
<b>Report Author:</b>	Catherine Rees
<b>Report Number:</b>	CR165-2018
<b>Date:</b>	05/09/2018

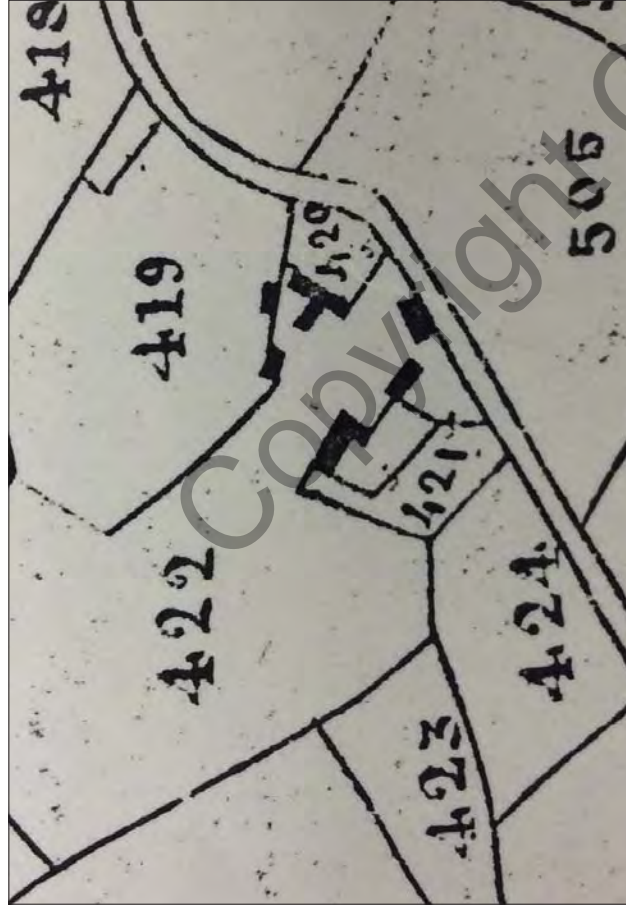
**Figure 2.** 1841 Tithe Map Showing Wern Wen  
(Source: Conwy Archives)

**5.0.5** The documentary record which could be sourced for Wern Wen was limited and nothing predating the 1841 Tithe Map of the area could be sourced (figure 2) which directly related to the property.

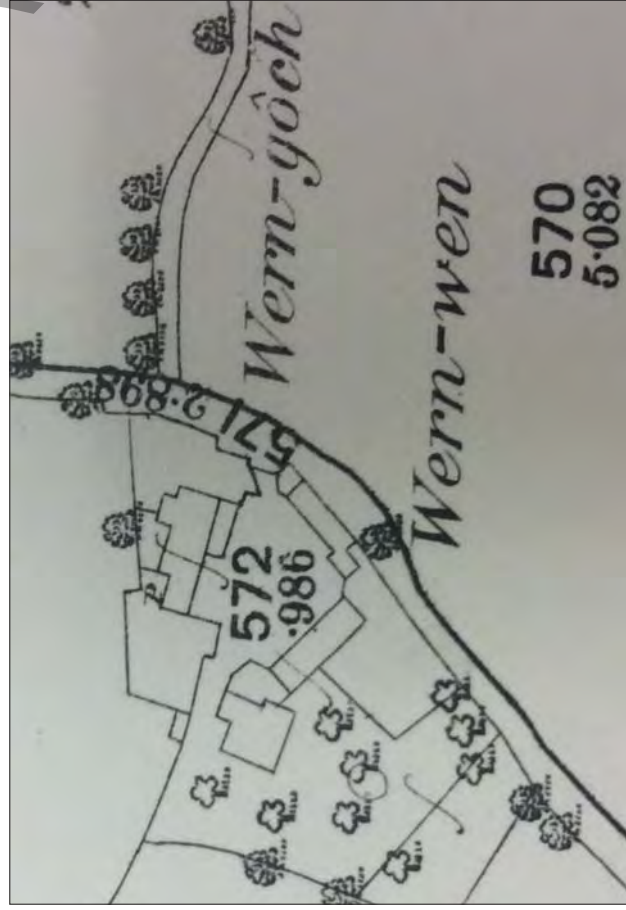
**Figure 4.** 1890 Ordnance Survey Map Showing  
Wern Wen (Source: Conwy Archives)

**5.0.20** During this period there are few changes to the property shown on the cartographic sources. The First Edition Ordnance Survey Map (figure 4) of the area shows that an outbuilding to the north-west of the main house which is shown on the 1852 map has been demolished and an extension to the stable block has been added. Between 1900 and 1913 (figure 5) a rear porch is added to the farmhouse. No further changes were noted on the latest available historic map edition (1949).

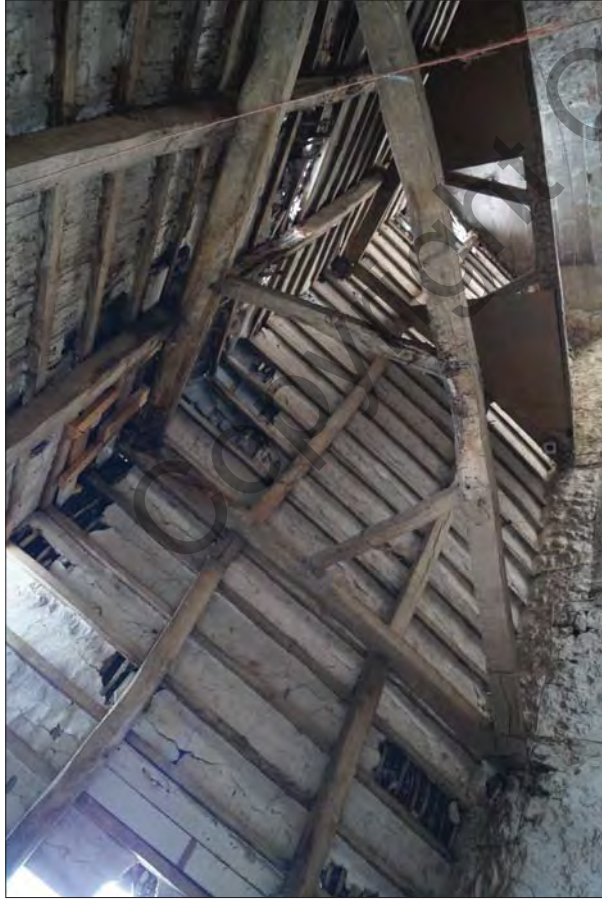
**Plate 47.** Wern Wen Barn Roof Structure (Taken Facing South-East)

**6.1.3.4** Within the main barn area itself the roof structure is of particular interest. There are “*pegged tie-beam trusses flanking the threshing floor which have raking struts and purlins supported by cleats. There is no ridge and the common rafters are (presumably) pegged at the apex. The roof of small slates is torched*” (quoted from communication with Richard Suggett RCAHMW).

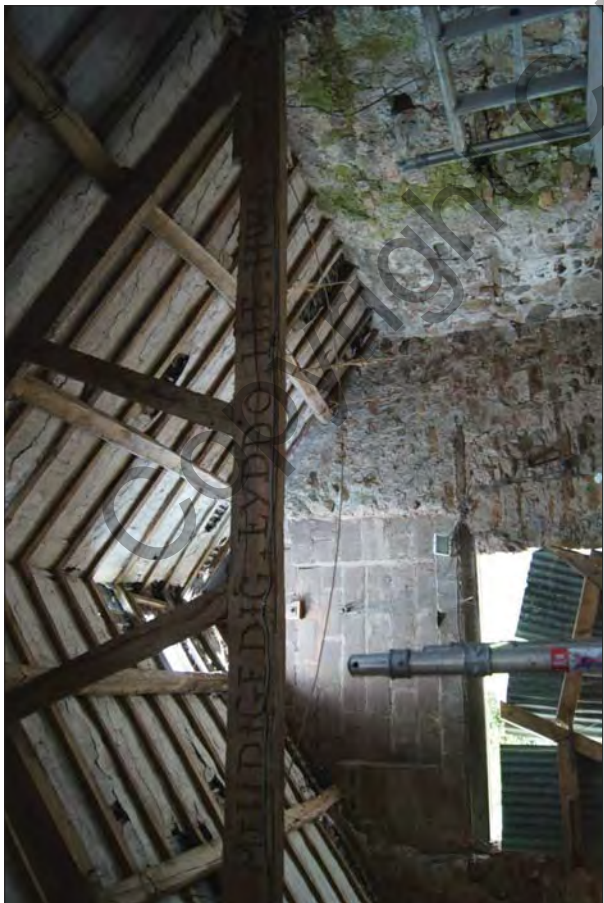
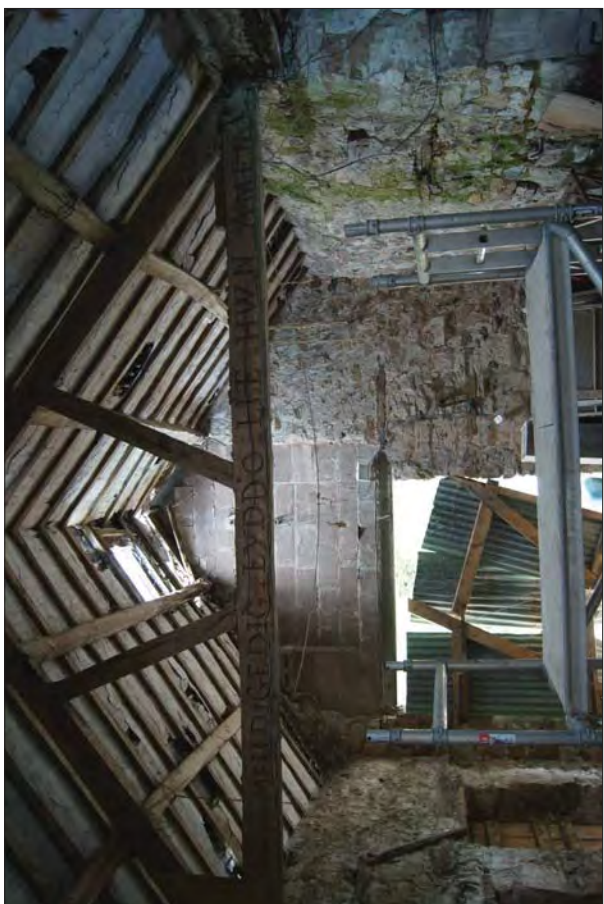
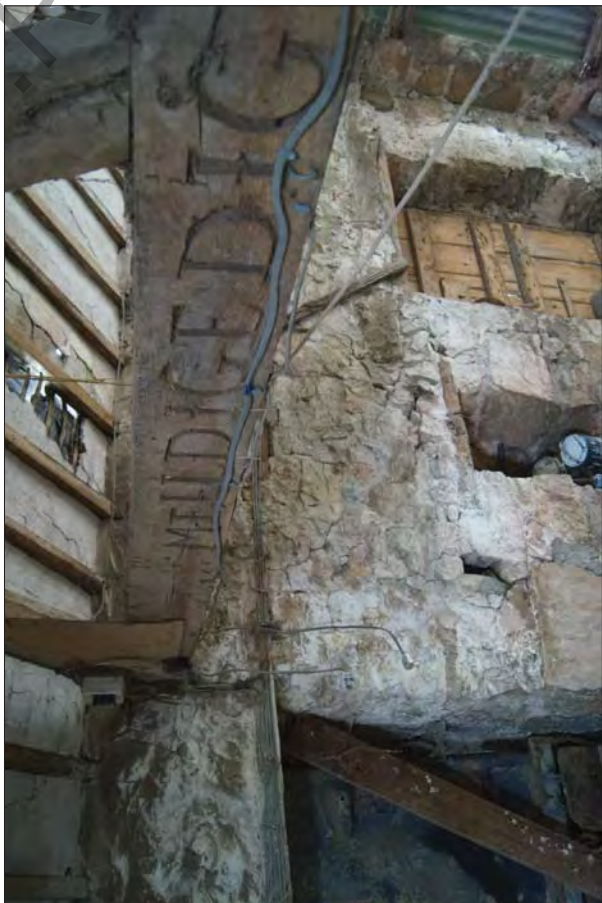
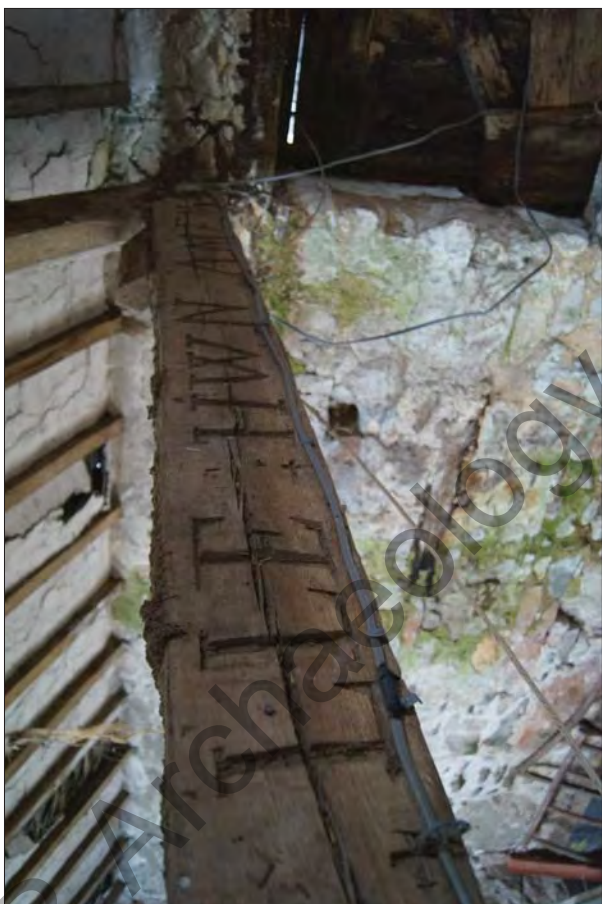
Plates 131 - 134. Curse Inscription Uncovered in Barn

**7.0.2** Of particular note, the building recording phase uncovered a Welsh curse on one of the barn roof trusses which is believed to be of early nineteenth century date. No known parallels for this could be found.

**6.1.3.5** During the initial site visit carving was noted on the tie beam of the southern truss, although it was obscured by boarding added to support the roof structure (plate 35). It was recognised as being of significance and a return visit was made to study and record this carving once the boarding was

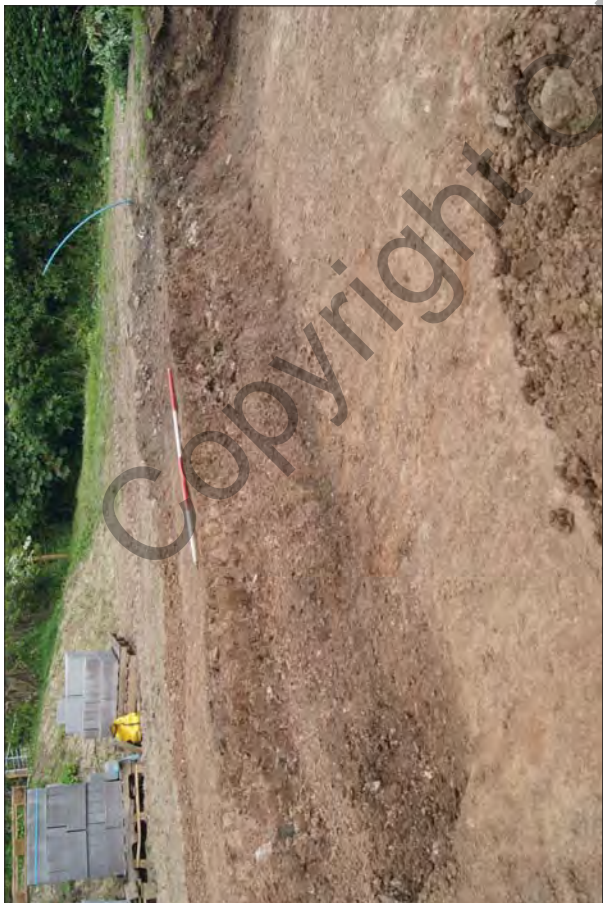
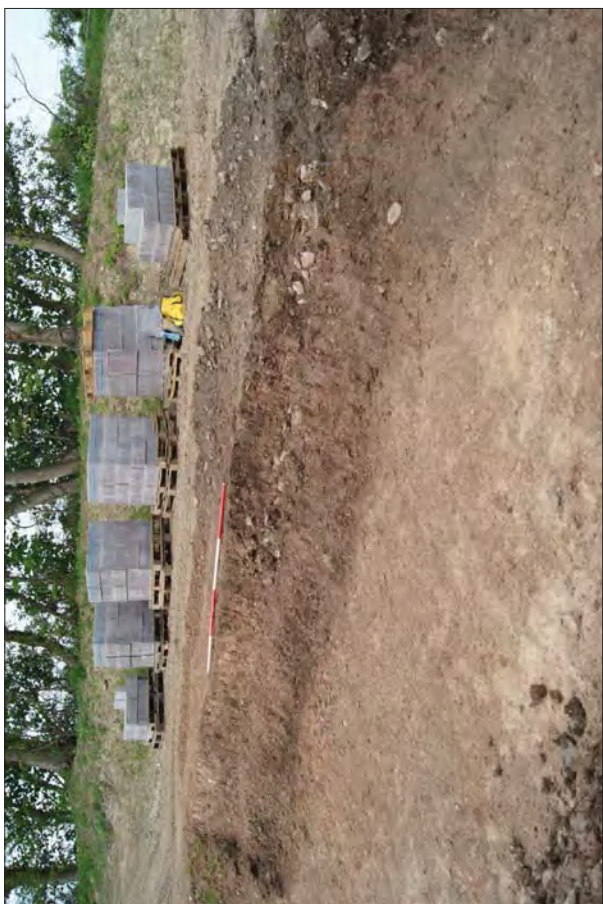
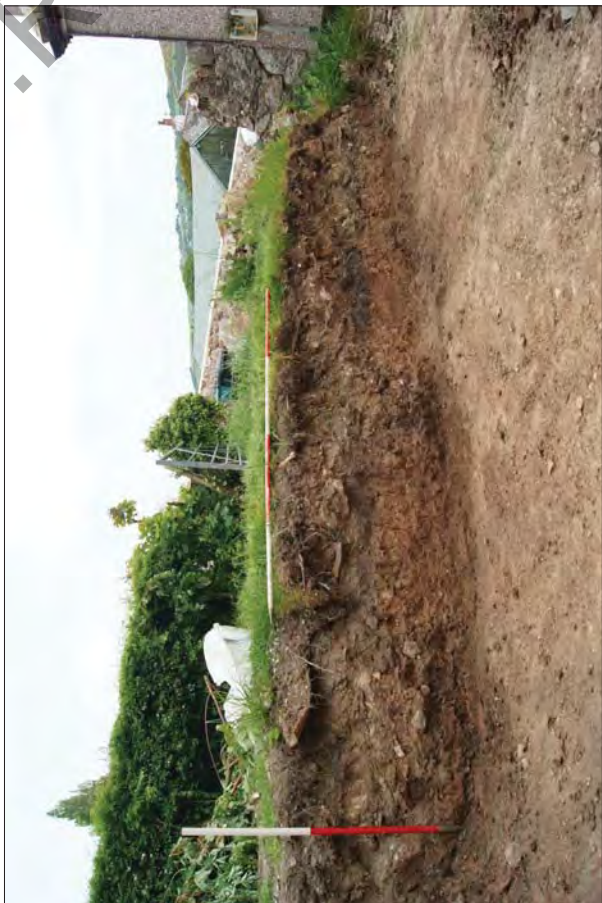
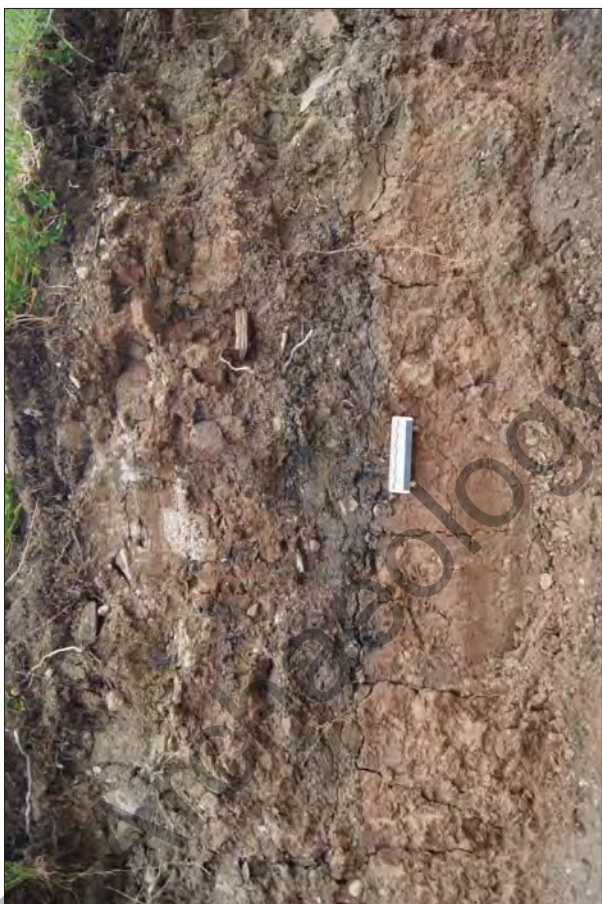
**Plates 135 - 138. Excavated Area for Extension at Rear of Farmhouse**

**7.0.3** The area to the rear of the farmhouse yielded no evidence for earlier building phases, and no archaeological features were uncovered.

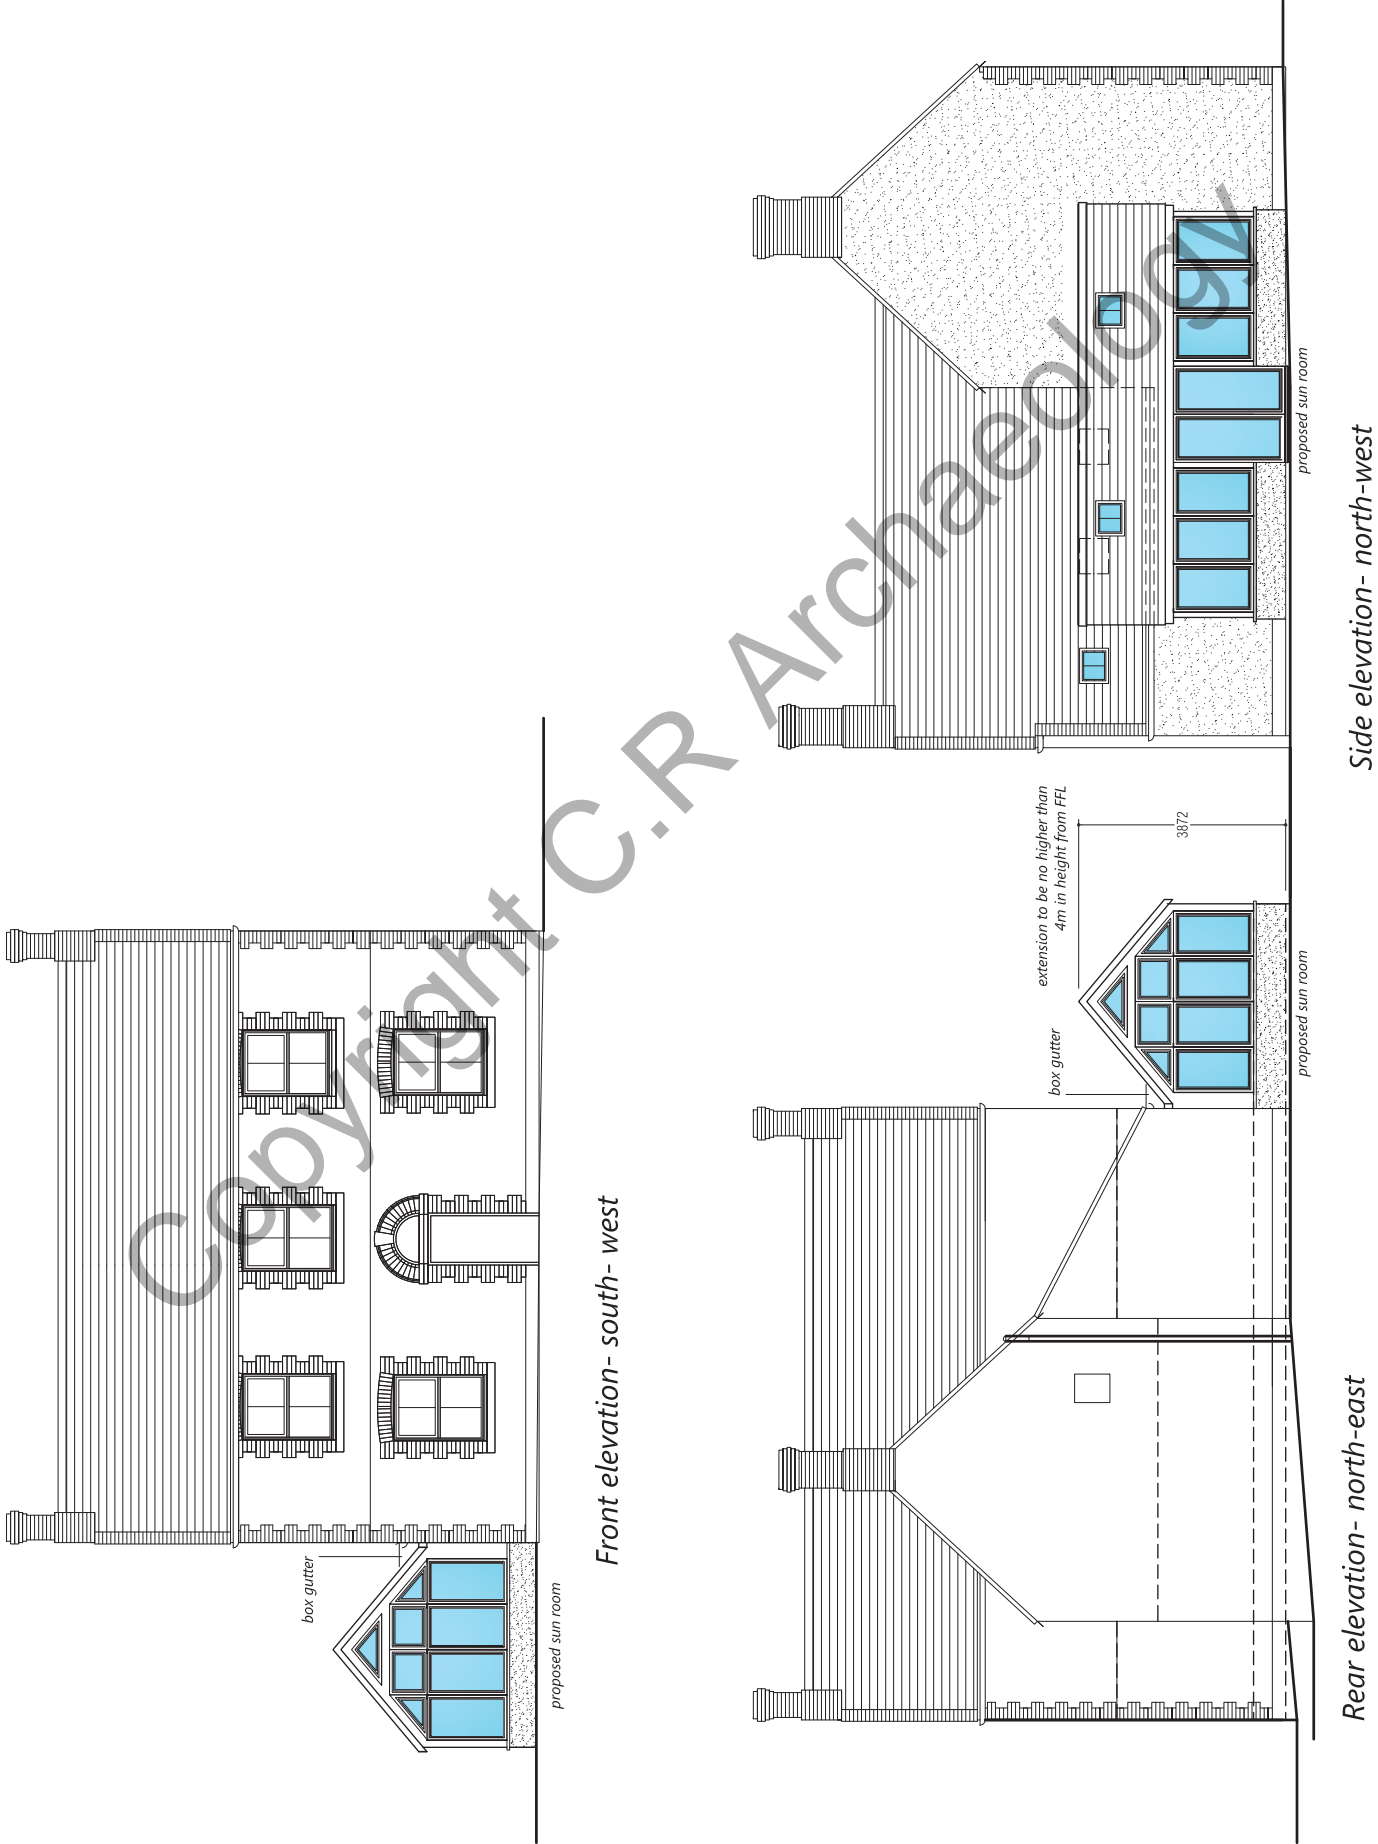
Sun room:  
Walls to up 600mm above FFL to be masonry cavity construction with render finish.  
Windows and doors: timber double glazed units, see elevations for style  
Roof: Natural mineral roof slates to match main roof- sample to be submitted to Local Authority prior to installation

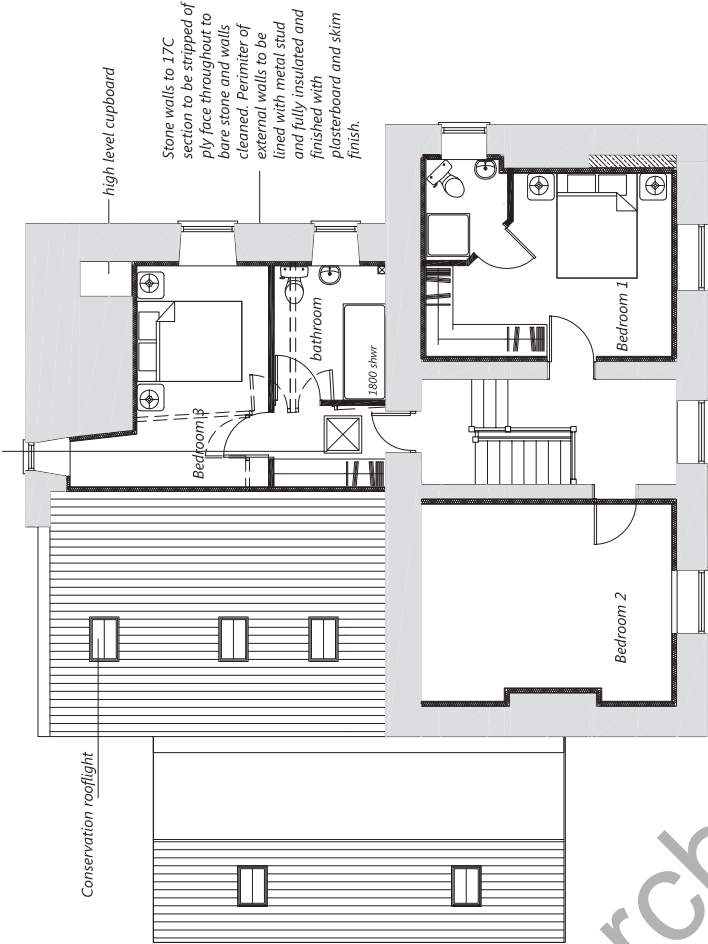
Proposed first floor layout plan

New roof access trap to be inserted into new ceiling (spacing of ceiling binders to be investigated to ensure trap is positioned between). Access to be provided in order to insulate the loft area

chimney recess to be studded out to create flat wall, Skirting section to match and marry into existing at chimney breasting and external wall
