# **Results of Archaeological Assessment at**

## **Pont Fawr, Llanrwst Scour Protection Scheme**

**Report Number CR183a-2019**

Compiled by C. Rees and M. Jones  
On Behalf of Cadarn Consulting Engineers

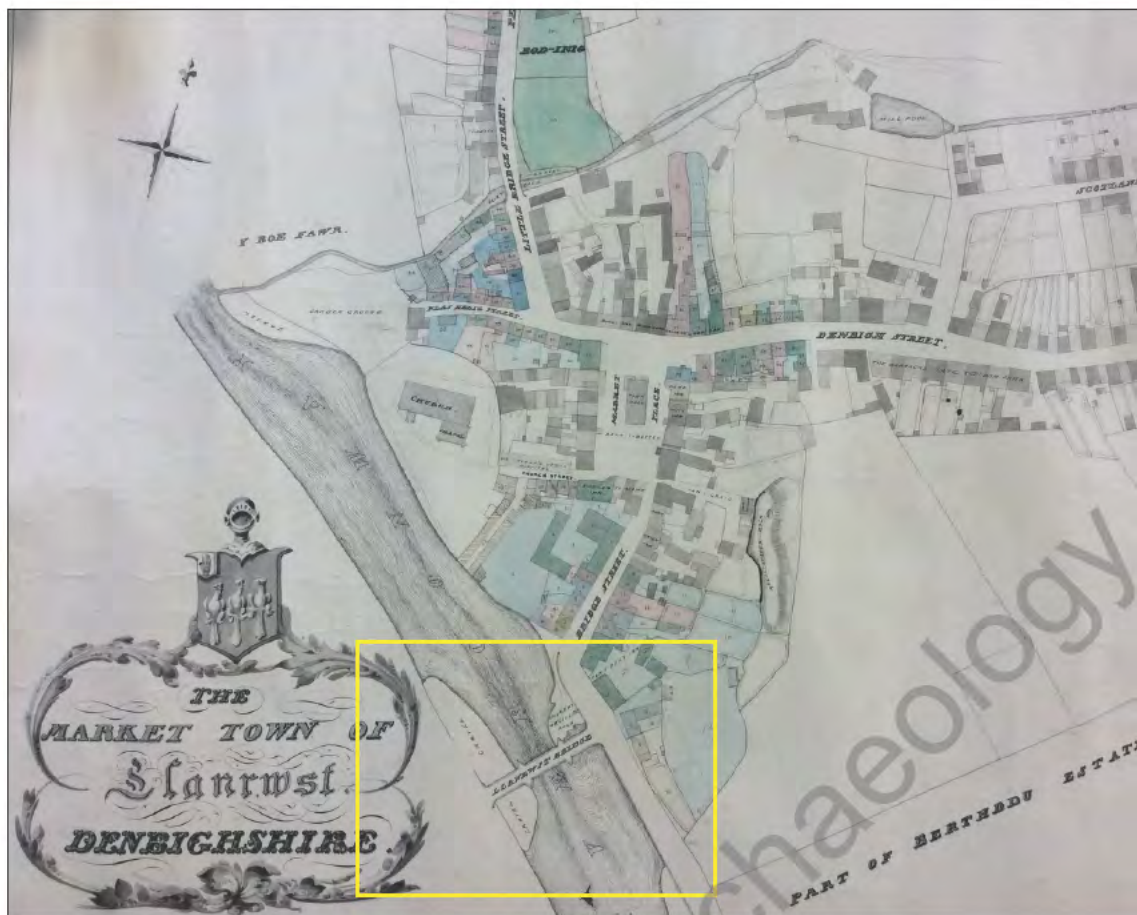
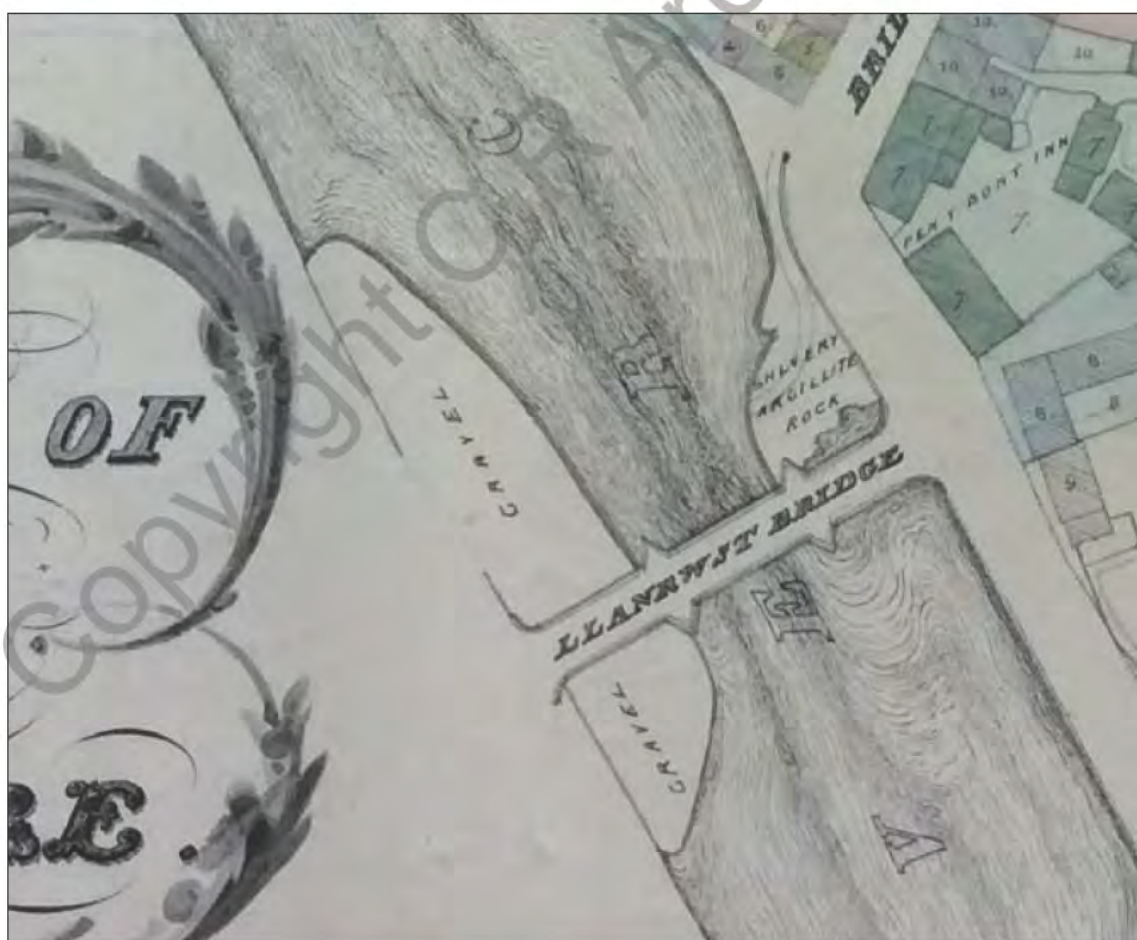
**Figure 4 (Above).** Mostyn Estate Map dated 1800  
(Source: Bangor University Archives MMS 8534)

**Figure 5 (Below).** Llanrwst Bridge Detail Shown on Mostyn Estate Map dated 1800  
(Source: Bangor University Archives MMS 8534)

**5.3.3** A slightly later Mostyn Estate Map dated 1800 (Bangor University Archives MMS 8534, figures 4 & 5) also only shows the properties in Denbigh, with the area to the south west of the bridge not included in the document. Llanrwst town is shown and there appears to have been development closer to the road. There is a clear depiction of the bridge and a deposit of "shlyery agrillite rock" is shown on the town side of the river. The opposite side shows a large deposit of gravel building up around bridge and bank (figure 5). This map is of sufficient detail that the refuges along the bridge are shown.

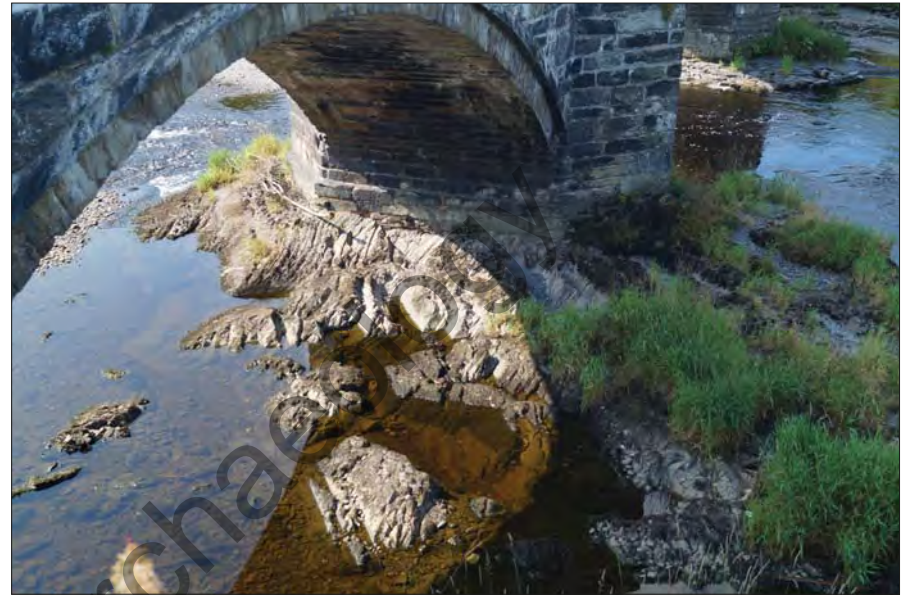
**Plate 6.** Pont Fawr, North Eastern Pillar

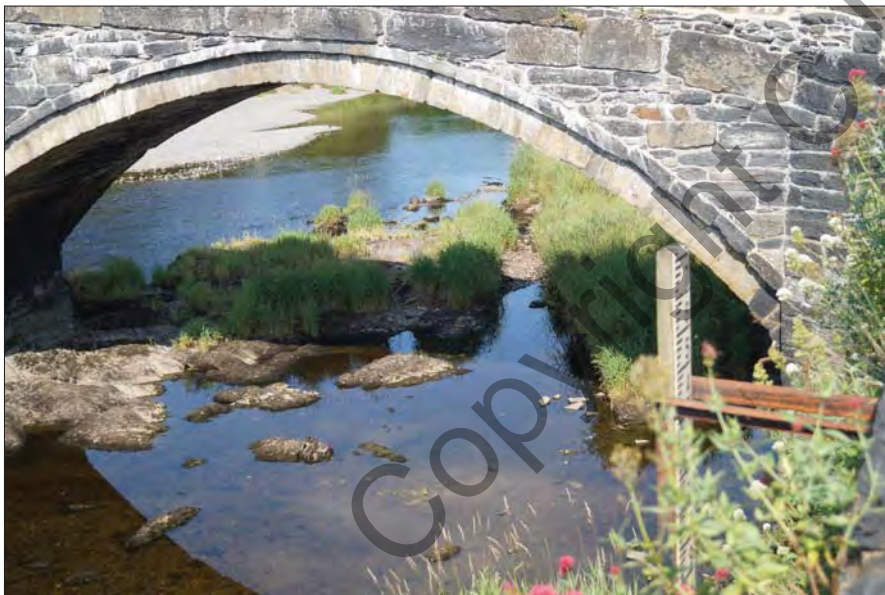
**Plate 7.** Pont Fawr North Eastern Bridge Span

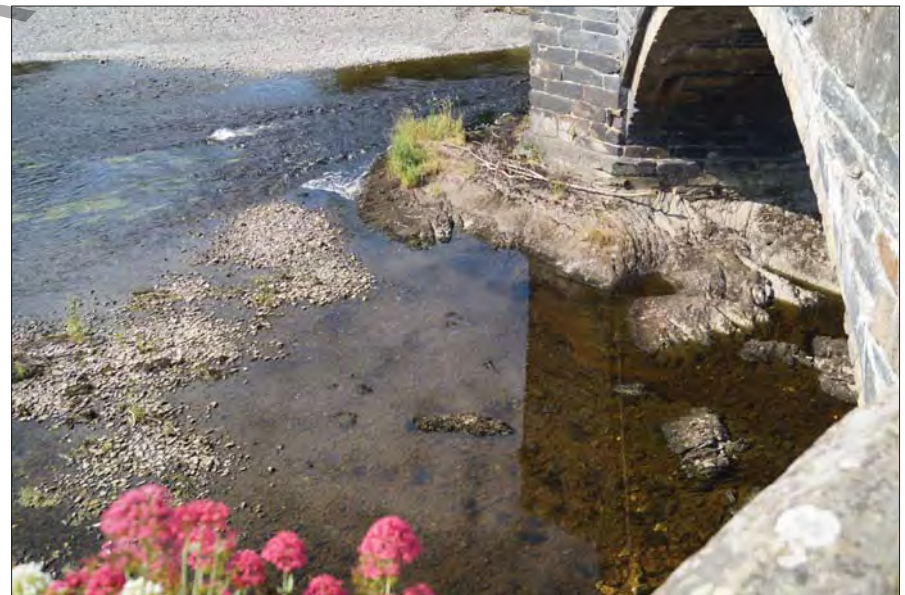
**Plate 8.** Pont Fawr North Eastern Bridge Span

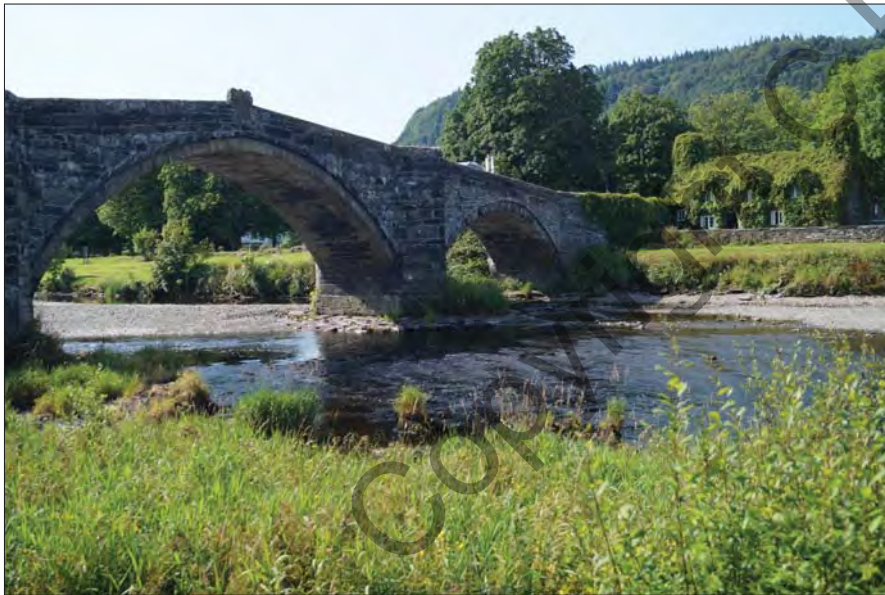
**Plate 15.** Pont Fawr, Taken from the North West  
South Western and Central Span

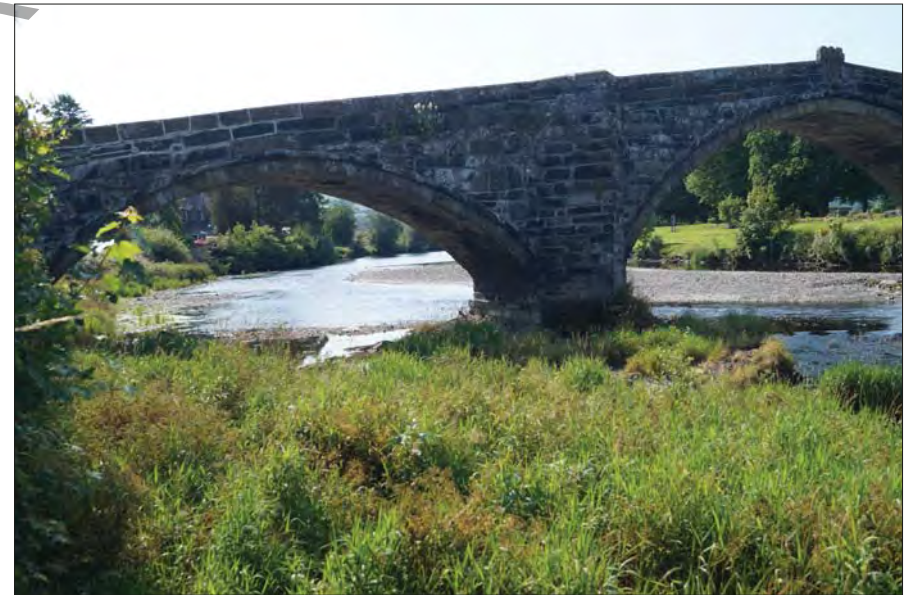
**Plate 16.** Pont Fawr, Taken from the North West  
North Eastern and Central Span
