Results of Archaeological Works at
Felin Rhyd Hir, Efailnewydd, near Pwllheli

Results of Archaeological Works at Felin Rhyd Hir, Efailnewydd, near Pwllheli

Planning Application Number:	C11/11/66/40/LL
National Grid Reference:	SH 3455 3579
Client:	Mr Adrian Priest
Report Author:	Catherine Rees
Report Number:	CR03-2012
Date:	21/03/2012

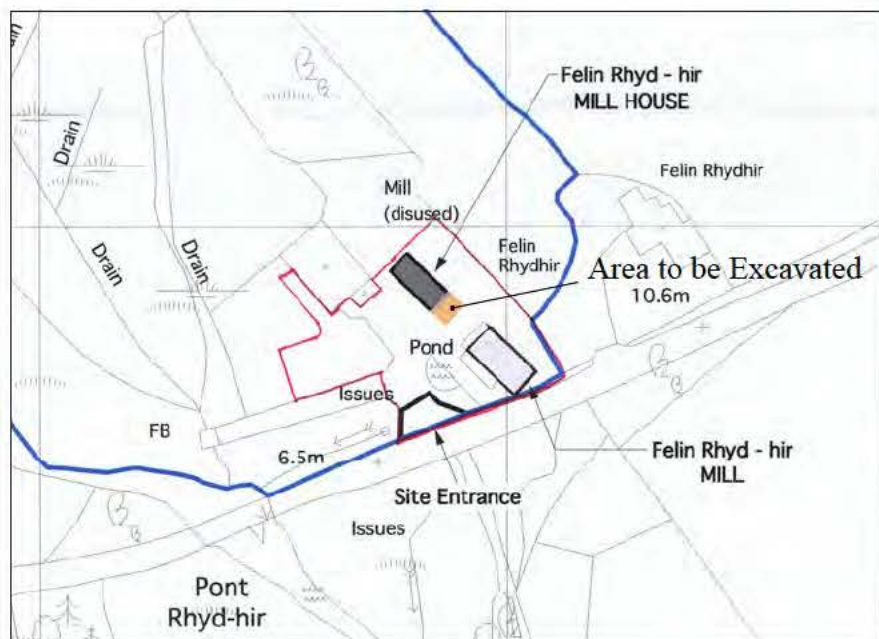
Plan of Felin Rhyd Hir Site

Due to the limited ground cover over the proposed excavation area, and the likelihood of encountering modern services all excavation was carried out by hand. A trench measuring 5m x 7m was excavated to encompass the entire area within the proposed extension footprint (Figure 2). The trench was excavated to the top of the archaeological horizon.

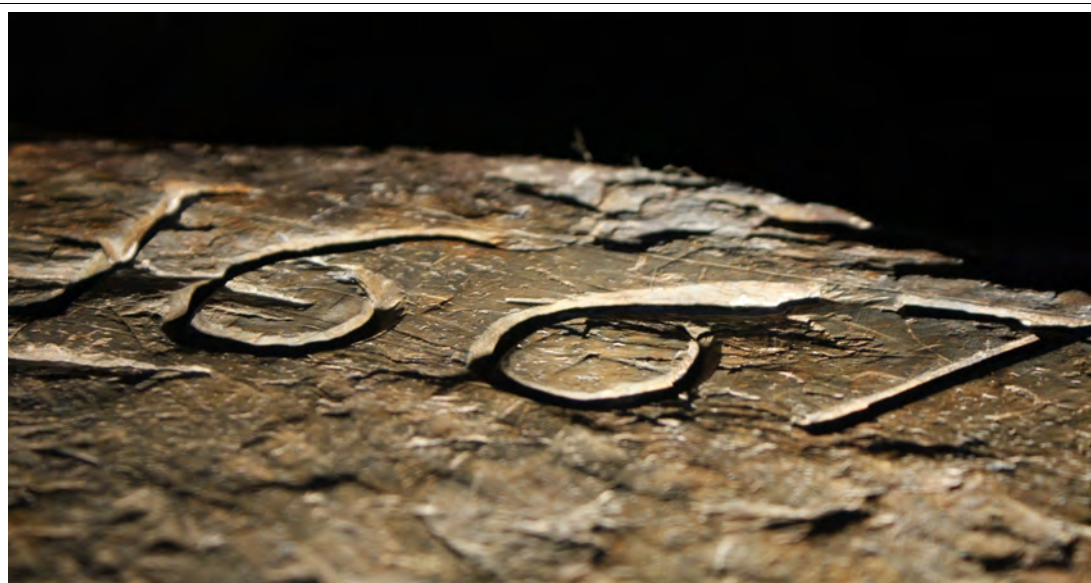
Figure 4. 1667 Date Stone Located Above the Mill Wheelshaft

Much of the Bodfel Estate including the corn mill was sold by its Welsh owners in 1671 but unfortunately the documents relating to the properties owned by the original estate have been scattered and lost, making any detailed search of the early history of the mill impossible. It is interesting to note that a carved date-stone, presumably belonging to the Bodfel phase of the mill, was reused above the shaft of the waterwheel. The stone bears the inscription 1667 and is shown below (Figures 4). The stone itself is discussed in greater detail in a subsequent section.

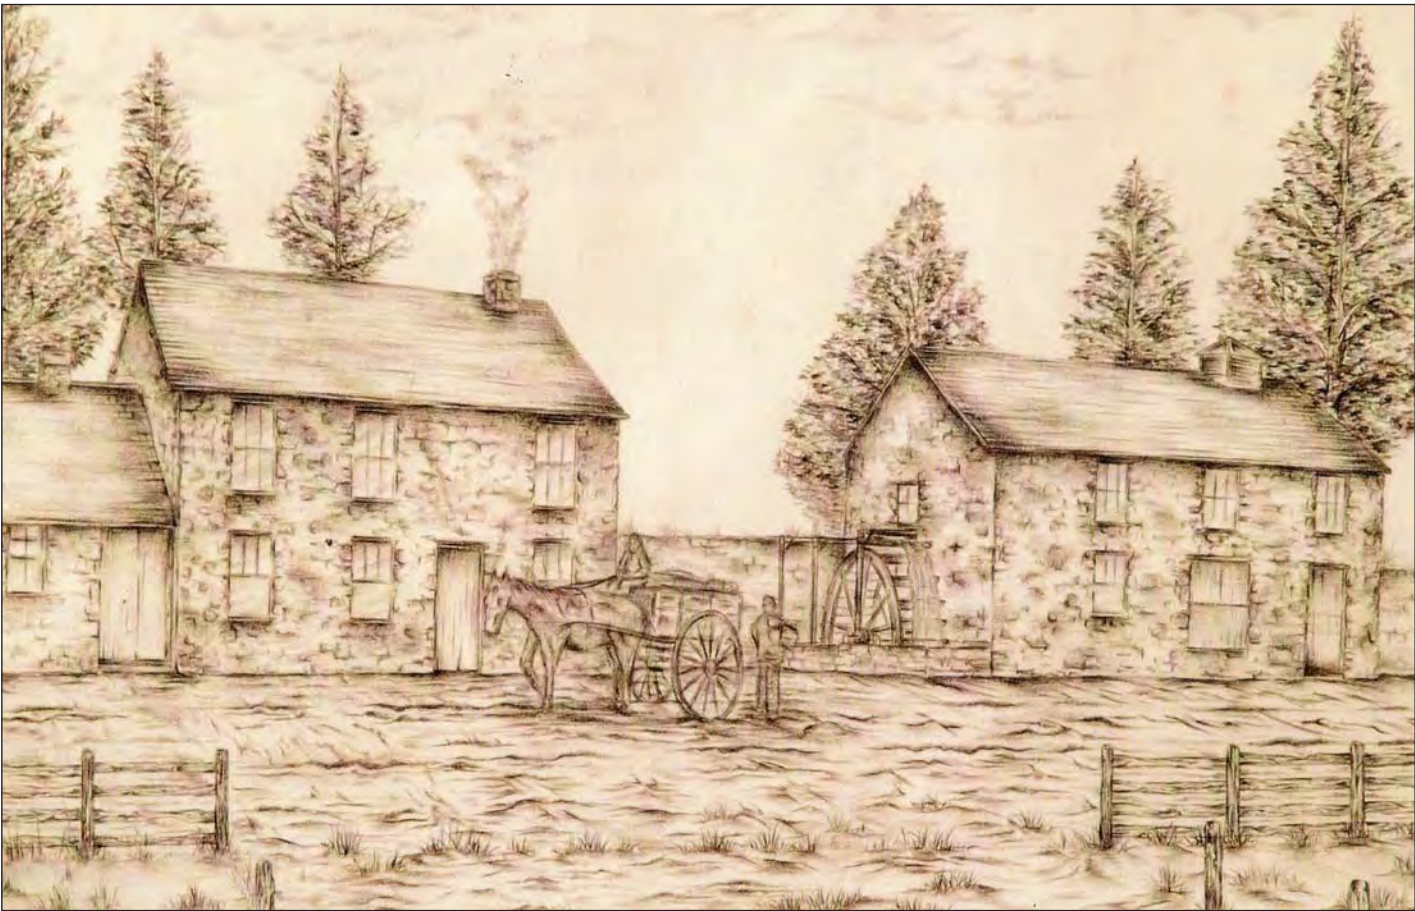
Figure 19. Undated Pencil Sketch of Old Mill House and Mill Whist Still in Use. There are no Structures Shown Between the two Buildings Indicative of an Early Twentieth Century Date. The Picture is Thought to Post-Date this but an Exact Date is Unclear. Of Particular Interest in this Picture is the Retaining Wall.

The Felin Rhyd Hir mill/kiln and the miller's house are a pair of contemporary structures, and strong stylistic similarities are evident (refer back to Figures 19 & 24). The buildings are positioned along the same north-west – south-east alignment (Figure 41) and are stone built in the local vernacular style, albeit on an industrial scale.

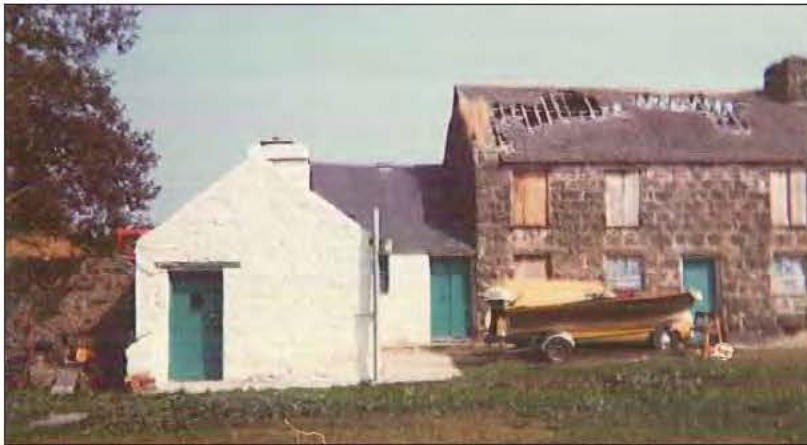
Figure 23. Photograph Taken c.1970 Showing the Miller's House. The Chimney is Surviving at This Point. It is of Interest That in the Photographic Survey Bricked-up Fireplaces Can be Seen at the Opposite End of the House.

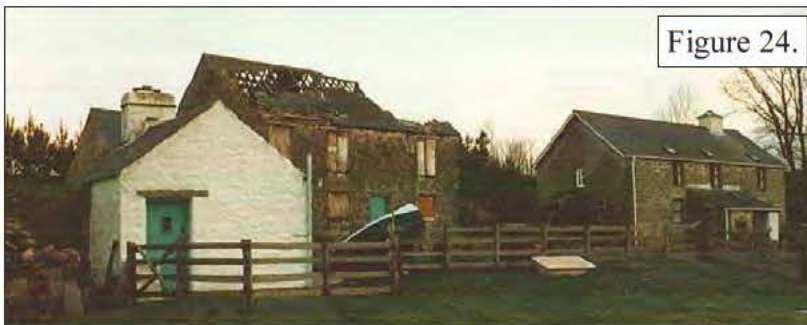
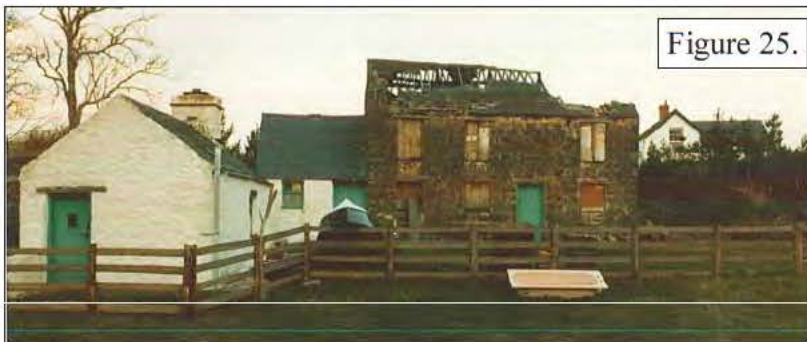
Figure 24.

Figures 24 & 25. Photographs Taken of the Miller's House & Mill in the Late 1980's Following the 1984 Earthquake

On July the 19th 1984 the Llŷn Peninsula was the epicentre of an earthquake measuring 5.4 on the Richter Scale (www.earthquakes.bgs.ac.uk). The miller's house was badly damaged by this event as it had been destabilised by the removal of the bank to the rear of the building. Figures 20-27 show the miller's house and surrounding area in the years following the earthquake and document its slow deterioration.

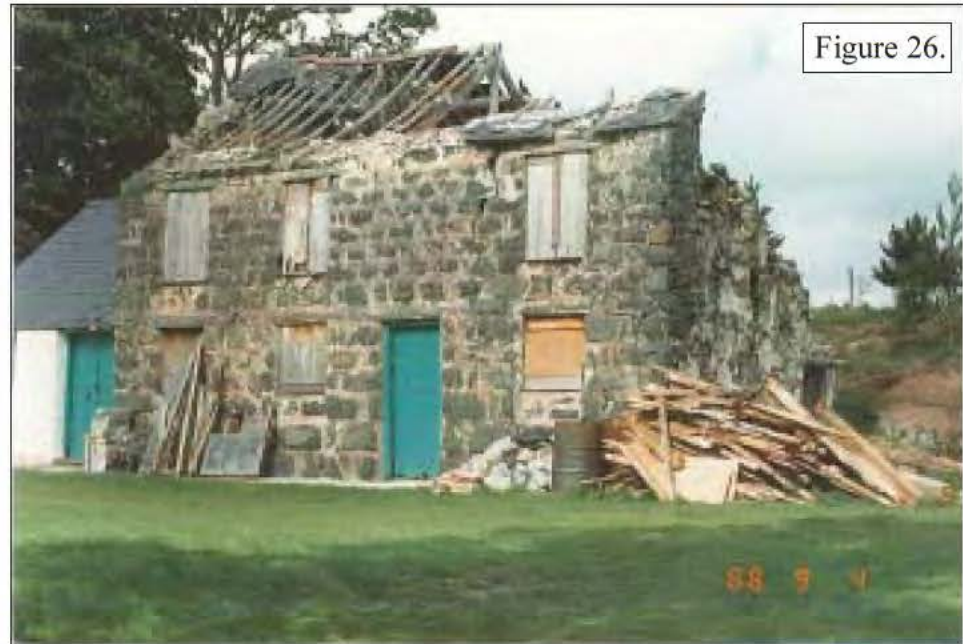
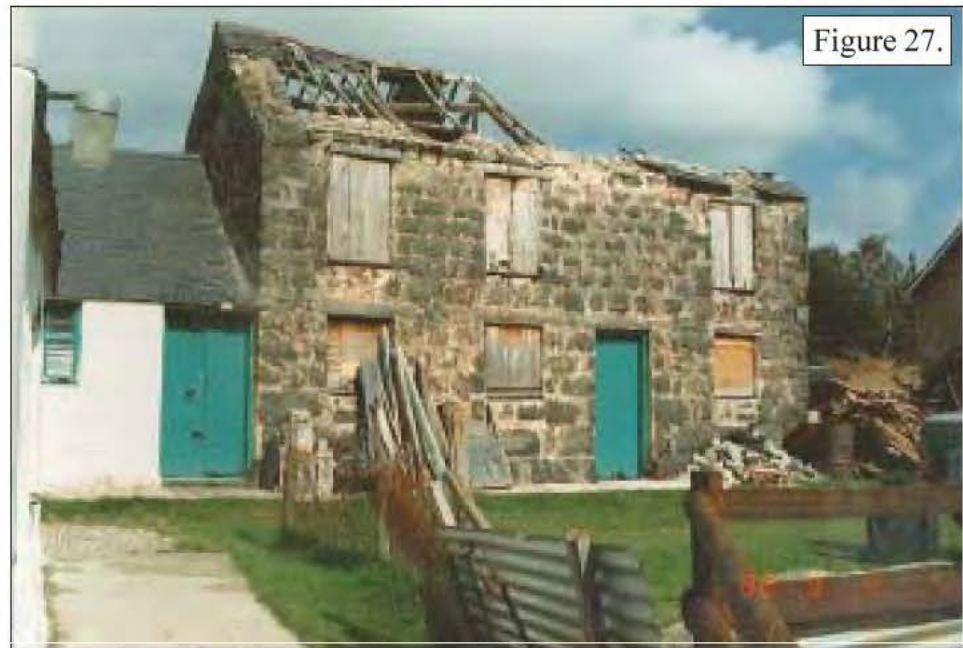
Figures 26 & 27. Photographs Taken of the Miller's House & Mill in the Late 1980's Following the 1984 Earthquake. Note The Large Crack in the Masonary

The house existed as a two/three storey structure until 2010 when the building had become so unsafe that Mr Priest was forced to take down the loft and first floor level of the house. All stone was retained, as were the roof slates, and it is intended that the original materials will be used in the restoration.

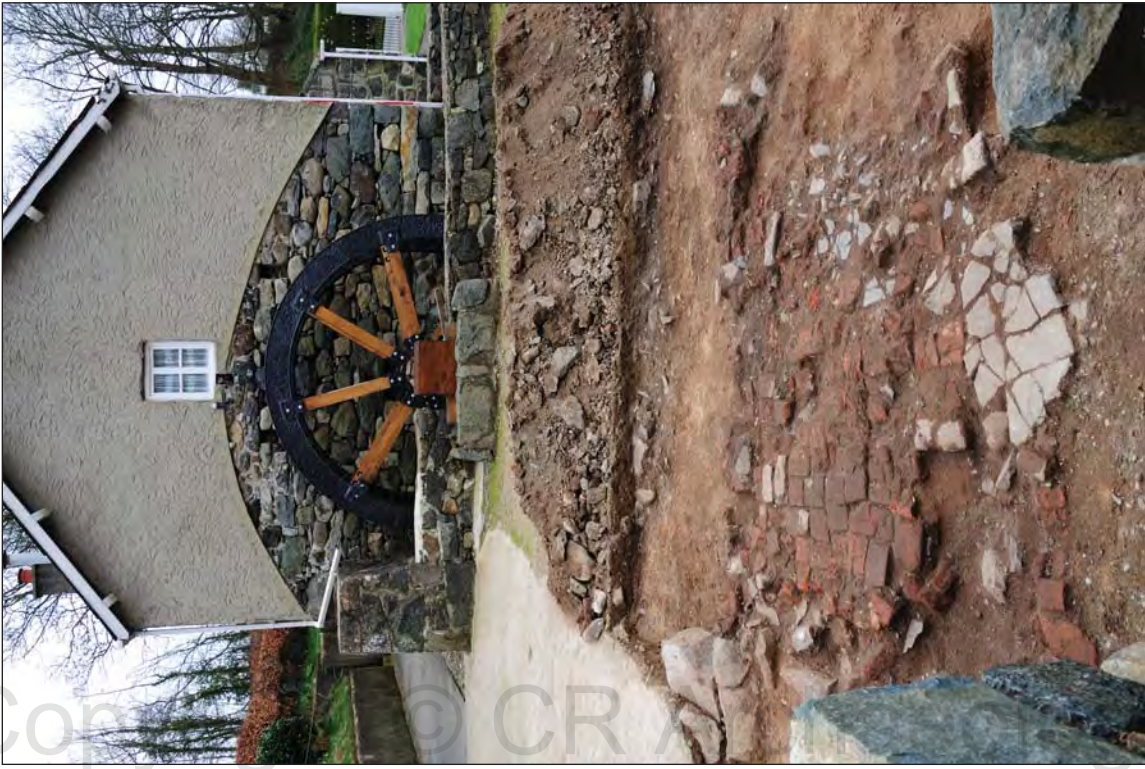
Figure 29. (Left) Post-excavation Photograph of Trench Demonstrating Alignment of Doorway, Brick Surface (02) and the Waterwheel

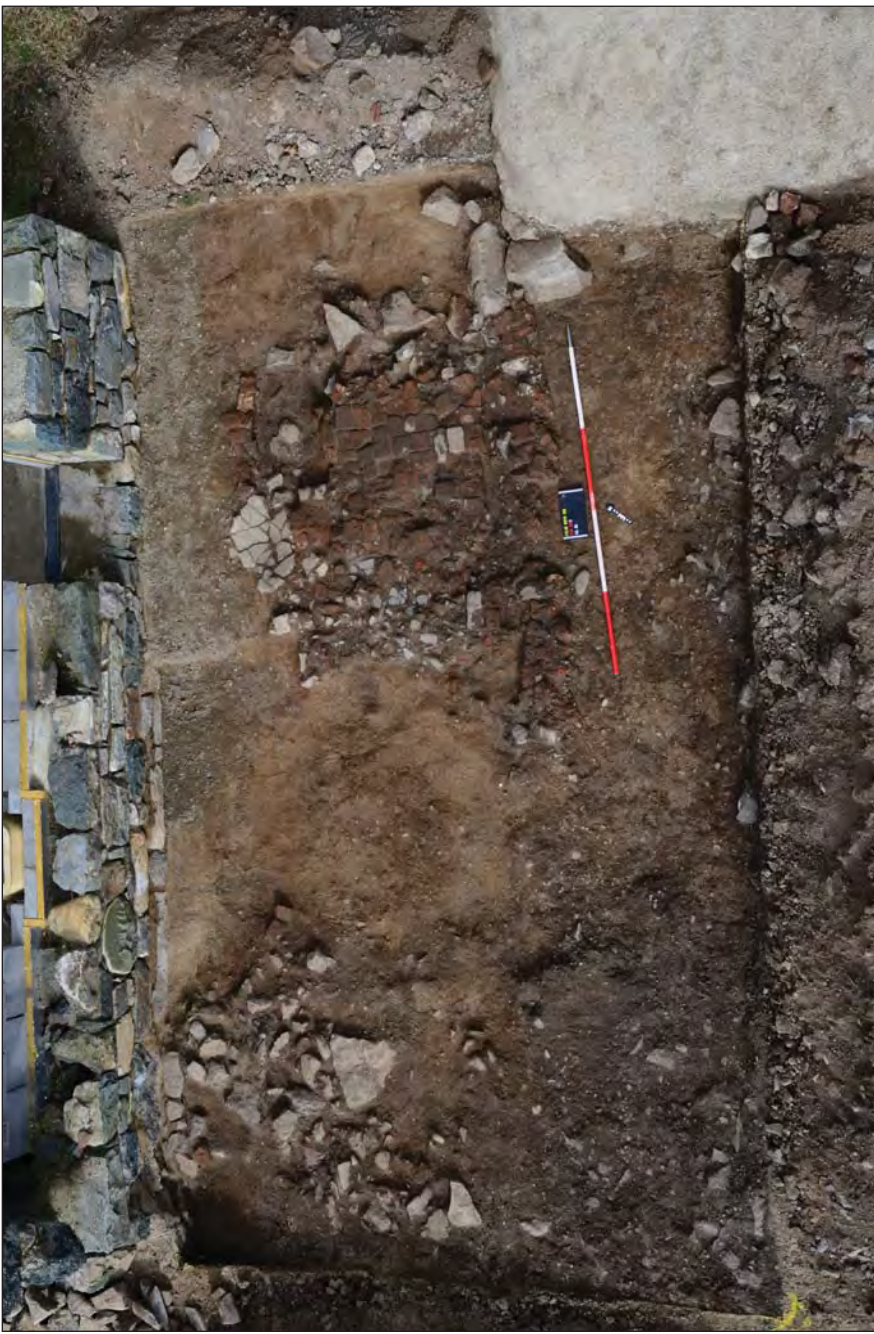
Figure 30. (Above) Post-excavation Aerial Photograph of Trench

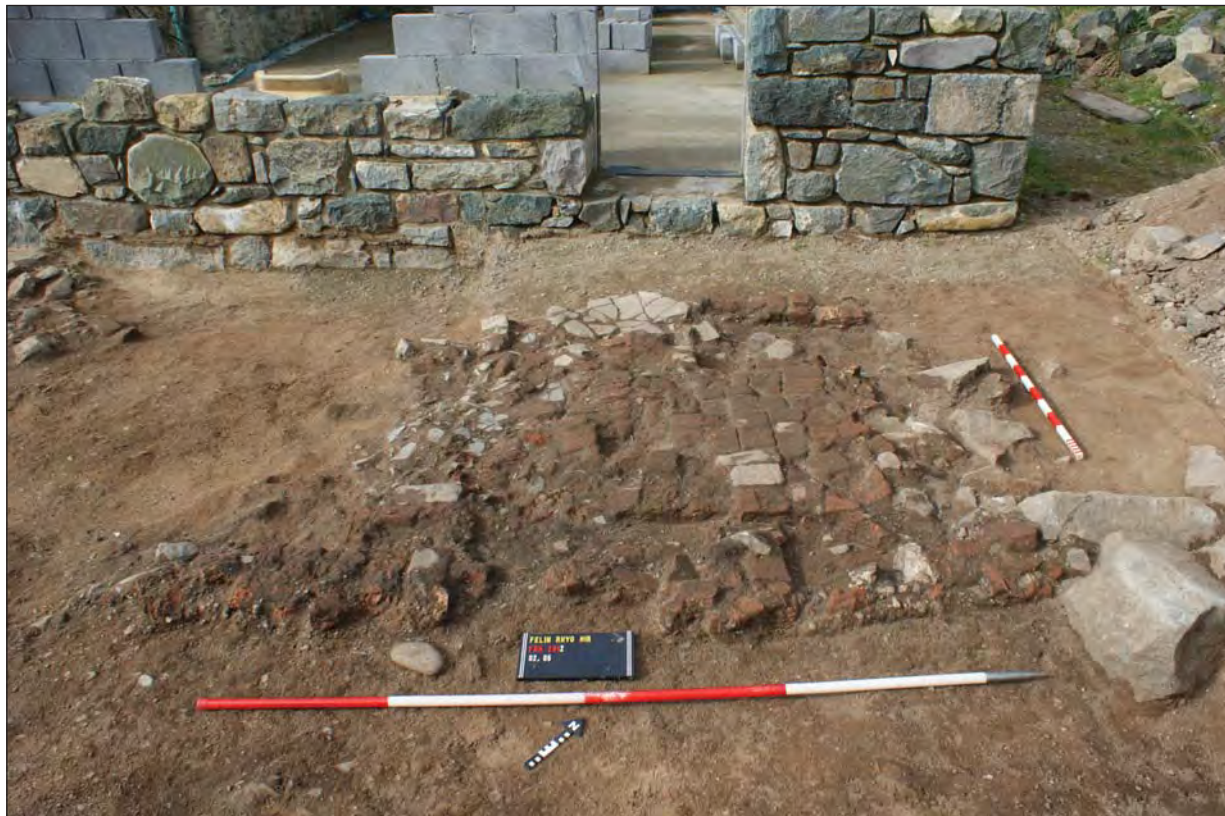
Below (01) directly opposite the doorway was a poorly laid predominantly brick surface (02) measuring approximately 2.70m x 2.20m and a single brick thick. The bricks were poorly fired and appear to have been reused from elsewhere as most were broken prior to being laid. The surface was also composed of a single stone slab which has been broken – presumably insitu. The surviving area of the surface is not thought to be the original extent as the feature is truncated to the south-west. The surface does appear to survive to its full north-eastern extent as the bricks appear to be laid to a height of three courses for a width equivalent to the length of one full brick (c.0.20m). It must be noted, however, that this added height occurs only against wall (05) and does not run the length of the surface.

Figure 31. Brick Surface (02) and Retaining Wall (05). Photograph Taken by C. Rees

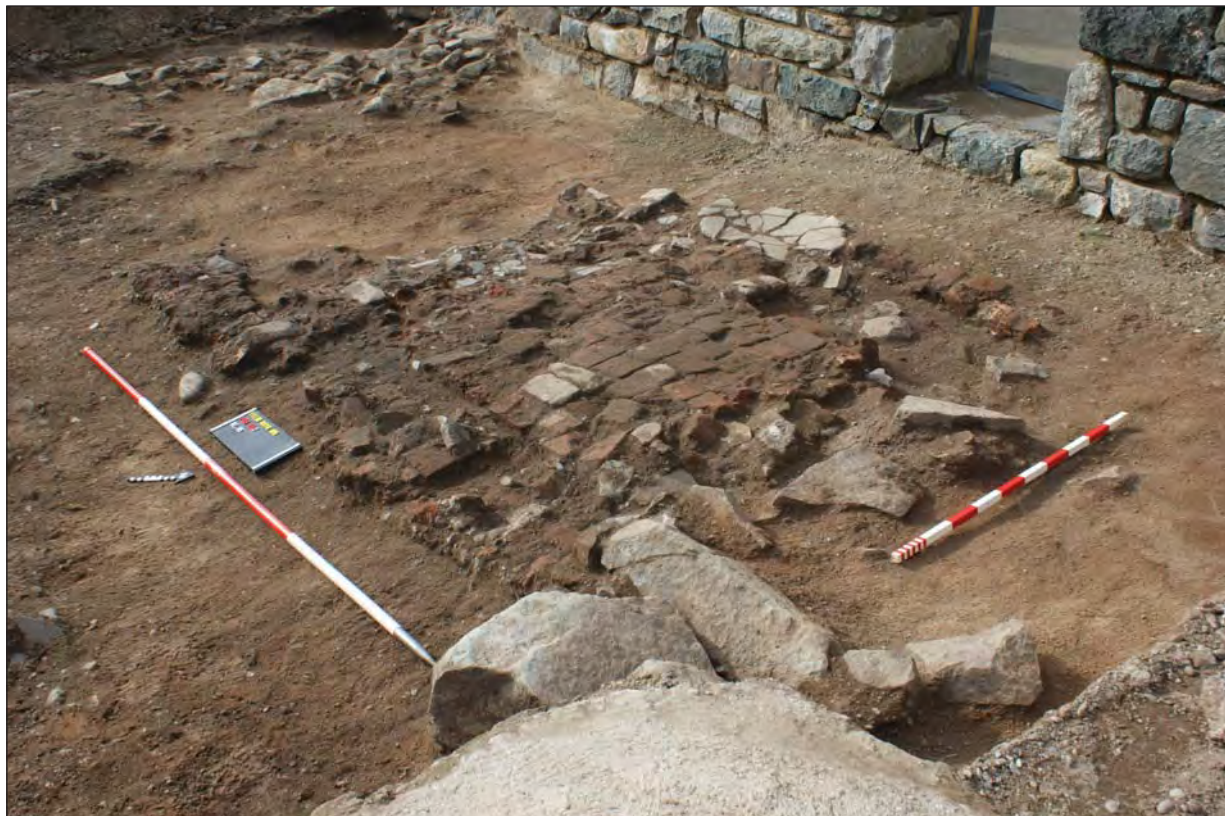
Figure 32. Brick Surface (02) and Retaining Wall (05). Photograph Taken by C. Rees

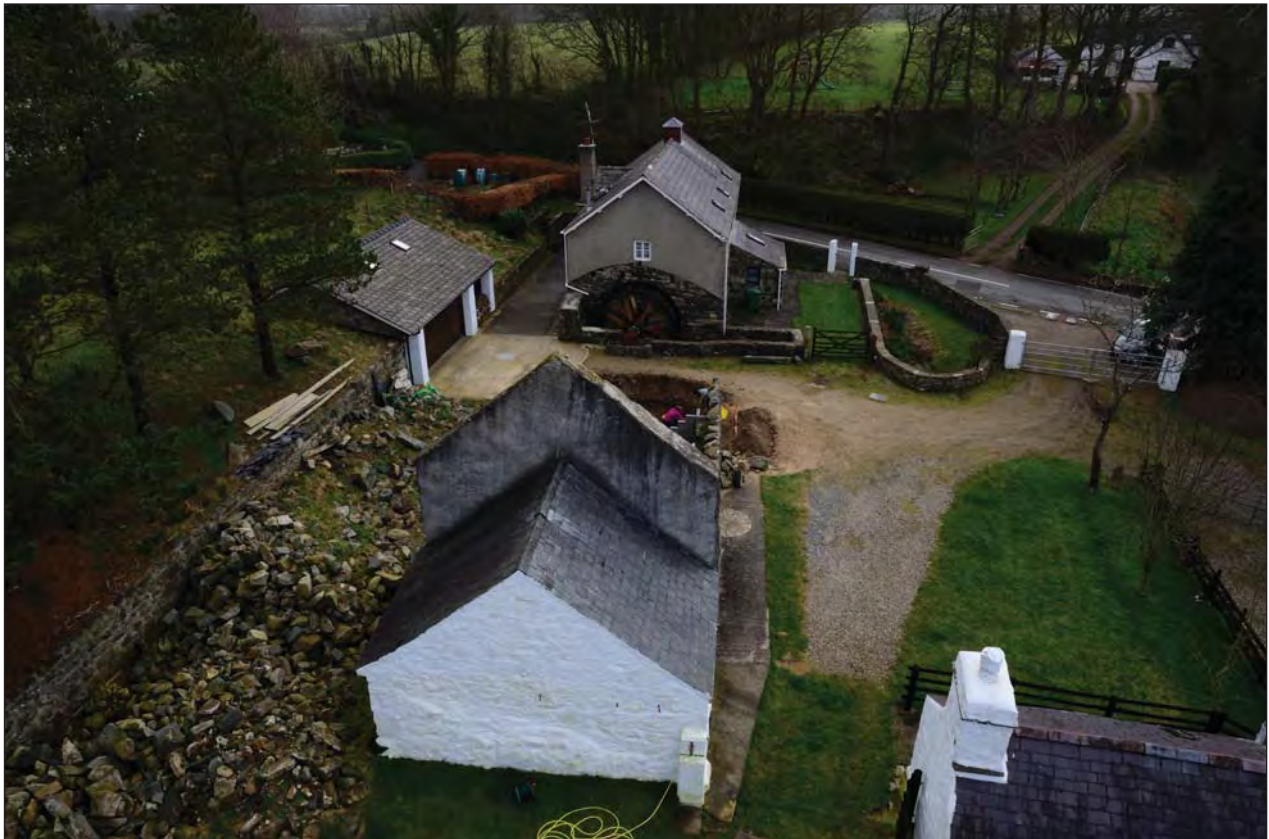
Figure 41. Aerial View of Felin Rhyd Hir Stable, Miller's House and Mill/Kiln Demonstrating The Clear Linear North-West - South-East Alignment of the Building Range

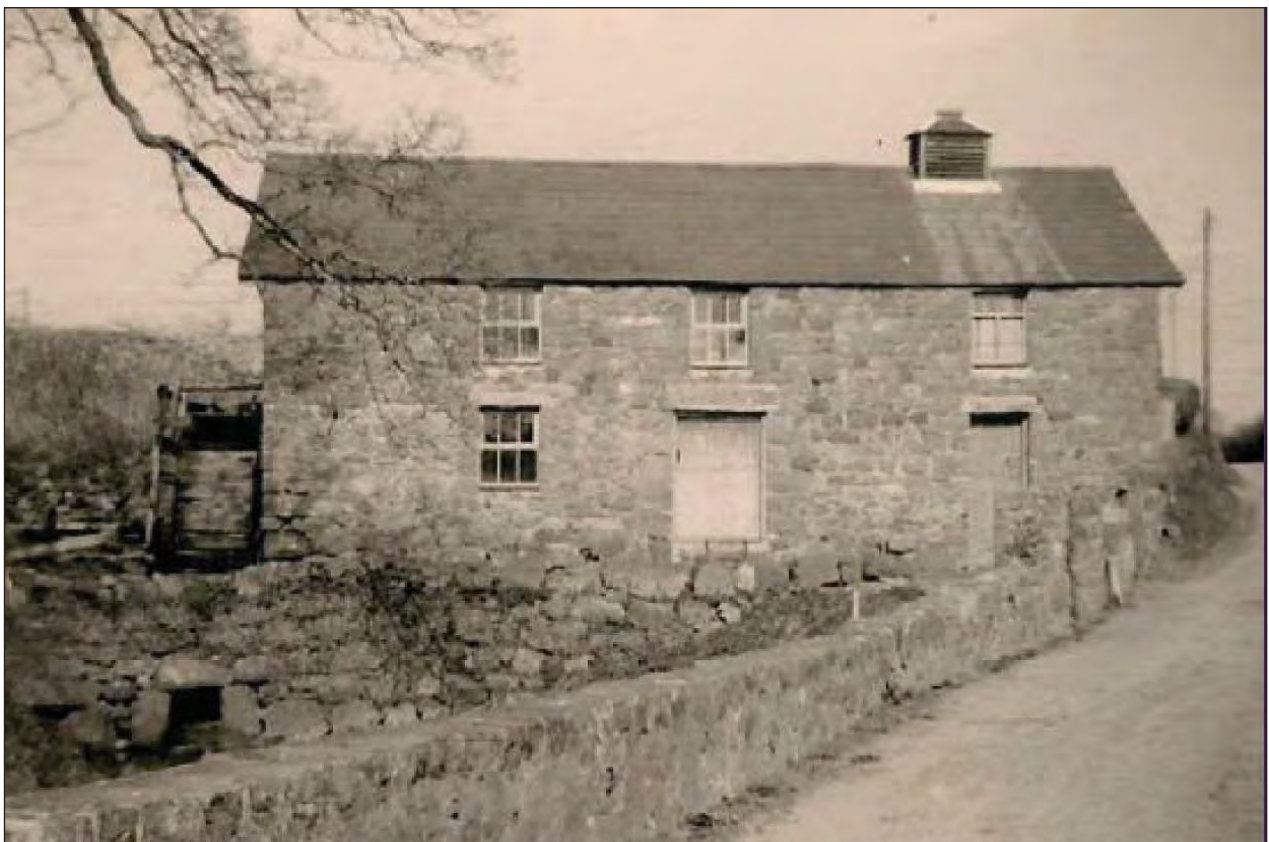
Figure 42. Front Elevation of Mill and Kiln Prior to Conversion to a Dwelling.
Taken c.1950

The mill building exterior was modified during the 1970's and 80's as is evidenced by a photograph of the mill taken c.1950 (photograph supplied by Mr Priest). The original wooden windows have been replaced with plastic frames and skylights have been inserted into the roof. A modern stone porch has been added covering the original front entrance to the mill and the front door to the kiln area has been replaced with a window. To the rear of the building the doorway through which the first floor of the mill was reached has been replaced with a UPVC window. Ribbon pointing with cement was also carried out during this period of works.

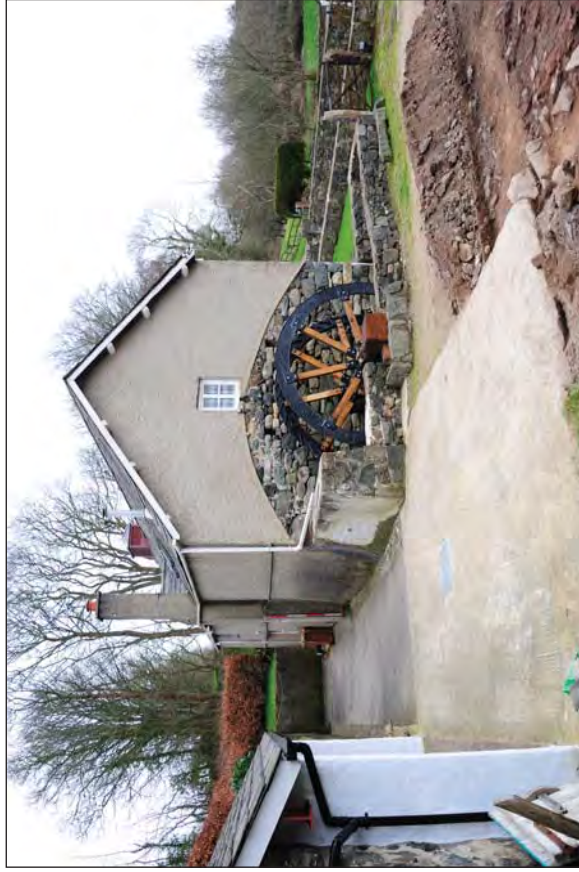
Figure 43. Gable & Rear Elevation of Mill House and Kiln. The Chimney is a Modern Addition. The Rear Elevation Would Not Have Originally Been Visible Below First Floor Level

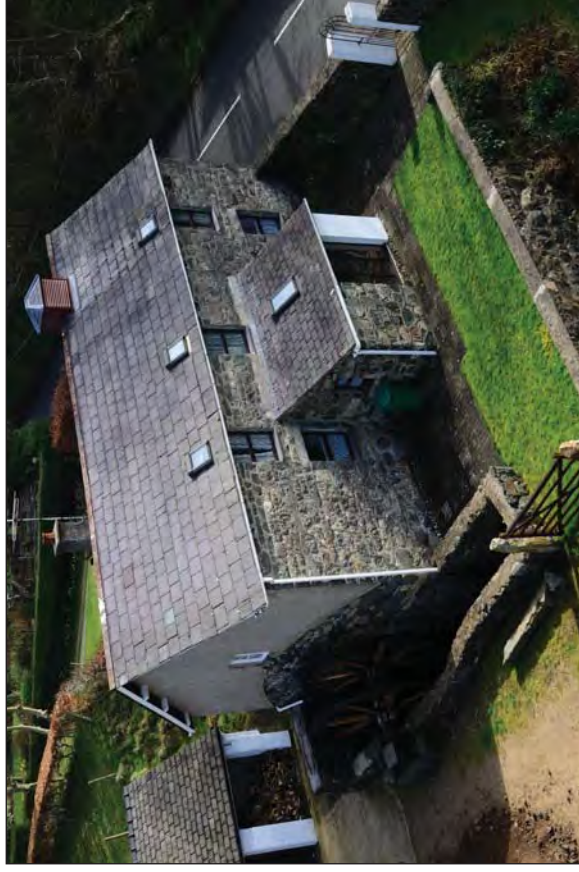
Figure 44. Aerial View of Front Elevation of Mill & Kiln Showing Modern Porch

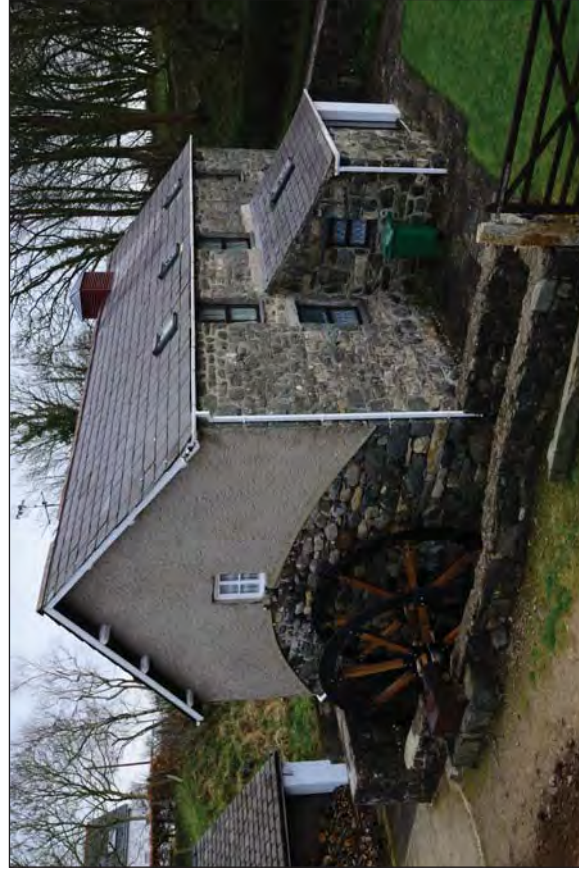
Figure 45. Waterwheel and Front Elevation of Mill House and Kiln. Note Hard Cement Render Which is Rather Out of Character with the Building as a Whole

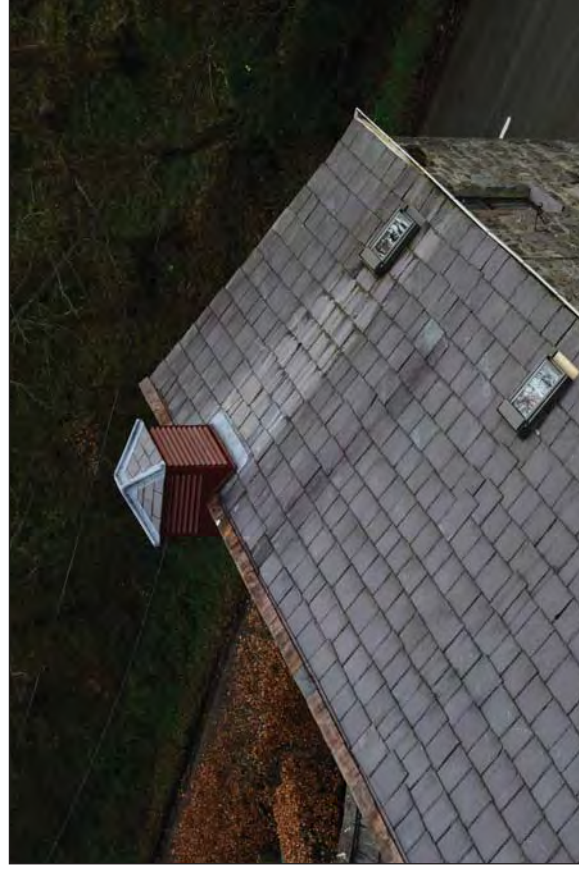
Figure 46. Slate Roof With Slatted Wooden Cupola Roof Vent (Largely Reconstructed) Serving as Evidence of Use as Corn Drying Kiln

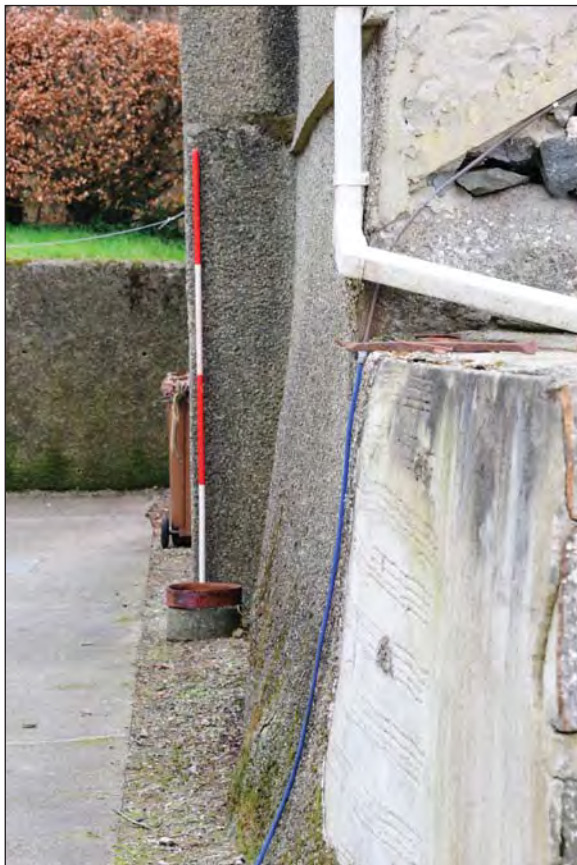
Figure 47. Rear of Mill/Kiln Structure.
Note Splaying of Rear Elevation at
Base of Wall

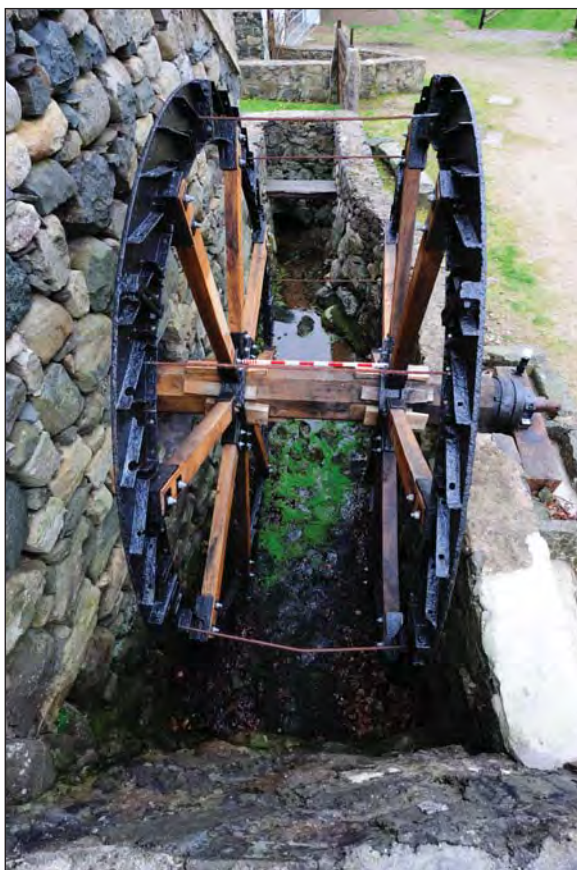
Figure 49. Waterwheel and Wheelpit.
Possibly Pre-dating the Mill Structure

The wheel is of the overshot type with forty, timber buckets. Fed by a launder from the mill down, now drained but still clearly defined and fed, originally, by a leat at its northern end. The leat has its origin higher up the Afon Rhyd-Hir at another mill, now demolished, near Llannor village. The leat was therefore some 1800 yards in length and followed, where feasible, a few feet below the 50-foot contour. The higher mill was referred to as “Melin Llanor”. The leat is still traceable for most of its length but a land improvement scheme has destroyed the site for some 300 yards before Efail-y-Bont, as have farm buildings at the Llannor end.

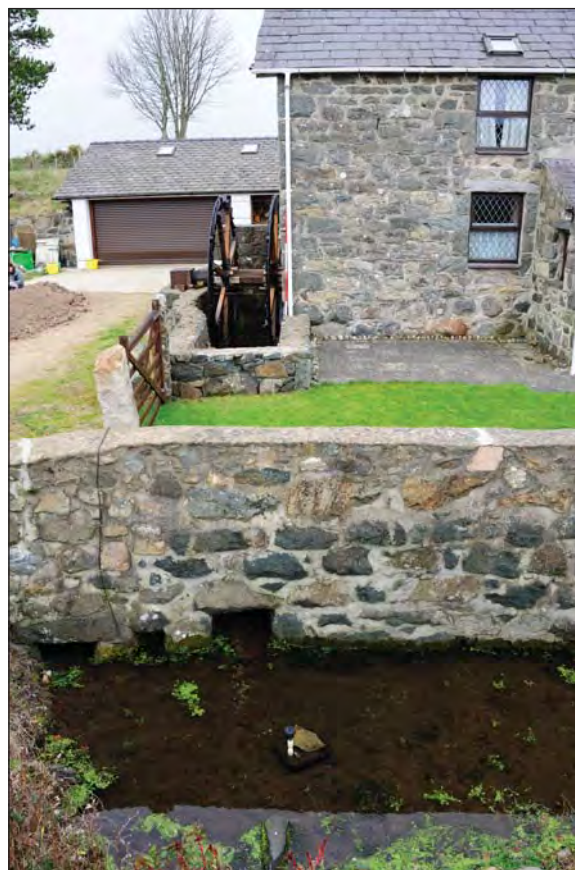
Figure 50. Waterwheel, Outlets and
Pond to the Front of Mill

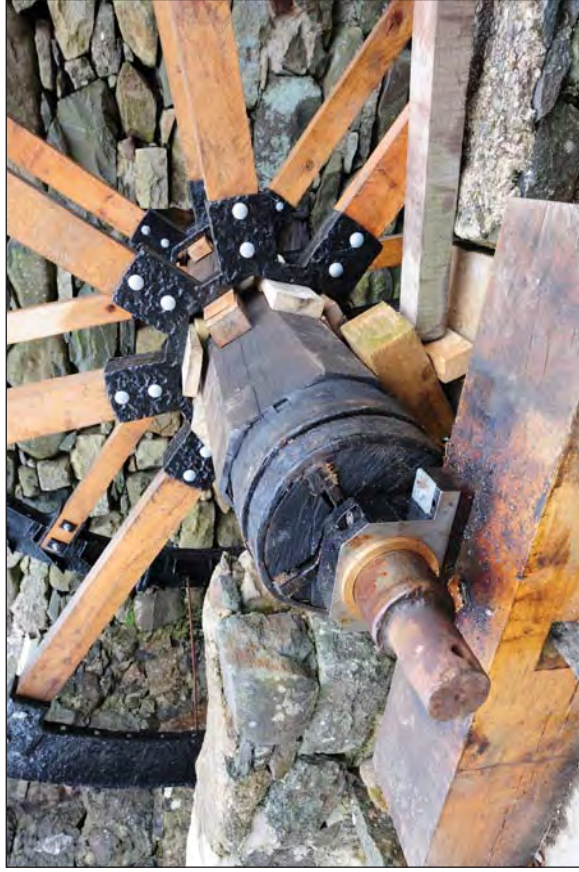
Figure 51. Added Attachment Which May Have Allowed the Water Power from the Wheel to be Utilised to Drive an Additional Mechanical Device - Possibly to Churn Butter

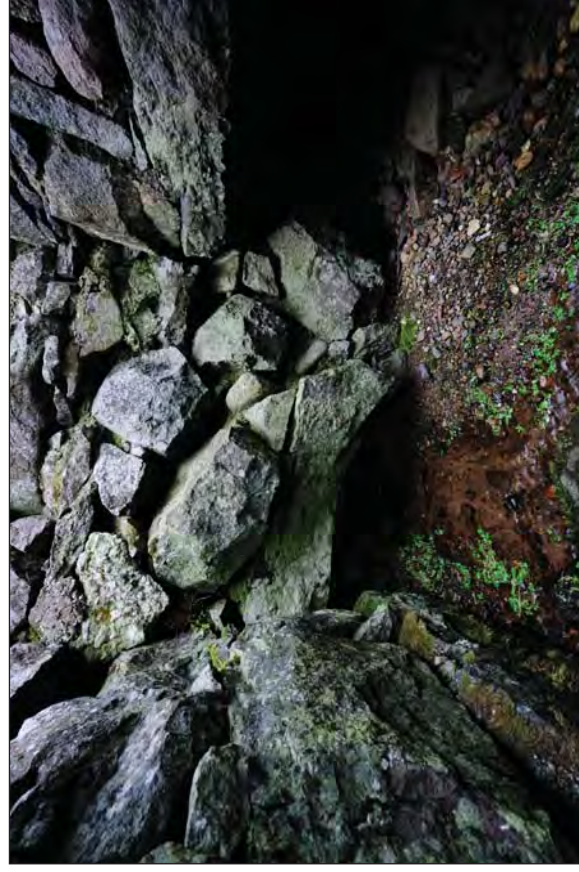
Figure 54. Stone Outlets at Base of Wheelpit. The Outlet to the Right is Believed to Function as an Overflow. This Mill Element May Pre-date the Current Mill Building

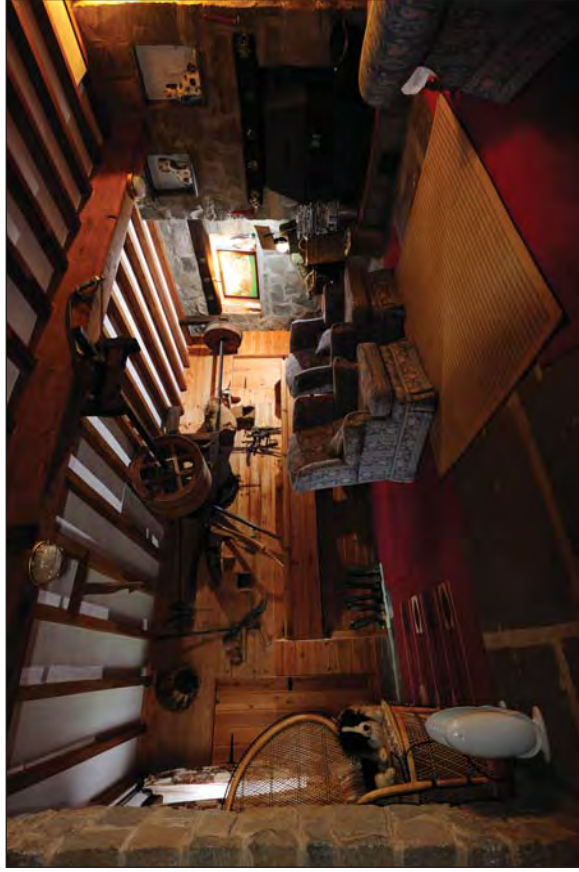
Figure 57. Ground Floor of Mill Showing Hurst Frame Boarding and the Iron Shaft/ Wooden Pulley System Belonging to the Sack Hoist

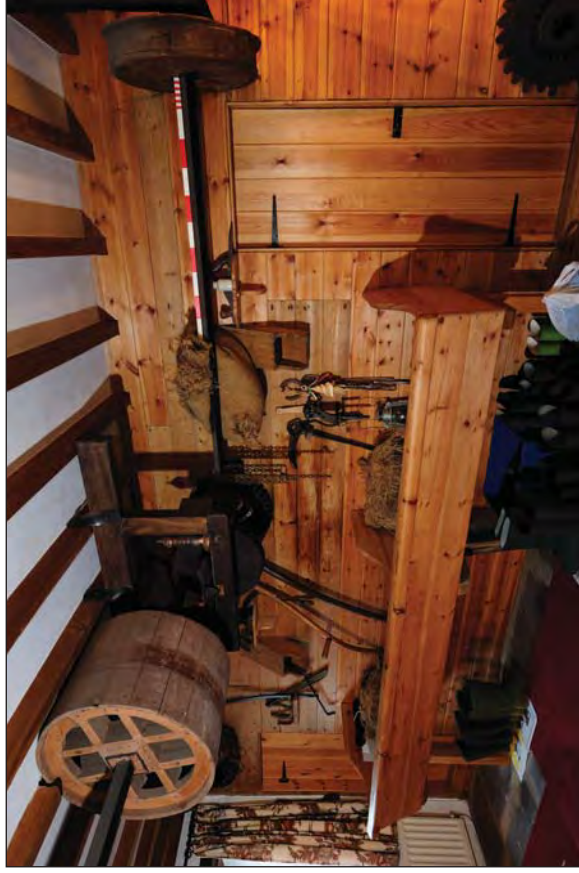
The majority of the machinery at ground floor level is hidden behind the boarding of the hurst screen (Figures 58 – 61). Iron shafts carrying wooden pulleys to drive the sack hoist, and dressing machines are visible in the living room. A collection trough and flour chutes are integrated into the hurst screen and form a feature wall (see Figures 55 – 57). A doorway leads from the living room into the kitchen which is located with the area previously occupied by the kiln.

Figure 58. Ground Floor of Mill Showing Hurst Frame Boarding With Associated Trough and Flour Chutes

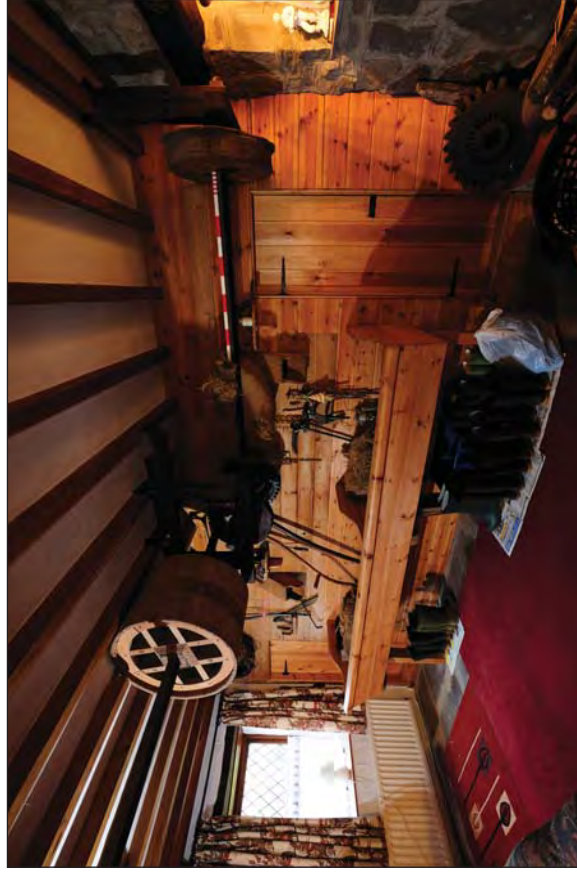
Figure 59. Ground Floor of Mill Showing Hurst Frame Boarding and the Iron Shaft/ Wooden Pulley System Belonging to the Sack Hoist

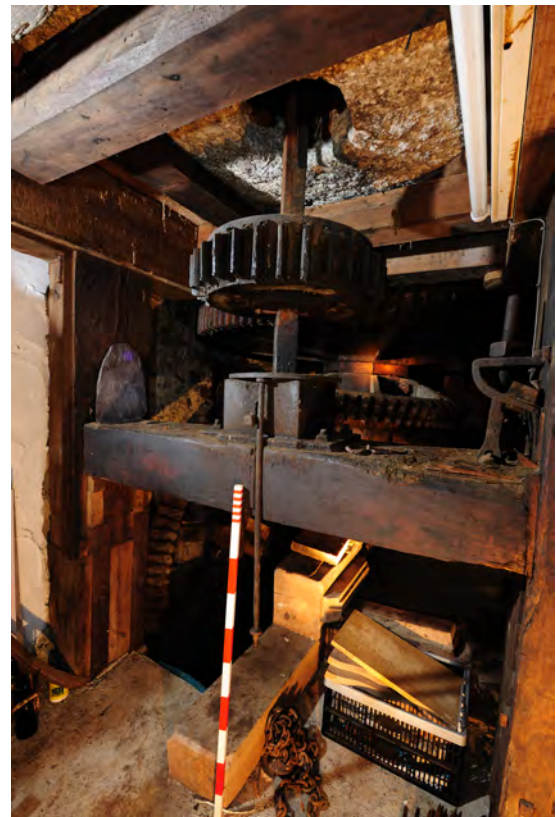
Figure 64. Bedstone Visible at
Top of Photograph

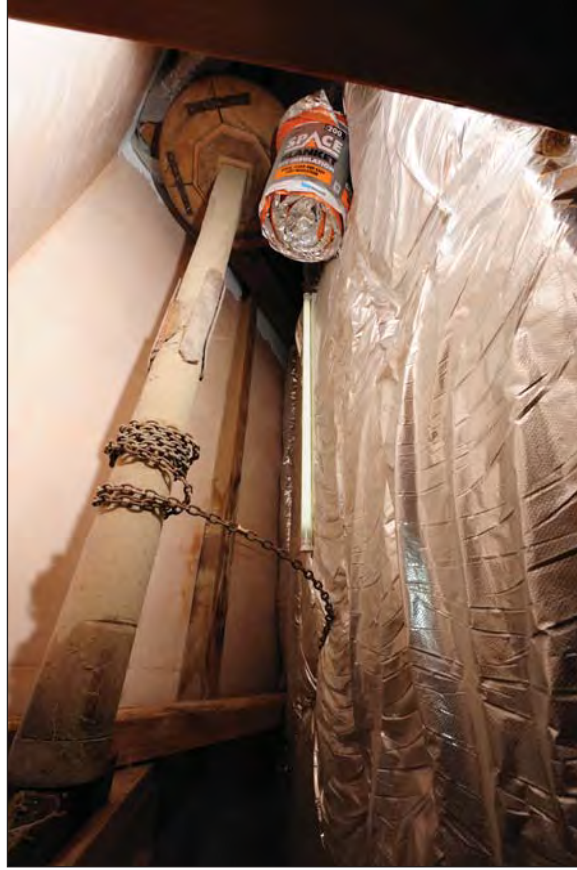
Figure 72. Sack Hoist in Attic Space

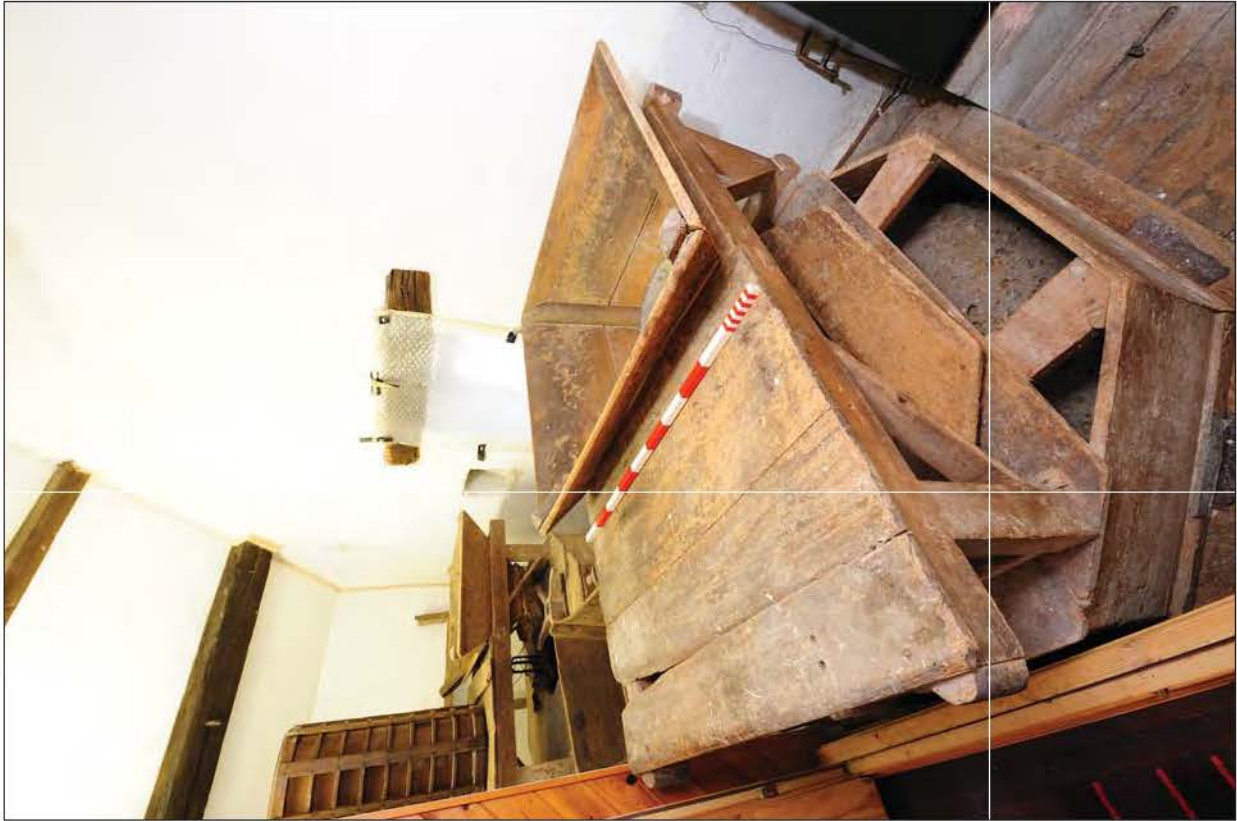
Figure 73. Grain Hoppers, Horse Frames and Octagonal Tuns Preserved at First Floor Level

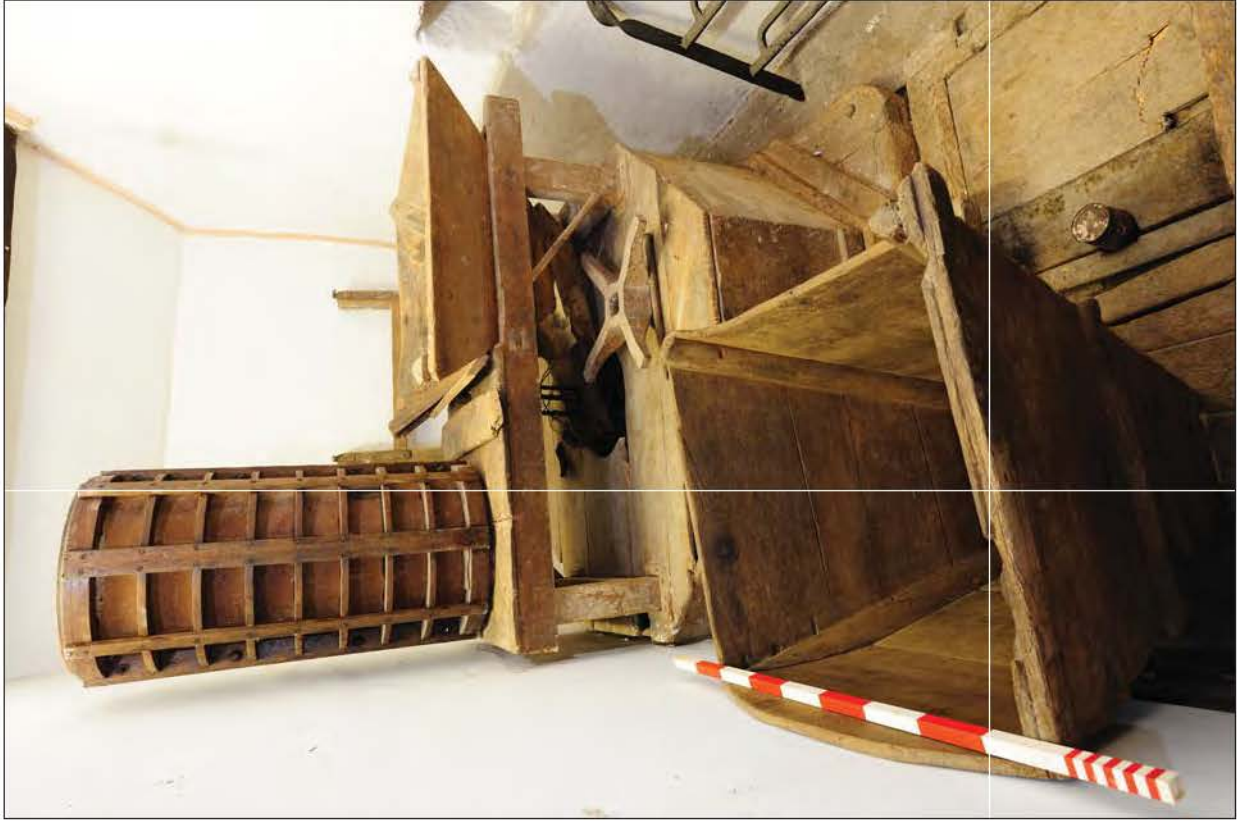
Figure 74. Grain Hoppers, Horse Frames and Octagonal Tuns Preserved at First Floor Level

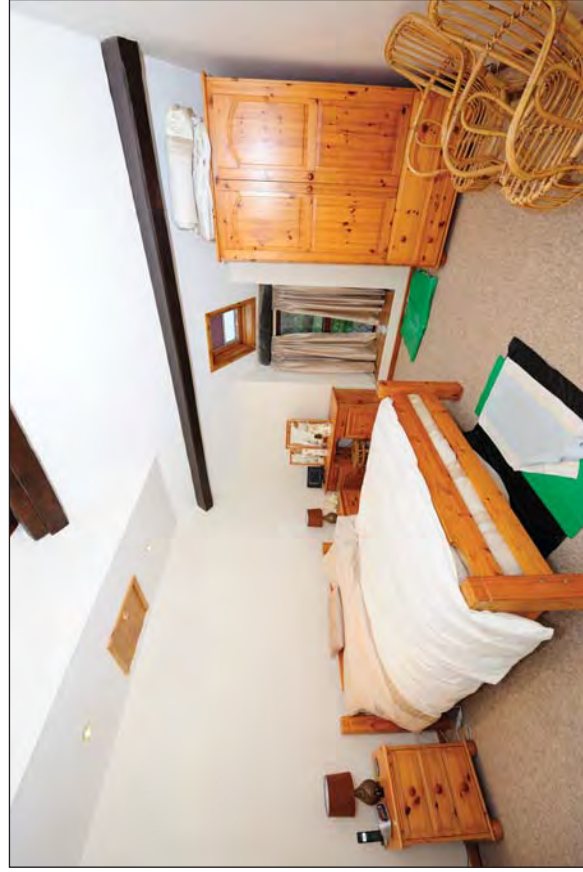
Figure 81. Kiln Interior - First Floor.
Now Used as a Bedroom. Kiln Vent is Located in Ceiling

At first floor level the drying floor of the kiln has been removed to allow habitation. The upstairs space has been divided into a bathroom and bedroom (Figures 79 – 82). The restored slatted wooden cupola vent is exposed in the bedroom ceiling. A large number of the tiles have been retained by the owner (Figure 83) and alternative sources can be consulted to reconstruct how the floor would have once appeared (Figure 84). It was previously possible to enter the rear of the building at first floor level via the top of the bank. This entrance now contains a window.
