Results of Archaeological Works at
Felin Rhyd Hir, Efailnewydd, near Pwllheli

Results of Archaeological Works at Felin Rhyd Hir, Efailnewydd, near Pwllheli

Planning Application Number:	C11/11/66/40/LL
National Grid Reference:	SH 3455 3579
Client:	Mr Adrian Priest
Report Author:	Catherine Rees
Report Number:	CR03-2012
Date:	21/03/2012

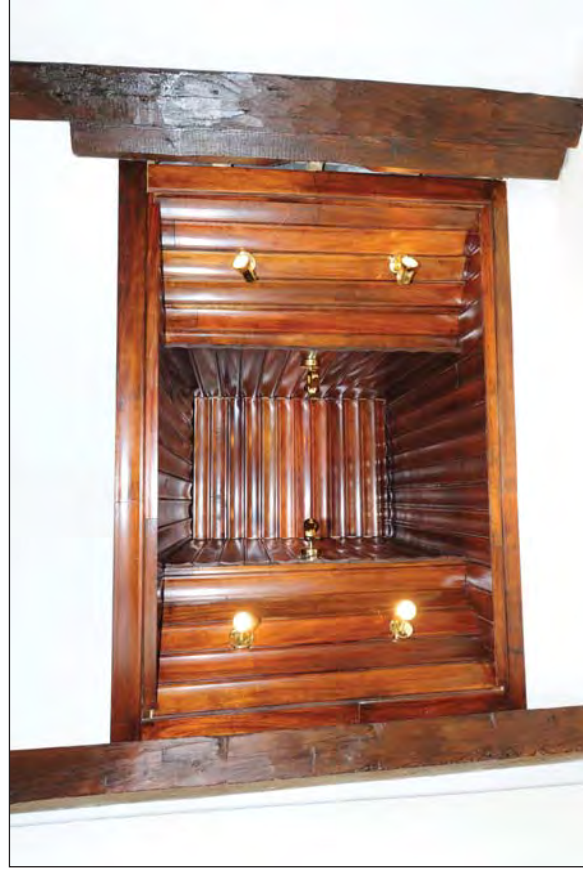
Figure 82. Kiln Interior - First Floor Bedroom.
Restored Wooden Slatted Cupola Vent in Ceiling

At first floor level the drying floor of the kiln has been removed to allow habitation. The upstairs space has been divided into a bathroom and bedroom (Figures 79 – 82). The restored slatted wooden cupola vent is exposed in the bedroom ceiling. A large number of the tiles have been retained by the owner (Figure 83) and alternative sources can be consulted to reconstruct how the floor would have once appeared (Figure 84). It was previously possible to enter the rear of the building at first floor level via the top of the bank. This entrance now contains a window.

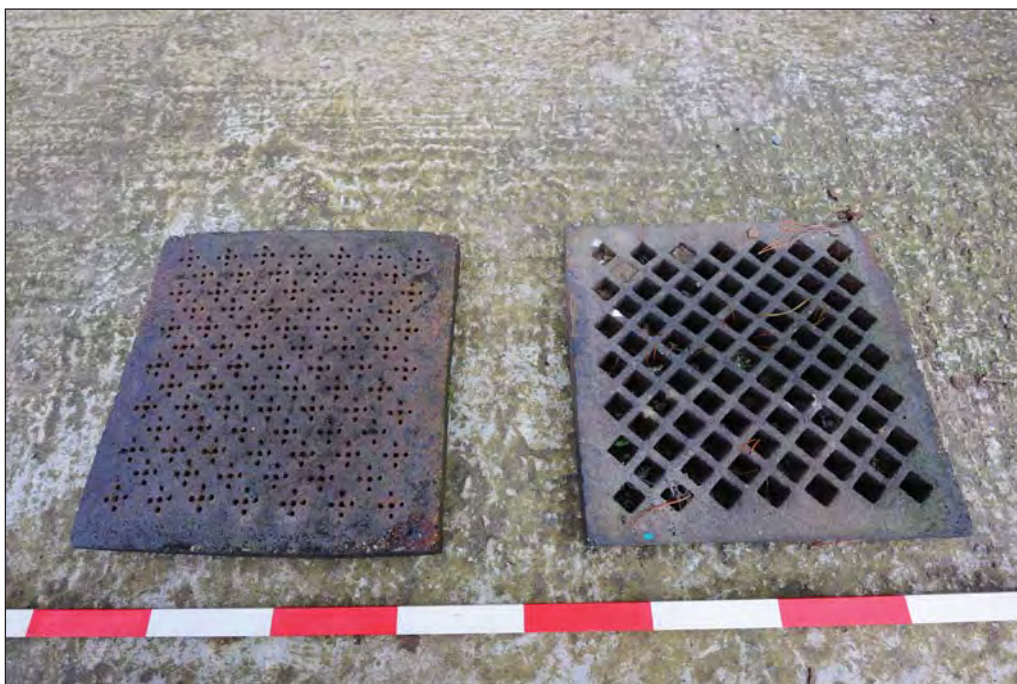
Figure 83. Salvaged Perforated Tiles From the Rhyd Hir Kiln

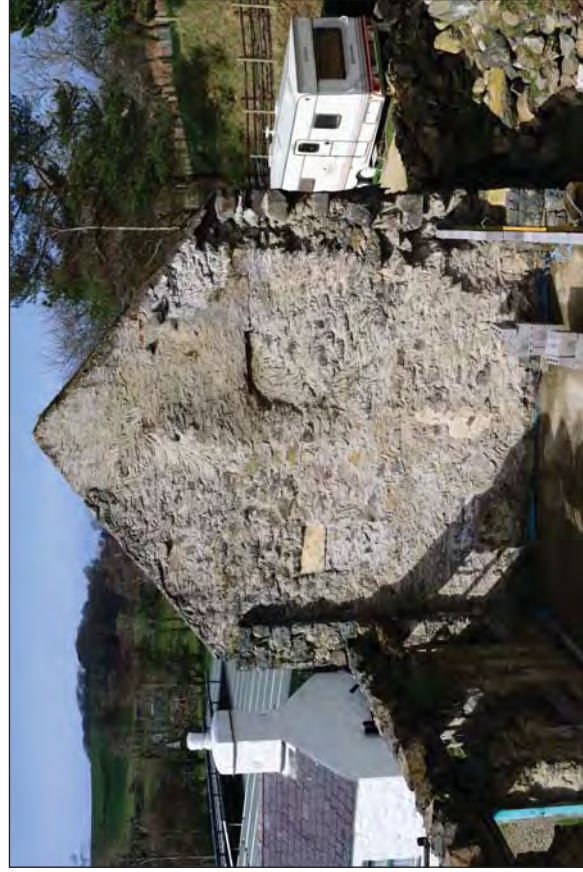
Figure 87. Aerial View of the Miller's House Showing Blocked Fireplaces in the Surviving Gable End

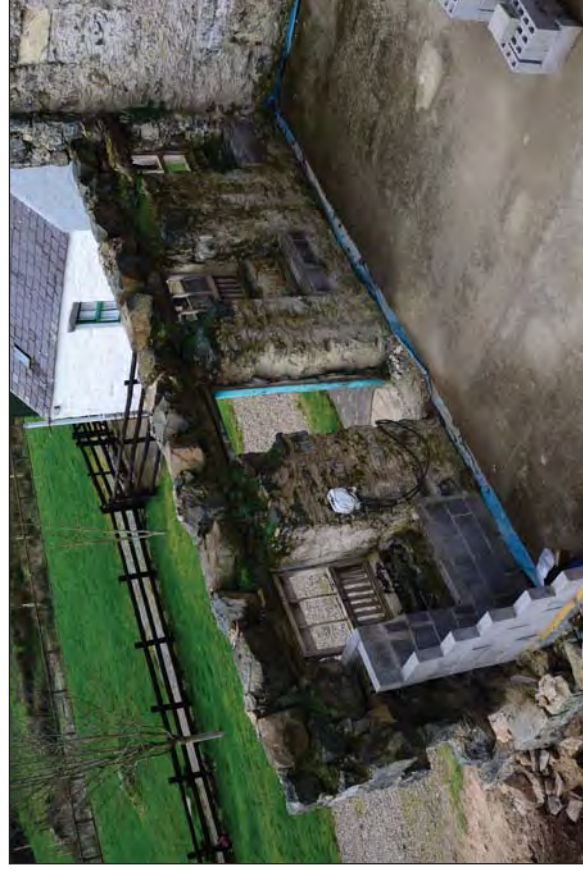
The windows in the miller's house were raised and the glass and frames replaced around the 1930's when the ground floor of the building was converted to stabling. The ground floor fireplaces in the building were blocked up. The first floor and loft space continued to be used as accommodation. The first floor was laid out as a parlour containing a table and chairs whilst the loft space contained beds. This arrangement was remembered by the current owner as having been maintained until his father took ownership of the property.

Figure 88. Aerial View of the Miller's House Showing Alterations to Window Heights

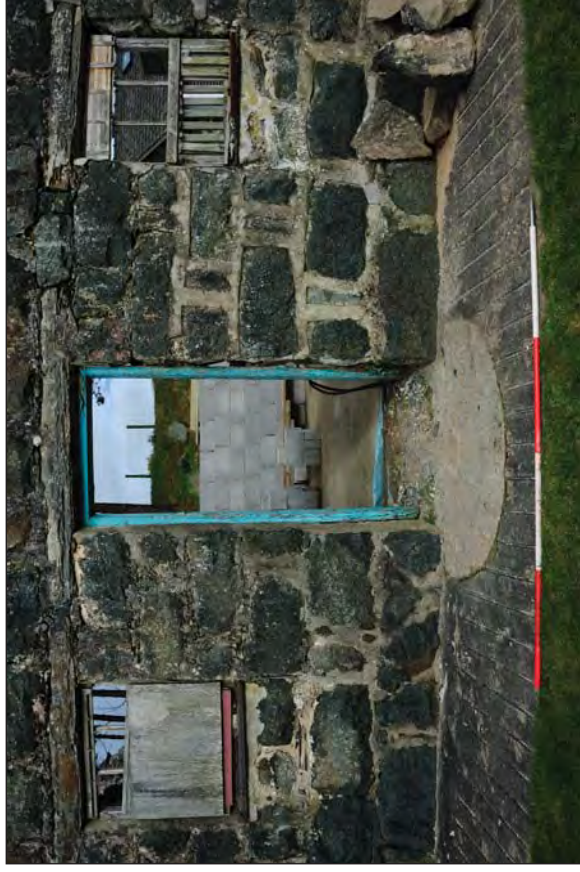
Figure 94. Miller's House Front Elevation Showing Old Millstone Incorporated as Front Doorstep

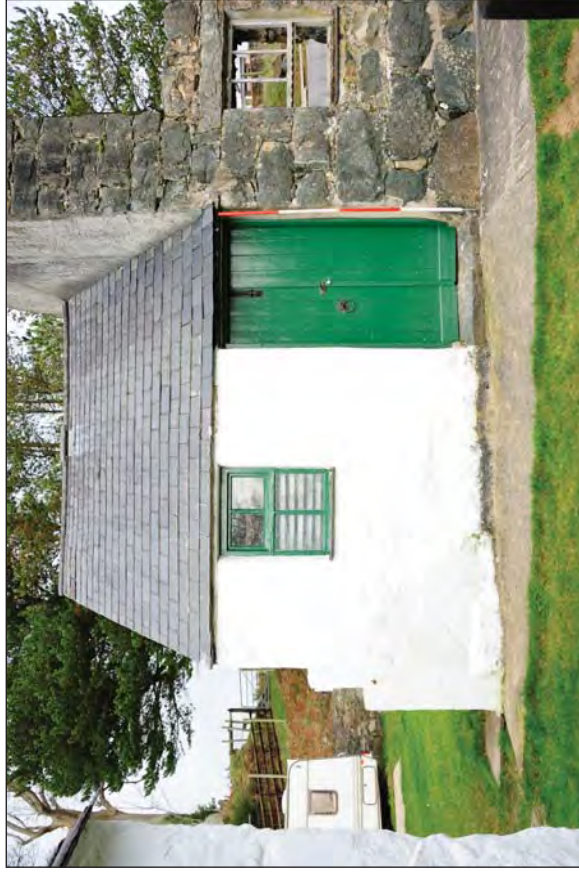
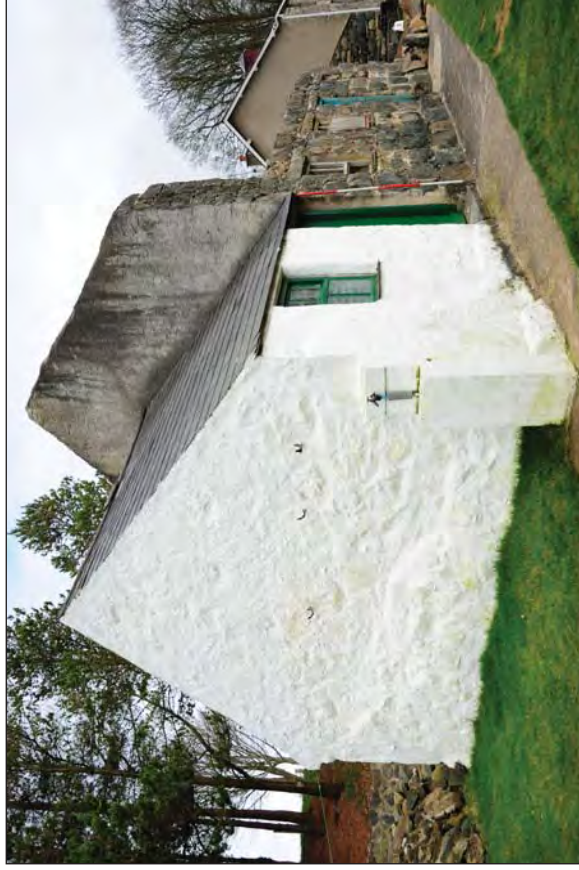
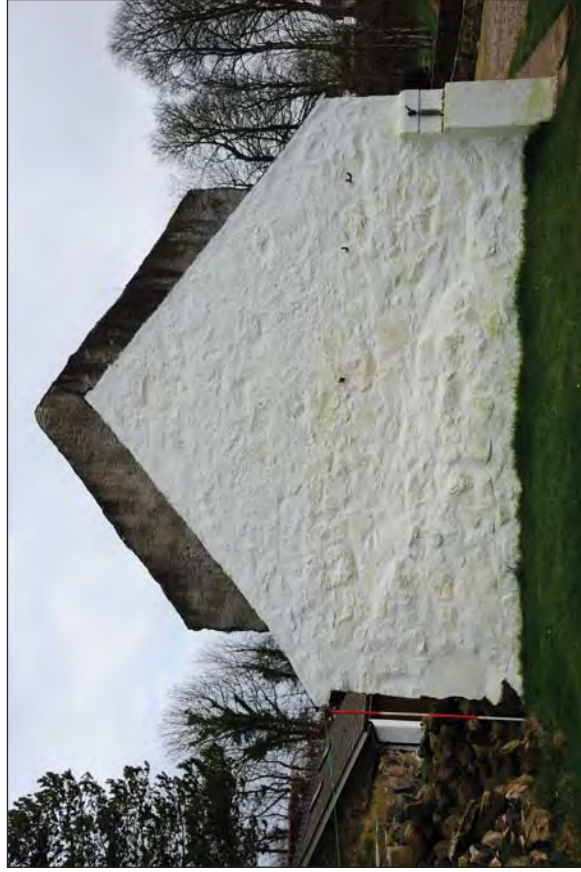
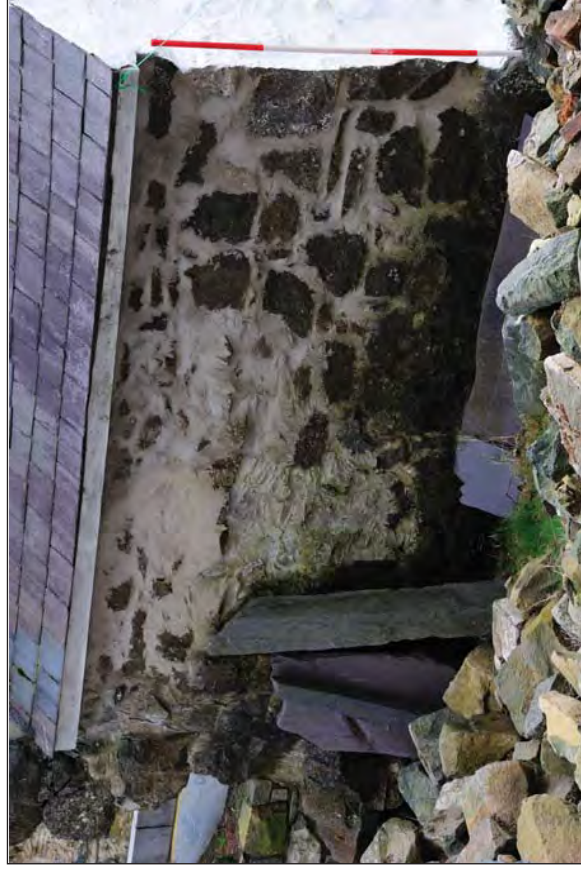
Figure 97. Stable Front Elevation

Figure 98. Stable Front and Side Elevation

Figure 99. Stable North-Western Elevation

Figure 100. Stable Rear Elevation

The stable is well constructed of local stone with a slate roof – the same materials used elsewhere in the mill complex (Figures 97 – 100). It has a carefully laid cobble floor which represents a clear investment of effort in creating an attractive space (Figure 103 – 104). The wooden hay rack to the rear of the stable survives (Figure 102). The building has a whitewash finish.

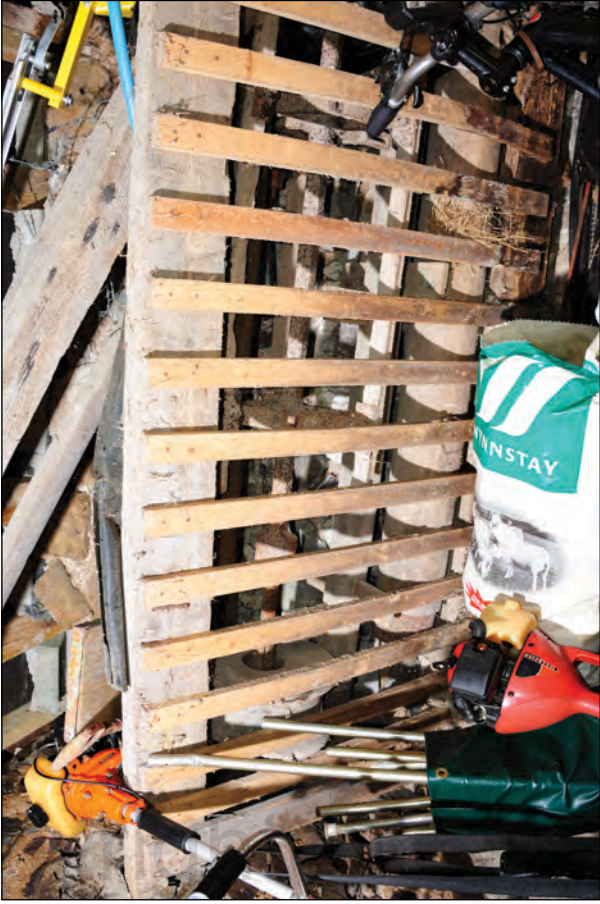
Figure 101. *(Above)* Stable Interior - Hay Rack

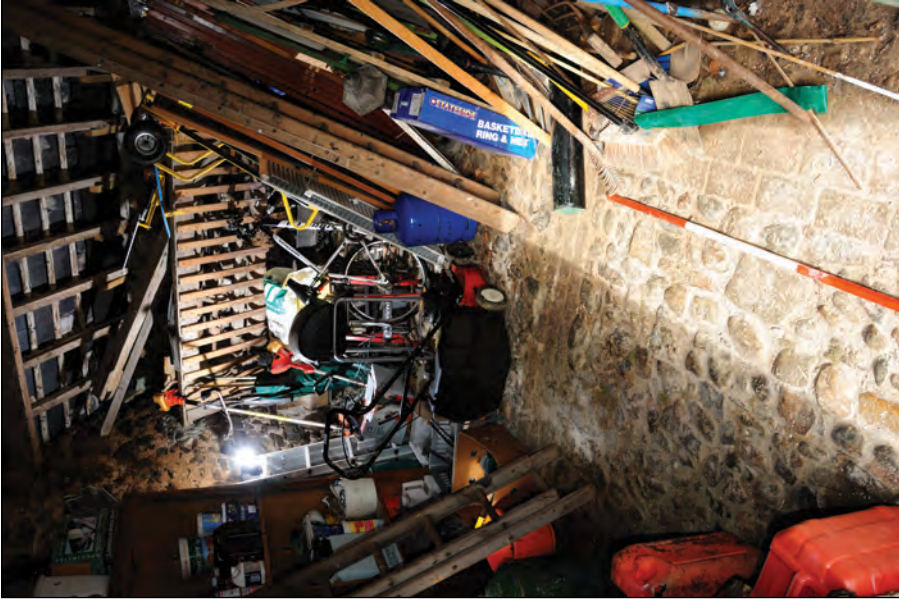
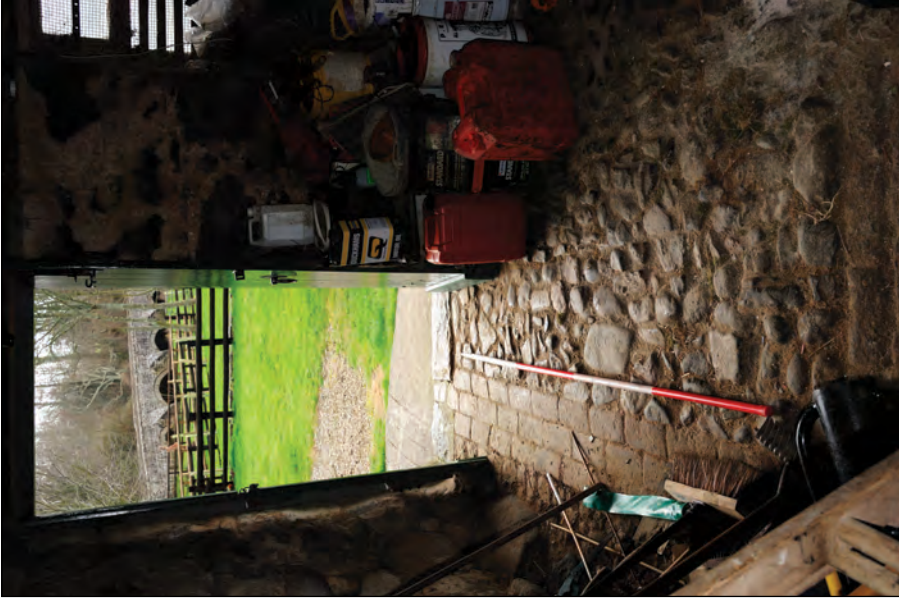
Figure 102. *(Left)* Interior of Stable Taken From Door

Figure 103. *(Far Left)* Interior of Stable Taken from Back of Room

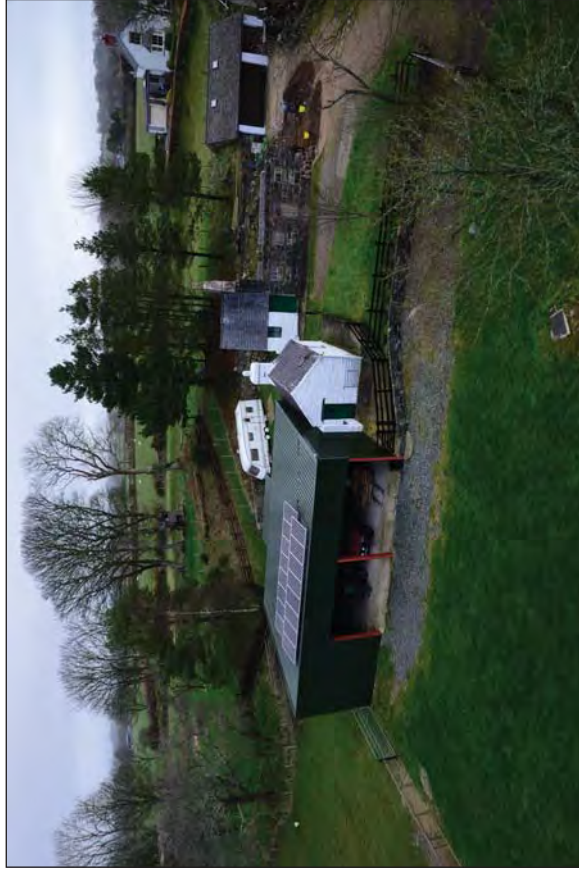
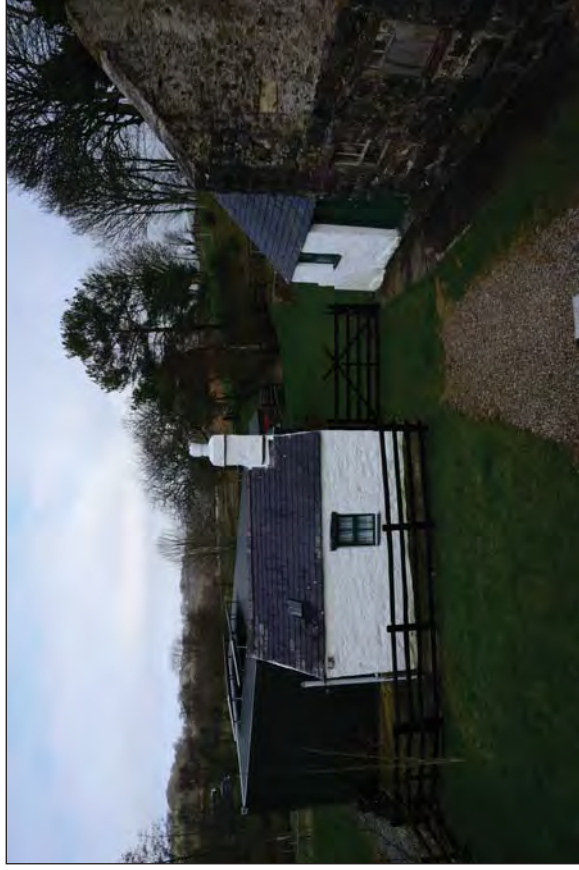
Figure 104. Cookhouse Front Elevation

Figure 105. Cookhouse South-Eastern Elevation

The cookhouse (Figure 105 – 108) is located perpendicular to the mill house and stable. It is attached to four large pigsties. As with the stable the cookhouse and pigsties do not appear on the 1841 Tithe Map but are marked on the First Edition O.S Map. These buildings are all very similar in appearance and may represent a secondary phase of investment in the mill complex, providing the tenants with a means to supplement their income. It is interesting to note that census returns after 1871 list the occupations of the household heads as farmers and millers rather than millers, and we know that they are working an area of 16 acres.

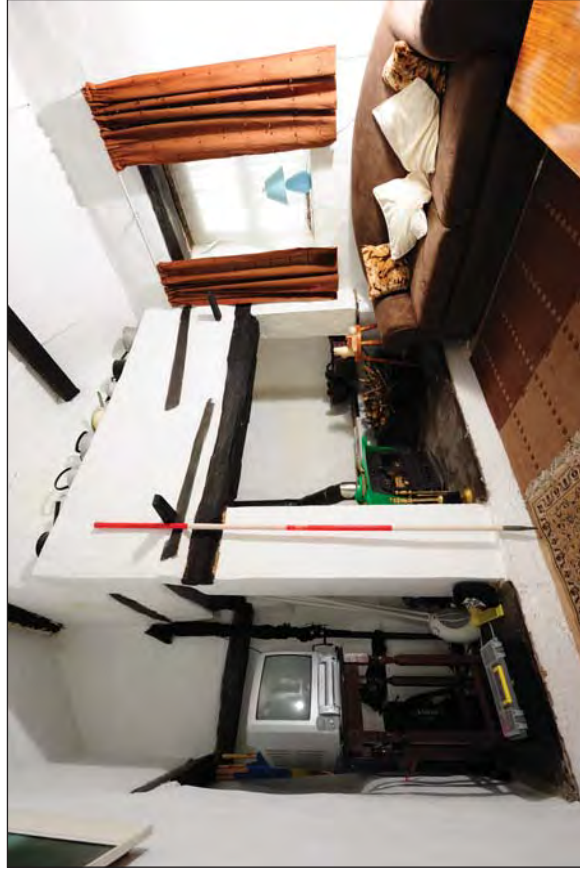
Figure 106. Cookhouse Interior - Large Boiler was Once Situated in Area Now Housing Television Set

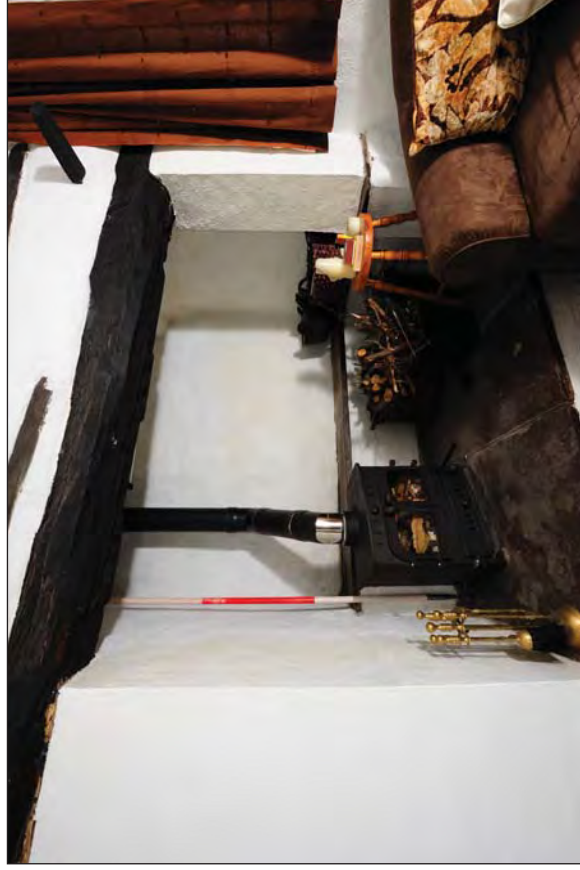
Figure 107. Cookhouse Interior Large Fireplace Once Contained Cooking Range

The interior of the cookhouse (Figures 107 – 108) would originally have been open plan, although a bathroom has been inserted into the structure. An inglenook fireplace, originally housing a large cooking range, was located against the rear wall of the room and a large vat was located to the left of the fireplace. The vat is believed to have been utilised in the production of molasses and other pig foodstuff with waste material from the milling process. Local eyewitness accounts state that the miller was not paid for running the mill but received benefit in kind in the form of foodstuffs for the pigs which were reared on site and sold on.

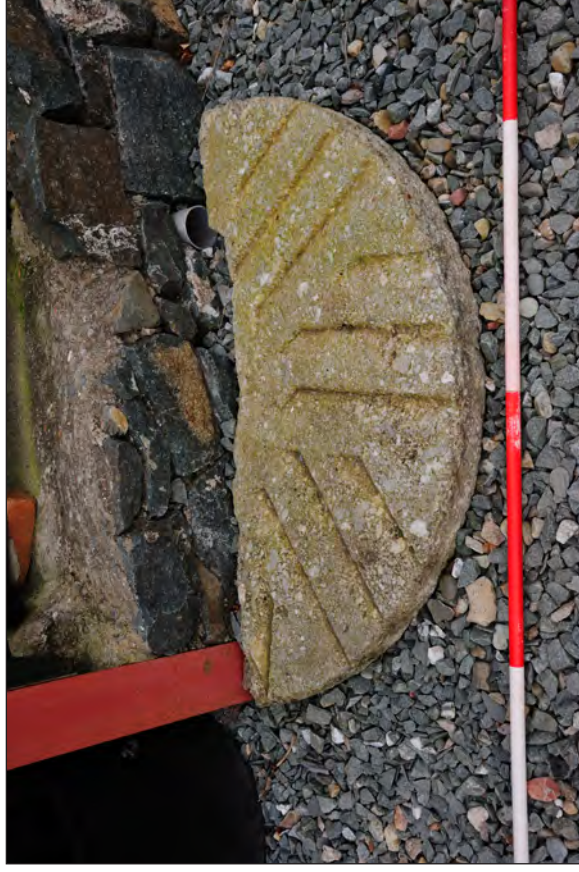
Figure 109. Broken Millstone Made of a Conglomerate Stone -
Possibly Quarried on Anglesey

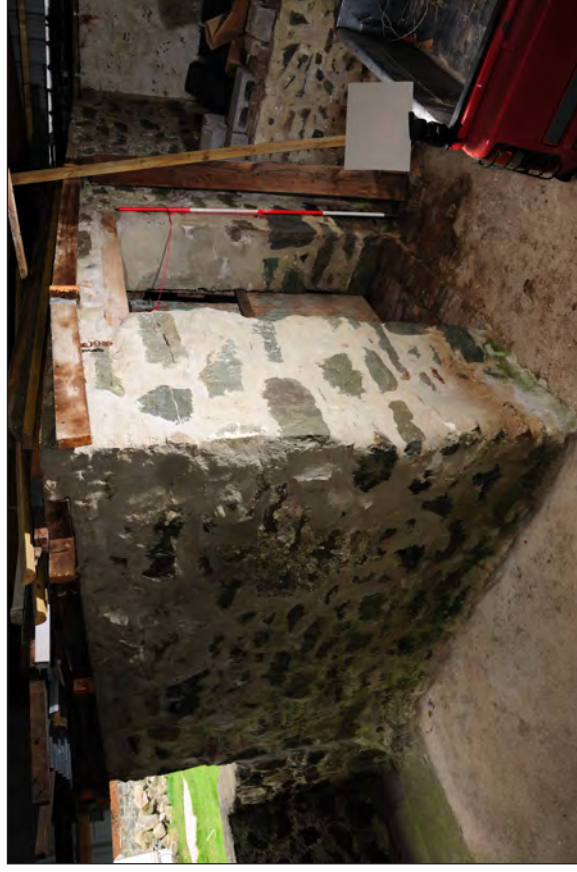
Figure 111. Surviving Stonework Hidden Inside
Modern Barn Covering

The current metal barn structure at Felin Rhyd Hir is clearly a modern construction but an examination of the interior reveals that, as with so much of the complex, a huge amount of historical material is preserved. The remains of the pigsties are housed within and Figures 108 – 114 show surviving structural details.

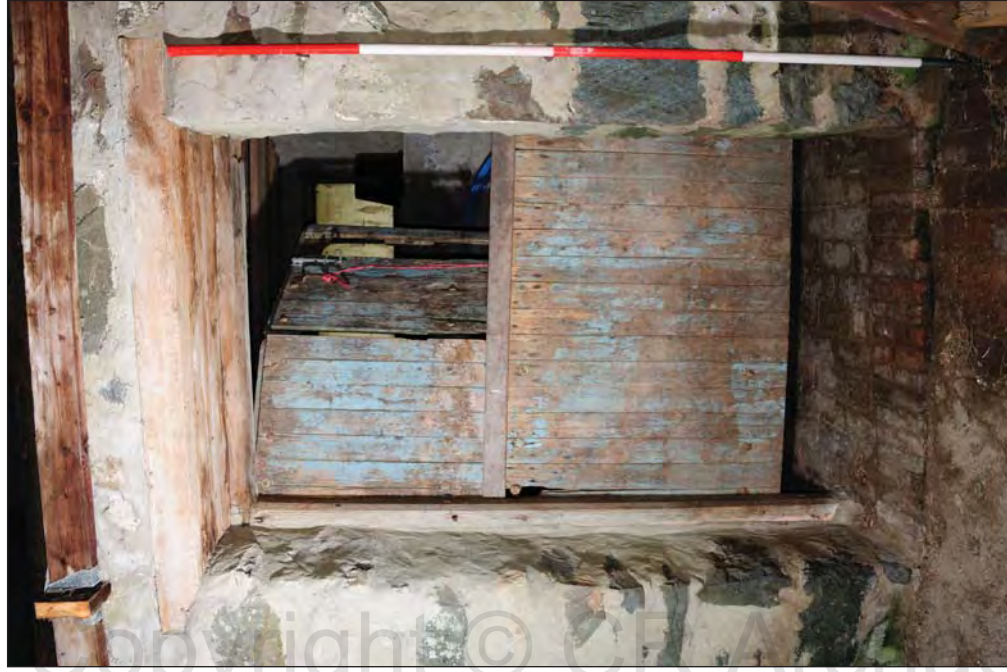
Figure 112. Surviving Stonework and Architectural Details Hidden Inside Modern Barn Covering

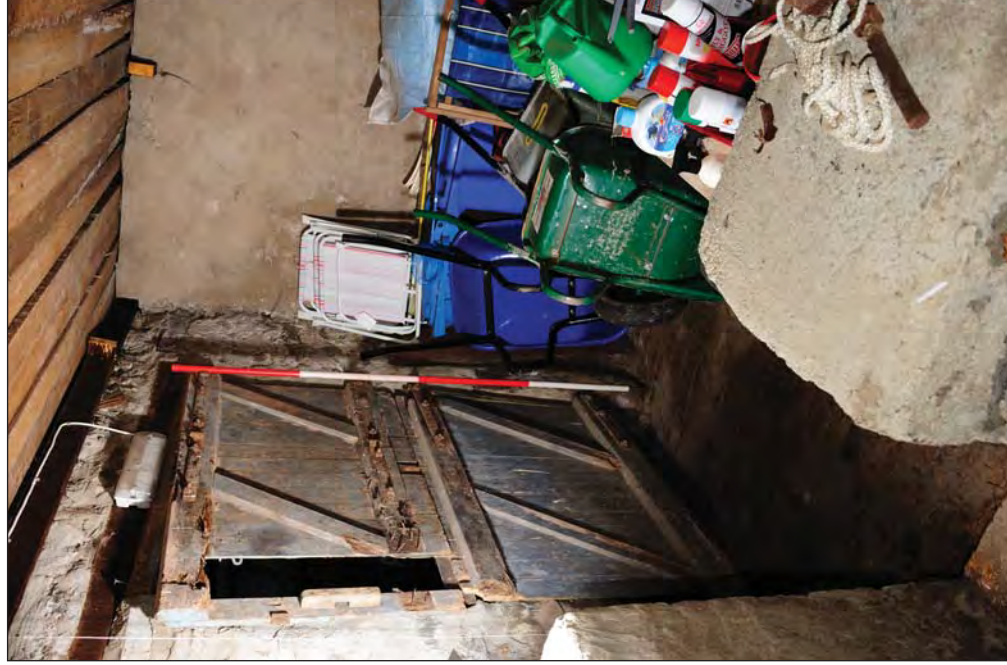
Figure 113. Surviving Stonework and Architectural Details Hidden Inside Modern Barn Covering

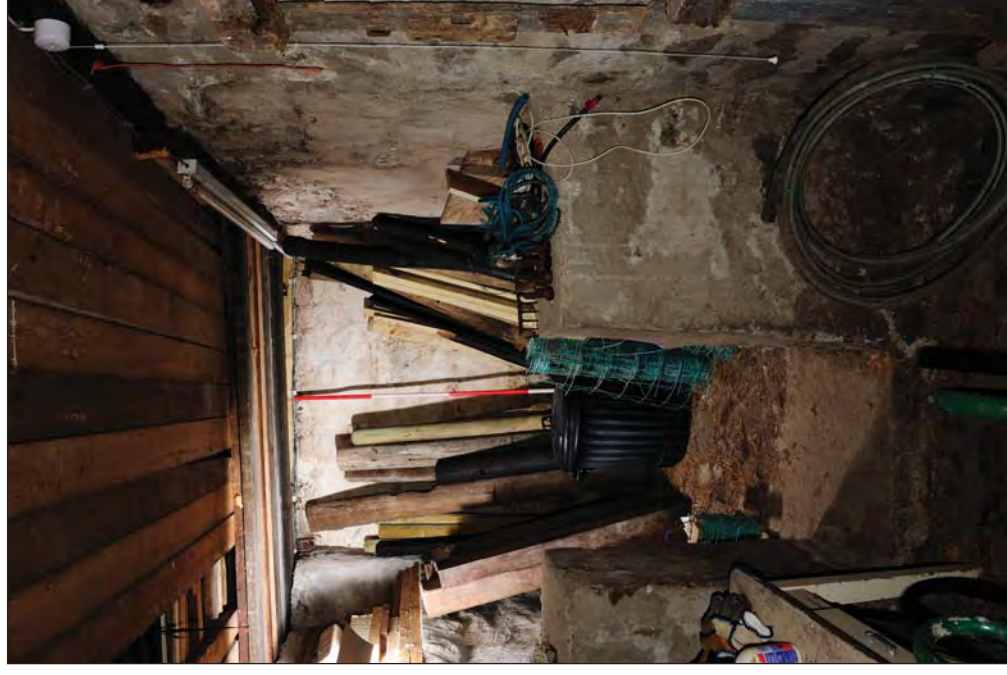
Figure 114. Surviving Stonework and Architectural Details Hidden Inside Modern Barn Covering
