**Results of Archaeological Works at
Benarth Hall Walled Gardens, Conwy**

Report Number CR05-2012

Planning Application Number:	0/33864
National Grid Reference:	SH 78809 76700
Client:	Mr M. Herman
Report Author:	Catherine Rees
Report Number:	CR05-2012
Date:	13/04/2012

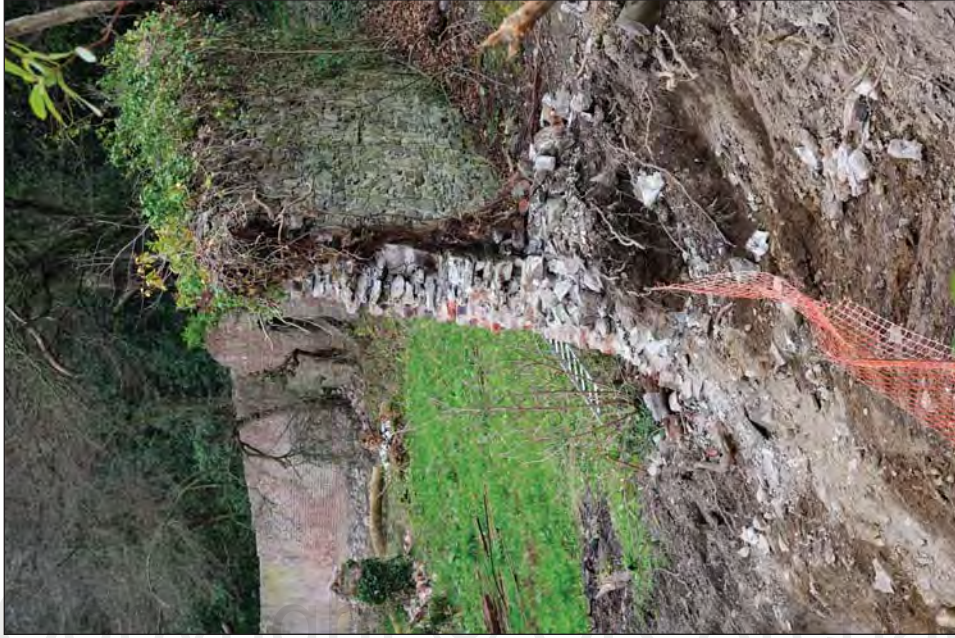
Plate 19. North-Western Garden Wall. Note The Differences Between This Wall and the Wall to the East of the Outbuilding. This Wall Has No Heating Ducts

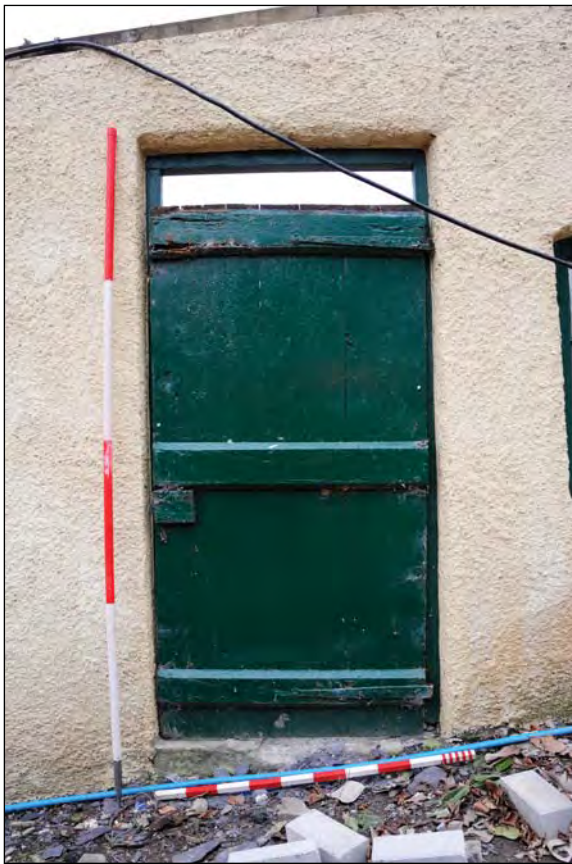
Plate 54. Outbuilding Side Entrance -
Would Originally Have Led to
The Store/Boiler room

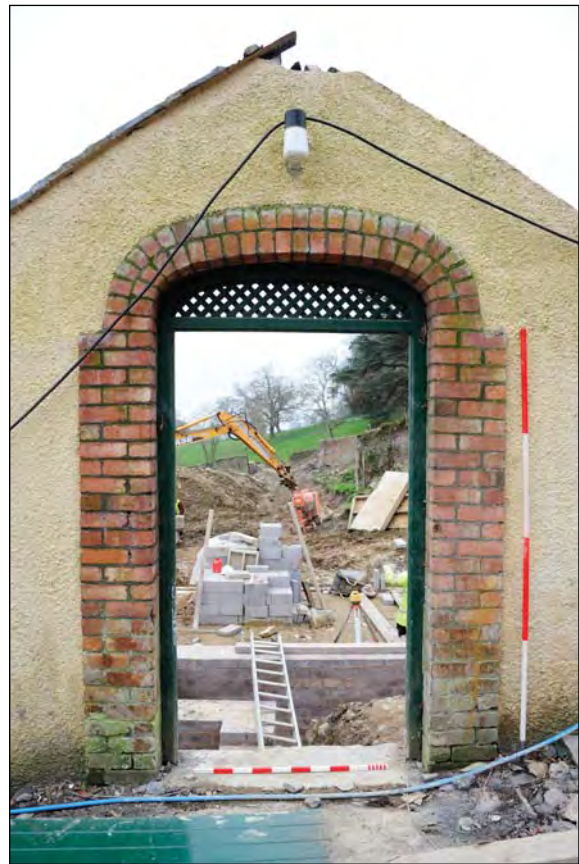
Plate 55. Outbuilding Main Entrance -
Would Originally Have Led Directly
Into the Walled Garden

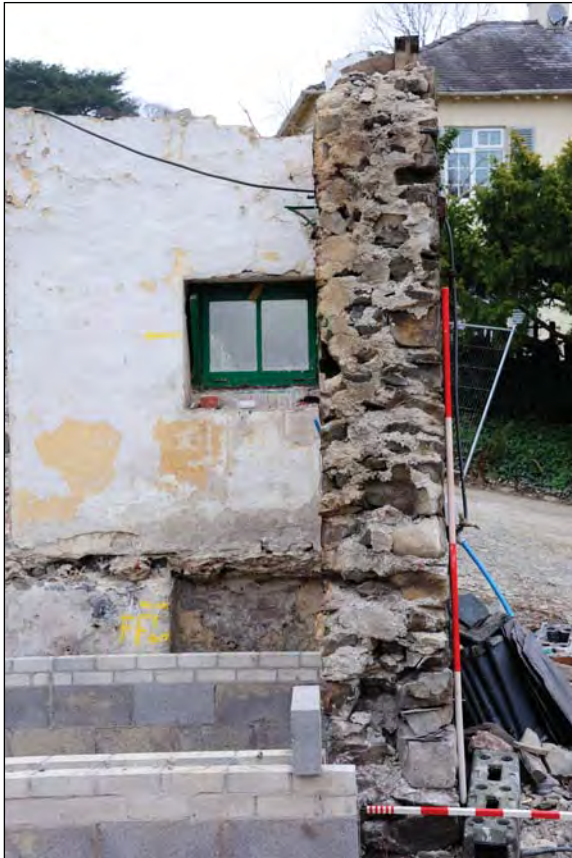
Plate 56. Outbuilding Rear Elevation
Showing Stone Wall Construction

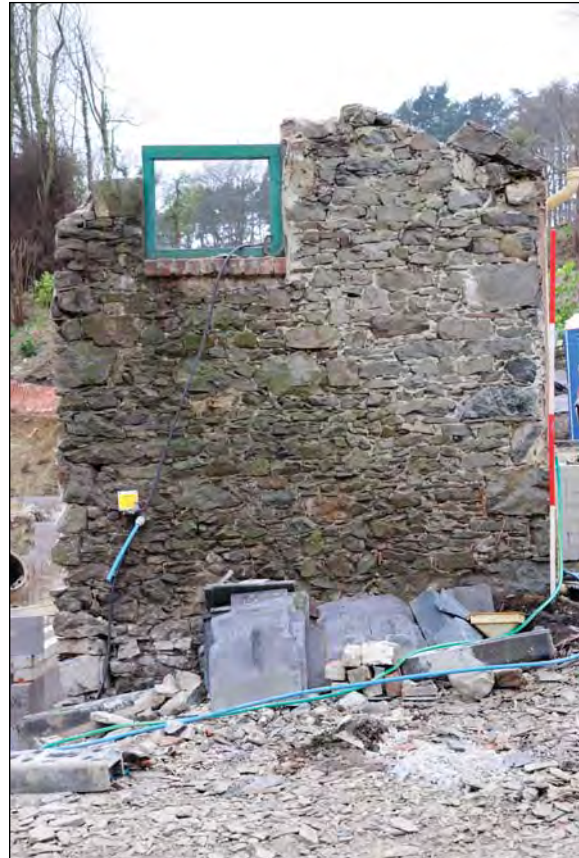
Plate 57. Outbuilding Side Elevation
Showing Stone Wall Construction

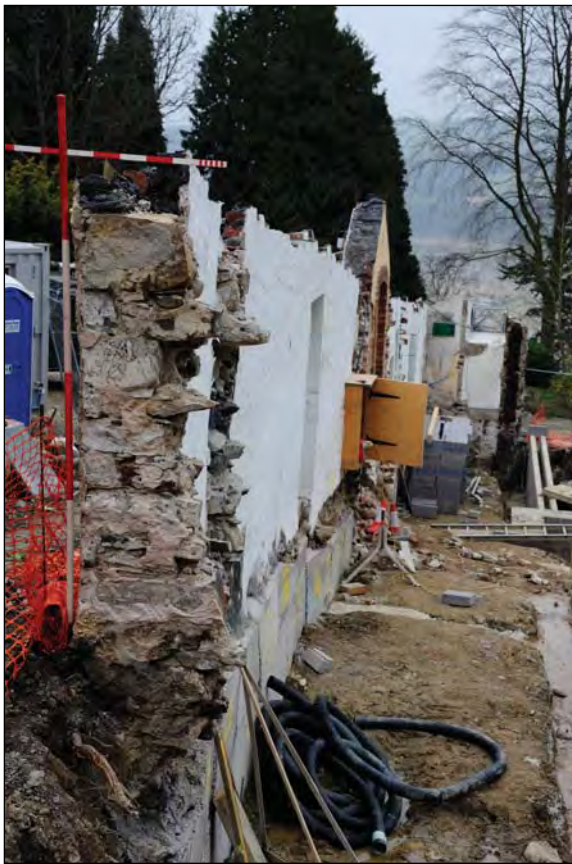
Plate 58. Outbuilding Front Wall
Showing Wall Construction

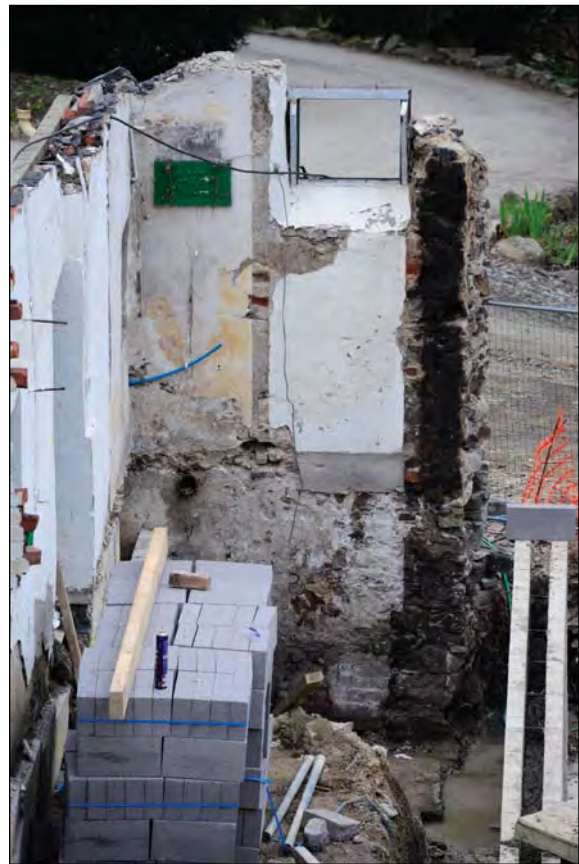
Plate 59. Outbuilding Side Wall
Showing Area Which Once
Housed the Boiler

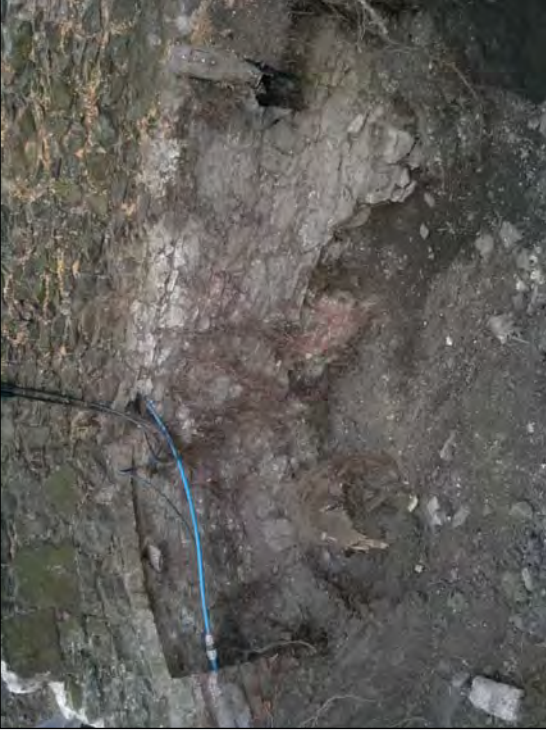
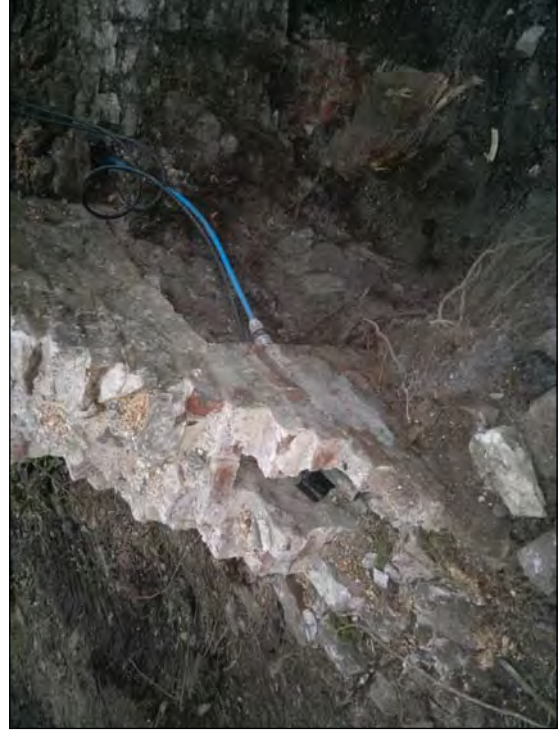
Plate 62. Boiler Area Below Outbuilding
Source: Mr. M Herman

Plate 63. Boiler Area Below Outbuilding
Source: Mr. M Herman

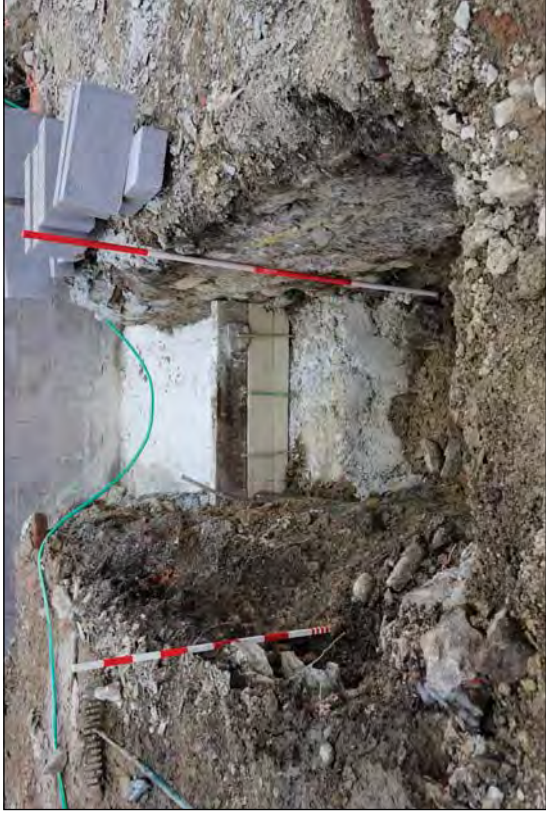
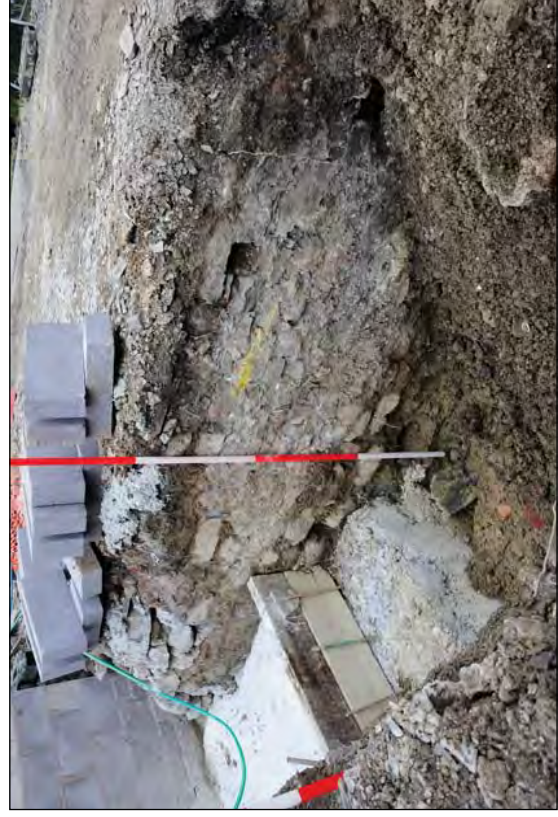
Plate 64. Remains of Glasshouse
Foundations/ Heating System

Plate 65. Remains of Glasshouse
Foundations/ Heating System

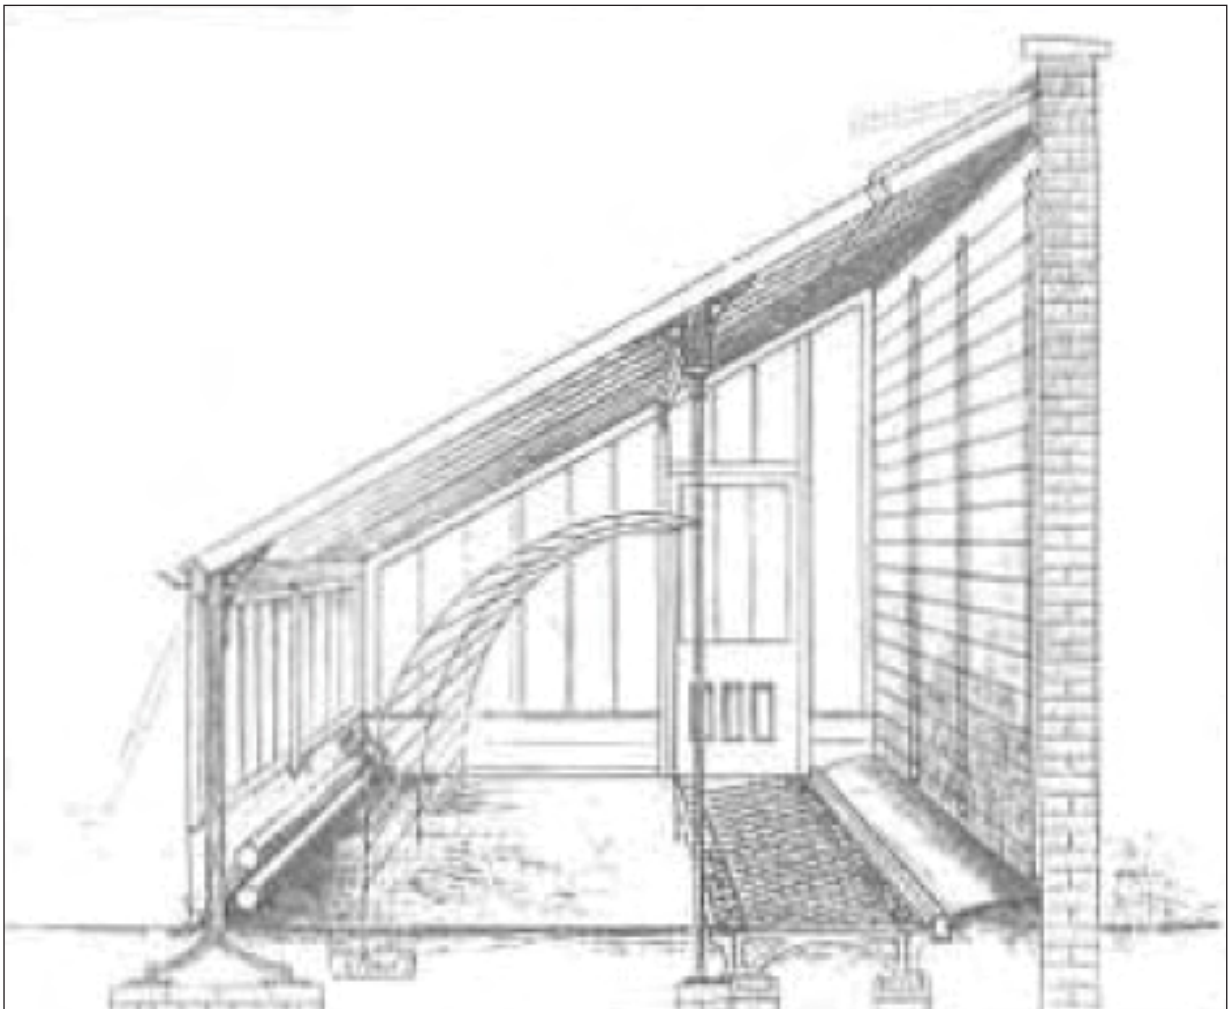
Plate 73. Cross-section Through Lean-To Peach House Similar to that at Benarth Hall.
Source Fosters & Pearson 1909 Sales Catalogue (Page 50)

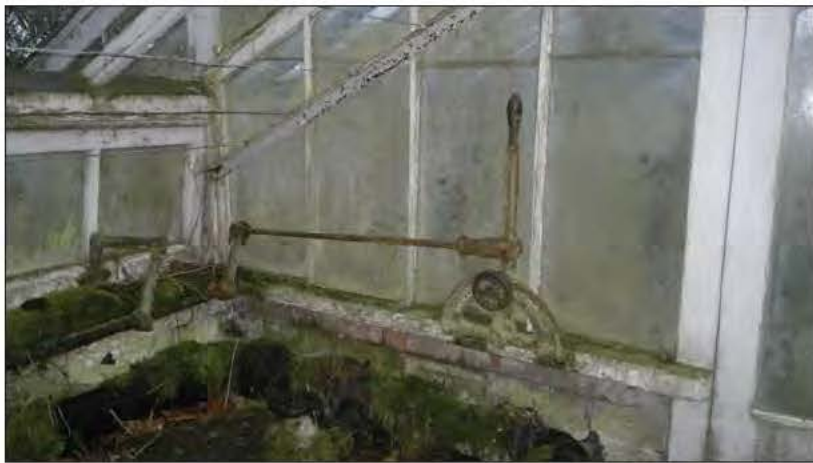
Plate 81. Central Greenhouse Interior Detailing
Mechanism for Opening Ventilation Flaps.
Photograph Source Mr. M Herman

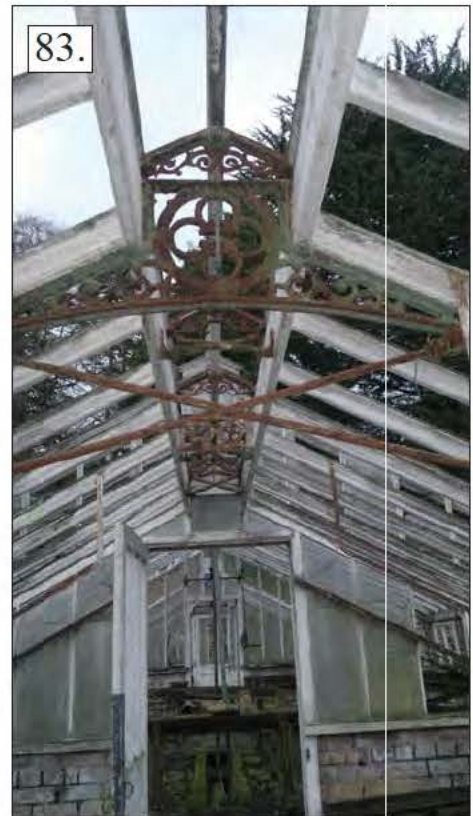
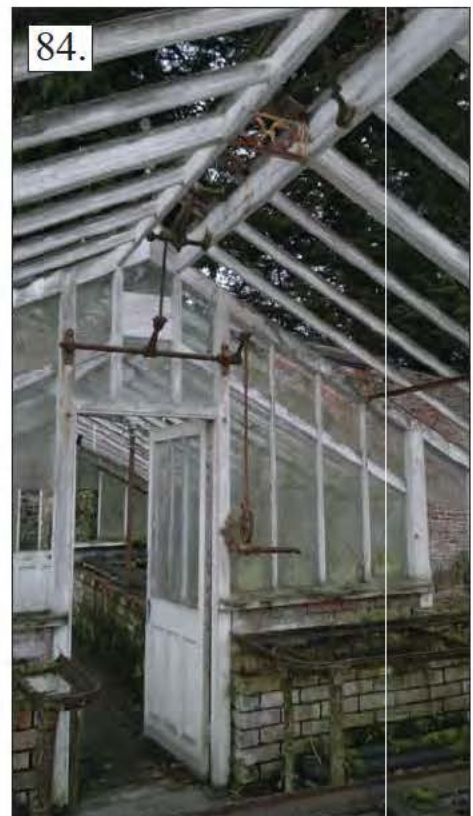
Plate 83. Southern Greenhouse
Roof Ironwork Details
Plate 84. Roof Mechanism
Central Greenhouse Section
Source Mr. M Herman

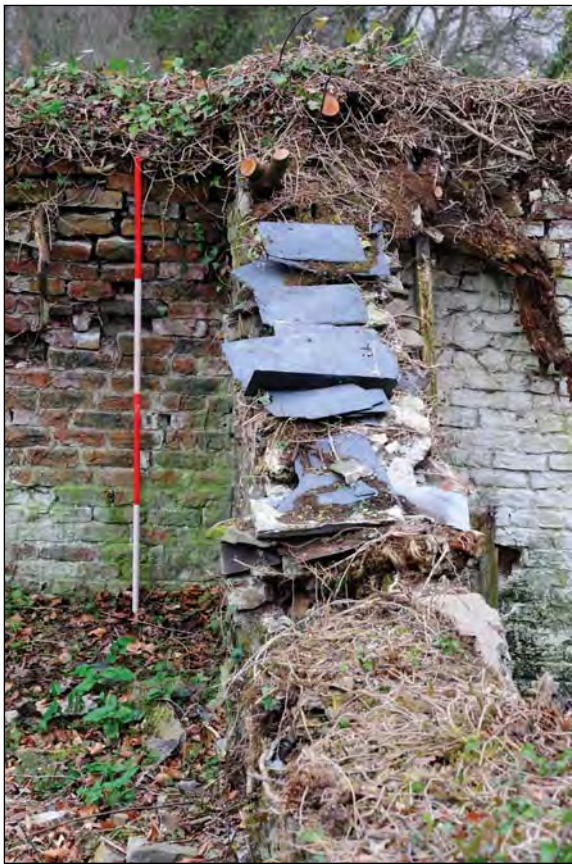
Plate 104. Stable Building Rear Wall and Roof Line with Surviving Slates.

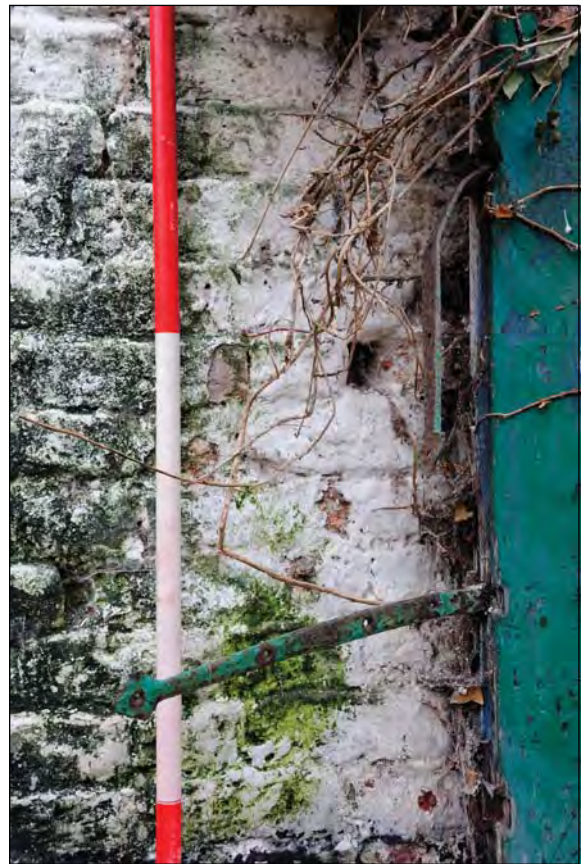
Plate 105. Iron Work on Stable Door-frame

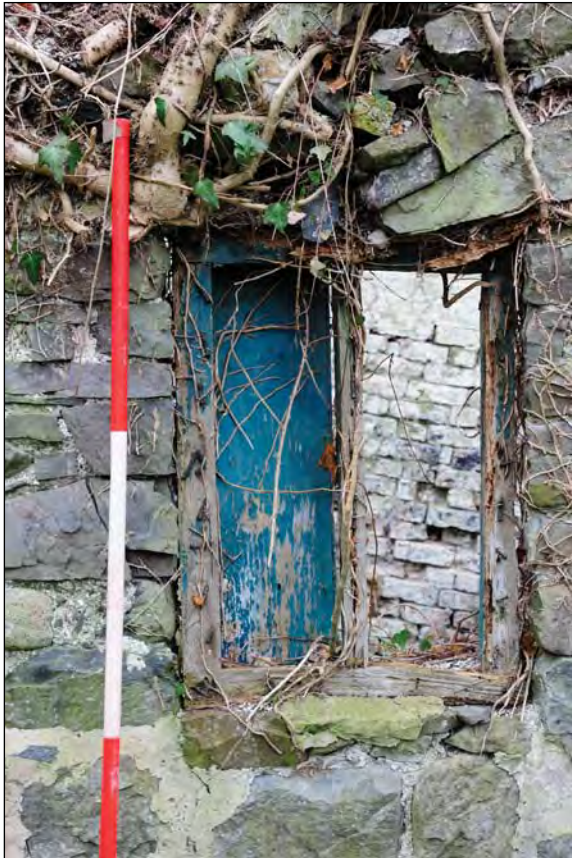
Plate 106. Stable Window Detail (Front Elevation)
