**Results of Archaeological Works at**  
**Barracks Cottage, Penmon, Anglesey**

NGR SH 62909 80638

**Report Number CR105-2016**

**C.R Archaeology**

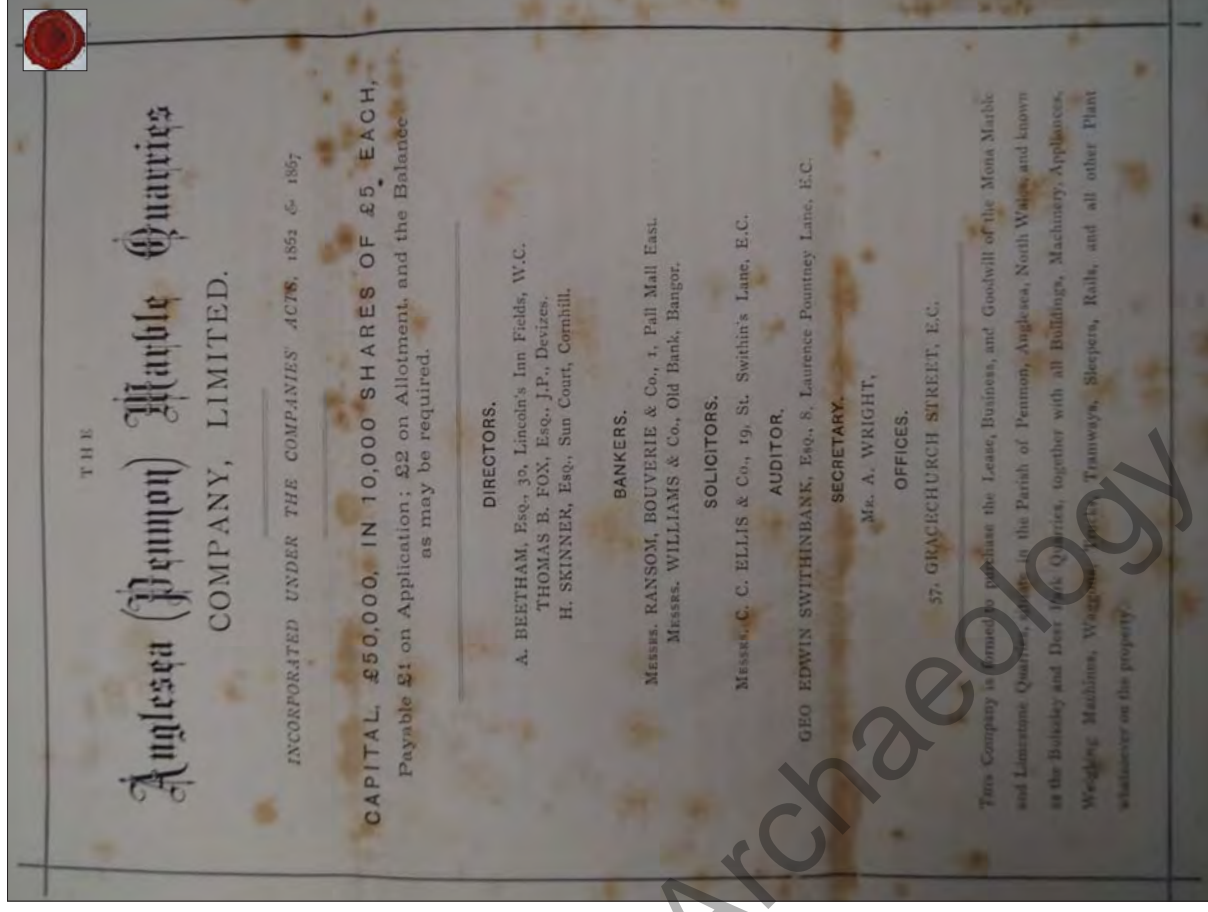
**Figure 3 (Left).** Extract from 1874/5 Promotional Material for the  
Newly Formed Anglesea (Penmon) Marble Quarry Company Limited  
(Source: Anglesey Archives WDAE/128)

This hypothesis is supported by information included in a prospectus produced by the Anglesea (Penmon) Marble Quarries Company Ltd in 1874 (figure 3). This document contained a series of reports which were commissioned to detail the previous high profile customers of the quarry and the buildings which have been built from its stone, to attest to the quality and quantity of the limestone at the quarry and to describe the current state of the quarry and scope for improvement (Anglesey Archives WDAE/128/1-5).

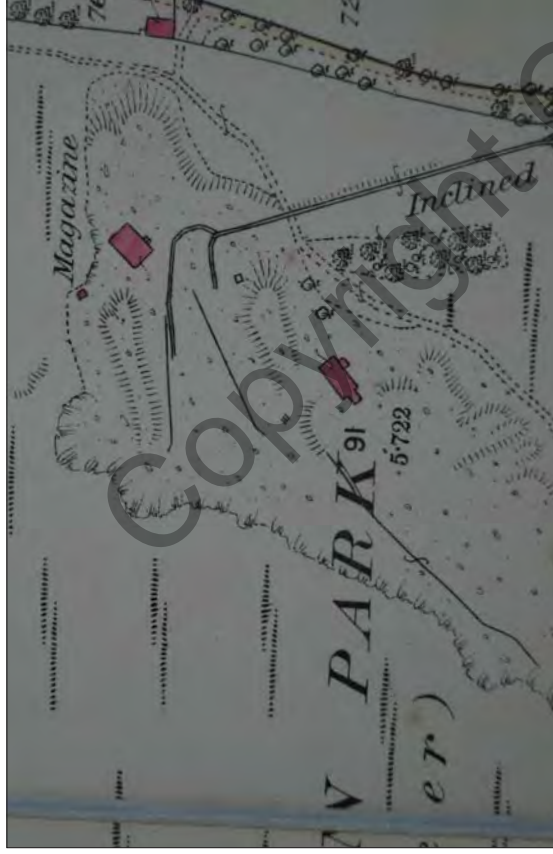
**Figure 6.** First Edition Ordnance Survey Map (Surveyed 1887)

The barracks building (both the Barricks and Marble Quarry House elements detailed above) are shown on the First Edition Ordnance Survey Map of 1889 (surveyed 1887, see figure 6). The building is shown as having a porch over the front doorway nearest to the bell tower. Other than the existence of a porch, the shape in plan is as survives today and on examination of the structure on the ground the Barracks Cottage was found to be of a single construction phase, rather than the south-western bay having been added at a slightly later date.

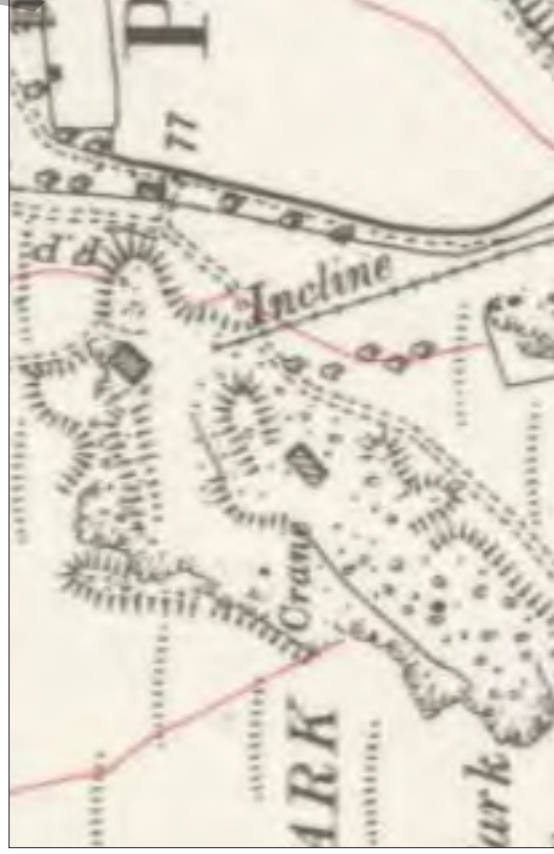
**Figure 8.** 1926 Edition Ordnance Survey Map (Surveyed 1914)

The Barracks Building is shown on the 1926 Ordnance Survey Map (surveyed 1914, see figure 8) and is no longer shown as having a porch or outbuildings.

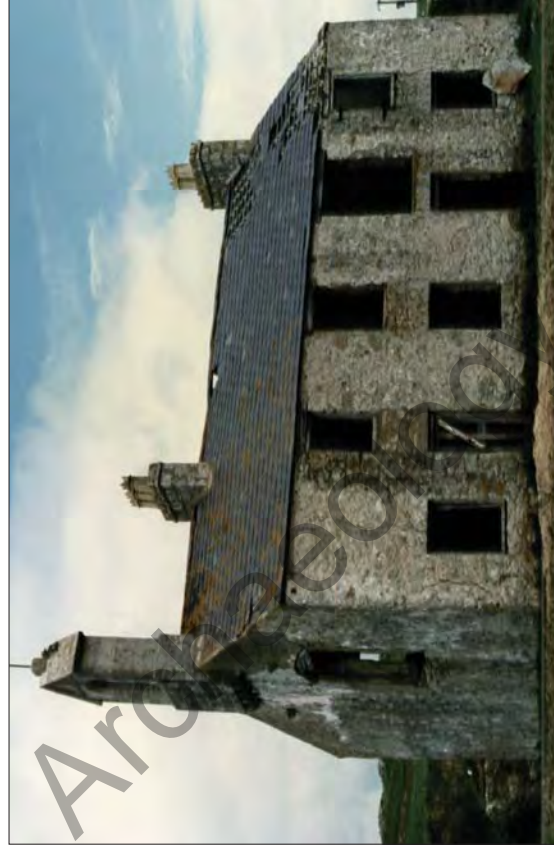
**Figure 9.** Photograph of the Barracks Cottage Taken Prior to the Collapse of the Bell Tower (Supplied by Client)

Figure 9 shows the derelict building prior to the collapse of the bell tower and the roof.

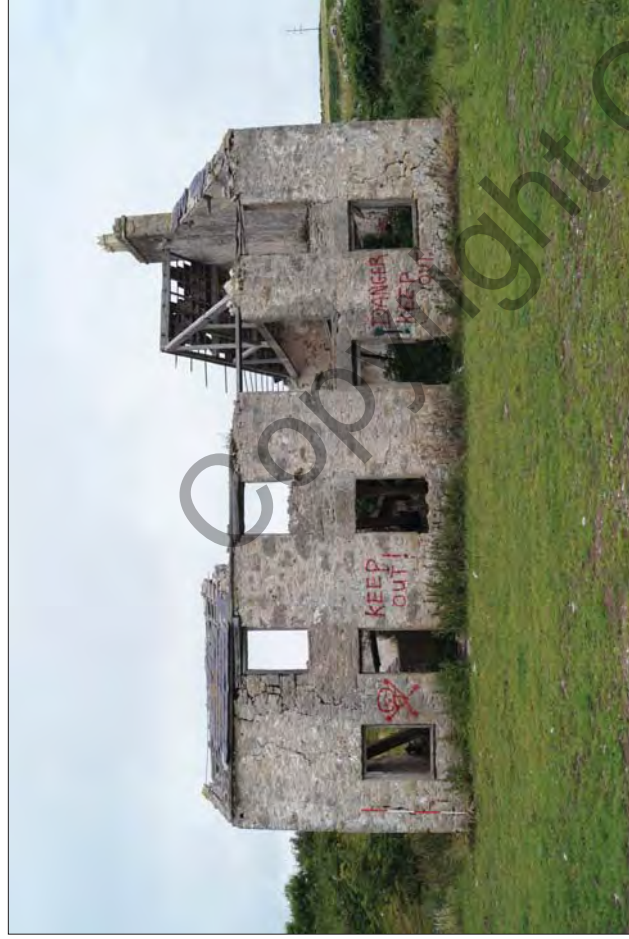
**Plate 1.** Barracks Cottage - Front Elevation (South-East Facing)

Barracks Cottage is a two storey, five bay structure with seven window openings and 2 doorways in the front (south-east facing) elevation (plates 1 & 2). At the time of the site visit there were no surviving doors or windows within the recesses. The window openings at the first floor level had been reduced in height at some point although it was unclear as to when this was undertaken. The window openings do seem rather large for a worker’s accommodation of this period but as mentioned previously this design has clearly been selected to showcase the materials and the building must not therefore not considered as only a barracks. It must also be noted that in the barracks portion of the block there were no window openings at first floor level to the rear of the building. The large windows in the south-eastern elevation would therefore have allowed the maximum amount of light to enter the building at this level.

The external finish on the building has not survived in its entirety and the frontage is currently of predominantly exposed stone, but there are areas where the original lime render survives.

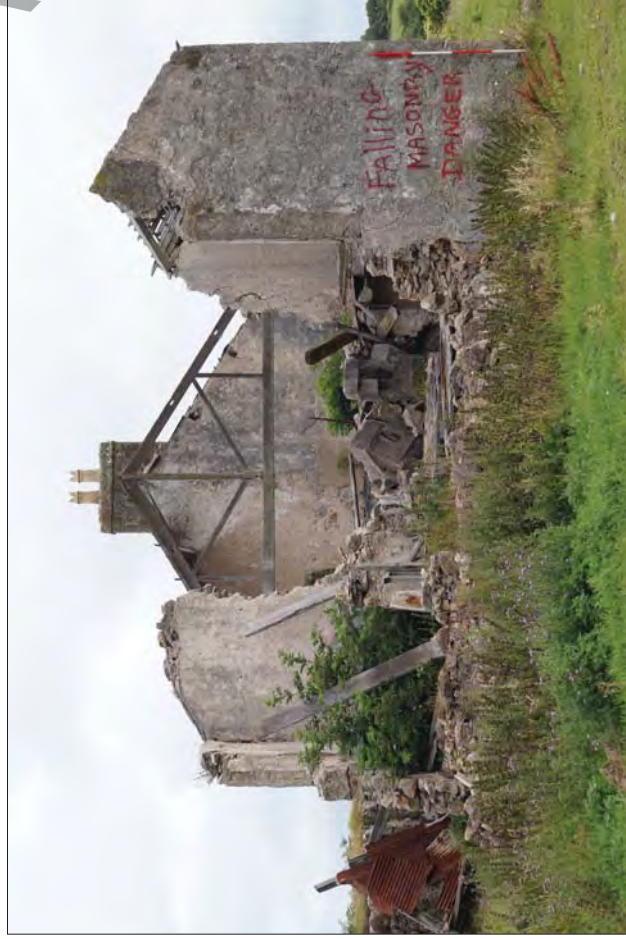
**Plate 3.** South-West Facing Gable Elevation  
Showing Collapsed Bell Tower

The building is currently derelict and the majority of original/historic interior features have not survived. The south-western gable where the bell tower was located has collapsed and the majority of the roof structure is missing.

The bell tower on the south-western gable is believed to be an original feature of the building and would have allowed the quarry manager to summon the men to work and to keep time throughout the day. It had collapsed by the time of the site visit (plates 2 & 3) but is shown in-situ in figure 9. The bell tower was not lime rendered and the dressed/carved stone used would have been an advertisement for the properties of the stone.

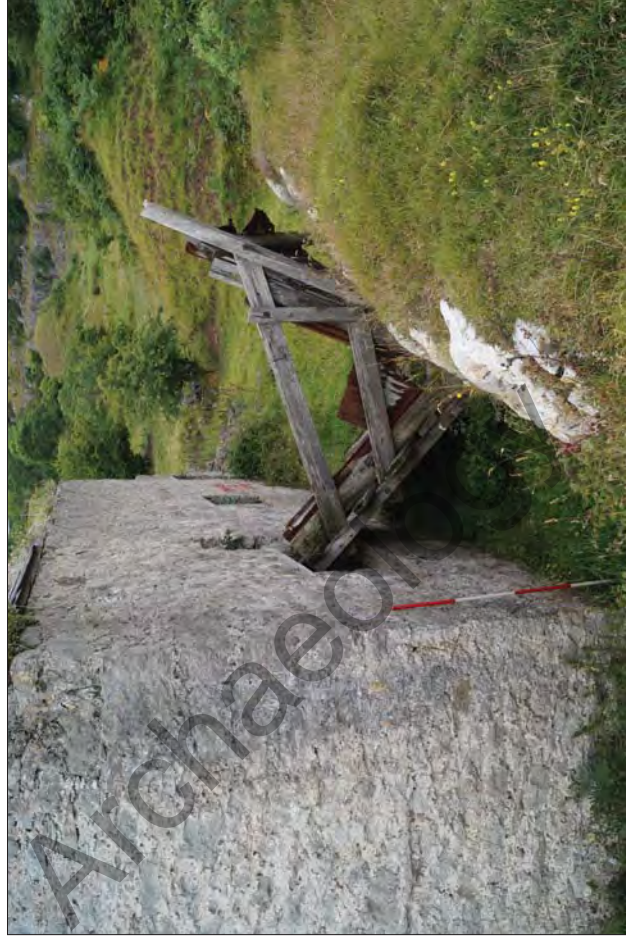
**Plate 4.** Rear (North-West) Facing Elevation

There are no openings in the north-eastern gable of the building. Traces of the roof lines of the lean-to structures are still evident on this elevation (see plate 8). The remains of a corrugated iron and wood structure was found at the rear of the building (see plate 4) which was presumably the remains of one of these structures.

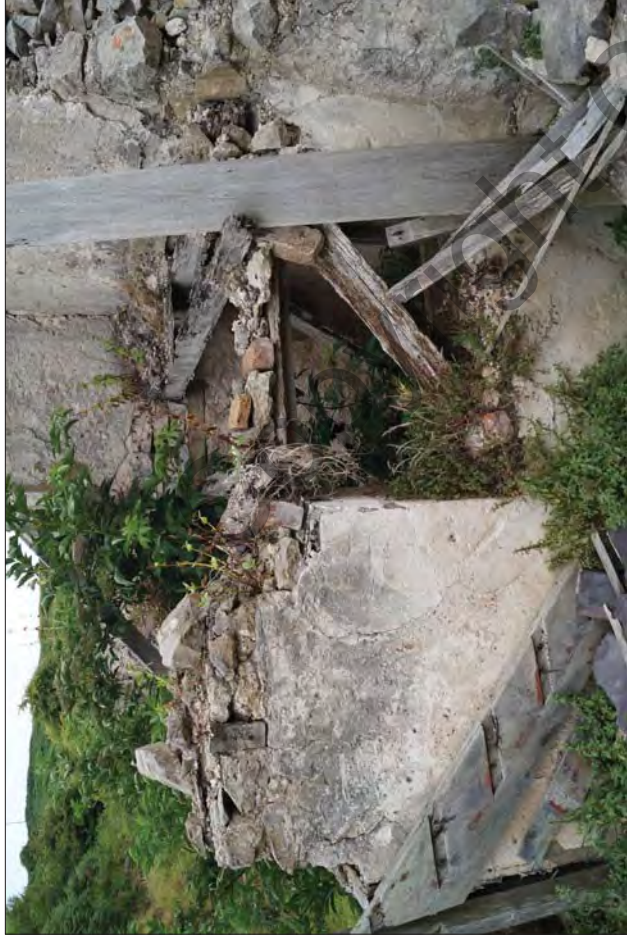
**Plate 13.** Surviving Internal Division of Space & Remains of Steps

In the office building there is a ground floor division in the same place as that found in the barracks. There was no doorway between the two spaces, just a window opening to allow light into the room (plate 13). It is postulated that this room may have functioned as a strong room but this is by no means certain and may have been another room for boarders. The remains of the stairway can be seen in plate 13.

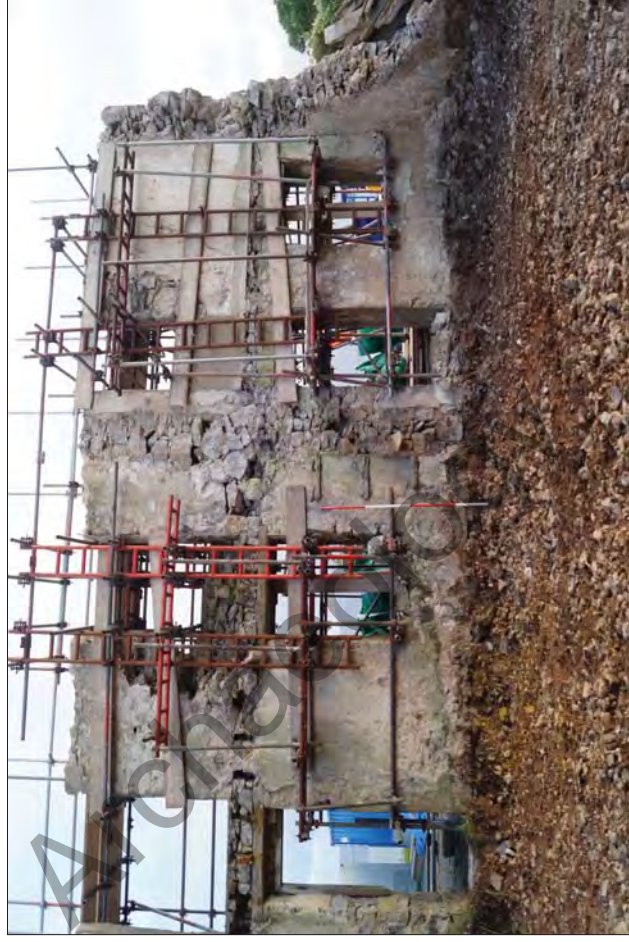
**Plate 16.** Barracks Cottage Interior -  
Front Elevation Following Clearance Works

When examining the dividing wall between the properties it is evident that this block is a single build rather an initial phase when the barracks was built, followed by the later addition of the office with bell tower (see plates 16 & 22).

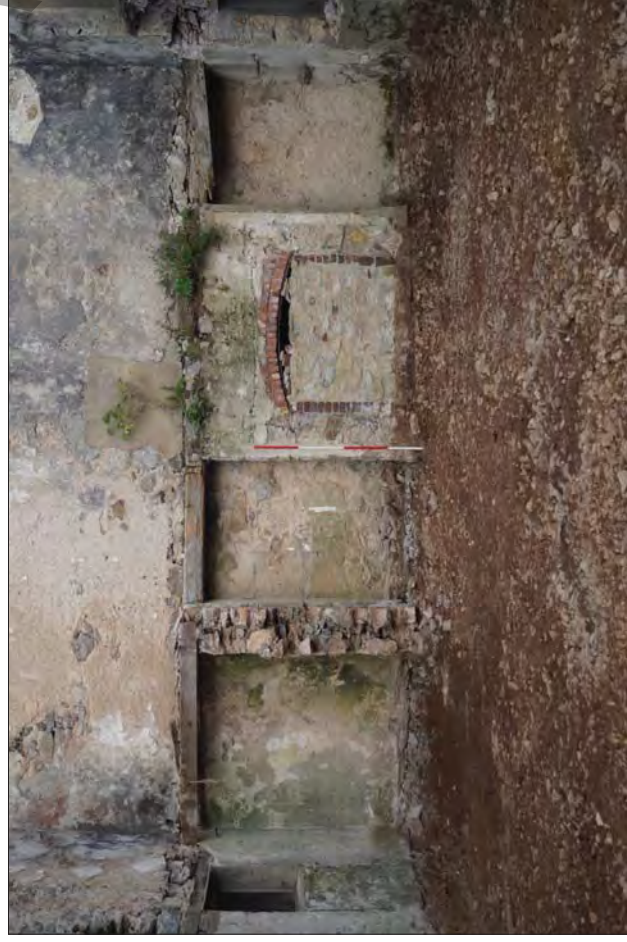
**Plate 19.** Detail of Ground Floor Area and  
Blocked First Floor Fireplace

There was no clear idea as to how the first floor space was divided, or if indeed it was divided. There is a small blocked fireplace in the north-eastern gable. If this space had been divided it would most likely have been on a north-west – south-east axis as to divide the space north-east – south-west would have blocked all light to the rear portion. It is also possible that this space was not divided and the fourth room was at the attic level although it must be noted that there was no evidence of roof lights.

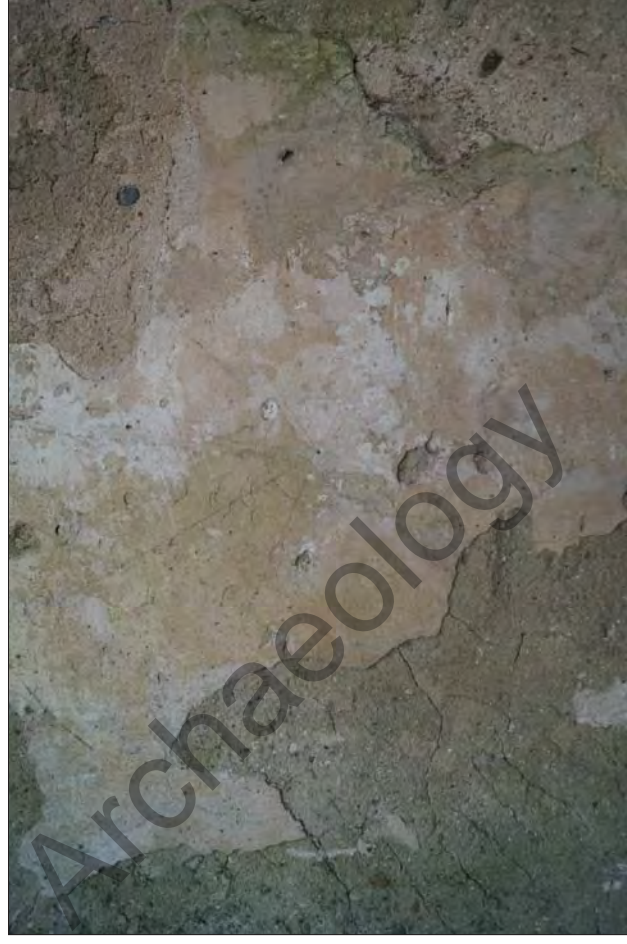
**Plate 20.** Pencil Graffiti in North-Western Niche

entrance. This is supported by the fact that there was never more than one boarder recorded as living with the families at the property. There was an interesting piece of pencil graffiti on the north-eastern gable wall within this space which appears to be a wheel with spokes or possibly a compass (see plate 20). The graffiti unfortunately not be dated and it may well postdate the building's use as accommodation.

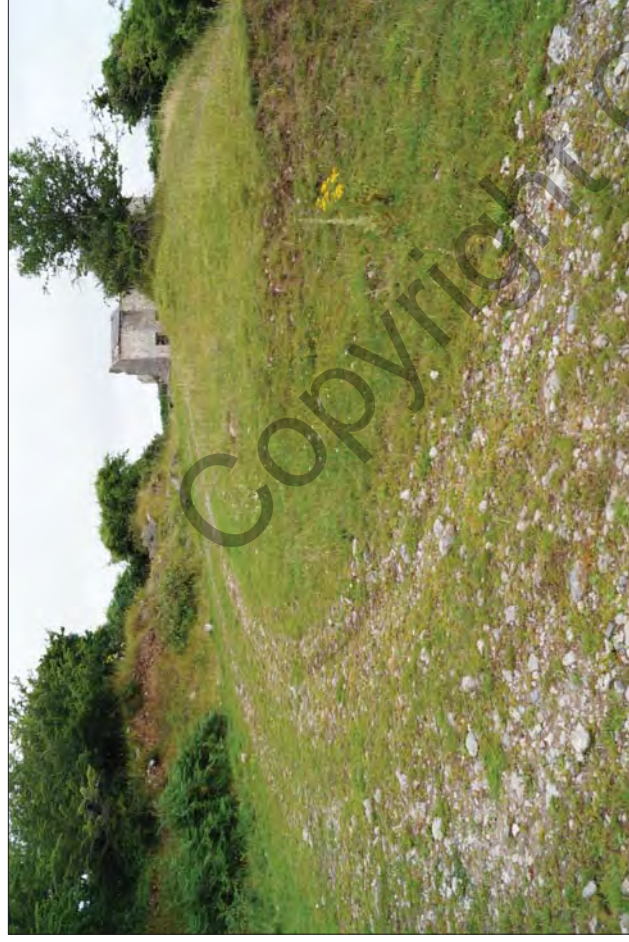
**Plate 25.** Barracks Cottage - View Up Inclined Plane

Barracks Cottage sits within a wider limestone quarrying landscape and it lies within the Penmon Park quarry (plate 27). The pathway up to the cottage partially follows the inclined plane (plates 25 & 26) and there are the remains of a retaining wall still visible within the quarry floor (plate 28). It is possible that parts of the smithy also survive but a detailed record/systematic search of the quarry area was not within the scope of the site works.

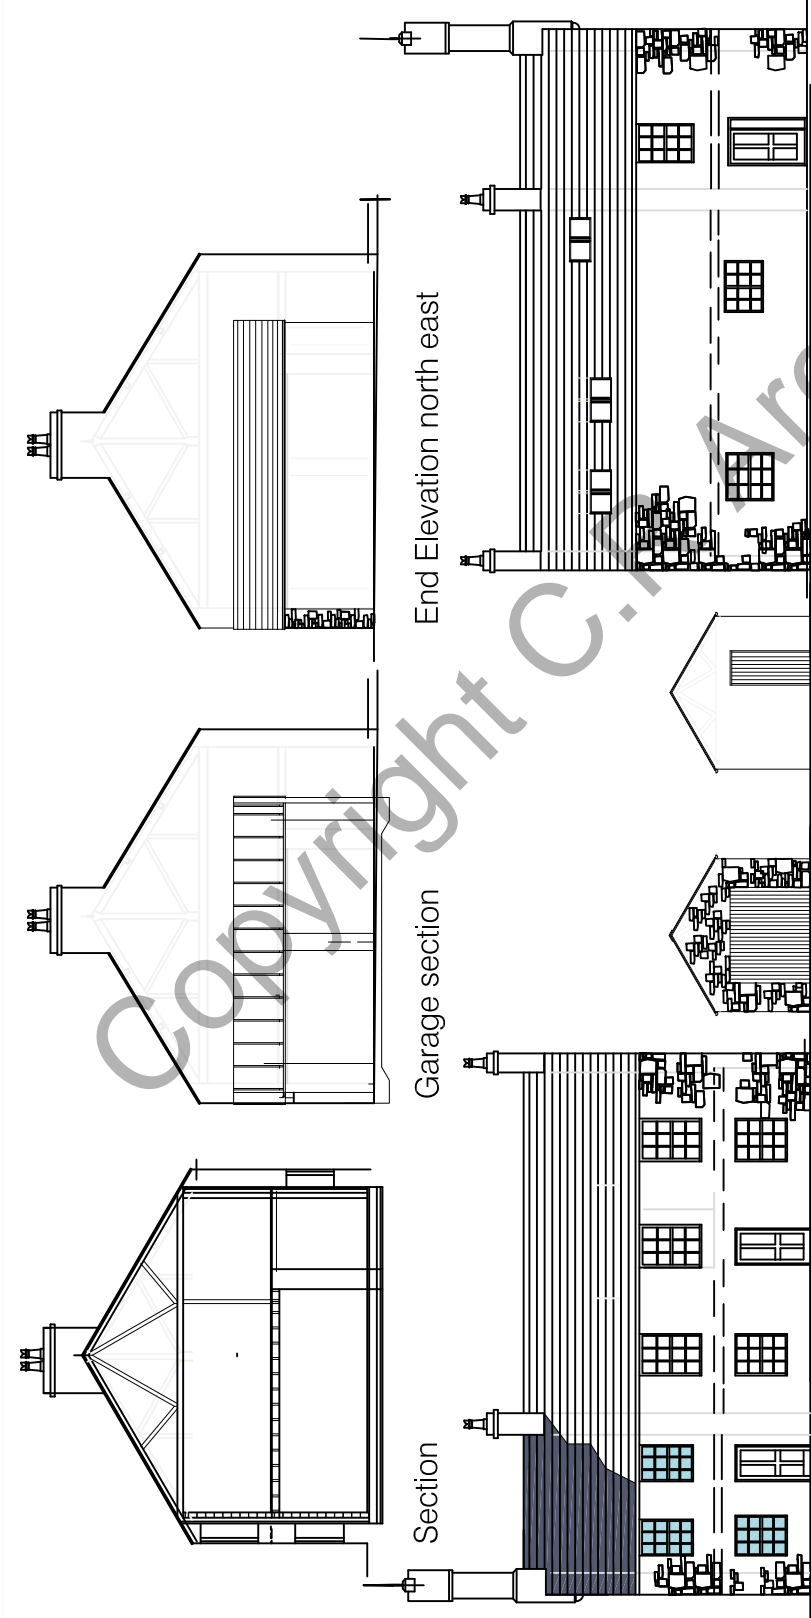
End Elevation south west

- ROOF : Natural slate at 30 deg pitch, fascia boards in dark grey preservative stain.
- BELTOWER : Rebuilt using recovered dressed limestone.
- CHIMNEYS : Coursed semi- dressed limestone with lime mortar pointing.
- WALLS : Limestone uncoursed rubble with spread lime mortar pointing finished with white microporous masonry paint.
- GARAGE: Front as main walls with side and rear walls granite aggregate on grey coloured mortar backing.Slate roof, timber doors.
- WINDOWS : Twelve pane vertical sliding sash spring loaded double glazed timber windows white finish
- FRONT ELEVATION : Twelve pane vertical sliding sash spring loaded double glazed timber windows white finish
- REAR ELEVATION : Twelve pane vertical sliding sash spring loaded double glazed timber windows white finish.
- Twelve pane side hung casement window.
