Results of Archaeological Works at

Amgueddfa Forwrol Llŷn, St Mary's Church, Nefyn (Works to Boundary Wall)

Report Number CR108-2016

Results of Archaeological Works at Amgueddfa Forwrol Llŷn, St Mary's Church, Nefyn

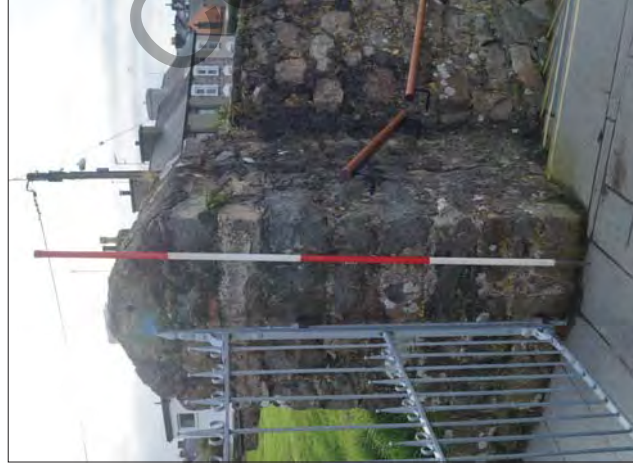
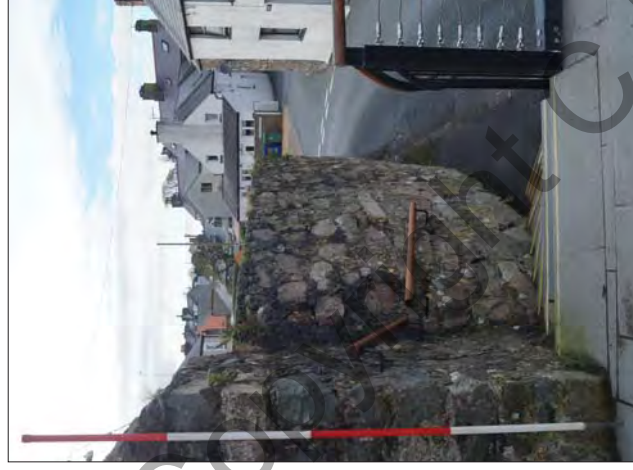
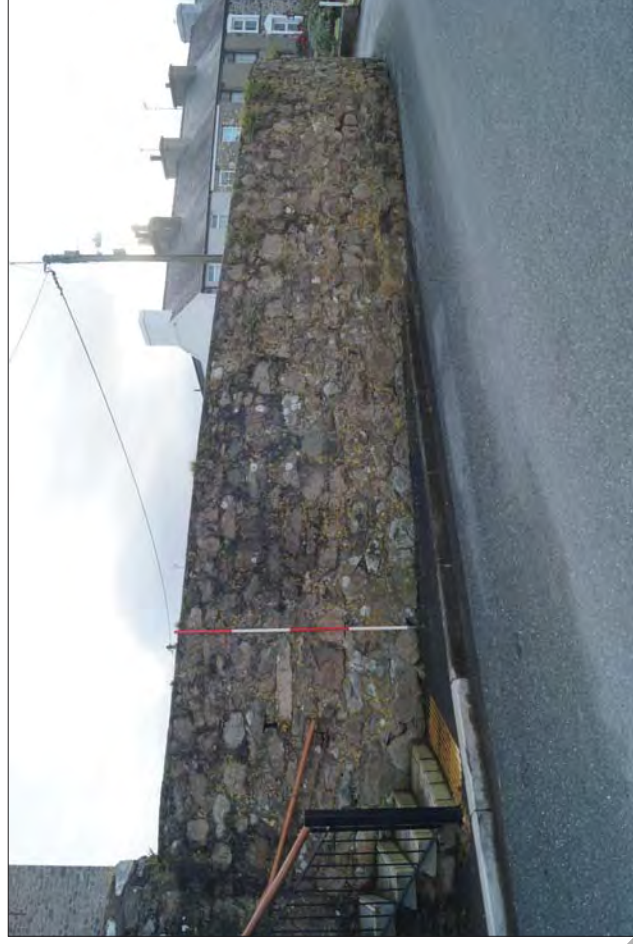
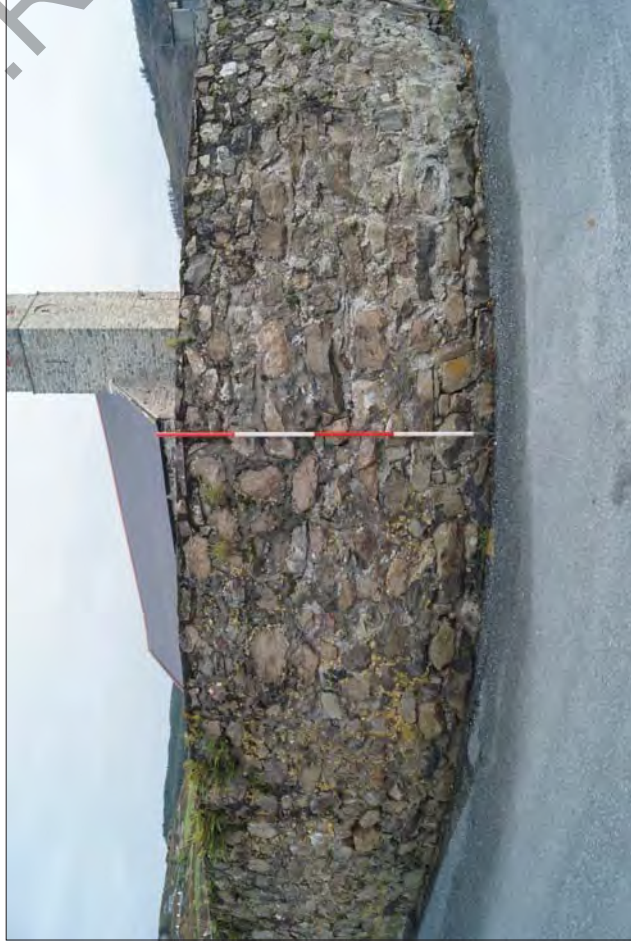
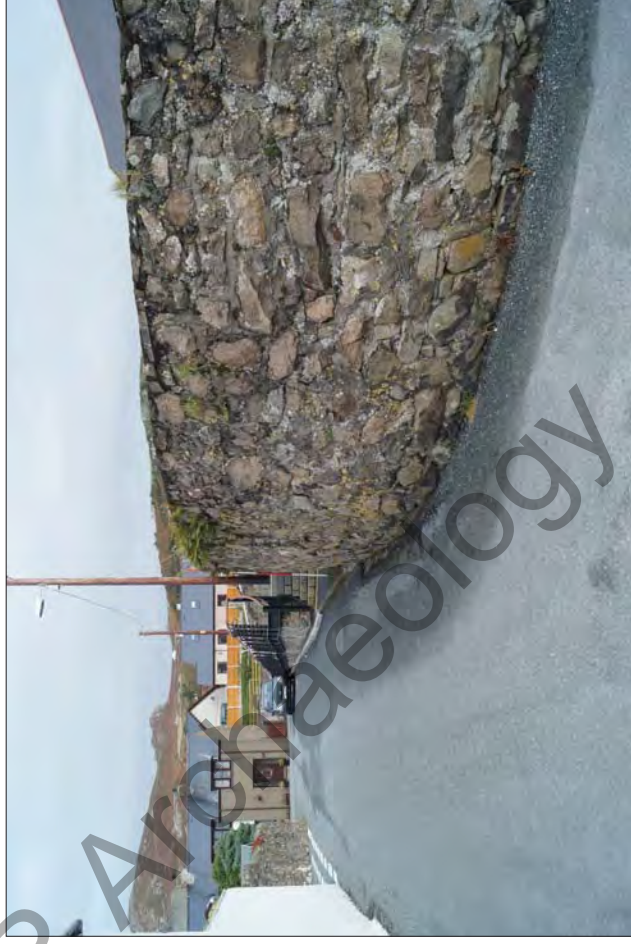
Plates 1 - 5. St. Mary's Church Wall Prior to Remedial Works

The works detailed in this report were remedial and required to rectify a structural problem with the churchyard boundary wall. The structure was bowing badly and was in danger of collapse and it was therefore necessary that a 25m wall section be taken down, strengthened and rebuilt.

The archaeological works at the church revealed that the area of church grounds behind the bowing boundary wall had been extensively remodelled during the nineteenth century. During this remodelling a vast collection of charnal material had been spread over a wide area and buried. This had allowed water to percolate easily through the remains and flow towards the wall. This coupled with the sheer weight of the material held behind the wall is believed to have resulted in the current structural problems.

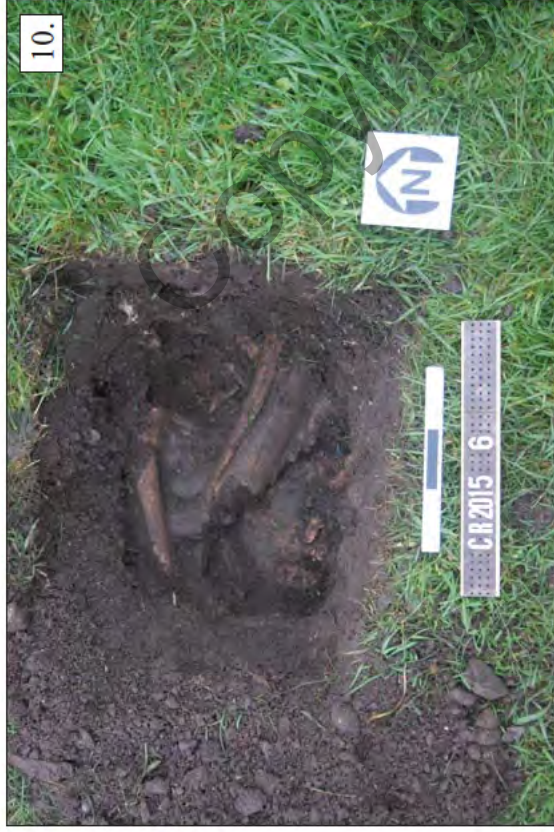
One posthole, posthole 6 contained a significant quantity of disarticulated human remains. The remains were present from a depth 0.20m below the ground surface (see figure 2 & plate 10). The depth of the remains continued beyond the required depth of excavation (0.50m). Small quantities of human bone were also recovered from the topsoil within all the other post holes within the church yard. No other archaeological material was recovered from the post holes within the road area.

Plate 10. Disarticulated Human Remains at the Base of Fence Post Hole 6

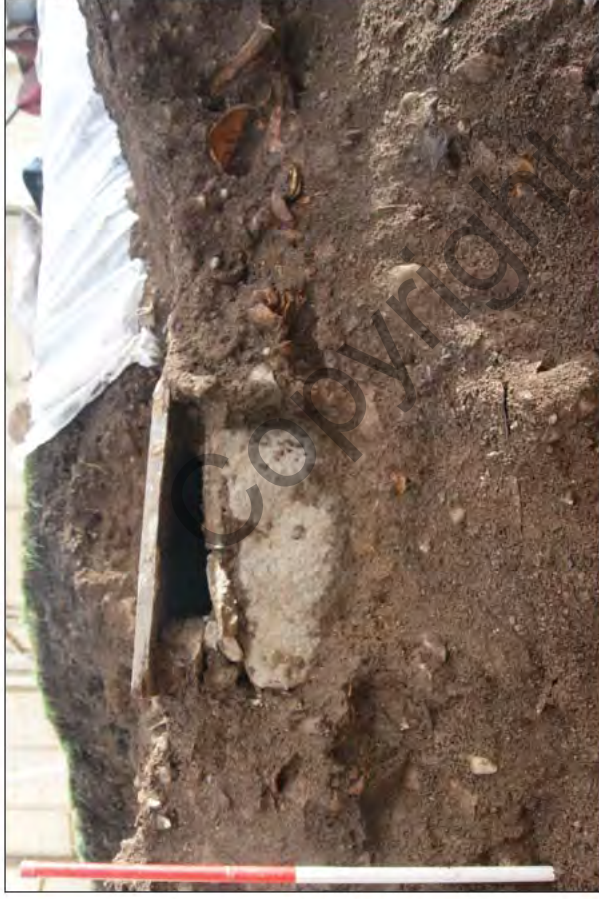
Grave cut [04] was cut through the pit fill (03) and was a single grave with a cut slate covering. As more than half of this grave lay outside the excavated area works involved only the removal of the head stone and the slight shortening the grave. It contained a single adult inhumation and the portion of the skeleton which lay within the affected area was moved within the grave and the grave resealed. The grave was thus recorded in section (figure 3).

Plate 15. Post Medieval Stone Built Grave [04]
Cut Through Charnel Pit [02]

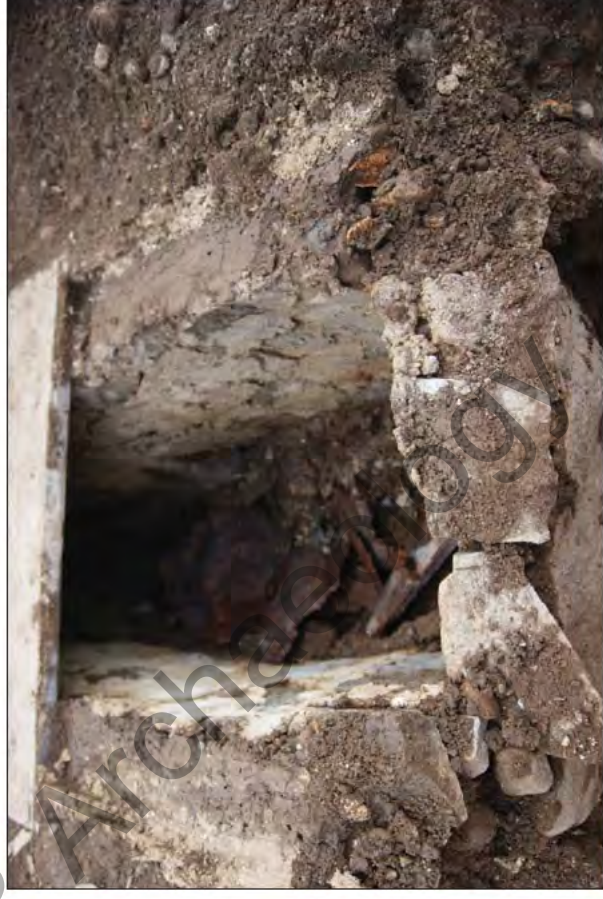
Plate 18. Grave [04] Following the Removal of
Capstone. Note In situ Iron Coffin Decoration

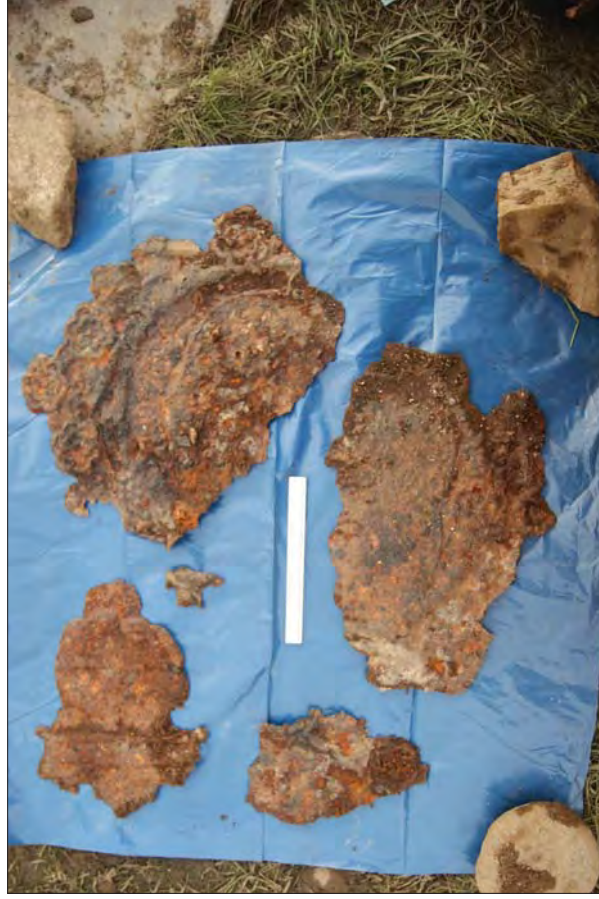
Plate 21. Remains of Iron Coffin
Plate within Grave [04]

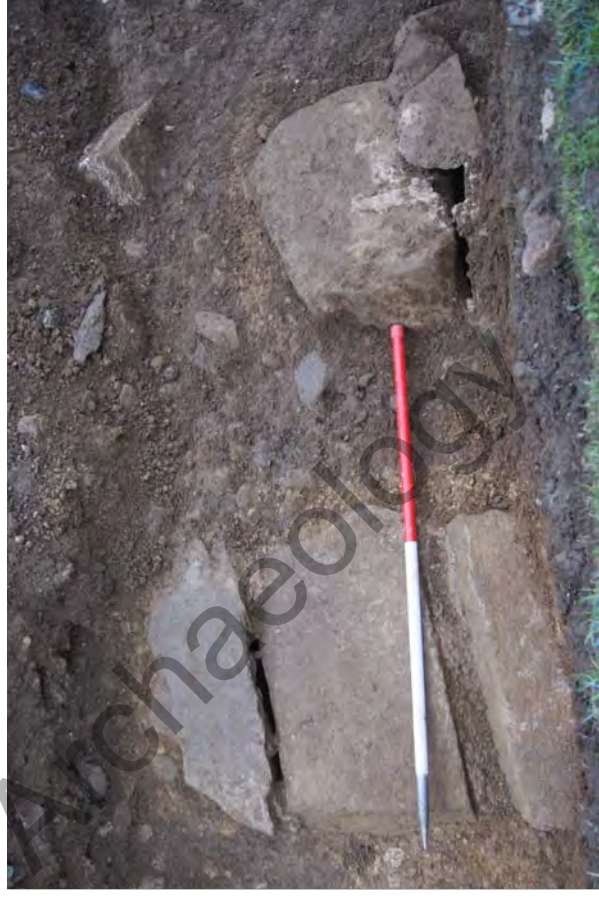
Plate 22. Capstones of Two Post Medieval Stone Built Graves
Graves 17 & 20 Situated Beneath the Charnel Pit

The majority of grave 17 was located outside the area affected by the new wall construction and in this instance it was possible that the plans could be altered slightly so that it was not necessary to remove this structure. One of the capping stones was removed to allow the interior to be photographed.

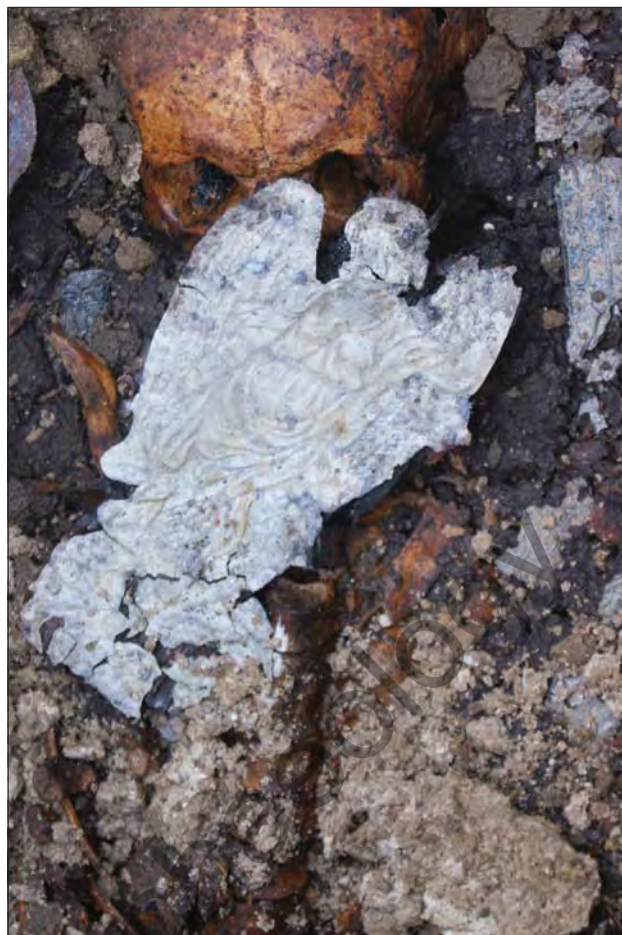
Plate 28. Detailed Shot of Tin
Angel Design Coffin Plate

Within the stone grave structure was a single well preserved adult skeleton (26) together with the remains of a wooden coffin. Many of the coffin fittings had survived including the iron coffin handles which were set within a triangular back-plate with impressed flower decorations. A tin coffin lid plate was also recorded. It had an embossed angel image and was found laying over the face/upper torso of the skeleton (plate 28). An iron shield shape coffin plate was also noted over the groin area.

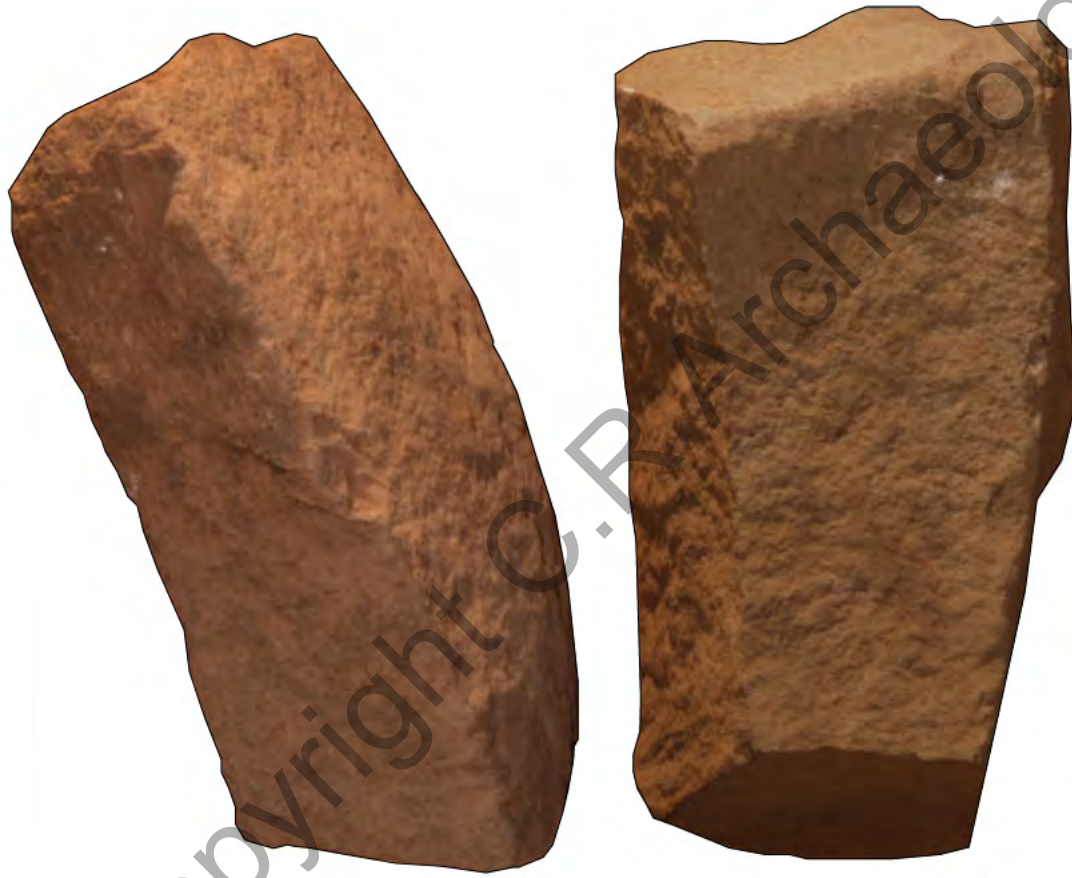
Figure 13. Fragment of Stone Bowl

A fragment of a small carved stone bowl was recovered during the works. The use of stone bowls within the earlier church are quite common, Holy water fonts called stoups were usually placed at the main doors of churches and churches will usually have a special basin (Sacramentum or piscine) which

leads directly into the ground for the proper disposal of Holy water. It is likely that the early church would have had both of these features. It was not possible to accurately date this fragment beyond a broadly Medieval attribution.
