**Results of Archaeological Watching Brief at  
Parish Church of St. Mary, Penllech**

**Report Number CR109-2015**

## **Results of Archaeological Watching Brief at**

**Parish Church of St. Mary, Penllech**

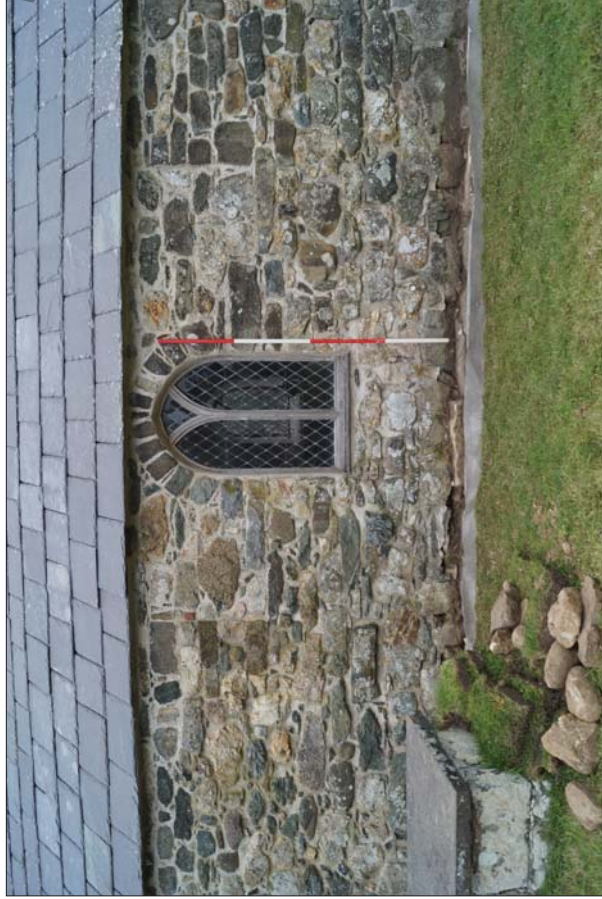
**Plate 7.** Southern Elevation Showing Nineteenth Century Window Flanked by the Remains of Two Lancet Windows

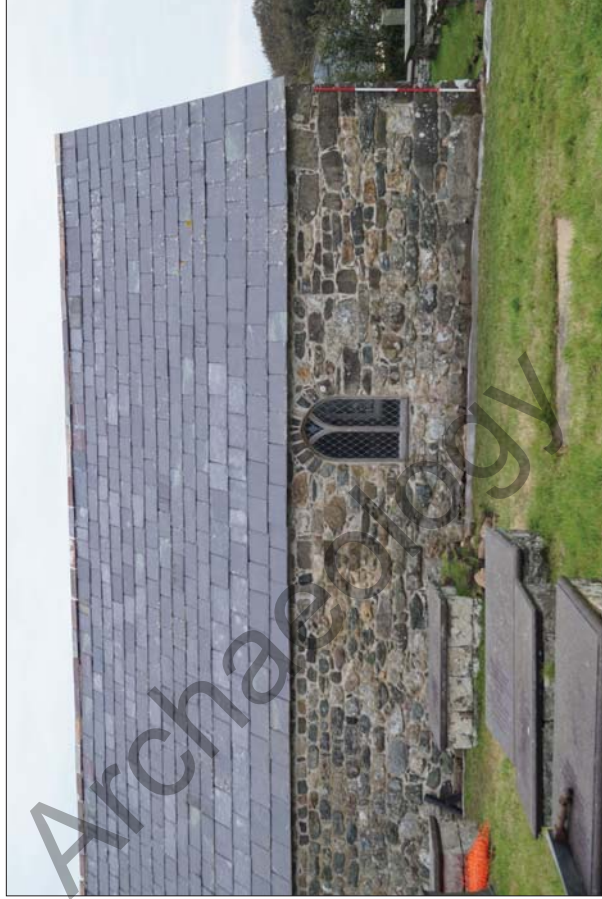
**Plate 8.** Southern Elevation Showing Nineteenth Century Window Flanked by the Remains of Two Lancet Windows (Wider Angle)

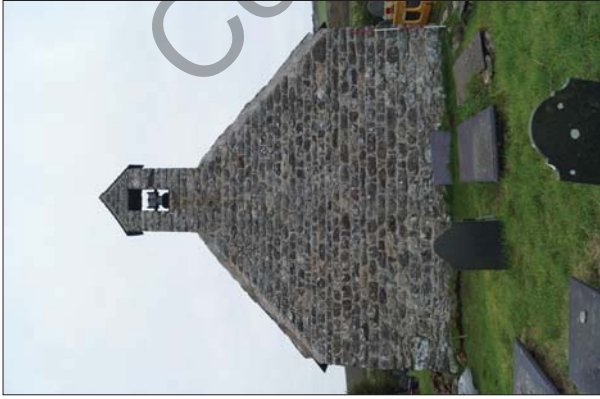
**Plate 9.** Western Elevation

The western elevation (plate 9) is largely of nineteenth century date, and the upper wall portion and bell tower all exhibit the characteristic neatness and regularity of the later masons. The lower section of the wall is however far less regular and is of the same phase as the nave remains observed on the northern elevation.

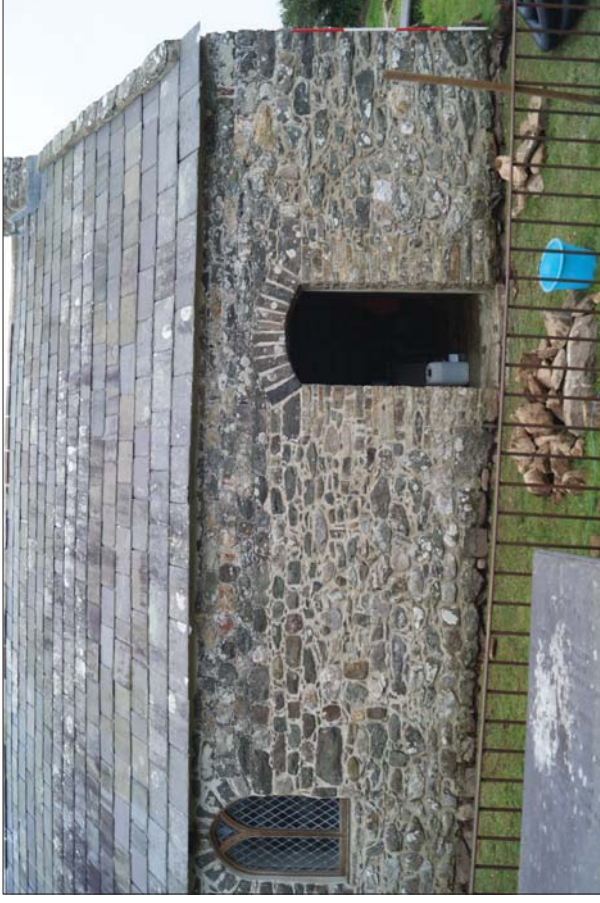
**Plate 11.** St. Mary's Church, Penllech. Northern Elevation  
Note Medieval Stonework at Base of Wall

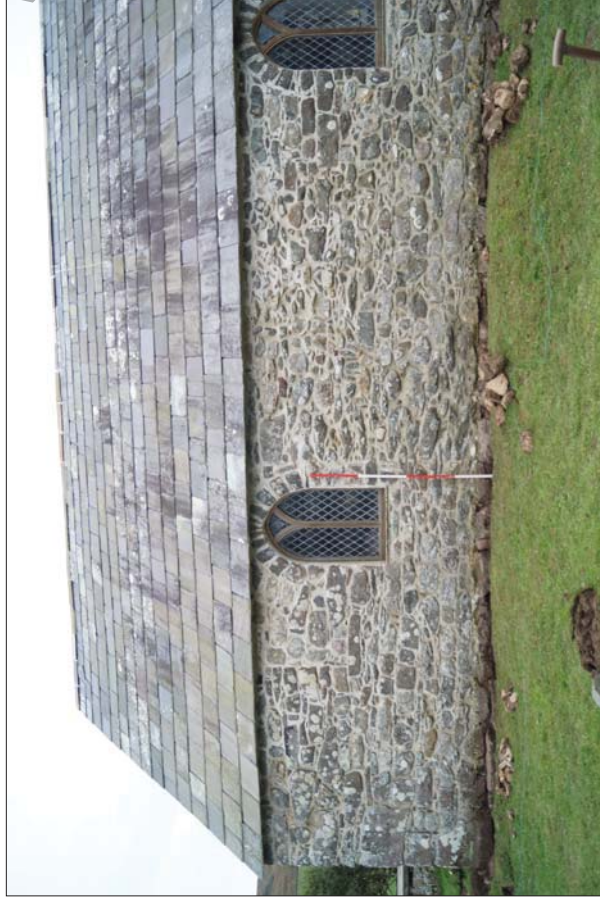
**Plate 12.** Northern Elevation Showing Patching with Smaller Stone Between Chancel and Nave and Remains of Lancet Window

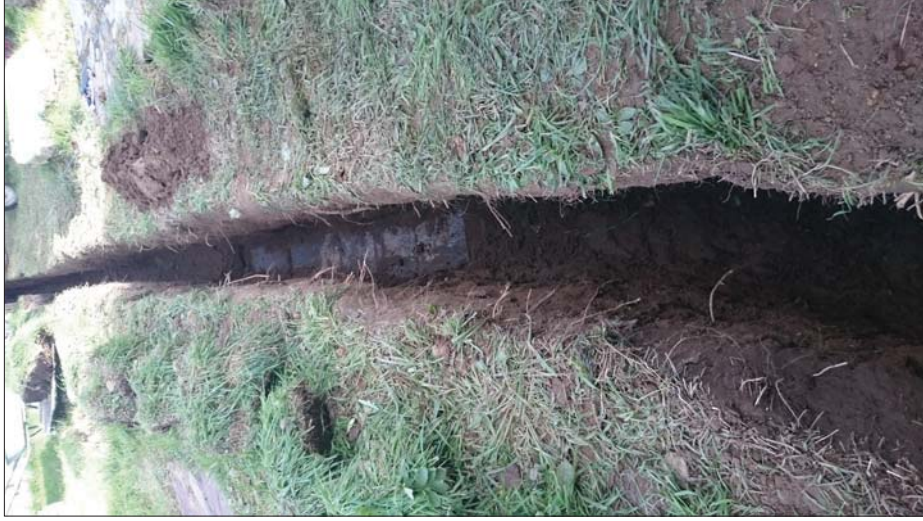
A single grave (context 05 see plates 14 & 15) was encountered during works. It was located 4.93m from the south-western corner of the church and was 0.90m below the ground level. The grave was not fully exposed as it lay partially outside the excavation limits. The grave was not disturbed as it lay below the required depth for works. It was slate-capped with six slate pieces and was 2.10m in length. They were not lifted for closer examination but the slates appear to have been roof tiles which had been re-purposed as a grave cover. Given the incorporation of slate into the grave it is likely that the grave was of nineteenth century date.

**Plate 14.** Trench 1 Facing East  
Showing Slate Capped Grave (05)

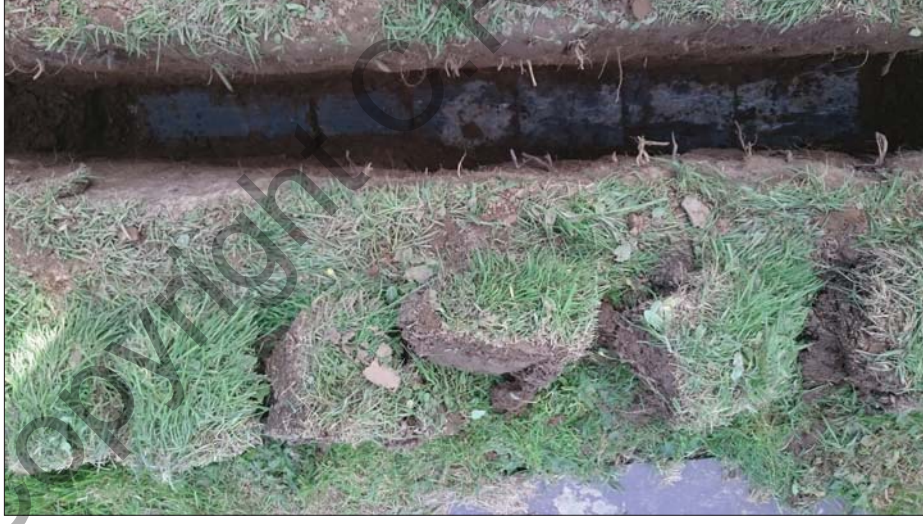
**Plate 15.** Trench 1 Facing East  
Showing Slate Capped Grave (05)

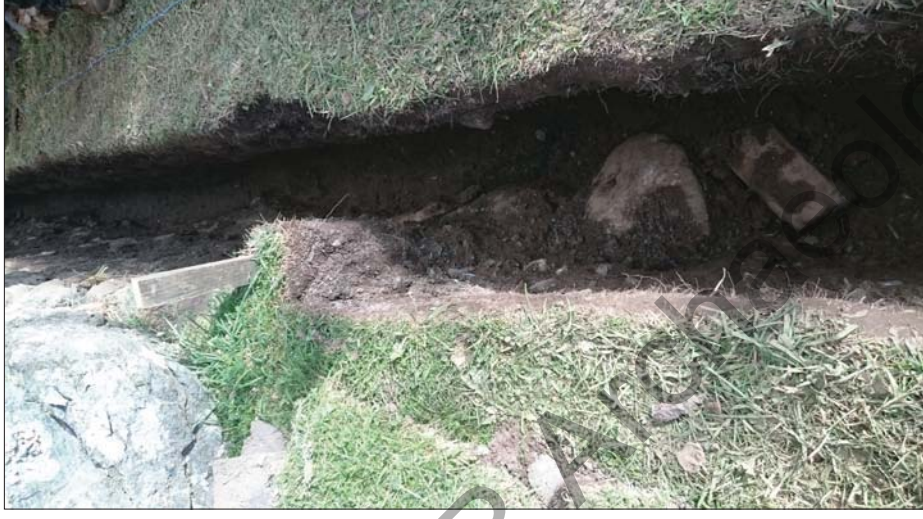
**Plate 16.** Trench 1 Facing East  
Showing Stone Rubble Foundations

As was observed within the other trenches the church foundations were earth bonded and no traces of mortar were found on any of the stones. The foundations were constructed using the same mix of rubble stone as was observed within the church walls themselves, although larger stones were generally used. The foundations in this portion of the church were partially stepped out from the walls above. This was a maximum of 0.16m from western elevation but were almost flush for the upper layers along the southern church wall. It was however evident that at the base of the trench the foundations stepped out further and are presumably from an earlier construction phase. The use of this construction method would indicate that the foundations belong to the Medieval church and had been reused when the western gable was rebuilt in 1840. The foundations for the church were very substantial and continued below the limit of excavation.

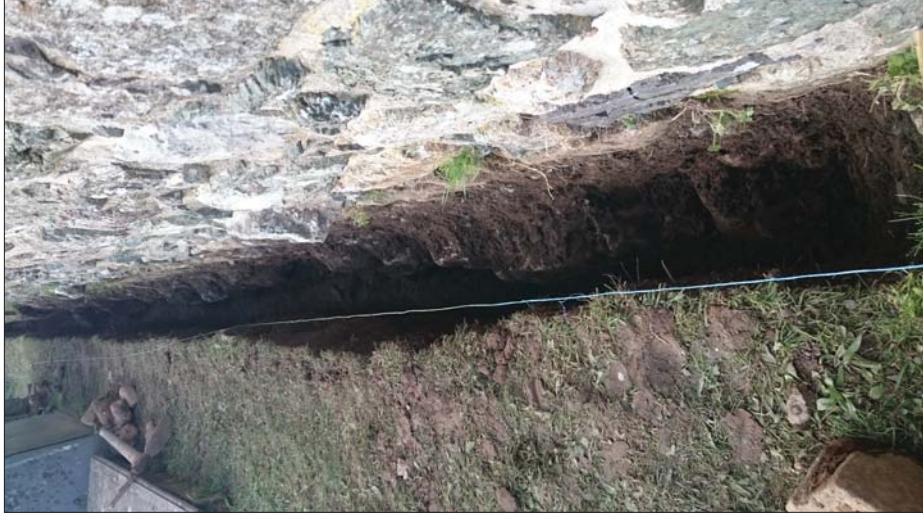
**Plate 17.** Trench 1 Facing West  
Showing Stone Rubble Foundations

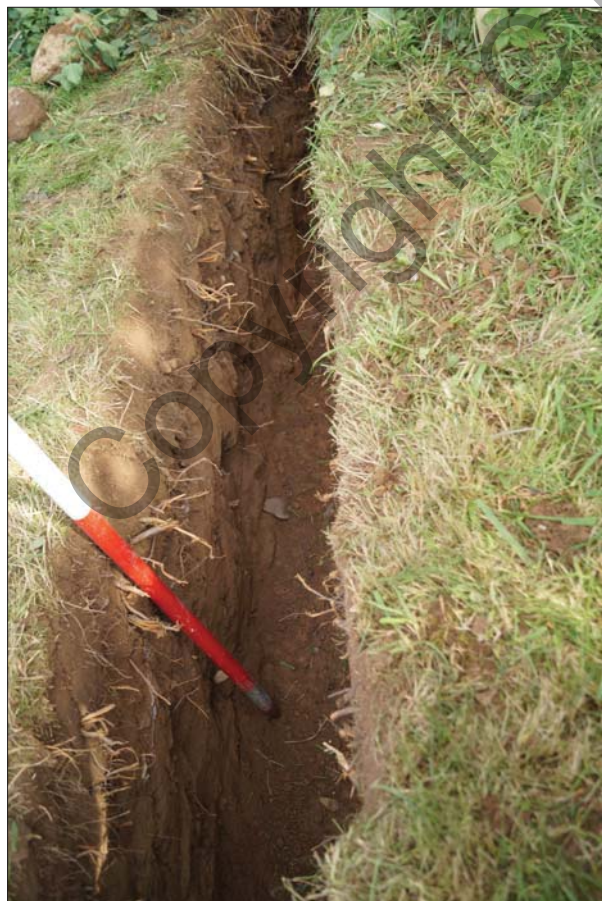
Three contexts were identified within this trench. The topsoil/turf layer (01) had an average depth of 0.20m, and was a mid-brown sandy clay with occasional small slate and angular stone inclusions. Context (02) had a maximum depth of 0.65m and was a mid-brown sandy-clay-silt mixed graveyard soil. It contained occasional small slate and angular stone inclusions. A very small number of very degraded human bone fragments were recovered during works and were placed at the base of the trench and reburied. The deposit was very mixed as a result of frequent digging within the graveyard. Context (03) was the underlying light-mid brown clay natural. It was reached at an average depth of around 0.60 – 0.70m. No burials were encountered in this trench.

**Plate 20.** Trench 2 Sample Section

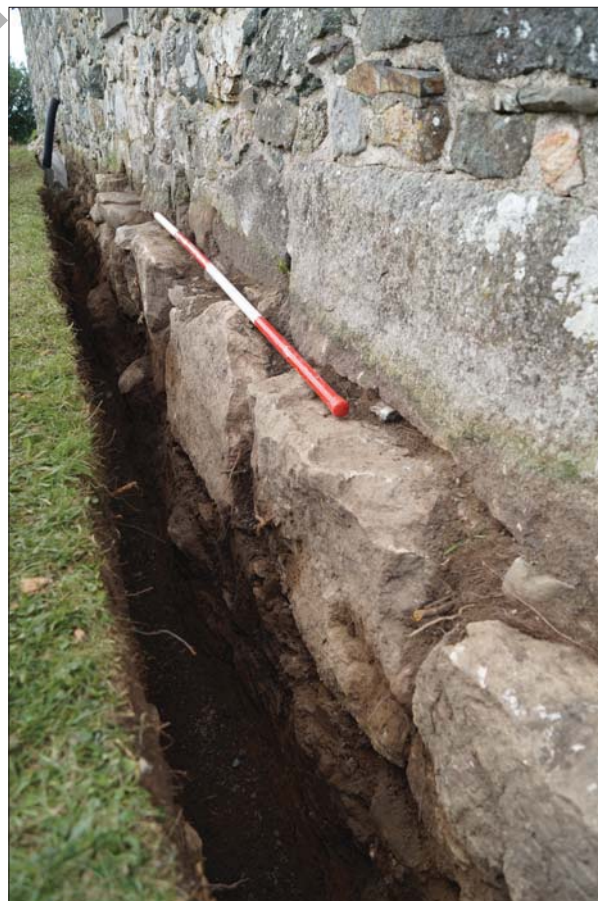
The church foundations uncovered in trench 2 showed that the foundations also step out at the chancel end of the church. They jut out up to 0.19m from the church walls above. This continues at ground level for 4.1m from the south-eastern corner the foundations. The foundations continue at this width at the lowest level of the trench but are stepped inwards to become almost flush with the church at the upper level. This is best demonstrated in plates 24 – 26. These upper foundations are also earth bonded and therefore also presumably Medieval but belong to a later phase than those encountered below .

**Plate 21.** Trench 2 Projecting  
Earth Bonded Church Foundations

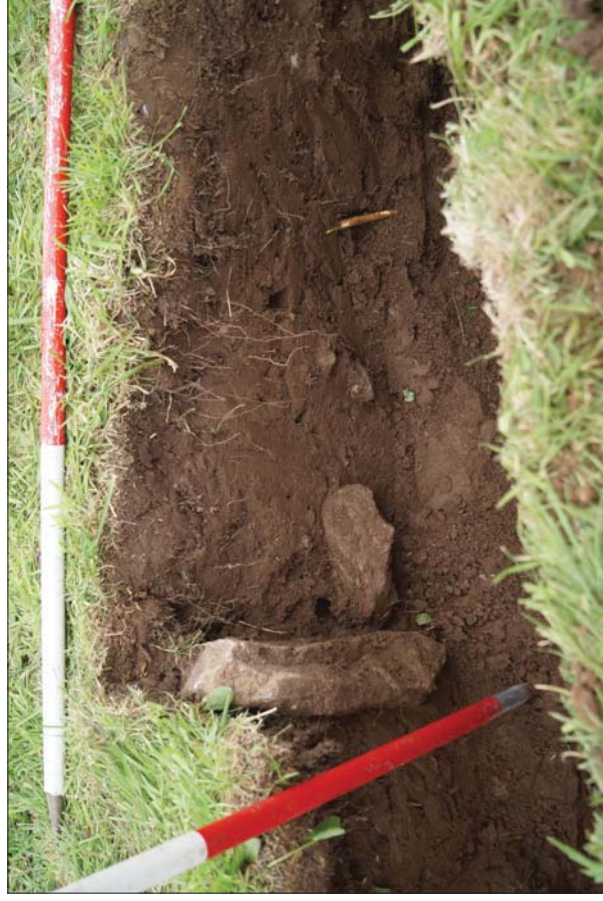
**Plate 29.** North Facing Section of Trench 3 Showing Remains Of Possible Eighteenth Century Cist Grave (04)

A single possible cist burial (context 04, see plate 29) was encountered during works. It was located approximately 3.1m from the north-western corner of the church. It was not excavated as the trench was repositioned so as to avoid disturbing the grave, although the trench section was cleaned to reveal an upright stone slab at the western head end of the grave and a possible base or side slab at 90° to it. The grave cut could not be identified due to the mixed nature of the soil but it did appear that the grave had more than likely been disturbed by later burials. The grave was of what appeared to be limestone construction and was similar to another grave found in the cemetery which was dated to the 1730's (plate 30).

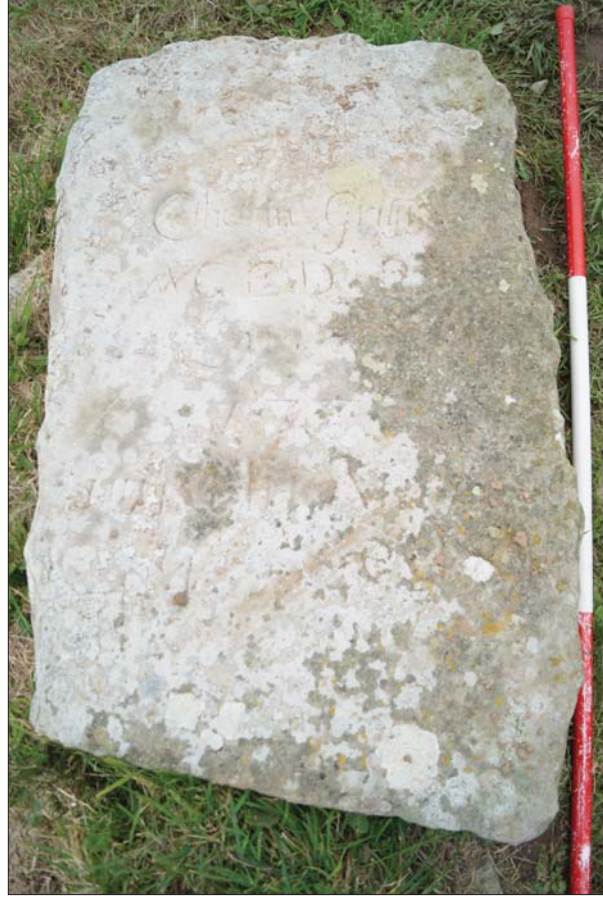
**Plate 30.** Early Eighteenth Century Grave Stone. Supported on Smaller Stone Slabs. Same Construction as Seen in Plate 29

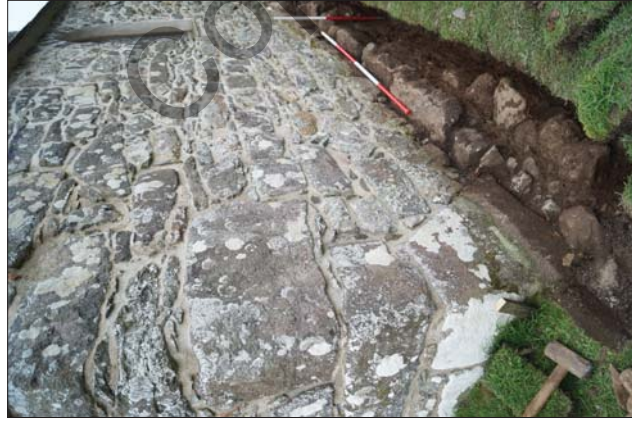
**Plate 32.** Eastern End of Trench  
Showing Foundations

A 0.35m in width (from the wall above, see plates 32 & 33) the church foundations uncovered in the eastern end of this trench were wider than those encountered in the other two trenches and confirm that the church is built on the foundations of an earlier structure. The current church is actually a little narrower and on a slightly different orientation than the earlier foundations, hence the significant stepping out of the foundations. It is also clear that the chancel and the nave are of different phases and presumably the church was lengthened when it was rebuilt.

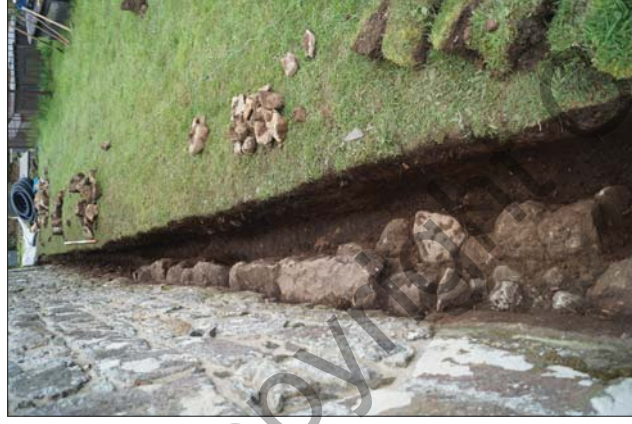
**Plate 33.** Eastern End of Trench  
Showing Foundations

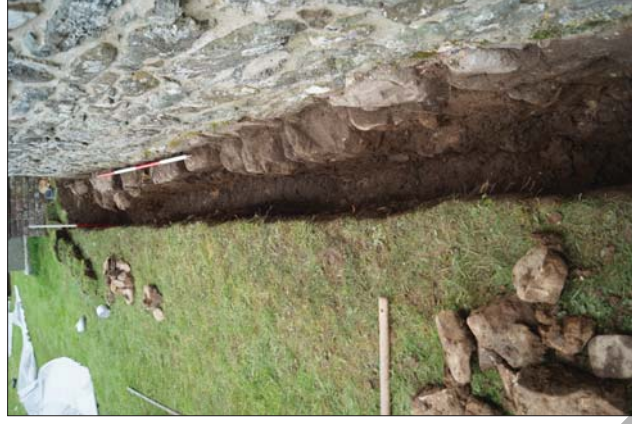
**Plate 34.** Eastern End of Trench  
Showing Foundations

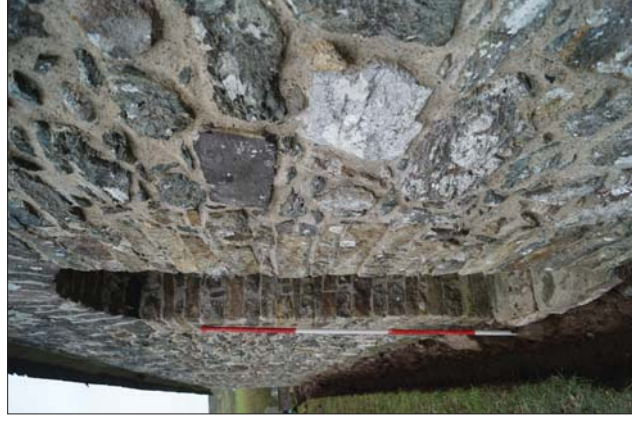
**Plate 35.** Trench 3 Facing East  
Showing Foundation Level

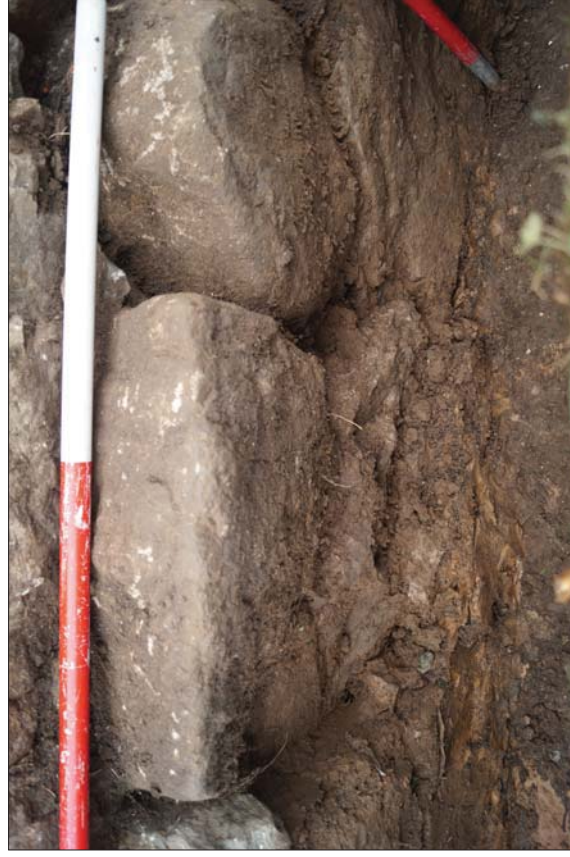
**Plate 36.** Trench 3 Showing Foundation Level Section Detail

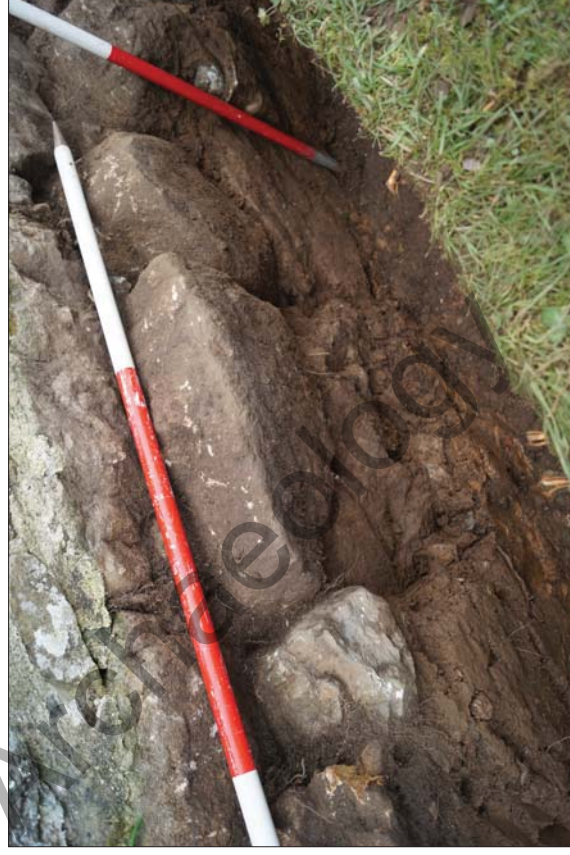
**Plate 37.** Trench 3 Showing Foundation Level Section Detail
