**Results of Archaeological Watching Brief at
Betws Garmon Church, Waunfawr**

Report Number CR110-2015

Compiled by M. Jones & C. Rees
on Behalf of The Church in Wales

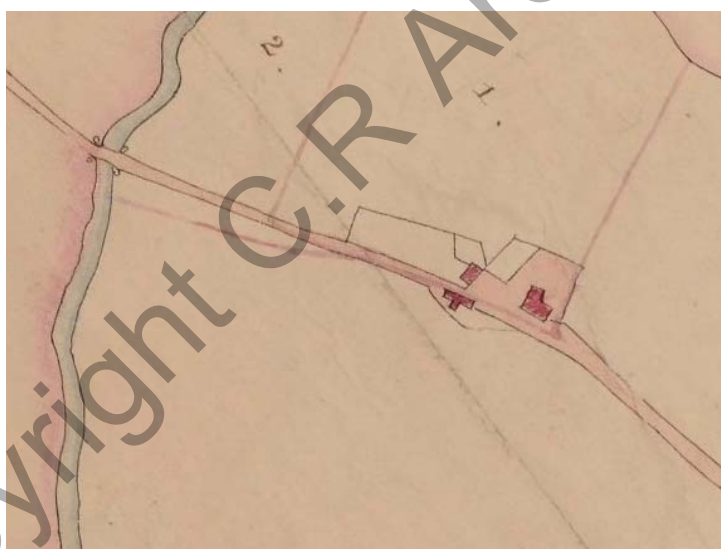
Figure 2. 1840 Tithe Map Showing Betws Garmon Church

The Tithe map (figure 2) shows the earlier church was located on the eastern area of the plot. It was built on a north-south axis, close to old rectory building which later became a public house.

It was believed that the previous church building was positioned between the present building and the nearby Betws Inn. This is supported by the tithe map (figure 2) and the orientation of the pre-1840's graves which all suggest that the first church was located to the east of the current church. The tithe map shows a rectangular building aligned on an east-west axis.

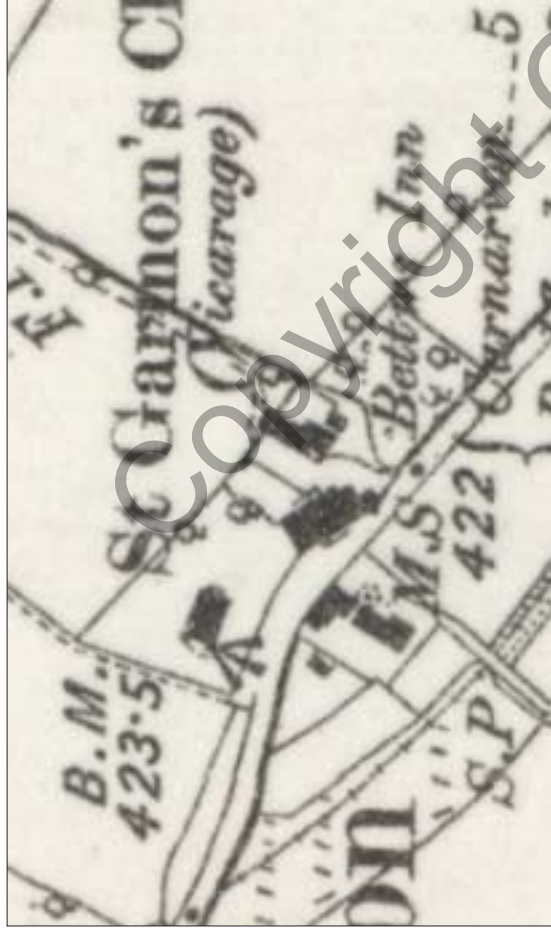
Figure 3. 1888 First Edition Ordnance Survey Map
Showing St. Garmon's Church

The “new” or current church is shown on the First Edition Ordnance Survey Map of Betws Garmon. There are no changes to the church building shown on the Ordnance Survey Map sequence. There are however two additional areas incorporated into the graveyard grounds. The first is a rectangular plot to the west which is shown on the 1901 map and the second a much larger plot to the north which appears to have become incorporated by the production of the 1919 map edition.

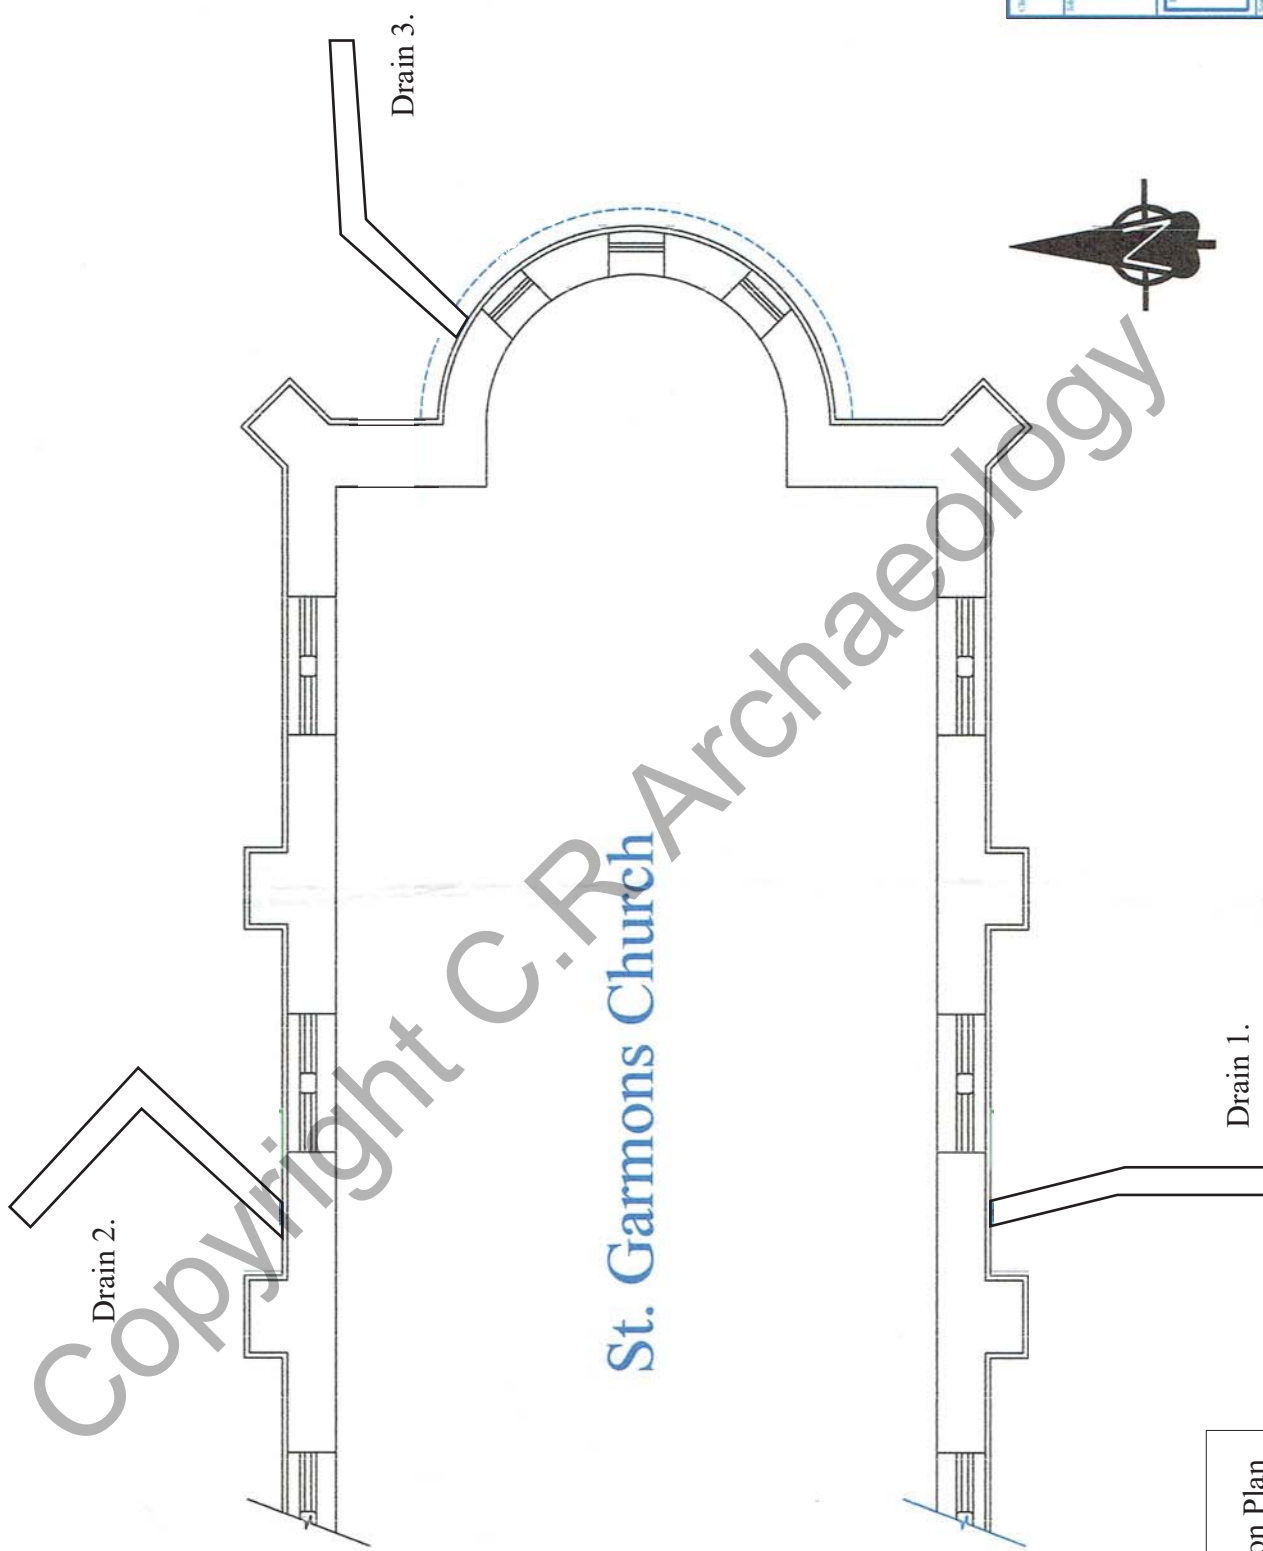
Figure 7. Trench Location Plan

The works carried out at the church consisted of the hand excavation of three drainage trenches. Each was approximately four meters in length and was excavated to a maximum depth of 0.85m. The first (drain 1) was excavated along the southern church wall, the second (drain 2) excavated on the opposite northern wall. The third drain (drain 3) was excavated on the northern side of the apse on the eastern wall. The positions of these drains are marked on the plan included as figure 7.

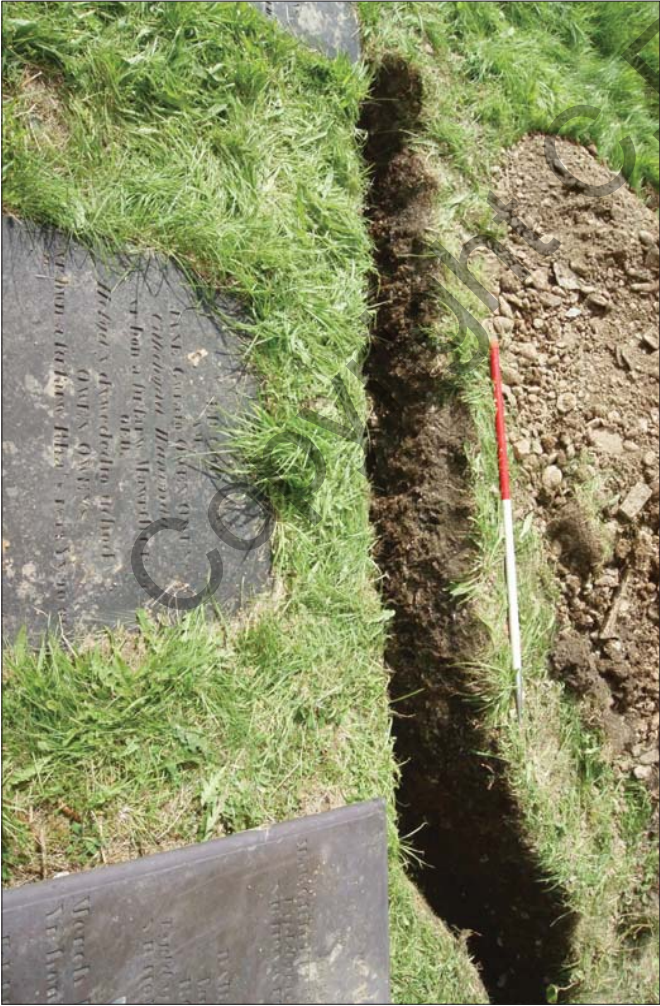
Plate 3. Drainage Trench 1

Drain 1 was orientated on a north-south axis and ran from the southern wall for a distance of c.1.90m. At this point the drain direction was slightly altered in order to avoid existing gravestones and continued for a further 2.10m. It had a maxim depth of 0.85m from the ground level.

Three contexts were identified within this trench. The topsoil (101) had an average depth of 0.22m, and was a brown clay silt with frequent small angular stones. Context (102) had a depth of 0.23m and was a yellow-brown clay-silt mixed subsoil. It contained regular rounded and angular large to small stones inclusions together with broken slate roof tiles. Context (103) was the underlying mixed graveyard soil. It was excavated to a depth of 0.40m but continued below this level. The deposit was a mid-brown soil-clay. It contained frequent slate and a regular distribution of rounded stone. A carved stone corbel believed to be of Medieval date was recovered from this deposit along with late 18th century coarse ware pottery.

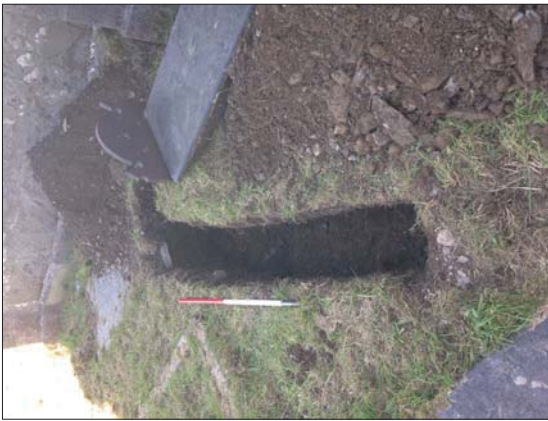
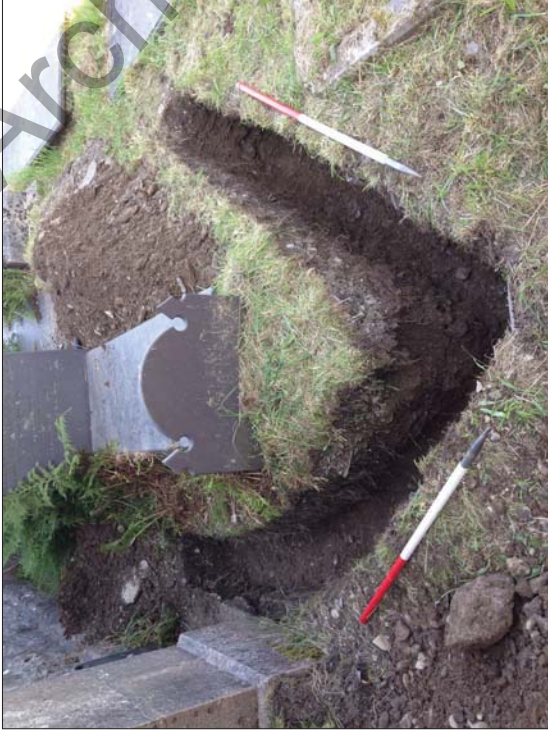
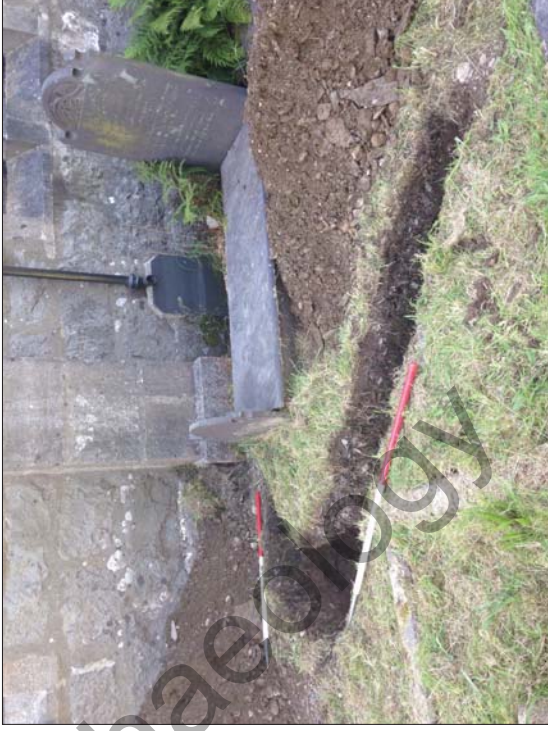
Plate 6. Drainage Trench 2

Drain 2 ran from the northern church wall and proceeded in a northerly direction for 1.80m. At this point it turns sharply, almost at a 90 degree angle, before continuing for a further 2m in order to pass between upstanding tombs.

The trench had a maxim depth of 0.70m from ground level. Three contexts were identified within this trench. The topsoil (201) had an average depth of 0.20m and was a brown clay-silt with frequent small angular stones. Context (202) had an average depth of 0.34m and was a yellow-brown clay-silt mixed subsoil. It contained regular rounded and angular stones and broken slate roof tiles. Context (203) was excavated to a depth of 0.16m but continued below this level. It was a mid-brown clay soil containing frequent slate, and a regular distribution of rounded stone. Late 18th century coarse ware was also recovered from this deposit.

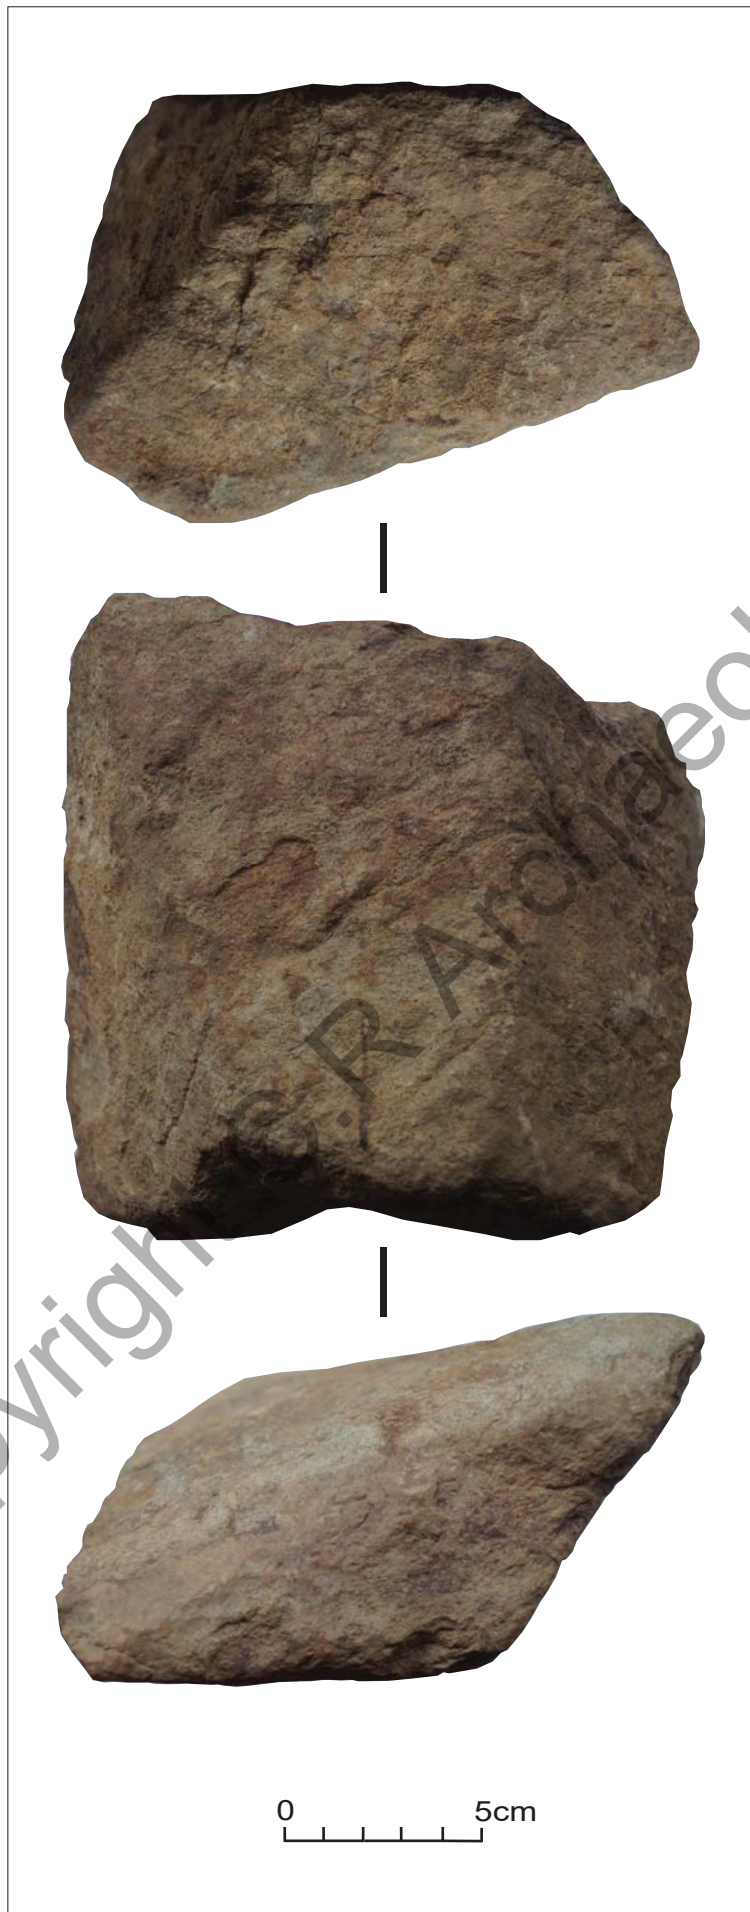
Figure 8. Medieval Stone Corbel

The aforementioned stone corbel is trapezoid in section, measuring 0.15m in width, a height of 0.13m and a depth of 0.08m. These sides have been dressed but not finished further to produce a smooth surface. The most likely origin of this stone was as part of the window tracery for the earlier Medieval church. Based on the shape and size of the stone it is most likely to be part of a window mullion (the vertical element of a large window which separates individual panes).

The carved stone window mullion is believed to have originated from the earlier, Medieval, church. It does not appear to have been used as part of a foundation deposit for the current building and is most likely building rubble which has been mixed into the surrounding area following the demolition of the original church.

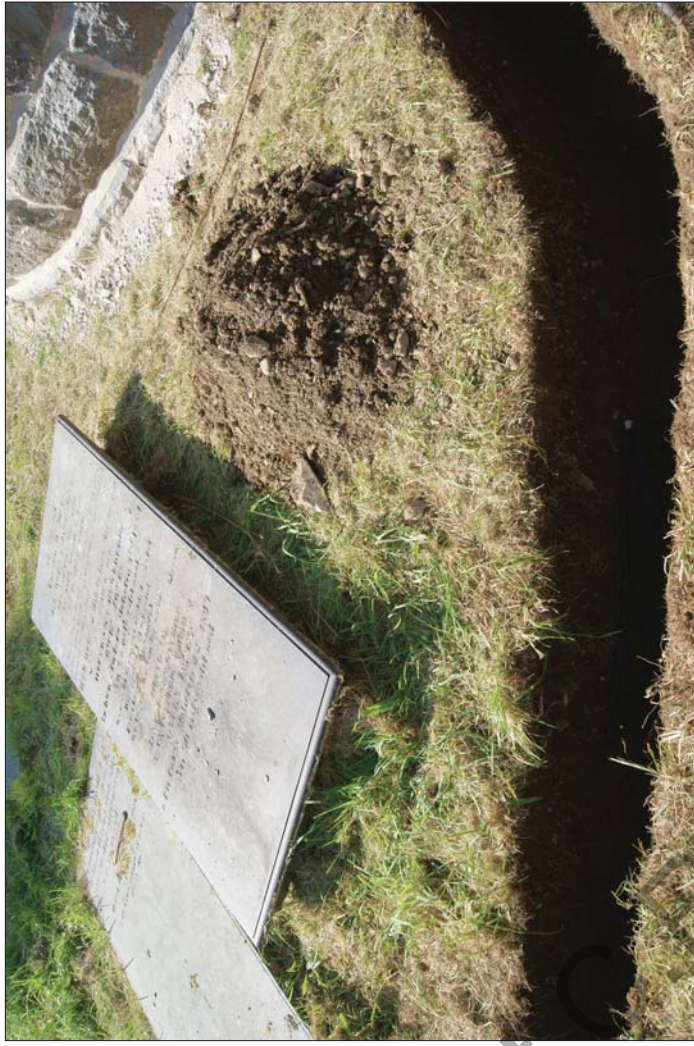
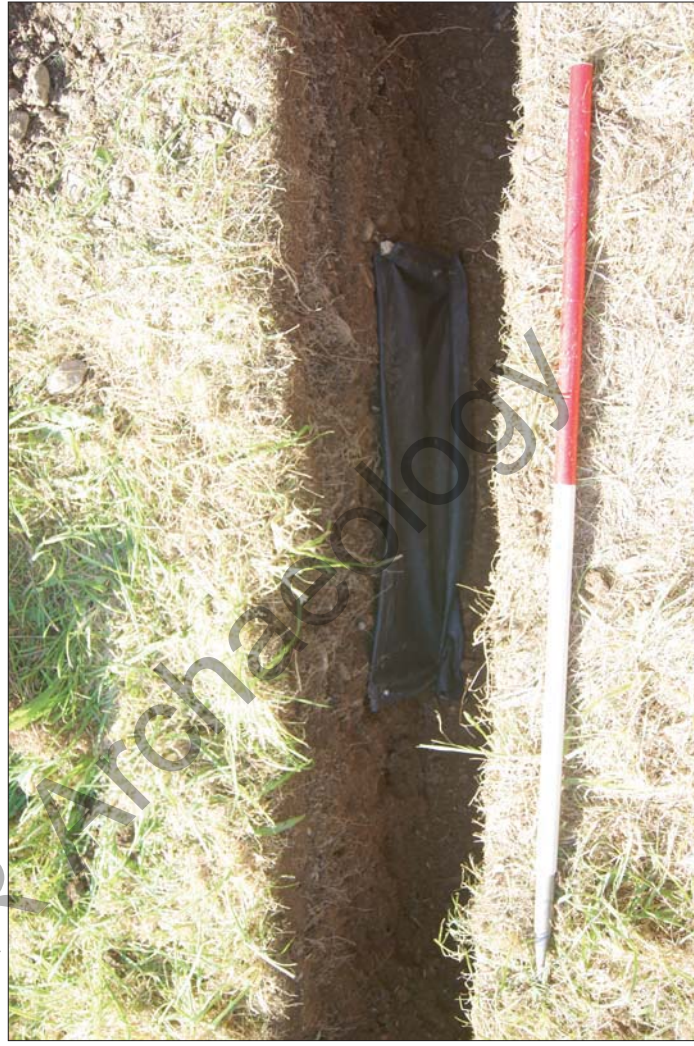
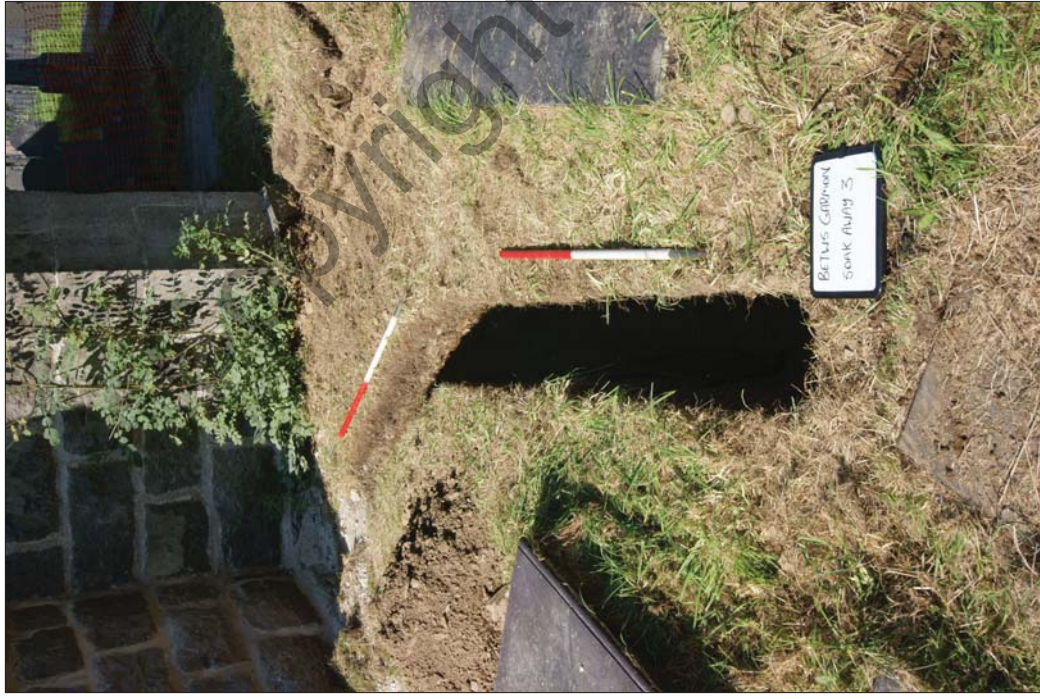
Drain 3 ran from the eastern wall of the church on a south-western - north-eastern axis for 2m. At this point it turns to avoid gravestones before continuing on an east – west axis for 2m. It was excavated to a maxim depth of 0.64m from ground level. Three contexts were identified within this trench. The topsoil (301) had an average depth of 0.22m and was a brown clay silt with frequent small angular stones. Context (302) had an average depth of 0.32m and was a yellow-brown clay-silt mixed subsoil. It contained frequent rounded and angular stones of assorted sizes and broken slate roof tiles. Context (303) was excavated to a depth of 0.10m but continued below this level. It was a mid-brown soil clay containing frequent slate, and a regular distribution of rounded stone.

Plate 9 (Above). Drain 3 Plan View

Plate 10 (Top Right). Drain 3 Sample Section

**Plate 11 (Below Right). Drain 3 Showing
Terram Covering Possible Grave**

The possible cut of a grave was identified within this deposit and could have been associated with a family tomb located close to the edge of the drainage trench cut. Some toe bones were recovered eroding from this cut. These human remains were placed back into a small hollow made in the trench section. Protective terram was placed over the trench side in order to protect the remains from disturbance for the duration of the drainage works. No excavation works were undertaken as the majority of the remains were located outside the development area.

No structural remains were encountered during the excavation of the three drainage trenches. A single grave cut was encountered in trench 3 but was not excavated as it lay outside the development area. The mixed nature of the soils encountered during the works attests to the high level of disturbance within the area which clearly corresponds with the use of the site as a grave yard.
