# 1 - 2 Stanley Street, Holyhead

**Report Number: CR136-2017**

## **Results of Building Recording & Analysis at 1 – 2 Stanley Street, Holyhead**

<b>Planning Reference Number:</b>	N/A
<b>National Grid Reference:</b>	SH 24660 82601
<b>Clients:</b>	Isle of Anglesey County Council
<b>Report Authors:</b>	Catherine Rees & Matthew Jones
<b>Report Number:</b>	CR136-2017
<b>Date:</b>	04/03/2017

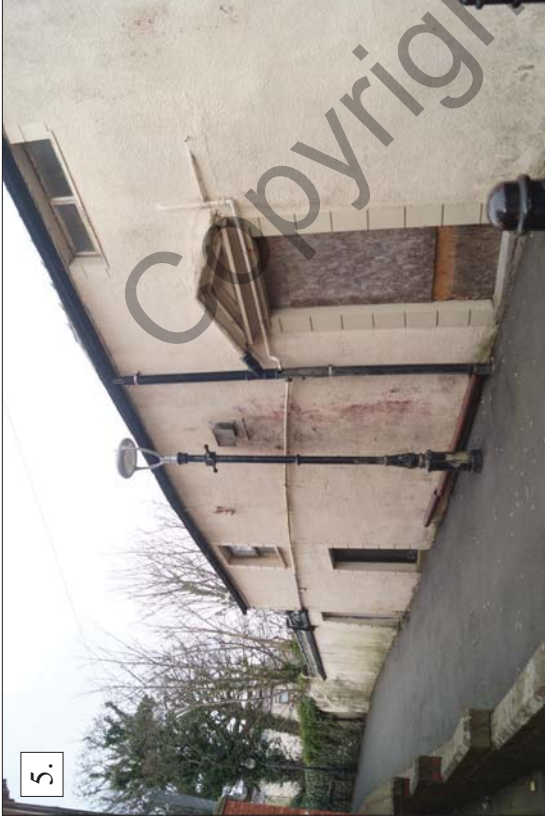
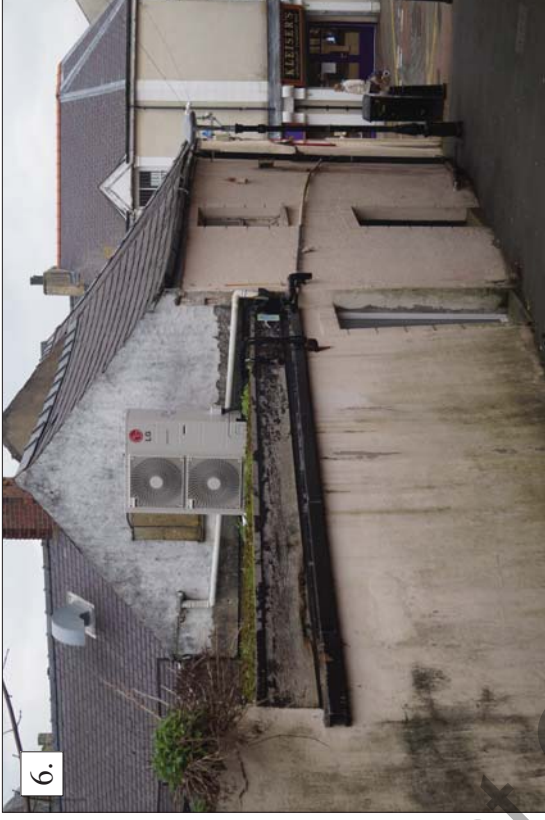
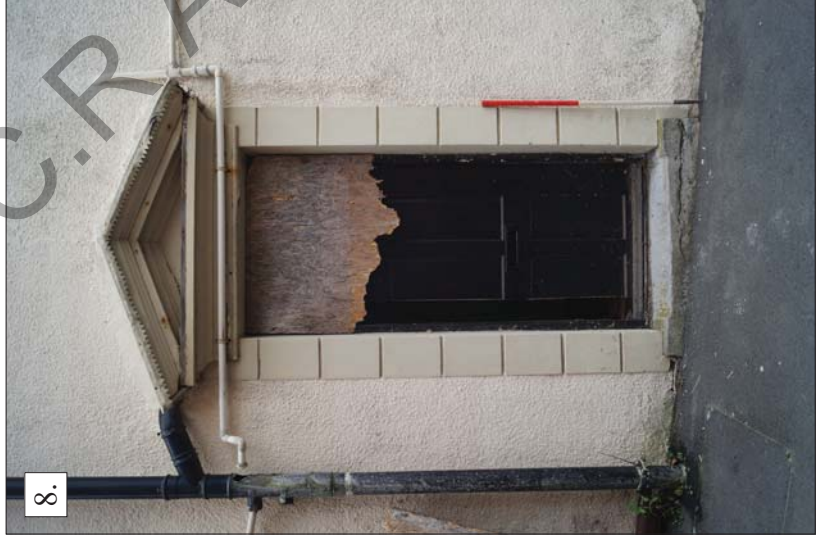
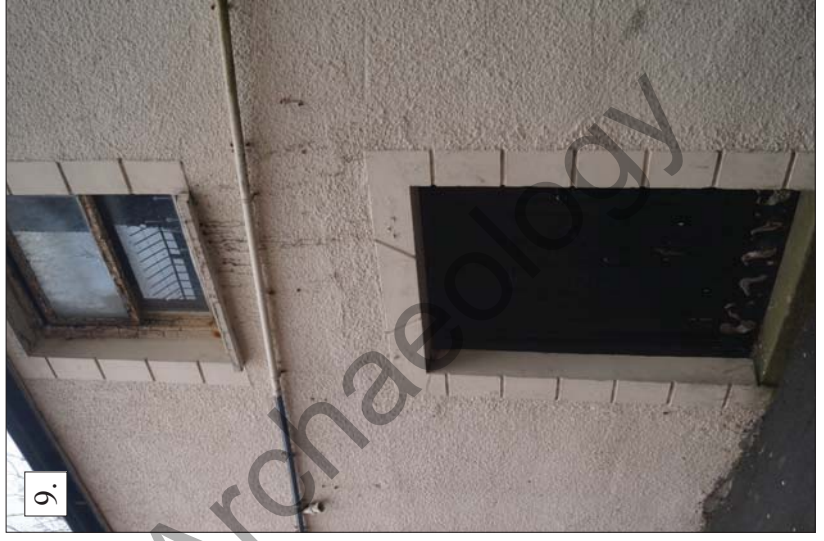
**Plates 5 - 9. 1 - 2**  
Stanley Street South  
Facing Elevation

*6.2.9 All the walls are painted and rendered. The render generally appears to be cement based. There are rusticated details to the sides of the windows and doors. These seem to be recent additions and do not appear on archive photographs taken during the 1960s.*
