**Results of Archaeological Works at**

**Deganwy Castle Hotel, Station Road, Deganwy**

**Report Number CR23-2013**

## **Results of Archaeological Works at Deganwy Castle Hotel, Station Road, Deganwy**

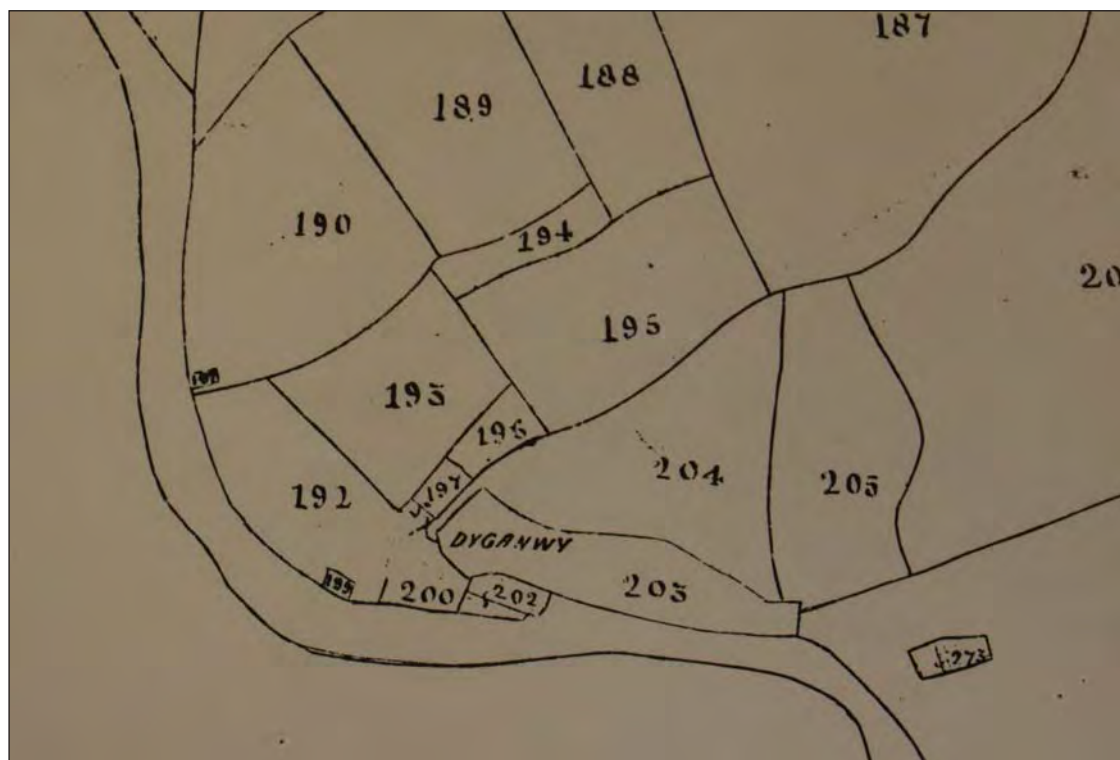
**Figure 5.** 1846 Tithe Map Portion Showing Deganwy House  
Source: Conwy Archives

This is the earliest document which provides a plan of the building footprint at Deganwy House, albeit of a schematic nature. It shows two parallel ranges of buildings, one of which is likely to now form the original core of the Deganwy Castle Hotel and the other was possibly demolished during later building works. There is also the possibility that the second range is that which lies between the core and the river (labelled as Element 4a) as an examination of the building materials and style of this wing indicate it would likely have been built prior to the mid nineteenth century.

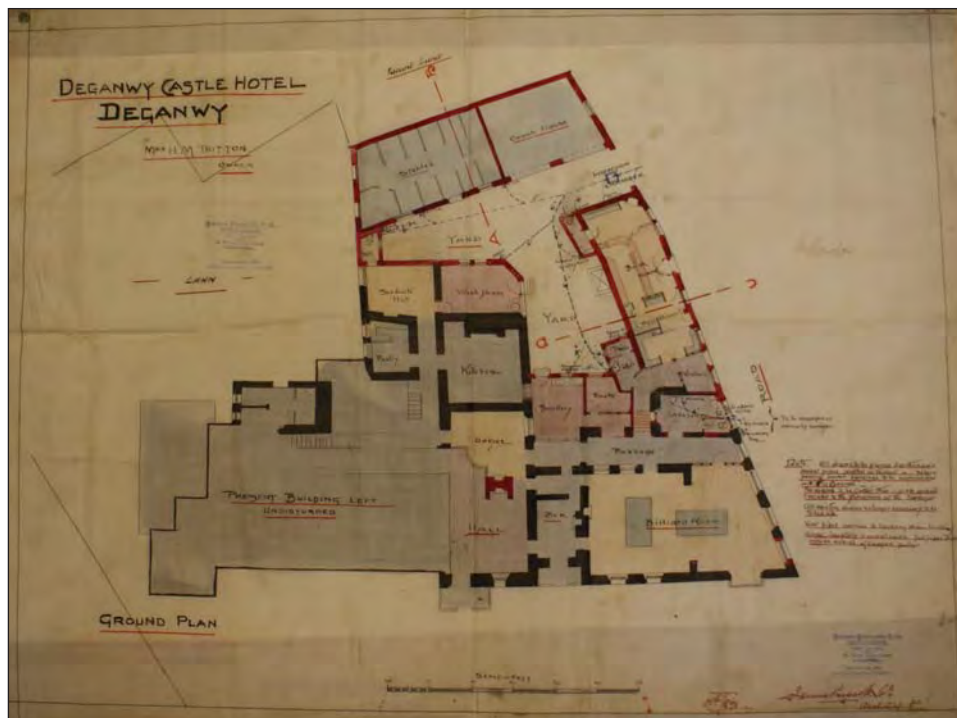
**Figure 10.** Proposed Modifications to the Deganwy Castle Hotel 1898.  
 Note the Existing Building in the Footprint of the 1919 Wing.  
 Source: Conwy Archives Doc C Maps & Plans 23/1/131

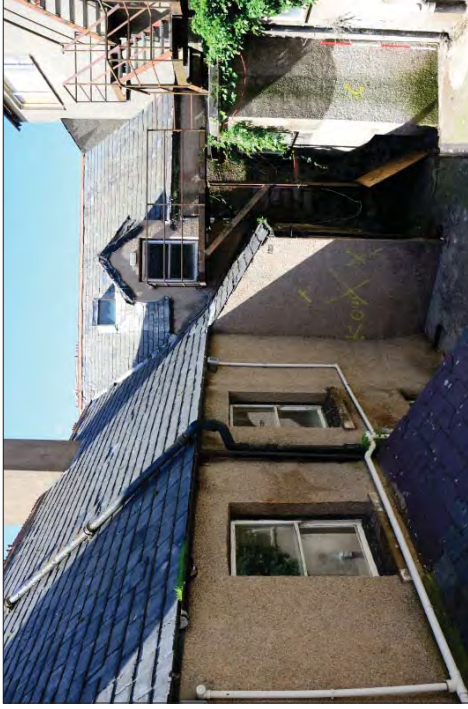
**Plate 13.** Elements 1 East Facing elevation Prior To the Commencement of Works

The exact construction date is unknown and all that can be determined with any certainty is that this portion of the Deganwy Castle Hotel was built pre-1748. Based on stylistic comparisons this core area has been assigned a mid 17<sup>th</sup> century date (Lloyd Morris 2011:1) although as noted above it may have even earlier origins. In her work Lloyd Morris also notes that the substantial stone walls and three massive chimney stacks are indicative of a high status building. No records could be sourced from this early phase of the buildings development but this area of the building is believed to have been built as a farmhouse for a wealthy landowning family.

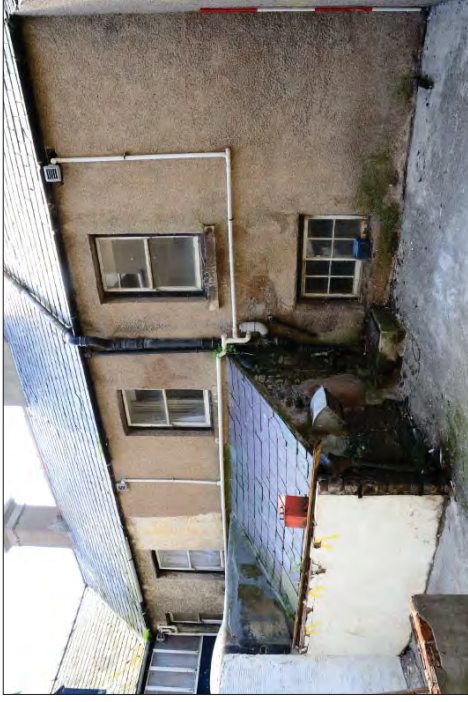
**Plate 14.** Elements 1 East Facing elevation Prior To the Commencement of Works

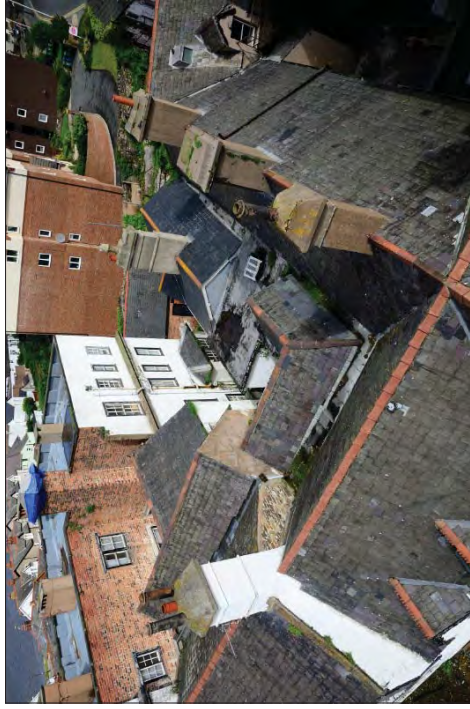
**Plate 16.** Aerial View of Element 1 Facing North Showing Roof Pitch and Large Chimney Stacks

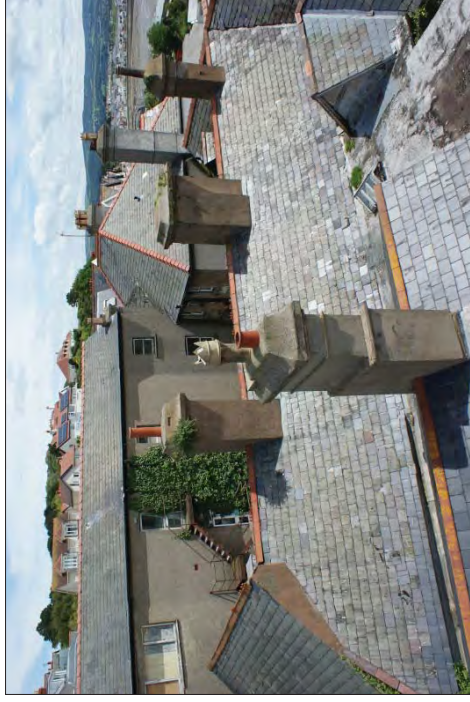
**Plate 17.** Aerial View of Element 1 Facing East Showing Roof Pitch and Large Chimney Stacks

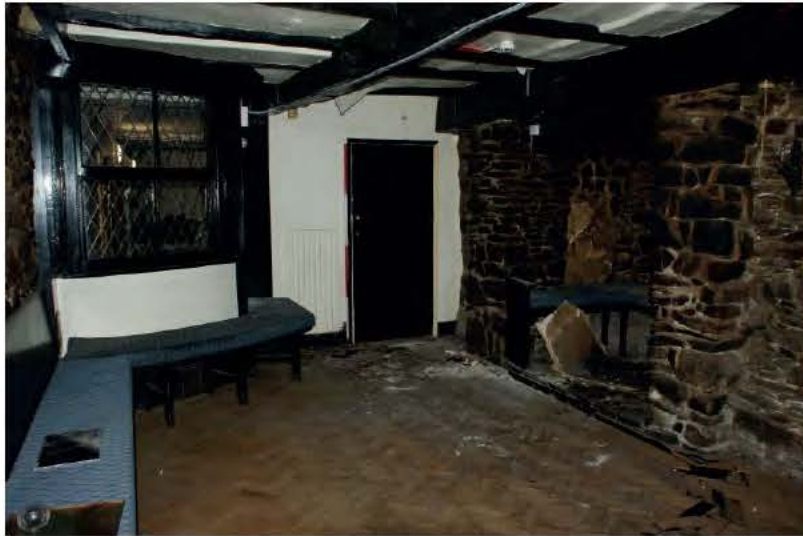
**Plate 27.** Ground Floor Central Room  
Showing Fireplace

The focal point of this room was the large stone fireplace similar to those found in the rear two rooms. It was concealed behind a later timber and copper Art Nouveaux surround. Although in-keeping with the historic wood panelling mentioned above it is noted that this feature is fixed in place using screws and glue and is believed to once again an older element brought from elsewhere rather than a surviving historic decoration (Lloyd Morris 2011: 12).

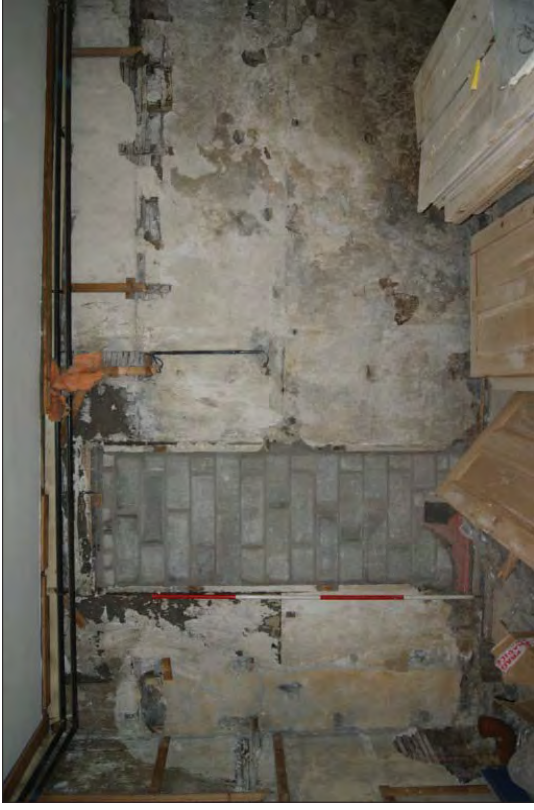
**Plate 94.** Element 4a Manager's Office Ground Floor Level. Door Re-blocked as Leads to Outside

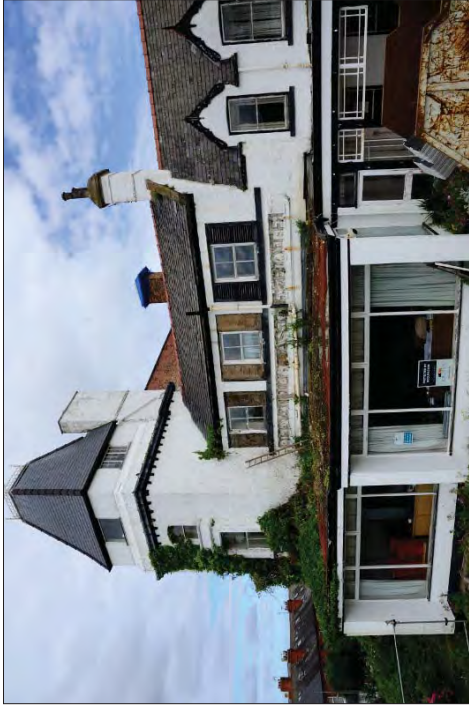
**Plate 116.** Element 6 Tower  
Front & Side Elevations

The windows and shuttering at ground and first floor levels (Plates 125, 128-9) are original although the windows in the second floor are relatively modern replacements and as part of the current scheme of works these will be restored to their earlier appearance as shown on historic elevations and photographs. The stairway leading to the second floor and roof of the tower are contemporary with the 1919 extension rather than the tower itself (Plate 127).

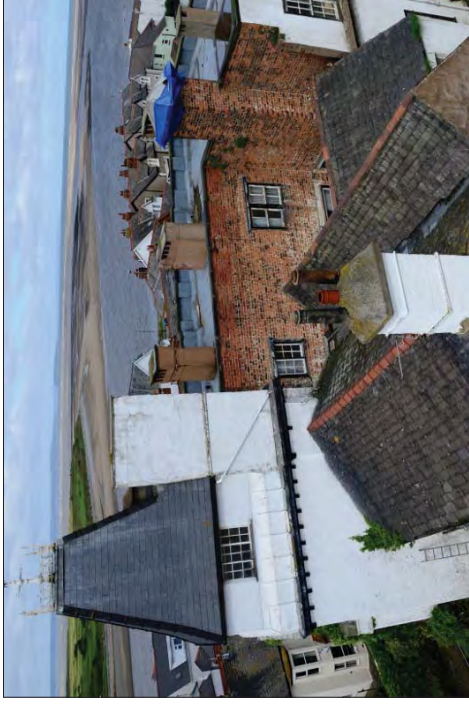
**Plate 117.** Element 6 Tower Side Elevations

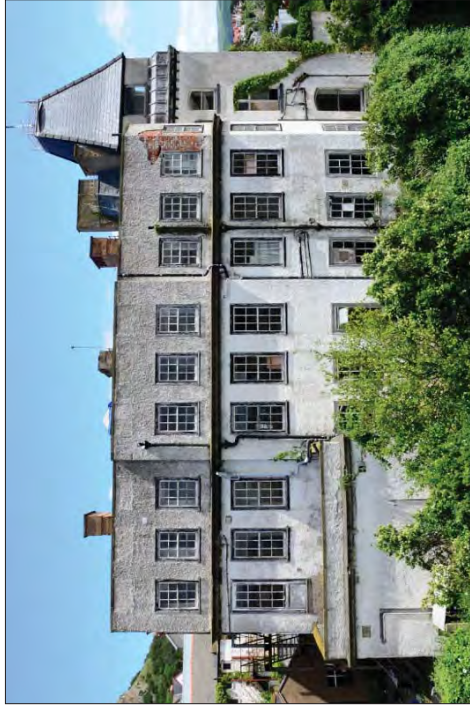
**Plate 119.** Element 6 Tower  
Front & Side Elevations

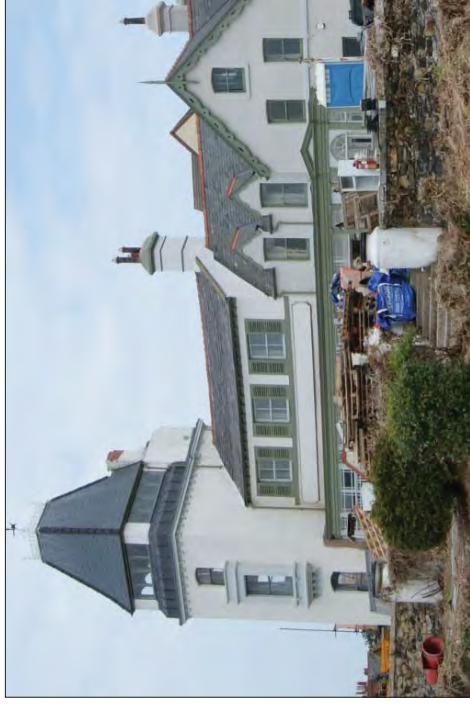
**Plate 120.** Element 6 Tower Front & Side Elevations  
Tower Windows Replaced to Original Design

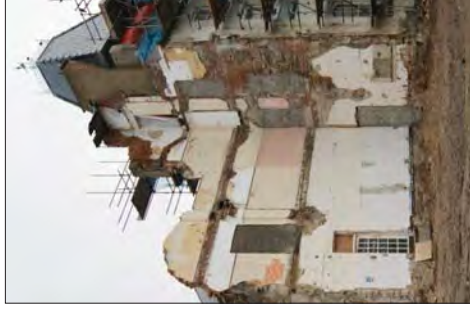
**Plate 121.** Rear Elevation  
Following Demolition of  
1919 Wing

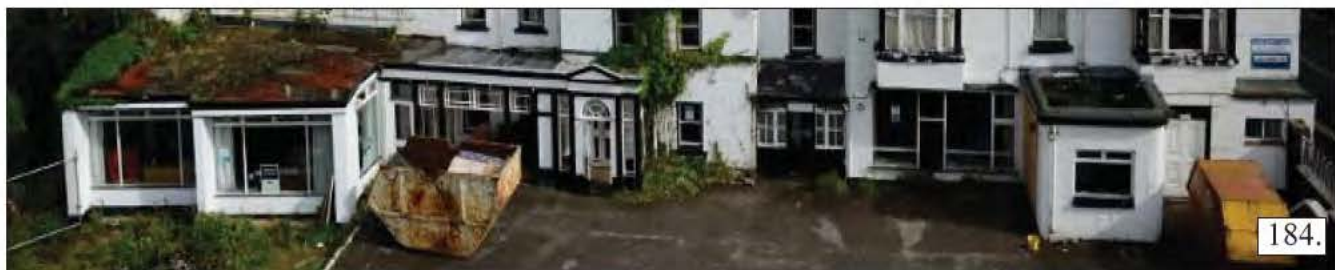
**Plates 183 - 184. Building Elements 12a, 12c & 12d**

A number of modifications were made to the front elevation of the Deganwy Castle Hotel during the 1960's and 70's. The extensions are of brick/breeze block construction and none are of any great note architecturally. The flat roof designs used have generally caused problems with water accumulation and ingress and all are set to be removed.
