Building Recording & Analysis

**Site of the Former Kwik Save,
44 Market Street, Holyhead**

Report Number: CR36-2013

Results of Building Recording & Analysis at Site of the Former Kwik Save, 44 Market Street, Holyhead

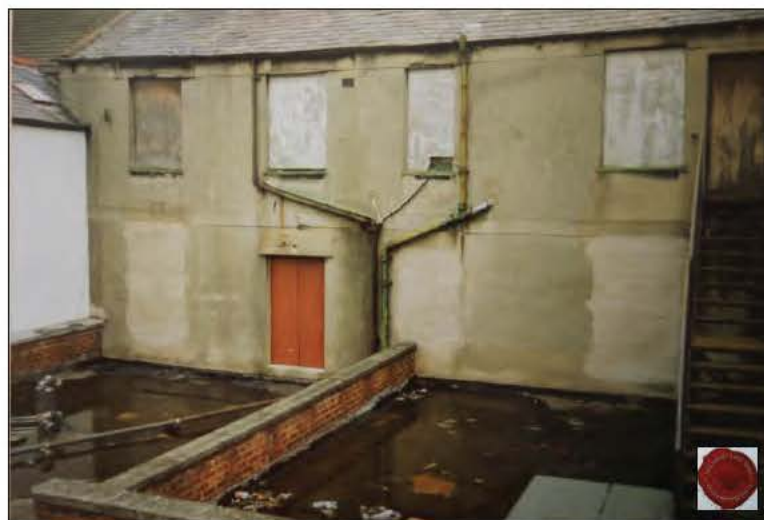
Figure 40. 44 Market Street Rear Elevation Taken 1970
(Source Anglesey Archives WM/2406)

The rear building elevation had also been significantly altered over time as can be seen from cartographic evidence and from examination of the building interior. A photograph of the rear of the building taken in 1970 also shows clear evidence of the blocking of window/doorway openings observed when in the building. The positioning of openings on the second floor mirrors that found at the front of the building with four openings arranged in a symmetrical pattern.

The rear elevation of the building housed four blocked openings, three windows of the same size and one which was narrower. There was also a modern fire escape inserted near the left hand gable. This insertion had also damaged one of the window openings. Two of the windows had wooden lintels with some surviving laths and the remaining two had a replacement lintel of a stone conglomerate material. It is unclear as to why one of the windows was narrower but it is clear from the 1970 photograph (figure 40) that the openings were all the same height.

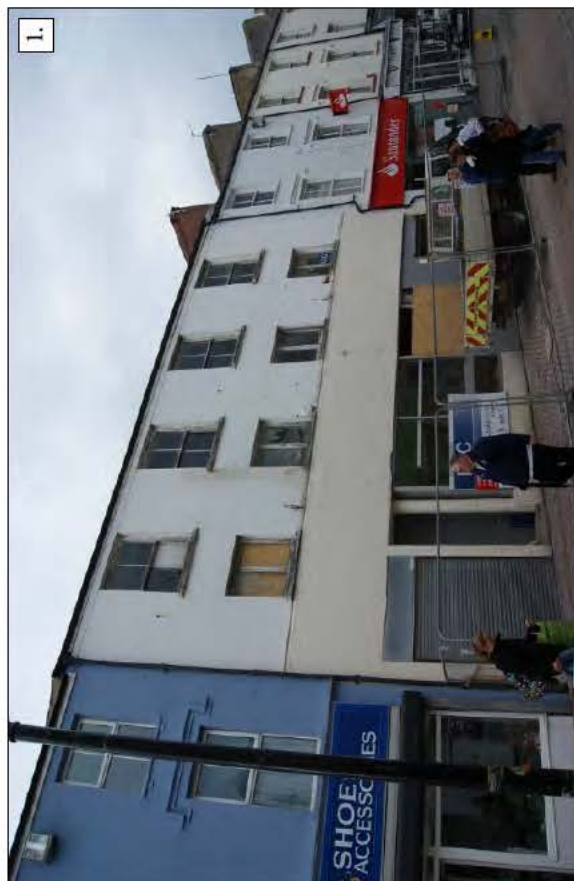
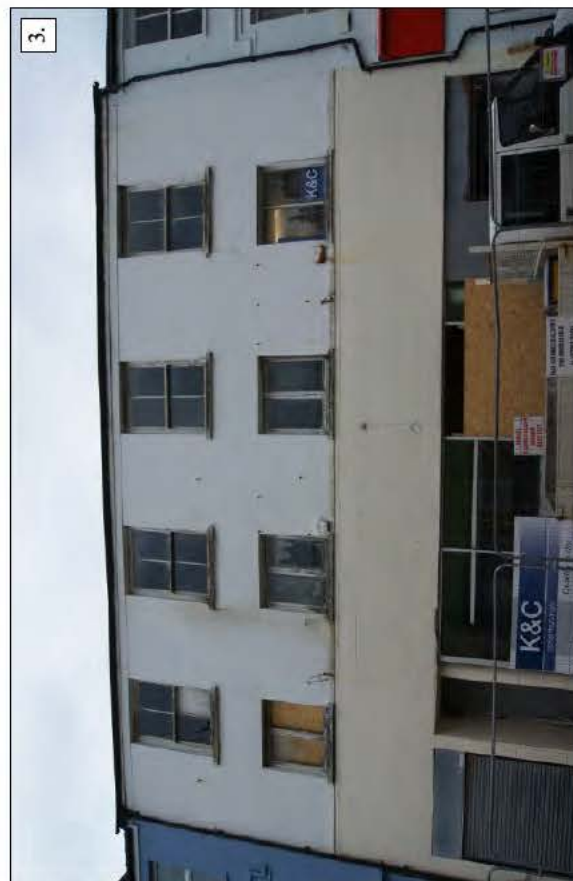
Plates 1 - 4. 44 Market Street Front Elevation

The first floor also houses four windows arranged directly beneath those of the second floor. These windows are a modern modification and it is evident when comparing historic photographs with modern observations that the earlier windows were removed when the building was converted into a supermarket. The 1970 photograph shows the building as a “Stop and Shop” and it is clear that the height of the windows was reduced to allow for the addition of the wide banded shop signage.

The full height of the windows can clearly be seen when viewing from the inside as much of the internal wall covering has been removed to expose the modern bricking up of the original openings. The windows for this floor will be discussed in the interior section of the report.

The ground floor of the building has been altered beyond all recognition and the original doorways/openings replaced by modern shop fittings including large glass windows and doors and metal roll-shuttering. Photographs and map evidence show that the King's Head originally had two entrances and two sash windows arranged directly below the windows on the floors above. The sash windows are mid nineteenth century or later design with panes arranged two over two as seen surviving on the second floor. The door to the south led into the public house and the door to the north allowed access to a passageway through the building and out into the stable yard at the rear.

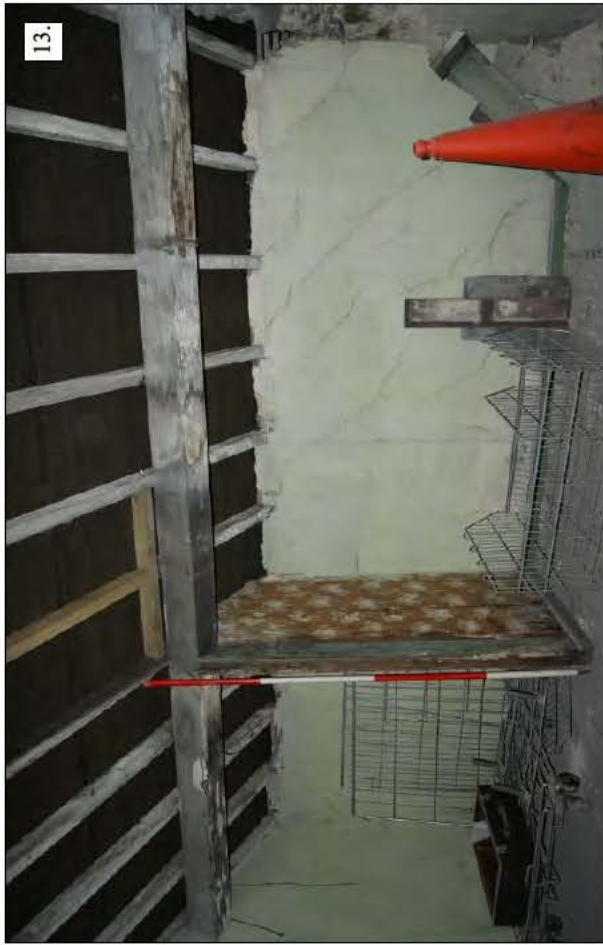
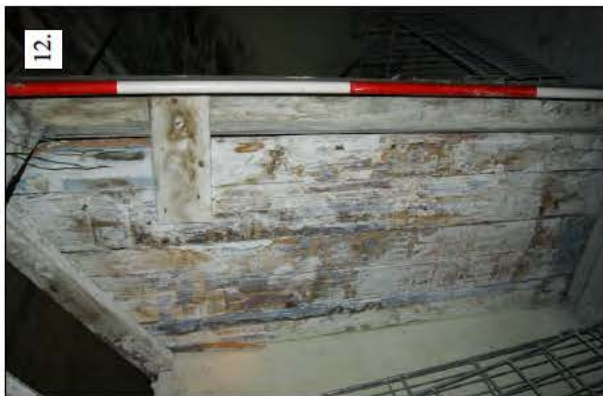
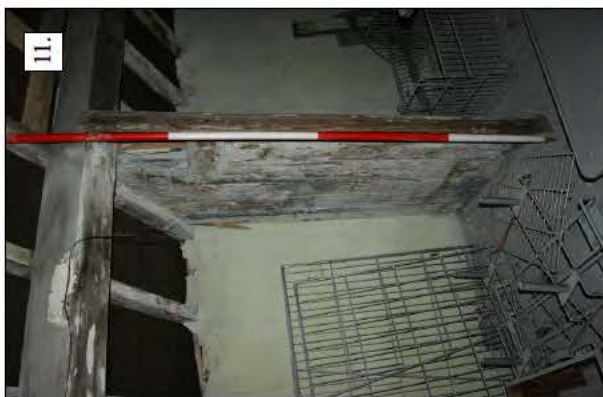
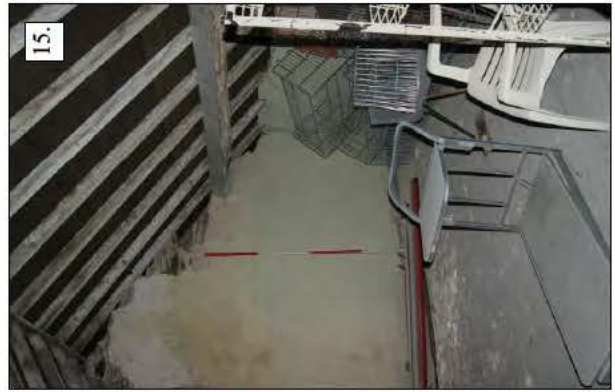
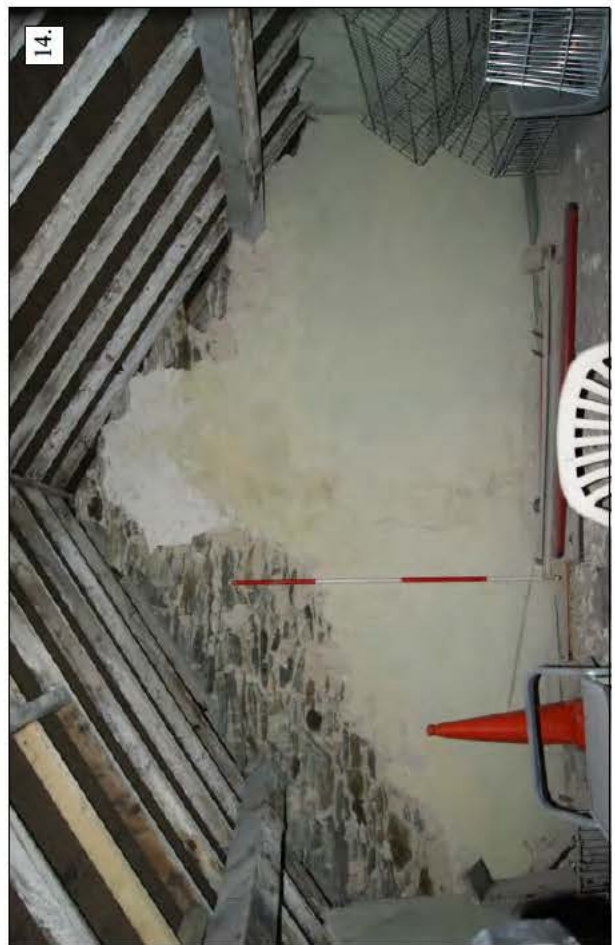
Plates 11 - 15.
Attic Level (Third
Floor) - Room 1

The gable wall was seen to have been constructed from the local schist stone used in the rest of the building. The render at the base of this wall was still intact and it is possible that a fireplace similar to those observed on the first and second floors was concealed from view. This was the same for Rooms 1 & 3.

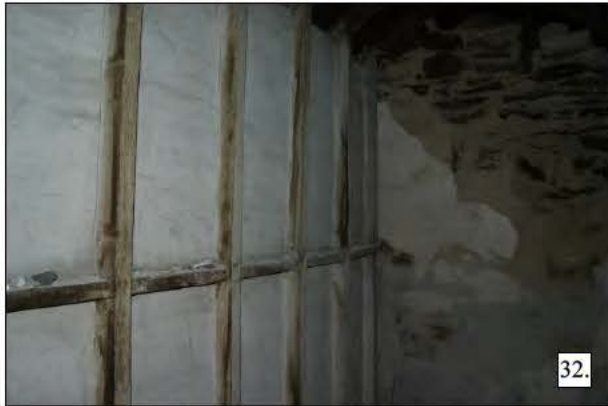
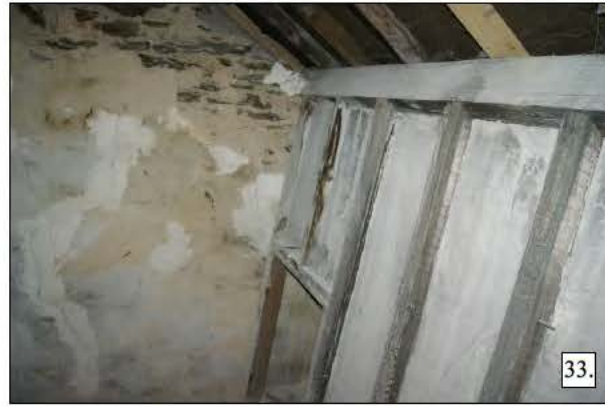
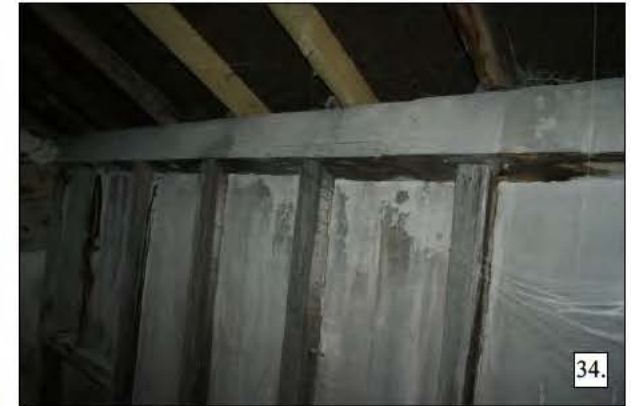
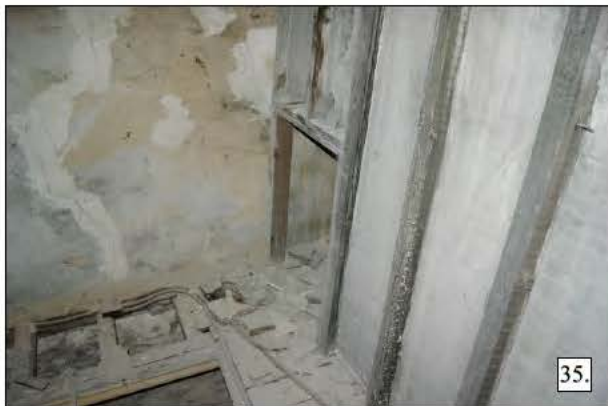
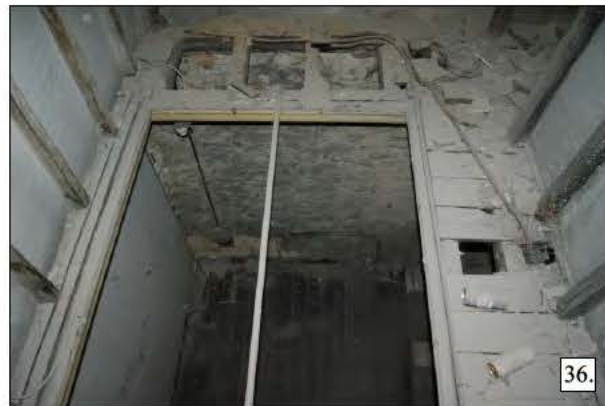
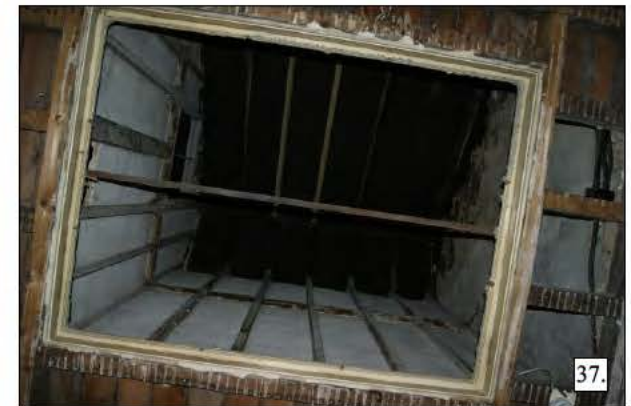
Plates 32 - 37. Attic Level (Third Floor) Room 4. No Scales Used Due to the Lack of Safe Areas for Access

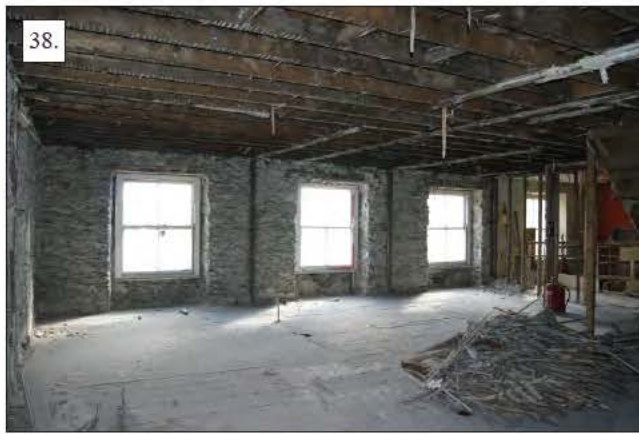
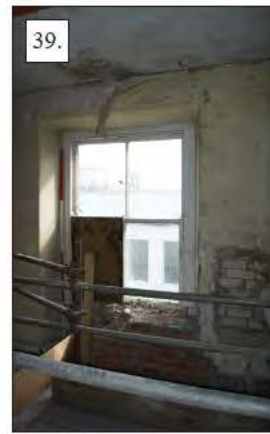
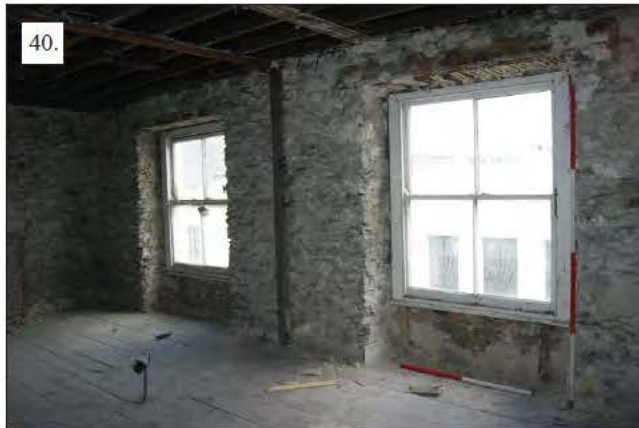
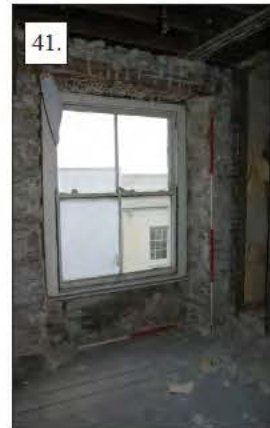
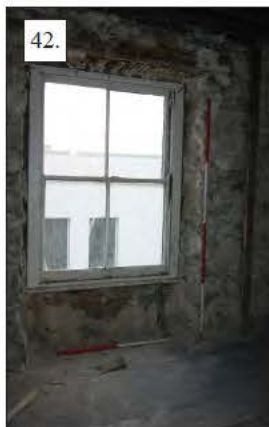
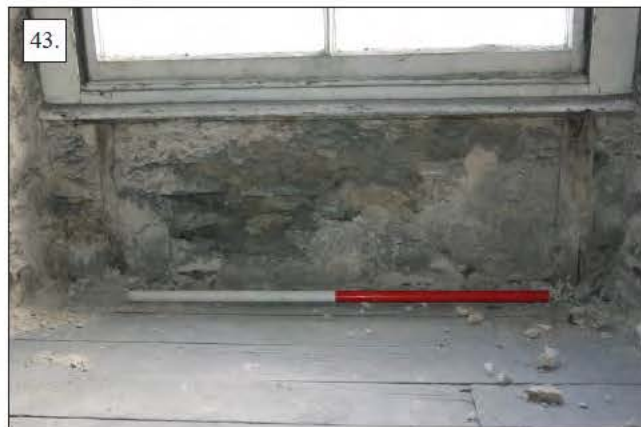
Plates 38 - 45. Second Floor Following Stripping-out of Building.
Series of Photographs Showing Window Details in the Front Elevation

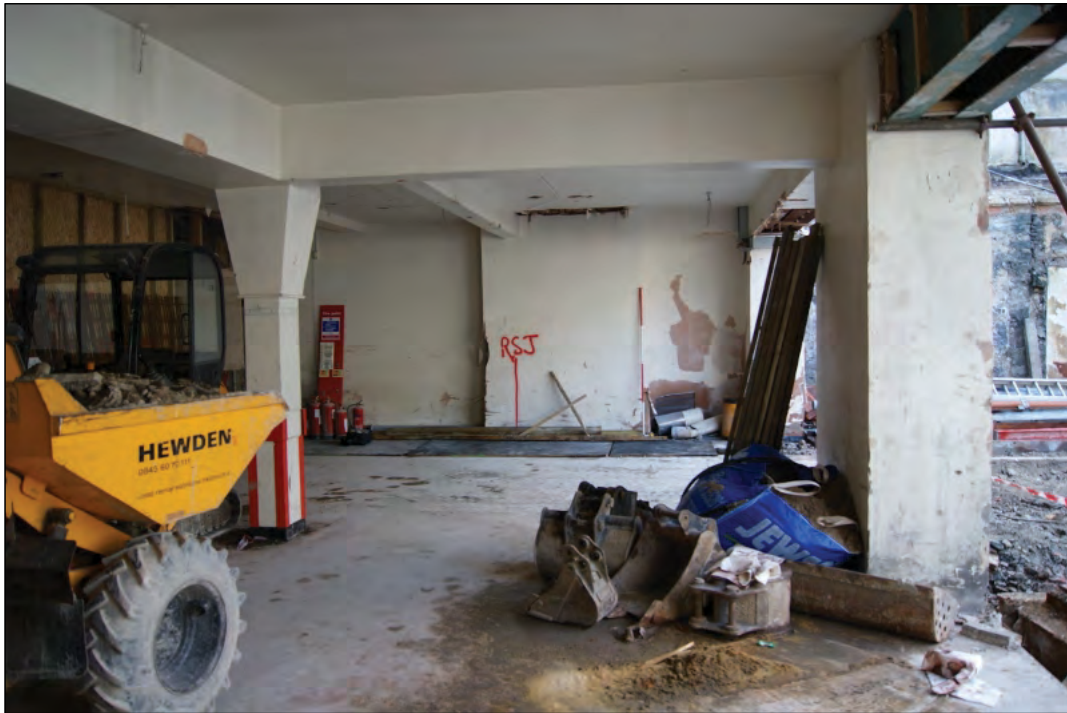
As mentioned above the ground floor of the building has been altered beyond all recognition and the original doorways/openings have replaced by modern shop fittings including large glass windows and doors and metal roll-shuttering. Internally no original features survived and the rear wall had been demolished prior to our arrival.

Where the concrete floor had been removed in one small area there was evidence that there was a cellar beneath the building but this had been backfilled with rubble and the dimensions, nature and construction could therefore not be ascertained.

Plate 77. Ground Floor Level. General Shot Taken Facing South

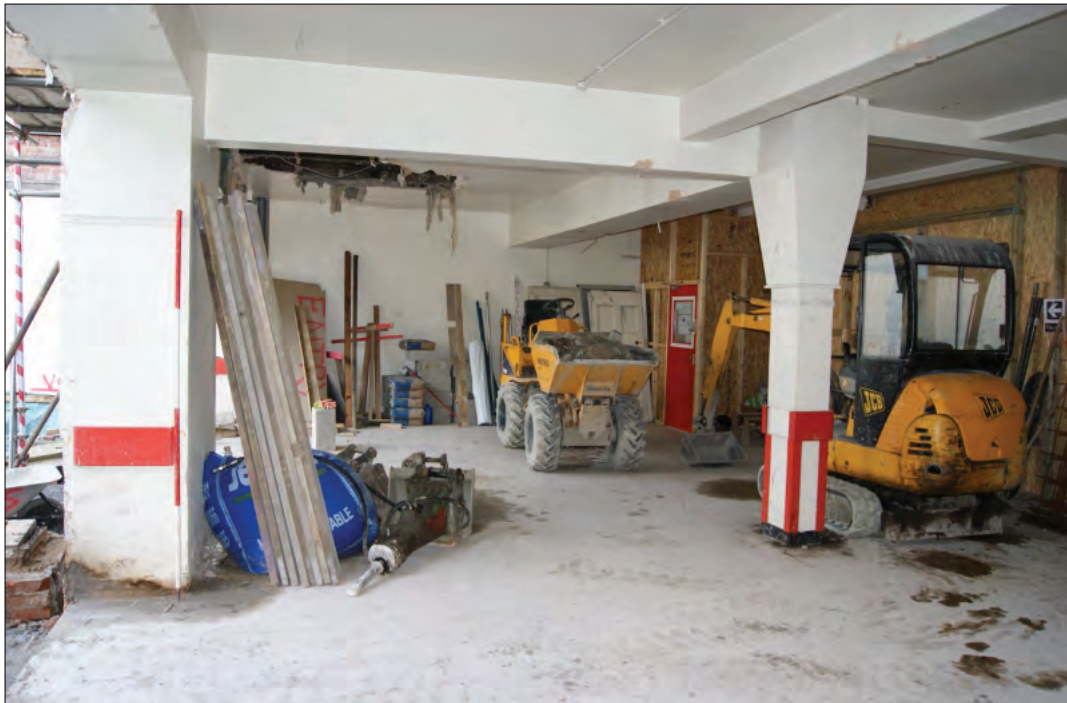
Plate 78. Ground Floor Level. General Shot Taken Facing North
