## **Building Recording & Analysis at**

# **11 - 13 Stanley Street, Holyhead**

**Report Number: CR45-2013**

## **Results of Building Recording & Analysis at 11 - 13 Stanley Street, Holyhead**

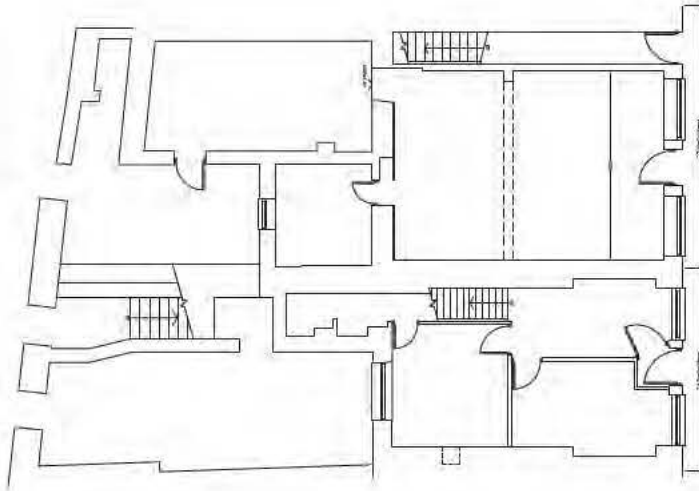
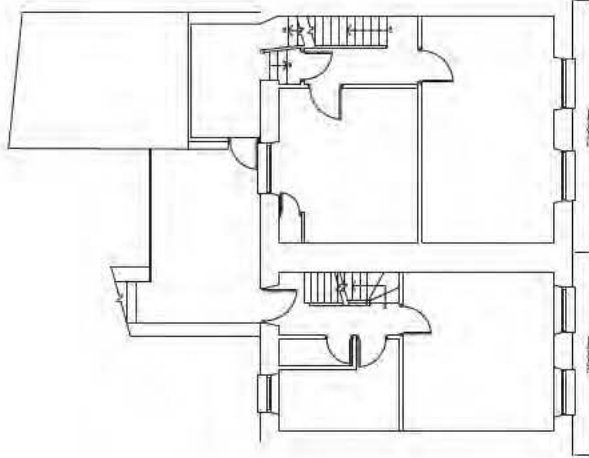
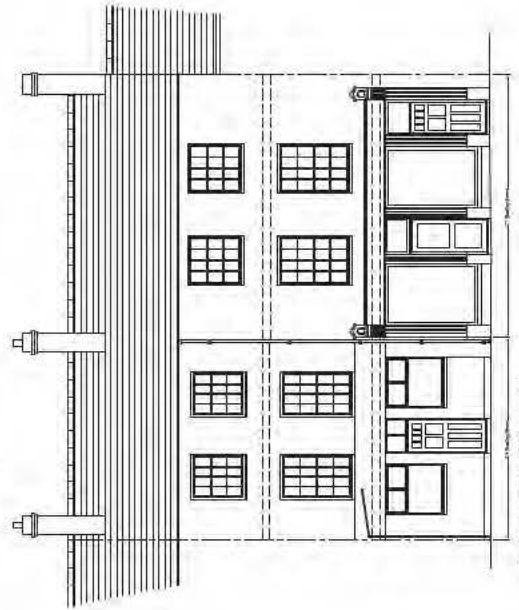
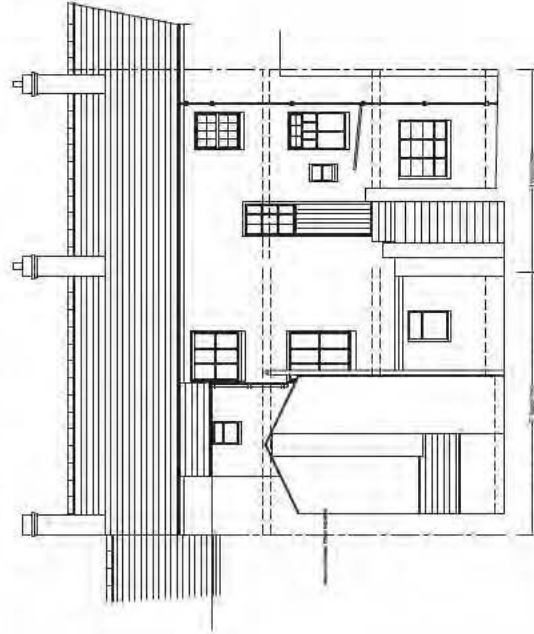
Figure 28. Existing Floor Plans and Elevations for Numbers 11 - 13 Stanley Street

Existing Ground Floor Plan

Existing First Floor Plan

Existing Front Elevation

Existing Rear Elevation

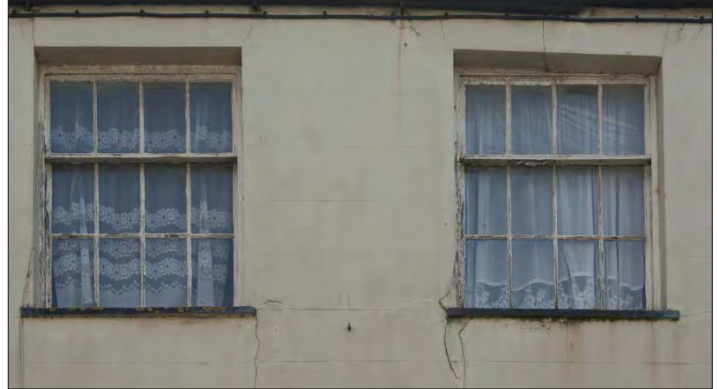
**Plate 8 (Above Right).** Original Four Over Eight Concealed Box Sash Windows At Second Floor Level. Note Also Narrow Glazing Bars and Lack of Window Horns Indicative of a Later 18th Century Date

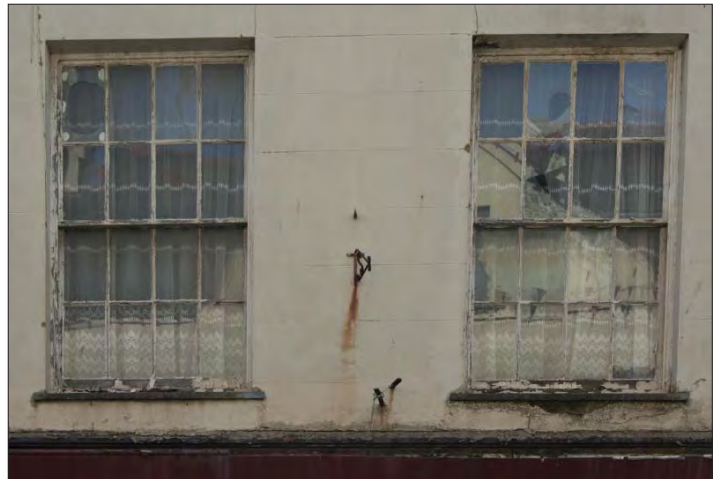
**Plate 9 (Centre Right).** Eight Over Eight Concealed Box Sash Windows at First Floor Level. Contemporary With Those On Second Floor

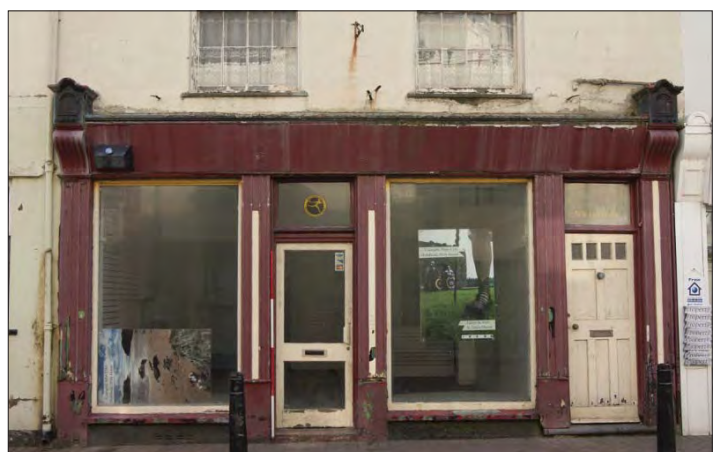
**Plate 10 (Below Right).** Wooden Victorian Shop Frontage. Ground Floor

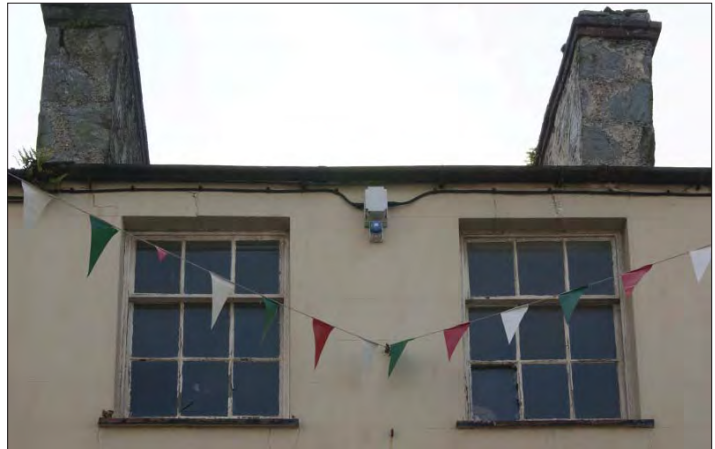
**Plate 12 (Above Right).** Original Three Over Six Concealed Box Sash Windows At Second Floor Level. Note Also Narrow Glazing Bars and Lack of Window Horns Indicative of a Later 18th Century Date

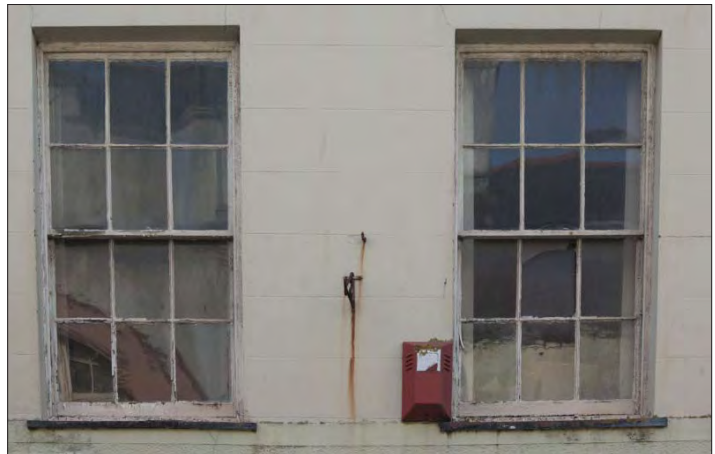
**Plate 13 (Centre Right).** Six Over Six Concealed Box Sash Windows at First Floor Level. Contemporary With Those On Second Floor

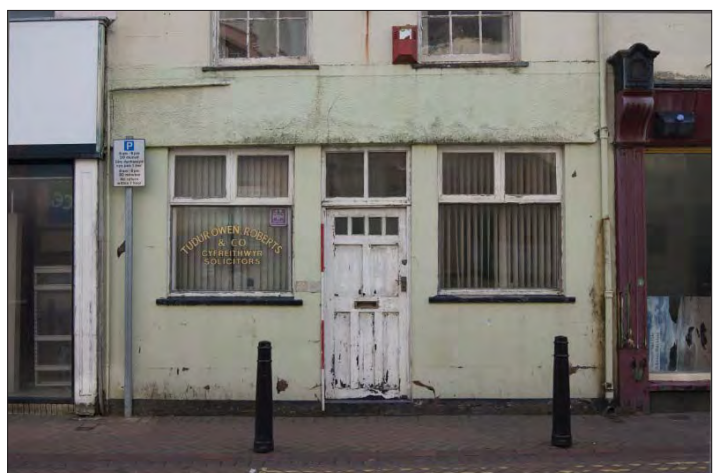
**Plate 14 (Below Right).** Ground Floor. Doorway is Not Believed to be in Original Location and Windows are Modern

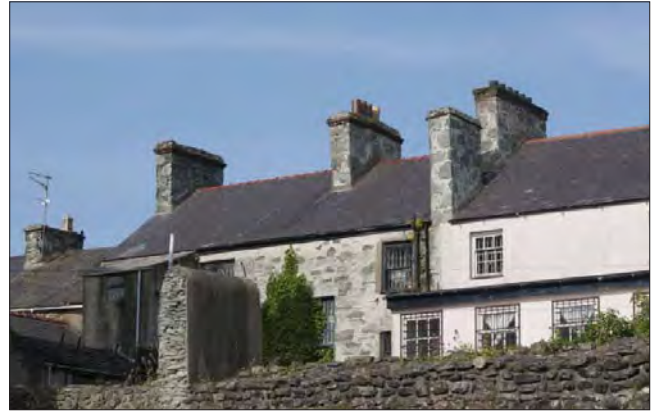
**Plate 16.** Rear Elevations of 11 & 13 Stanley Street

The classic symmetrical proportions of the front elevations are to a certain extent mirrored at the rear of the buildings although later additions and remodelling has obscured much of the detailing. The windows at ground floor level in both properties are not original with a modern casement in the extension to property 11 and an Early – Mid Twentieth Century cast iron casement in property 13. The proportions of this window are not in-keeping with those at the other floor levels and this wall is likely to have been replaced when the building extension was removed.

The window openings at first and second floor level on the main buildings are in their original position although the first floor window of property 13 is a later replacement. The two windows on Number 11 are of the original proportions although the both windows are later replacements. This is evidenced by the presence of window horns as they were not used until the mid-nineteenth century.

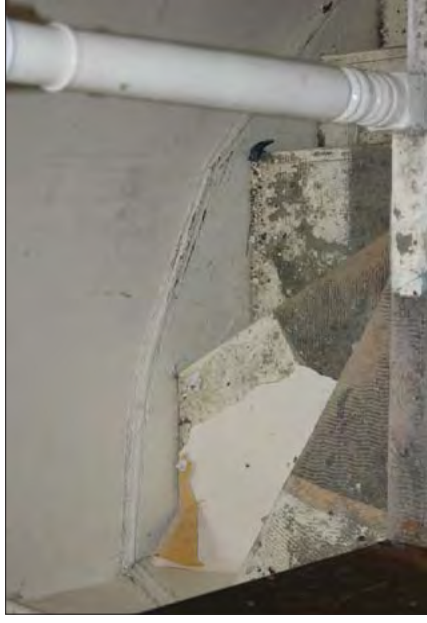
**Plate 29.** Stairs Turn at First Floor Level.  
Balustrade is a Mass Produced  
19th Century Example

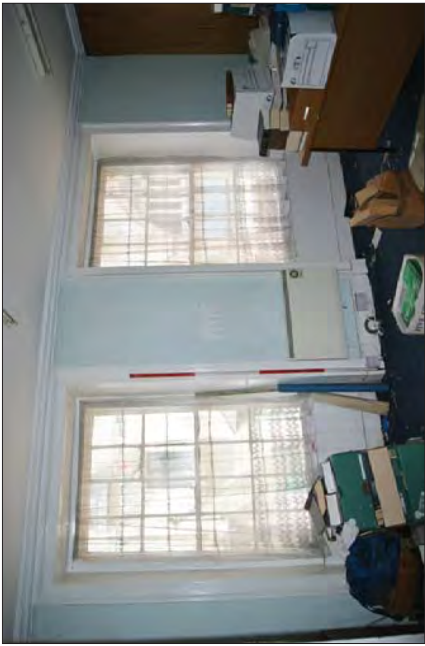
**Plate 33.** 11 Stanley Street First Floor Room 5 Eight Over Eight Original Georgian Sash Windows

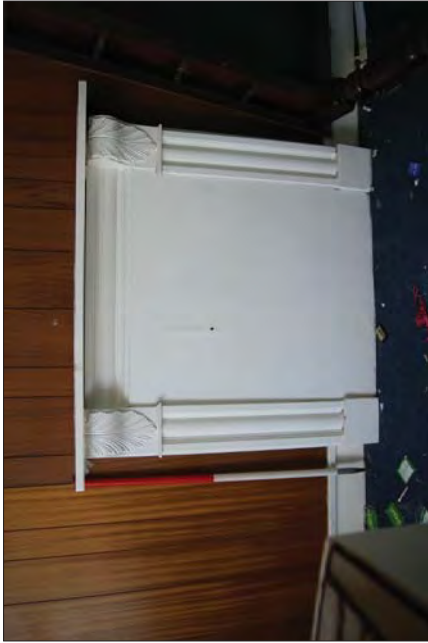
**Plate 35.** 11 Stanley Street First Floor Room 5 Fireplace Believed to be an Original Feature

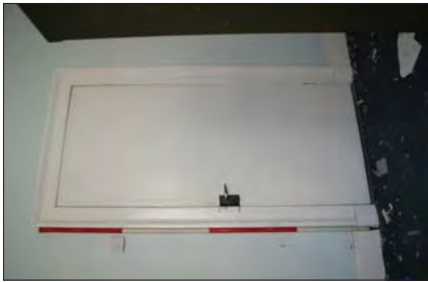
**Plate 37.** Original Skirting Boards and Door Frame Door is Replacement

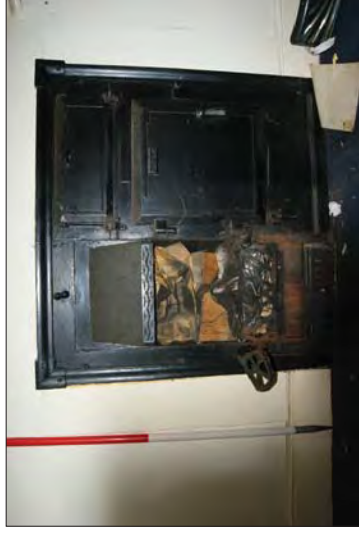
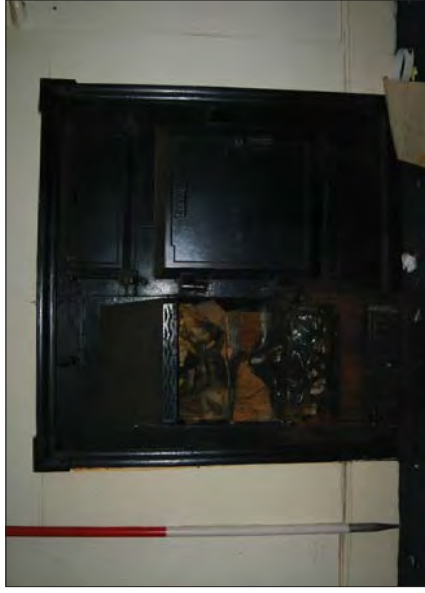
**Plate 40.** 11 Stanley Street First Floor  
Room 6 Victorian Cast Iron Range

**Plate 41.** 11 Stanley Street First Floor  
Room 6 Victorian Cast Iron Range

Although not original, there is an Early Victorian cast iron range in this room. It is remarkably well preserved and many of the loose fittings such as the kettle stand have survived. This range has clearly been well used and maintained over its life and there are a variety of date stamps evident on the ironwork. The earliest of these dates is 1857 and the later stamps attest to the piecemeal replacement of worn elements over time.

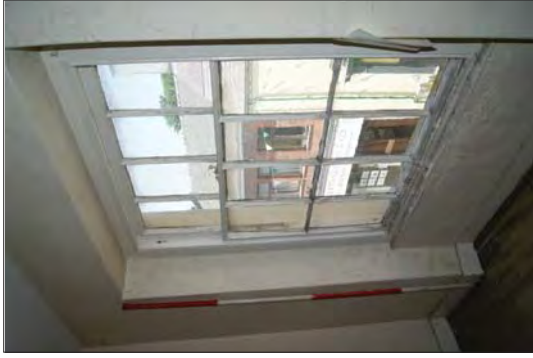
**Plate 46.** Second Floor Room 8 Four Over Eight Sash Window

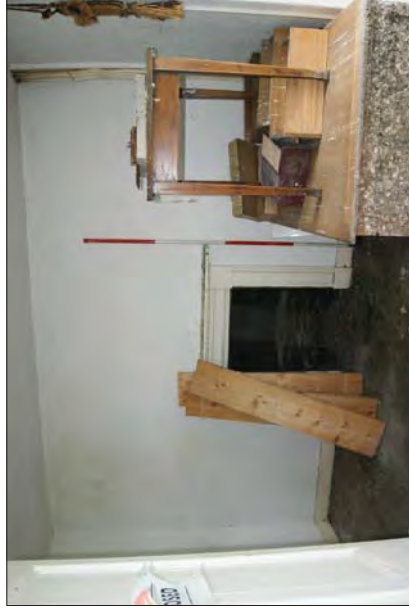
**Plate 50.** 11 Stanley Street Second Floor Room 9 Cast Iron Grate

Room 9 is located at the rear of the property. There is an original fireplace surviving in this room (Plate 50). As at first floor level, the sash window in this room is a later Victorian replacement.

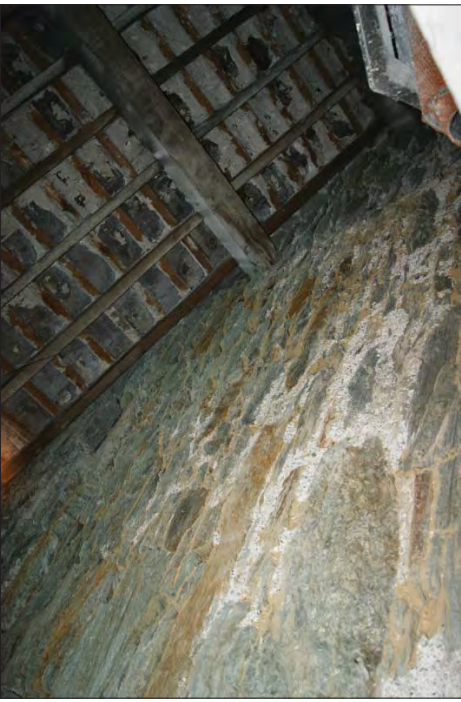
**Plate 57.** 11 Stanley Street Attic Showing Building Scar Possibly the Remains of an Earlier, Lower Gable Wall Which Was Incorporated into Building

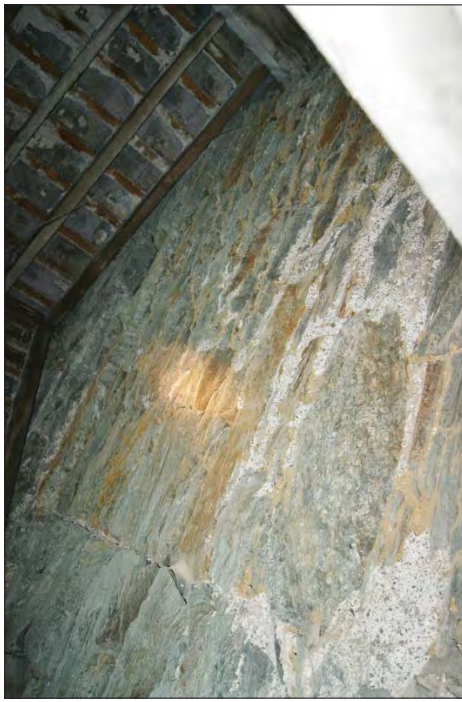
**Plate 58.** 11 Stanley Street Attic Showing Building Scar Possibly the Remains of an Earlier, Lower Gable Wall Which Was Incorporated into Building

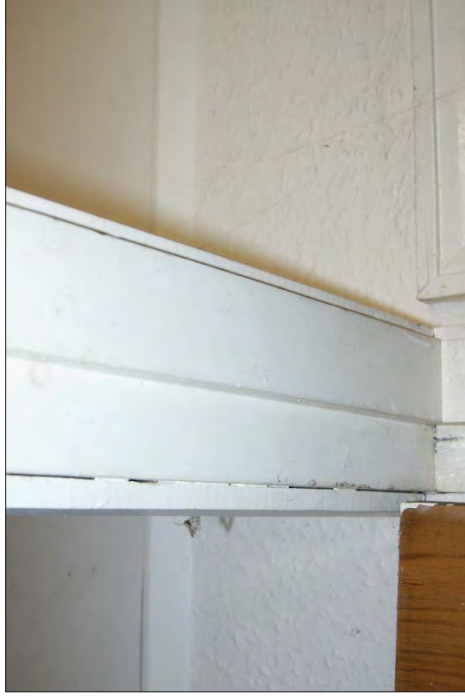
**Plate 65.** 13 Stanley Street Ground Floor Partition  
Between Rooms 1 & 2. Note Continuation of  
Picture Rail Confirming Later Date of Division

As noted in Rooms 1 & 2 there is also a picture rail in this room. The window is a modern replacement. The areas under the stairs are accessed from this room.

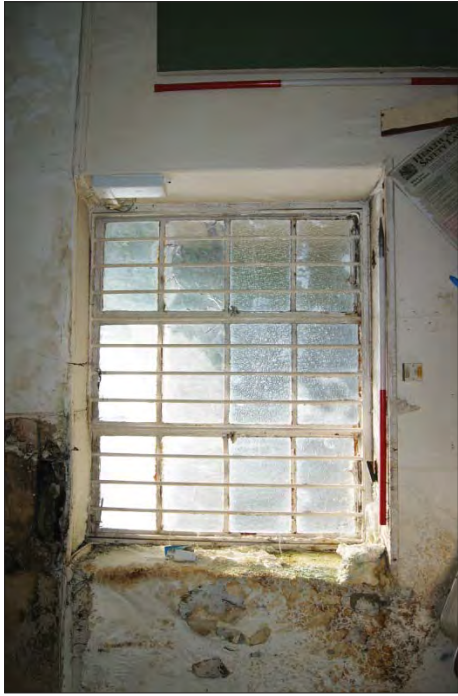
**Plate 67.** 13 Stanley Street Ground Floor Room 3 Cast Iron Casement Window

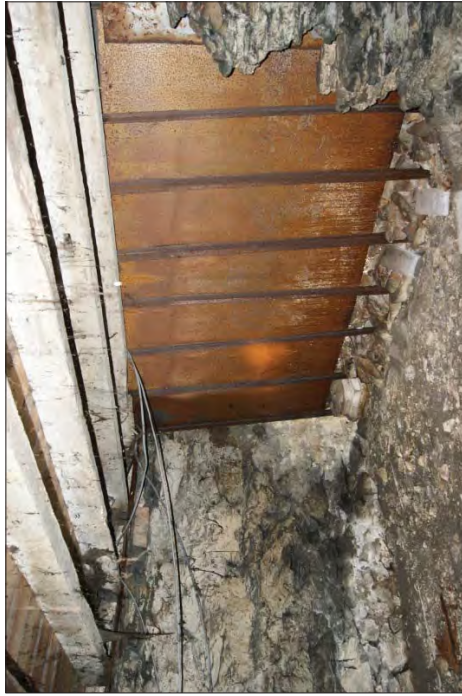
**Plate 71.** 13 Stanley Street Cellar Showing Steel Blocking

There is a partially blocked cellar below the property. The original access point was not found and it was entered following the removal of floorboards beneath the stairs. Some of the space had been backfilled with rubble and some screened off with a metal plate. Of interest in the cellar was a tailor's dummy which presumably belonged to the David Jones & Son Drapers who lived on Stanley Street from the 1880's until the 1940's.

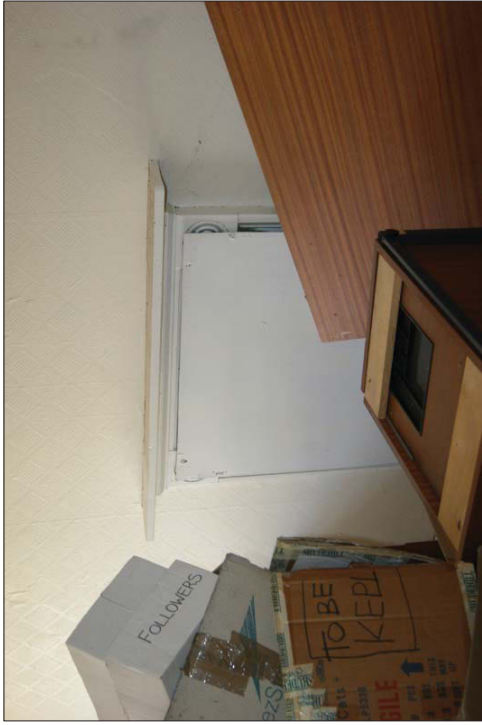
**Plate 95.** 13 Stanley Street Second Floor Room 7  
Fireplace is the Same Design as in Room 8

Room 8 is located to the rear of the property. There is what is believed to be an early/original fireplace in this room. The door is of Victorian date and is a four panelled example as found in the other rooms on this floor.

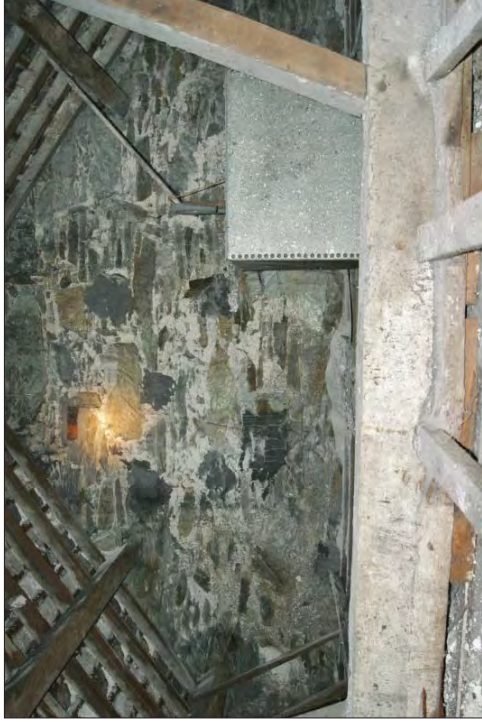
**Plate 100.** 13 Stanley Street Attic Space  
And Roof Structure

There is a large attic space which was accessed via a hatch. Despite the height of this space it did not appear to have been converted for use and there were no floorboards laid.
