## **Building Recording & Analysis**

# **Caernarfon Castle Public House Holyhead**

**Report Number: CR48-2013**

## **Results of Building Recording & Analysis at Caernarfon Castle, Summer Hill, Holyhead**

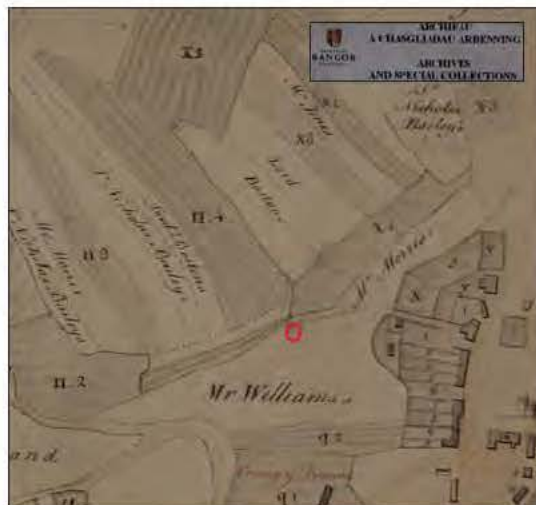
**Figure 8.** 1769 Stanley Estate Map of Holyhead. Approximate Position Later Occupied by The Caernarfon Castle is Marked in Red (Source: Bangor University Archives Penrhos Manuscripts 772-3)

An estate map of Penrhos lands commissioned by Sir John Thomas Stanley in 1769 (figure 8) names the land as being owned by a Mr Morris but but no properties are shown in the location of the Caernarfon Castle. Summer Hill road is shown leading up from Stanley street. In her work Lucy Williams (1944: 55) provides an interesting description of the Morris Gardens.

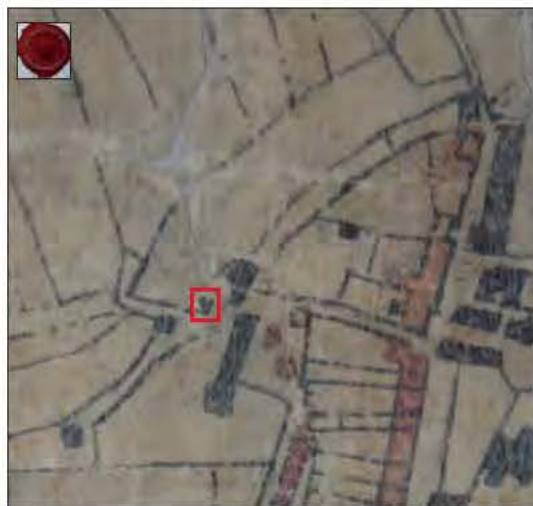
**Figure 9.** 1820 Stanley Estate Map of Holyhead. The Caernarfon Castle is Marked in Red (Source: Anglesey Archives WMaps/52/1)

An estate map produced for the Stanley family in 1820 (figure 9) shows the continued increase of housing density. It is the earliest map to clearly show the Caernarfon Castle which is shown as a single square building at the top of Summer Hill. In the location of “Y Parlyrau” described by Lucy Williams there is a building marked.

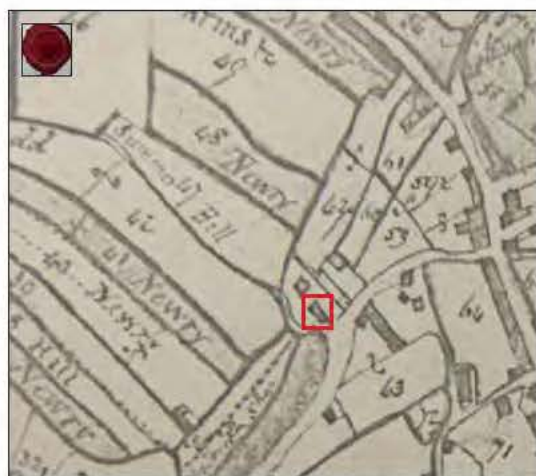
**Figure 11.** 1841 Tithe Map of Holyhead. The Caernarfon Castle is Marked in Red (Source: Anglesey Archives WMaps/53)

These new inhabitants had to be accommodated and the remaining rural characteristics of the town which had survived the earlier part of the century were rapidly lost by the time of the production of the Tithe Map of the town (figure 11). The area of the Caernarfon Castle public house is not listed on the schedule but a building is shown in this area although this document does not correspond with the buildings on the earlier plans or the building described as 'Y Parlyrau'. The main street outline as surviving today is largely established, although there was continued infilling within the street layout into the early twentieth century (Rowlands 1989: 16).

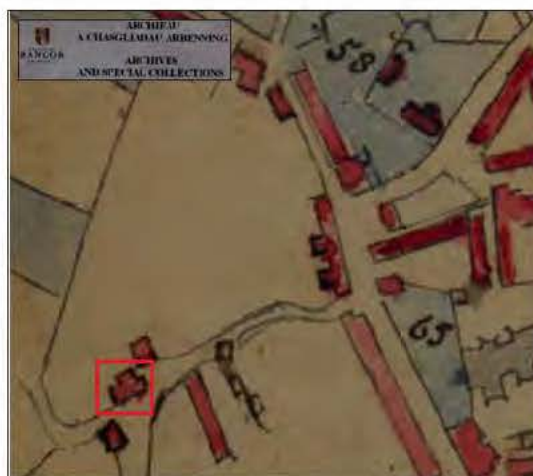
**Figure 12.** 1850 Lligwy Estate Map of Holyhead. Position of The Caernarfon Castle is Marked in Red (Source: Bangor University Archives Lligwy Papers 214)

A Lligwy Estate Map dated 1850 (figure 12) shows the Caernarfon Castle much as it appears on the 1838 Telford plan. It is not owned by Lord Boston and is therefore not listed on the map schedule.

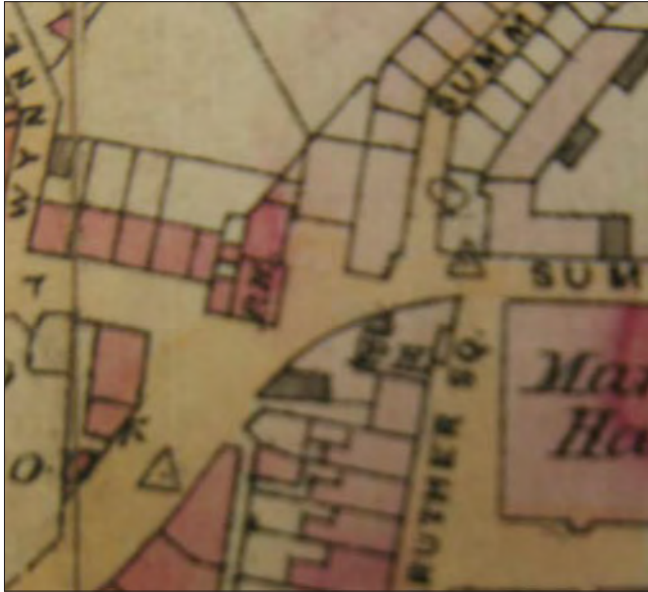
**Figure 19.** 1888 First Edition Ordnance Survey Map Showing Caernarfon Castle Public House

Ordnance Survey produced their first map of Holyhead in 1888 (figure 19) and a larger scale edition of 1890 (figure 20) which show the property in detail for the first time. The Caernarfon Castle is marked as a public house and the houses to the east which are later demolished to build the Market Hill Shops are shown in detail. The positions of the buildings do not correspond with those shown on the sketch if the Caernarfon Castle is the end building with the two windows as was suggested. There is however a greater correlation if Lucy Williams' description of the building location as under the Market Hill Shops is correct. Were this the case then rather than the end building being the Caernarfon Castle it would have been the southern end of the building running along Summer Hill and the Caernarfon Castle would actually be the building in the left foreground of the picture. The building with the figures in front would be the building shown on the 1890 Ordnance Survey as being between the Caernarfon Castle northern extension and the Summer Hill building. This interpretation is also flawed however as looking at the picture the “Parlurau” element is much narrower than the adjoining building and this is not shown on the Ordnance Survey Maps. In the absence of the original photograph and without knowing the sources from which earlier authors have worked this is as far as the story can be corroborated and it is by no means a definitive explanation.

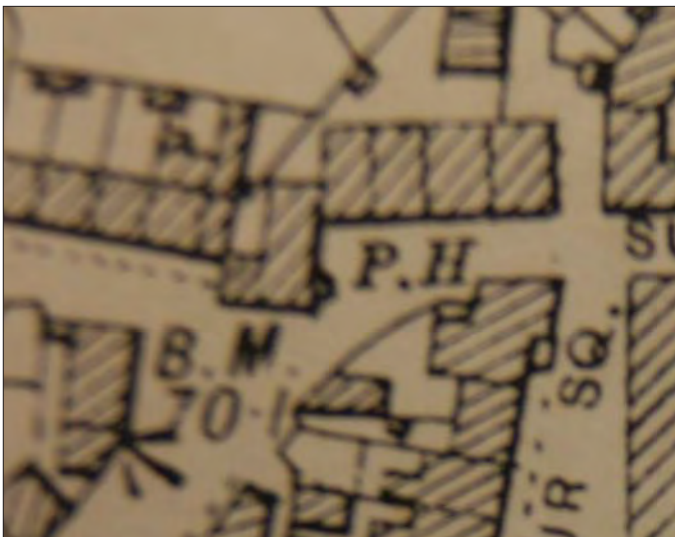
**Figure 22 (Left).** 1900 Second Edition Ordnance Survey Map Showing Caernarfon Castle Public House

The Ordnance Survey 2<sup>nd</sup> Edition dated 1900 (figure 22) shows that the neighbouring properties discussed above have been demolished and been replaced by a terrace of four properties – The Market Hill Shops. Although originally built as individual units the neighbouring property to the Caernarfon Castle was later amalgamated into the public house. When these buildings were erected the two smaller northern outbuildings associated with the Caernarfon Castle were demolished. The porch on the front elevation of the Caernarfon Castle is first shown on this document.

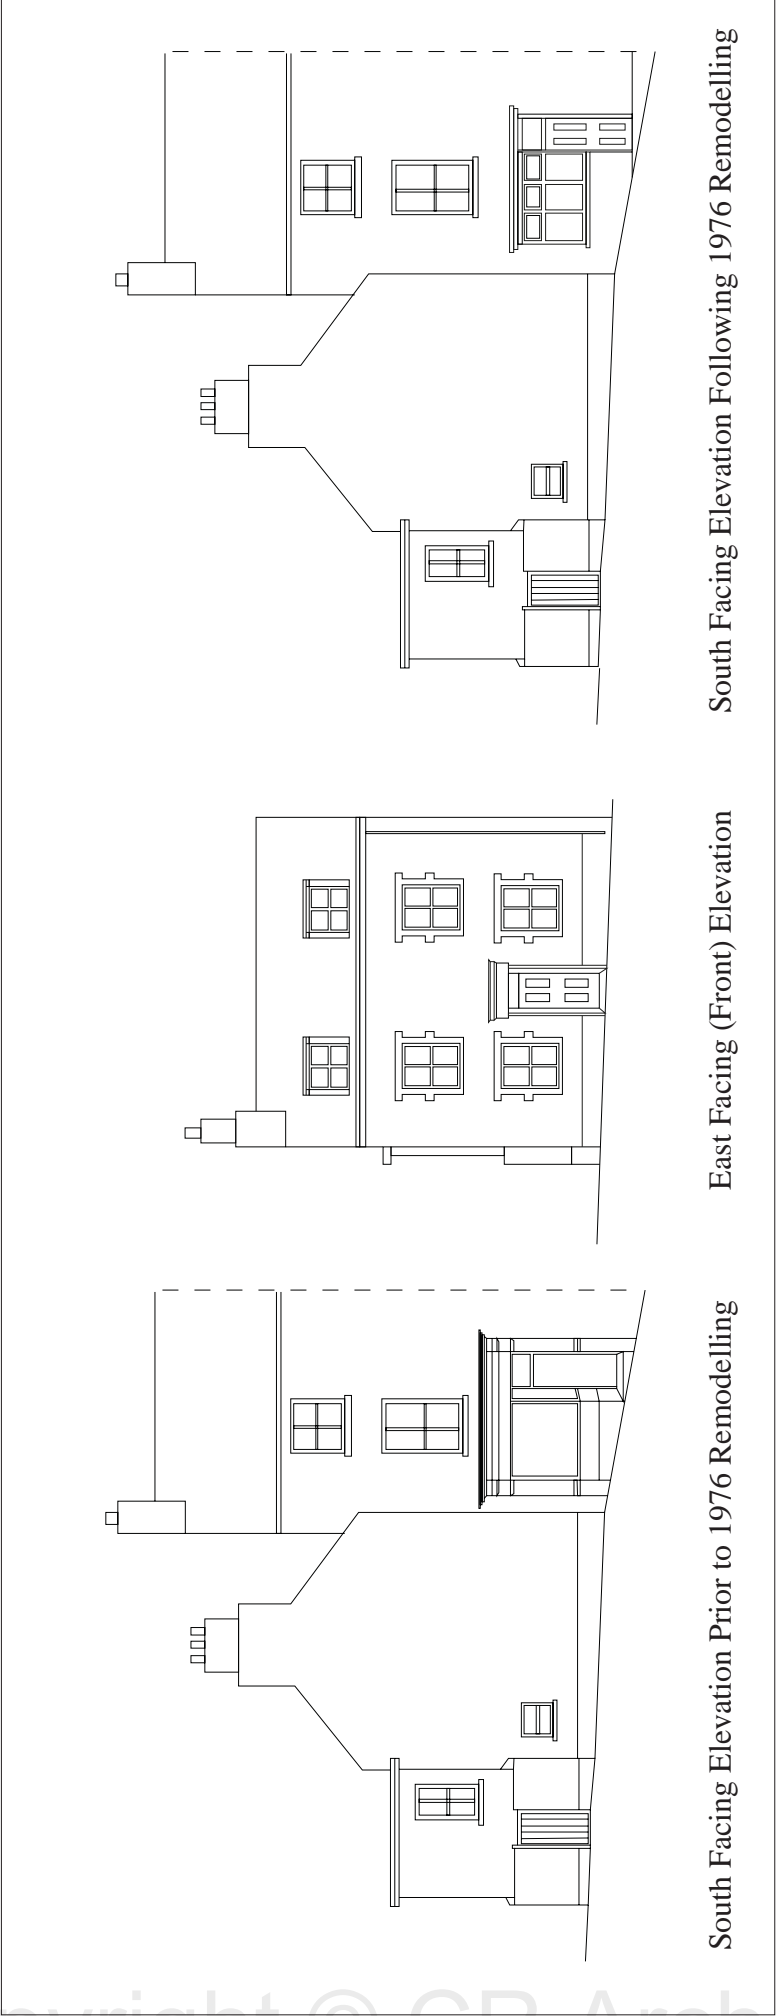
**Figure 28.** Caernarfon Castle Public House Elevations - Copied From 1970's Originals. Scale Given 8'0" to 1 Inch

The elevations of the main public house show that there was no change to this during the works. The shop elevation was however heavily modified and the late Victorian wood and glass frontage was removed in favour of a smaller window and door. This was later replaced with UPVC faux leaded glass windows and the doorway was blocked.

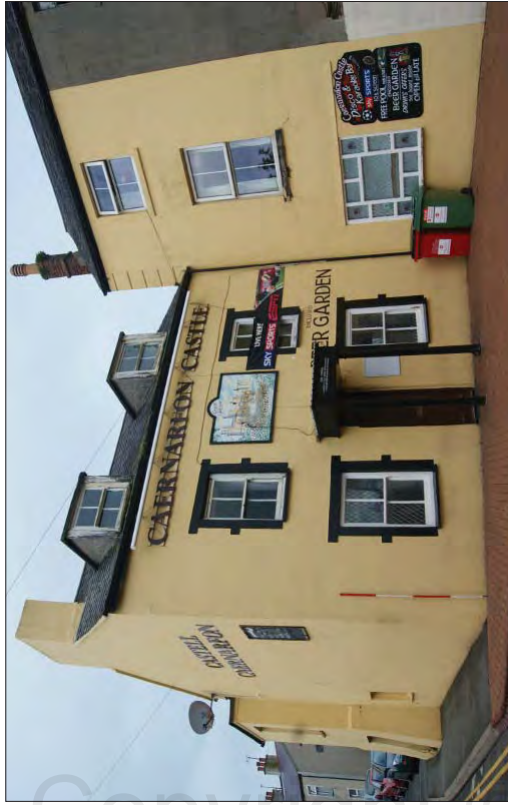
**Plate 1.** Caernarfon Castle Public House  
Front & Southern Elevation

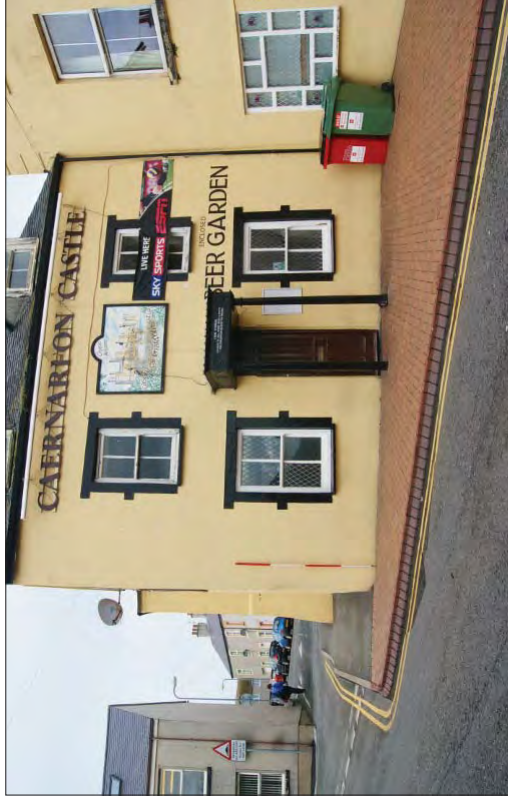
The late Georgian façade is, in common with the prevailing taste in industrial north-west Wales at this time, of a modest sub-classical design (Haslam et al 2006: 127) with four windows arranged symmetrically around a central entrance and two flat roofed dormer windows positioned in line with the lower windows. This arrangement is original but the door and windows have been replaced in the later part of the nineteenth century. The windows are two-over-two recessed box sash with window horns. The faux leaded panes at ground floor level are modern replacements. The iron porch is a later addition and cartographic research has shown that it was added between 1890 and 1900. There is a single chimney and blocked opening in the southern gable end of the building.

**Plate 2.** Caernarfon Castle Public House  
Front Elevation

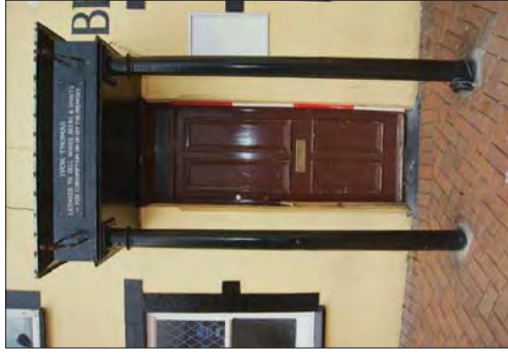
**Plate 3.** Front Porch  
Dated c.1900

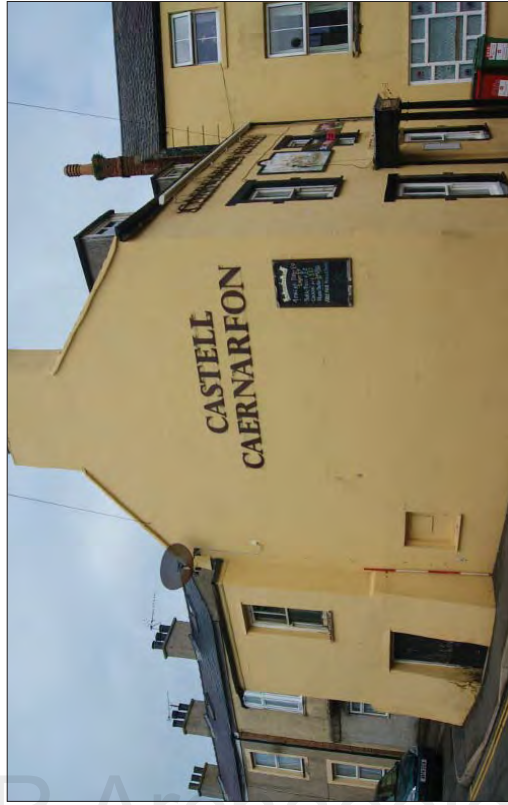
**Plate 4.** Caernarfon Castle Public House  
Southern Elevation

On the first floor of the southern elevation there is a single recessed box sash window with horns of similar date to those in the front elevation. It has glass panes in a two-over-one arrangement with the large lower pane likely to be a later replacement. A second window is located in the rear (western) elevation at first floor level but in this instance it is a modern replacement. A third window is located in the northern elevation. This window is a modern replacement and although it is likely that there was a window in this location it is believed that the original was taller and that the window opening was reduced when this room became used as a bathroom.

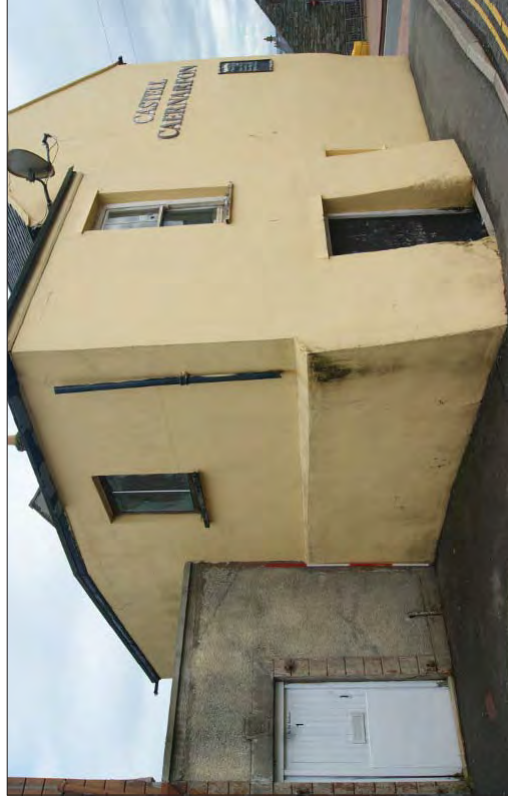
**Plate 5.** Caernarfon Castle Public House  
Southern Elevation & Rear Elevation

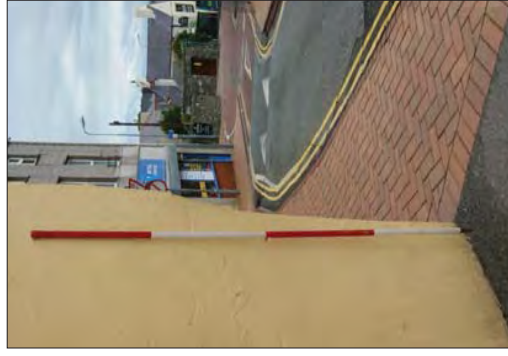
**Plate 6.** Detailed Shot of  
South-eastern Corner

The building core has a simple slate gabled roof and the schist building material is masked by a stucco render. Of interest on this structure is the shaped lower portion of the south-eastern corner wall which has been slightly recessed and curved – presumably to prevent injury to passing persons and animals.

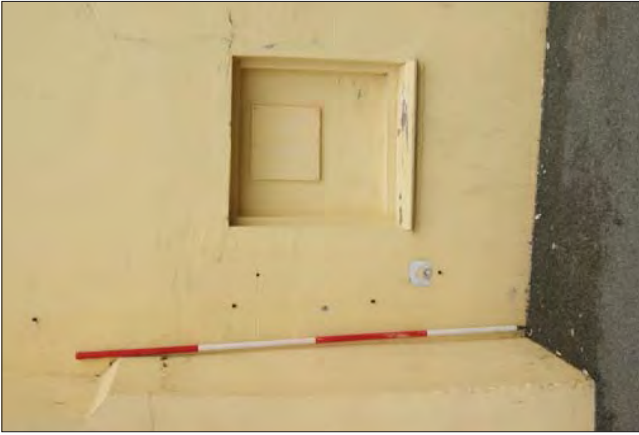
**Plate 8.** Caernarfon Castle Rear Extension & Blocked Opening

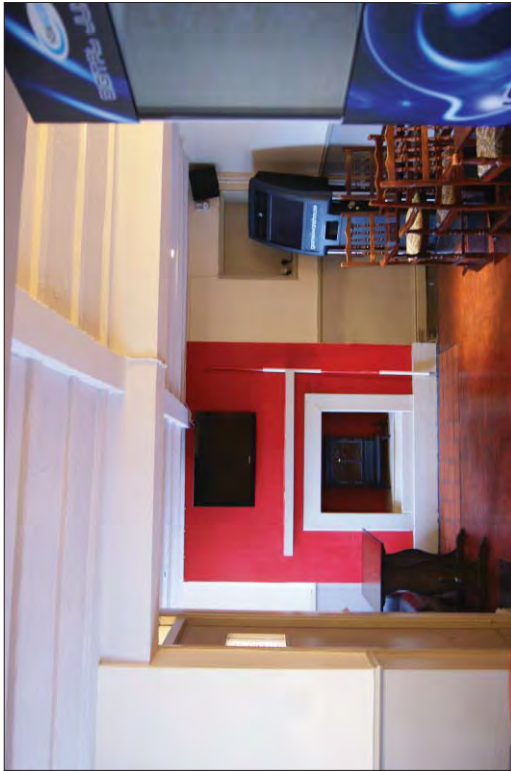
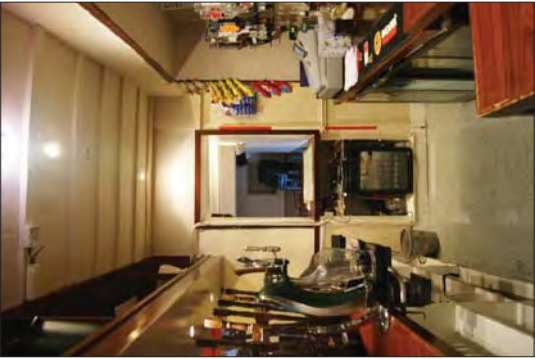
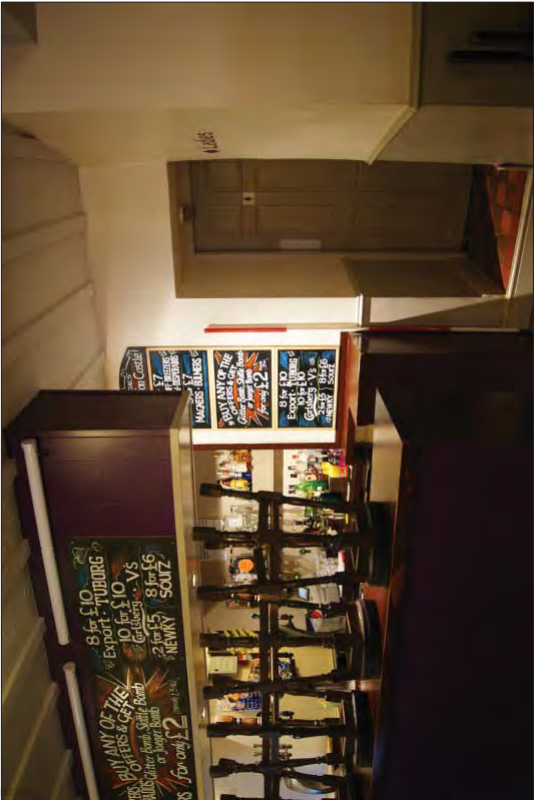
The ground floor area is currently in use as a bar with pool area, cellar and toilets. The current layout of the rooms is largely open plan and the previous internal divisions shown on the 1976 pre-modernisation plans have been removed. The fireplace is in its original position but the earlier surround has not been retained. The skirting boards and chair rails are all also modern replacements

Plates 12 - 17.  
Room 1.  
Ground Floor Bar Area

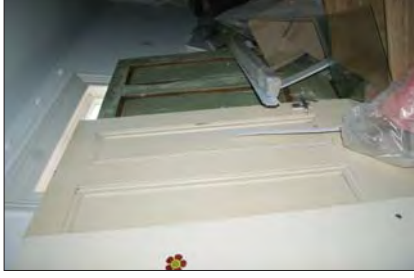
**Plate 26.** Victorian Doors to be Rehung

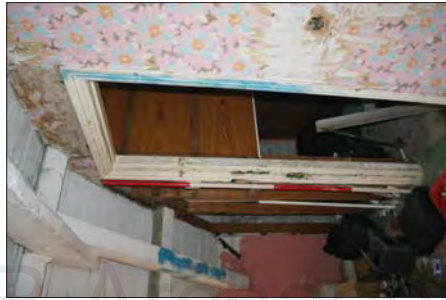
The chimney breast survives in Room 10. It was covered in render and it was not clear whether this concealed a blocked fireplace. This would seem likely given that these rooms appear to have been part of the original building layout.

**Plate 37.** Room 10  
Attic Bedroom

As mentioned above the roof is leaking and until it can be made watertight these rooms will deteriorate. If this process is not halted then the last remnants of the surviving original interior features will be lost.

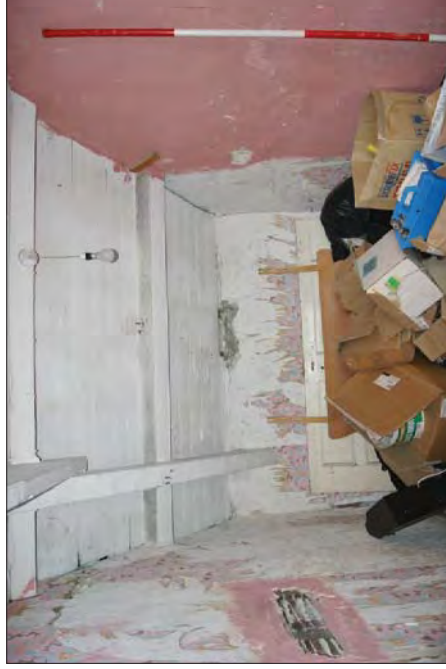
**Plate 39.** Room 10 Detail of Wooden  
Ceiling & Roof Structure

The attic level of the Caernarfon Castle is the most intact area of the building and original wooden panelling and lathe and plaster dividing walls survive. Unfortunately these features are currently under threat due to a leaking roof and dormer window which has already caused damage to this floor and the floor below.

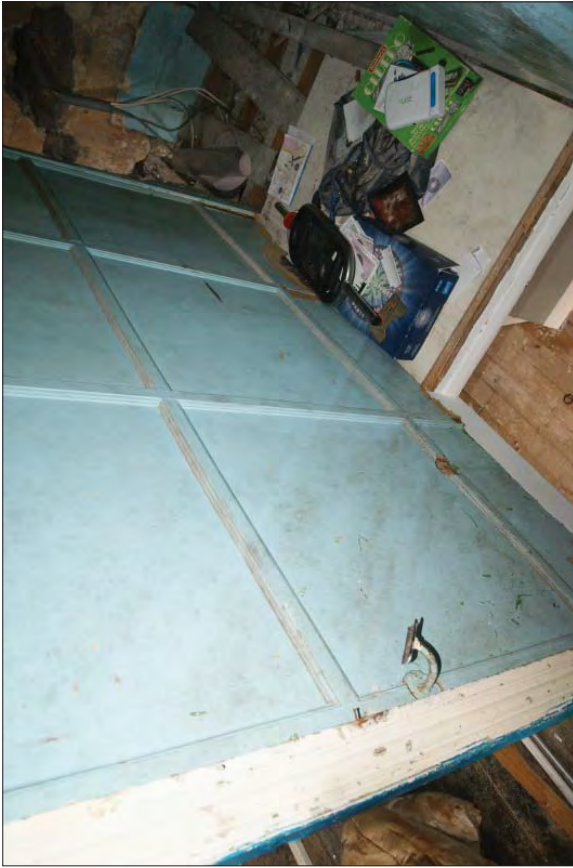
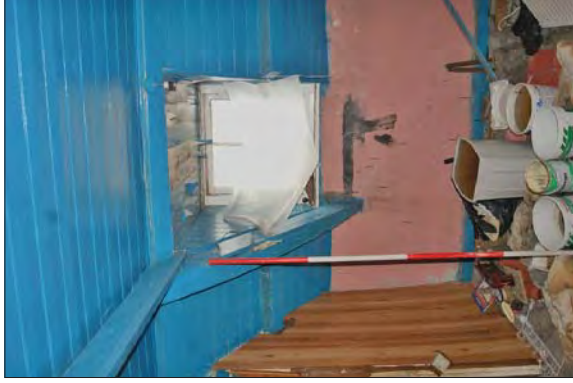
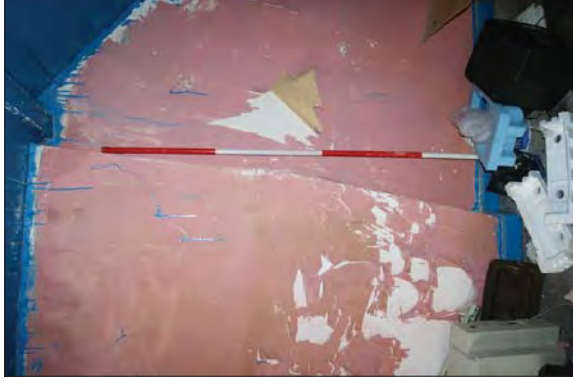
**Plate 41.** Surviving Early Panelling Attic Hallway
