Results of Archaeological Watching Brief at ATS Euromaster, Caernarfon

Report Number CR52-2013

Compiled by Matt Jones & Catherine Rees
on Behalf of Commercial Development Projects Ltd

Planning Application Number:	C12/1142/14/LL
National Grid Reference:	SH 247998 363000
Client:	Commercial Development Projects Ltd
Report Author:	Matt Jones & Catherine Rees
Report Number:	CR52-2013
Date:	09/12/2013

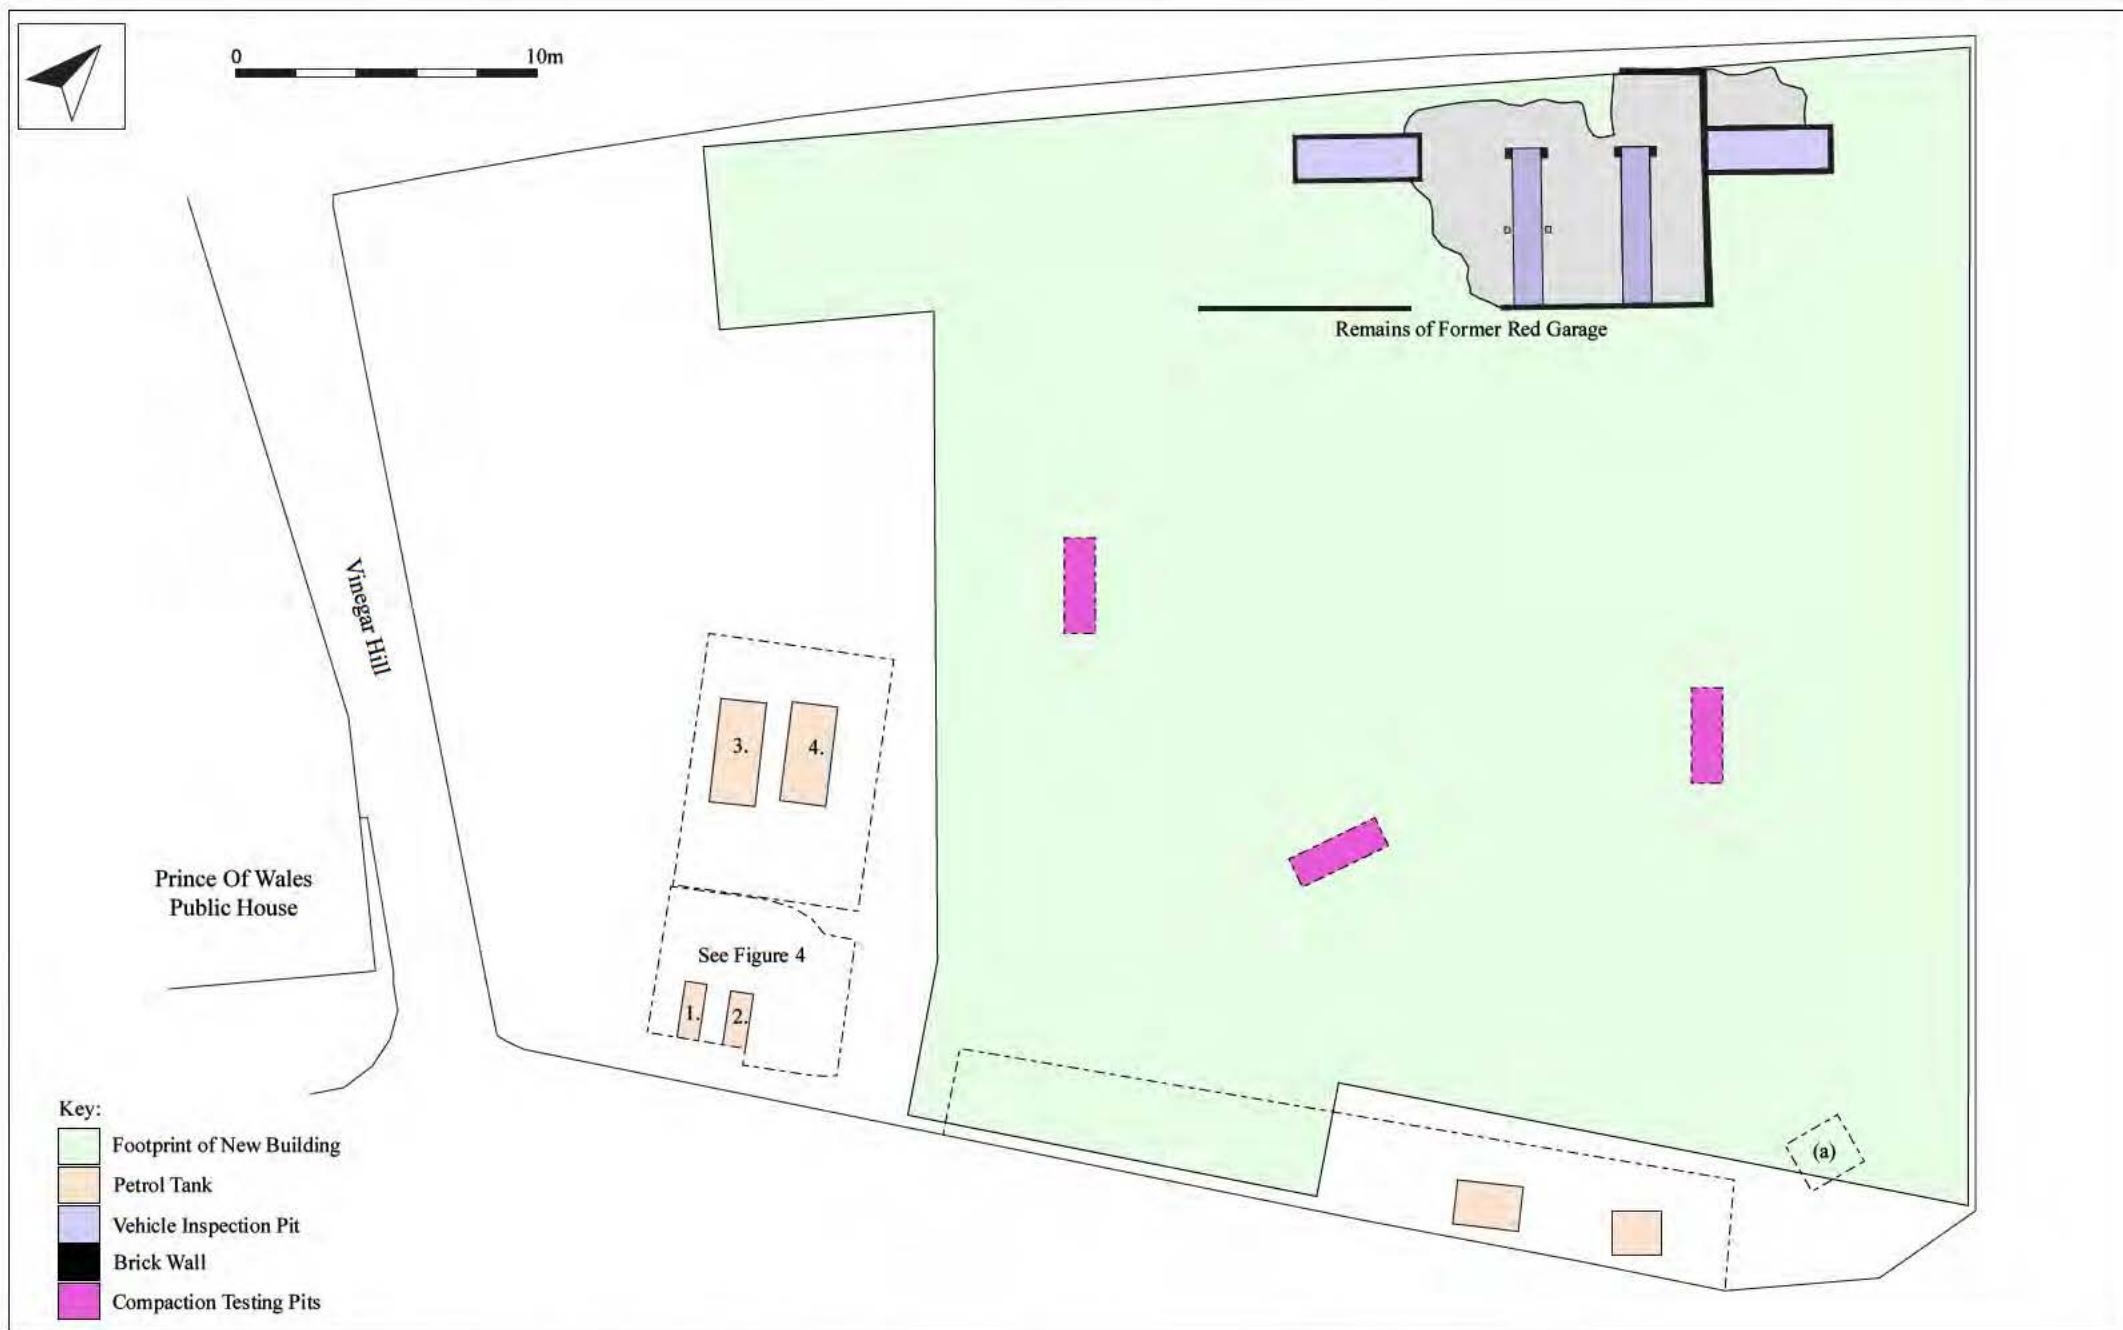
Figure 3. Location of Features, Excavated Areas and Inspection Pits on Former ATS Site

Four larger petrol tanks were identified to the south of the main building footprint and are numbered one to four on the plan (Figure 3). Tanks one and two (28) were located to the east of site and closest to the pavement. These tanks appear to have been placed within an existing cellar (19) and surrounded by sand (Plates 5 & 6 and Figure 4.). The walls of this cellar were built out of a red sand stone and were internally faced with a white plaster. These materials are the same as were observed in the older cellars of the neighbouring Prince of Wales Hotel.

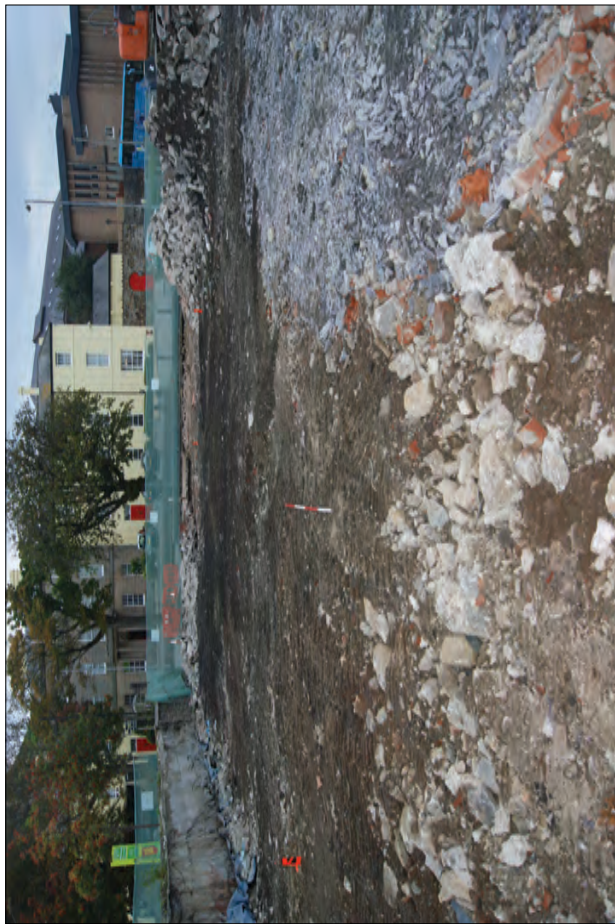
Plate 1. General Shot of Site Following Stripping to Level

The stripping of the soil to a depth of between 0.30m and 0.50m revealed only a layer of mixed or disturbed material consisting of damaged concrete, clinker, brick and crushed brick along with later 20th century rubbish within a mid brown clay silt matrix. This material is likely to have come from the later stages of the ATS site use (Plate 1).

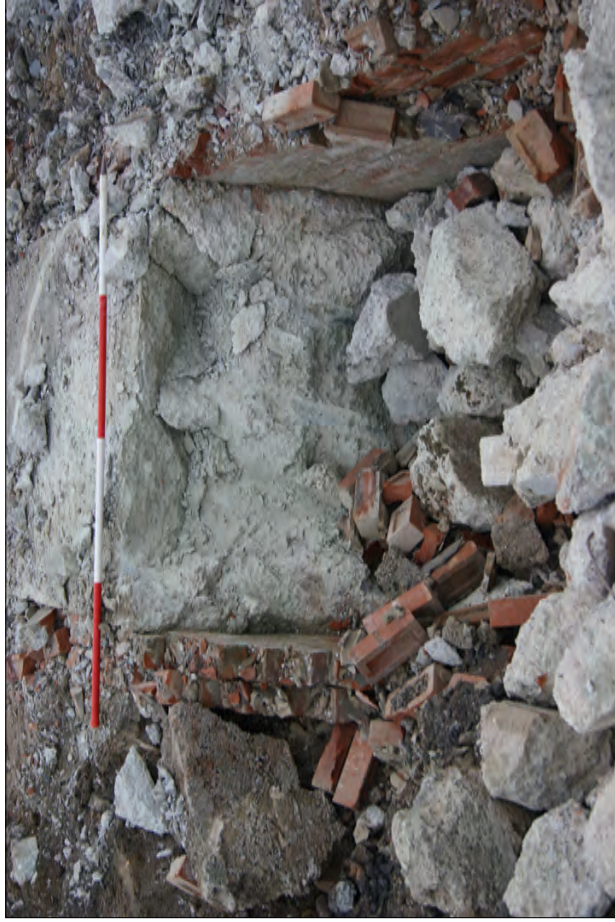
Plate 2. Red Garage Inspection Pit

A large spread of crushed slate was identified in the northern corner of the site which had been used to fill and cover an area of remains from the Red Garage. These remains were a series of brick and slate walls which had been rendered with a white concrete plaster along with four vehicle inspection pits (Plate 2).

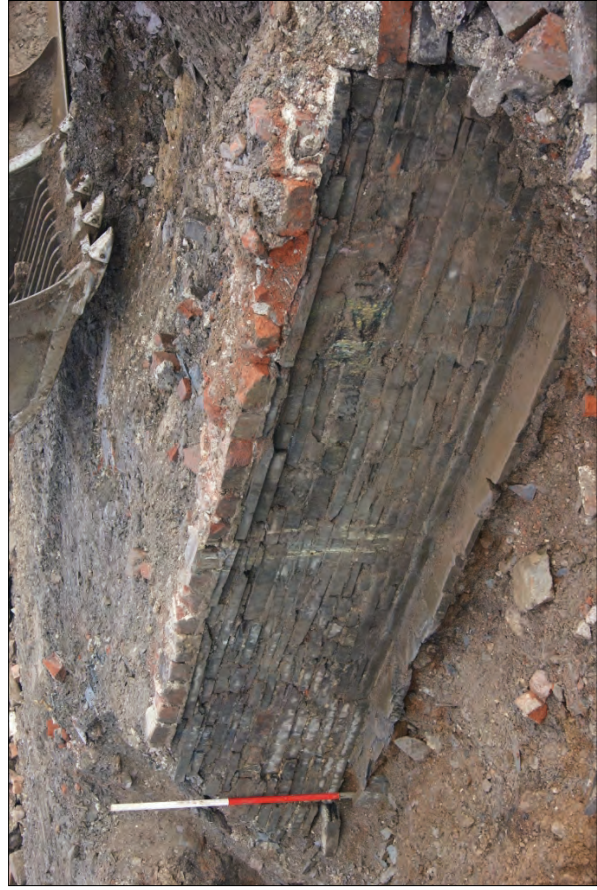
Plate 12. Red Garage Wall -
Slate and Brick Construction

A single wall (16) built out of cut slate slabs with occasional brick was recorded (see Figure 3 and Plate 12). The wall was approximately 1.00m in height and had a thickness of 0.35m. This wall corresponded with the wall of the Red Garage remains which were identified at the earlier stage of excavation and are likely to have belonged to the same construction phase.

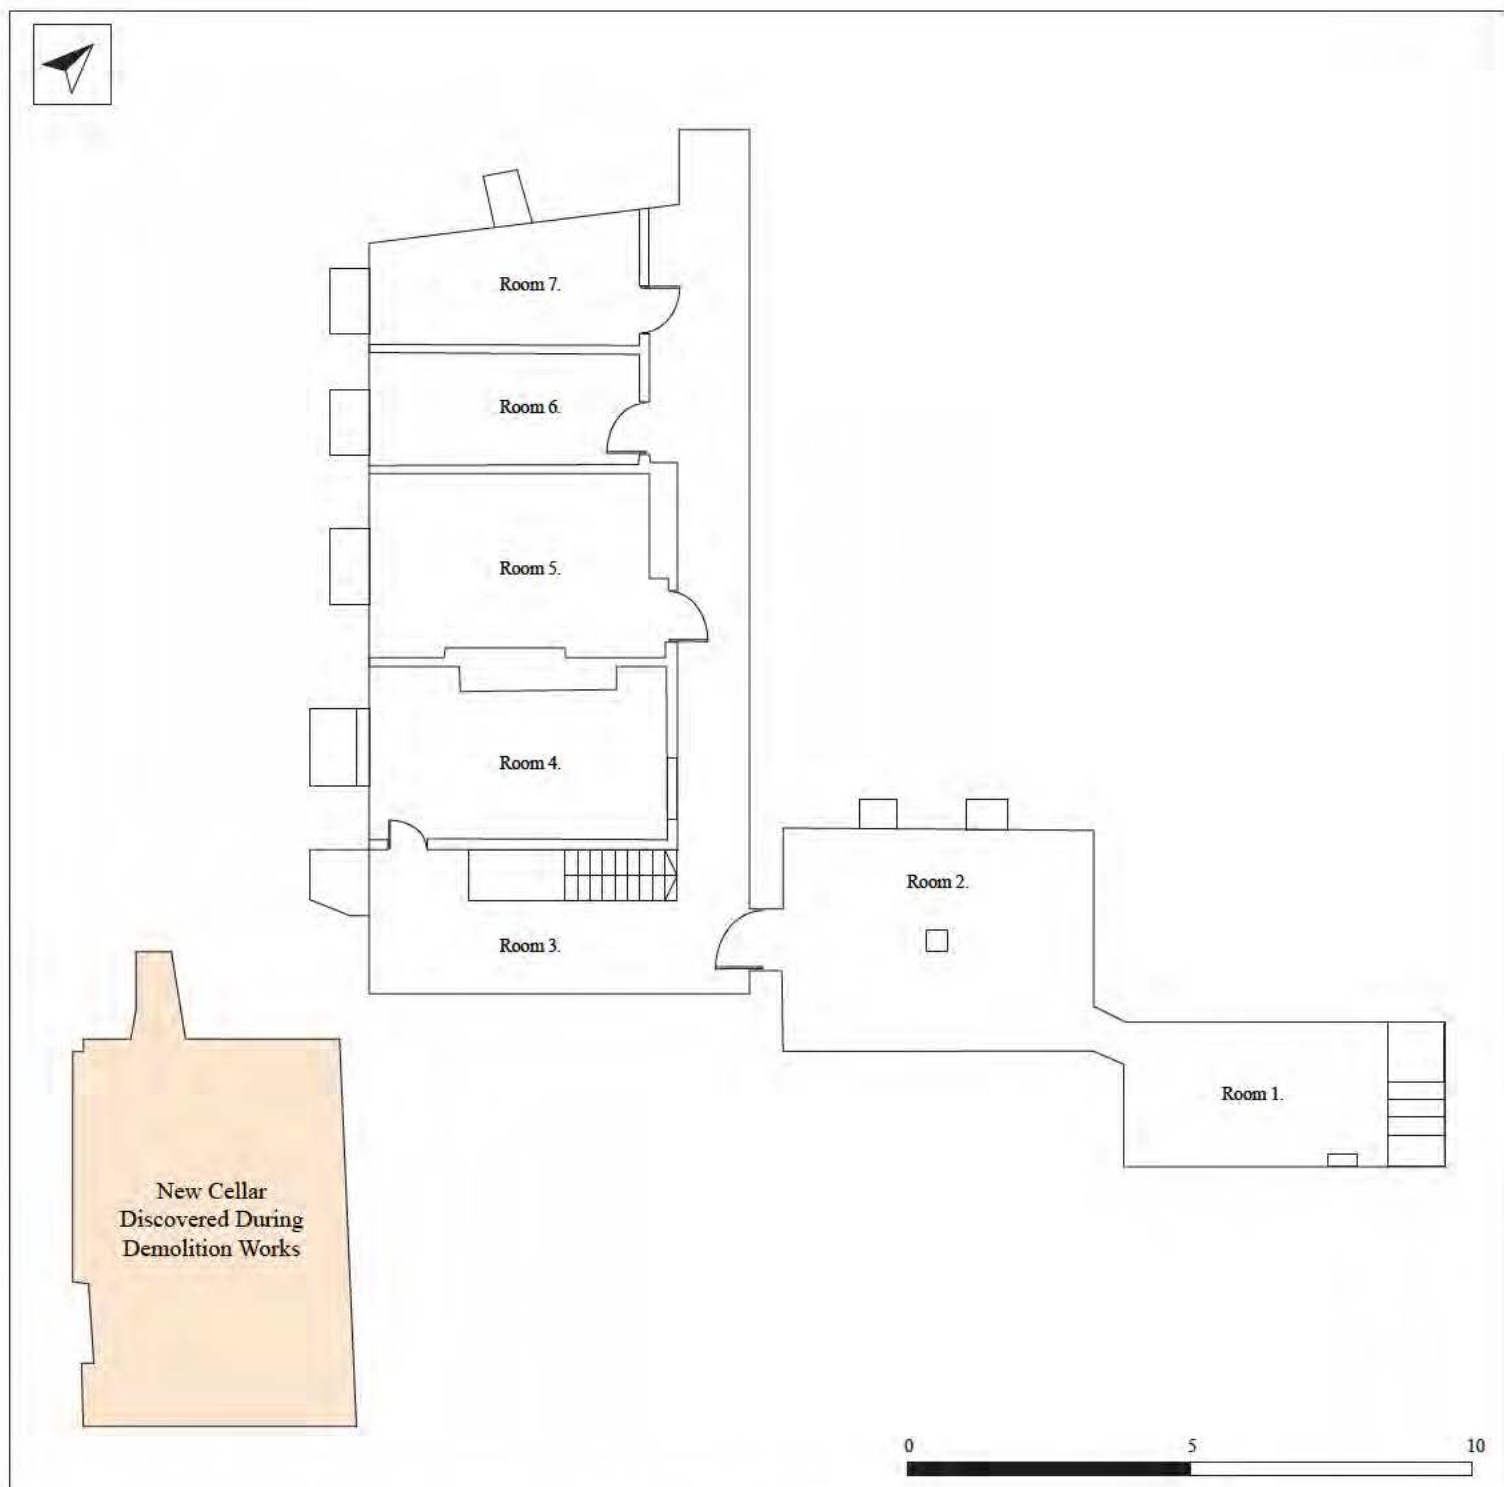
Appendix D. Location of New Cellar Discovered During Demolition of the Prince of Wales Public House

Additional Cellar Uncovered During Demolition of the Prince of Wales Public House
