Results of Archaeological Assessment at

A55 Tal y Bont Flood Alleviation Scheme

Report Number CR95-2015

C.R Archaeology

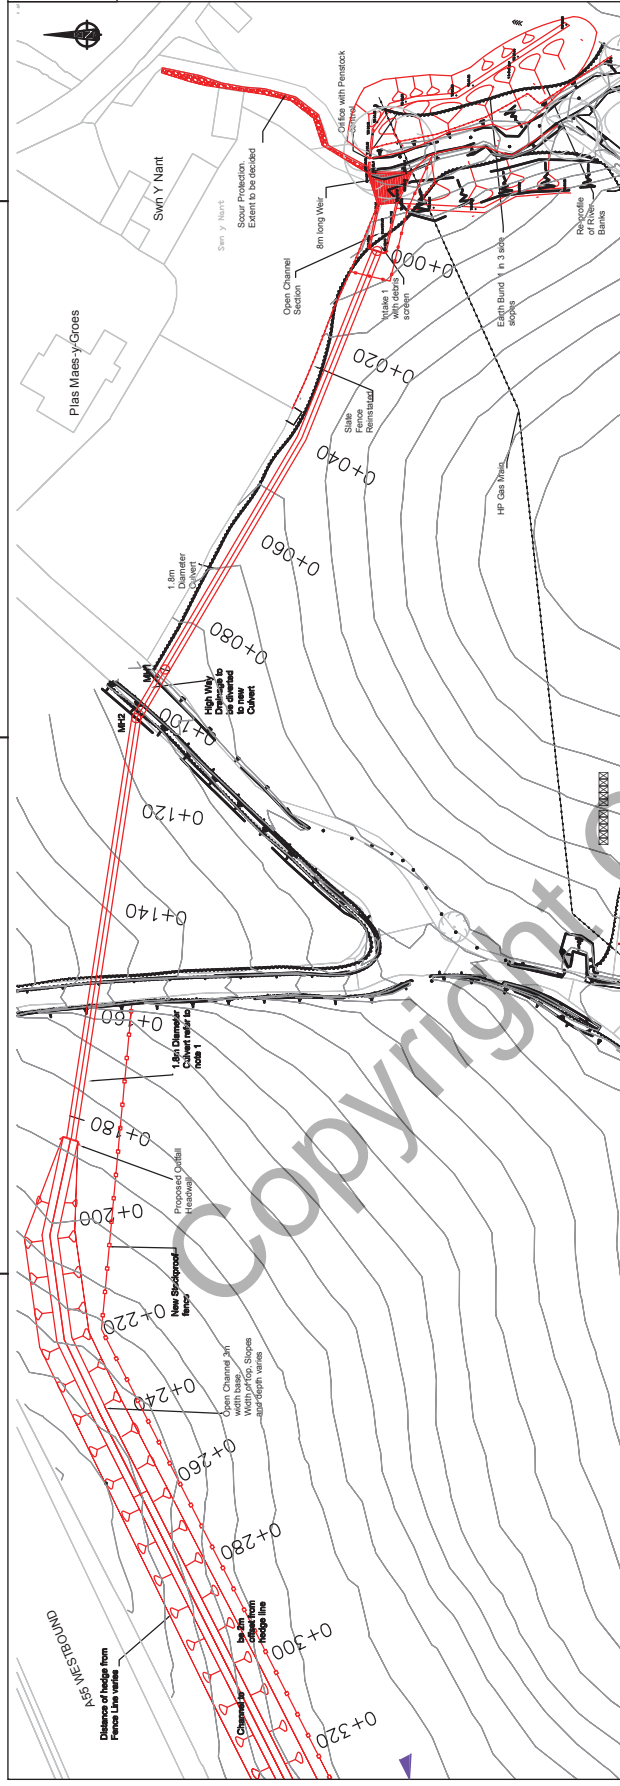
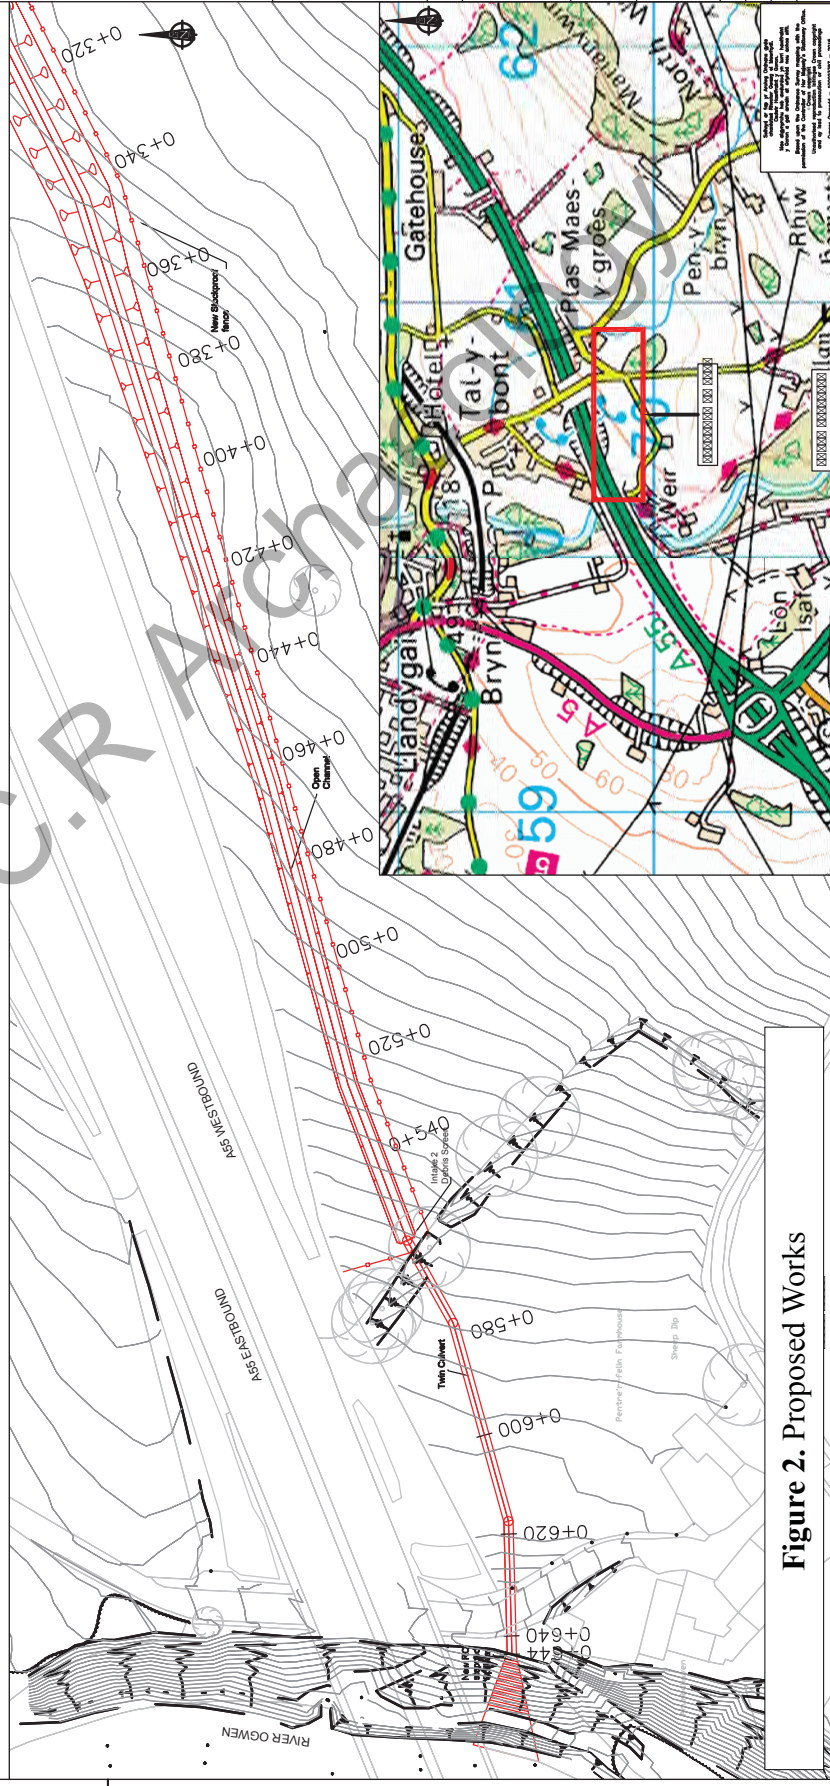
Figure 2. Proposed Works

The proposed scheme is located to the south of the village of Tal y Bont, between the A55 and the northern boundary of the Snowdonia National Park. The scheme extends for approximately 720m from its eastern terminus at an unnamed tributary of the Afon Ogwen, curving gently to the north and terminating at the Afon Ogwen, where it is crossed by the A55. The anticipated width of the scheme varies from approximately 15m to approximately 65m. The site traverses two minor roads and four parcels of agricultural land, mainly characterised by improved pasture. Field boundaries comprise a mixture of hedgerow, post and wire fencing, slate and wire fencing and stone walls. Figure 2 details the proposed works.

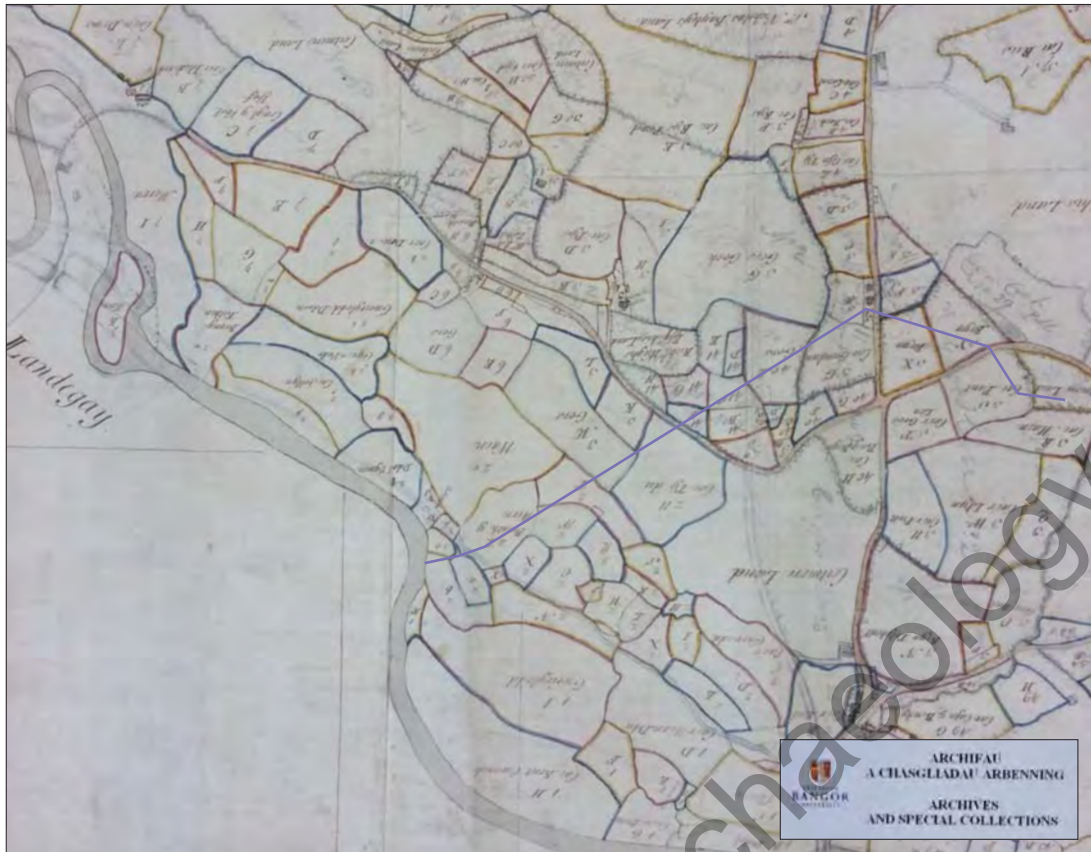
Figure 4. 1768 Penrhyn Estate Map
 (Source: Bangor University Archives XM/Maps 3156/1)

The earliest map which could be sourced for the proposed development area was a Penrhyn Estate Map dated 1768. This document is included as figure 4 and shows that the land is parcelled off into much smaller units than survive today, a feature which is most evident in the plots which front onto the road. With the exception of the A55 the road network surrounding the proposed development site is largely established by this point. There does however appear to be a trackway running

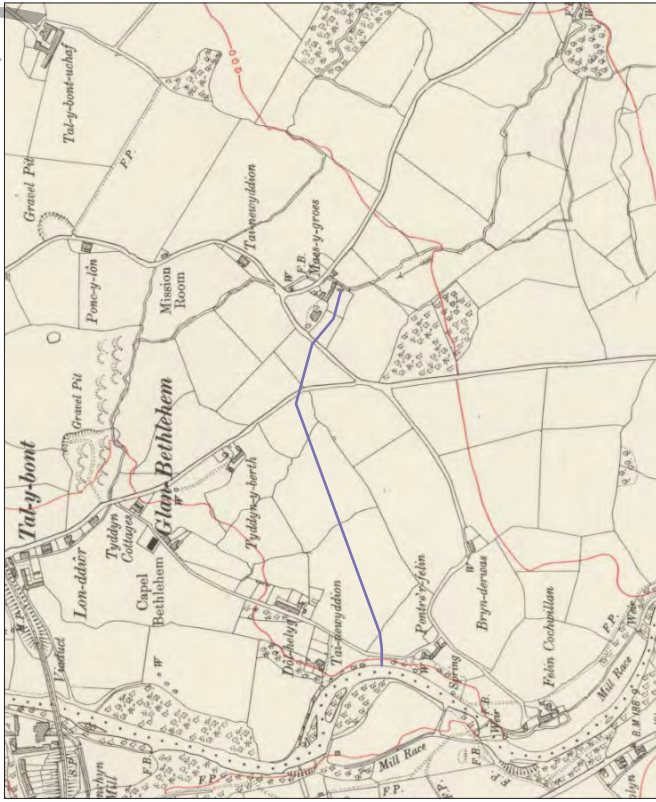
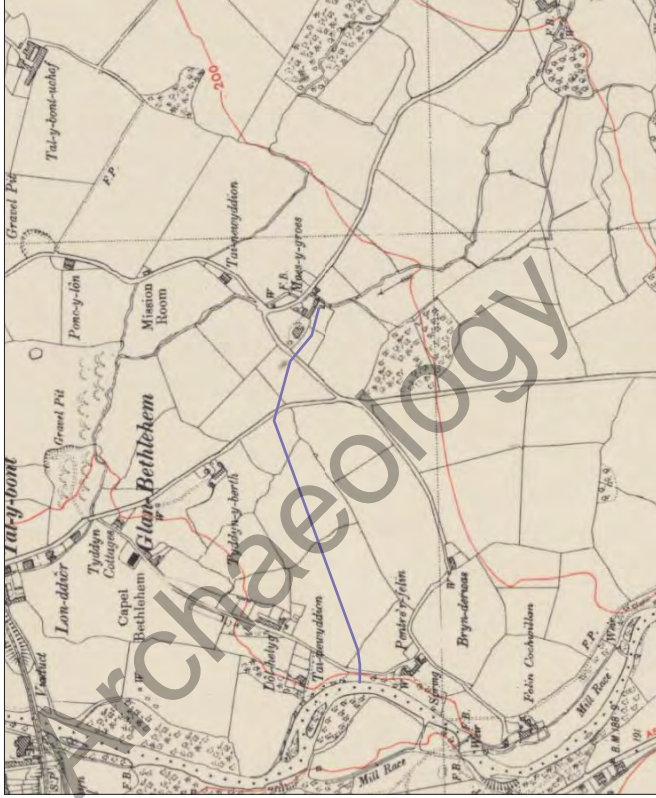
The first edition Ordnance Survey Map shows the continuation of the removal of the field boundaries to create ever larger units of land. These field boundaries remain unchanged throughout the map sequence (figures 6 – 9) up until 1948. A sheepfold is noted on the first edition (1889) which may be located within Plot 3, although the exact position of this feature is unclear.

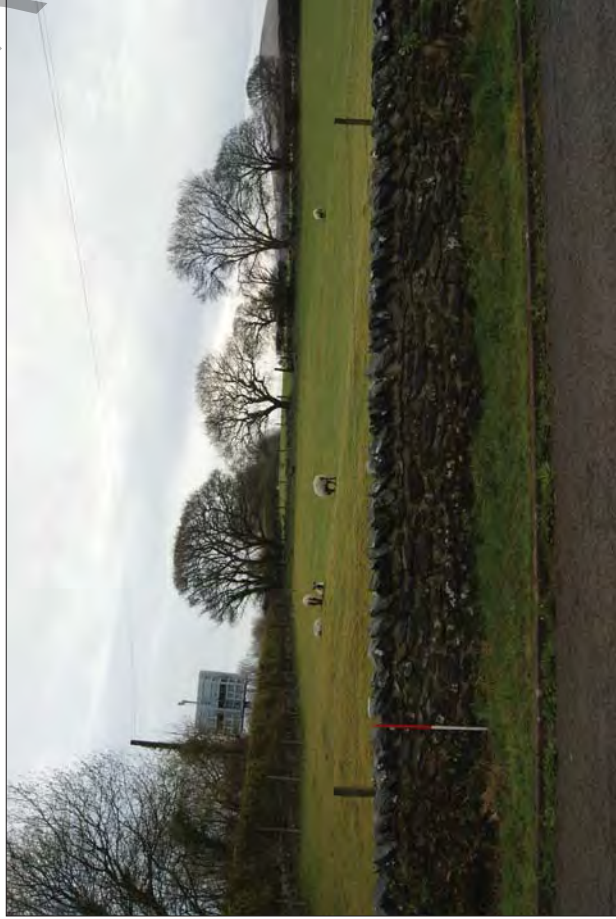
Plate 3. Rebuilt Stone Field Boundary

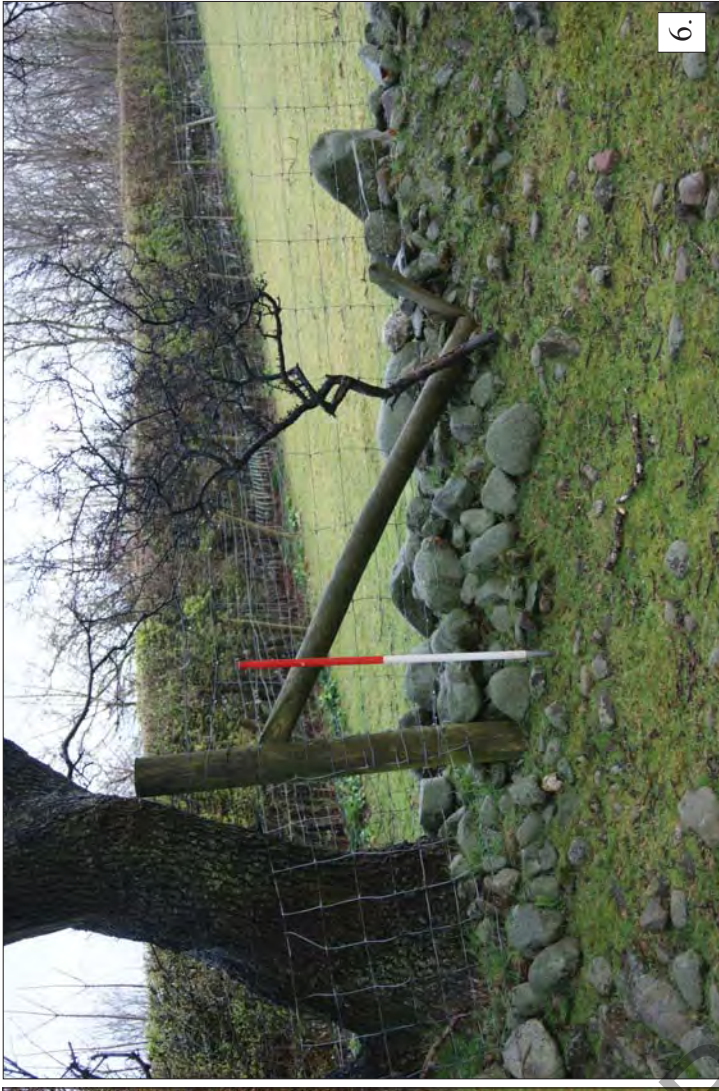
6.

The eastern boundary wall (SH 60333 70114) has collapsed and has been replaced by a post and wire fence (plate 6). The old wall had been constructed using large and medium boulders with a clay and stone core (plate 7). There are some large mature trees growing along the edge or within the wall core.

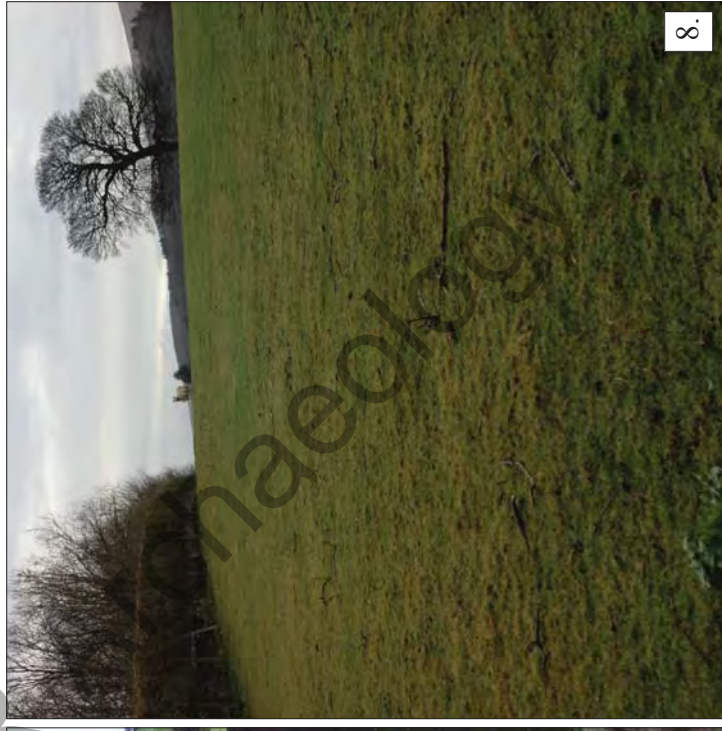
Plot 2 is a large sub rectangular field which slopes towards the A55. The gradual slope observed in plot 1 continues for 60 meters (plate 8), at which point the field flattens out.

Plate 8. Plot 2
Facing East

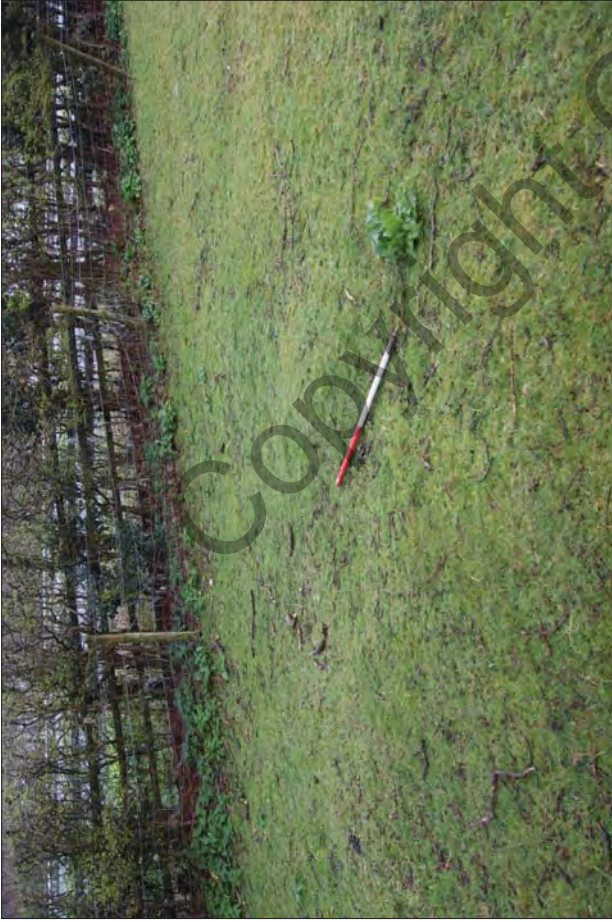
Plate 9. Undulations in Plot 2 Facing North-East

On the western side of the boundary wall between plots 1 & 2 five regular undulations (plate 9) approximately 1.5m apart were identified. These features could possibly be remnants of ridge and furrow or possible archaeological features although it is also plausible, given their close proximity to the road, that they could have been a result of groundworks associated with the A55.

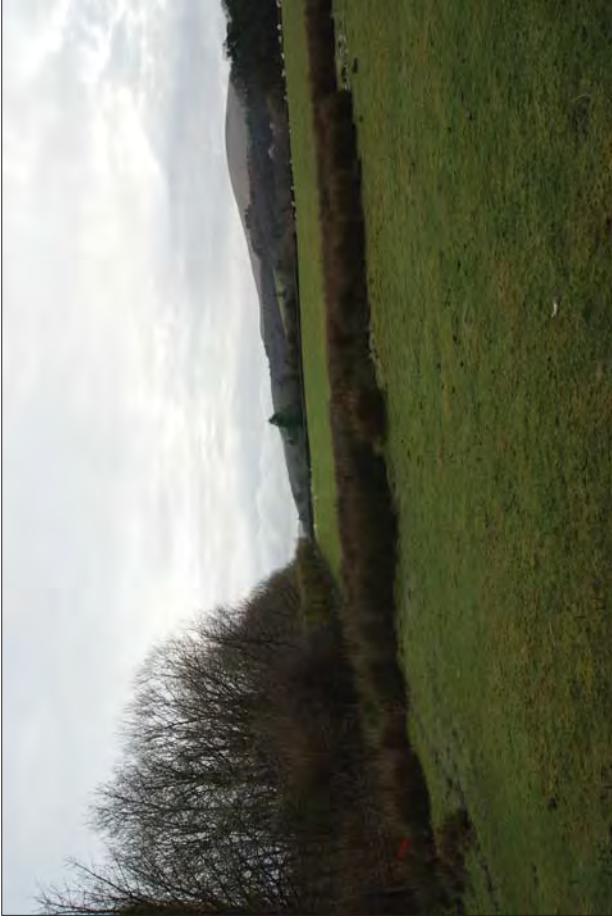
Plot 2 continues at level until you reach a marshy area (plate 10) which is fed by a spring further to the south of the field (plate 11). The level ground continues to the field boundary (plate 12) and no further features were noted along the proposed development route. The field boundary between plots 2 & 3 has been replaced by a wooden fence (plate 13) although a ruined stretch of walling does remain. Plate 14 shows an area of this wall and, as in the neighbouring plot, it is faced with large boulders, has a clay and stone fill and a hedge growing along it.

Plate 10. Plot 2 Facing East Along Development Line Showing Marsh Area

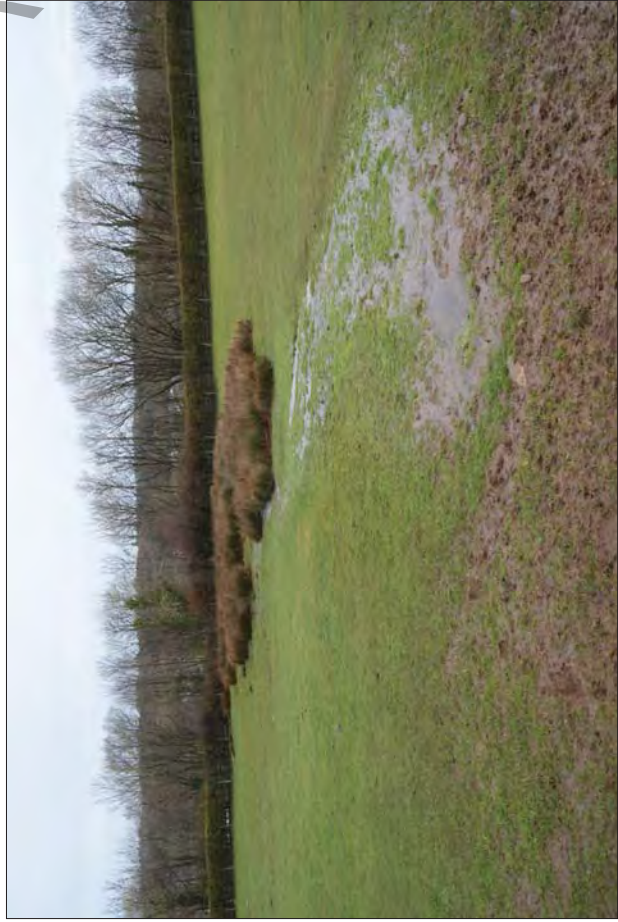
Plate 11. Plot 2 Showing Marsh Area Facing North

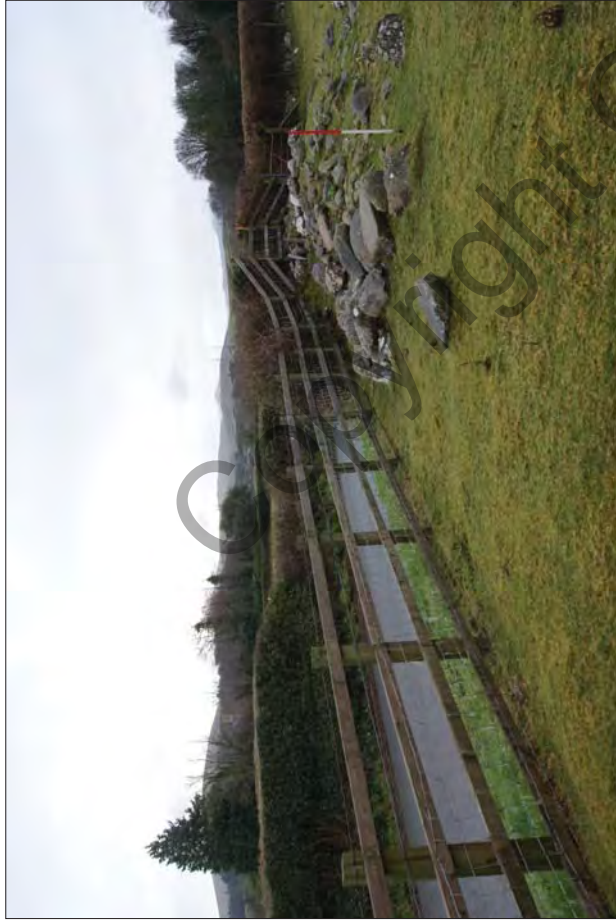
Plate 13. Modern Replacement Fencing and
Remains of Previous Field Boundary in Plot 2

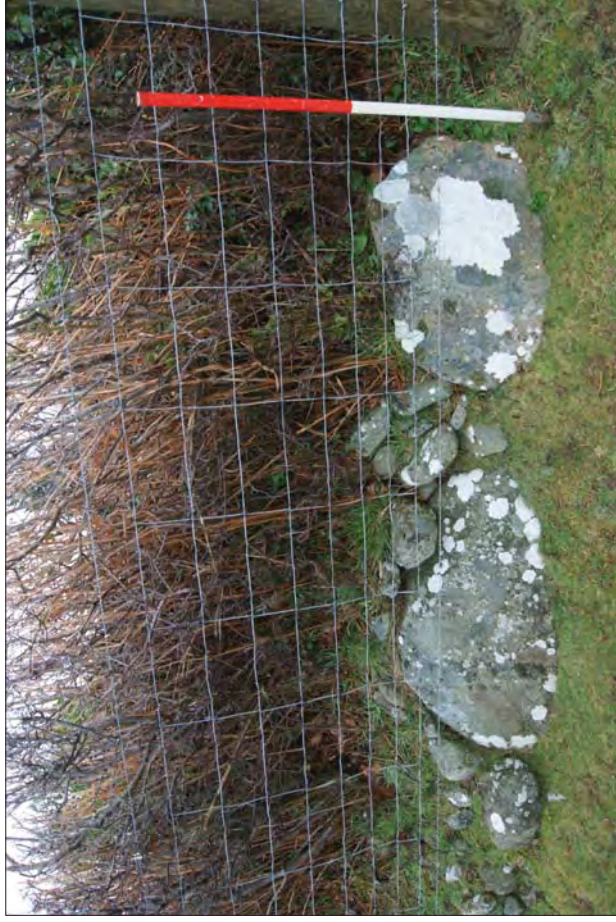
Plate 14. Modern Replacement Fencing and
Remains of Previous Field Boundary in Plot 2

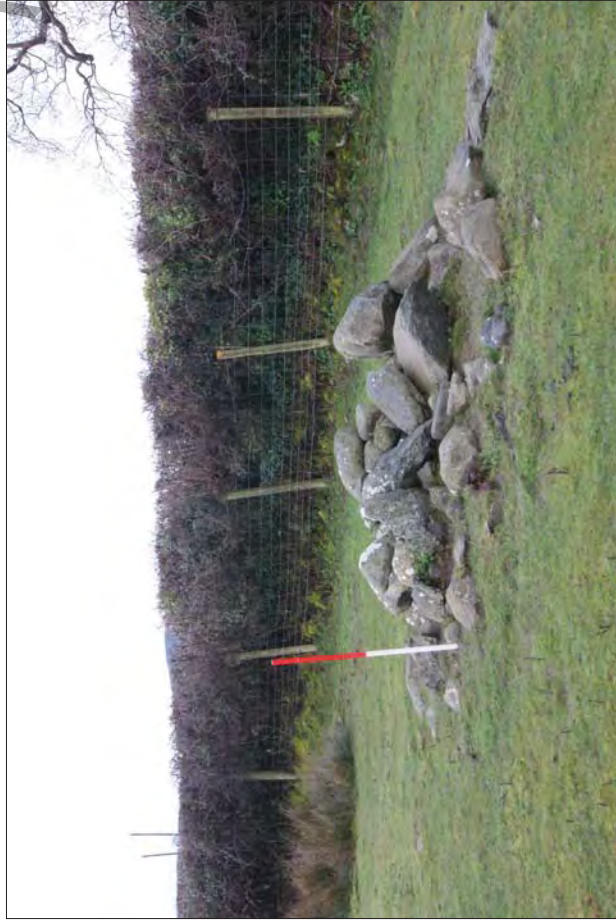
Outside of the development area but still within plot 2 clearance cairn was noted (plate 15) at SH 60408 70030. This is likely to be the remains of a removed boundary wall. There was also a large amount of stone noted around the trees (plate 16) within the field. It is unclear as to the origin of this stone.

Plate 15. Plot 2 Clearance Cairn

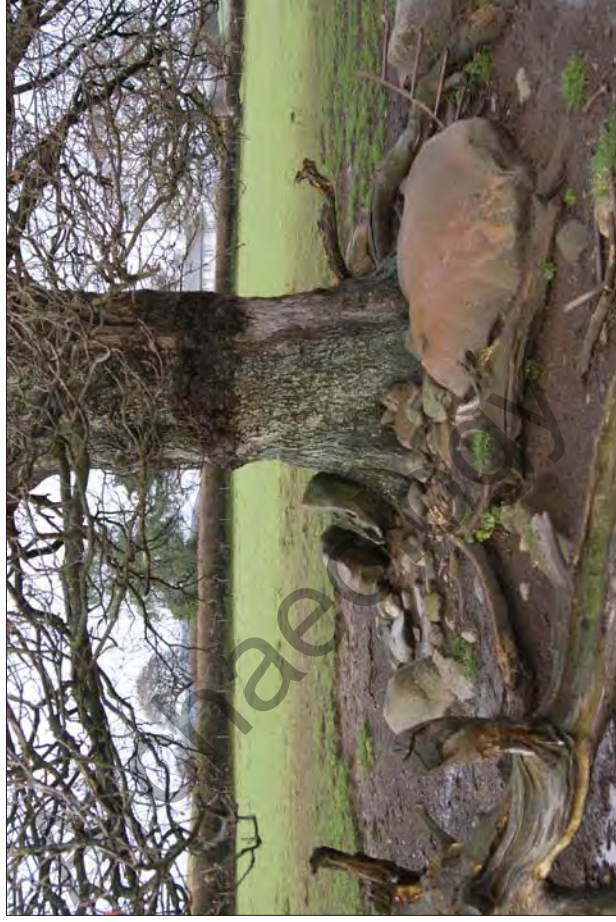
Plate 16. Plot 2 Large Boulders Around Tree

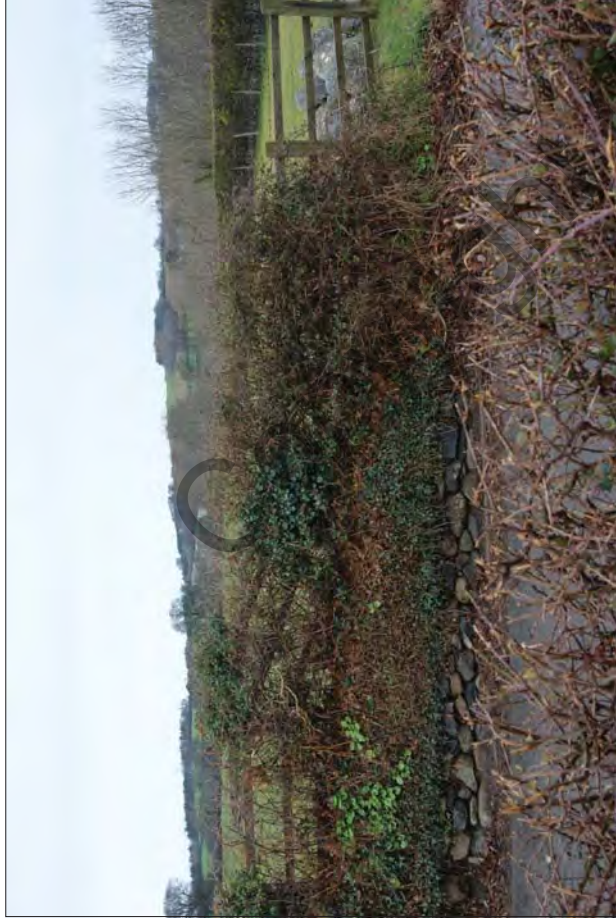
Plate 17. Lane Between Plots 2 & 3

Plate 17 shows the lane which must be crossed to access plot 3.

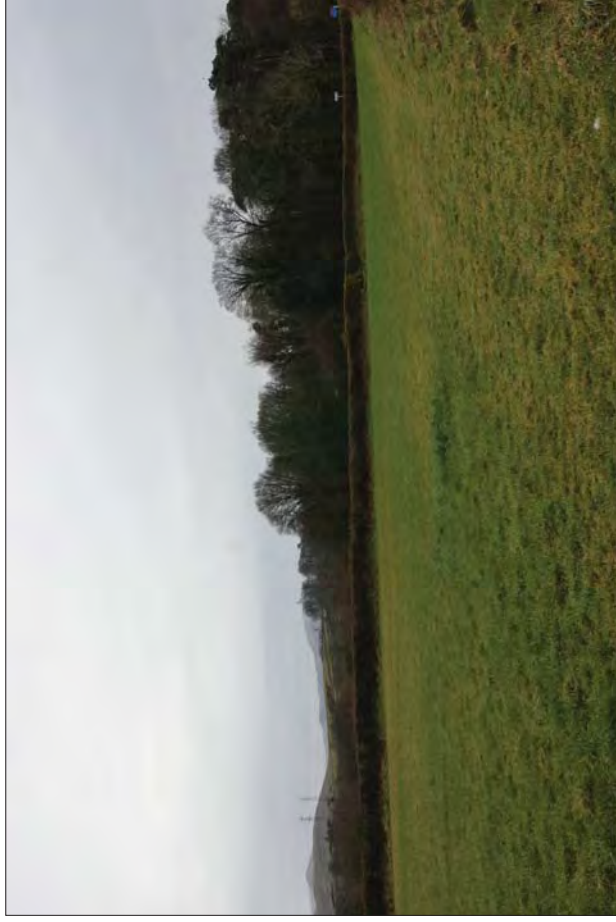
Plate 18. Plot 3 Facing South-East

Following the construction of the A55 plot 3 has become a long thin sub-rectangular field with a triangular point at its south-western corner. This plot was overgrown with scrub grass which was damp underfoot (plate 18). The boundary at its south-eastern end was constructed from a stone faced base with clay fill and slate fencing in-bedded on top which was held together by wire (plates 19 & 20). A lane is crossed to gain access into plot 4.

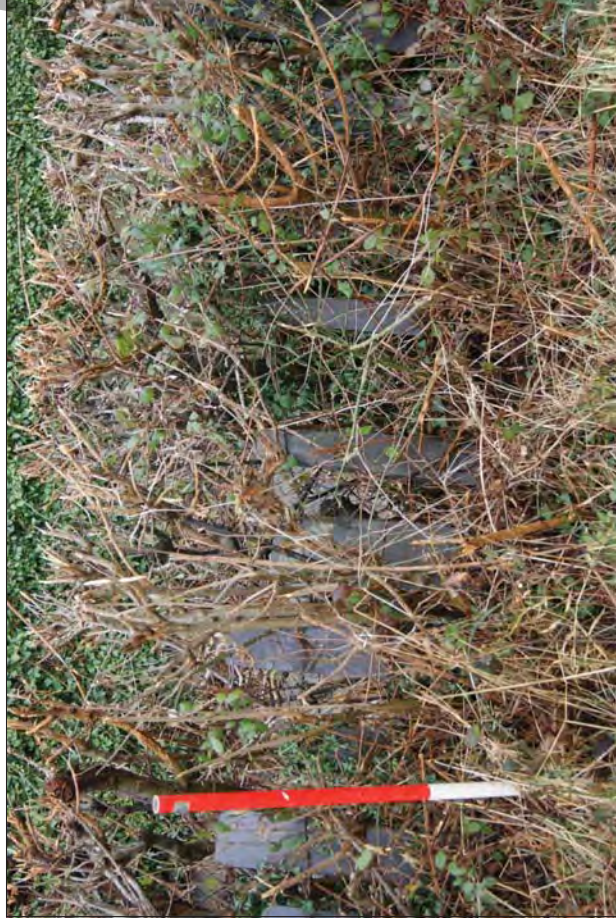
Plate 19. Slate Field Boundary Plot 3

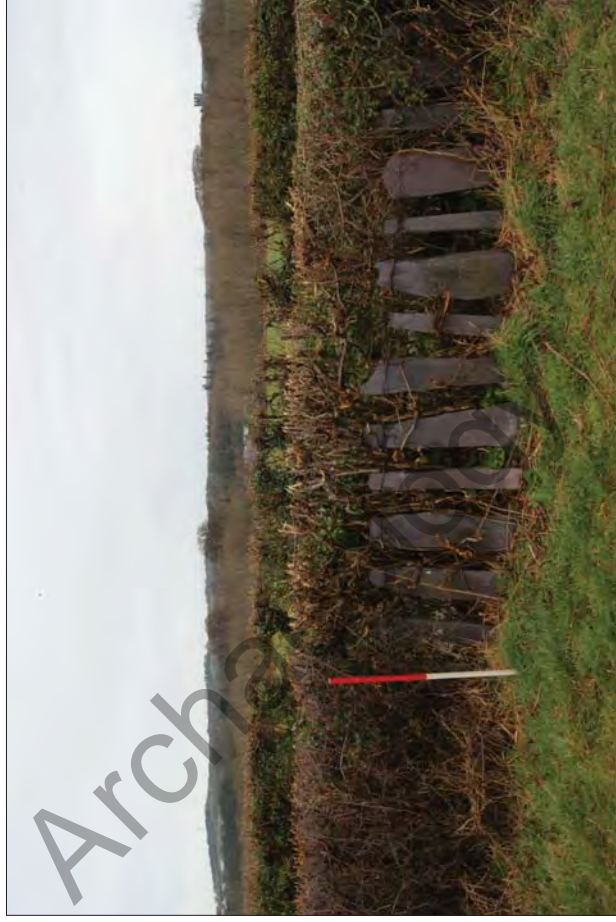
Plot 4 was a small squarish field with lanes to the north and west, a wooded area to the south and Maes Y Groes house to the east. The north-western boundary with the lane is slate and wire fencing behind a hedge (plate 20). The proposed development will head south-east (plates 21 - 23) and will run along the eastern boundary of Maes Y Groes towards a river at the eastern end of the field. The field raises towards the south-west forming a flat topped hill. Some large medium stones were noted protruding from the top of this raise. The development will cross the river (plate 24) where a large bund will be built along the river edge SH 60906 70156.

Plate 20. Slate Field Boundary Plot 3
