Results of Archaeological Works at Bodfasarn (South-Western Wing), Clynnog Fawr

Report Number CR97-2016

Planning Application Number: C09D/007/34/CR
National Grid Reference: SH 41431 49620
Client: Mr David Crombie

Report Author: Catherine Rees & Matthew Jones
Report Number: CR97-2016
Date: 15/02/2016

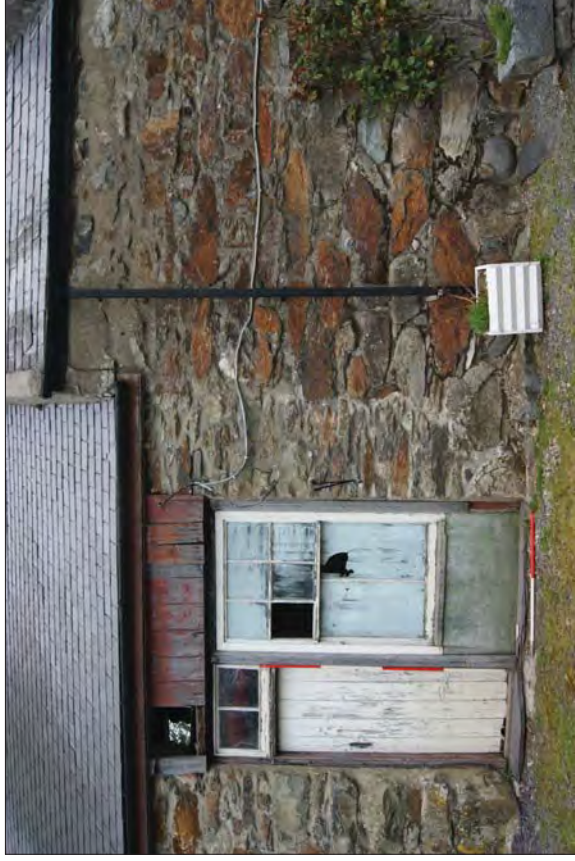
Plate 7. Phasing Change Evident Against Main House Range

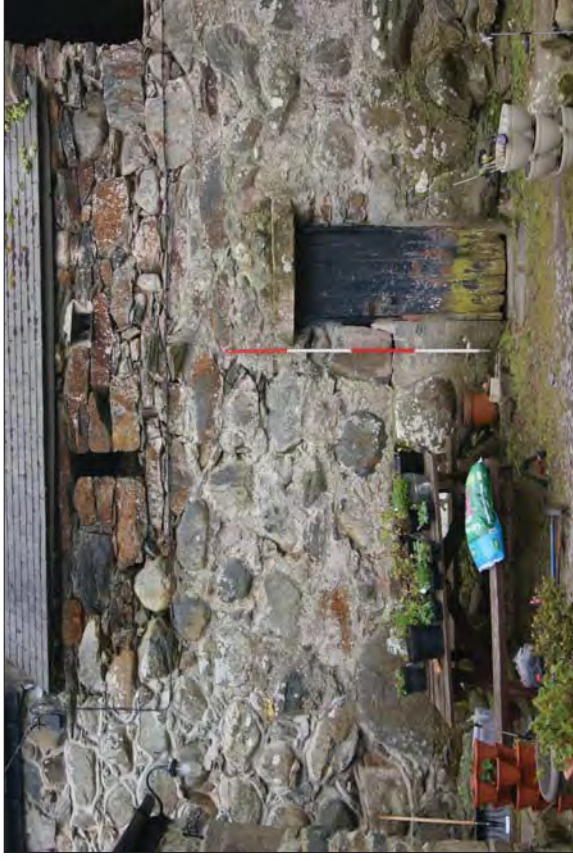
Plate 18. Rear Elevation Showing Later Addition of First Floor

The first floor window is located just beneath the roof eaves and the window opening is part of the secondary modification to this wing, and was added when the first floor was added. The window is a fixed, 2 over 2, 4 pane design with narrow wooden glazing bars. The larger size of the glass panes and glazing bar thickness this window would indicate a late nineteenth or early 20th century date to the window itself although it may have been taken from elsewhere and the insertion here may be slightly later. This window may even have originally been part of a larger sash window which has been cut down and laid on its side. This interpretation is supported by the obvious reuse of salvaged

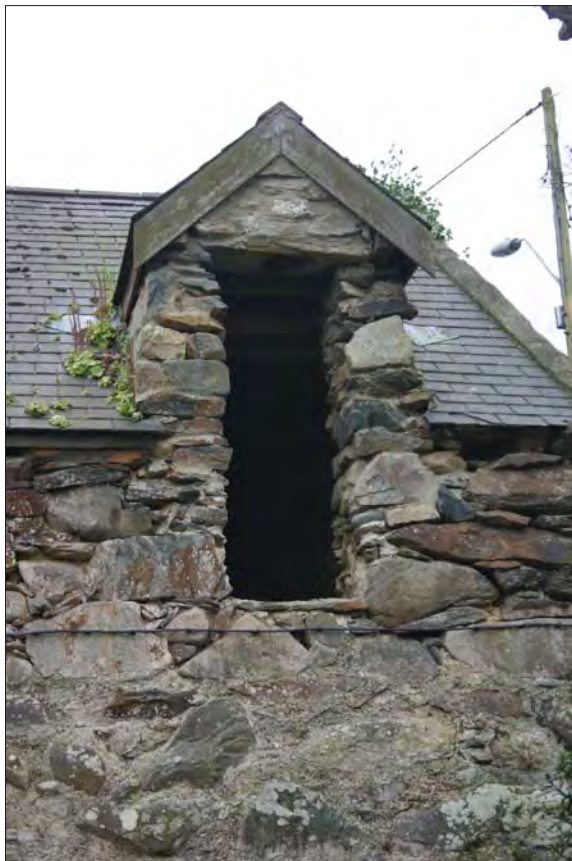
Plate 21. Rear Elevation
First Floor Opening

There are four openings to the rear of the building – doorways at first and ground floor level and a ventilation slot and possible owl hole at first floor level. The first floor doorway/pitching hole has no timber framing, nor is there any evidence that any was ever in use. The opening would have allowed crops, presumably hay and straw but also possibly grain to be loaded directly up to the first floor level from the back of a cart or wagon without having to be carried up the narrow stone steps at the front of the building. The first floor level would have functioned as a storage area for crops harvested from the lands associated with Bodfasarn and we know from historic records that it was originally a farm and continued to function in this role throughout its time as an inn.

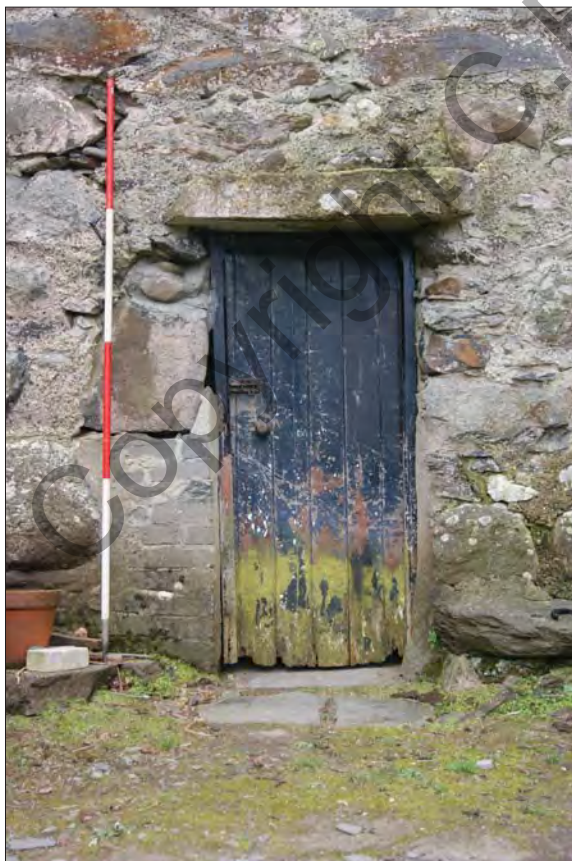
Plate 23. Rear Elevation
Ground Floor Doorway

There is a centrally placed doorway at ground floor level. This lower portion of this opening is clearly relatively modern and this doorway was presumably a window opening which was later enlarged. As was observed at the front of the building the door and frame were likely not new when incorporated into the building but were salvaged from elsewhere.

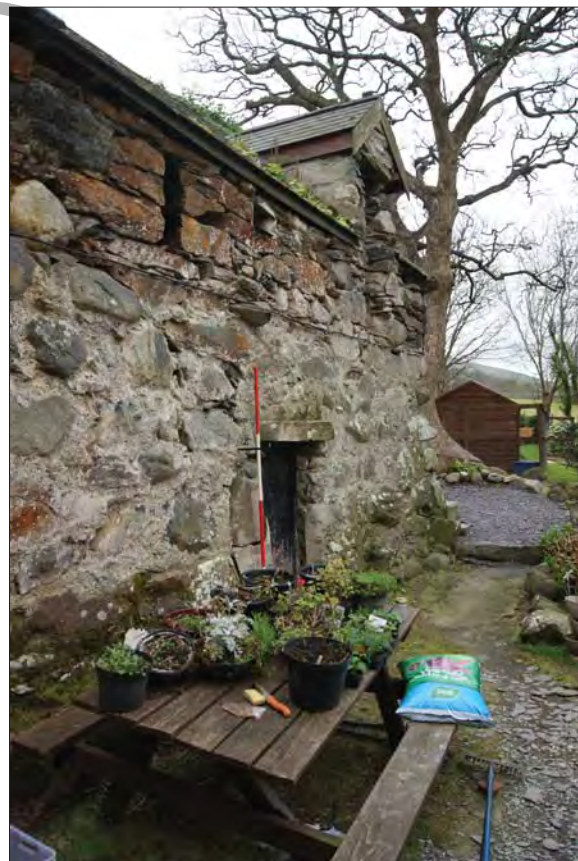
Plate 24. Rear Elevation Detailing Large
Boulders Projecting at Ground Floor Level

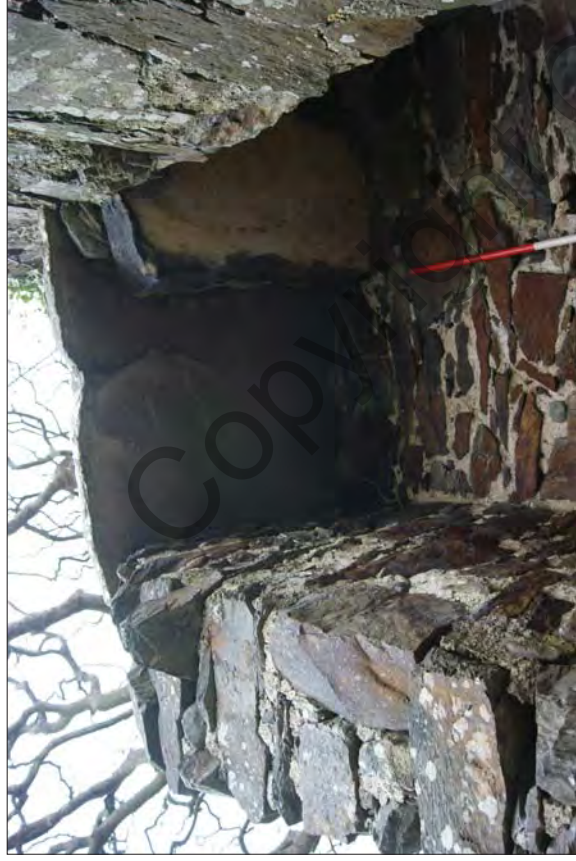
Plate 25. Large Slabs Roofing External Stairway

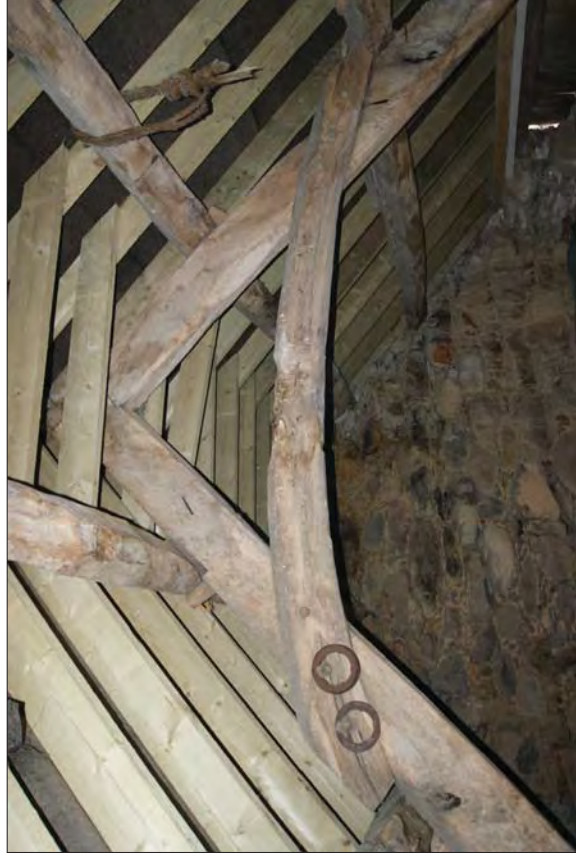
Plate 30. Roof Detail Showing Original Wooden Frame and Modern Replacement Roof and Rafters

It is noted in the RCAHMW description of the building that the stable retained the old roof slates but this has since been replaced following a severe storm within the last ten years.

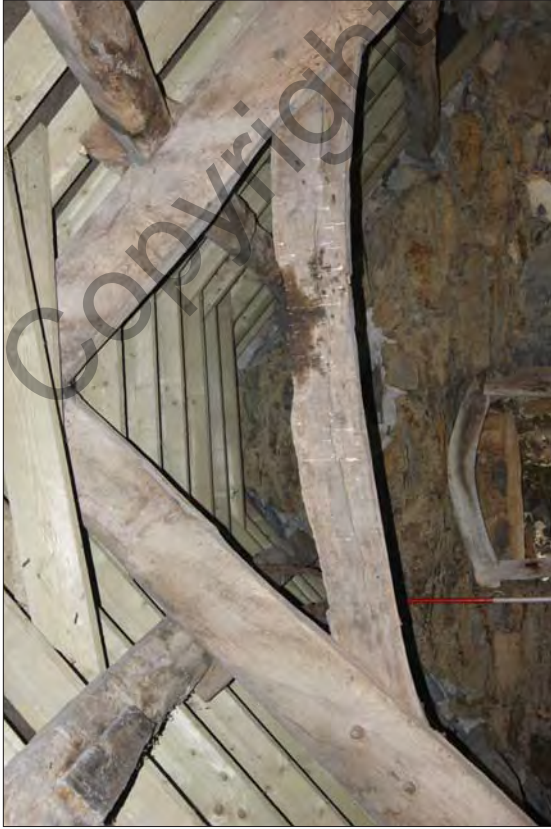
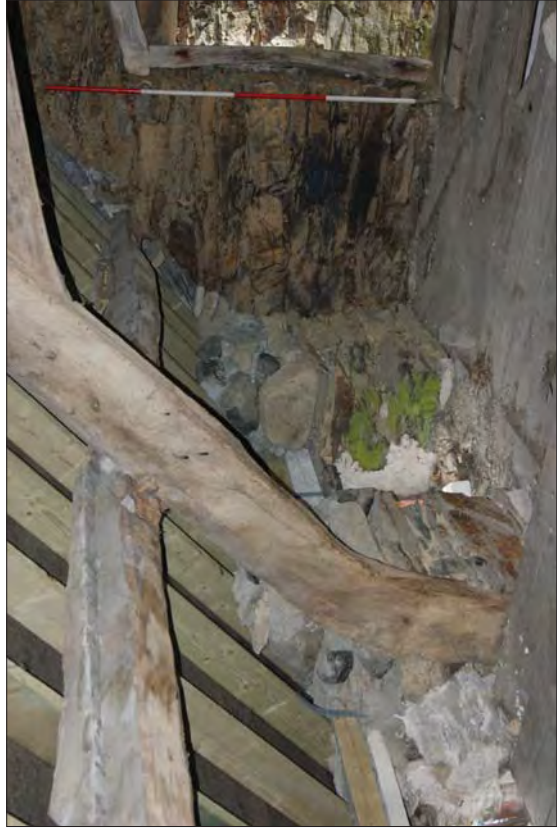
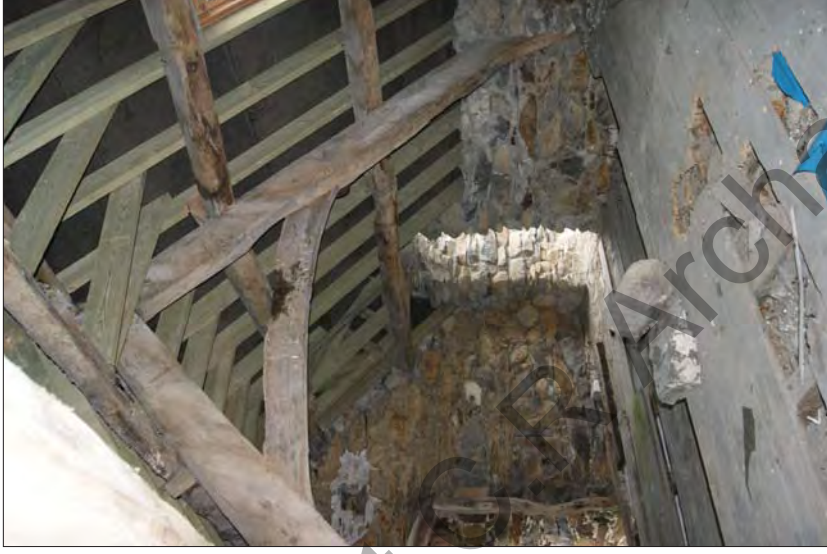
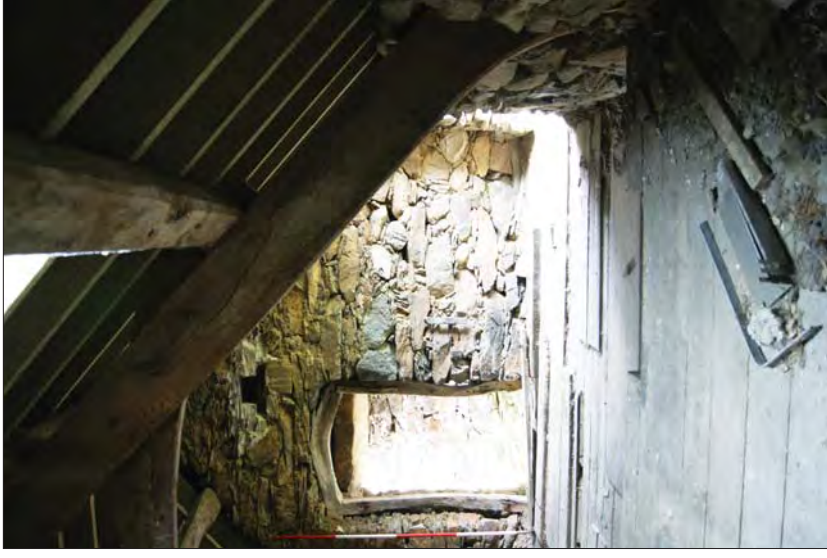
Plates 33 - 36. Pegged Collar Beam Truss Showing Curvature of
Paired Principle Rafters

Of particular interest within this room is the roof structure which is a pegged collar beam truss. This type of roof structure is fairly common in this region and nearby house Pant Glas Ucaf which has a date of 1562 is noted as having an open roof structure carried on a single collar beam truss (RCAHMW 1960: 43). There is however a slightly curious element to this roof structure and that is the use of a curved pair of timbers for the frame. These timbers are likely to have been reused material and it is a strong possibility that they have come from an earlier cruck building in the local area. It may be a possibility that they are reused ships timbers although this interpretation has become increasingly challenged by historic building specialists. The former hypothesis would be supported by the proximity of the house to the sea (c. 550m) and the second by the pegged door frame through which entry to this space is gained which may well have come from the same source as the roof.

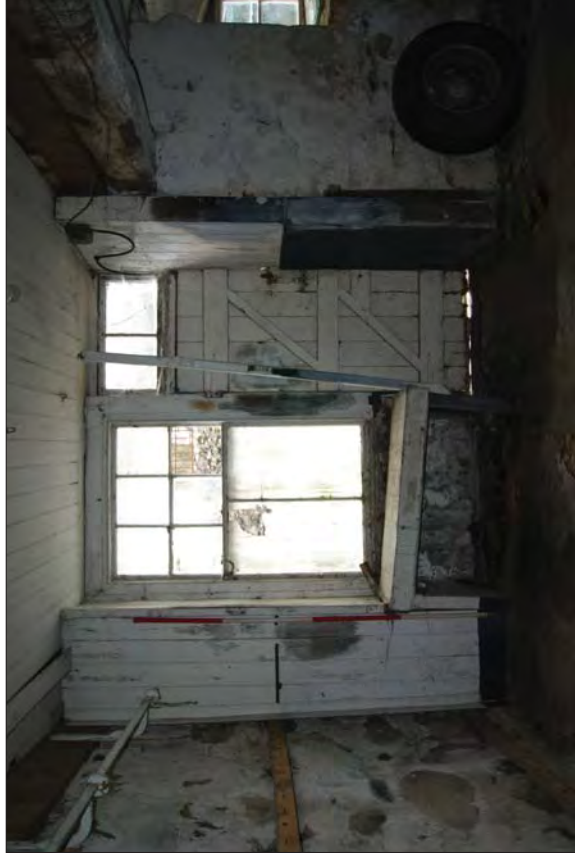
Plate 38. Shop Frontage/Entrance in Front Elevation at Ground Floor Level

The ground floor window is believed to be in its original position although the brick window header is a later modification, presumably of contemporary to the addition of the upper floor. The higher stone cambered arch is visible from inside the building. The window itself is a fixed 4 pane design with the panes arranged 2 over 2. It is of late nineteenth or early twentieth century date but was likely added when the stables was converted for use as a butchers shop sometime between 1911 and 1930.

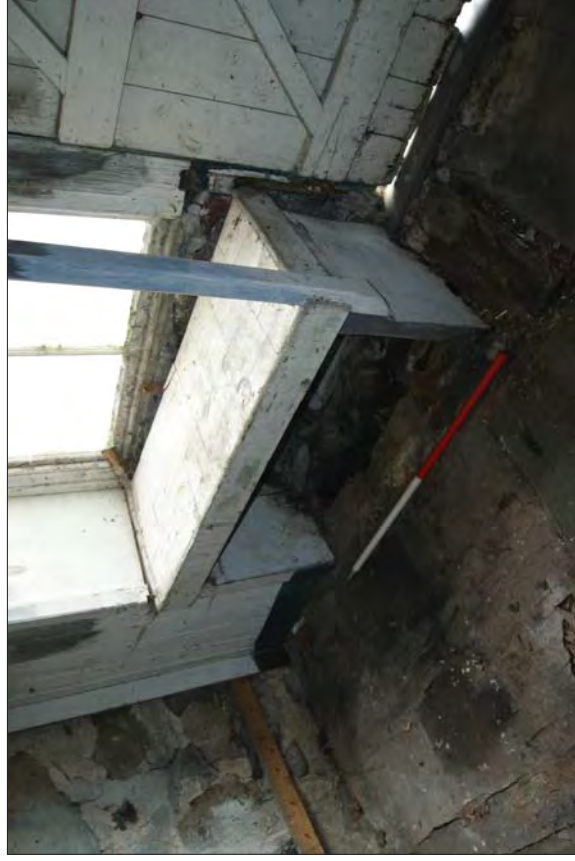
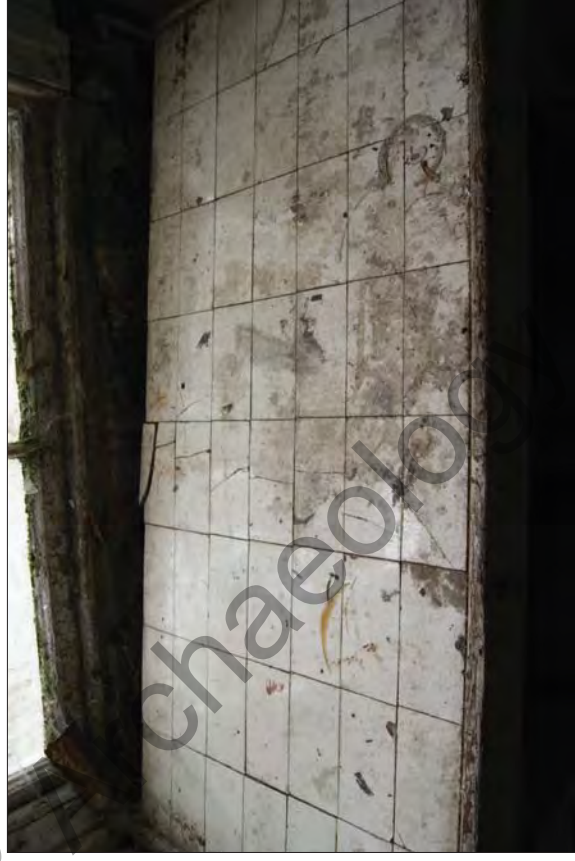
Plate 39. Tiled Work Surface Used When Building Was in use as a Butcher's Shop

Plate 40. Tiled Surface Detailed Shot

There were a number of surviving features from the era of the butchers shop including wooden wall panelling, a tiled table under the window and hooks/racks on the walls. The current floor is presumably also of this phase. These features were removed during the current works and a site visit was made. Nothing new was revealed on the uncovered wall elevations, and a few patches of cobbles were noted below the wooden floor.

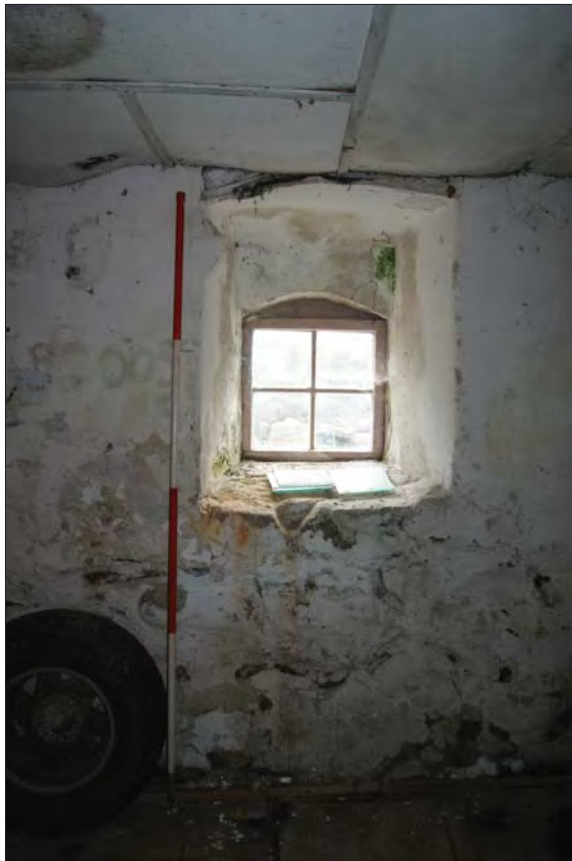
Plate 45. Ground Floor Window in Front Elevation. Later Blocking Evident

The large window opening in the front elevation, which has been reduced in height, and the window to the rear are both indicative of the use of this building as a stable as the horse was generally afforded much taller, more spacious and better lit accommodation than cattle or ox (Brunskill 2000: 164).

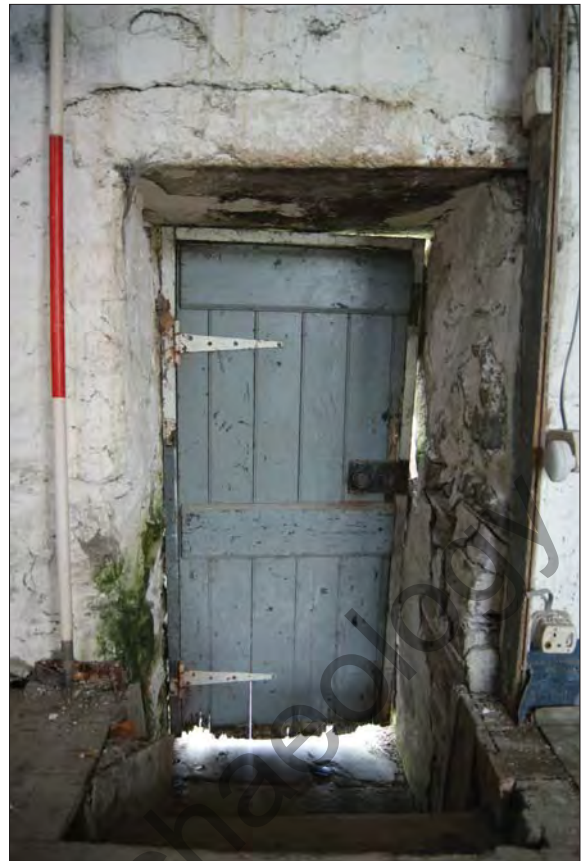
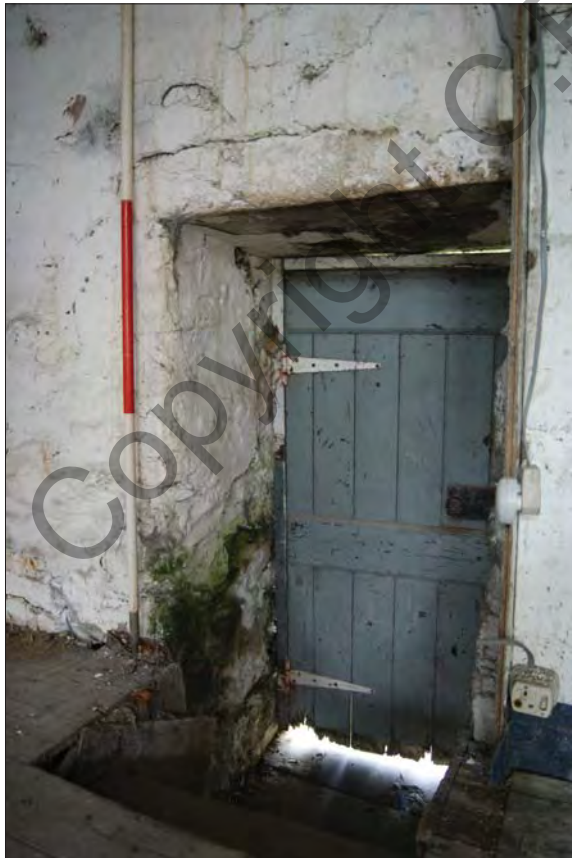
Plate 46. Ground Floor Doorway in Rear Elevation. Steps Lead from Raised Floor

Plate 47. Ground Floor Doorway in Rear Elevation. Note Wall Thickness

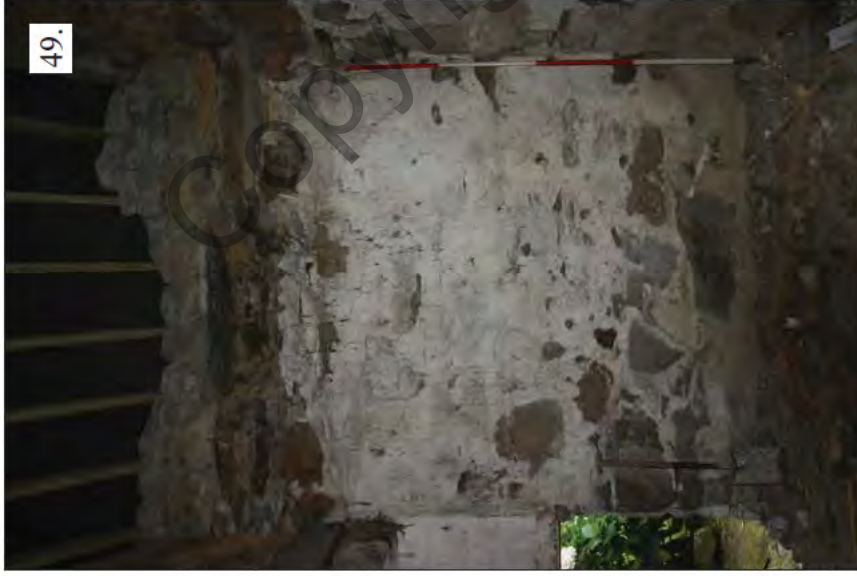
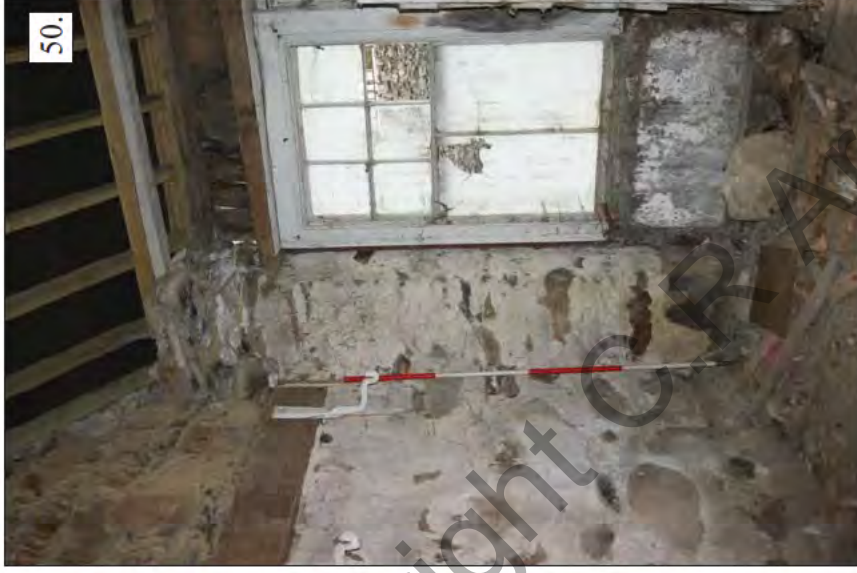
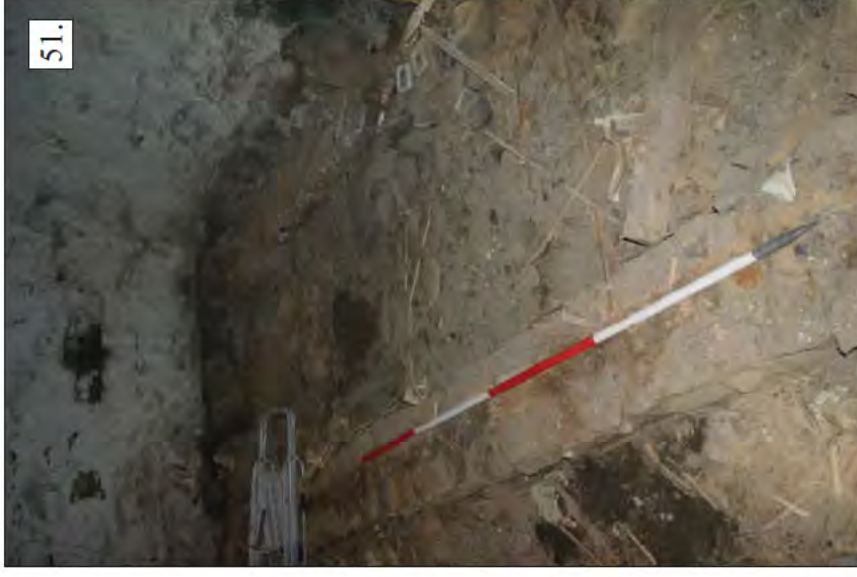
Plate 49. Ground Floor Rear Wall Following Removal of Wooden Panelling

Plate 50. Ground Floor Front Wall Following Removal of Butcher's Shop Fittings

Plate 51. Ground Floor Following Removal of Floor

Plate 52. Ground Floor Following Removal of Floor (Taken from First Floor Level)

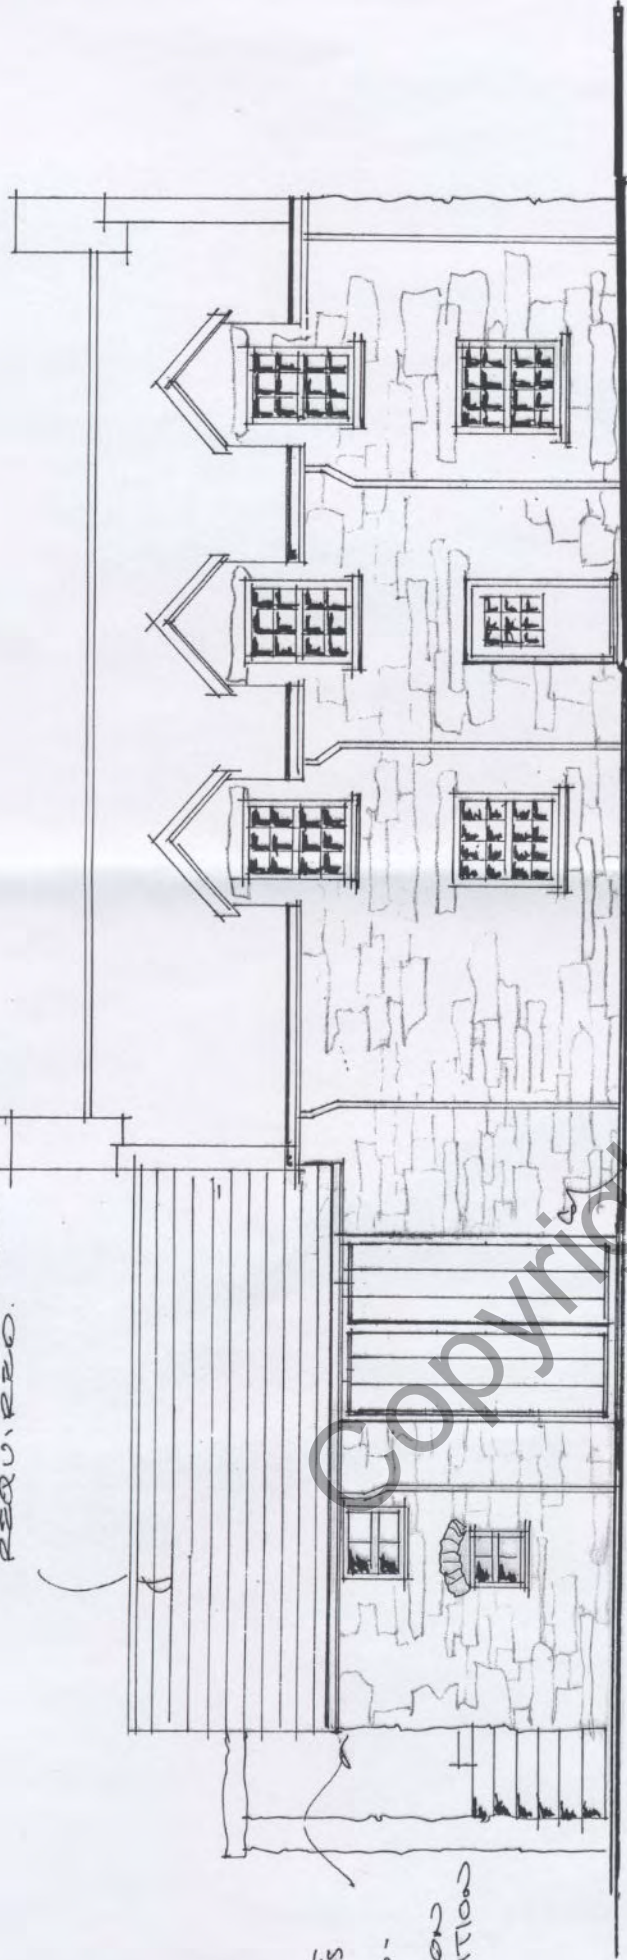
proposed front elevation

NEW TIMBER DOUBLE HUNG - OPENABLE WINDOWS FIXED IN POSITION TO SUIT WIDTH OF EXISTING OPENING.

NEW TIMBER WINDOWS FIXED IN POSITION DESIGN REPLICATED FROM EXISTING

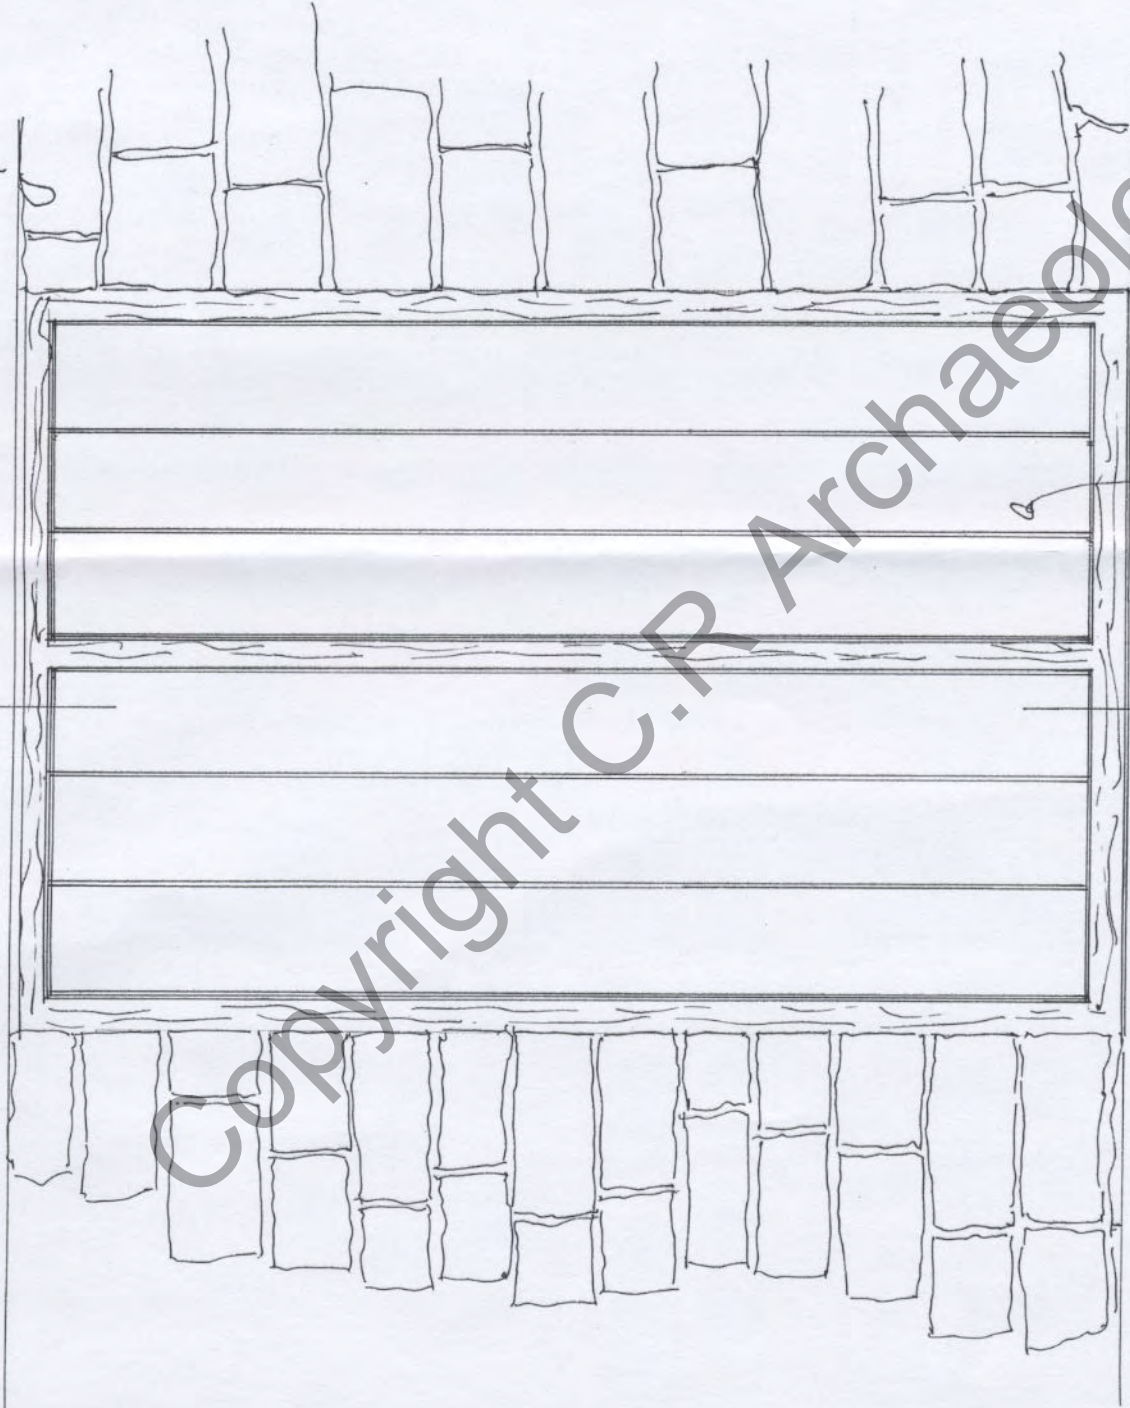
PROPOSED FRONT ELEVATION
 WINDOW. SCALE 1:25 A

NARROW VERTICAL
 BARS TO DOORS
 100mm WIDE OAK
 FRAMEWORK
