REPORT NO.385

LAND AT TYDDYN BACH

EXISTING BUILDING RECORD

APRIL 2012

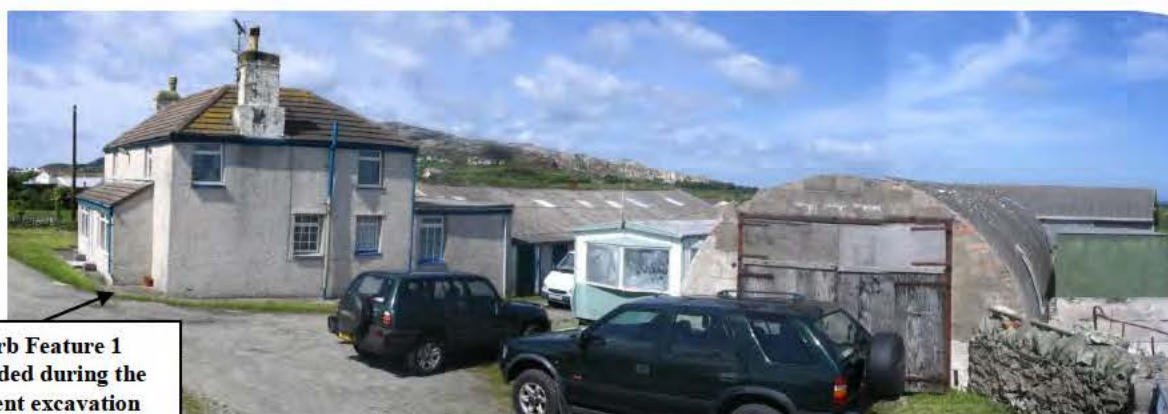
Plate 2 below: Tyddyn Bach farm complex viewed from the east, May 2006

Kerb Feature 1
recorded during the
current excavation

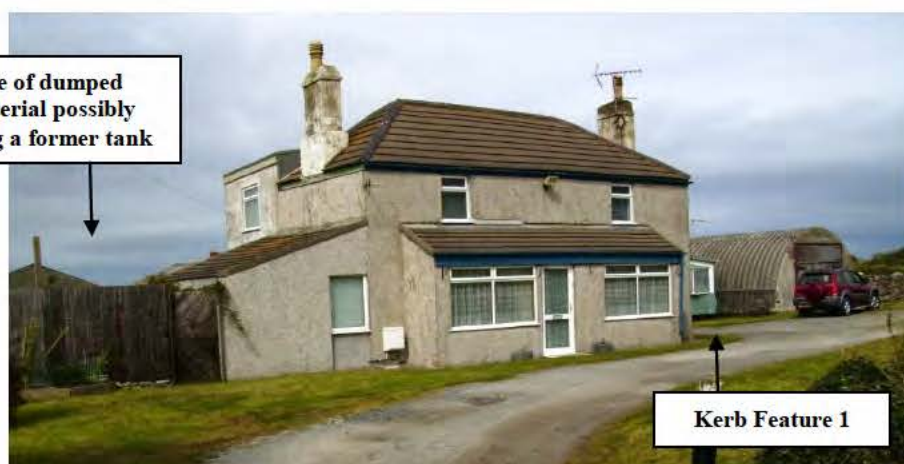
Plate 3 left:

site of dumped
material possibly
filling a former tank

Kerb Feature 1

Tyddyn Bach,
farmhouse from
the south prior to
excavation

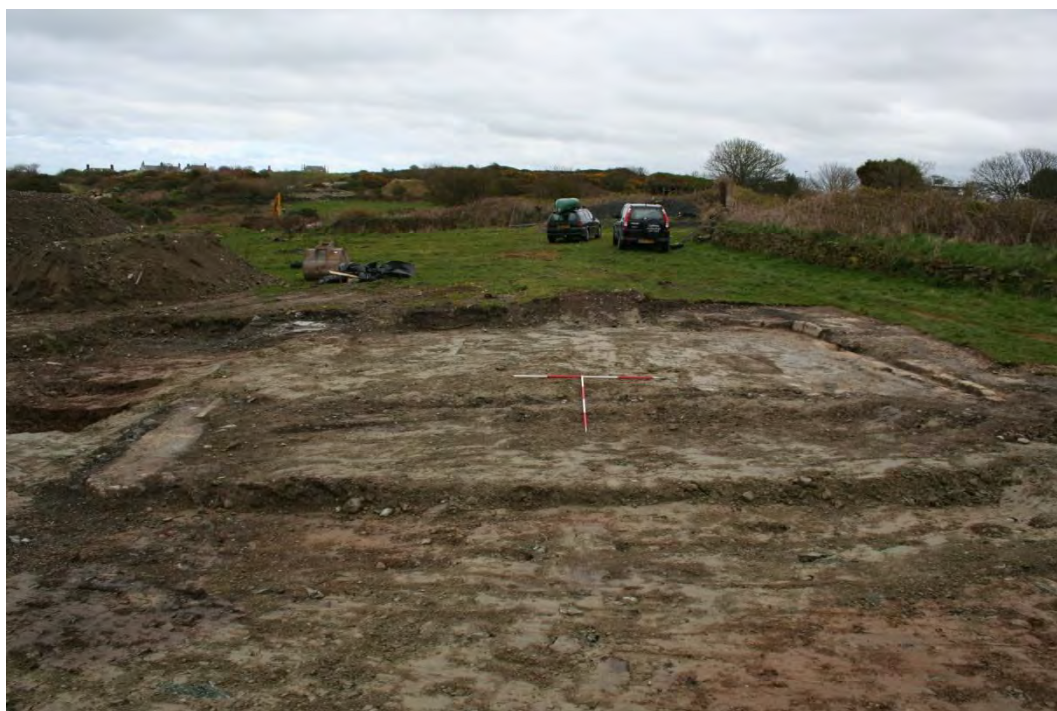
Plate 5: House site strip, view from the west, April 2012

The area was excavated to an average depth of between 0.4 and 0.5m onto natural buff coloured silty sand with naturally occurring angular stones. In addition three 1m deep test pits were excavated in random positions as the excavations progressed in order to test the natural. Although several minor features were revealed, the excavation showed that the farmhouse, Barn 'C' and any adjoining modern features had very shallow foundations, all of which must have been removed during the demolition process.

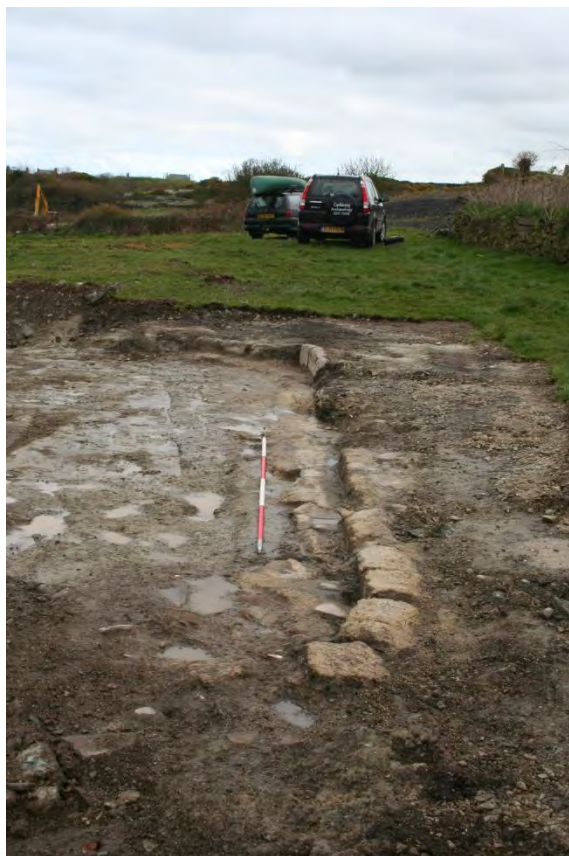
On the south side of the excavated area, the remains of the stone kerb that retained the access track in front of the farmhouse partly survived for a length of approximately 7m (Feature 1; Plates 2, 3 & 6). The feature is clearly defined on the Topographical Survey (Plan 1 *previous*). As the kerb turned north, several sections of cast-iron drain pipes were excavated, one of which was embedded in the natural subsoil (Feature 3). The drain pipes defined the eastern extent of the farmhouse, of which there was no evidence (see Plate 2). Further north, an area of disturbed slate slabs with a service pipe running east to west (Feature 4, Plate 8) was uncovered in the location of the rear entrance to the farmhouse from the northern single storey addition as seen in Plate 2 *following*. The back wall of the house also appeared to be defined by the remains of a c.550mm wide concrete wall running east-west for c.3.5m (Feature 5; Plate 9), which may have formed the foundation for a brick wall. The western extent of the feature appears to define the extent of the house. Beyond the concrete, a modern stone soakaway pit was encountered together with a soakaway trench recorded for c.2.5m as it headed in a westerly direction (Feature 6).

**Plate 6: Feature 1, the stone kerb,
view from the west**

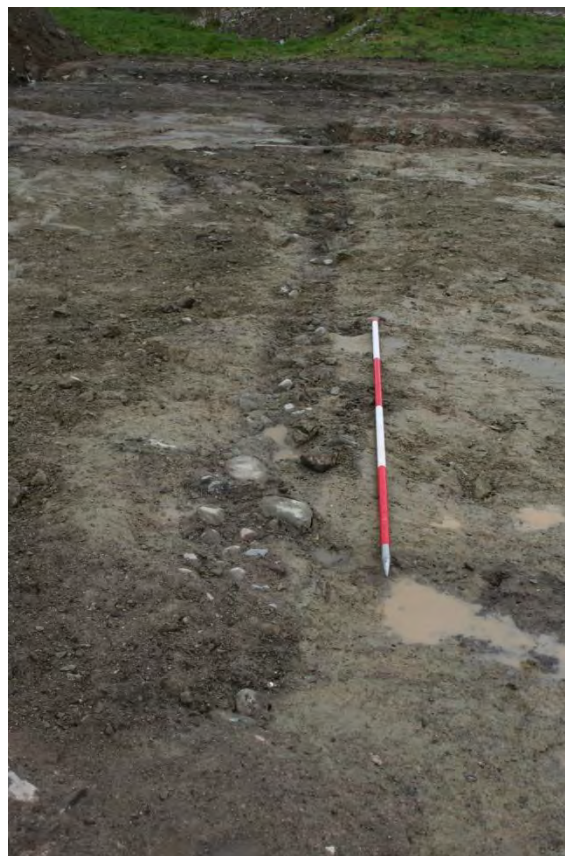
The only feature within the footprint of the 2006 farmhouse was a shallow stone filled linear feature (Feature 2; Plate 7). The feature extended 9.8m from the front of the 2006 house to the concrete footing Feature 5. The >200mm wide feature was no more than 100mm deep and is interpreted as a service trench that may have been abandoned and concreted over perhaps when modern services were introduced into the property in the 20th century and the floors re-laid with concrete.

**Plate 7: Feature 2, the stone filled drain
viewed from the south-southwest**

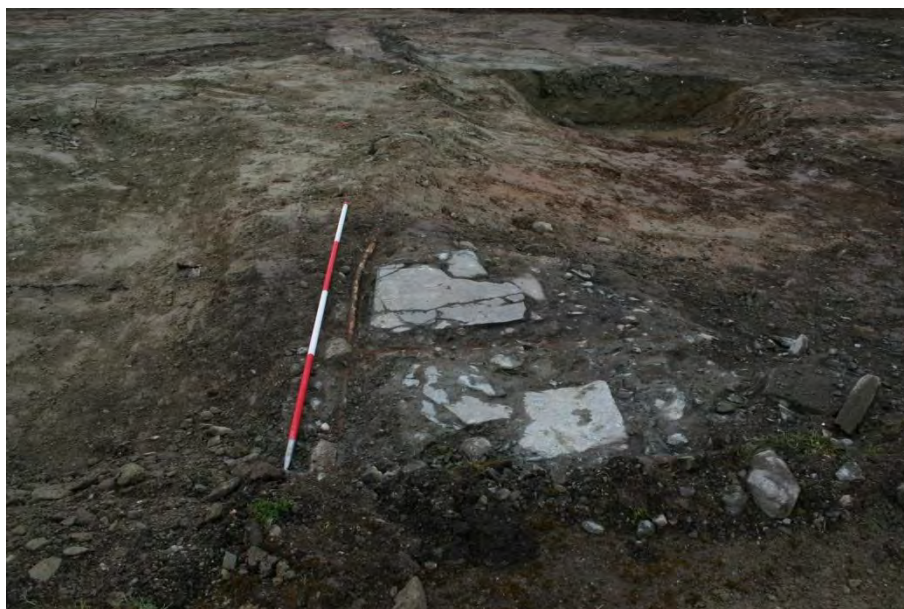
Plate 8:

**Feature 4, disturbed slate
floor and adjacent
service pipe.**

**Sample trench to test
natural seen in the
background.**

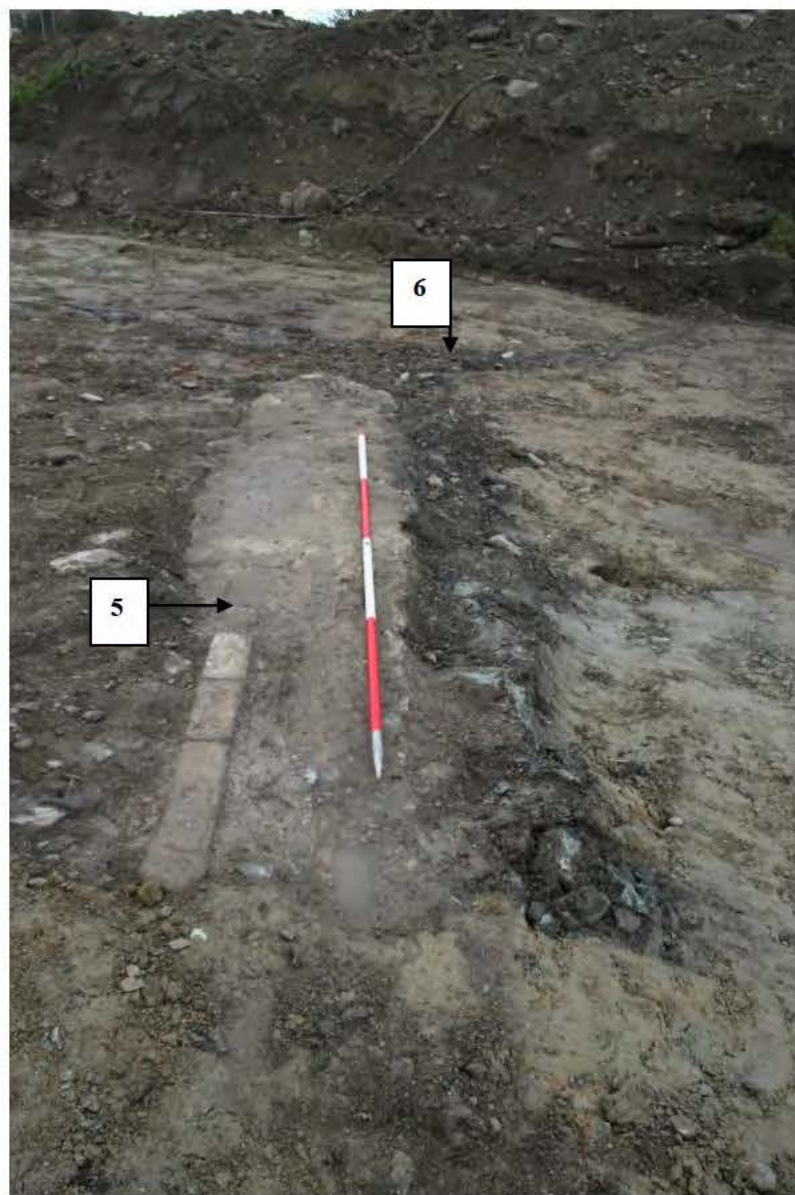
Plate 9: Feature 5, the back wall of the farmhouse & Feature 6, the soakaway, viewed from the east

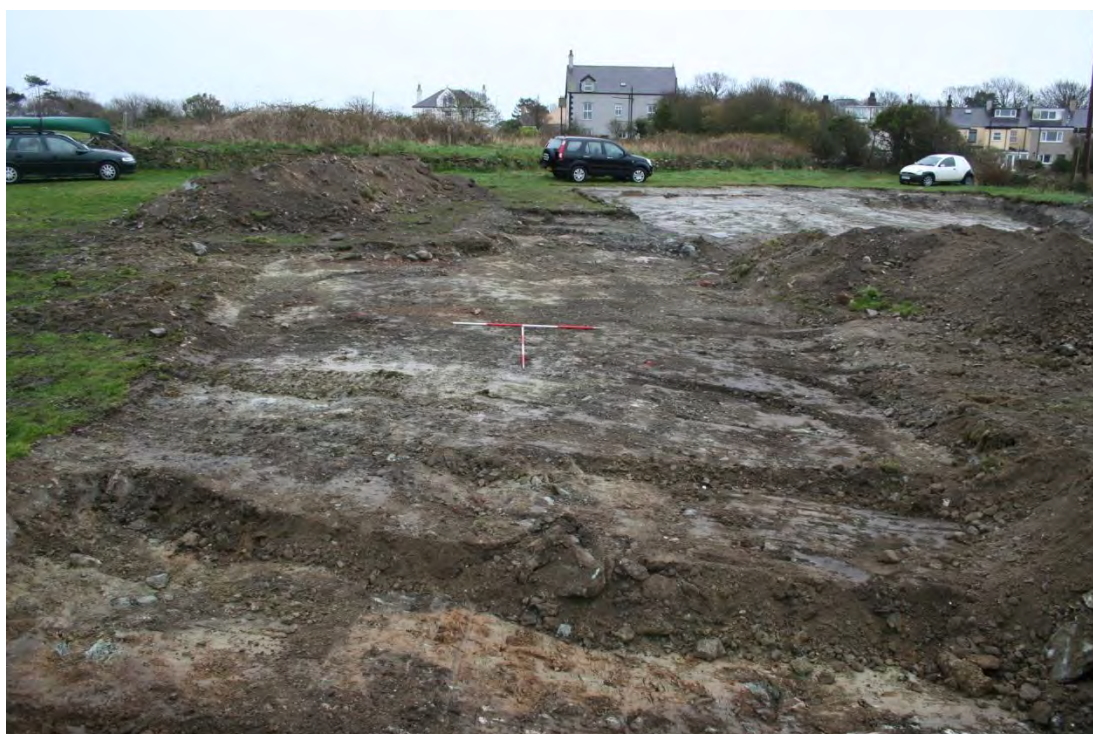
Plate 11: Excavating in area of Building 'C', view from the north. April 2012

Excavations in the area of Barn 'C' revealed no in situ evidence, although a small slab of 9" red quarry tiles embedded in a concrete base and a damaged L-shaped section of concrete were uncovered embedded into natural (Features 8 and 9). Both features were displaced and possibly dragged to this position during demolition. No evidence of the stone barn 'C' or any other outbuilding was uncovered.

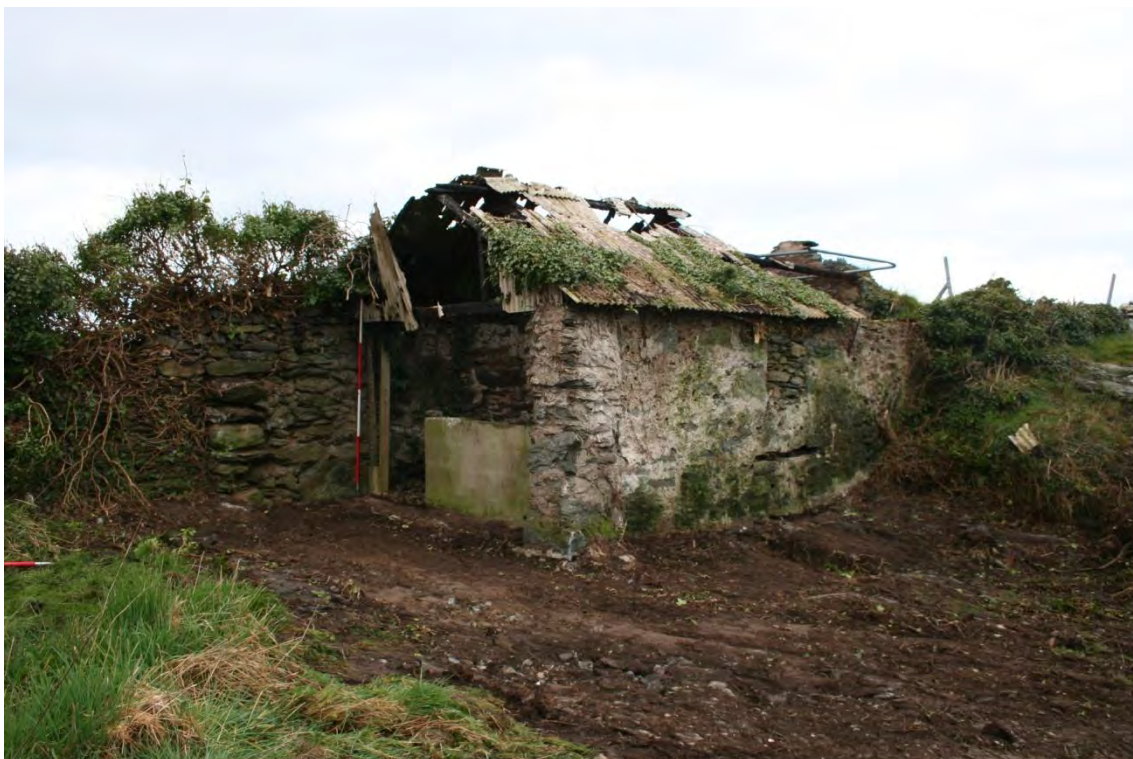
Plate 14: Barn 'A', view from the northeast

Barn A abuts the bedrock outcrop on its north side. The barn measures approximately 6.5m north-south by 2.9m wide internally. The c.550mm thick rubblestone walls stand to a height of 2.1m above a stone sill set above the bedrock. Bedrock appears to have been utilised for the floor, as much as can be seen. The barn is currently covered with a corrugated roof supported by three trusses made up of modern bolted timbers. The structure has been vandalised and burnt since 2006 and the interior was consequently unexamined, in the interests of health and safety.

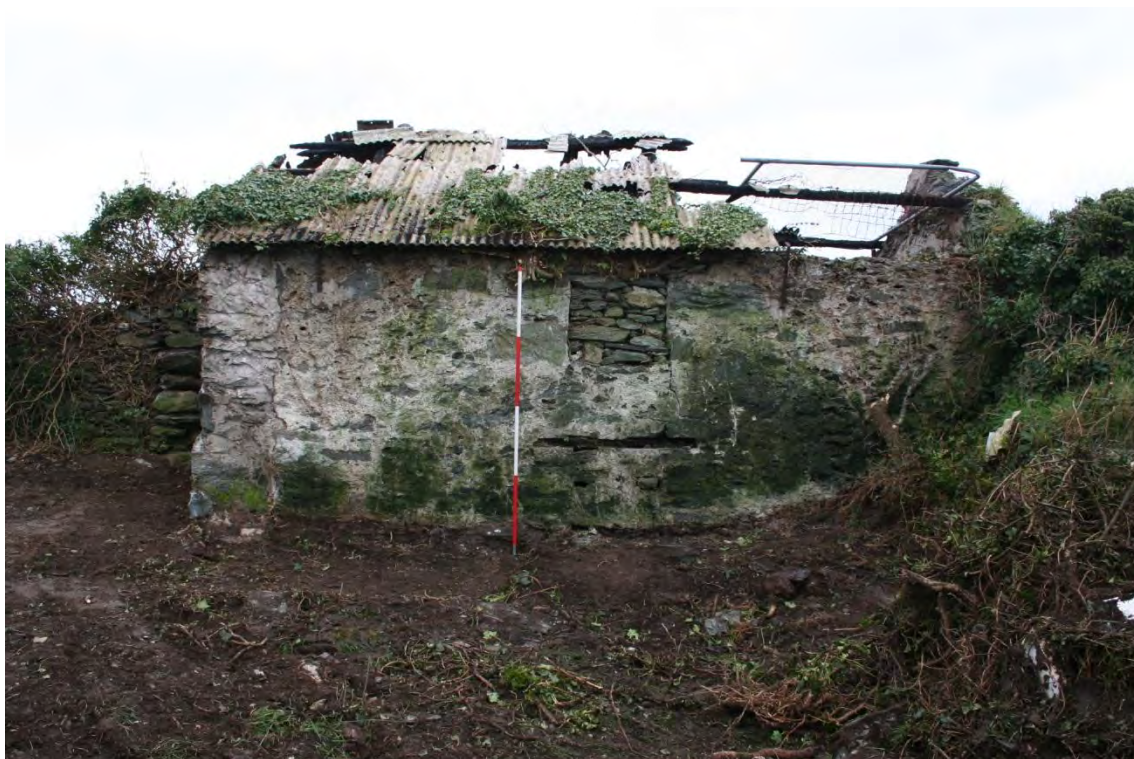
Plate 15: Barn 'A', east elevation

A 1m high concrete half-wall has been inserted into the south elevation, presumably in the mid-20th century, to form a pen. The c.800mm square window in the east wall may have been blocked at the same time and the building rendered to protect the stonework. The rendering appears to have been undertaken in two stages; first in daub and subsequently in a cement based render.

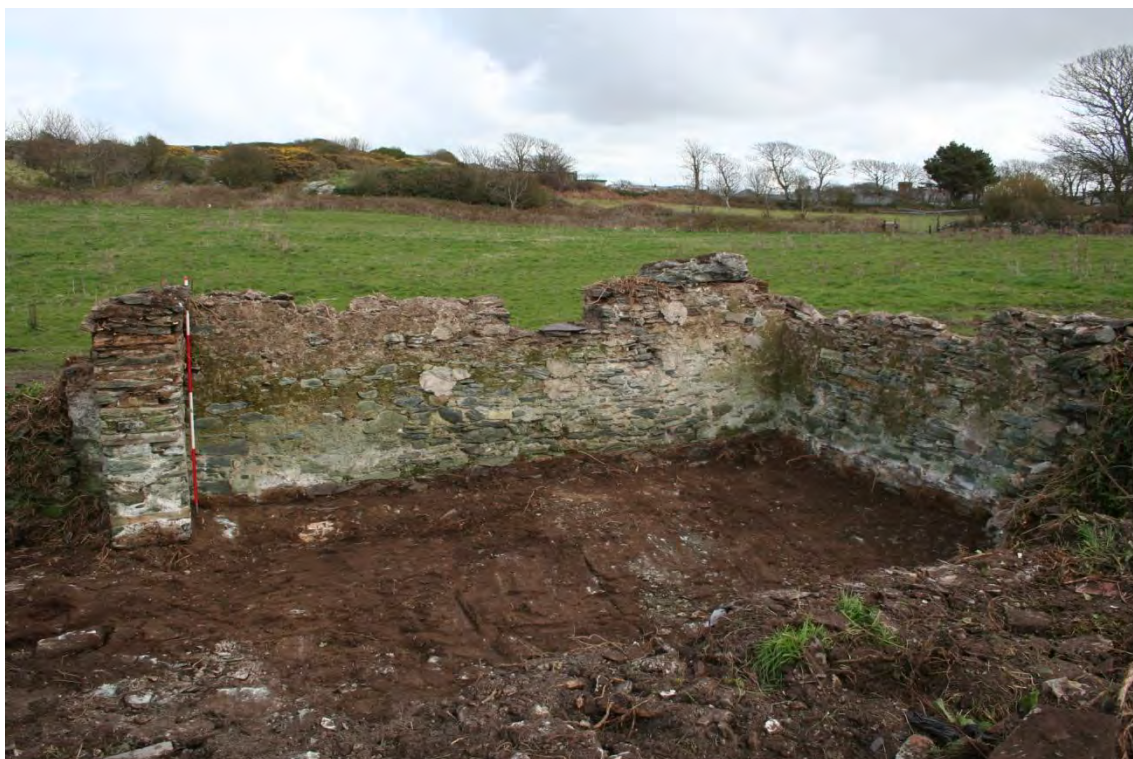
Plate 17: Barn 'B' excavated interior viewed from the west

In 2006 the building was completely overgrown and it was impossible to see the extent of the damage. Prior to recording the barn, > 0.8m of overburden and modern demolition material was removed from the interior of the barn.

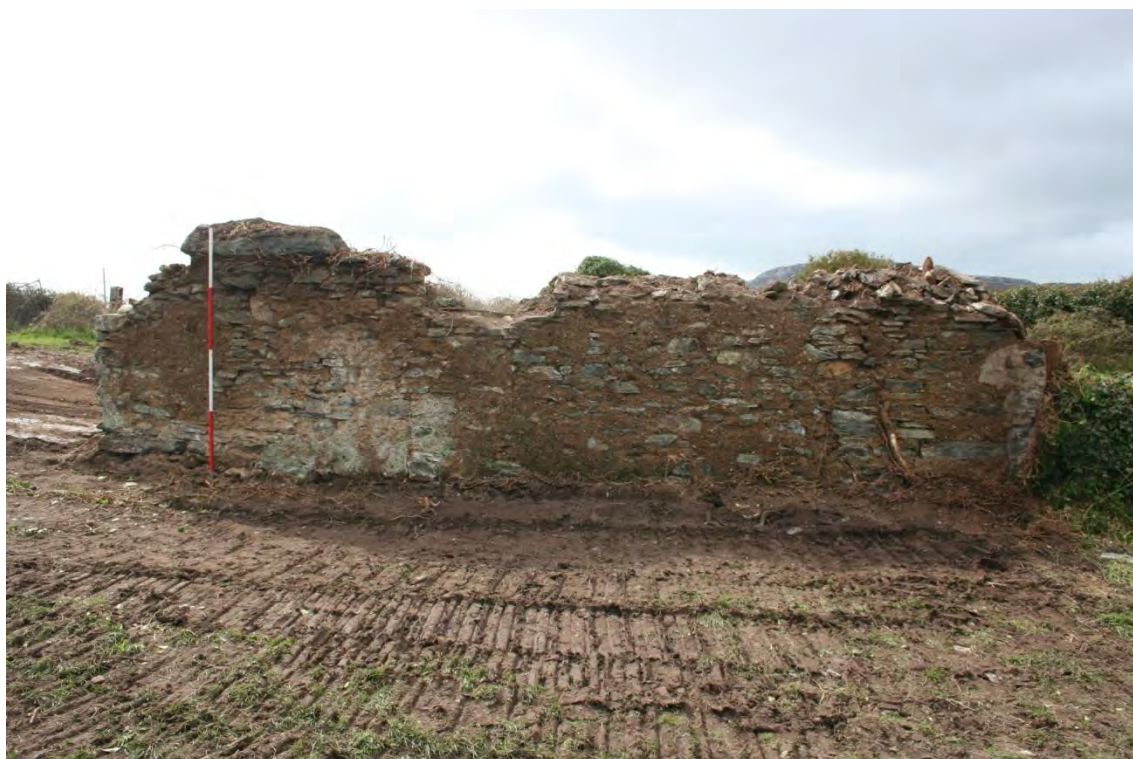
Plate 18: Barn 'B' east elevation

The barn utilises the east and south enclosing walls to form a rectilinear structure c.6.6m north-south by 3.6m wide. The c.550mm thick rubblestone walls stand to a maximum height of 2.1m laid above the natural subsoil. The barn is on a similar alignment to Barn 'A' with a c.1m wide window in the east wall. Barn 'B' appears to be slightly larger overall. The west and north walls are almost entirely demolished and there is no evidence of the former roof construction.
