UNMANNED SITES INTERPRETATION INSTALLATIONS - WATCHING BRIEF REPORT

CN006 SEGONTIUM ROMAN SITE

AN011 TREFIGNATH BURIAL CHAMBER

AN016 HOLYHEAD MOUNTAIN HUT CIRCLES

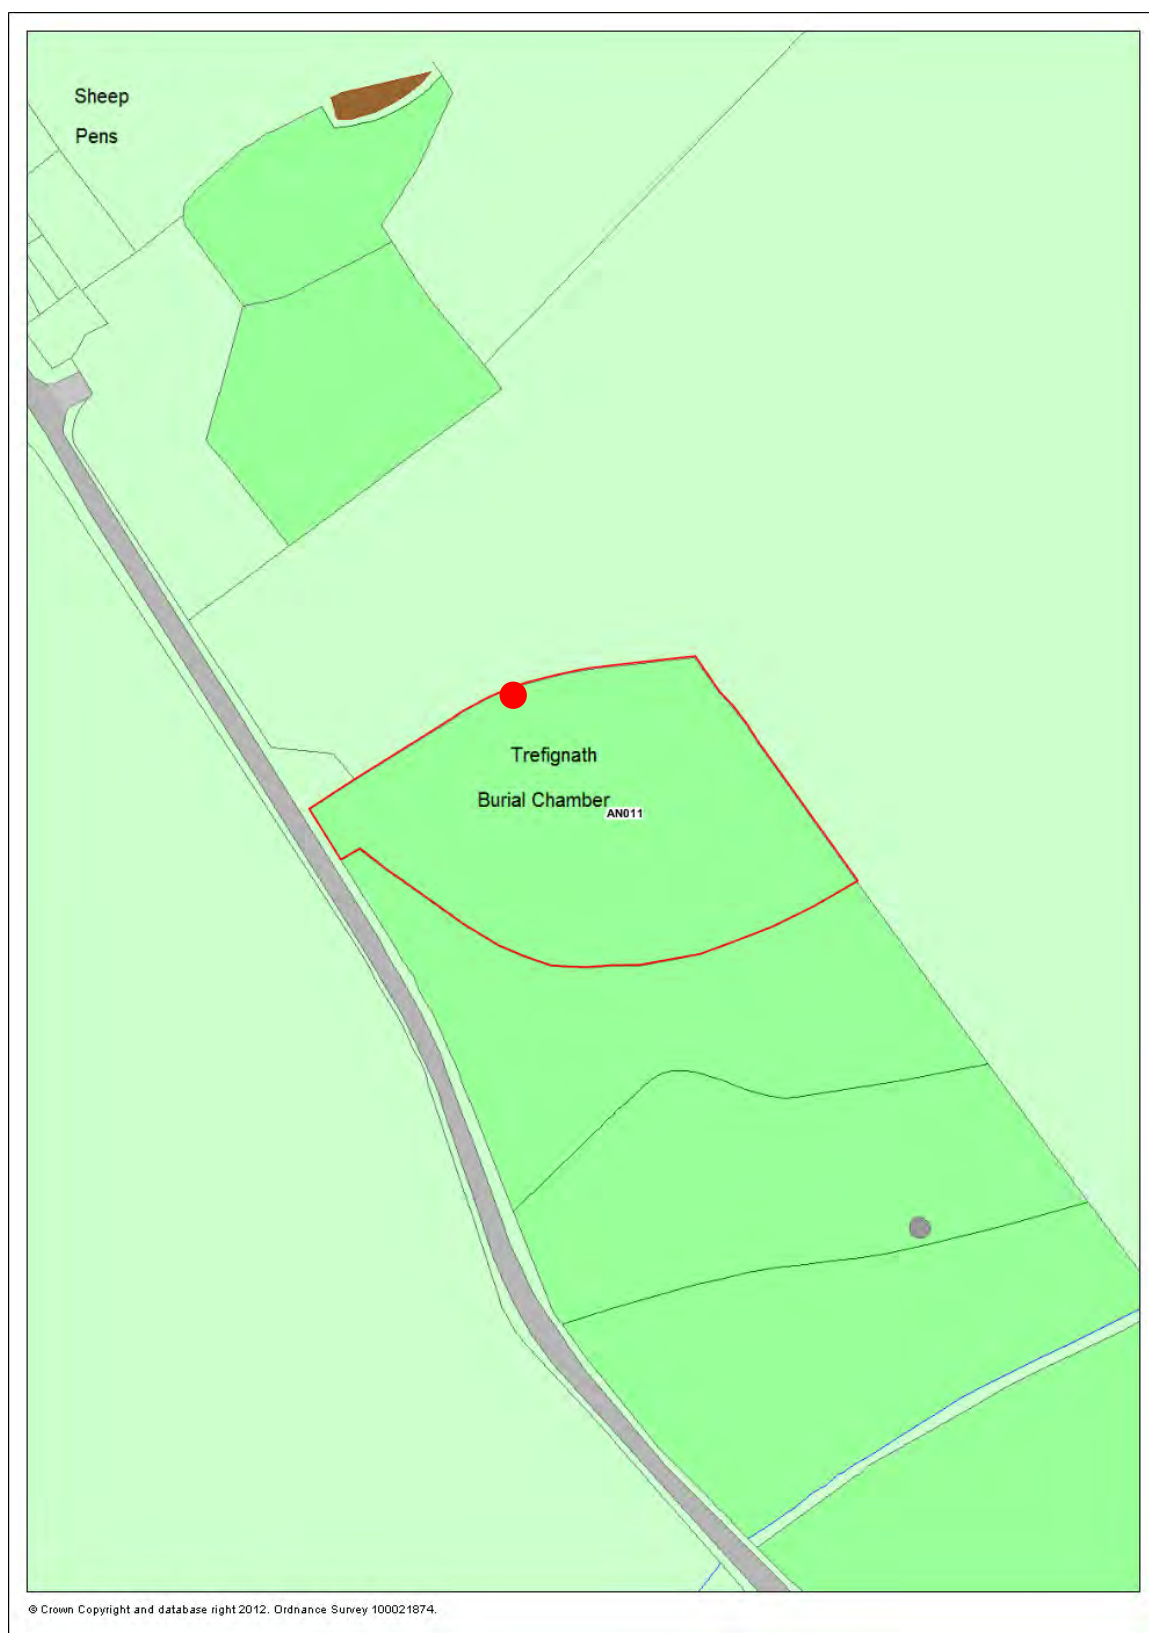
Figure 3: AN011 Trefignath Burial Chamber - Map showing location of the scheduled area and approximate position of interpretation panel (red spot).

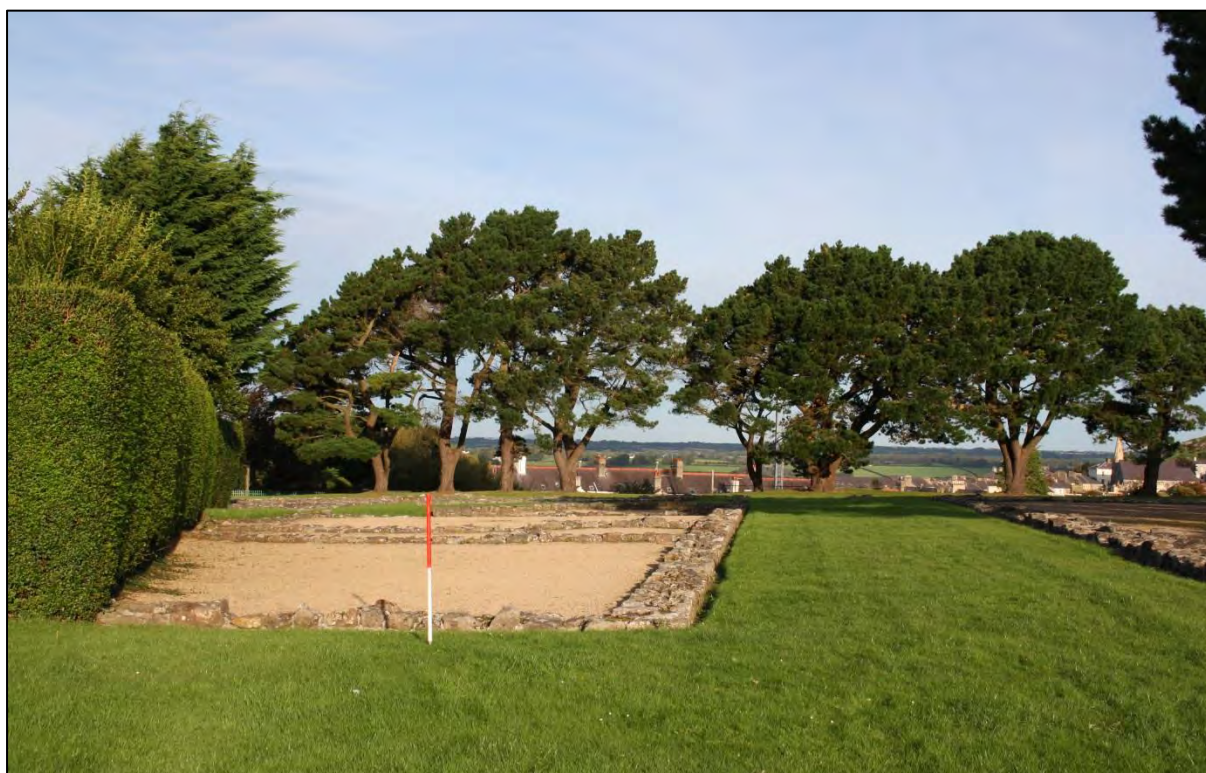
The panel was to be placed in a position identified previously by Adele Thackray (Cadw) to the contractor, at SH 48579 62395. After discussion the panel was rotated to reflect the view shown on the panel with the actual view. A 1m x 0.6m x 0.2m deep hole, aligned NE-SW, was hand dug for the insertion of a steel box frame to hold the feet of the panel, which were then set into concrete contained within the box. All material was excavated onto a plastic sheet to minimise impact on the grass. The entire excavated material comprised a dark greyish-black loamy-silt topsoil (01) with c.5% slate chips and pebbles. Four sherds of 18th and 19th century ceramic and a fragment of bottle glass, and a single sherd of residual Roman ceramic were retrieved (see Appendix I). After installation of the panel, the turf was relaid over the excavated area.

Figure 5: Location for new panel, facing NW

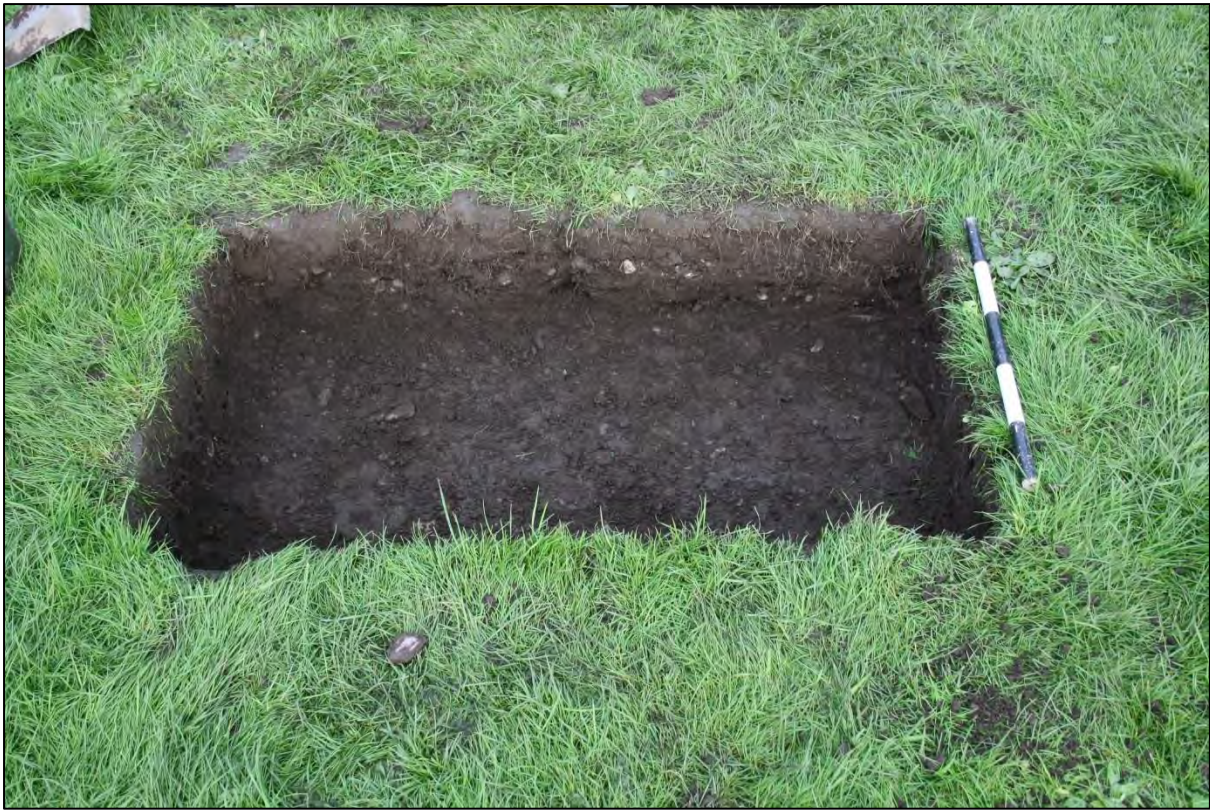
Figure 6: Trench for new panel, after excavation, facing NW

No deposits of archaeological significance were disturbed by the installation of the new interpretation panel. The material excavated probably reflects late post-Medieval levelling and disturbance material, derived from earlier excavations of the main site, and local development of modern housing. This is reflected in the ceramic and glass evidence.

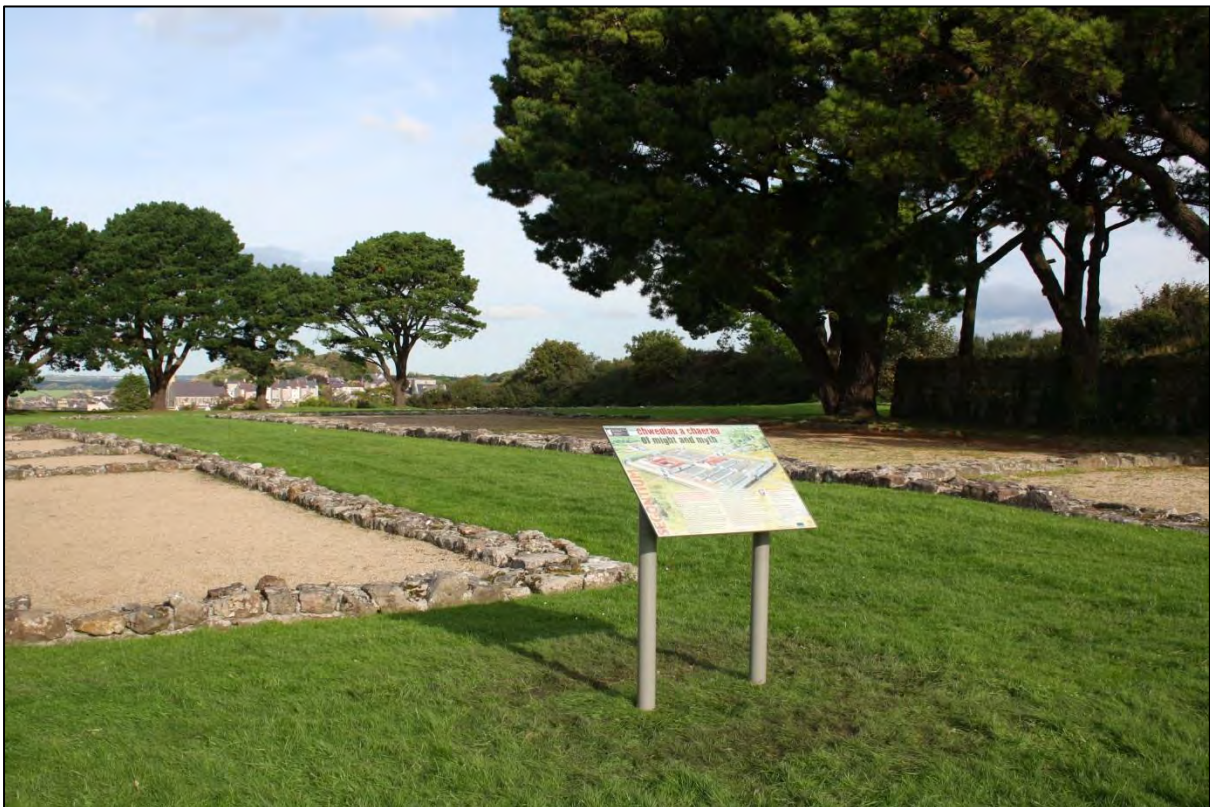
Figure 7: New panel in situ, facing N

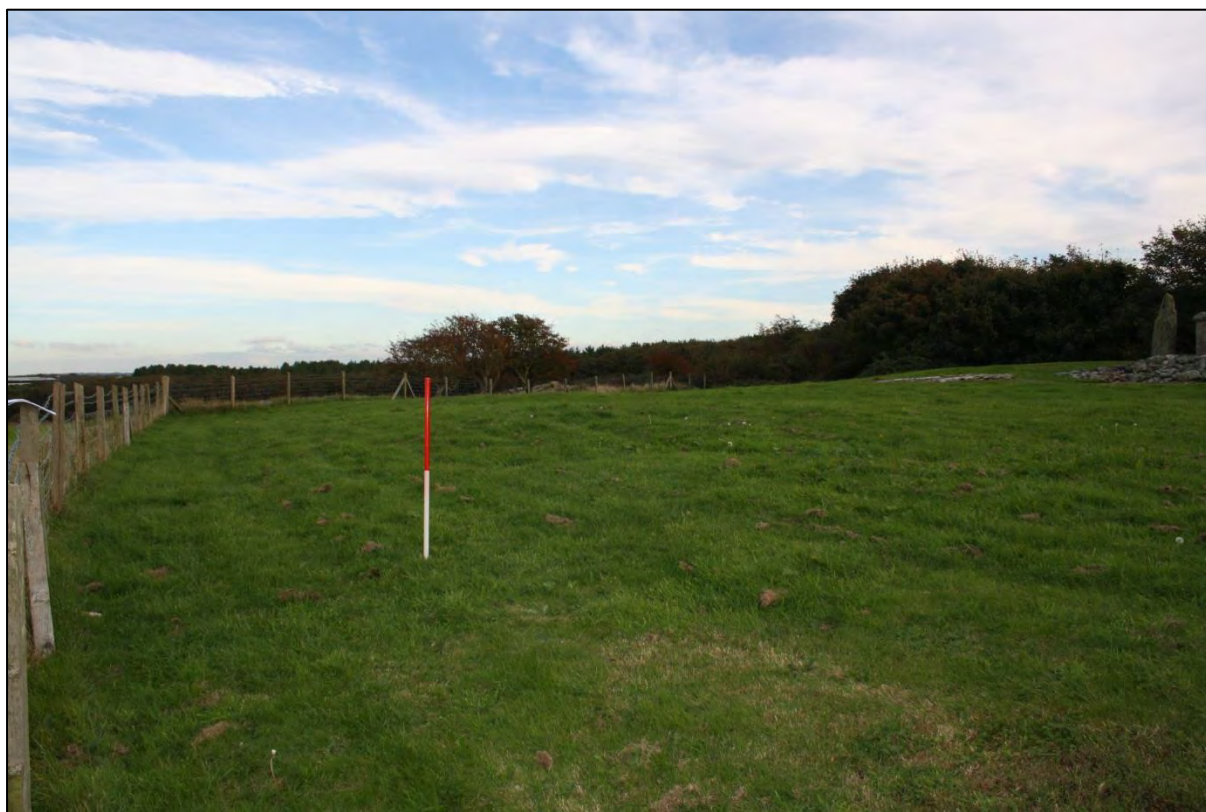
The panel was to be placed in a position identified previously by Adele Thackray and Erin Lloyd-Jones (Cadw) to the contractor at SH25853 80572. A 1m x 1m hole was hand dug for the insertion of a steel box frame to hold the feet of the panel, which were then set into concrete contained within the box. The excavation revealed a dark blackish-brown clay-silt (01) with occasional schist pebbles (<10%), overlying the natural schist bed-rock (02) which falls away sharply to the north. All material was excavated onto a plastic sheet to minimise impact on the grass. The turf was then relaid over the excavated area. Six sherds of 19th and early 20th century ceramic were retrieved (see Appendix I).

Figure 8: Site for new panel before excavation, facing E

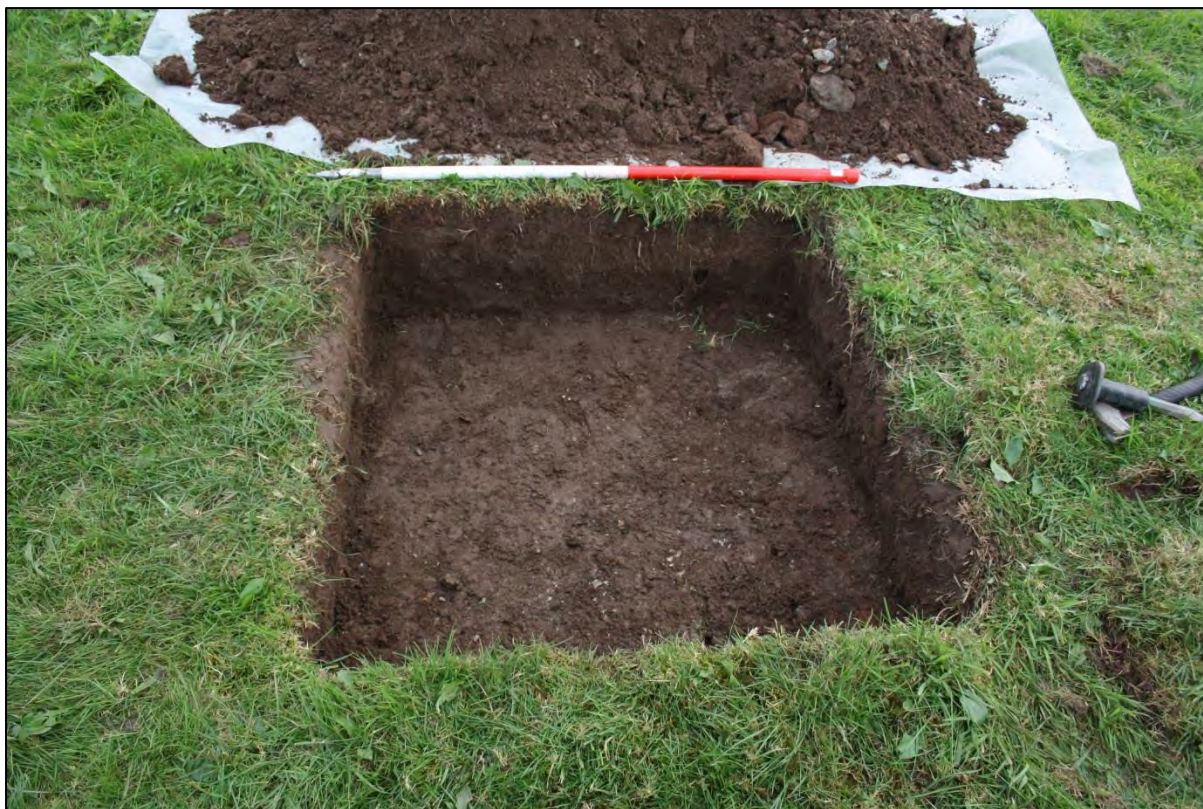
Figure 9: Site for new panel after excavation, facing S

No deposits of archaeological significance were disturbed by the installation of the new interpretation panel. The material excavated probably reflects late post-Medieval levelling and disturbance material, derived from earlier excavations of the main site, and local agricultural activity. This is reflected in the ceramic evidence.

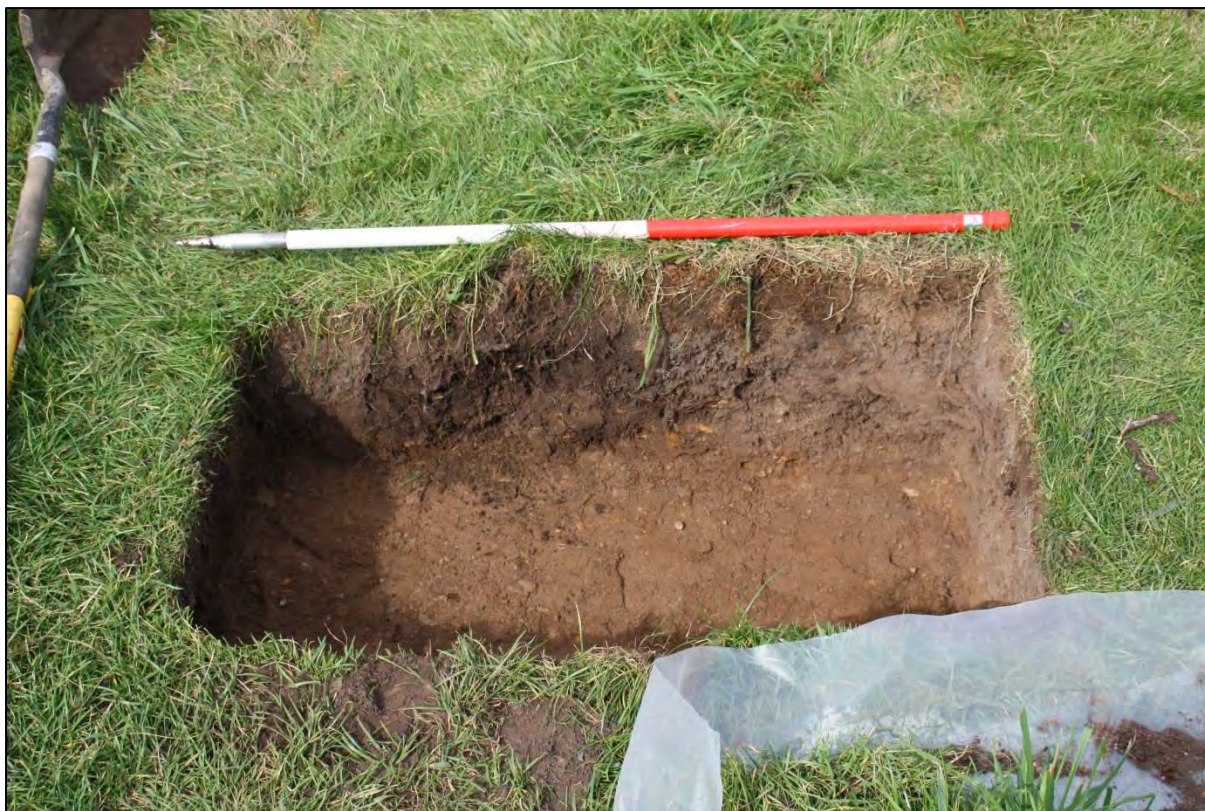
This was located at SH21064 81794, adjacent to the stile and gate onto the road. A 1m x 0.6m hole, aligned NE-SW, was hand dug for the insertion of a steel box frame to hold the feet of the panel, which were then set into concrete contained within the box. As the hole was dug into a slope, it was 0.2m deep at the south-western end, but almost 0.4m deep at the upslope, north-eastern end. All material was excavated onto a plastic sheet to minimise impact on the grass. The excavation revealed an orange-brown subsoil with iron staining (03), overlain by up to 0.2m of greyish-brown sandy-silt (02). The uppermost deposit comprised a rooty, peaty brown topsoil (01) with bracken roots. There were no artefacts recovered. After installation of the panel, the turf was then relaid over the excavated area.

Figure 10: Trench for new panel, I after excavation, facing NW

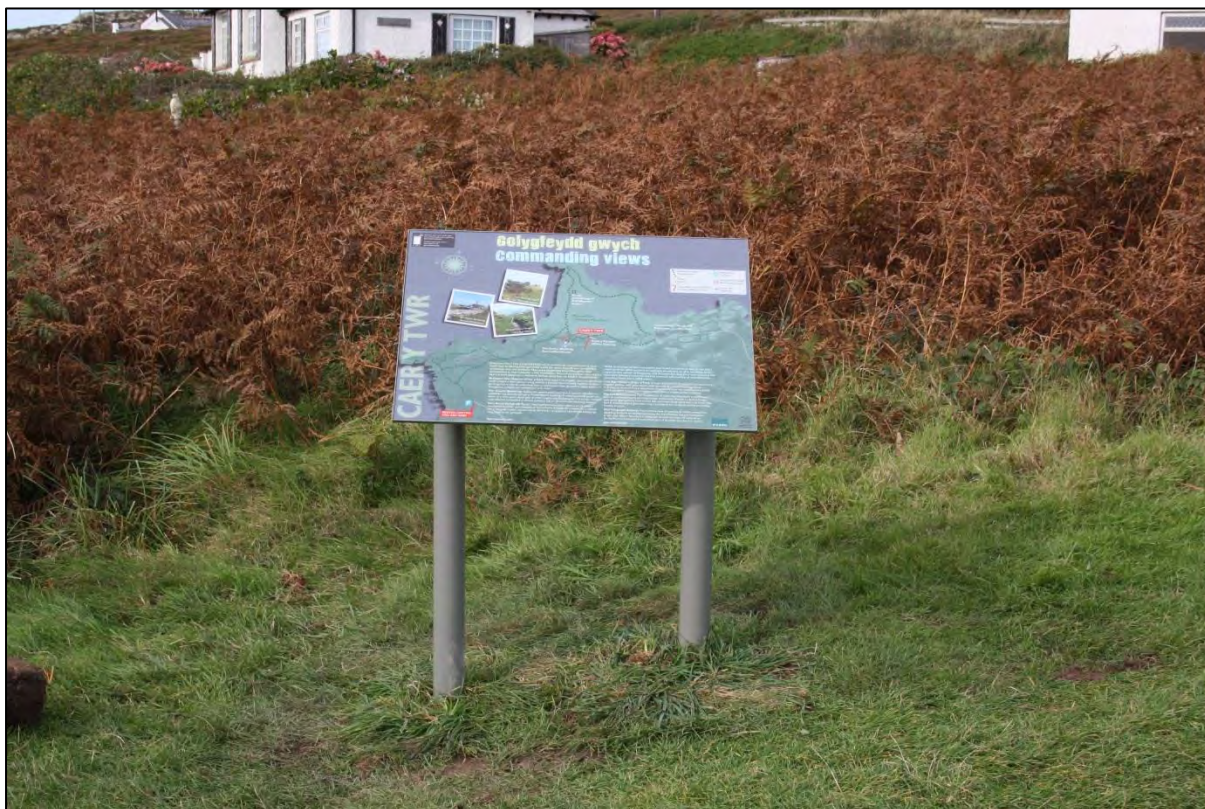
Figure 11: New panel I in situ, facing NW

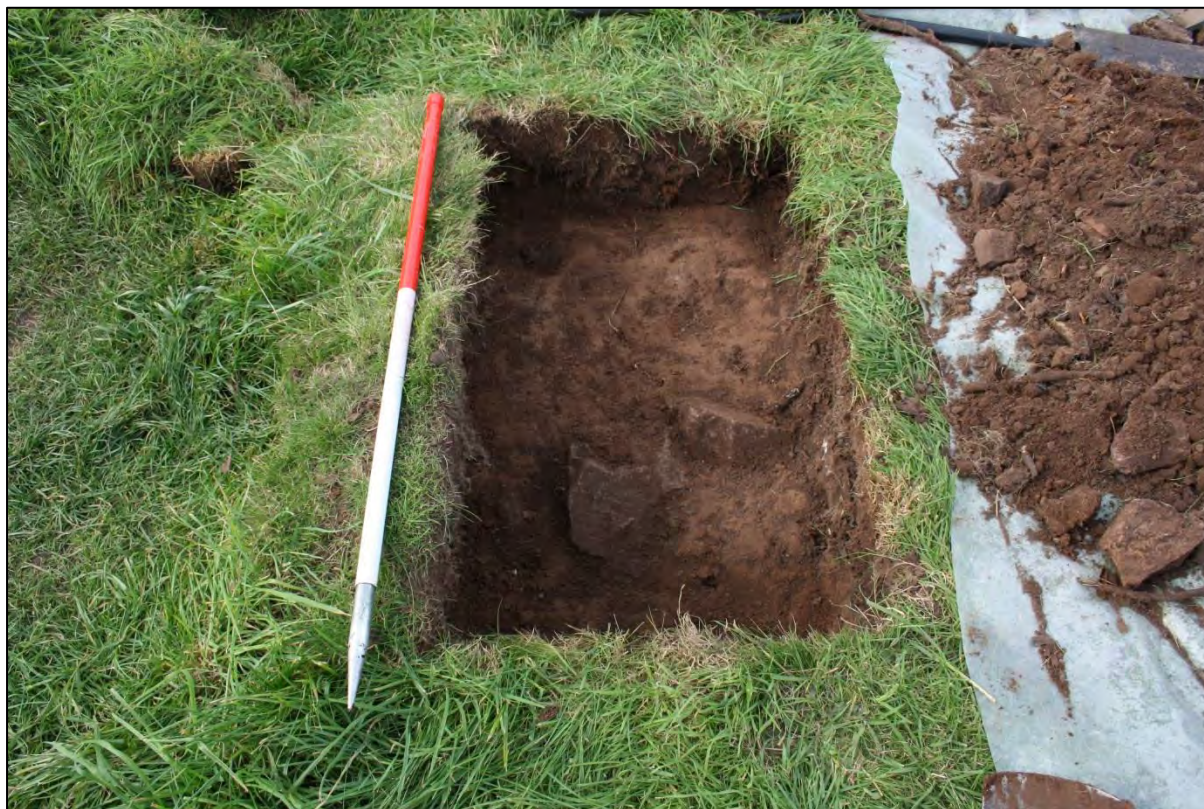
This was located at SH21123 81953. A 1m x 0.6m x 0.2m deep hole, aligned NW – SE, was hand dug for the insertion of a steel box frame to hold the feet of the panel, which were then set into concrete contained within the box. All material was excavated onto a plastic sheet to minimise impact on the grass. The excavation revealed a firm, orange-brown clay-silt (04). It is possible that this reflects an old ground surface, related to the earlier excavations at the site, and/or to the adjacent hut circle itself. Towards the south-eastern end of the trench were two angular/sub-angular stones up to 0.25m diameter, embedded in the base of the trench. Two areas of disturbance in the SE and SW corners represented the holes for the earlier panel. The basal deposit was overlain by a 0.10-0.12m thick relatively loose, grey-brown sandy-silt (03) with frequent angular stone (c.40%), and bracken roots. This was interpreted as probable back-filling from earlier excavations of the adjacent hut circle. A leached podzol layer and associated lower iron deposit overlay this (02) with a rooty layer above (01). There were no artefacts recovered. After installation of the panel, the turf was then relaid over the excavated area.

Figure 12: Trench for panel 2, part-excavated, facing NW

No deposits of archaeological significance were disturbed by the installation of the new interpretation panels. It is possible that the deposit (04) revealed in the base of the trench for Panel 2 reflects an old ground surface, related to the earlier excavations at the site, and/or to the adjacent hut circle itself. Certainty of this interpretation would only be confirmed by further investigation.

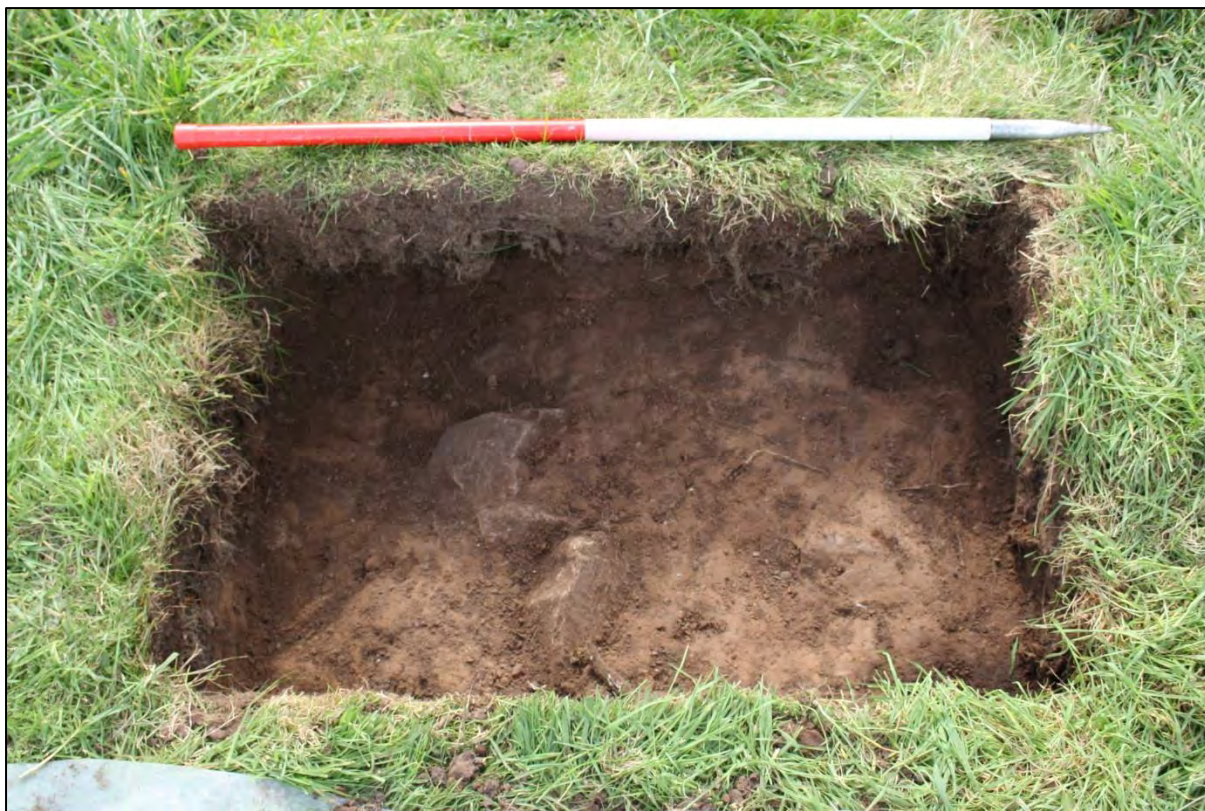
Figure 13: Trench for panel 2, part-excavated, facing SW

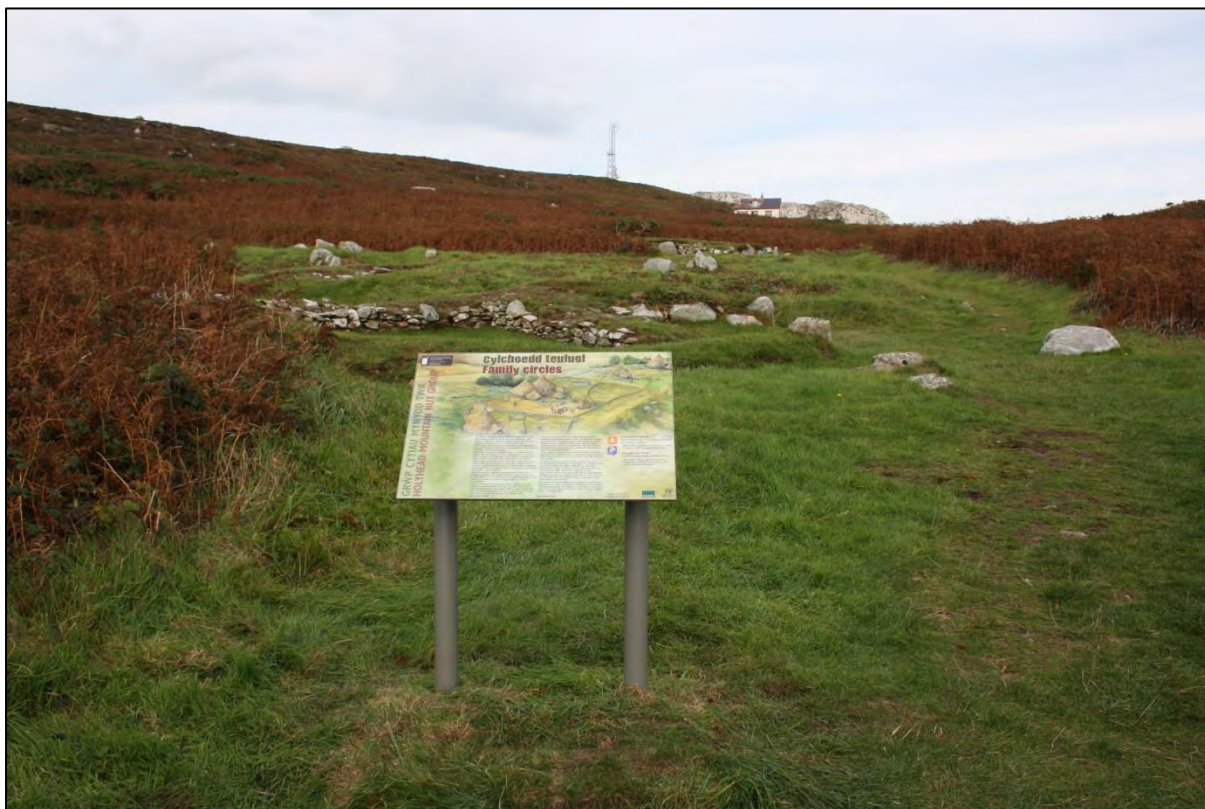
Figure 14: New panel 2 in situ, facing N

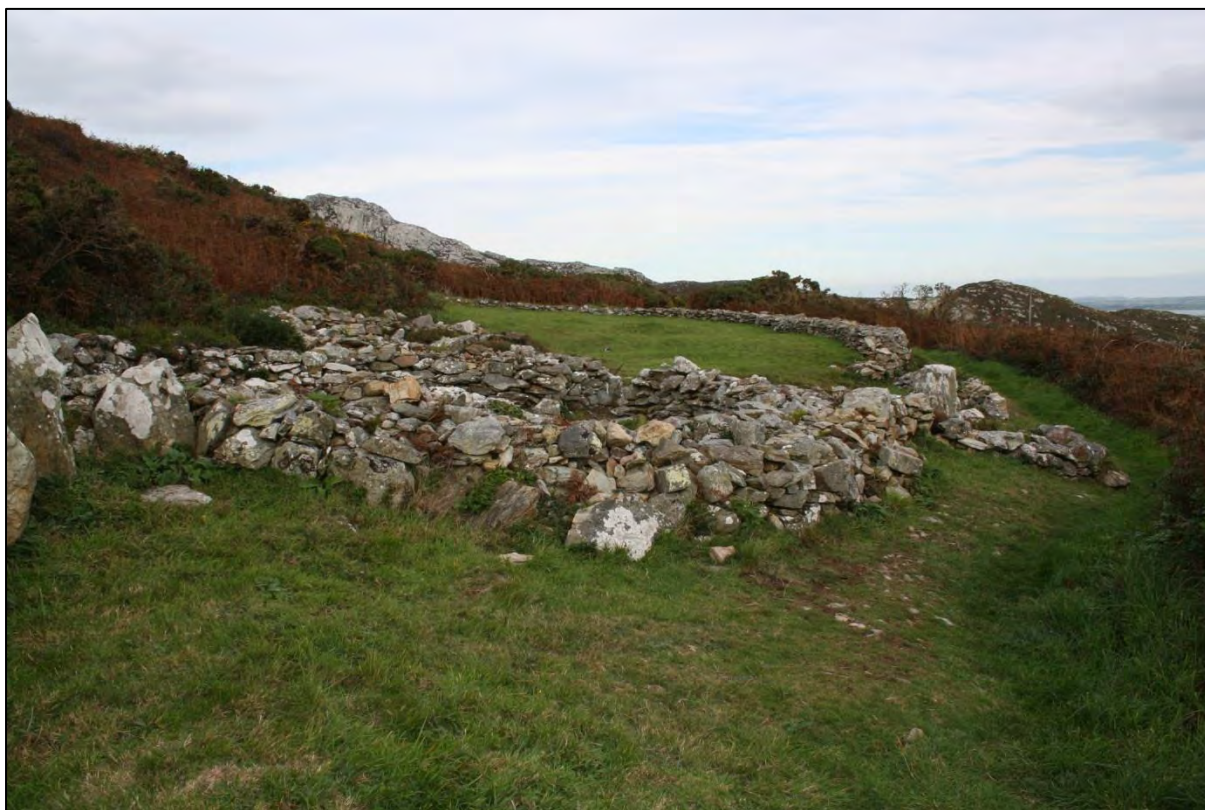
(Removal of earlier panel only). The legs of the earlier panel were cut through at ground level using an angle grinder, and sharp edges flattened. No ground disturbance took place. This was located at SH21327 82122.

Figure 15: Site of 3rd panel after removal, facing NE
