**REPORT NO.230**

**ERYRI HOSPITAL**

**HISTORIC BUILDING RECORDING**

**JANUARY 2006**

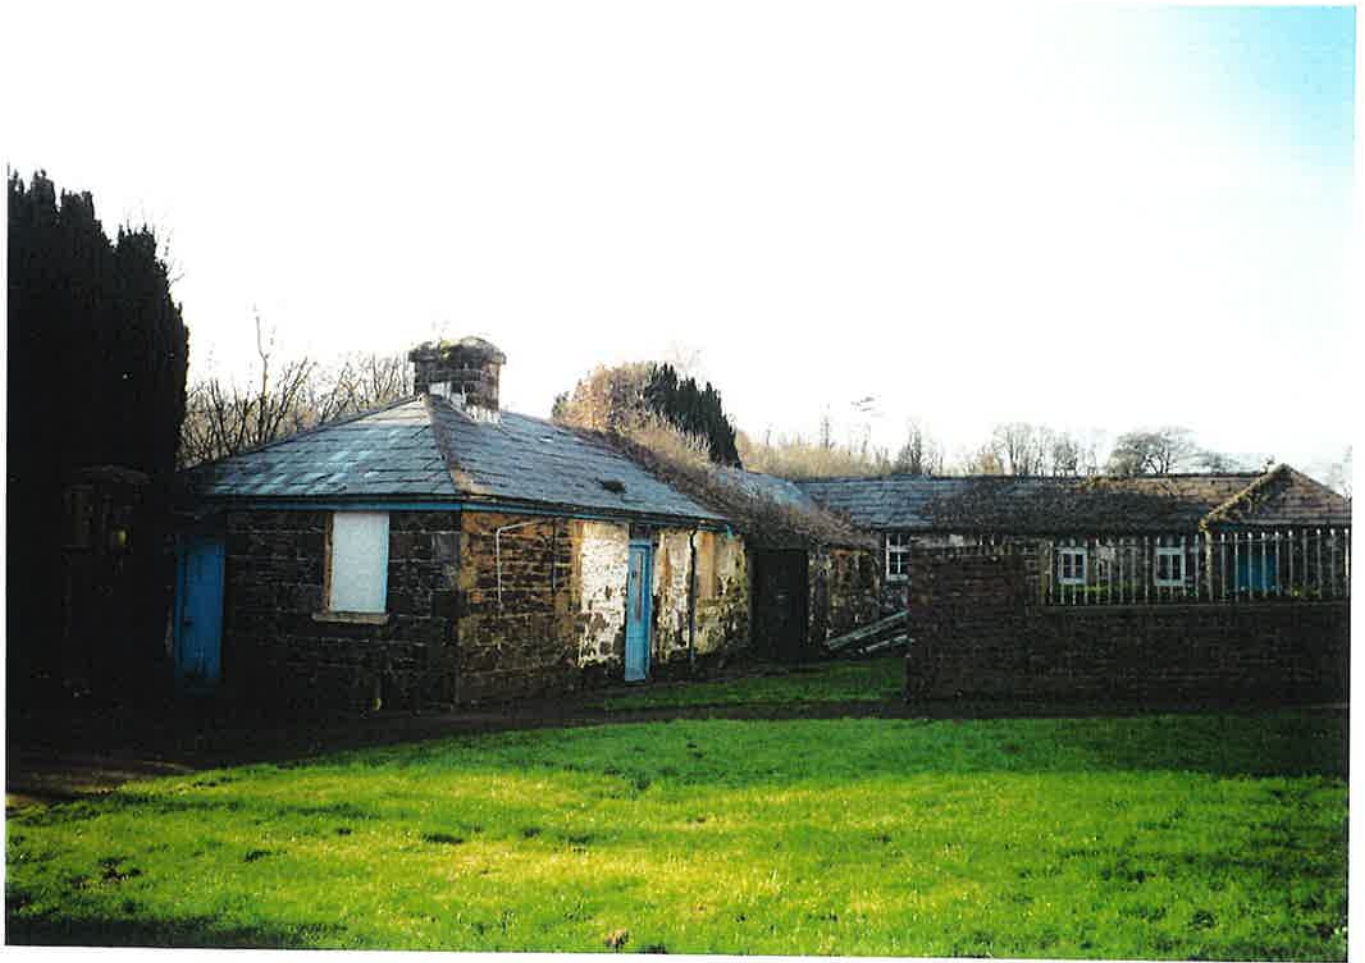
Gatehouse east elevation: single door with slate threshold and boarded opening with stone sill (*Plate 1*). South elevation: three rectangular windows (*1.3 x 1m*), on 10cm deep stone sills, that once lit the gatehouse are now boarded.

Plate 1 above: *Building No. 1* - the Western gatehouse and buildings enclosing the west side of the open area south of *Wing A*, as recorded on the c.1881 Plan (*Fig. 3*). View from the east. The west side of the open area is now a hedged garden, while the central area is lawned as seen in the foreground above.

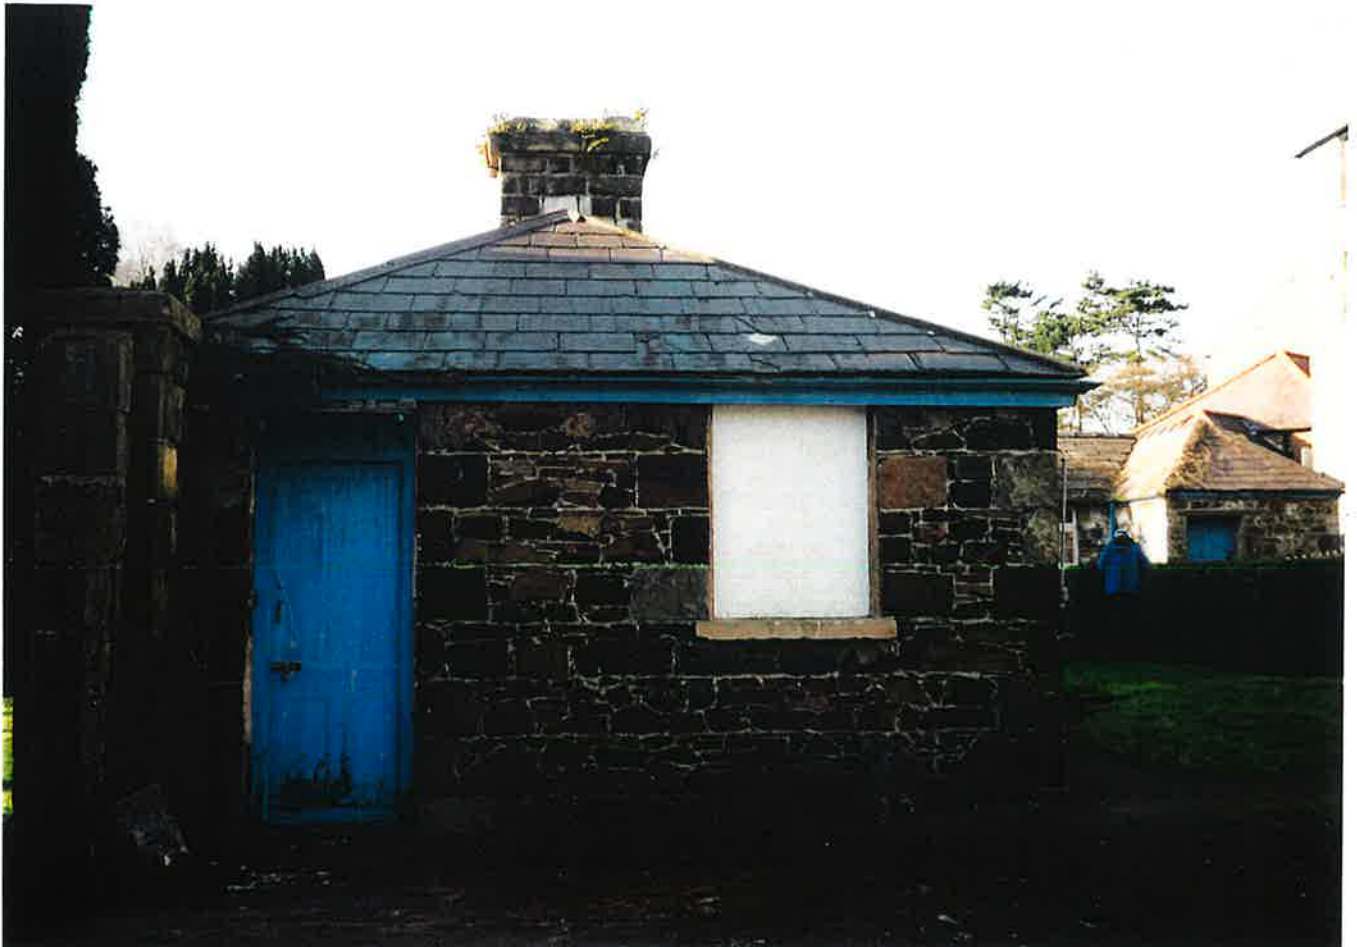
Plate 2 below: Western gatehouse, east elevation; single door with slate threshold & blocked opening with stone sill.

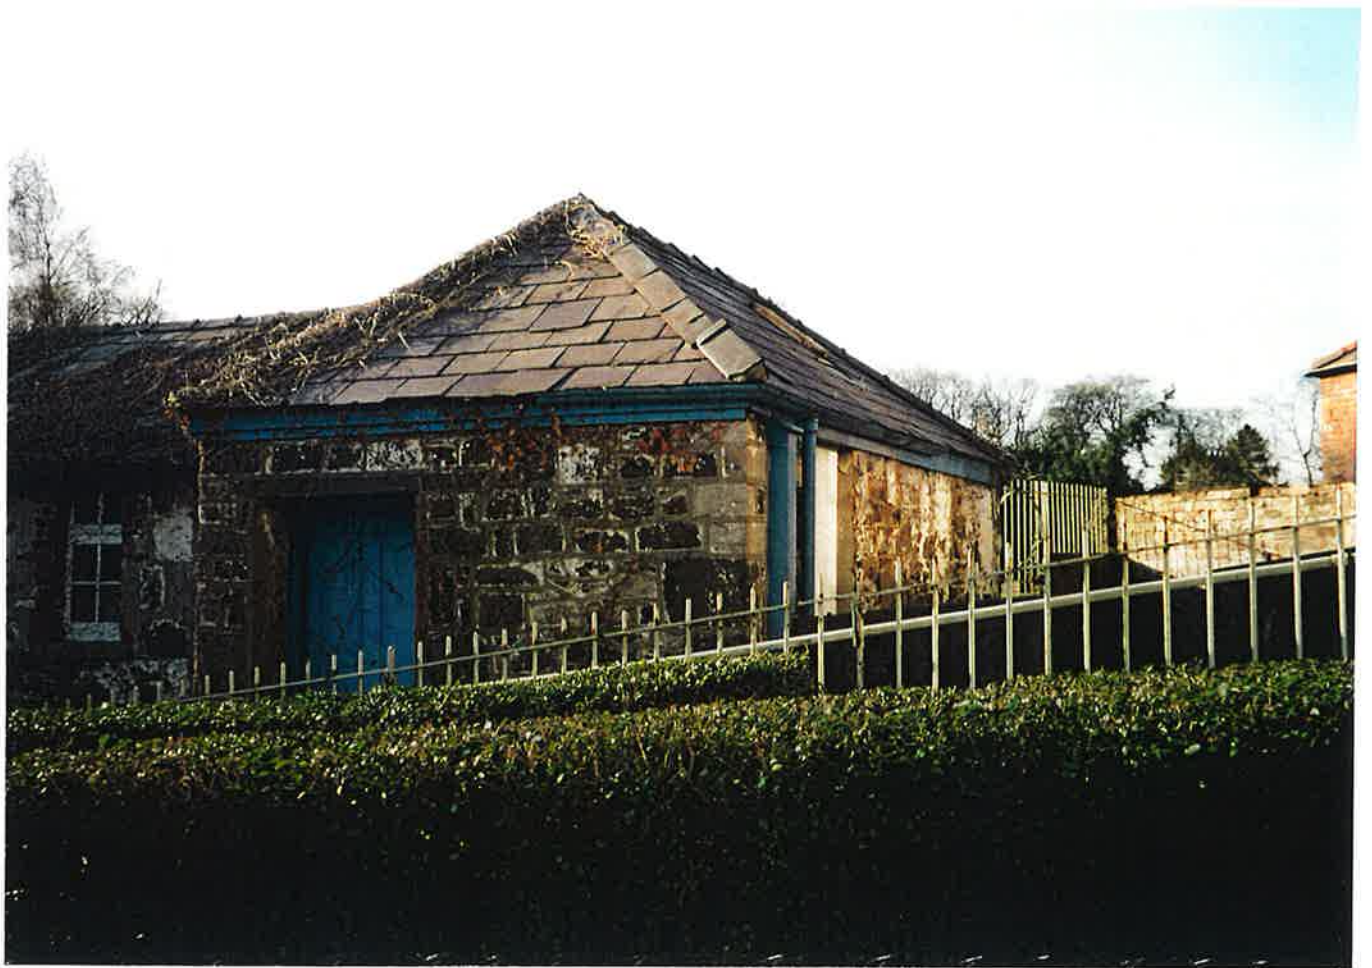
Plate 3 above: The east and north elevations of the right hand wing of the western gatehouse buildings, echoing the gatehouse roofline (see Plate 4 below).

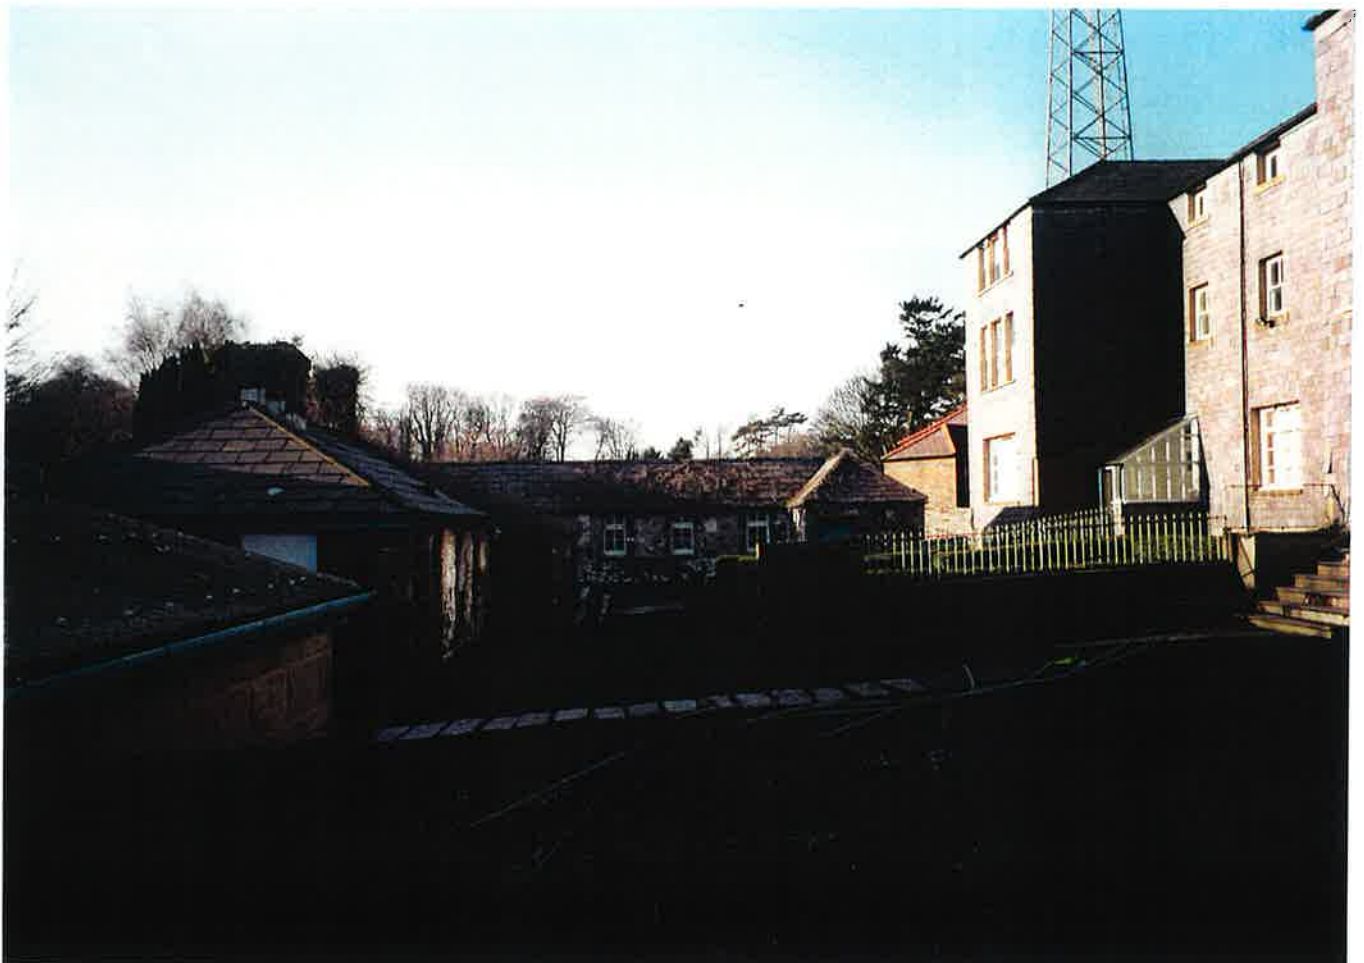
Plate 4 below: Western gatehouse and buildings enclosing the open area south of *Wing A*, viewed from the east with the slate clad main elevation (south-face) of the workhouse seen on the right.

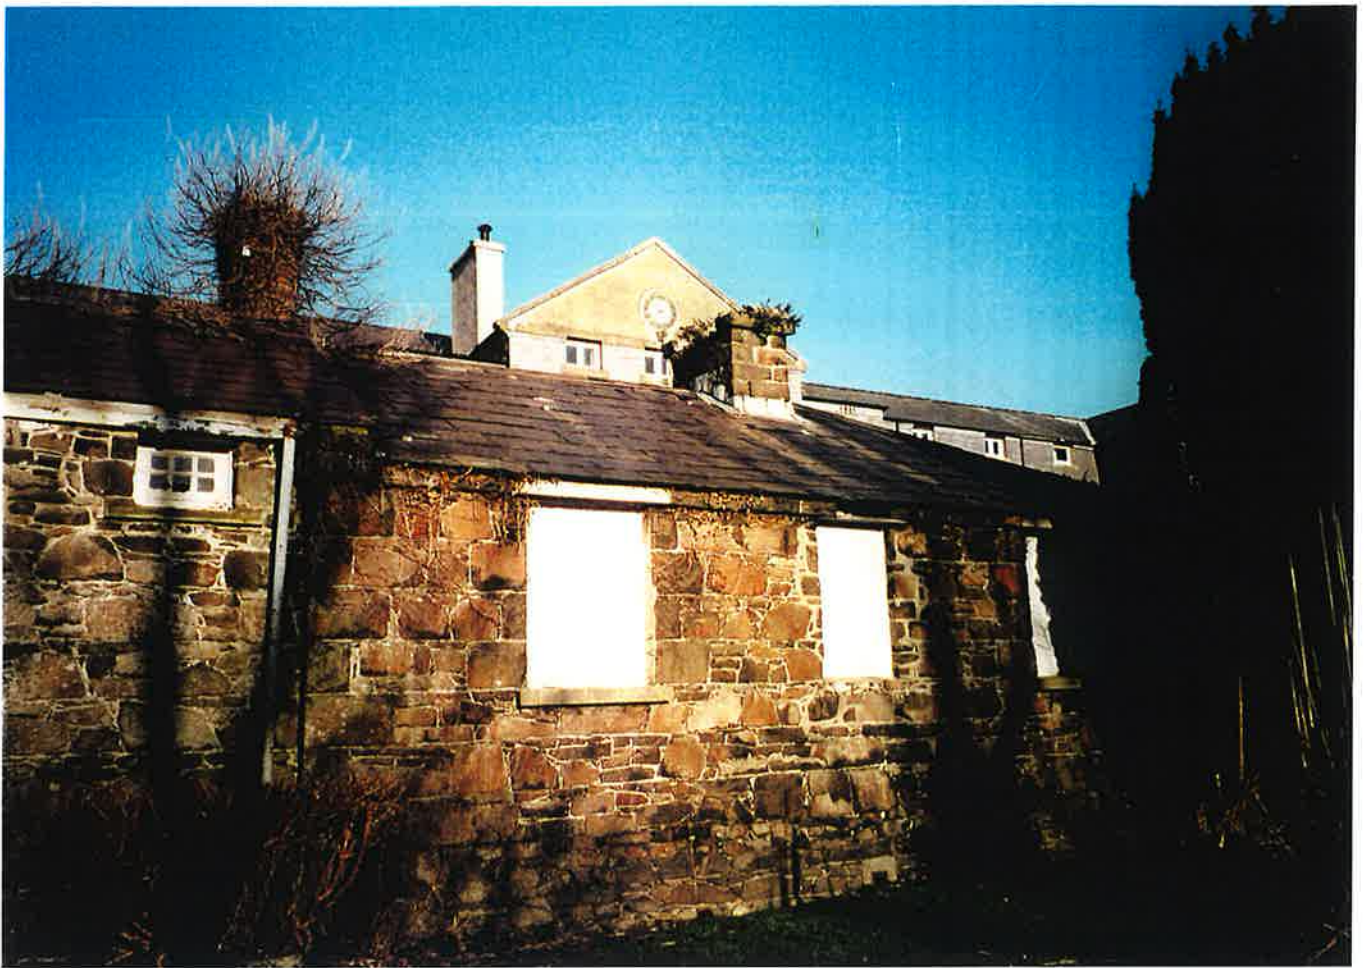
**Plate 5 above:** Part of the south elevation of the western gatehouse and buildings enclosing the west side of the open area south of *Wing A*. Viewed from the south, where a large part of the elevation is obscured by conifers.

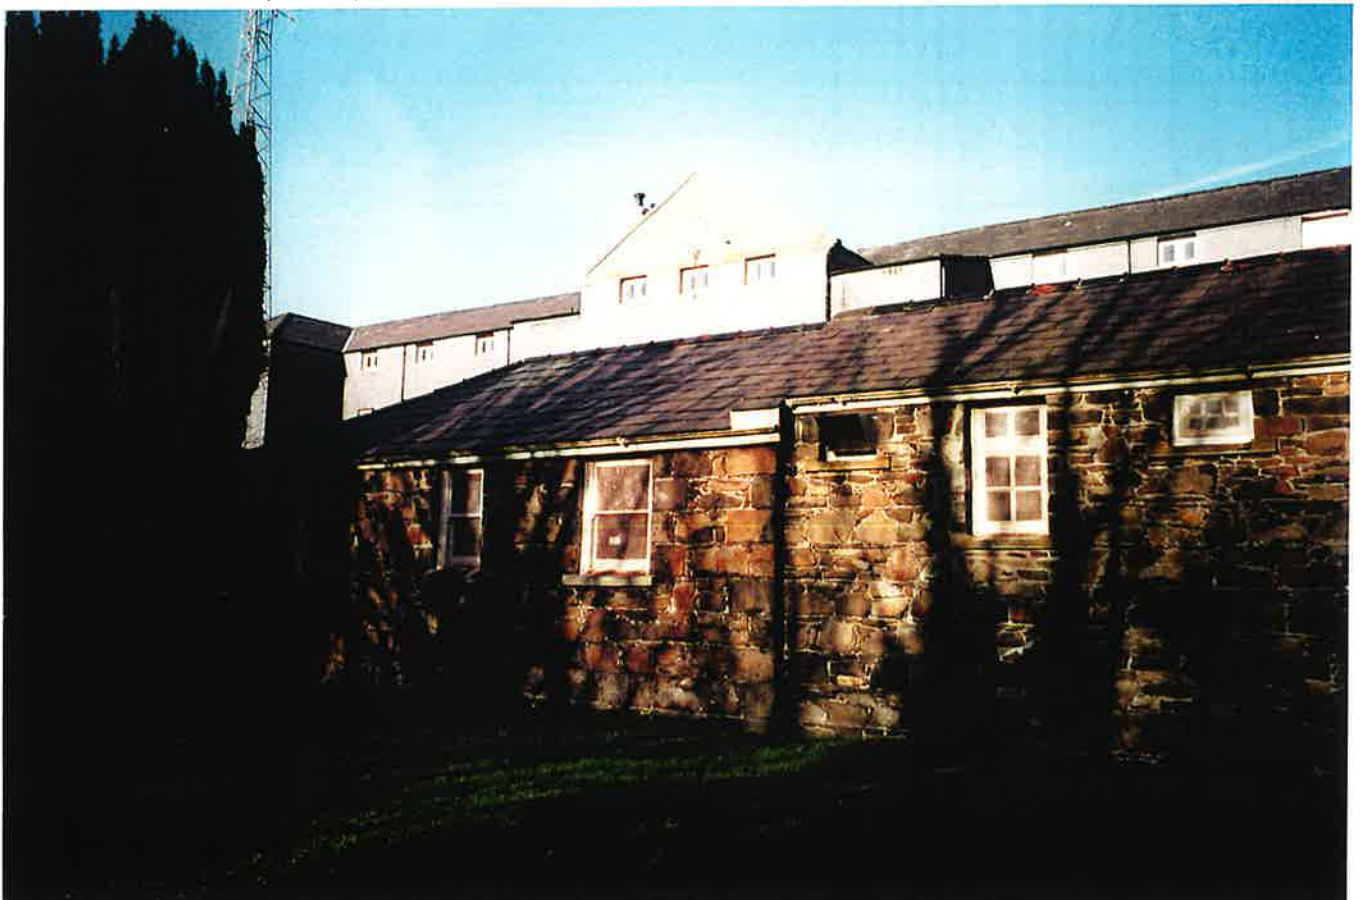
**Plate 6 below:** Part of the south elevation of the *Building No. 2* - eastern gatehouse and buildings enclosing the east side of the open area south of *Wing A*. Viewed from the southeast, where the elevation is also largely obscured by conifers. *See Plates 7 & 8 also.*

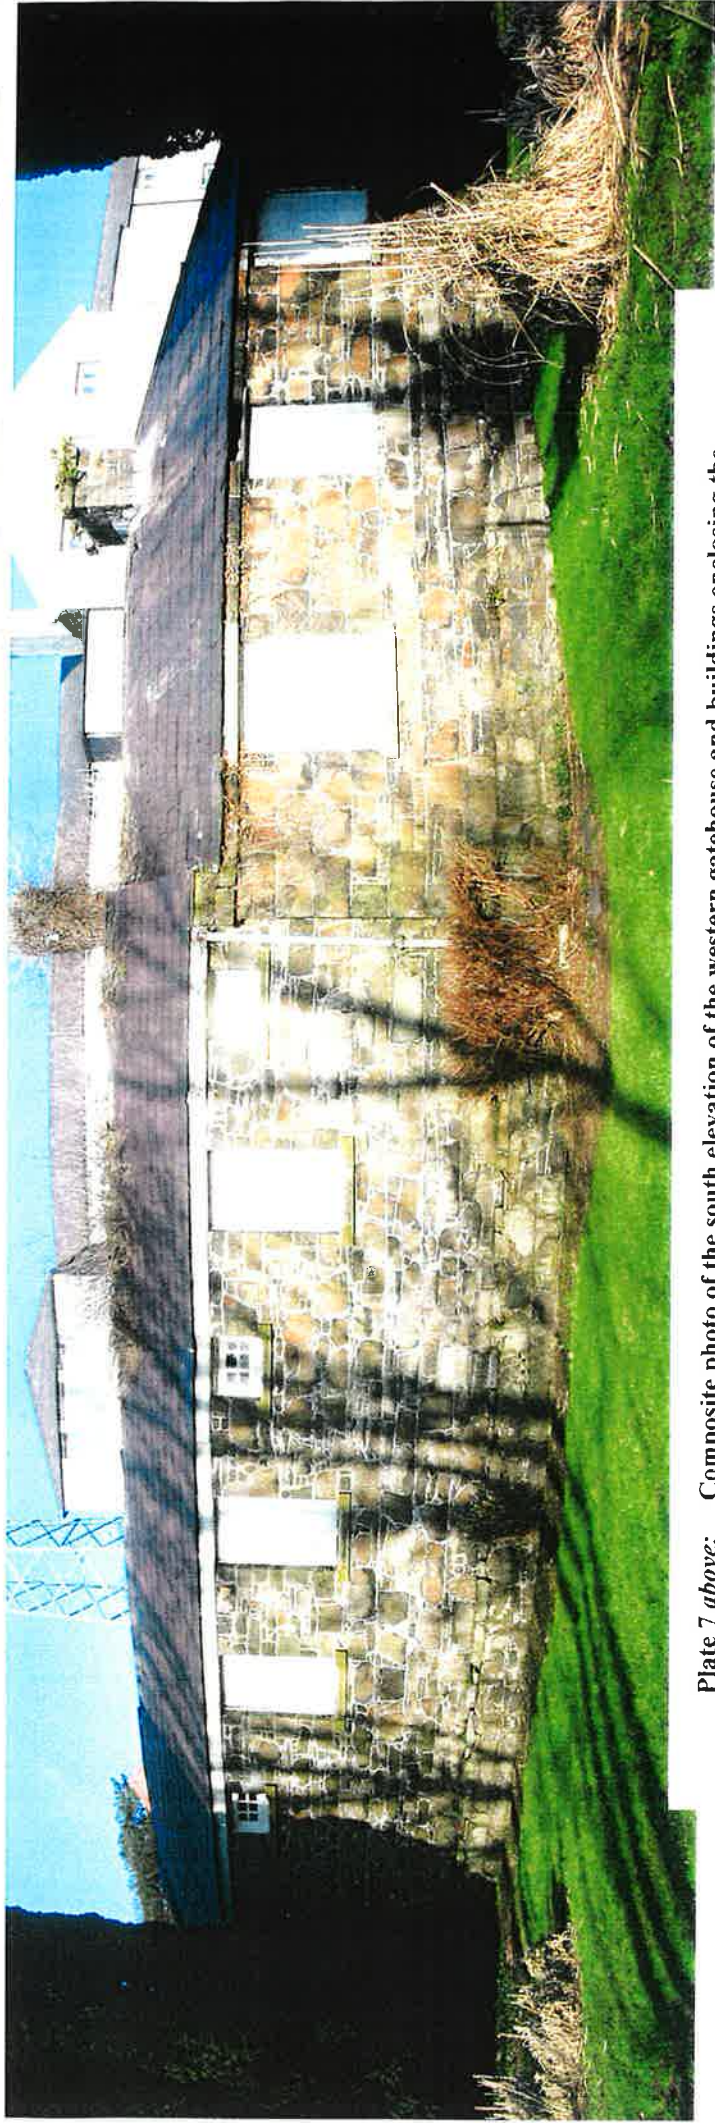
Plate 7 above: Composite photo of the south elevation of the western gatehouse and buildings enclosing the west side of the open area south of *Wing A*. Viewed from the south.

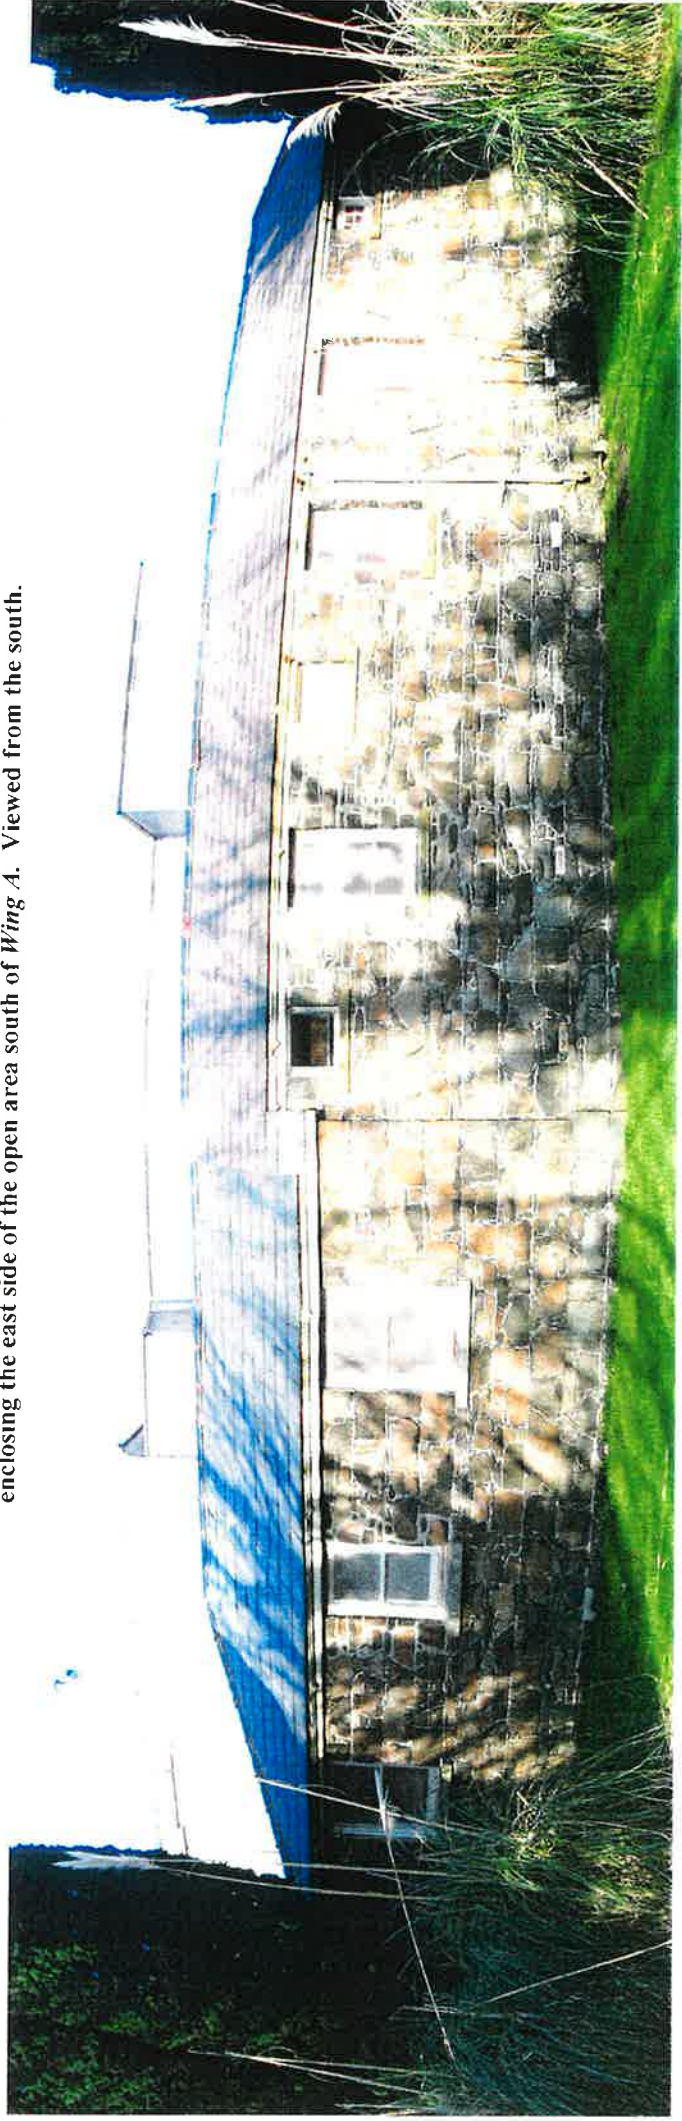
Plate 8 below: Composite photo of the south elevation of the *Building No. 2* - eastern gatehouse and buildings enclosing the east side of the open area south of *Wing A*. Viewed from the south.

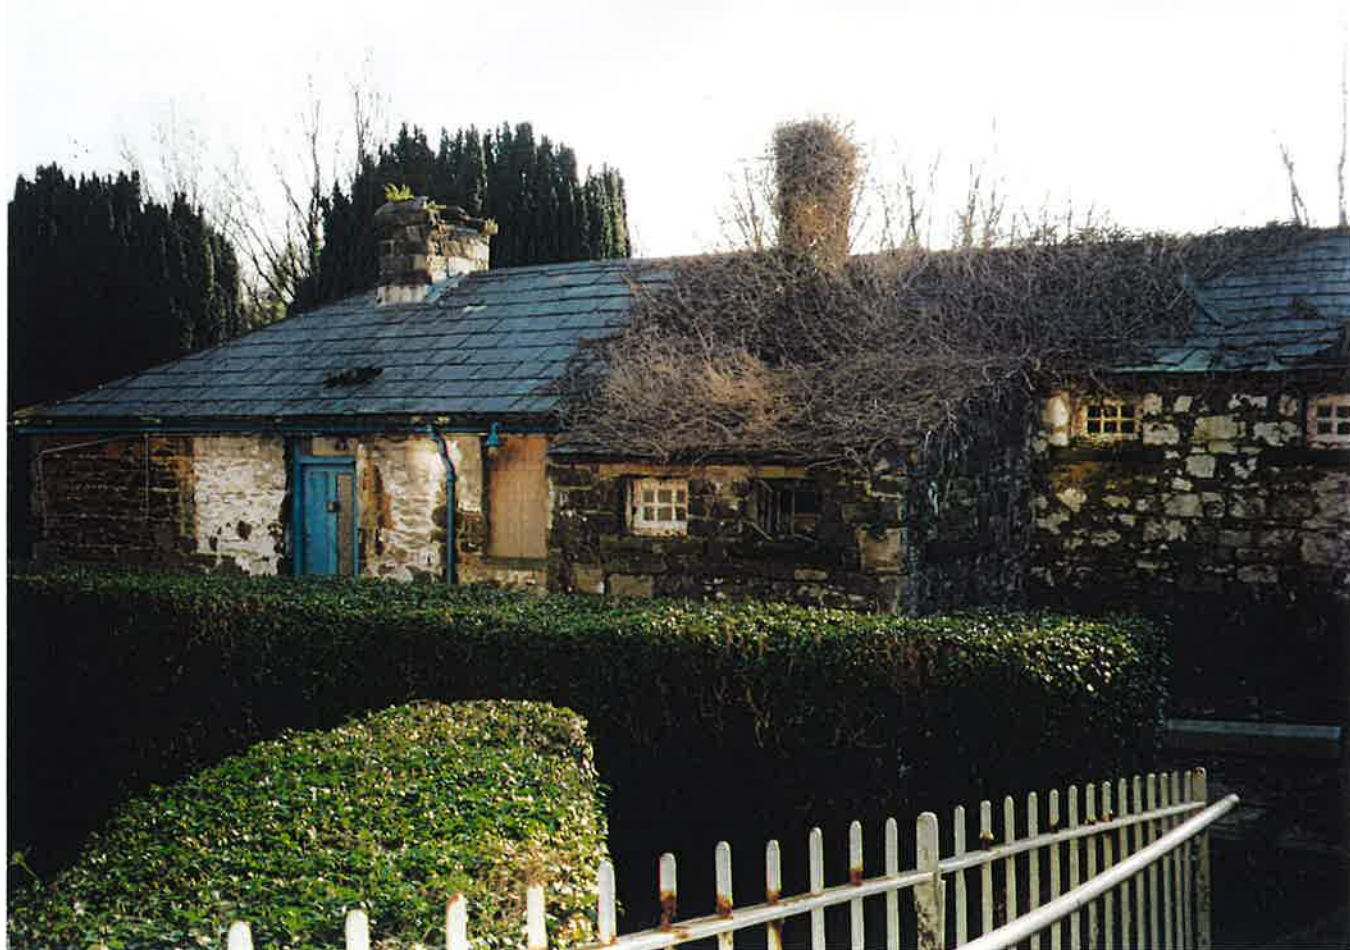
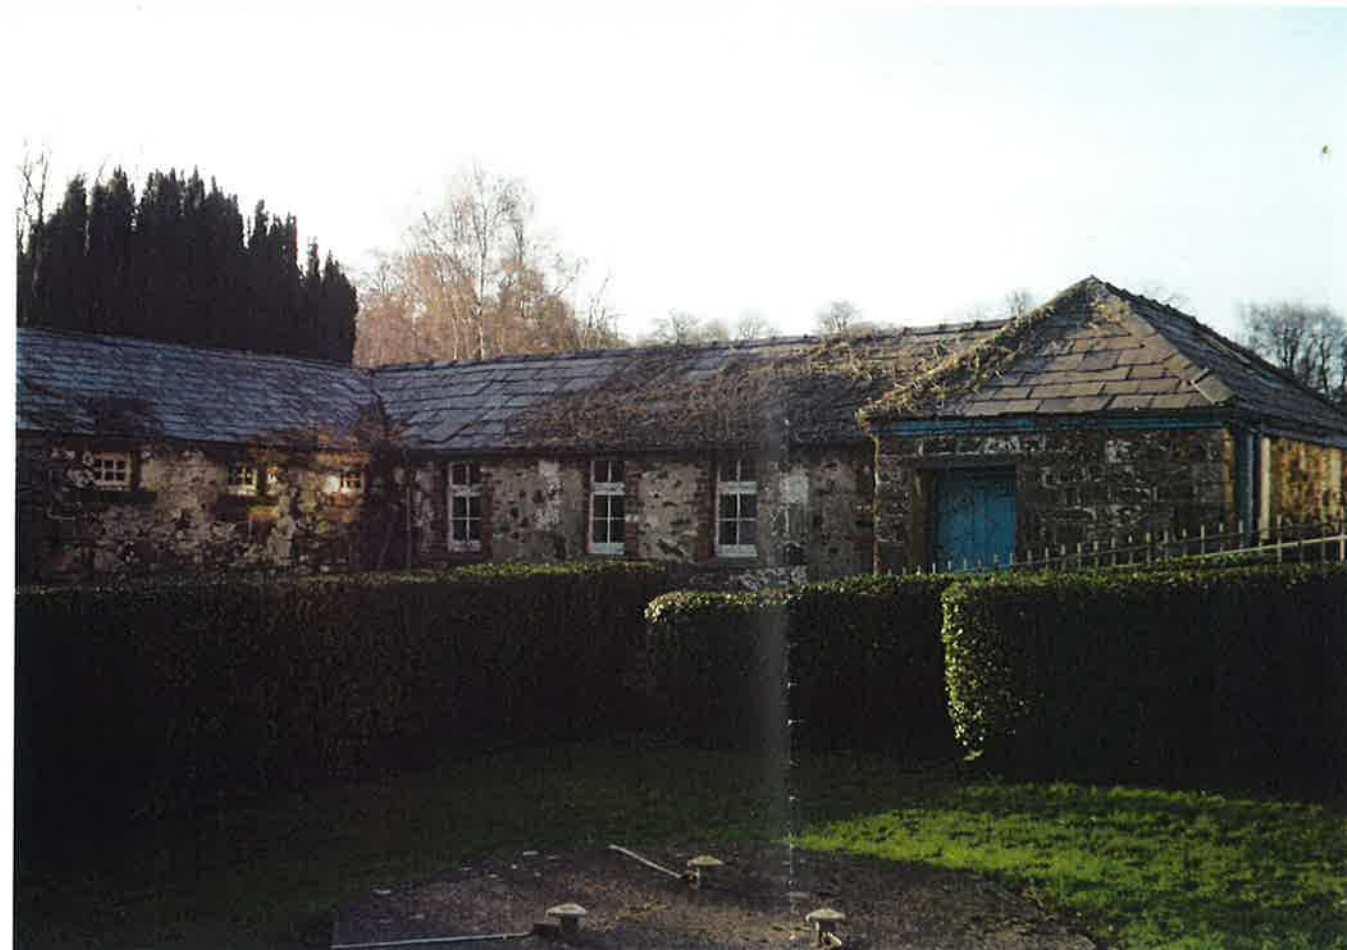
The north elevation of the gatehouse includes a single door and window. The porch (*Plate 9*) at the junction of the gatehouse and the stores leads into the large storeroom. The room has a quarry tiled floor and the area appears to have been abandoned in the post-WW2 period (*c.1948*) (*Plate 14*). During the site visit, the room was piled high with disused hospital beds and mattresses bound up in sacks. Four small 6-pane lights face north. The room gave access to the west wing of the range of buildings, which had concrete floors.

Plate 9 above: The western gatehouse and buildings enclosing the open area south of *Wing A*. Photo left, viewed from the north, shows the gatehouse and central porch, which leads into the stores area (Plate 14). Photo right shows the west wing and the right hand return as shown in Plate 3.

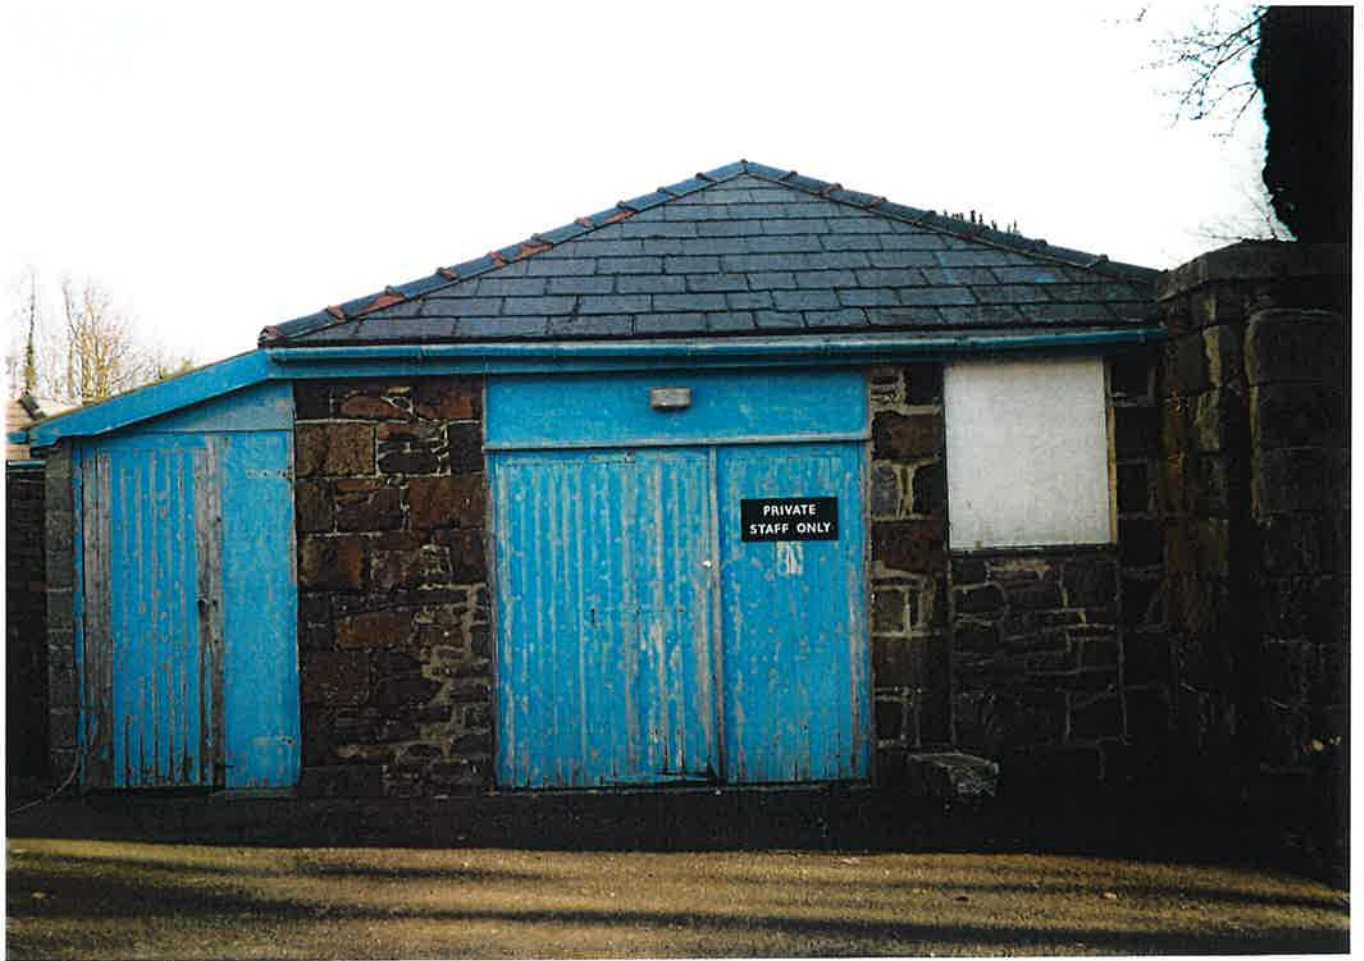
Plate 11 *above*: Eastern gatehouse, south elevation with double doors replacing the former entrance door seen blocked on the right.

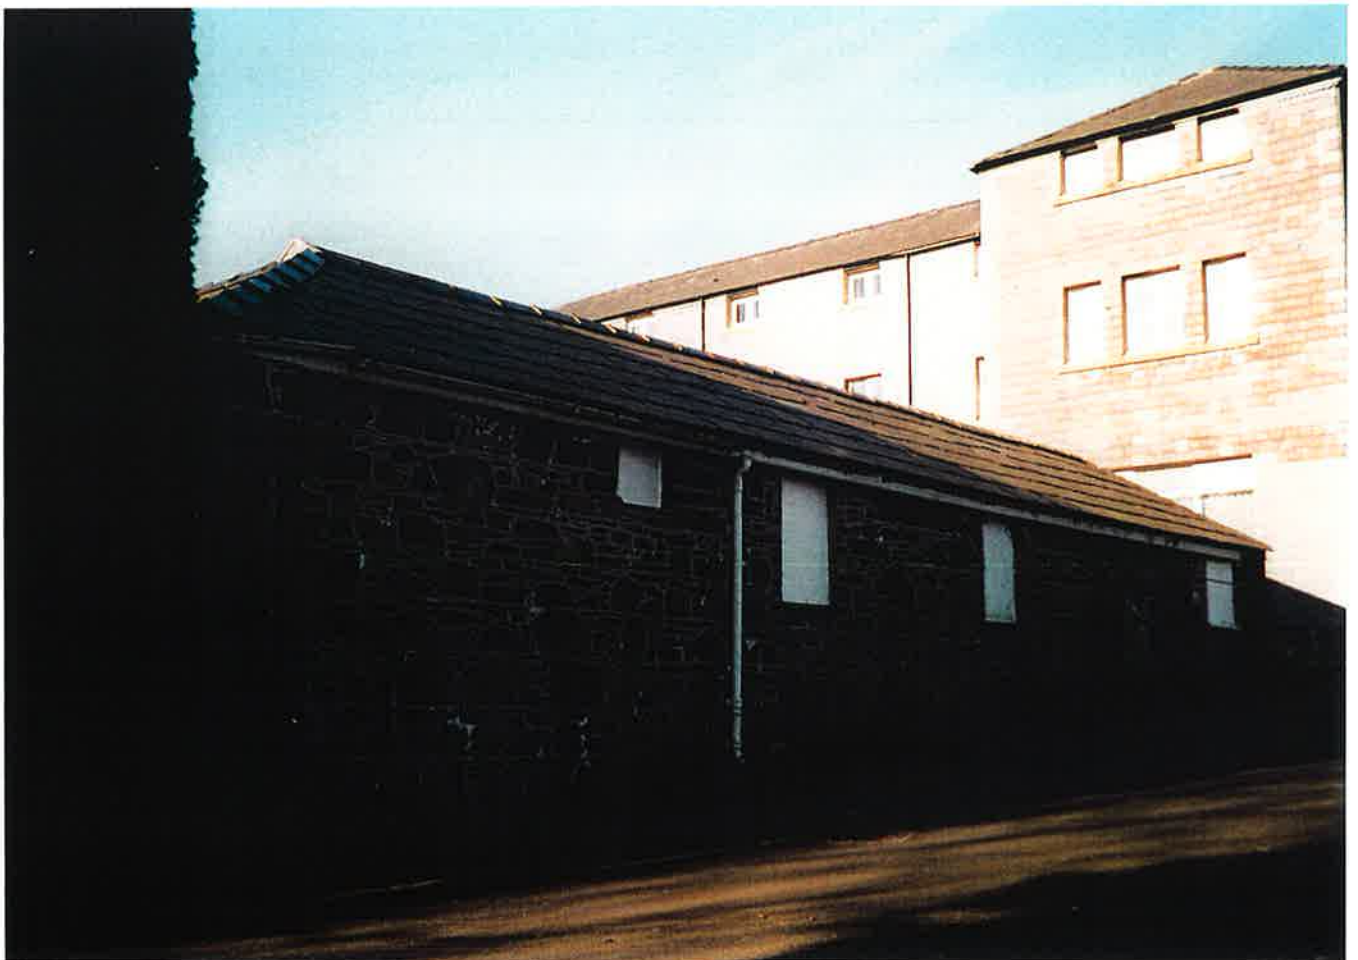
Plate 12 *below*: Eastern gatehouse, east elevation viewed from the southeast, with the main elevation (*south-face*) of the workhouse with slated facade seen in the background.

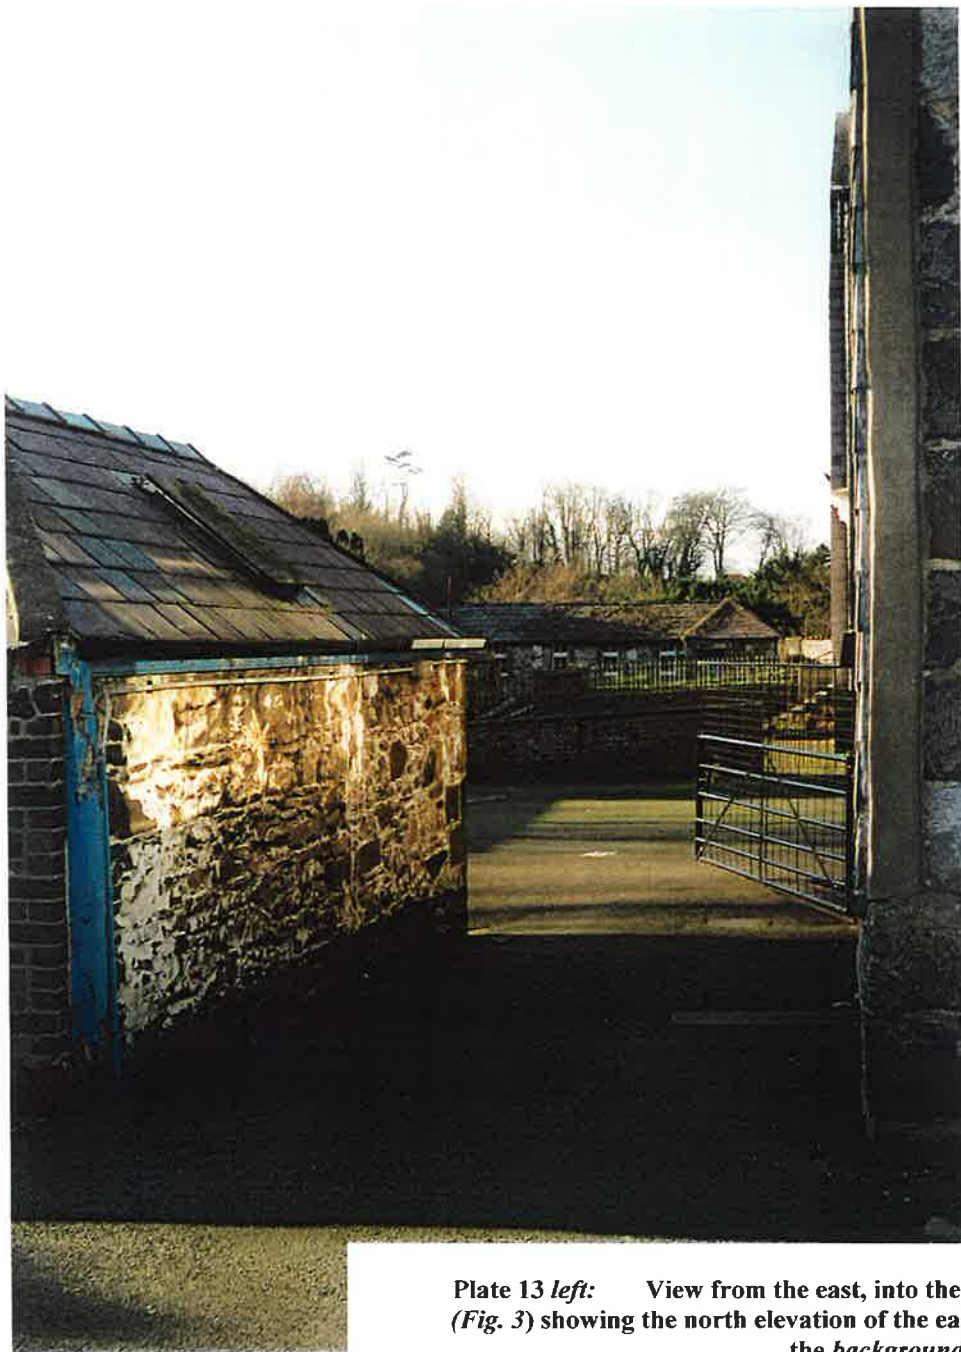
Plate 13 *left*: View from the east, into the former open area south of *Wing A*, as recorded on the c.1881 Plan (*Fig. 3*) showing the north elevation of the east gatehouse wing *photo left*; the west wing of the west gatehouse in the *background* and the workhouse main wing *right*.

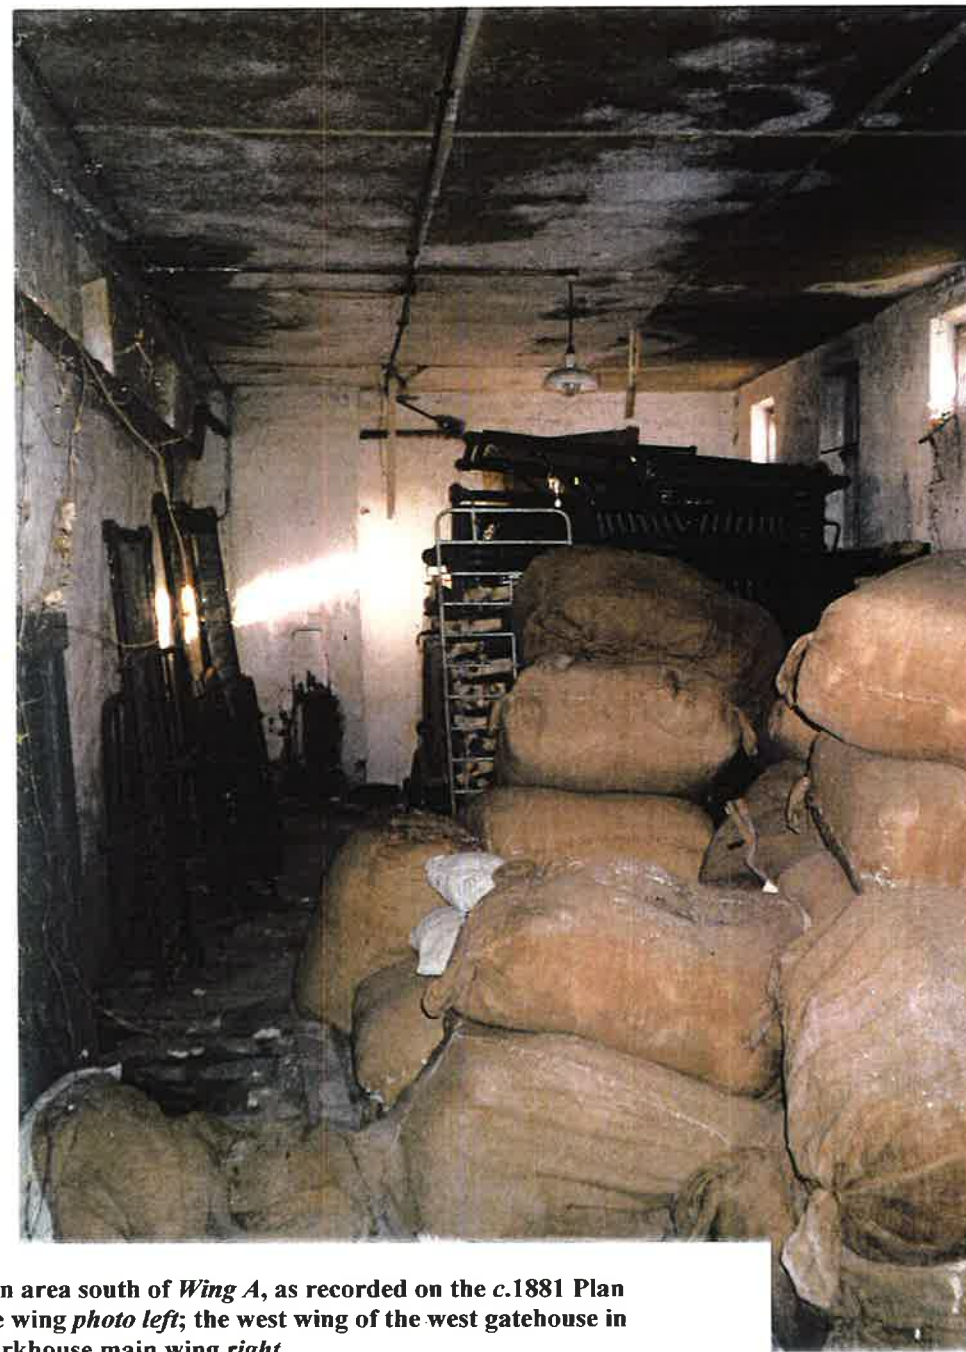
Plate 14 *right*: Internal view of the western gatehouse stores; one of the few rooms which appear to have been abandoned in the post-WW2 period (c.1948).

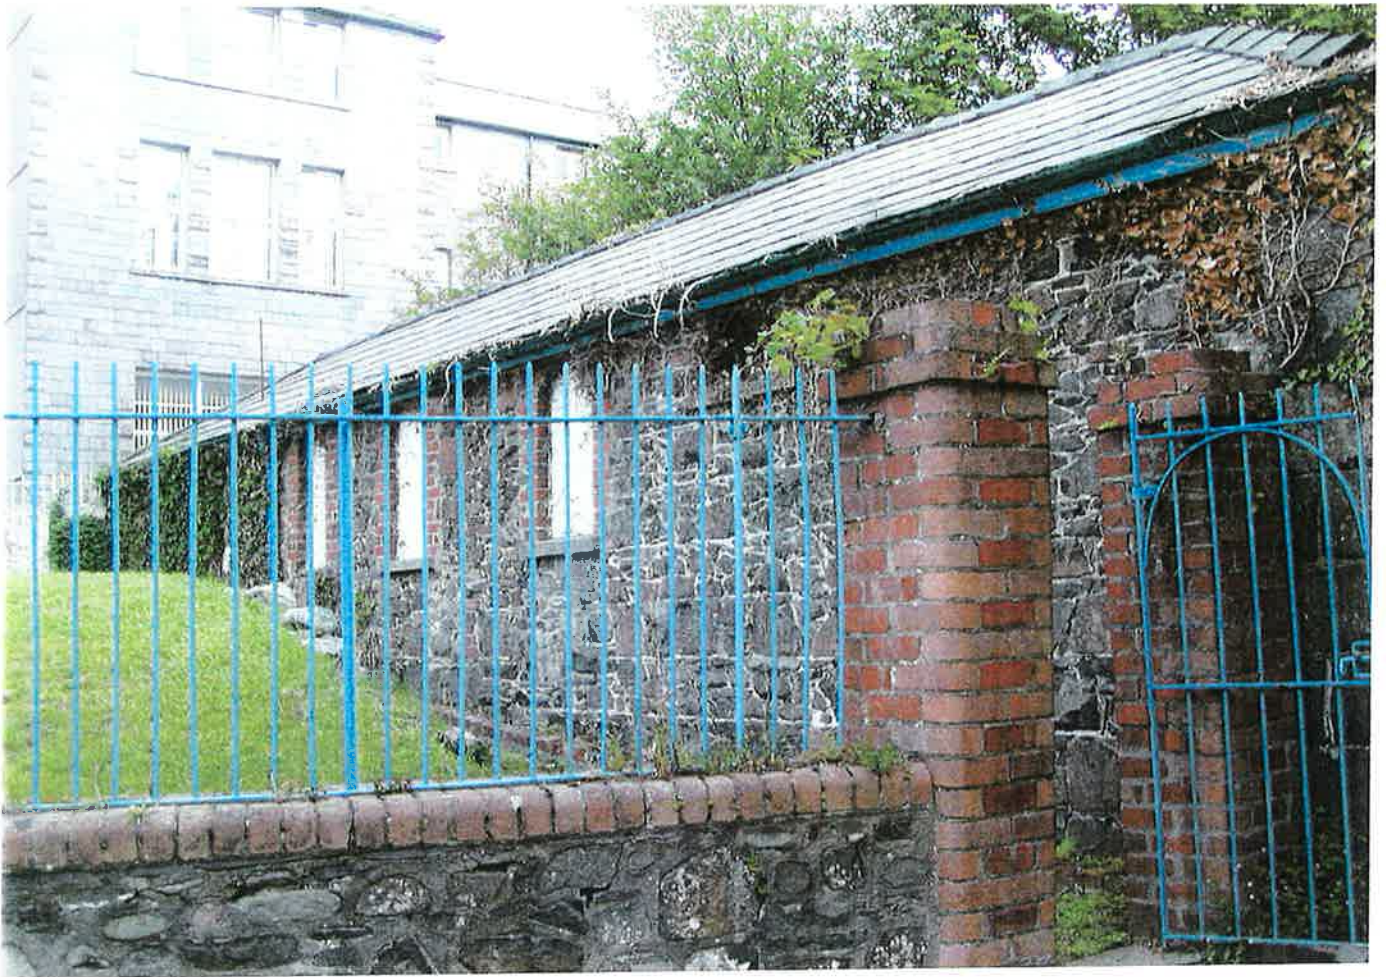
Plate 15 above: The west elevation of the west wing of *Building No. 1* - the Western gatehouse range.  
Viewed from the south

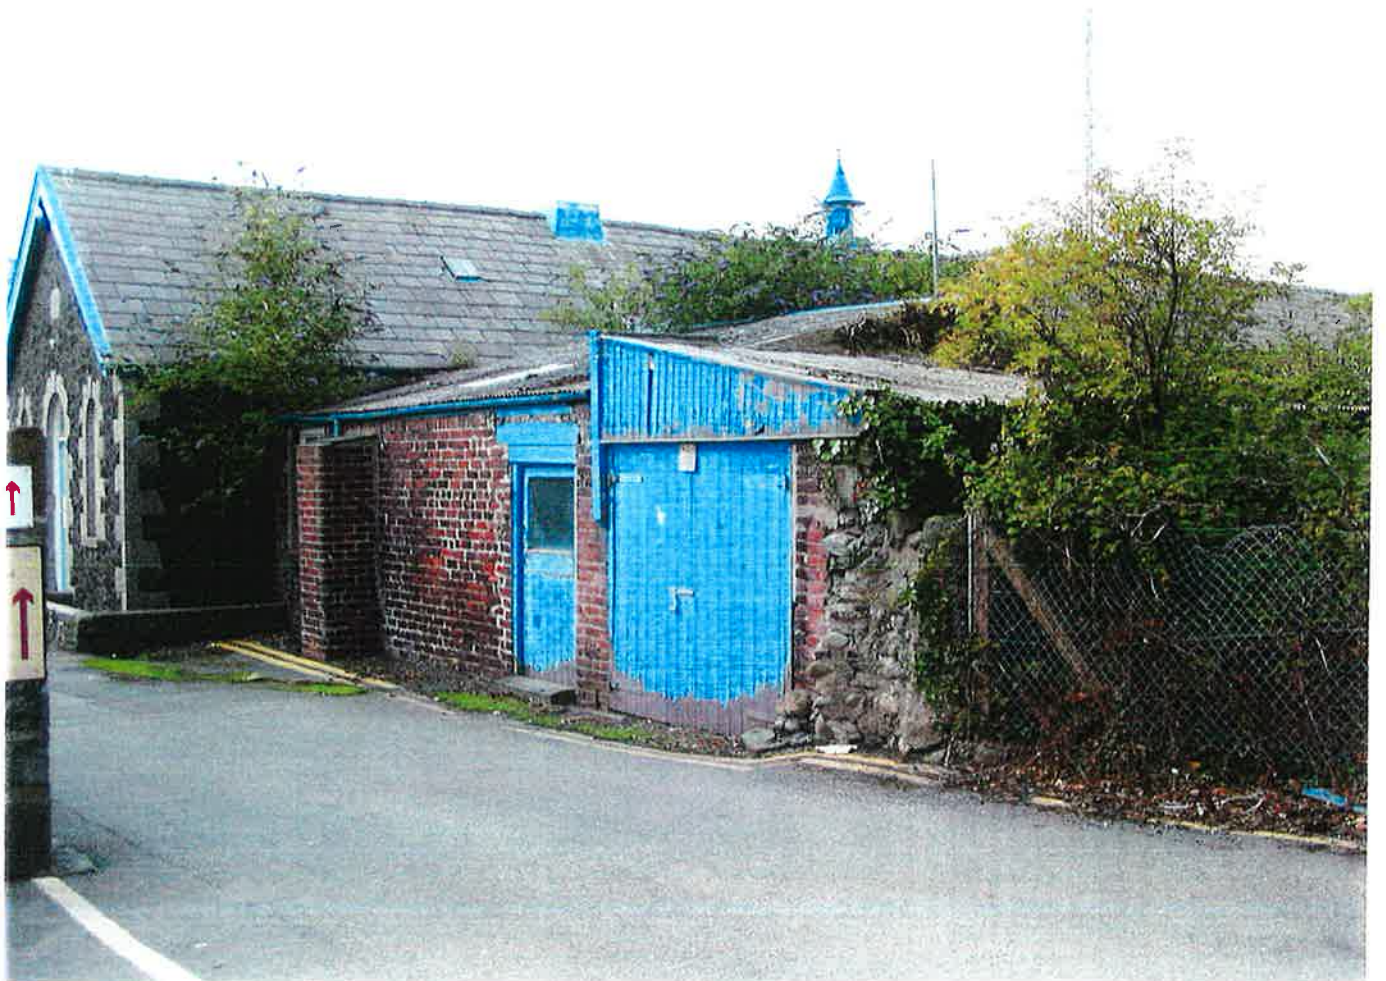
Plate 16 below: The east elevation of *Building No. 4* - the c.1881 building 'F', which has been enlarged into a brick garage. Viewed from the north with the chapel in the background.
