**REPORT NO.230**

**ERYRI HOSPITAL**

**HISTORIC BUILDING RECORDING**

**JANUARY 2006**

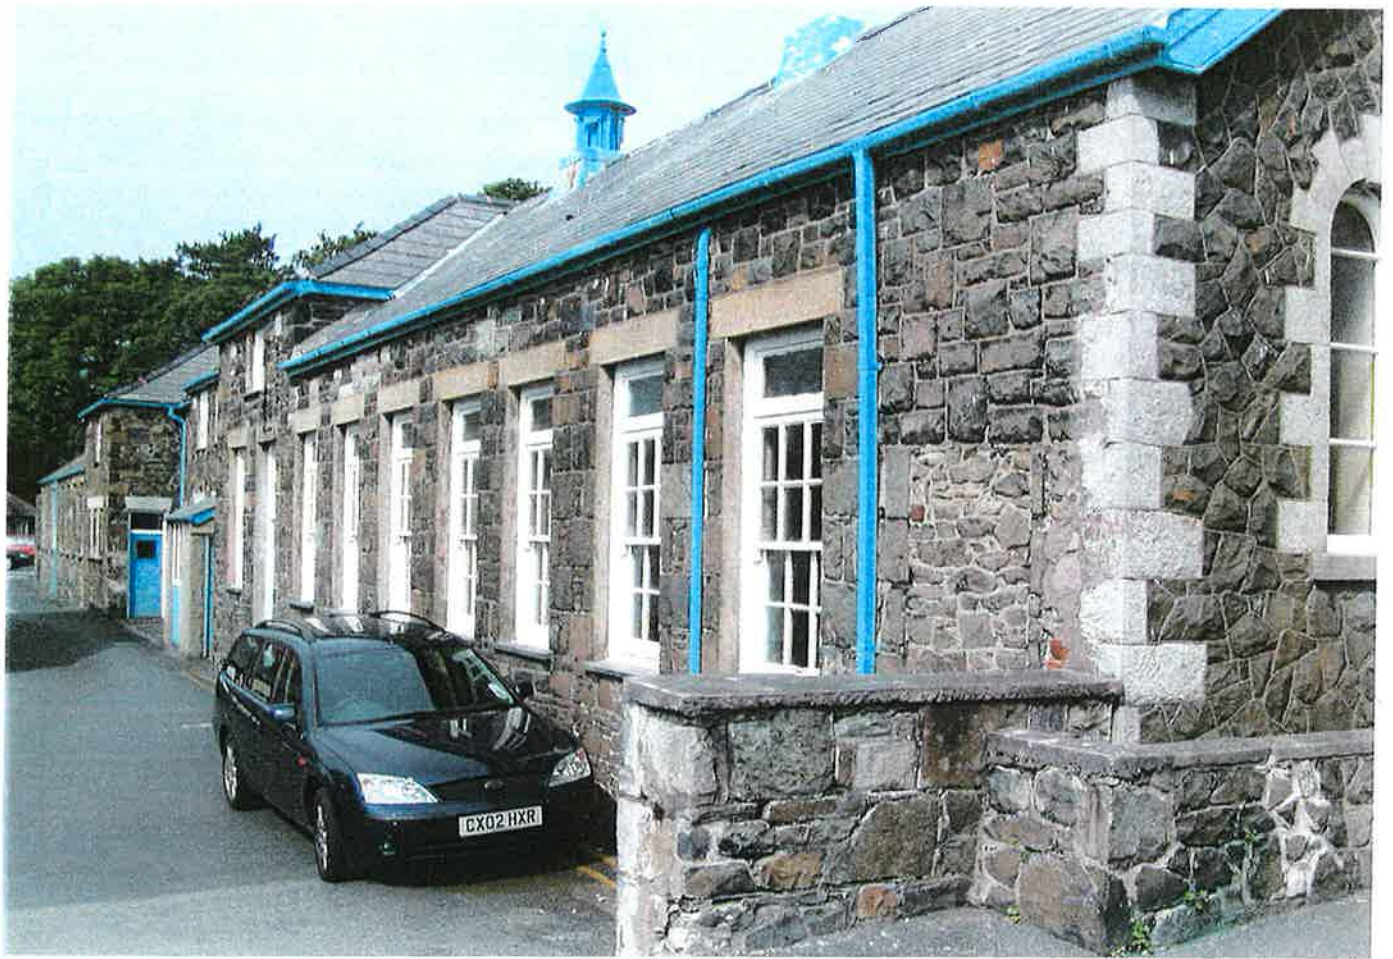
Plate 17 *above*:  
The Chapel forms the east side  
of the north wing.  
View from the east records  
the south elevation.

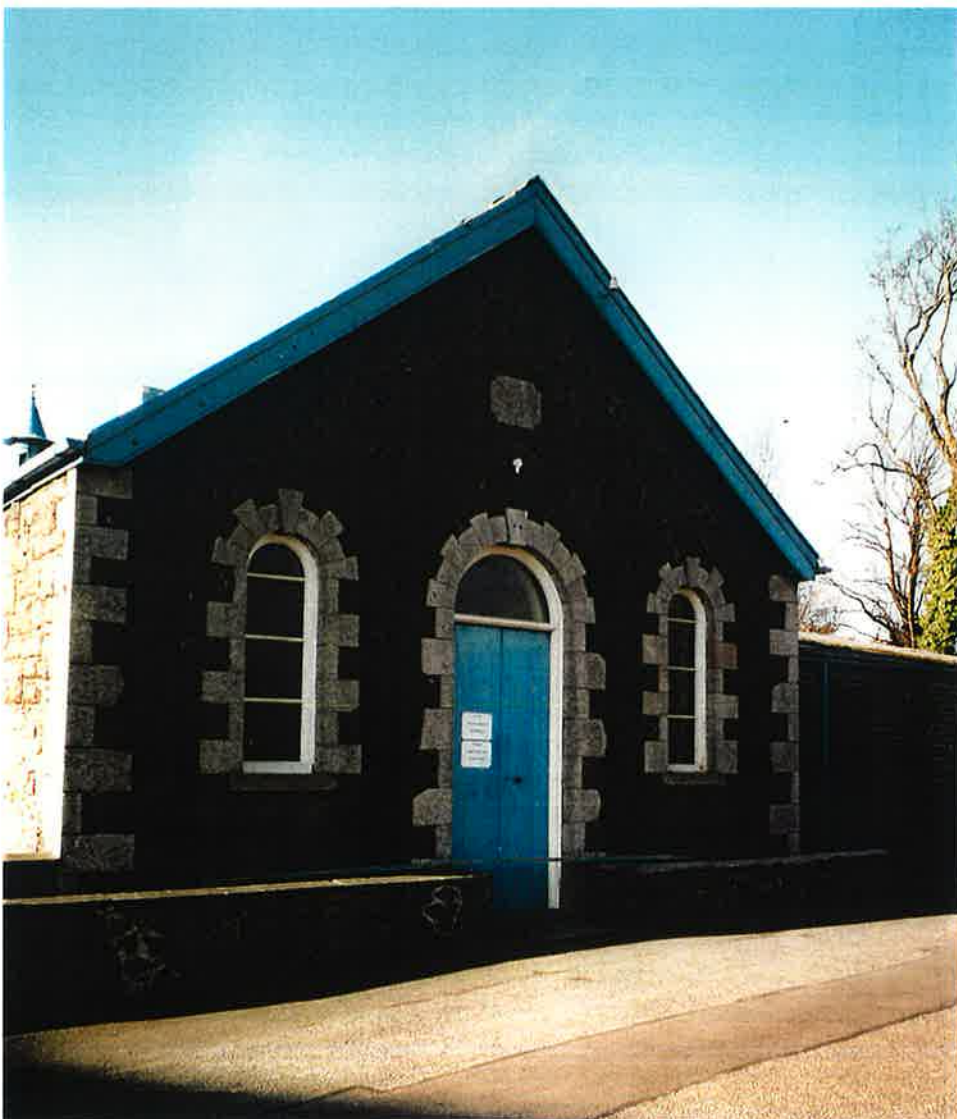
Plate 18 *left*:  
Chapel, east elevation.

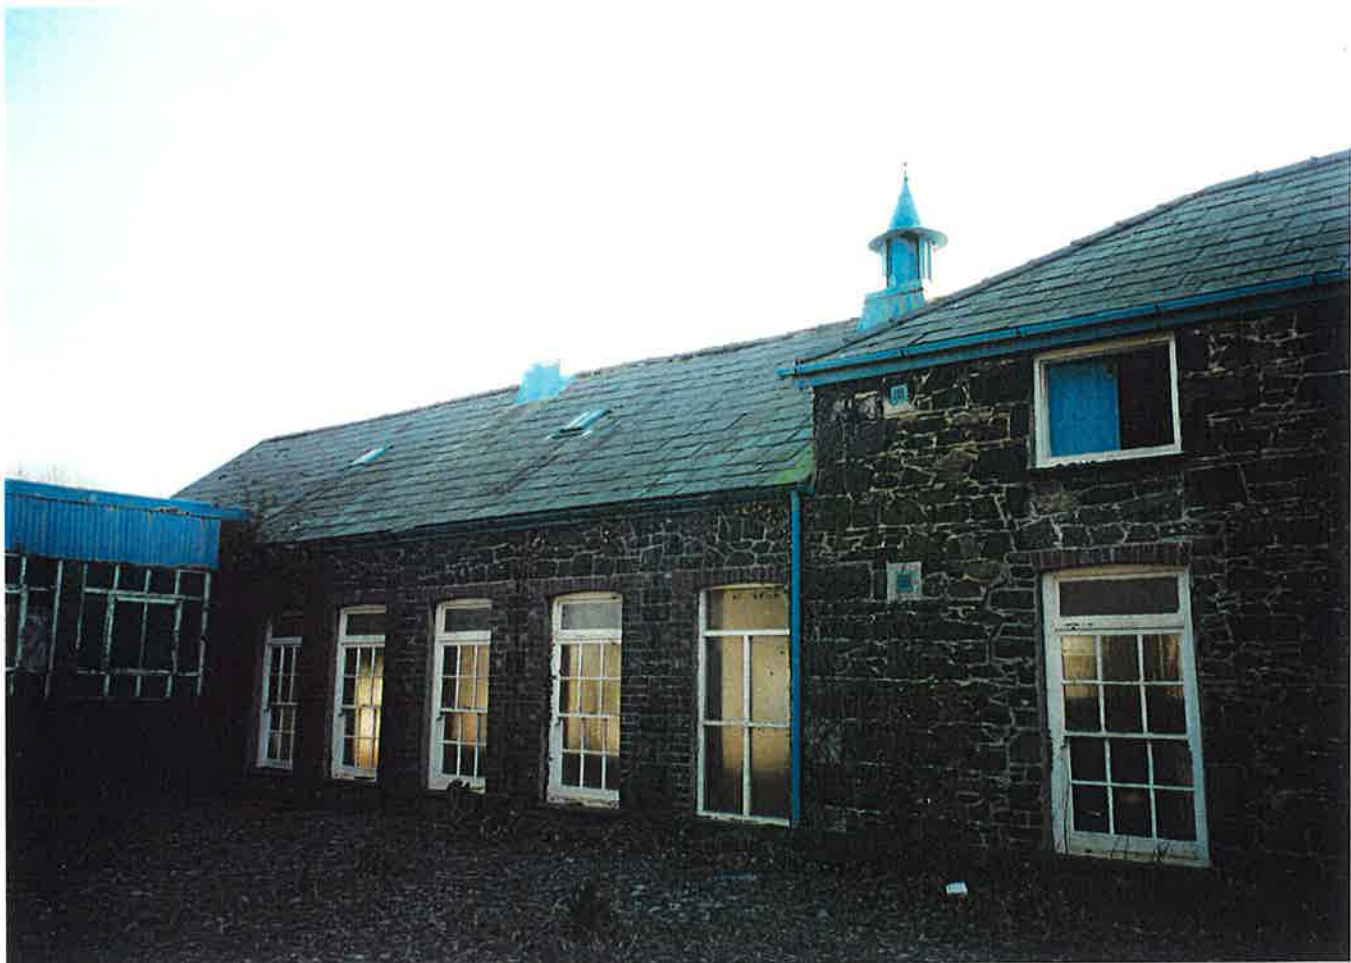
Plate 19 *above*: The north elevation of the chapel, viewed from the northwest. The back of the chapel backed onto the Firewood Yard in 1881 (*see Fig. 3*).

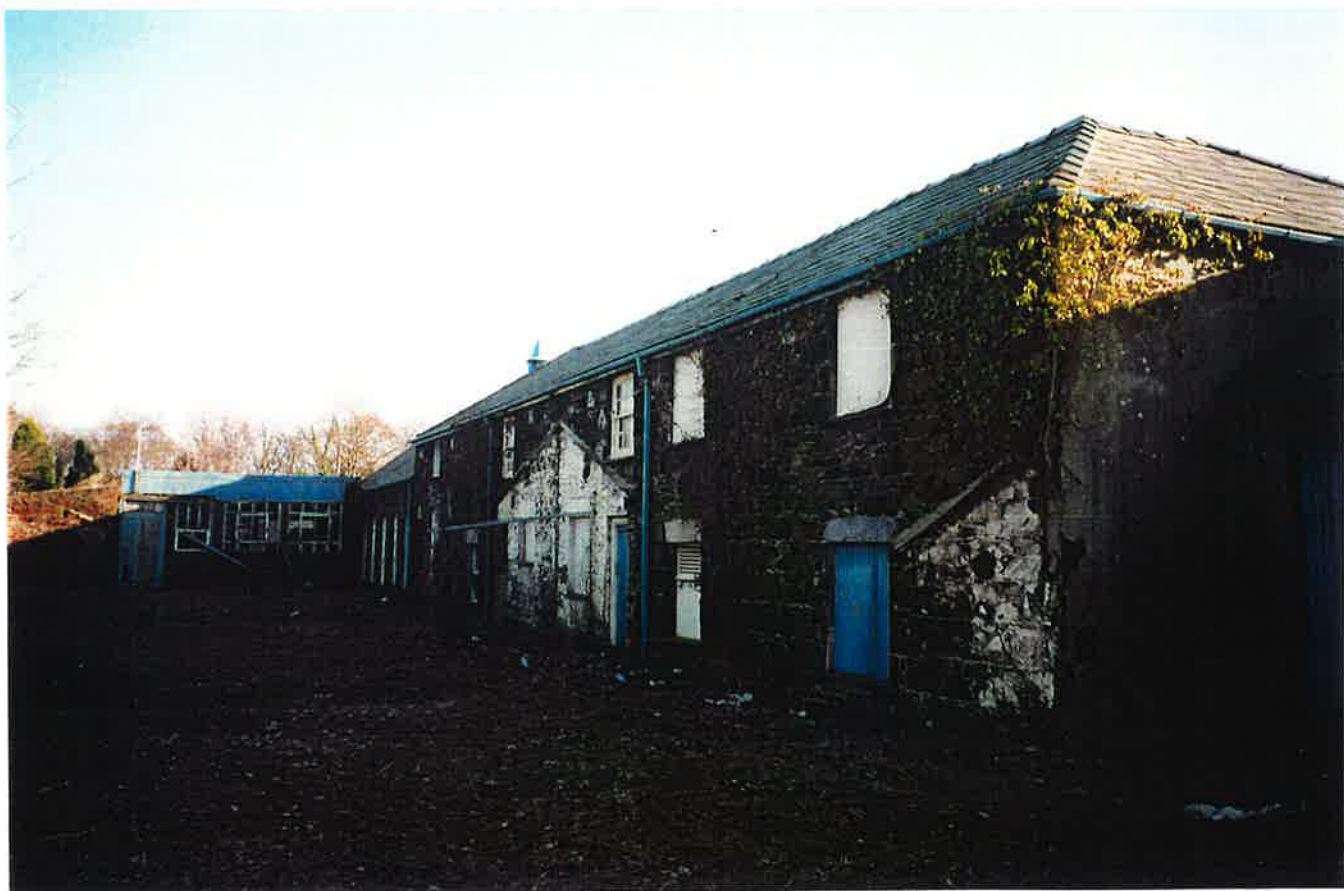
Plate 20 *below*: View from the northwest towards the central block of the workhouse north wing, which housed the c.1881 engine house, joiners, tailor and shoemakers shop (*Fig. 3*). The white painted brickwork indicates where the c.1881 woodcutting shop has been demolished. Background left shows the garage (*Fig. 1 – Building 4*) also to be demolished (*Fig. 3 – building ‘F’*).

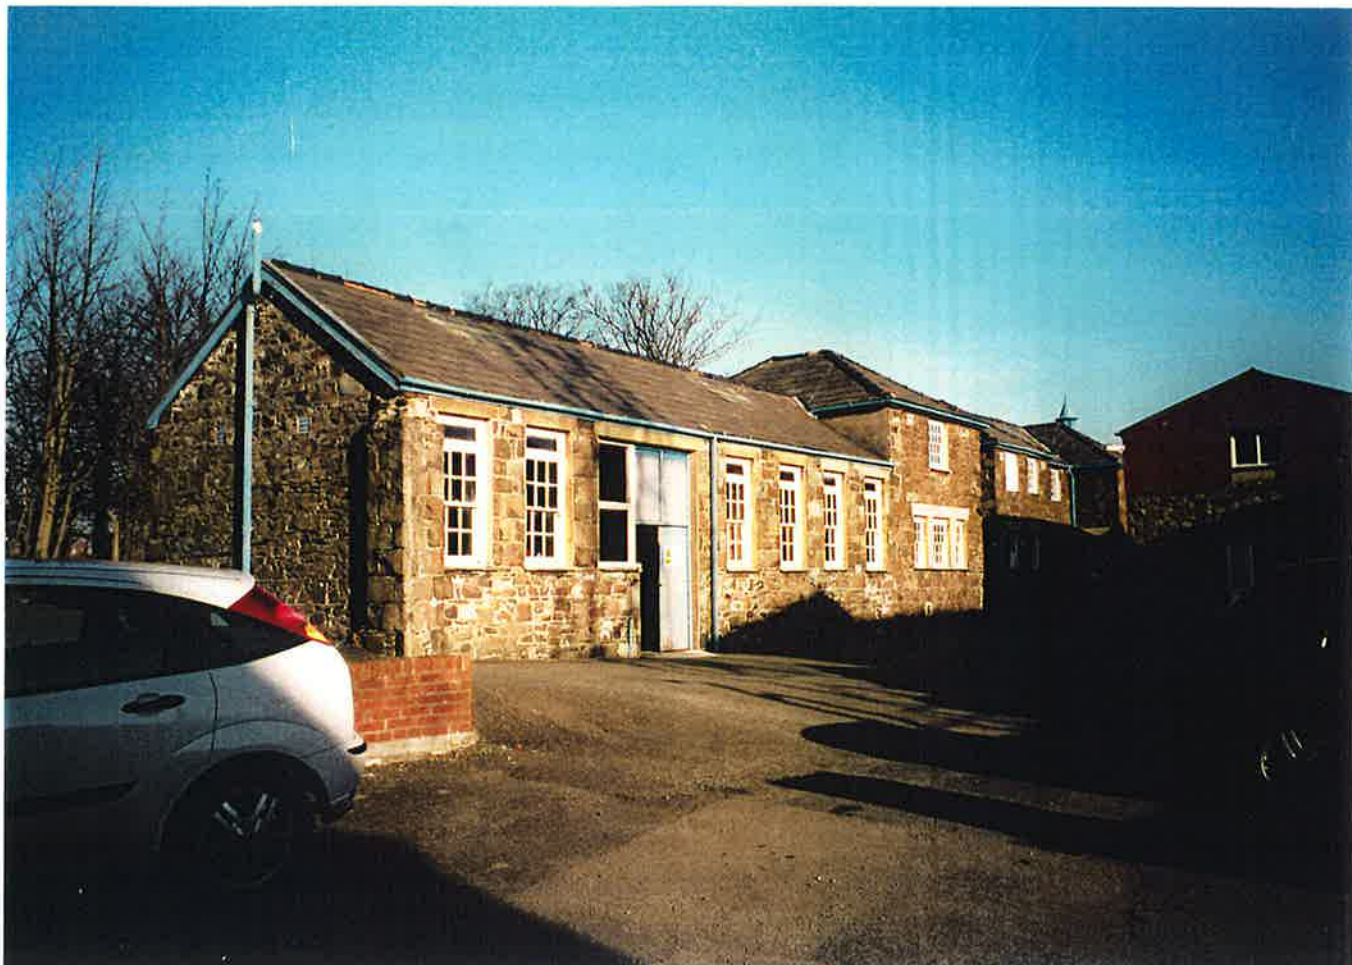
Plate 21 *above*: View from the southwest towards the north elevation of the existing stores, recorded as *Wing E Laundry* on the c.1881 plan (Fig. 3).

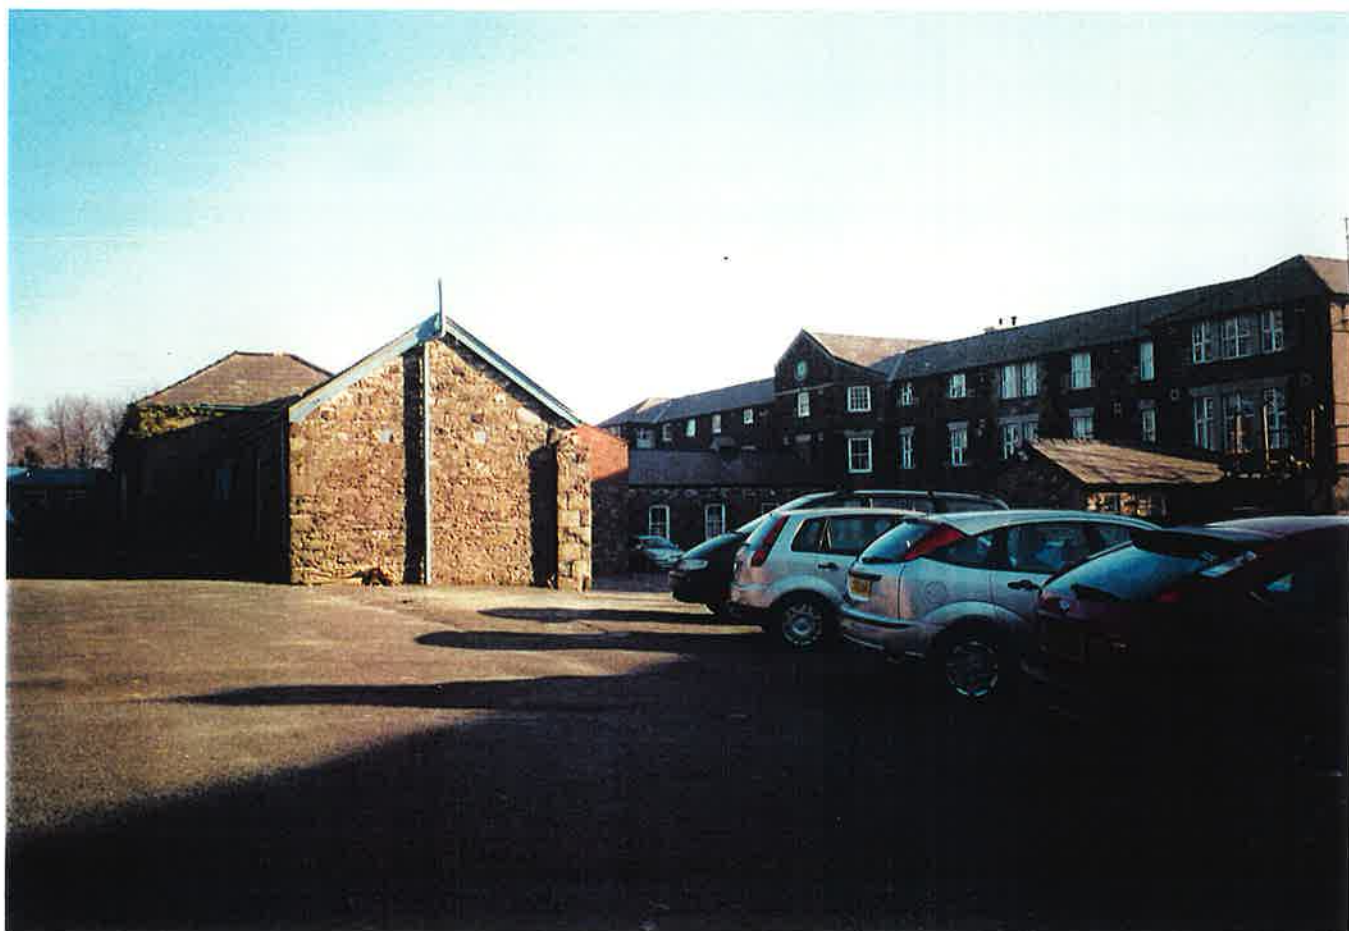
Plate 22 *below*: View from the west towards the c.1881 *Laundry and Wing E*. The main workhouse building and c.1881 *cross-wing A*, which separated two open yards can be seen to the right.

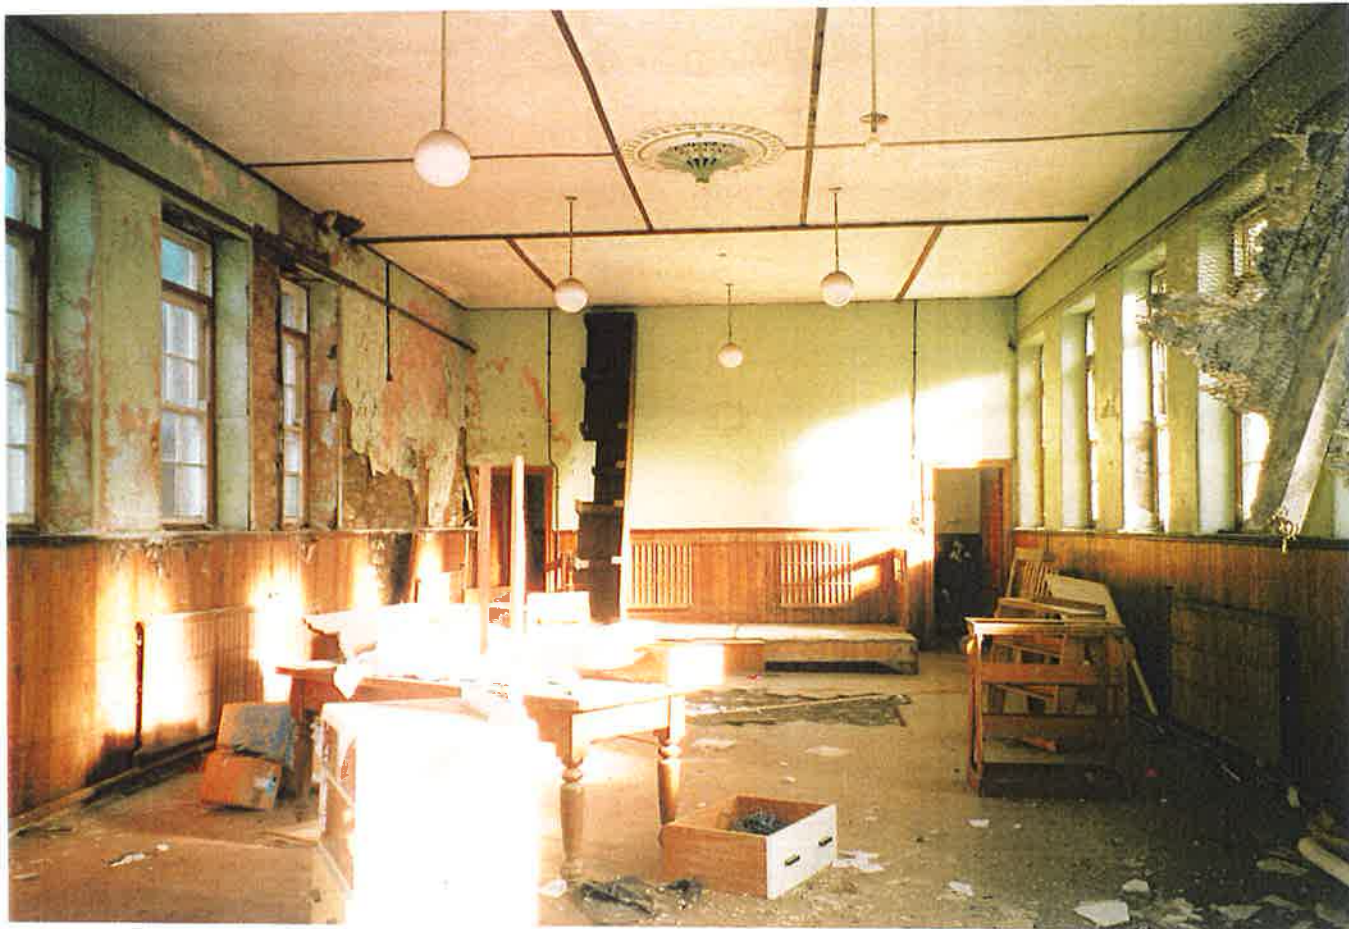
Chapel interior

Plate 23 *above*: View from the west and Plate 24 *below*, view from the east.

Internally, the single storey chapel has parquet flooring throughout, tongue & groove dado panelling, plastered walls and ceiling (*Plate 27*). A wooden dais at the east end is flanked by doors into the eastern porch (*Plate 23*). An area at the west end is enclosed by wooden panelling (*Plate 24*).

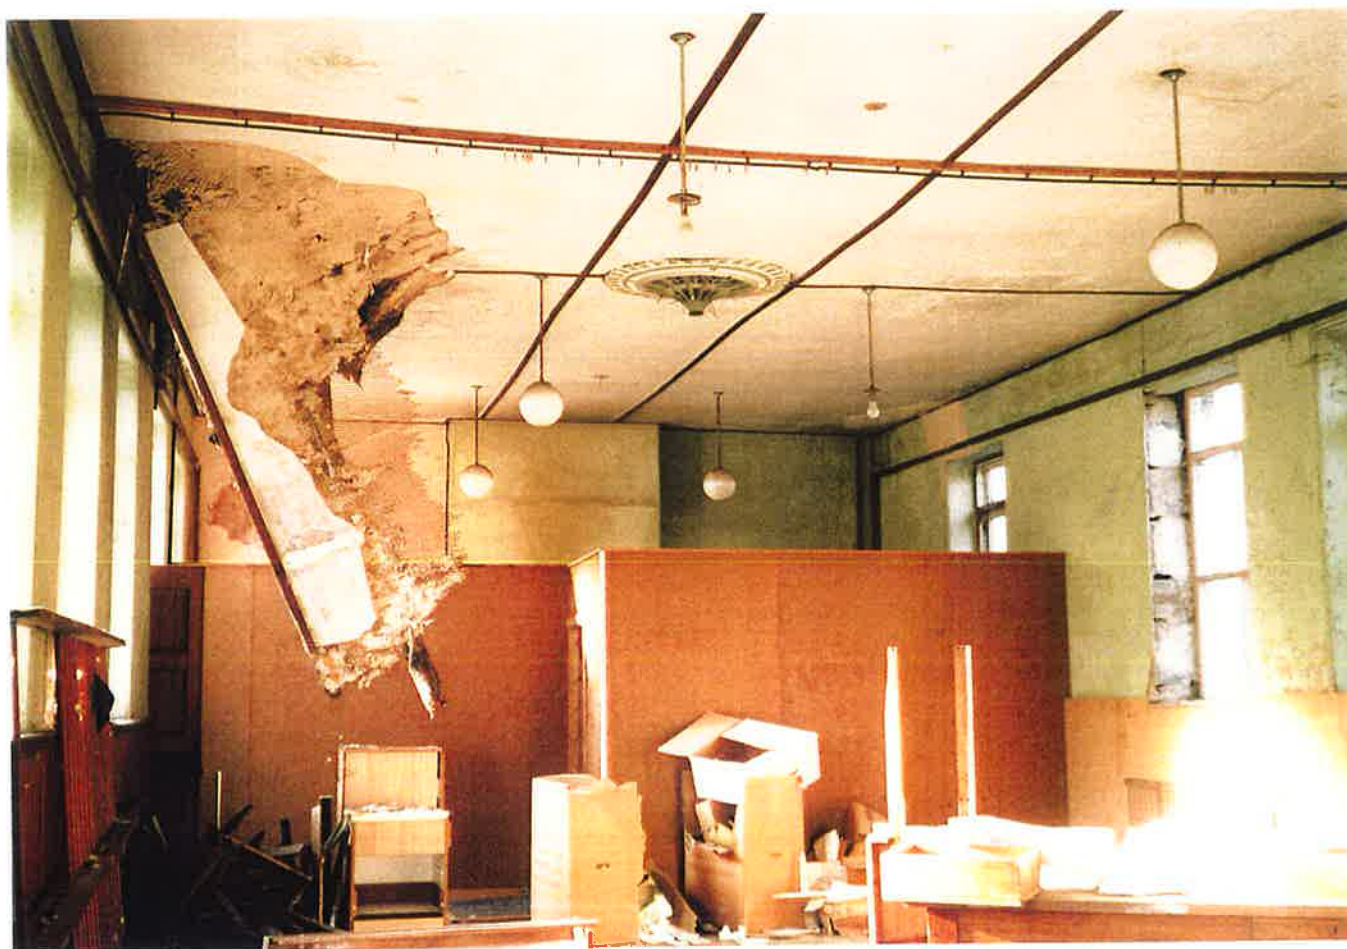
Plate 25 left:

Interior of the former c.1881 Laundry in Wing E, now used as a store. View from the east.

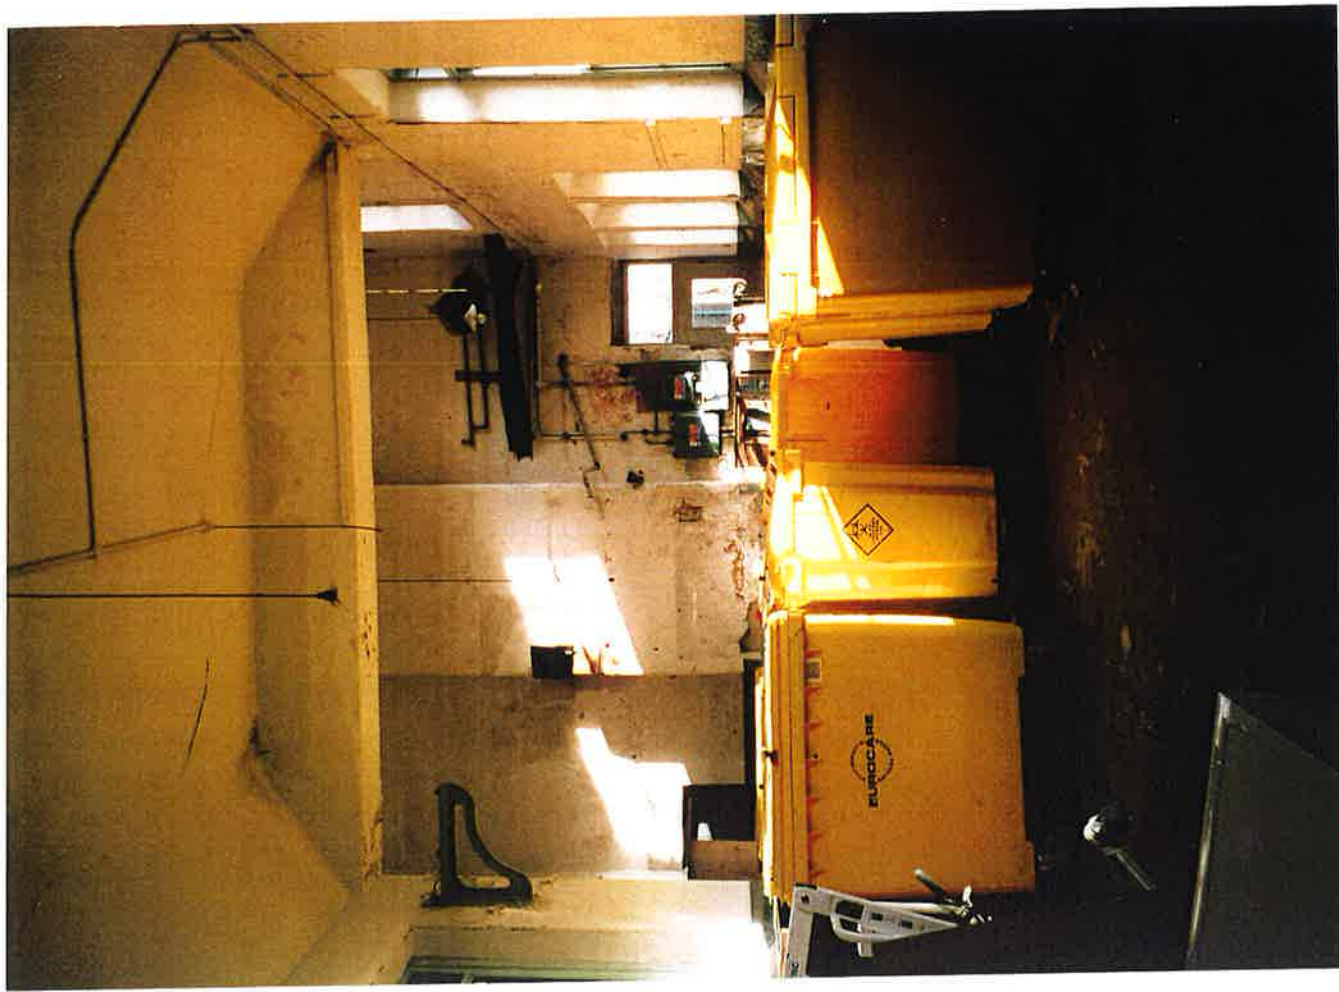
Plate 26 right: as above, view from the west.

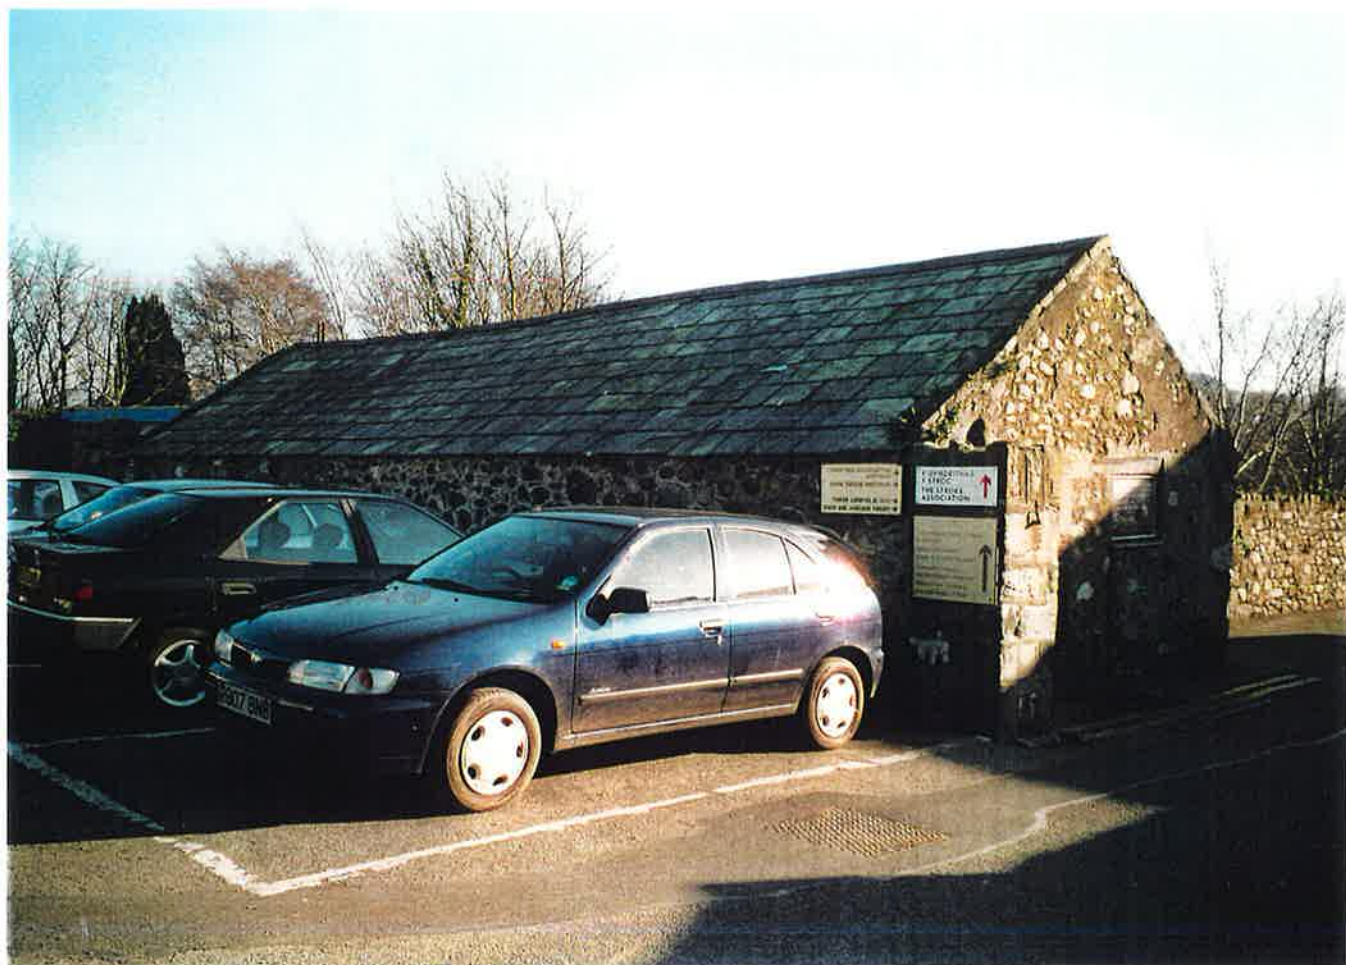
The detached two-compartment building is surmounted by a slate roof (*tiles 0.34m x 0.65m*) with red ceramic ridge tiles and a single skylight at the west end. The building is enclosed on the south side by a stone wall, which forms a yard area currently used to store dustbins (*Plates 29 & 30*). A small lean-to shed adjoins the east gable, filling the gap between the building and the enclosing stone wall. A small rectangular opening in the west elevation appears to have replaced a larger opening with flanking red brick trim. This possible doorway has been blocked with rubblestone. The north elevation faces Eryri car park (*Plate 28*).

Plate 28 below: Detached stores - - *Building No. 5* - recorded as buildings 'T' & 'J' on the c.1881 workhouse plan (Fig. 3). View from the north.

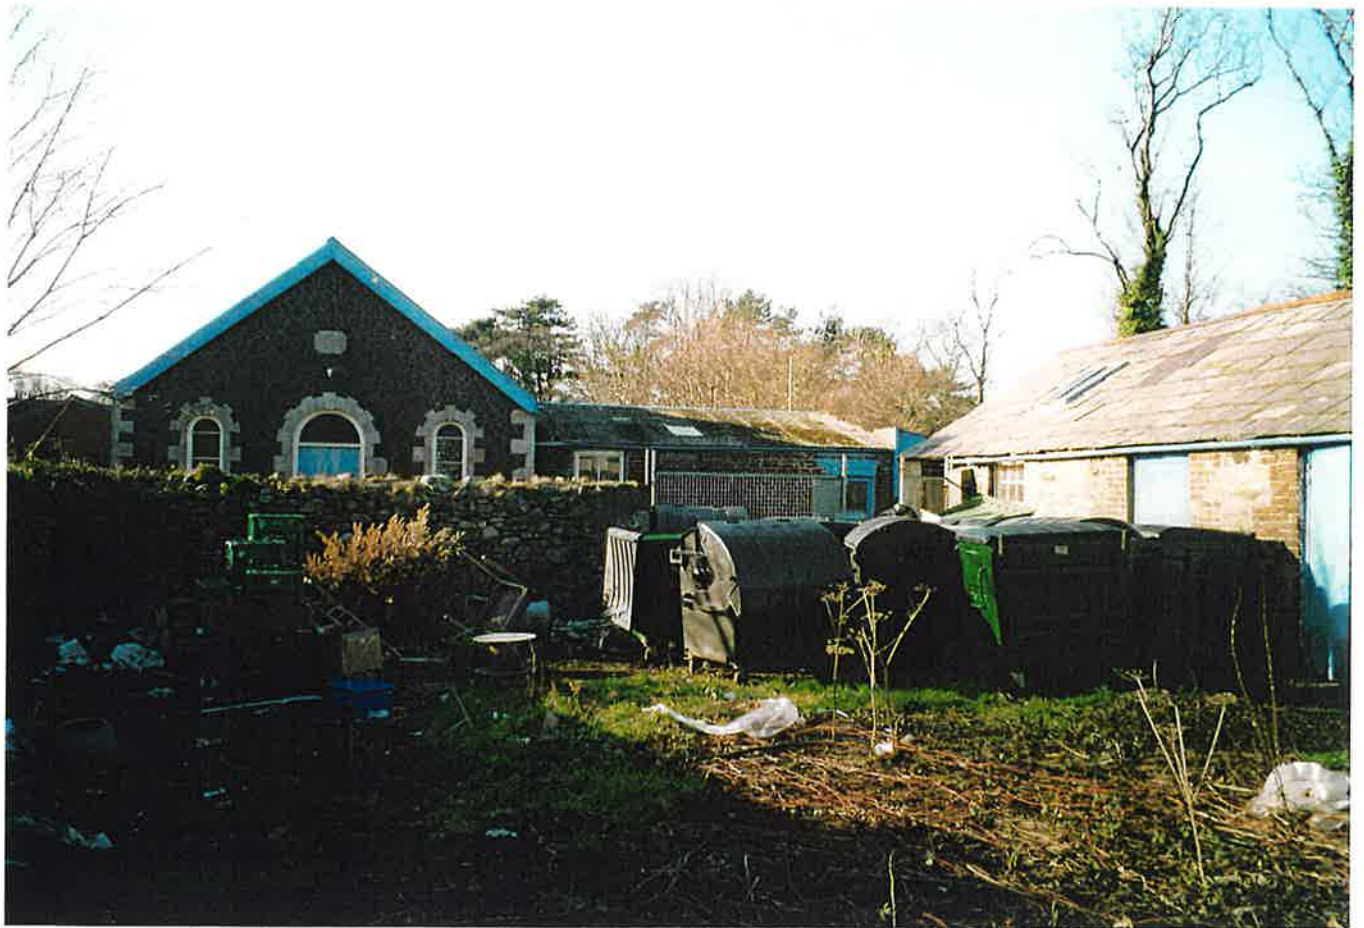
Plate 29 above: Detached stores (*right*) with enclosed stone wall on the south side and Chapel east elevation in the background.

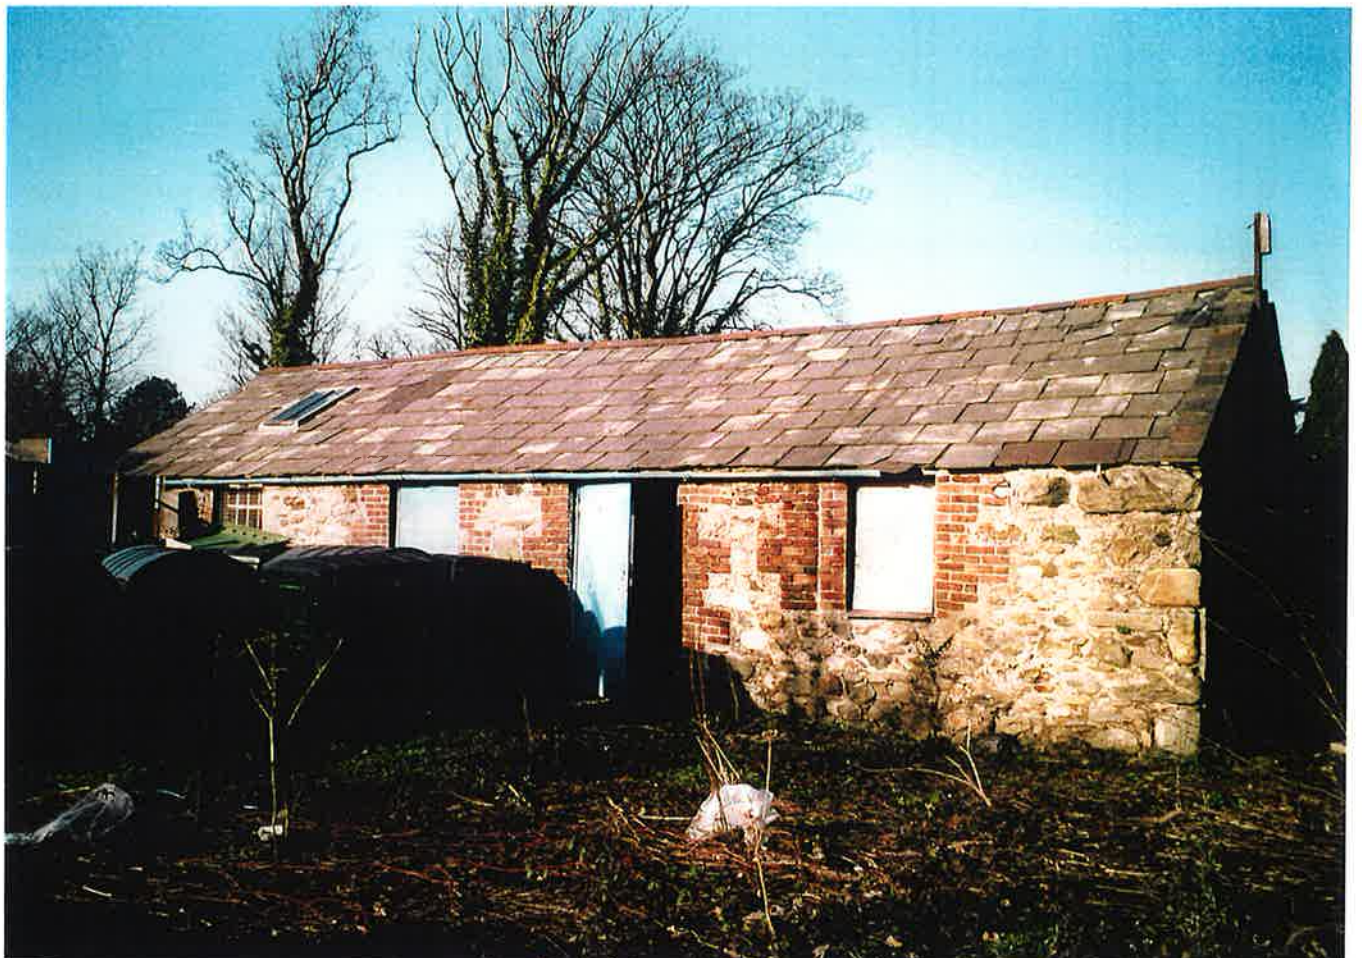
Plate 30 below: Detached stores south elevation.

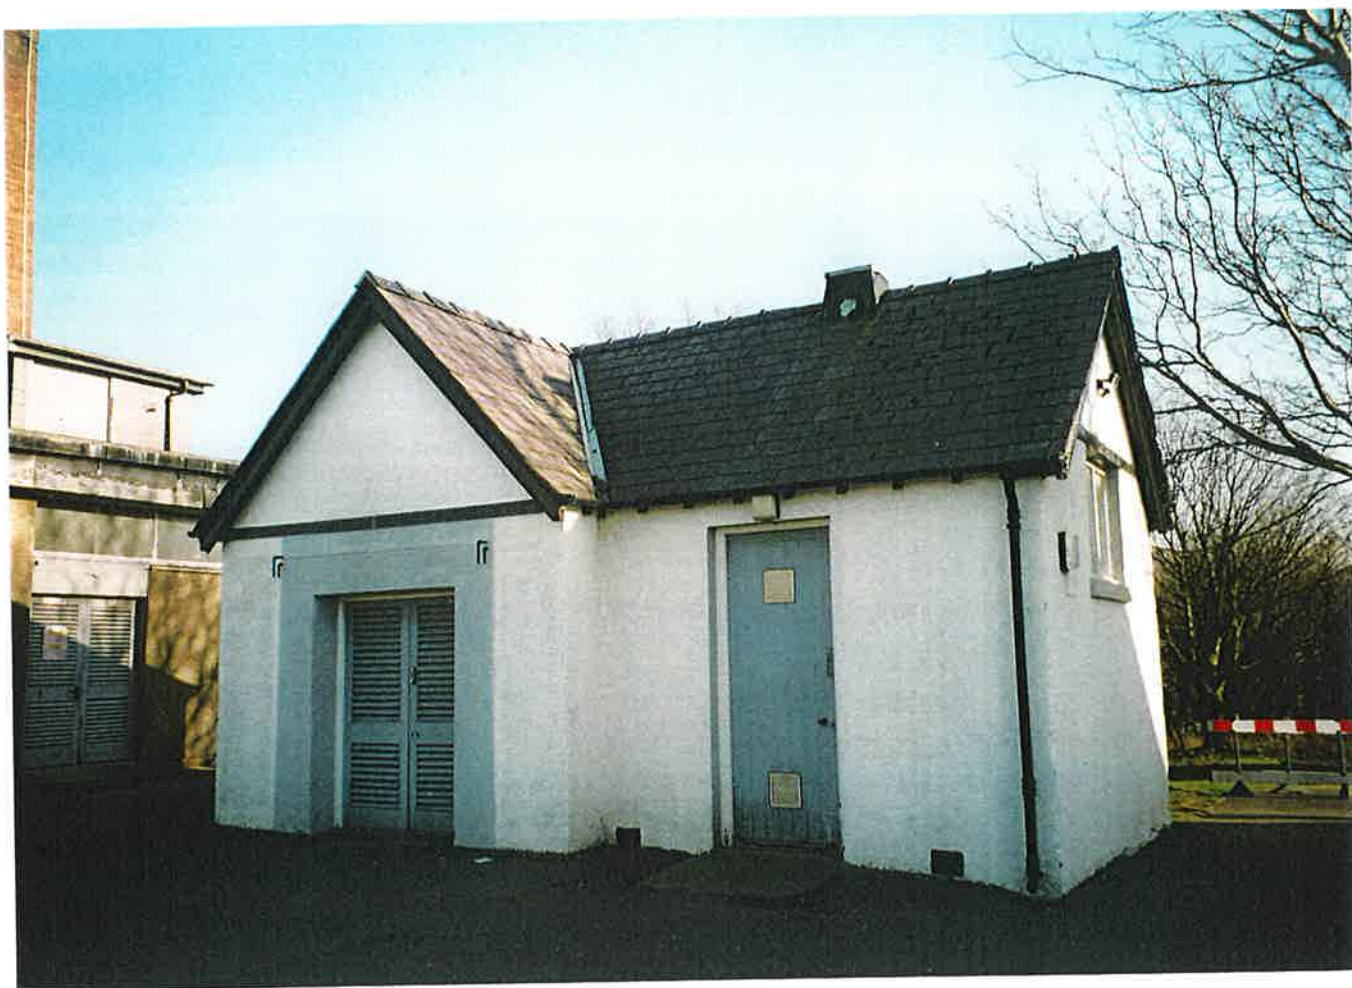
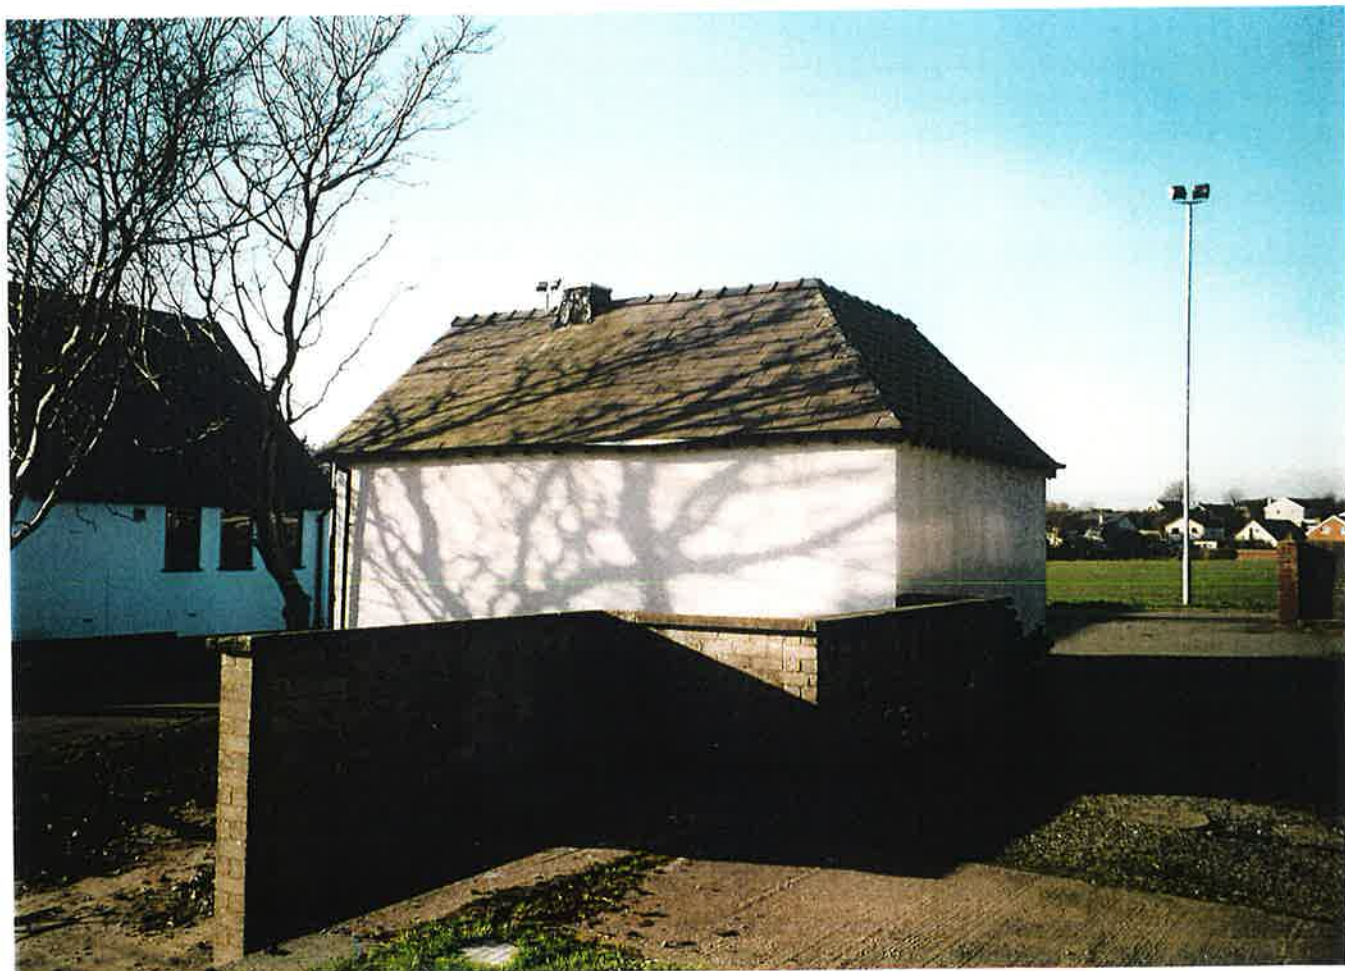
Eryri Hospital Mortuary - Building No. 6, recorded on site by the OS in 1918

Plate 31 *above*: North elevation & Plate 32 *below*, south and east elevations.

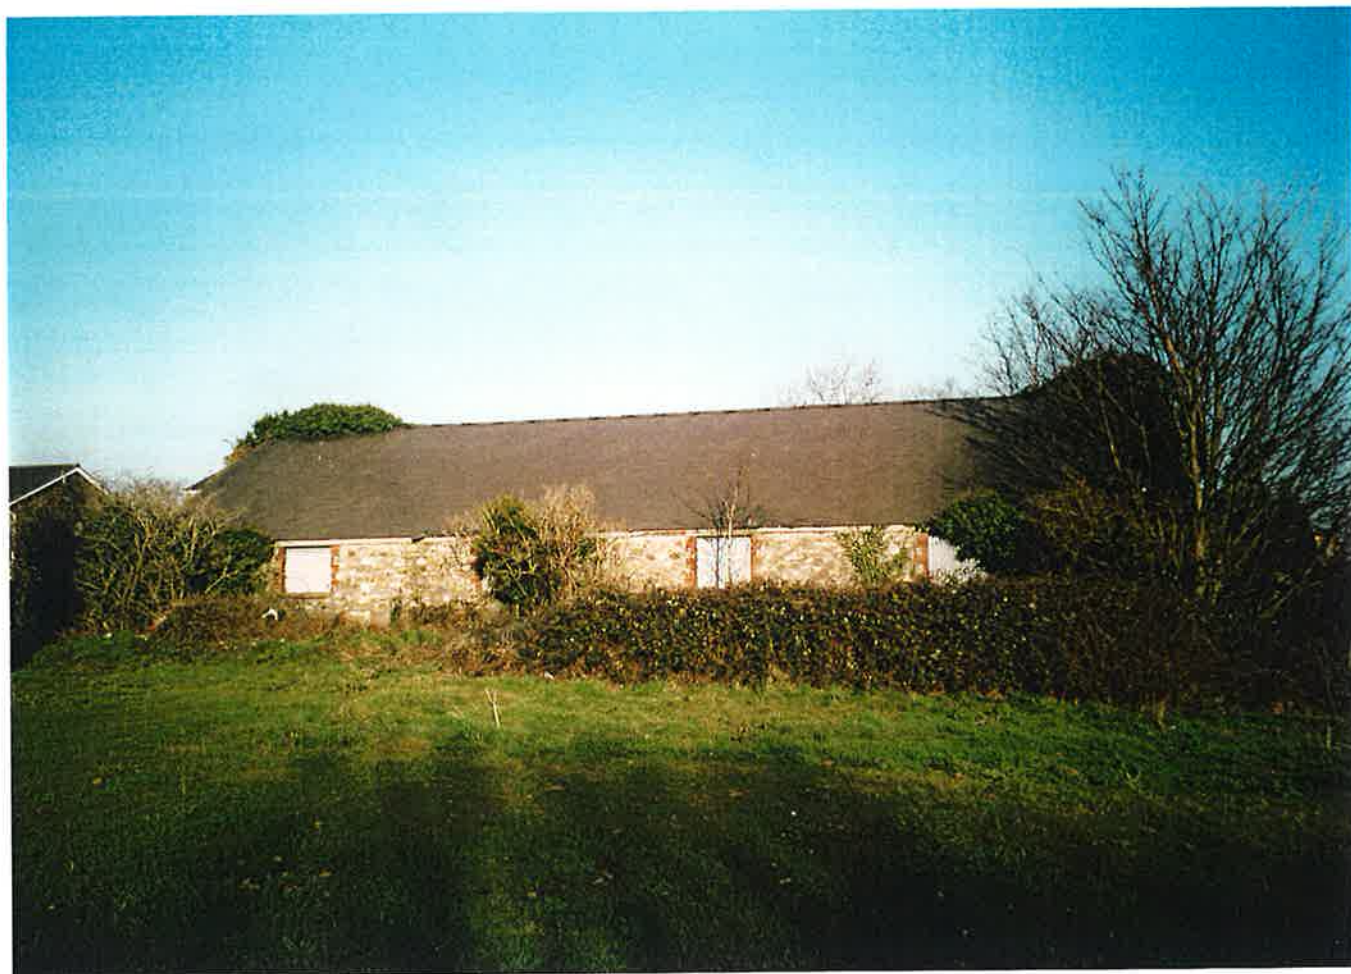
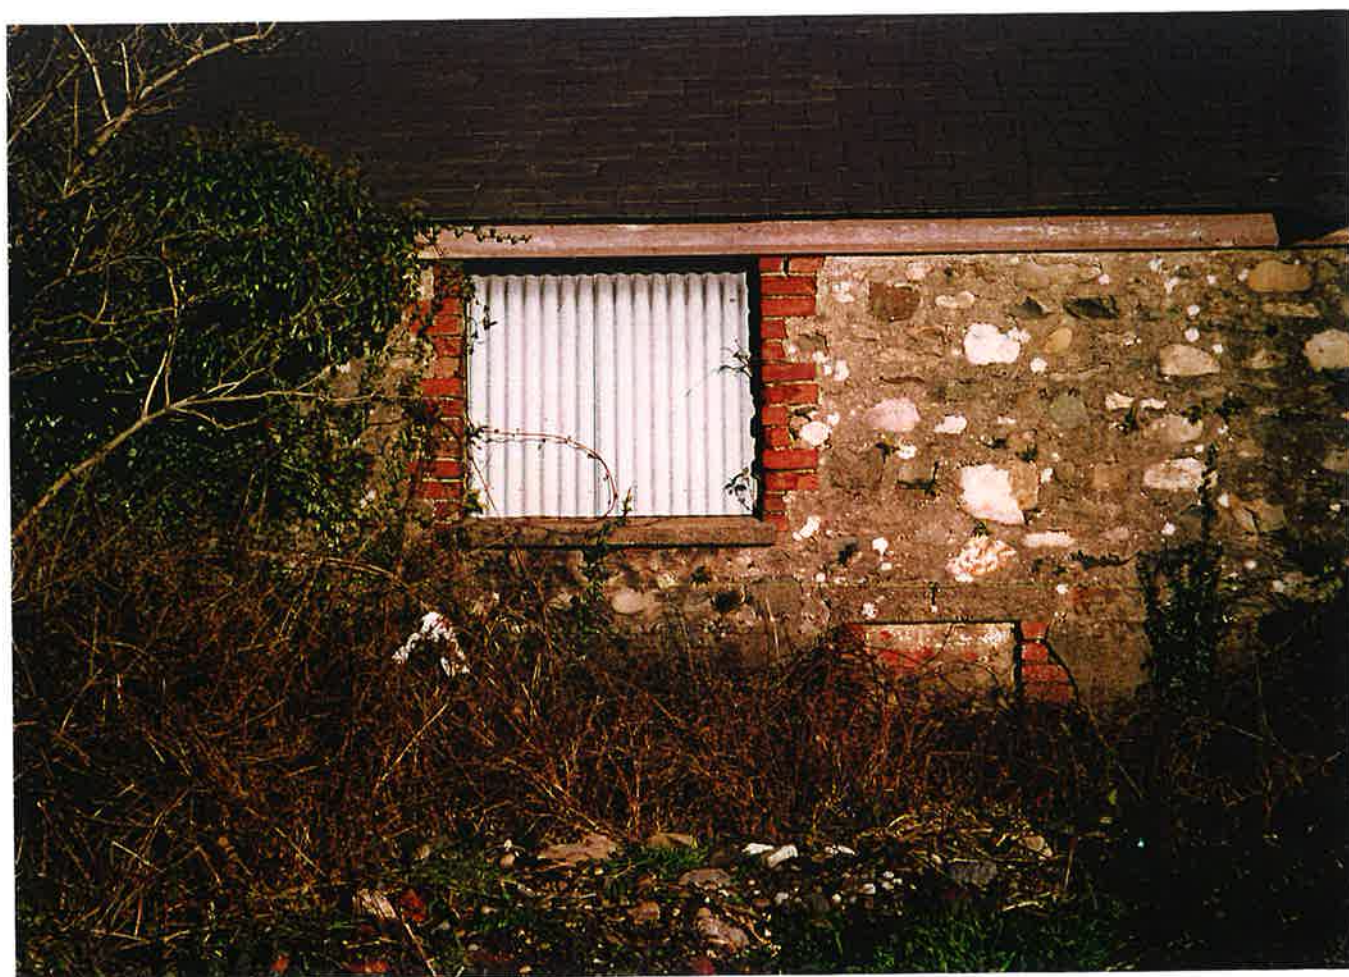
Piggeries - Building No. 7, recorded on site by the OS in 1900

Plate 33 above: West elevation & Plate 34 below, sample detail of window & pig hatch.

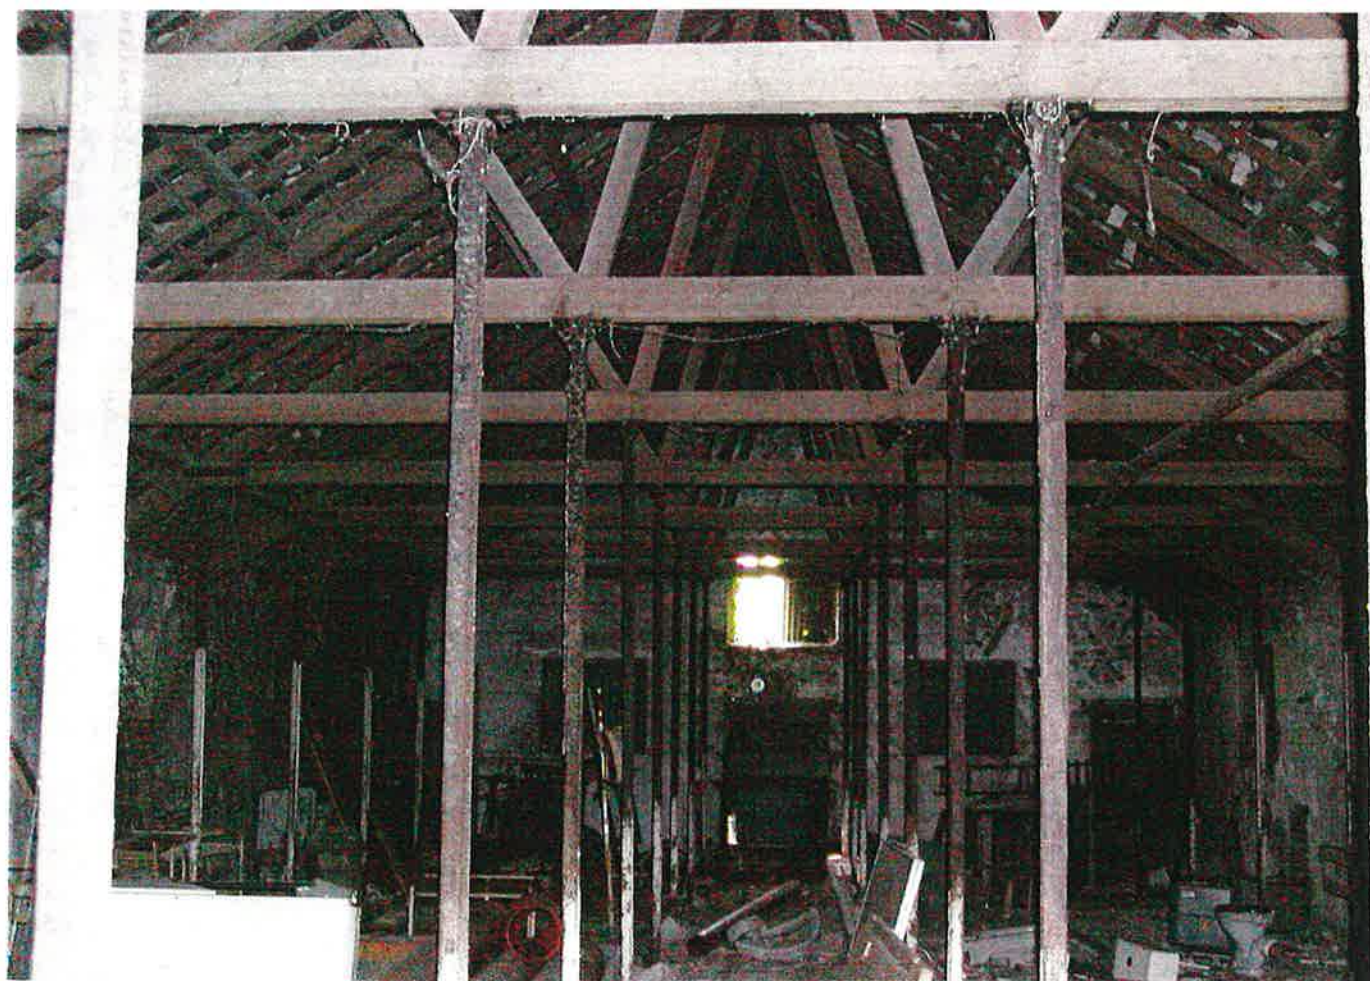
**Plate 35** *above:* Piggeries, internal view from the north.
