***Land at Cae Clyd, Manod, Blaenau  
Ffestiniog***

***Archaeological Recording and  
Desktop Study***

***February 2013***

***EAS Client Report 2013/03***

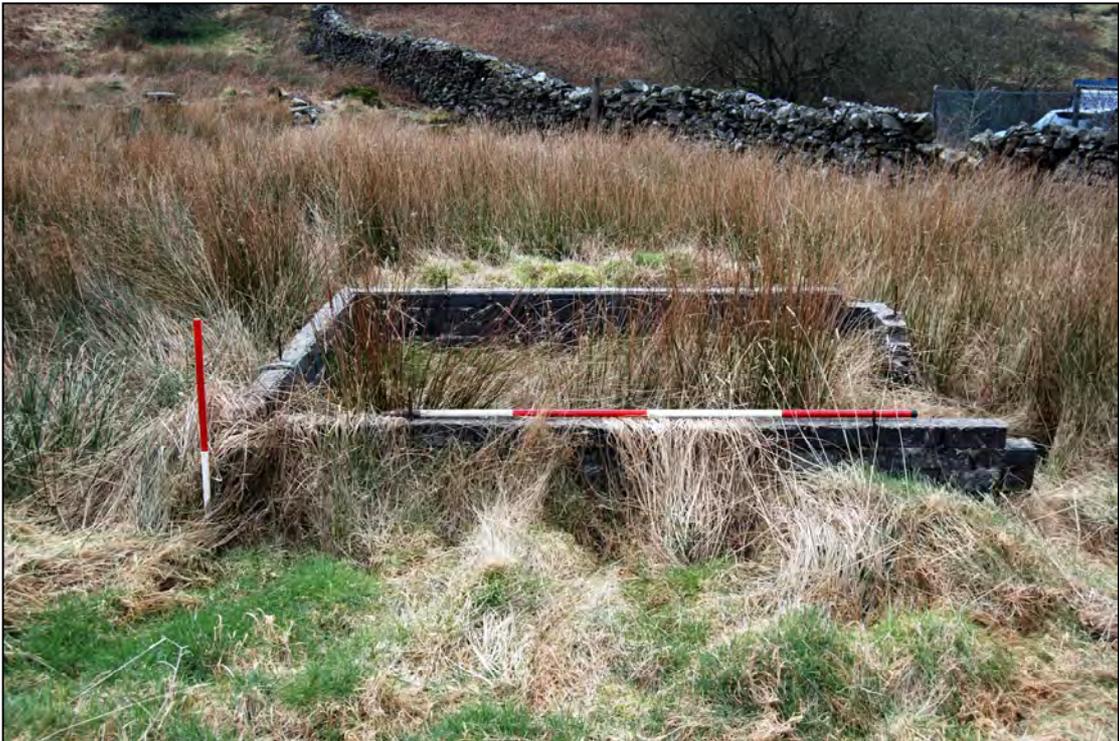
Plate 2: Brick built building base (PRN 36503)

In the north western corner of the development is the base of a rectangular building (Feature A, Figure 10, Plate 2). This consists of a single skin, brick, dwarf wall on concrete footings defining a building 3.1 x 2.33 m in size. Standing to a height of four courses, there are a series of metal pins in the top surface suggesting that there was a wooden superstructure resting on the walls. The form of this building is reminiscent of a green house, however no signs of broken glass was noted around this building. This feature is clearly later than the others on the site and has been given the PRN number 36503.

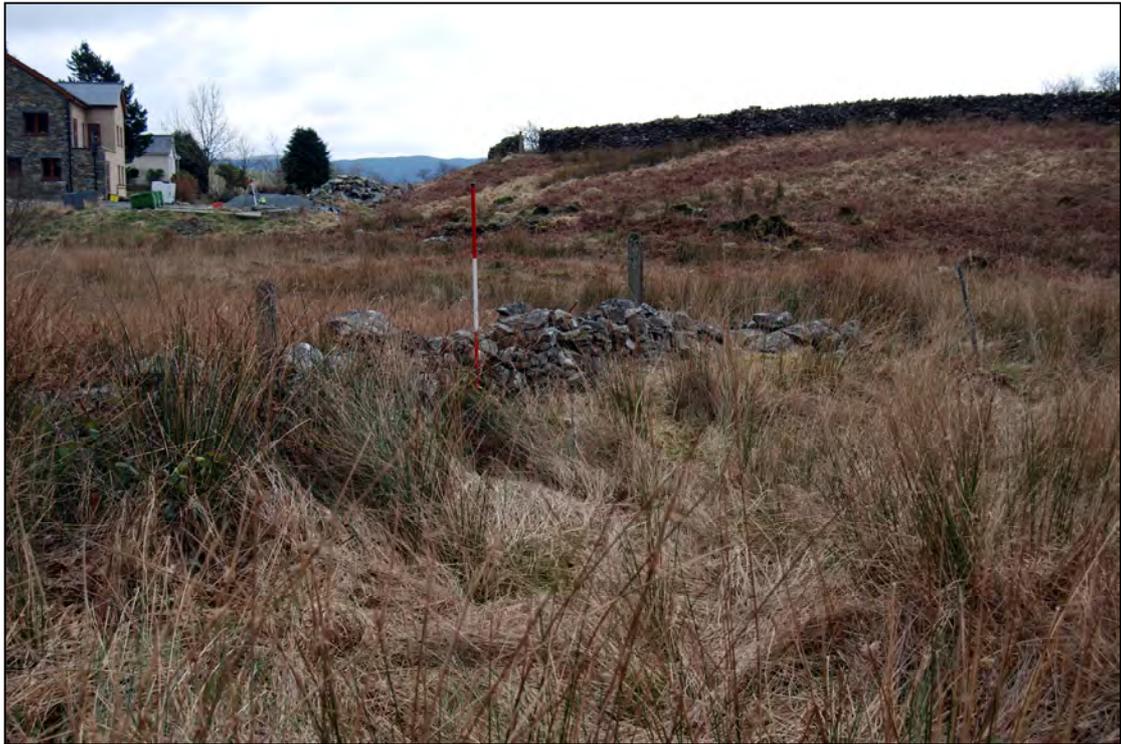
Plate 3: Wall C, looking SE

A small enclosure occupies the north western corner of the development area (Features C, and F, Figure 10) defining an area of 34.4 x 19.2 m. This has been assigned the PRN number 36502. The

walls defining this enclosure are of dry stonework and now stand to only a few courses (Plate 3) in some places. The enclosure crosses the silted ditch which drains the field to the west. The relationship between the ditch and the enclosure is uncertain, superficially it would appear that the southern end of the enclosure may be later than the ditch, however given the nature of the remains this is not certain. Whilst Wall C corresponds with a boundary shown on the Ordnance Survey maps, Wall F is on a different alignment suggesting a re-organisation of the complex after 1919. There are three spreads of stone attached to the walls of this enclosure. Feature D is a rectangular platform 1.4 x 2.6 m in size standing approximately 0.3 m above the background (Plate 4). No features on the Ordnance Survey maps could be related to this feature. The spread of stone to the north of the ditch (Feature E, Figure 10) (Plate 5) partly suggest that the northern side of the ditch may have been revetted, however there is also a feature on the 1919 Ordnance Survey map which may correlated with this feature. The wall of the southern end of the enclosure (Wall F) runs into the stone spread (Feature E), crossing the ditch as it does so.

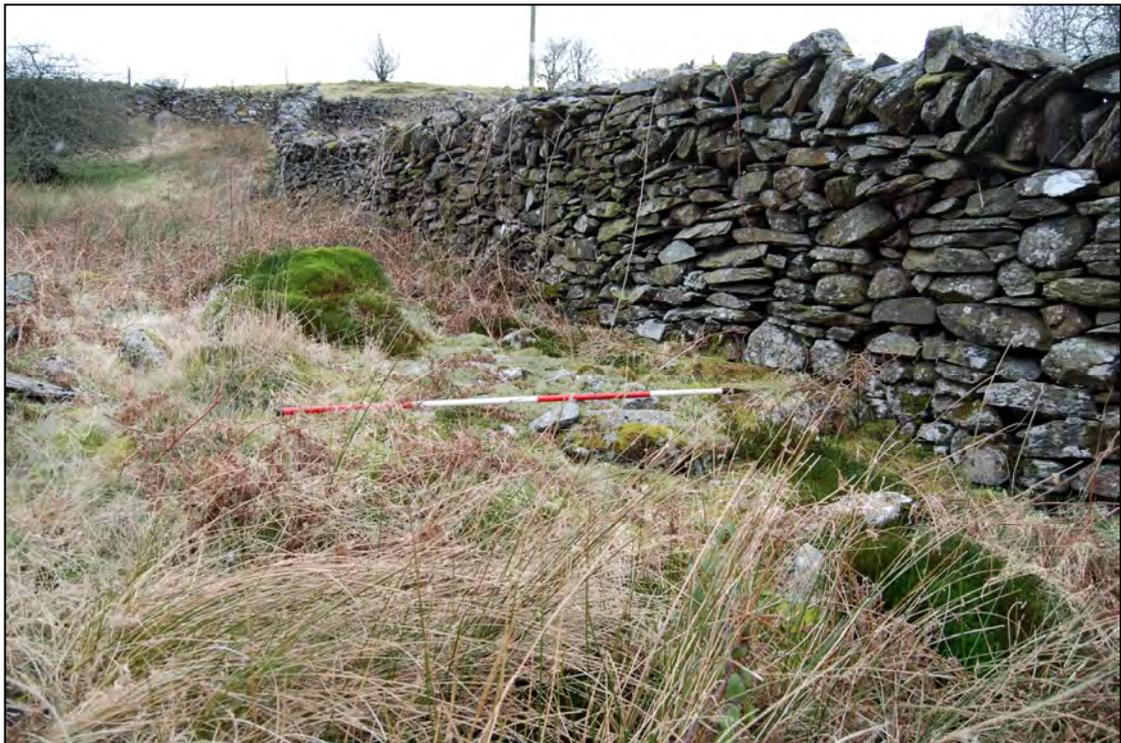
Plate 6: Platform G, looking south

Another platform (Feature G, Figure 10) (Plate 6), is a sub-rectangular platform approximately 4.8 m x 3.0 m in size. Now a tumble of stones, this feature appears to correspond with small building shown on the 1901 Ordnance Survey map and a small enclosure on the 1919 map.

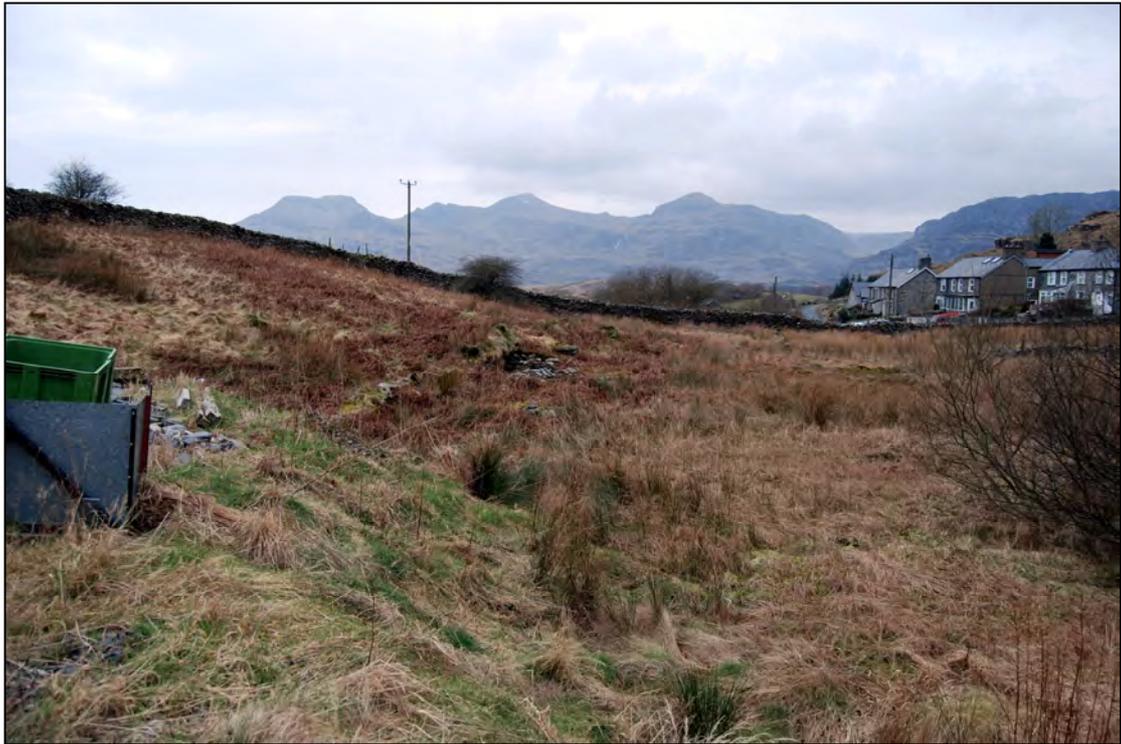
Plate 7: General view of the structures revetted into the hill slope, looking SW

A range of at least four small structures, linked by a revetting wall occupies a band across the development area (Plate 7). These have been grouped together as PRN 36501 as they are clearly part of a single phase of use. Feature H (Figure 10, Plate 8) was a small structure, probably a building, 3.0 x 3.2 m in size.

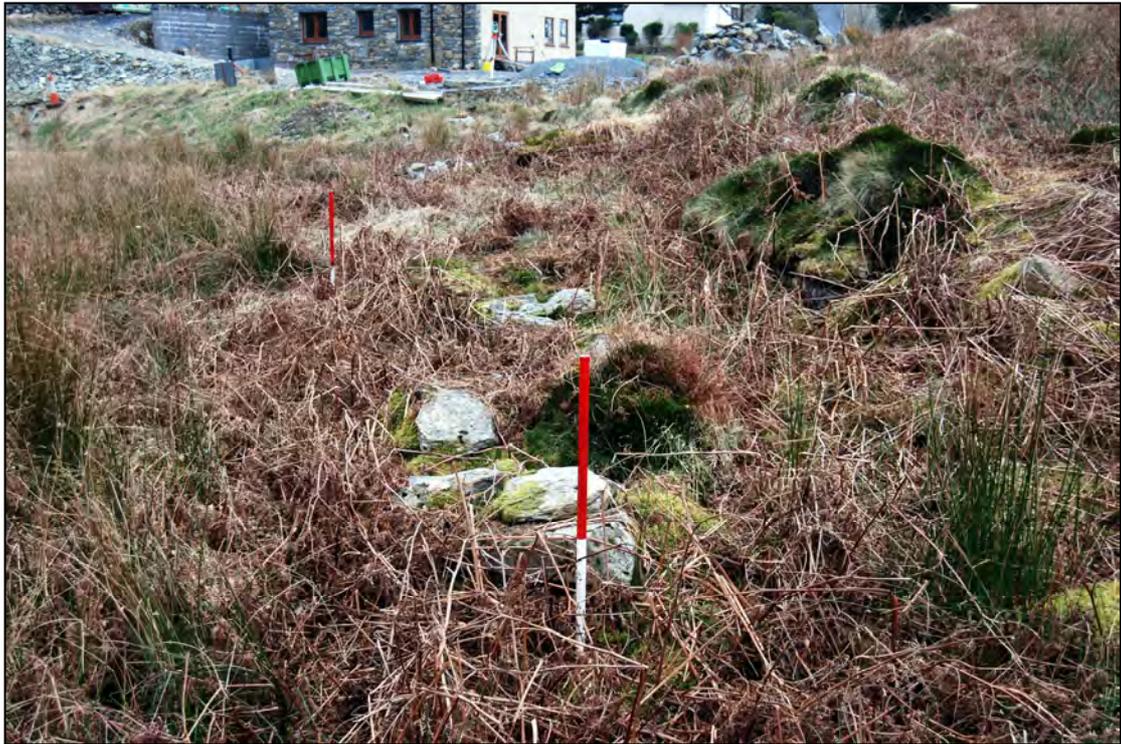
Plate 9: Structure I looking ESE

Structure I, appear to have been a small roofed building 3.3 x 2.3 m in size, with an open pen to the west (Plate 9). This is linked to Structure J by a distinct scarp in the hillside which was probably originally revetted with a dry stone wall. Structure J is the best preserved of the remains in this group. There is a central rectangular feature which was probably a roofed building (Plate 10) 2.3 x 2.7 m in size. This had at least two open pens attached, one to the east 2.3 m square (Plate 11), and another to the north which is more difficult to determine, although the 1901 Ordnance Survey map suggest there may have been a complex of small enclosures attached to the north of the building. Both the probable building and the pen to the west are attached to a dry stone wall revetting the hill slope (Feature L, Figure 10). The walls are integrated with each other suggesting they are part of a single phase of construction.

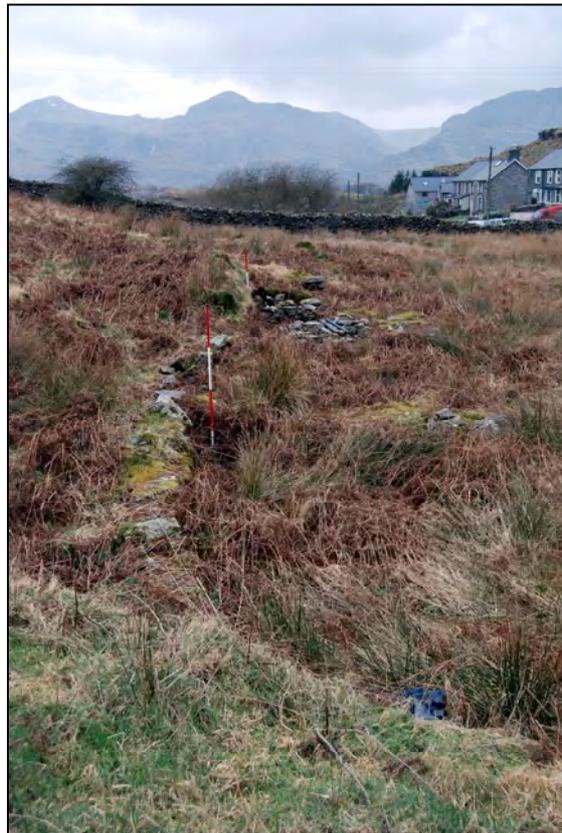
Plate 12: Feature M and Retting Wall L, looking WNW

The remains of an “L” shaped wall defined Structure M (Plate 12). This appears to be attached to the remains of a field boundary (Feature K) running in to the wet ground to the north where it is lost in vegetation.

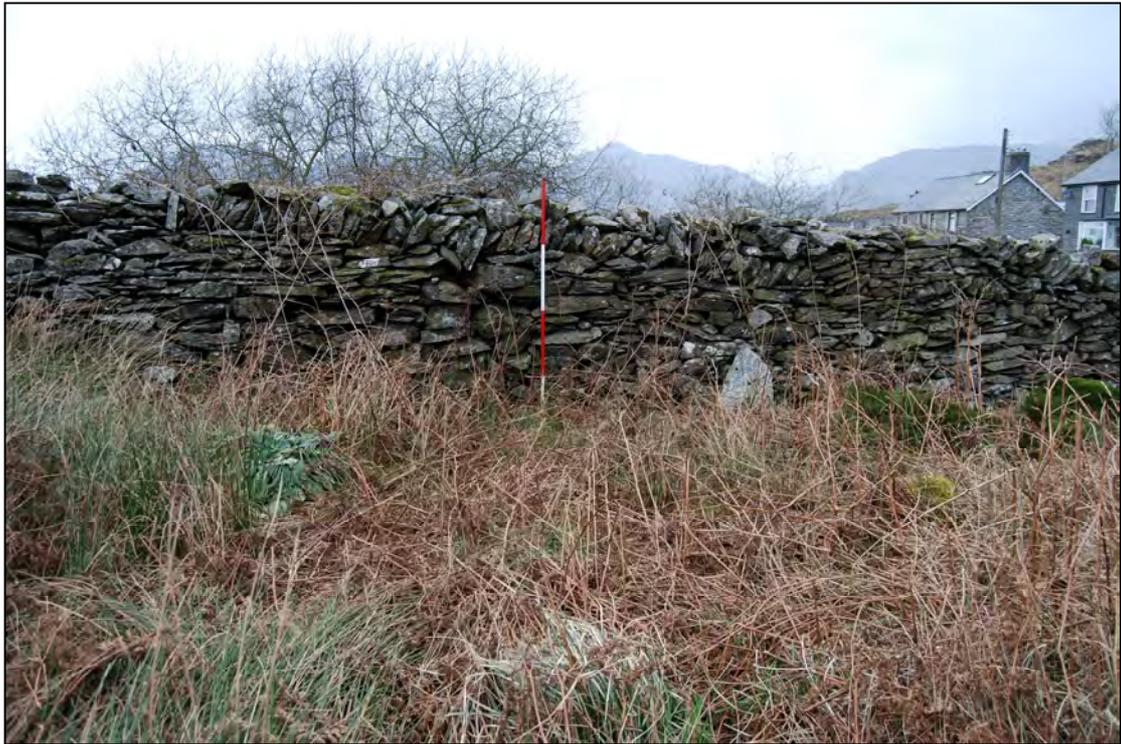
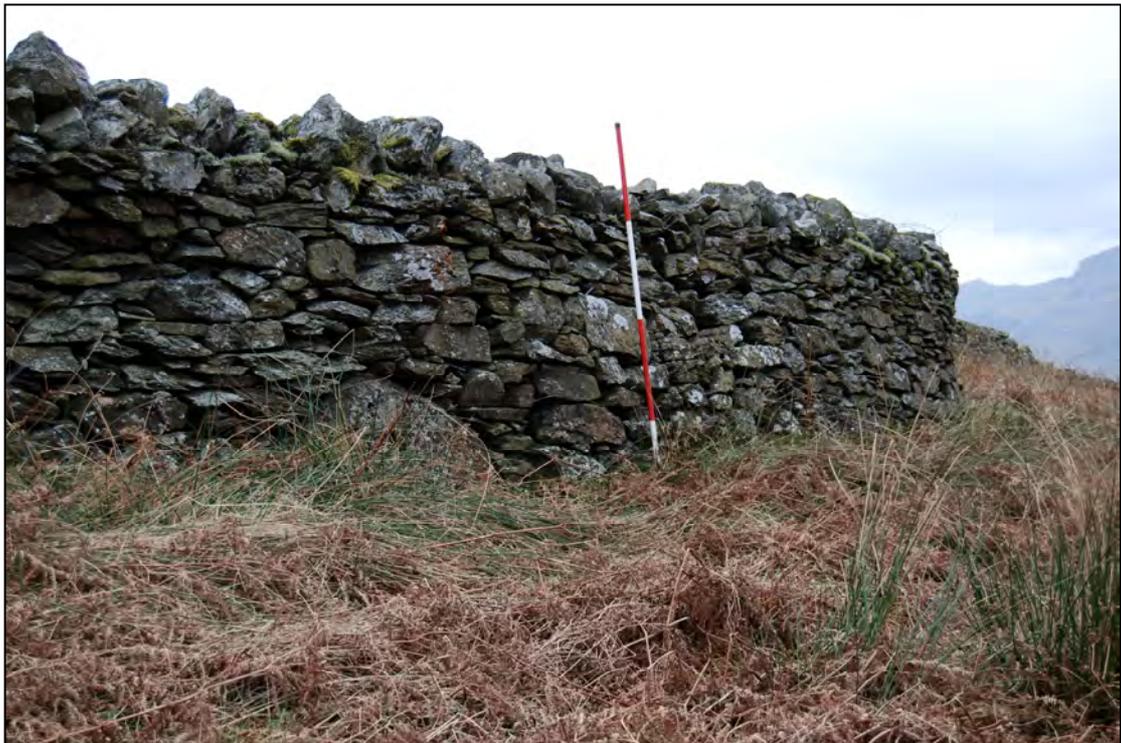
The other three sides of the development area are defined by dry stone walls. Those to the south and west (Walls N and O, Figure 10) (Plates 13 and 14) appear to be of a single build. They stand to a height of 1.7 m with pitch stone coping in places. Wall P (Plate 15) divides the plot from the road to the north. There is no sign of any opening in this wall except for the opening at the western end which would appear to be a secondary feature. This would suggest that there was no access to the small buildings shown on the 1901 Ordnance Survey map from the north and therefore it is less likely that these buildings were related to the houses of Tai-isaf. The boundary wall have been grouped under the PRN number 36504

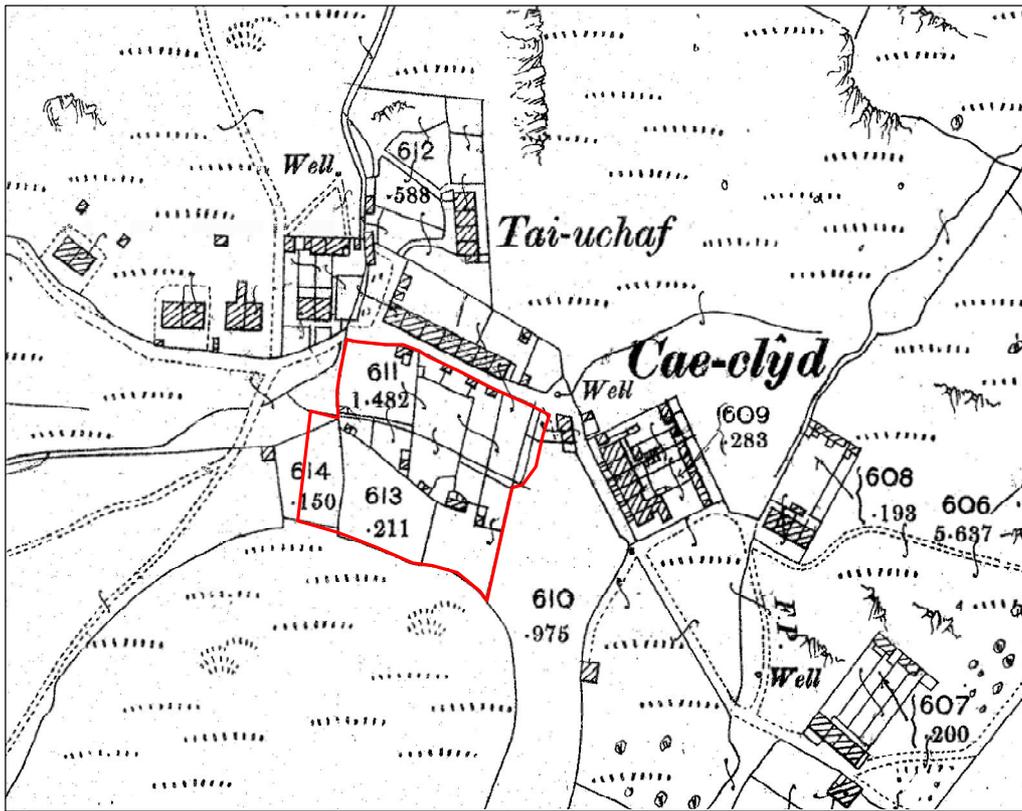
Figure 7: Extract from the Ordnance Survey  
Second Edition Merionethshire IV.14 Map 1901  
Scale 1:2500

associated structures within the development area. More detail is seen on the Second Edition 1:2500 map of 1901 (Figure 7). This shows the series of small fields and associated structures in more detail. There are a series of four roofed structure along the northern boundary, one of which has an associated pen. Initially they would appear to be possible outside toilets (Ty Bach) associated with Tai-isaf, however there are only three structure which could serve this function for the seven cottages. These structures are also located towards one end of the terrace. There are also a series of five roofed structures shown in the southern half of the plot. These all have associated open pens and are therefore likely to have been animal pens. It would seem likely that all of the structures shown within the development area are probably associated with the housing and control of animals.

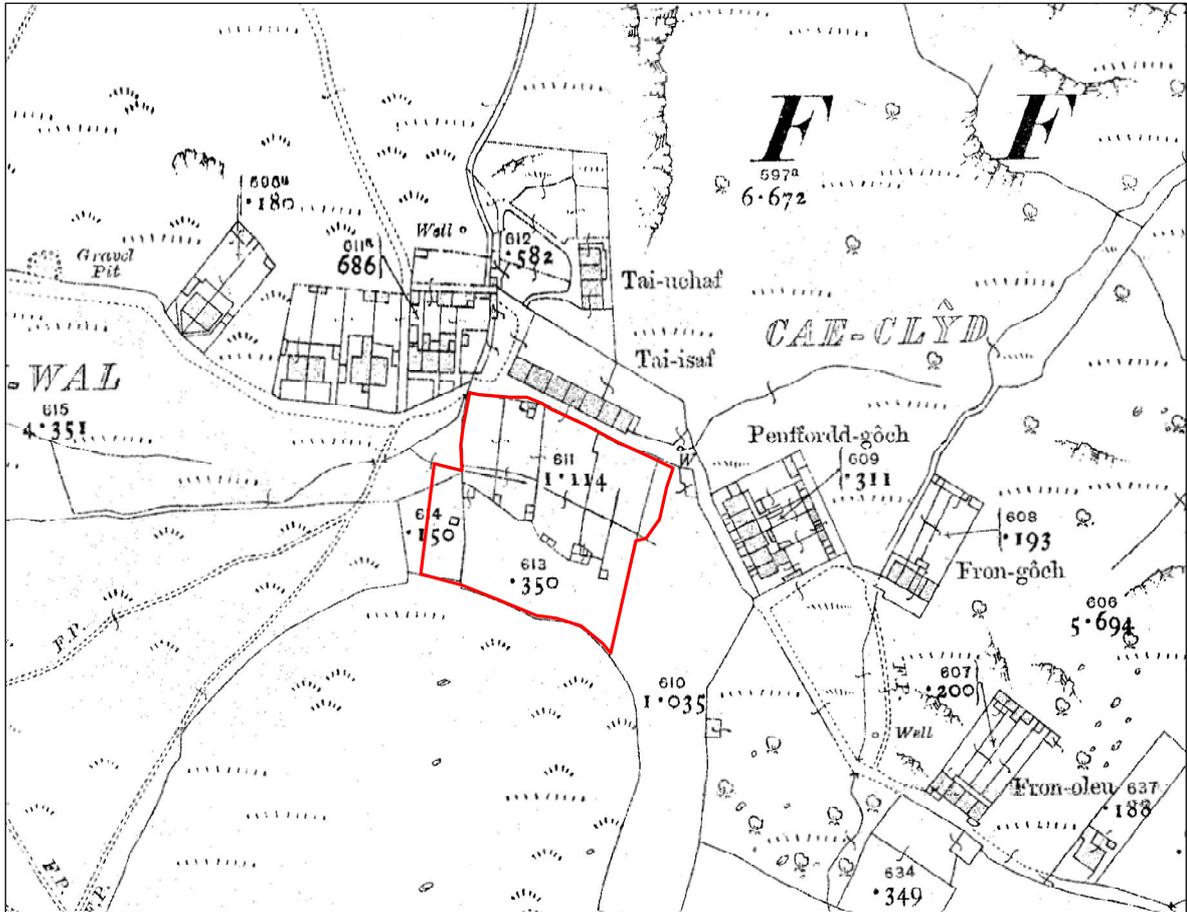
Figure 8: Extract from the Ordnance Survey  
Merionethshire IV.14 Map 1919  
Scale 1:2500

The layout shown on the Second Edition mapping would appear to be relatively short lived. By 1919 and the subsequent mapping by the Ordnance Survey (Figure 8) the field system and its associated buildings are already going out of use. The small structures along the northern boundary are already missing and the structures in the southern half of the development area now appear to be roofless. Some of the field boundaries are also missing. The only building to retain its roof is the building associated with a small pen on the northern boundary.

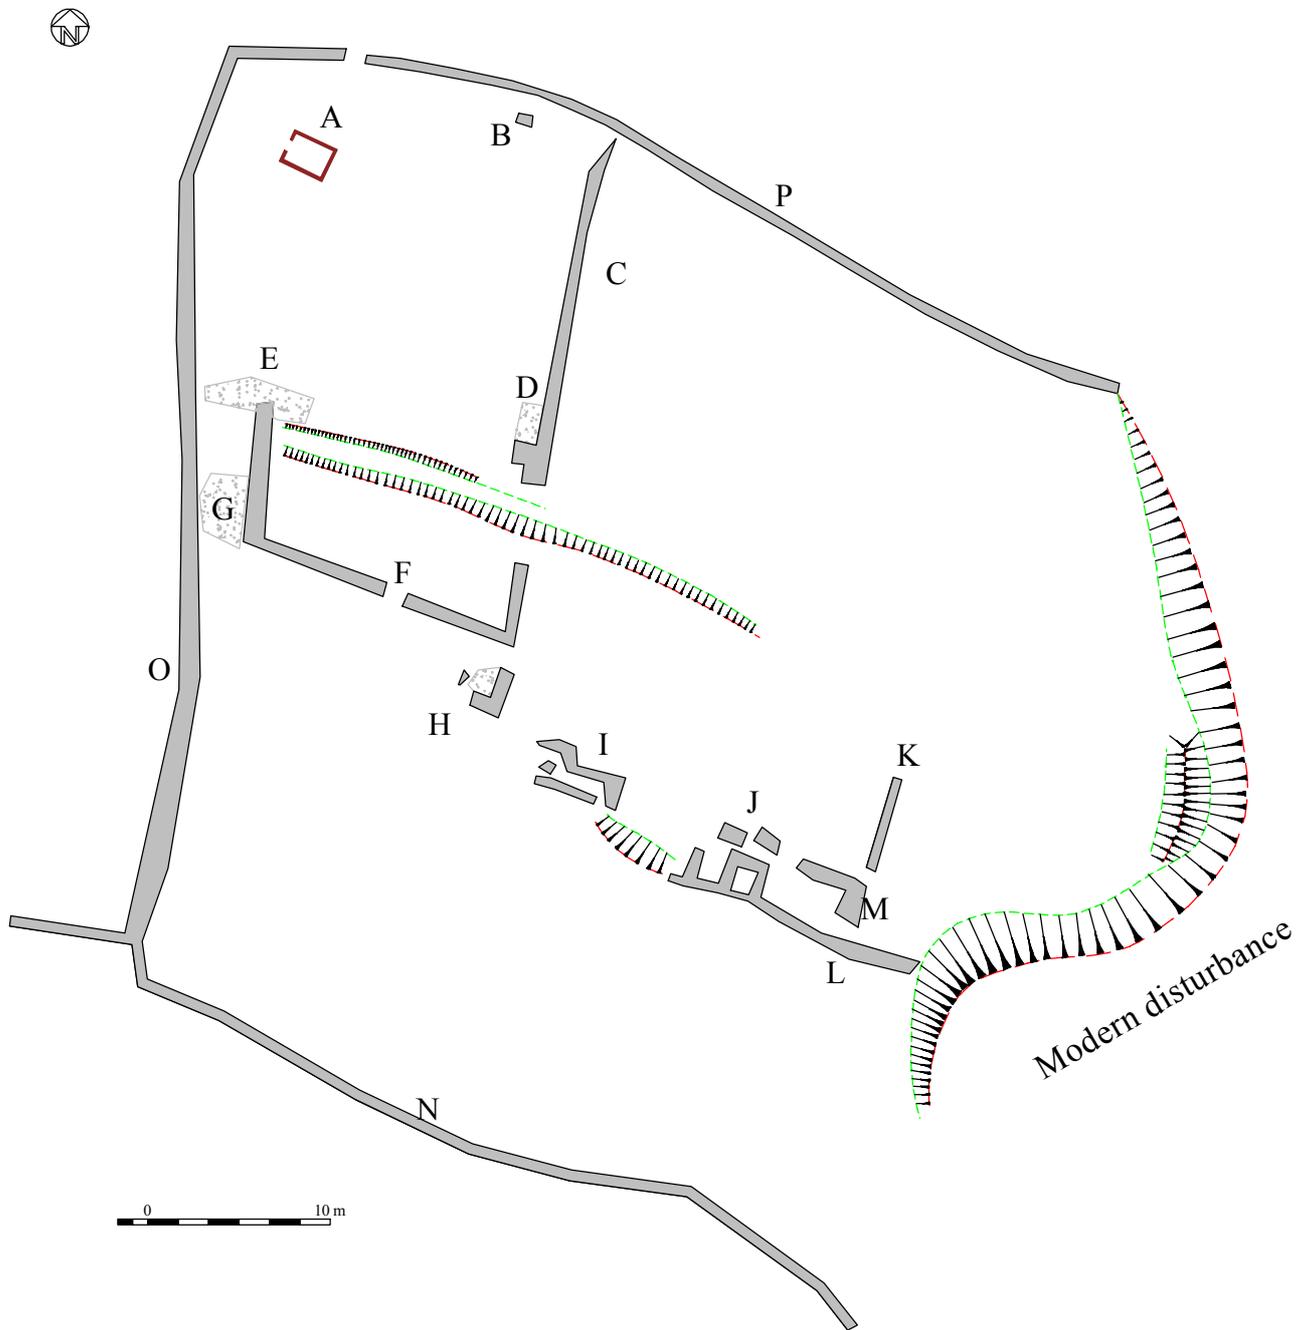
Figure 10: Plan of the Site  
Scale 1:500

The topographic survey located and recorded a number of features within the proposed development area. Most of these are rather ruinous, rarely standing above a few courses of stonework. The features located broadly correspond with those shown on the Ordnance Survey maps of 1901 and 1919, however there are two feature that do not directly correspond to the mapped features. The results of the topographic are shown on Figure 10 with the background contours on Figure 11. The features have been grouped into four groups and for each of these groups a PRN number has been assigned (Figure 13).

Little survives of the buildings shown along the northern boundary on the 1901 Ordnance Survey map with the exception of a single large stone (Feature B, Figure 10) which corresponds with the western building with an attached pen.

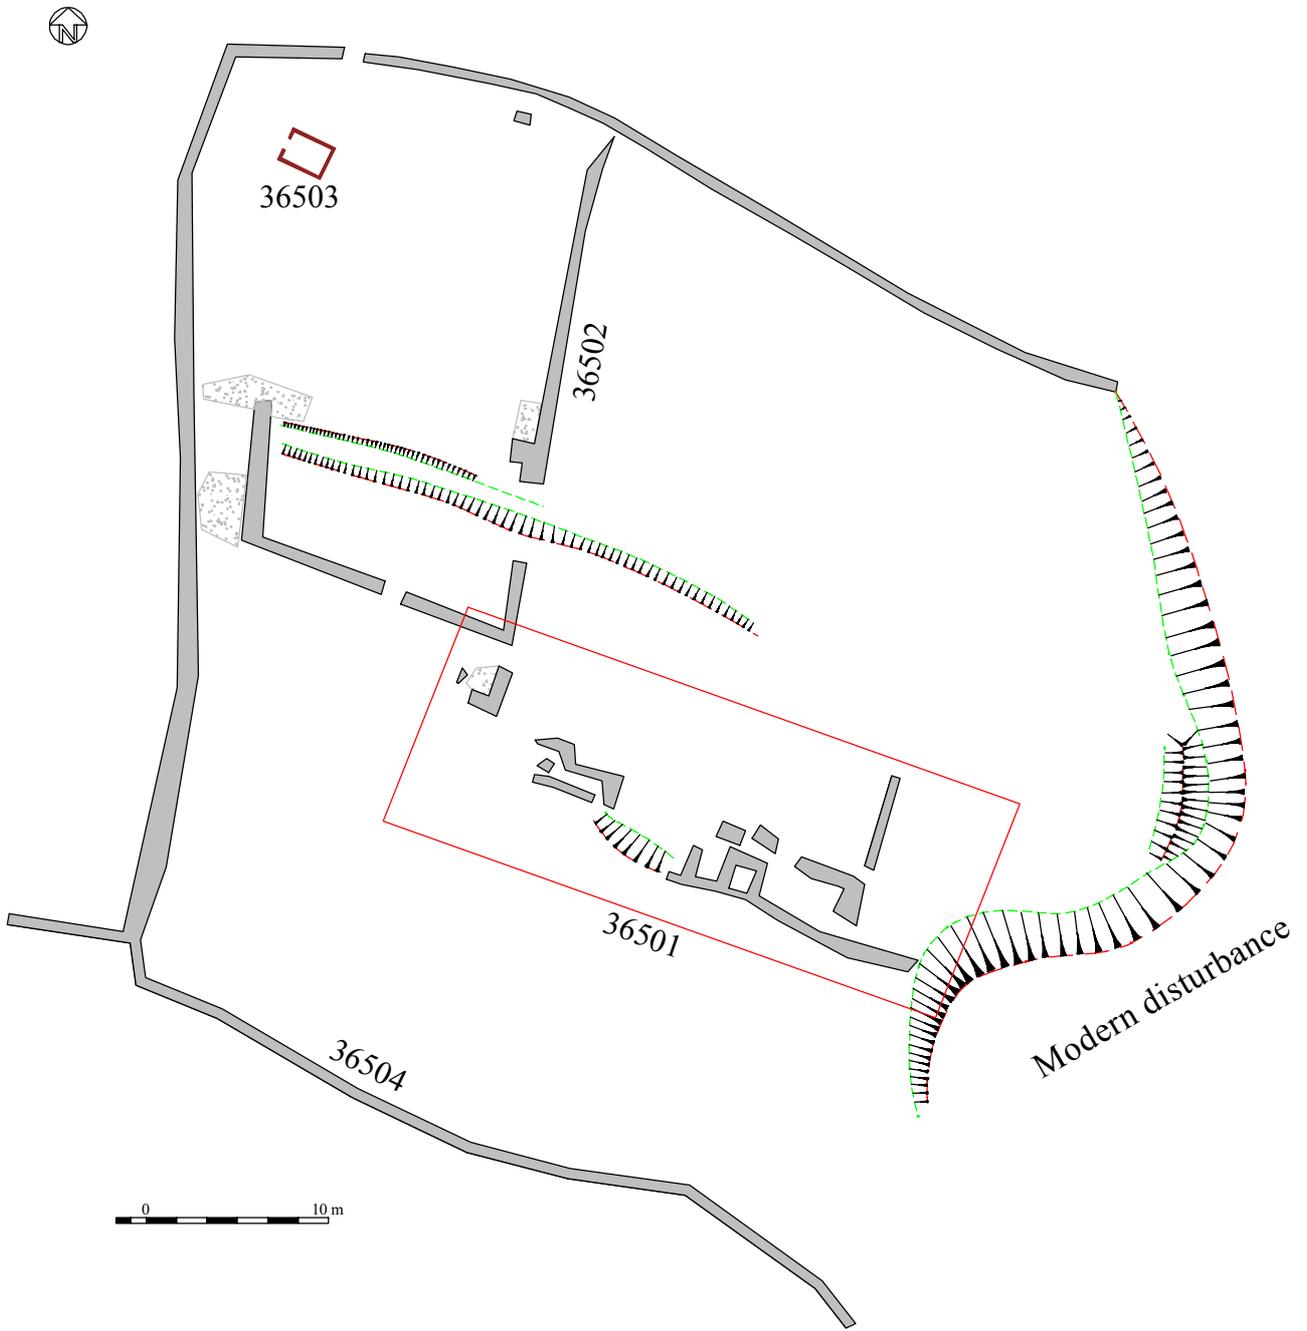
Figure 13: PRN Numbers  
Scale 1:500

All of the features associated with this group have been assigned the PRN Number 36501 (Figure 13) are shown on the 1901 Ordnance Survey mapping. They appear to represent a series of small roofed buildings with associated pens and field boundaries. The style of the building would suggest that they may have been for pigs, being too small for cattle and including small roofed
