# **North West Wales Dendrochronology Project Llanerch y Felin, Rowen, Conwy NPRN 26709**

**EAS Client Report 2012/11  
December 2012**

# **Llanerch y Felin, Rowen, Conwy**

**By  
I.P. Brooks**

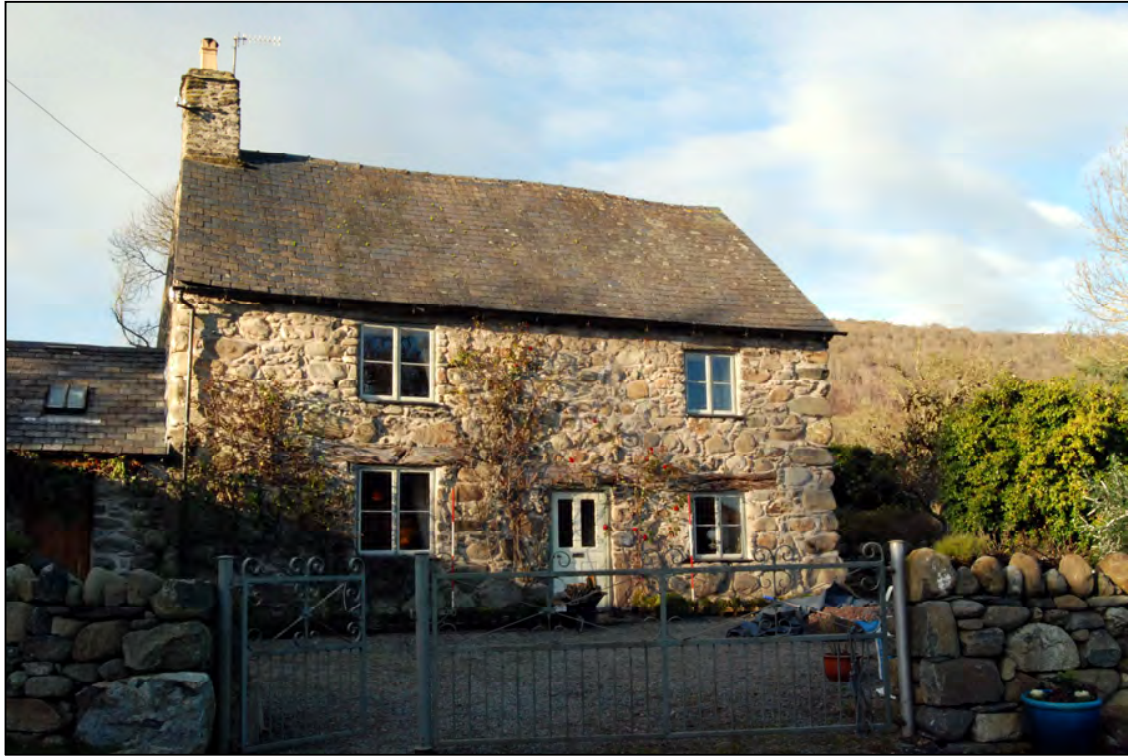
Plate 1: Front elevation

The front elevation (Plate 1) has modern replacement windows occupying earlier openings. The lower openings all have large oak lintels (Plates 4 – 6). These are arranged at slightly different levels with each of the lintels being slightly lower to the south. The lintel over the centrally placed front door (Plate 5) extends noticeably to the north suggesting that the original opening was much wider. This view is supported by the narrowness of the wall to the north of the doorway (Figure 3).

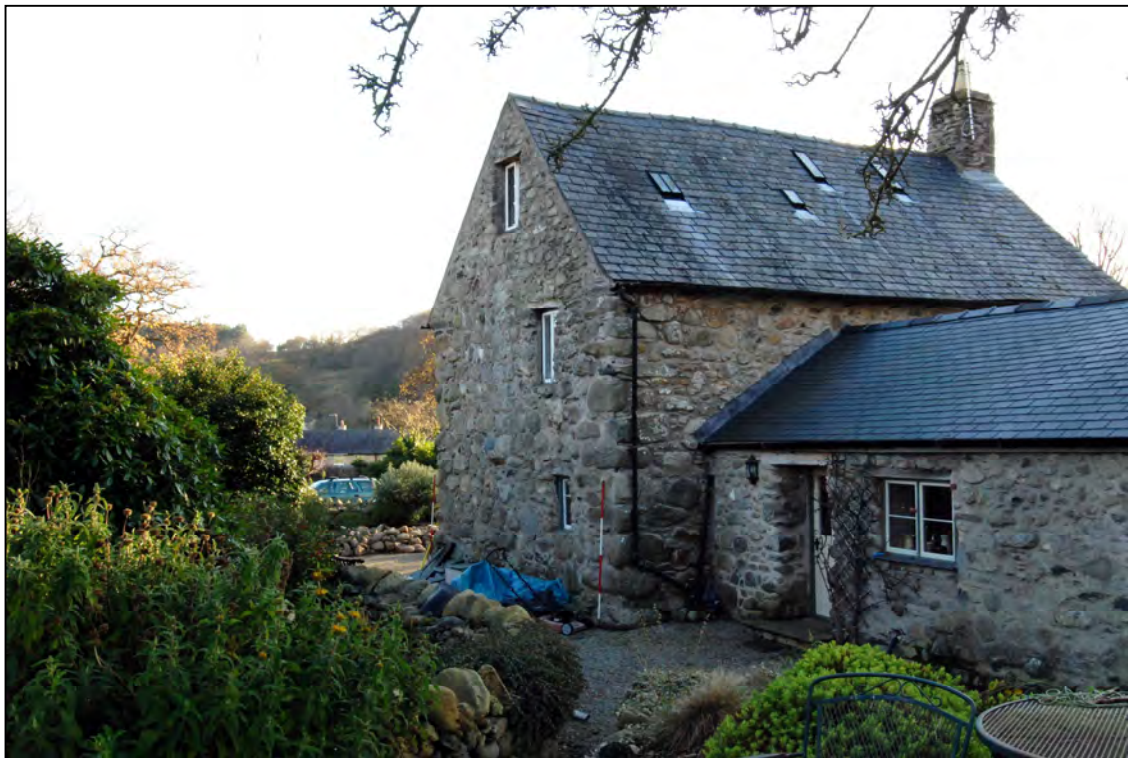
Plate 2: The northern gable end

The northern gable end has three window opening, each lighting a different floor. Once again these contain modern replacement windows, although they are probably in earlier openings. There is a marked bulge in the wall at first floor level associated with the window which might suggest this window may have been replaced.

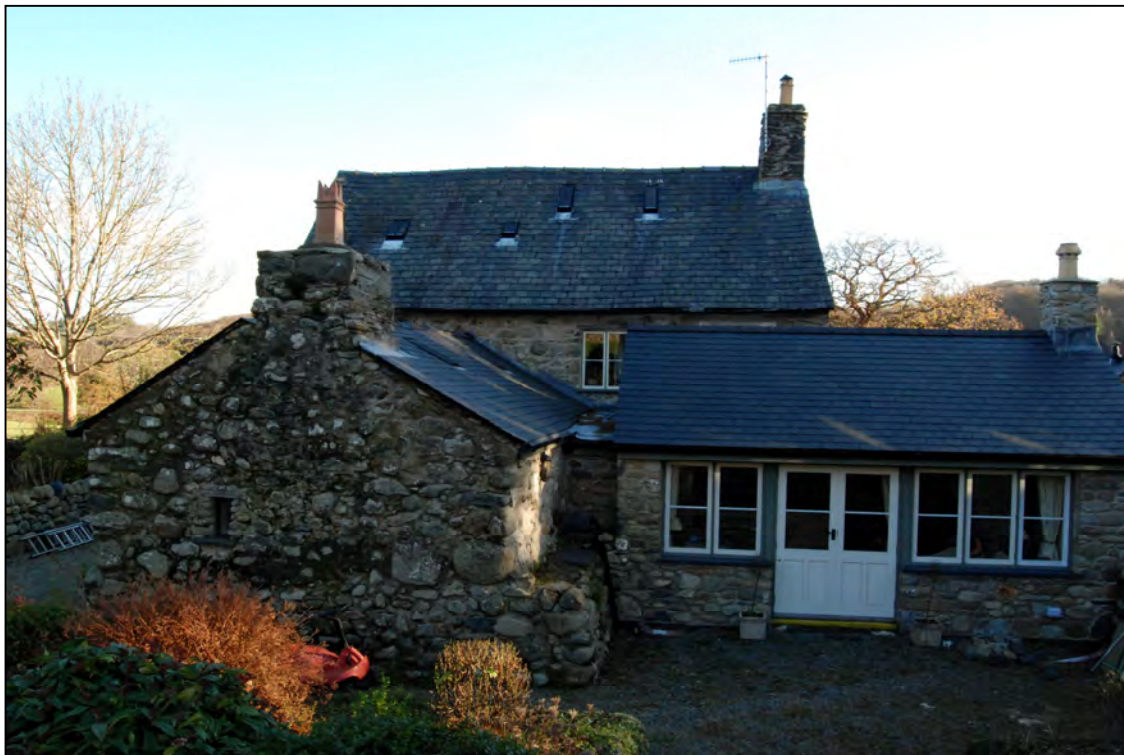
Plate 7: The rear elevation

The rear of the building is largely masked by later extensions (Plate 7), although a single window giving light to the first floor landing is visible (Plate 8). This has a slightly twisted oak lintel, although the window itself has been replaced.

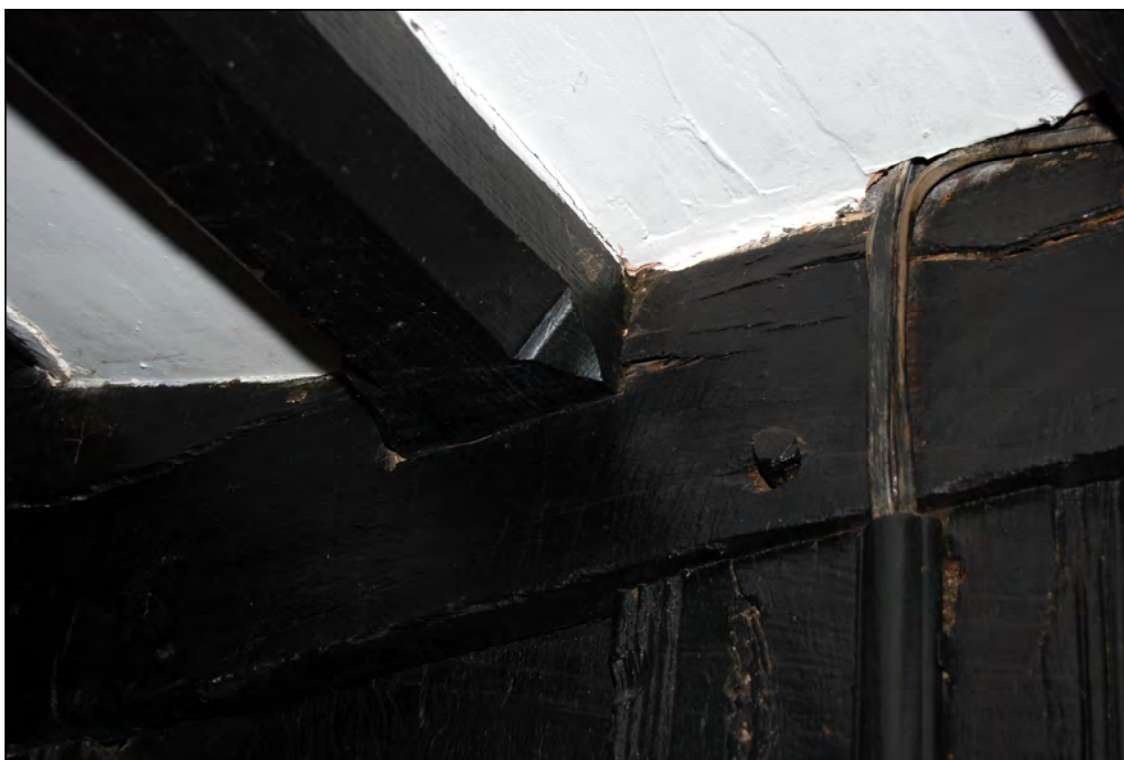
Plate 12: Stop on a joist in the ground floor hall

On the ground floor (Figure 3) the house is divided into two rooms by a post and panel partition. To the south is a ground floor hall. This is dominated by large open fireplace with a heavy bressumer (Plate 9) which extends from the eastern wall of the house to the edge of the partially blocked stair to the west (Plate 10). Originally the site of a winding mural stair adjacent to the fireplace, it was partly cut into the western wall and southern gable. The opening for this feature is braced with a diagonal beam from the end of the bressumer to the western wall of the house. The staircase can be traced in the structure of the house leading to the attic suggesting that at least one end of the first floor was ceiled. The ceiling of the ground floor hall has a central beam which is moderately chamfered and has straight stops (Plate 11). The joists, however, are also chamfered, but have ogee stops (Plate 12) and are coggd into the main beam.

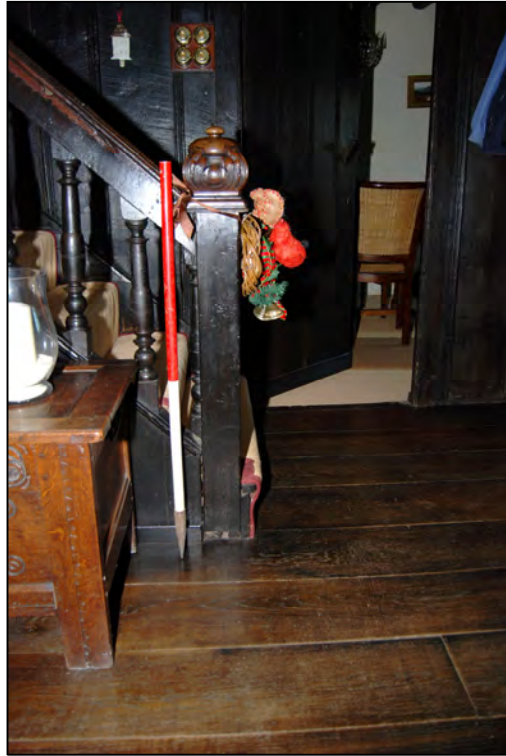
Plate 13: The ground floor section of the staircase

The original cross passage has been blocked at its western end and a replacement staircase added. This has turned balusters, a moulded rail and square newels with moulded cappings (Plate 13). The ground floor newel cap (Plate 14) is carved with acanthus leaves supporting a cushion and has a cushion shaped finial.

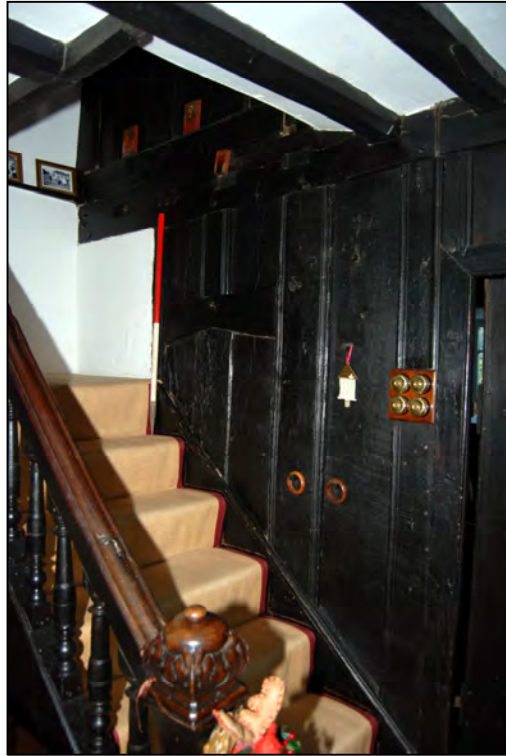
Plate 15: Doorway blocked by the staircase

The staircase blocks an original doorway in the partition between the ground floor hall and the parlour, which is now used as a dining room (Plate 15). The door head (Plate 16) has a flattened pointed arch of sixteenth century type (Alcock and Hall 1994, 20). The partition originally spanned both the ground and first floors, although on the first floor level it is now largely recorded by a series of peg holes in one of the ceiling beams. On the ground floor level, the face onto the hall has posts with reed- moulded edges (Plate 17), although the panels are plain. At the western end of the partition there are a series of stamped carpenter's marks (Plates 18 – 20) identifying each of the posts. The partition has been cut by a centrally placed, later doorway which was presumably constructed at the same time as the stairs were inserted.

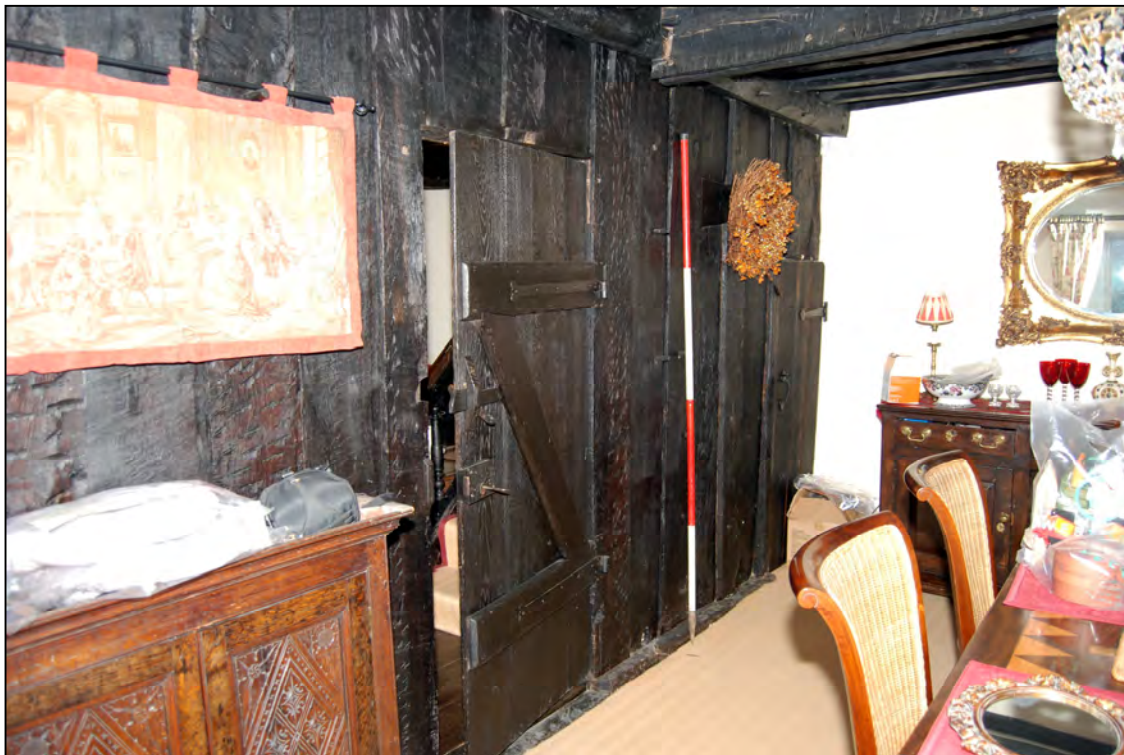
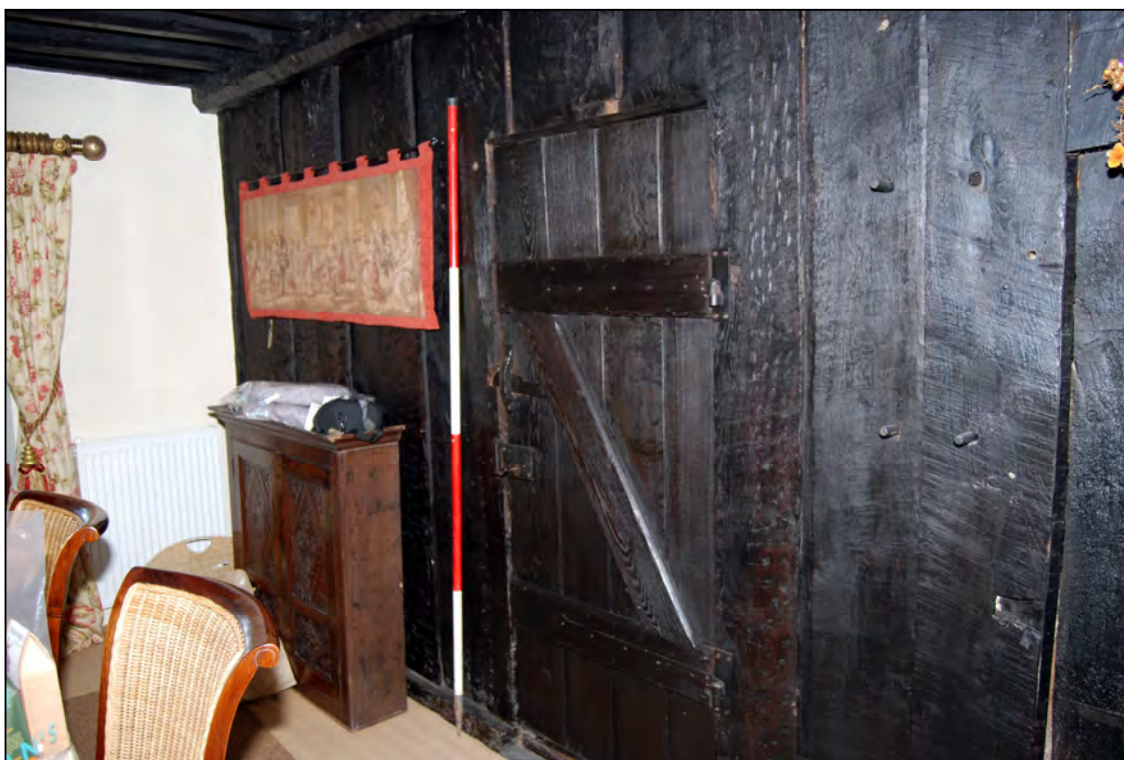
The parlour shows the back surface of the partition (Plates 21 and 22) showing the full extent of the blocked doorway (Plate 23) and a further later opening which gave access to the under stair space. What is now a single room was originally divided in two with a partition as is shown by the joist with a slot in its lower surface (Plate 24). As with the hall the joists in this room are chamfered and have ogee stops (Plate 25).

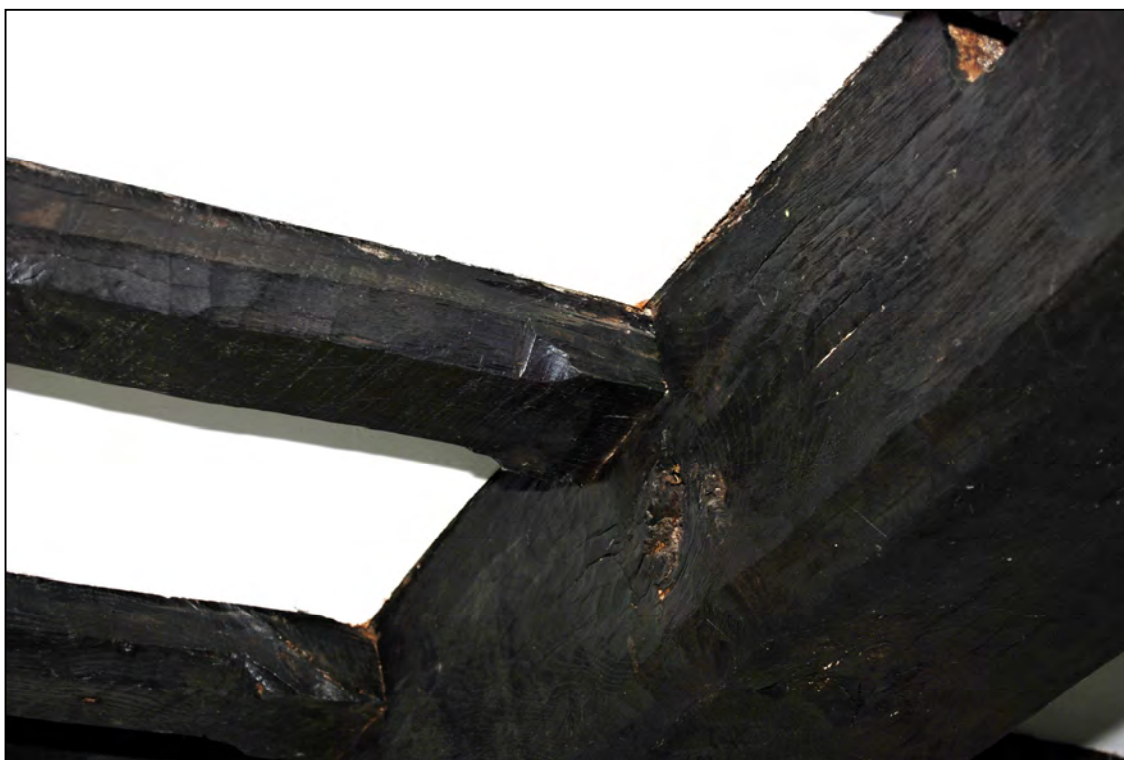
Plate 28: The joists in the bathroom

The first floor (Figure 4) now consists of three bedrooms and bathroom opening off a landing. The bathroom is in the south western corner of the house and includes the sub-circular chamber which originally held the mural staircase (Plate 26). Over this space is a ceiling beam set at an angle supporting the floor of the attic and a short spacer which defines the southern end of the rafters (Plate 27). The rafters are all chamfered and have ogee stops (Plate 28).

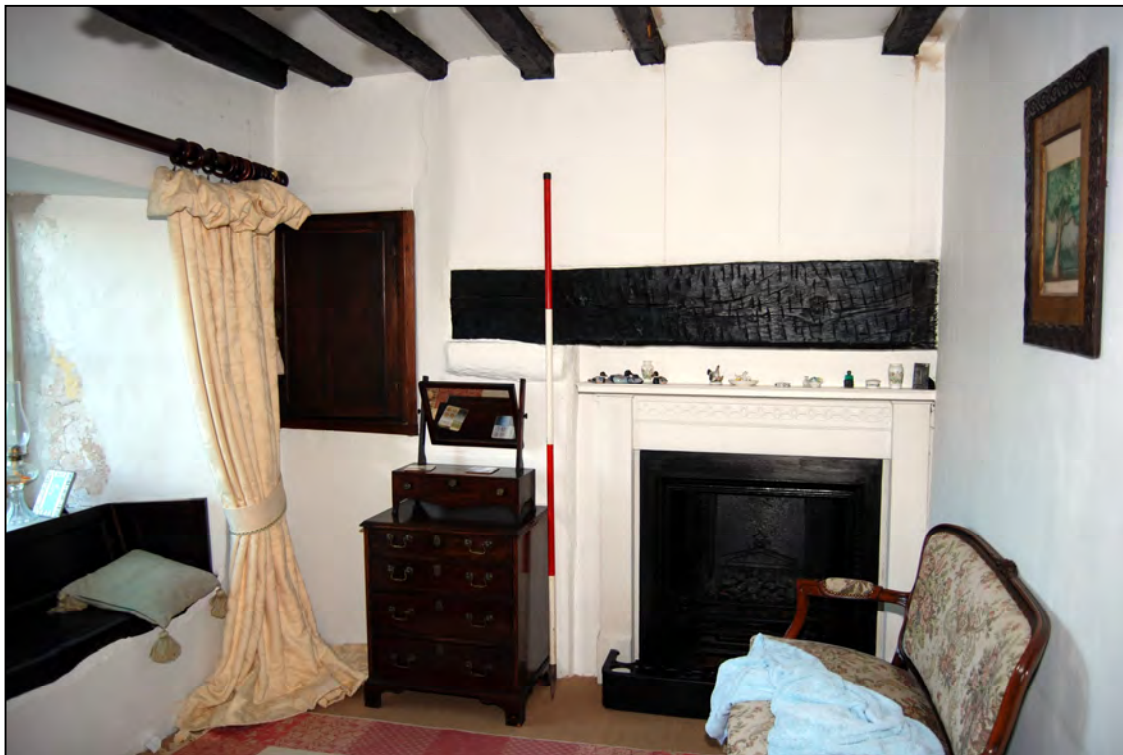
Plate 29: South eastern bedroom

The south eastern bedroom (Plate 29) has a fireplace with a wooden bressumer on its southern wall. This feature sits uncomfortably with the partition forming the western wall of the room demonstrating that this partition is a later feature. On the same wall as the fireplace and slightly to the east is a cupboard (Plate 30). This is reputed to have originally had a carved door (Chambers *pers. comm.*), although it now has much plainer furniture. The ceiling beam in this room runs through the western wall and across the landing. It is chamfered and has stepped stops (Plate 31). The associated joists are also chamfered but have simple straight stops (Plate 32).

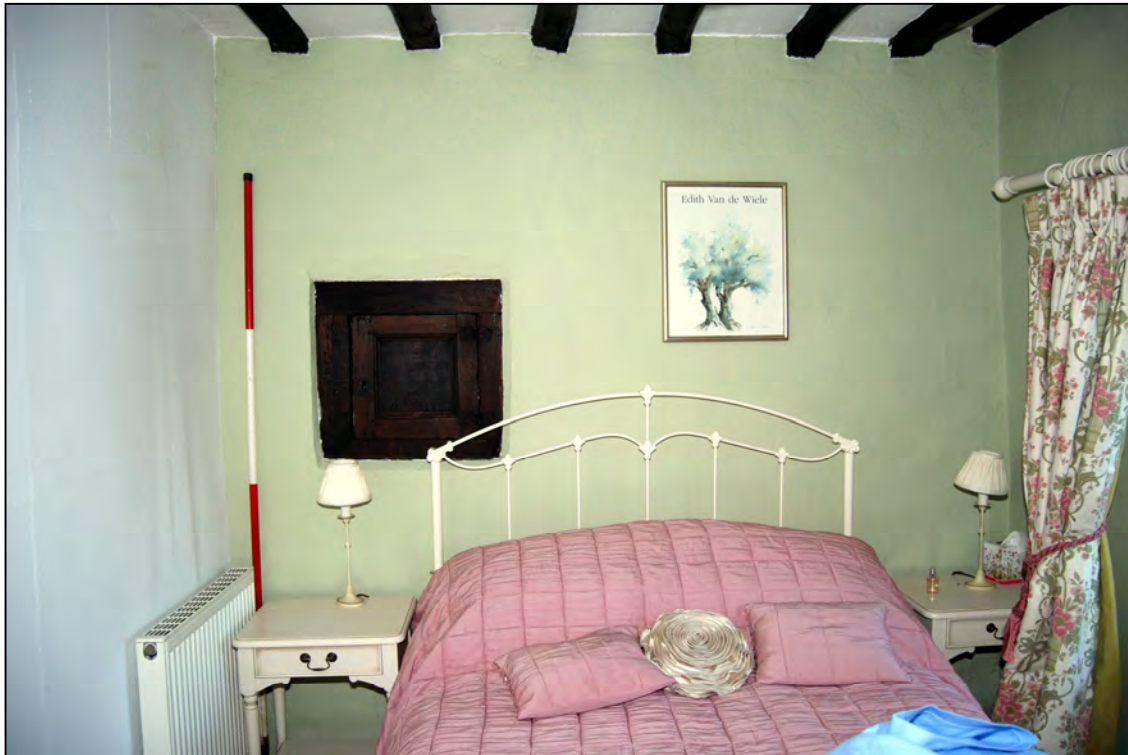
Plate 33: The north eastern bedroom, looking north

The north eastern bedroom (Plate 33) also has a built in cupboard, the door and frame of which, however, is of cruder work than that in the south eastern bedroom (Plate 34). It has handmade, butterfly hinges similar to seventeenth and early eighteenth century types illustrated by Alcock and Hall (1994, 24). The
