# Archaeological Assessment Commissioned by Mr. and Mrs. E.W. Parry

Engineering Archaeological Services Ltd.

Cleifiog Uchaf, Valley, Anglesey Archaeological Assessment

> EAS 2002/19 June 2002

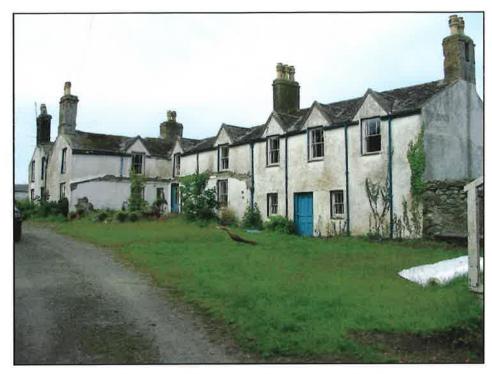
Plate 2: Cleifiog Uchaf House in AD 2002

The house has clearly been much added to and altered over the years. It was clearly, in its day, fairly elegant. Possibly a result of its use as annex to the Valley Hotel. Plate 2 shows the current condition of the front of the house while Plate 3 shows its condition in the AD 1980's. Of particular interest is the arrangement of the north east ground floor end of the house for an agricultural purpose, possibly a byre. Internally this part of the house had two rooms. Notable features include holes in the ceiling for the fixing of partitions and wooden pegs jutting out from

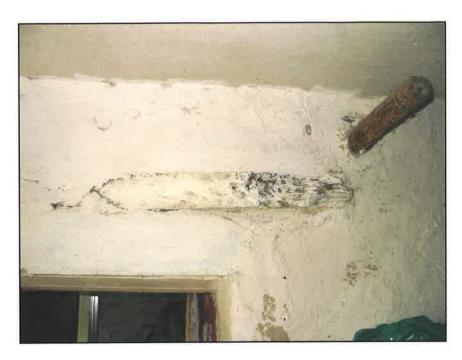
Plate 4: Internal detail of byre

the walls perhaps for storing harness or tools (Plates 4 and 5). The windows are smaller than the remainder of the house and the door is wider.

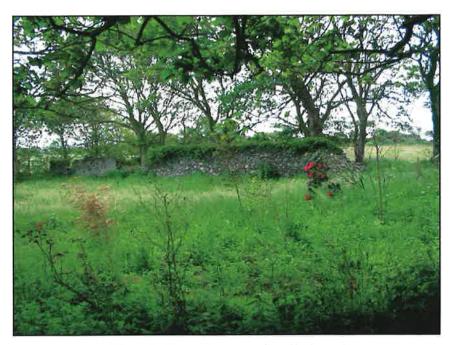
Plate 6: General view of walled garden

To the west of the house lies the walled garden. The external walls are crumbling and the internal divisions shown on the AD 1890 Ordnance Survey map are not visible. The garden has clearly not been used for its intended purpose for many years (Plate 6). Elements of Victorian wrought iron work survive alongside more recent additions (Plate 7).

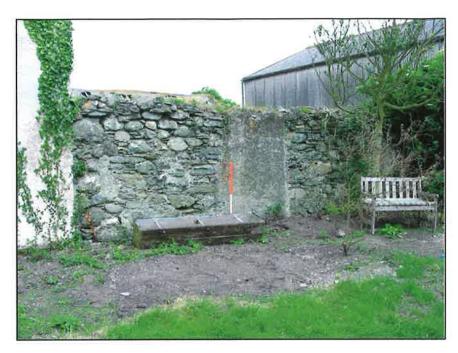
Plate 8: Surviving wall of possible stables

Directly to the north east of the house a structure thought by the owner to have originally been stables has mainly gone. Part of the wall which joins the front of the house remains with one blocked doorway visible (Plate 8).

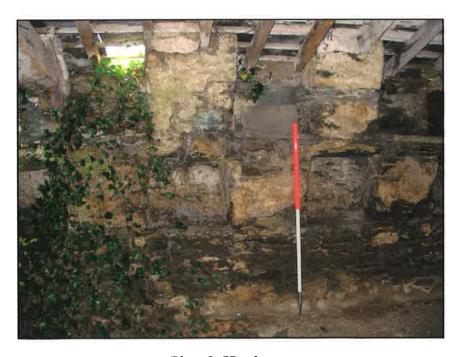
Plate 9: Hen house

To the south of the house, just inside the field a structure with a notable internal structure with small square recesses incorporated into the wall may well be a hen house (Plate 9).

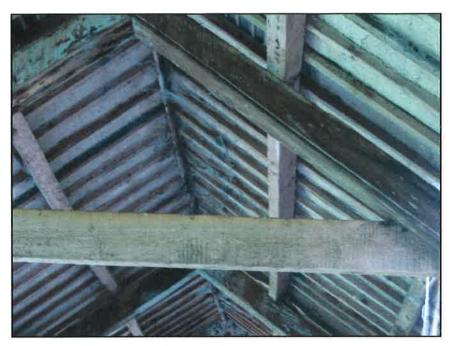
Plate 10: Cow shed roof

with two small enclosed yards to the rear on the north west side. The roof of the cow shed has a date of AD 1878 inscribed on the lath and plaster. This would date either the construction or re-roofing of the building. The roof timbers do appear to be a replacement. Some have clearly been reclaimed from elsewhere, possibly a house as they have molded details which would not normally be included in an agricultural building (Plate 10). The yards to the rear have their own access point to the fields on that side of the farm.

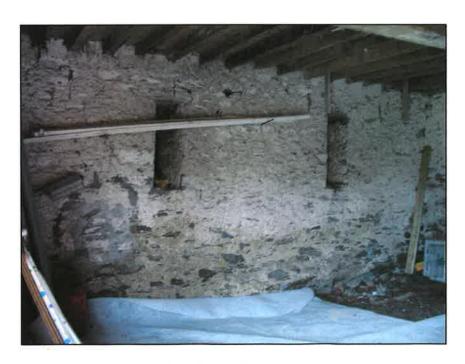
Plate 11: Inside the granary

On the west side of the yard a structure thought to be a granary is clearly the earliest structure as ventilation slits, now blocked, are incorporated into all four wall (Plate 11). Added to the north east side is a store with external stone staircase to the second floor and to the south west a series of pigsties which back onto a barn.

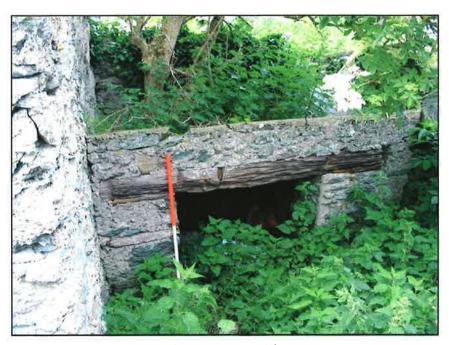
Plate 12: Corn drier

Tacked onto the gable end of the added store is a feature of some interest now in a much dilapidated state. The feature is thought to be a small corn or seed drier (Plates 12 and 13). All that survives is the fire box and part of the baffle system. The building within which the drier was housed survives only as a fragmentary wall on one side and a roof line scar on the gable end of the store.

The only structure which it is not possible to include in the proposal is the feature thought to be a corn drier. This feature is considered to be of interest in that although a number of such features are known in association with corn mills, for example at Melin Tyddyn Du, Maentwrog (Davidson and Dutton 1997) few now survive associated with farms (pers. com. Peter Crew, Snowdonia National Park Archaeologist). At Cleifiog Uchaf the feature only survives in an incomplete condition.

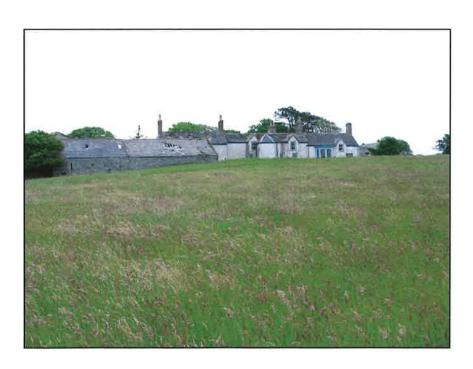
Plate 15: Field to the west of the farm yard

The fields around the farm yard are all improved grassland (Plate15). No obvious archaeological features were visible. Test pits dug in the field to the west of the farm yard showed topsoil to a depth of at least 0.5m.
