Archaeological Assessment

Engineering Archaeological Services Ltd.

Coed Marl Hall, Esgyryn
Archaeological Assessment

EAS 2002/26
September 2002

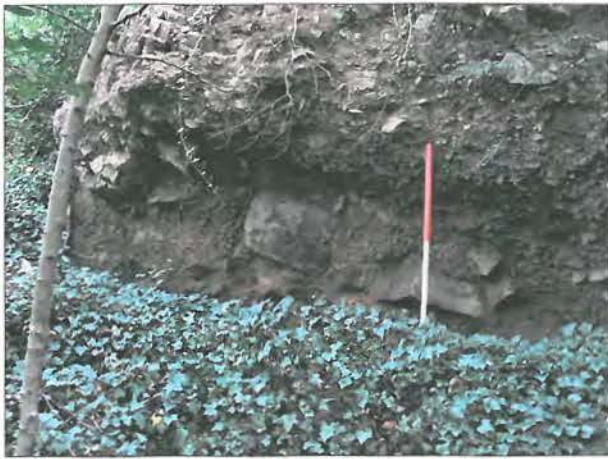
Part of three cave systems were recorded during the survey. By far the largest was PRN 16722 (Plate 1). This appeared to be a partial longitudinal section through the cave, revealed either through quarrying or by the natural collapse of a rock face. The stratigraphy exposed within the cave would appear to include an indurated breccia, over a less indurated breccia containing large limestone block, which in turn seals fine orange brown clayey sand. It is likely that the deposits extend both into the hillside and below the level of exposure.

Plate 1: Cave sediment within PRN 16722

burials (Aldhouse-Green 2000, 21). It is unlikely that PRN 16744 and PRN 16737 were large enough for human use, however PRN 16722 has considerable potential.

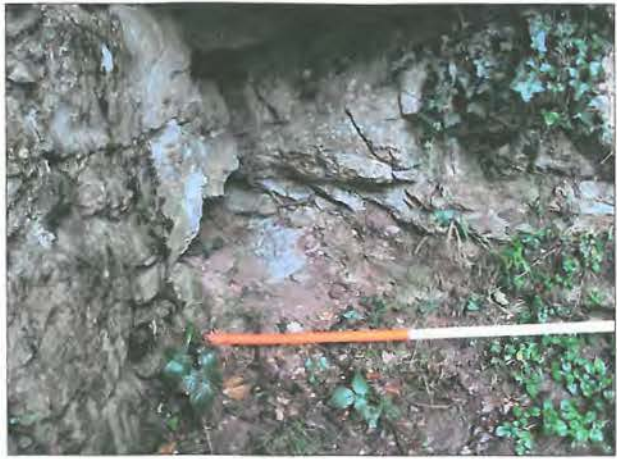
The other caves may be much smaller. PRN 16744 was seen at the top of Jacob's Ladder and it appears to extend out of the survey area (Plate 2). The deposits it contained include flowstone (stalatitic) deposits and red/brown cave sands.

Plate 2: Cave sediment at top of Jacob's Ladder (PRN 16744)

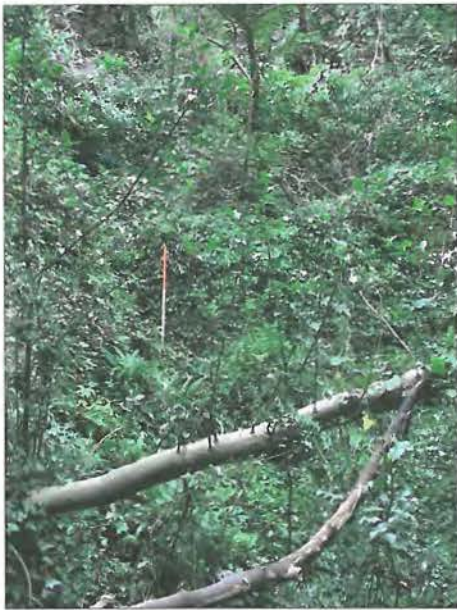
At one location in the south east corner of the site, two fairly large quarries, PRN 16719 (Plate 3) and 16721 would appear to represent organised quarrying activities. They are closely associated with a dwelling, PRN 16716, and the remains of a lime kiln, PRN 16717. Early Ordnance Survey maps, indicate the presence of a second lime kiln at a location close by now occupied by a car park (Figures 5 and 6). Both quarry faces show evidence for working at more than one level and PRN 16719 has a deliberately built earth and stone ramp, PRN 16723, for access to upper working levels.

Plate 3: Marl Bach Quarry (PRN 16719)

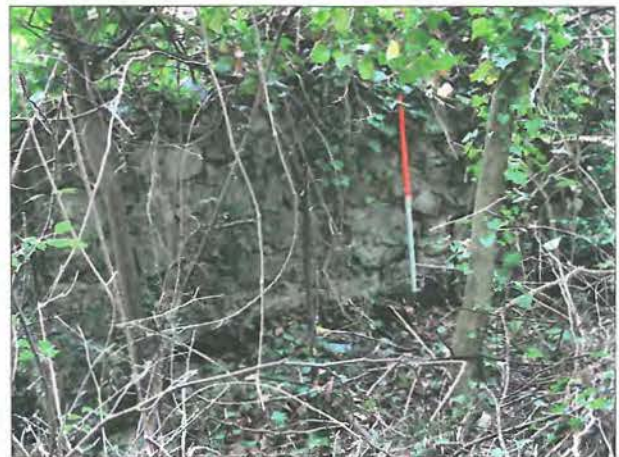
Plate 6: Marl Bach (PRN 16716)

PRN	GRID REF	SITE TYPE	PERIOD	DESCRIPTION	CONDITION	VULN.	CAT.
16,716	SH 80121 78600	Dwelling	Post Medieval	Cottage (Marl Bach) with outbuilding (16754). Cottage has at least two rooms and was slate roofed. Internal wall faces are lime plastered. External walls are 700 mm thick, the internal division is 500 mm thick. Walls are constructed of large limestone blocks, 0.4 x 0.5 x 0.6 m in size.	Ruinous but walls stand to 2 m in places. Very overgrown.	3	C
16,717	SH 80079 78601	Lime Kiln	Post Medieval	Sub-rectangular void, approximately 4 m square, with open side to Marl Lane. Potential flat charging platform to the east.	No structural survival apparent. Overgrown, inaccessible.	3	C
16,718	SH 80122 78599	Wall	Post Medieval	Stone revetting wall to the east of cottage 16716. Defines edge of plot. Maximum height 1.4 m, thickness 0.4 m. Composed of limestone blocks 100 x 100 - 200 x 300 mm size range.	Near complete in places, tumbled in others.	3	C

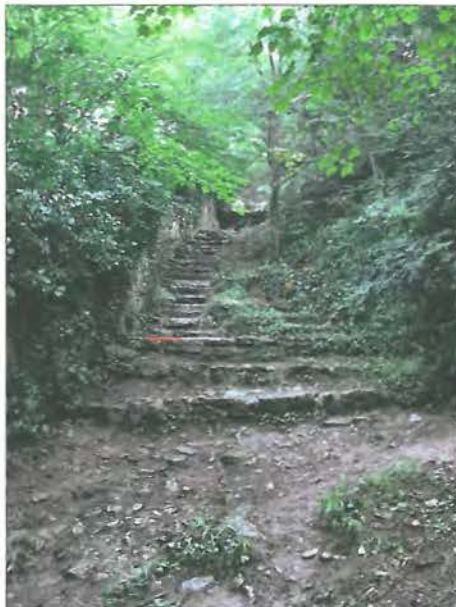
Plate 9: Jacob's Ladder (PRN 16743)

16,743	SH 79799 78987	Steps	Post Medieval	Series of twenty two steps made from limestone blocks running up part of the northern boundary to the north east of the spring pool. The steps are 3.3 m wide at the bottom of the flight and 1.4 m wide at the top of the flight. The steps do not appear worn but replace an older flight, the remnants of which are seen directly adjacent (Jacob's Ladder).	Good	4	B
16,744	SH 79804 79000	Cave	Pleistocene	Back of small cave at the top of steps 16743. Red brown cave sediments and flow stones visible.	Good	4	C
16,745	SH 79802 78994	Pathway	Post Medieval	Pathway leading into woodlands from road along northern boundary (The Nun's Walk). Defined by two stone walls. A substantial stone wall marking property boundary, 2.2 m high made of large limestone blocks, on the north, and smaller wall, 1.2 m high on the south. The path is 1.8 m wide and has occasional limestone block steps.	Fairly recently maintained. In places the surface of the path has been repaired with bricks and brick rubble.	4	B

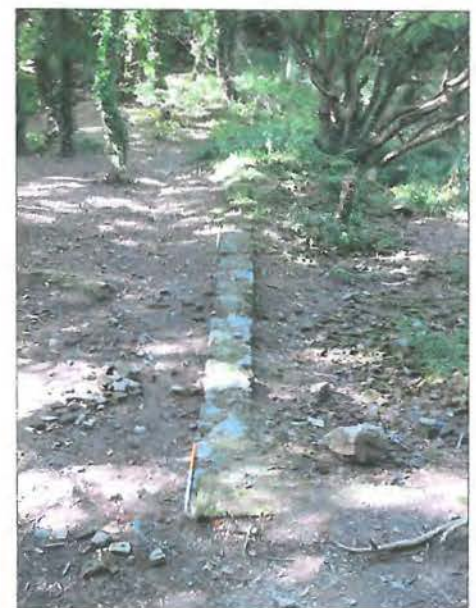
The lowest terrace, PRN 16751, runs between the hall and a brick walled garden, PRN 16747, and is in part still in use as a path. The brick walled garden survives as a limestone block foundation below a brick wall surviving to a maximum of 5 courses. The bricks are hand made (Plate 12). The feature is roughly 40m square, only the east and west walls are within the property boundary. It is not currently possible to tell where the entrances would have been. The feature sits within a series of terraces, PRN 16753 which appear to respect it, possibly being created when the ground was leveled to construct the brick garden.

Plate 12: Brick garden (PRN 16747)

PRN	GRID REF	SITE TYPE	PERIOD	DESCRIPTION	CONDITION	VULN.	CAT.
16,747	SH 79707 78924	Walled Garden	Post Medieval	The feature measures 40 m square, but only the south and east walls are within the property boundary. The feature has limestone block footings, 500 mm wide with five courses of a brick wall surviving above. The bricks are hand made, measuring 60 x 130 x 240 mm. The limestone blocks are 260 x 300 mm to 400 x 450 mm and bonded with a crumbly lime mortar.	Poor, bricks are strewn about and used to build fires.	3/5	B
16,748	SH 79728 78914	Ditch	Post Medieval	Wide, shallow ditch to the south of the brick garden (16747). 6 m wide, approx. 30 m surviving length, 1 m maximum depth. Tumbled limestone blocks at the north end suggest that the feature may have been stone lined.	Indistinct, silted up and overgrown.	3	B
16,749	SH 79768 78935	Terraced Path	Post Medieval	Two parallel terraces running between Marl Hall to a blocked entrance in the northern boundary. Both are 3 m across with a 6 m drop between the two. The lower terrace would appear to have been an access route or drive with the upper one perhaps for planting.	Indistinct	3	B

Many of the features may suffer some damage by woodland management activities if appropriate precautions are not taken. The walled garden is currently under threat from human activities in this area, lighting of bonfires etc.

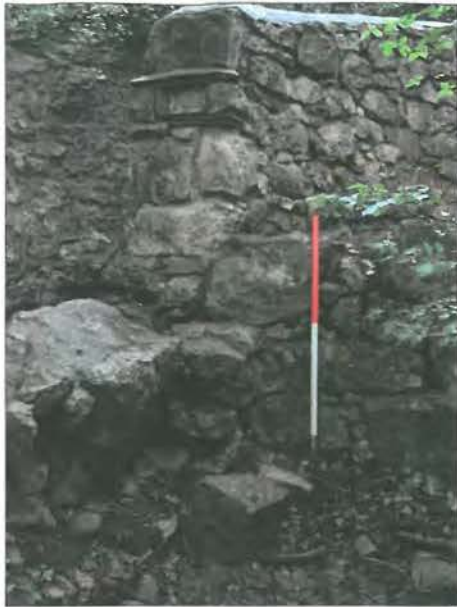
Plate 13: Possible entrance (PRN 16755)

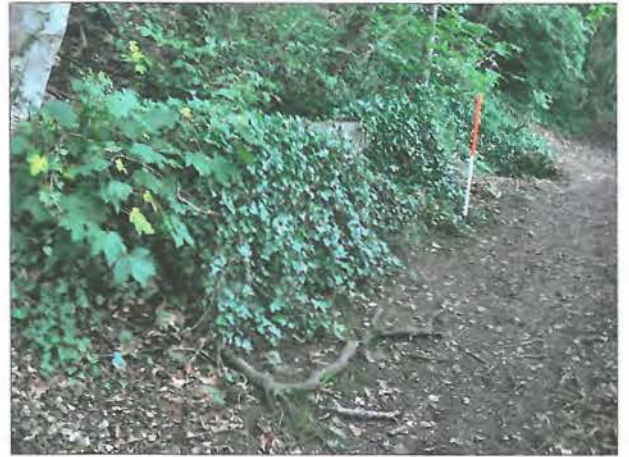
Plate 20: Brick cistern (PRN 16739)

PRN	GRID REF	SITE TYPE	PERIOD	DESCRIPTION	CONDITION	VULN.	CAT.
16,739	SH 79902 78762	Cisterns?	Post Medieval	A brick built and cement lined cistern with limestone blocks on the external faces. Bricks are machine made. The cistern measures 2 x 2.7 m and the visible height is 0.9 m. Adjacent is a hole of similar dimensions which may have once contained a similar structure.	Good but overgrown.	4	C
16,740	SH 79862 78949	Quarry	Post Medieval	Limestone exposure which has been quarried. 6 m high, 18 m long, 6 m wide. One main working face is evident with two smaller side faces.	Good.	4	C
16,741	SH 79839 78951	Steps	Post Medieval	Set of two steps set into path. Each step is composed of 3 or 4 large limestone slabs. The width of the steps is 1500 mm and the average block size is 150 x 300 x 450 mm.	Good	3	C
16,742	SH 79797 78972	Spring Pool	Post Medieval	Situated close to the northern boundary, a natural spring erupts from a crevice in a limestone exposure, flows through a channel in the rocks which may be partly man made to a natural pool. It the passes through the wall which defines pathway 16745 to a square man made pool defined by a series of low walls and steps. A stone stile bridges the wall to give access to the pool and the pathway. The feature appears recently maintained but sits an older footings.	Good	4	B
