***The Old Colliery, Pentre Berw
Building Survey***

March 2006

EAS Client Report 2006/3

*Survey Commissioned
by
Dewis
On behalf of
The RSPB.*

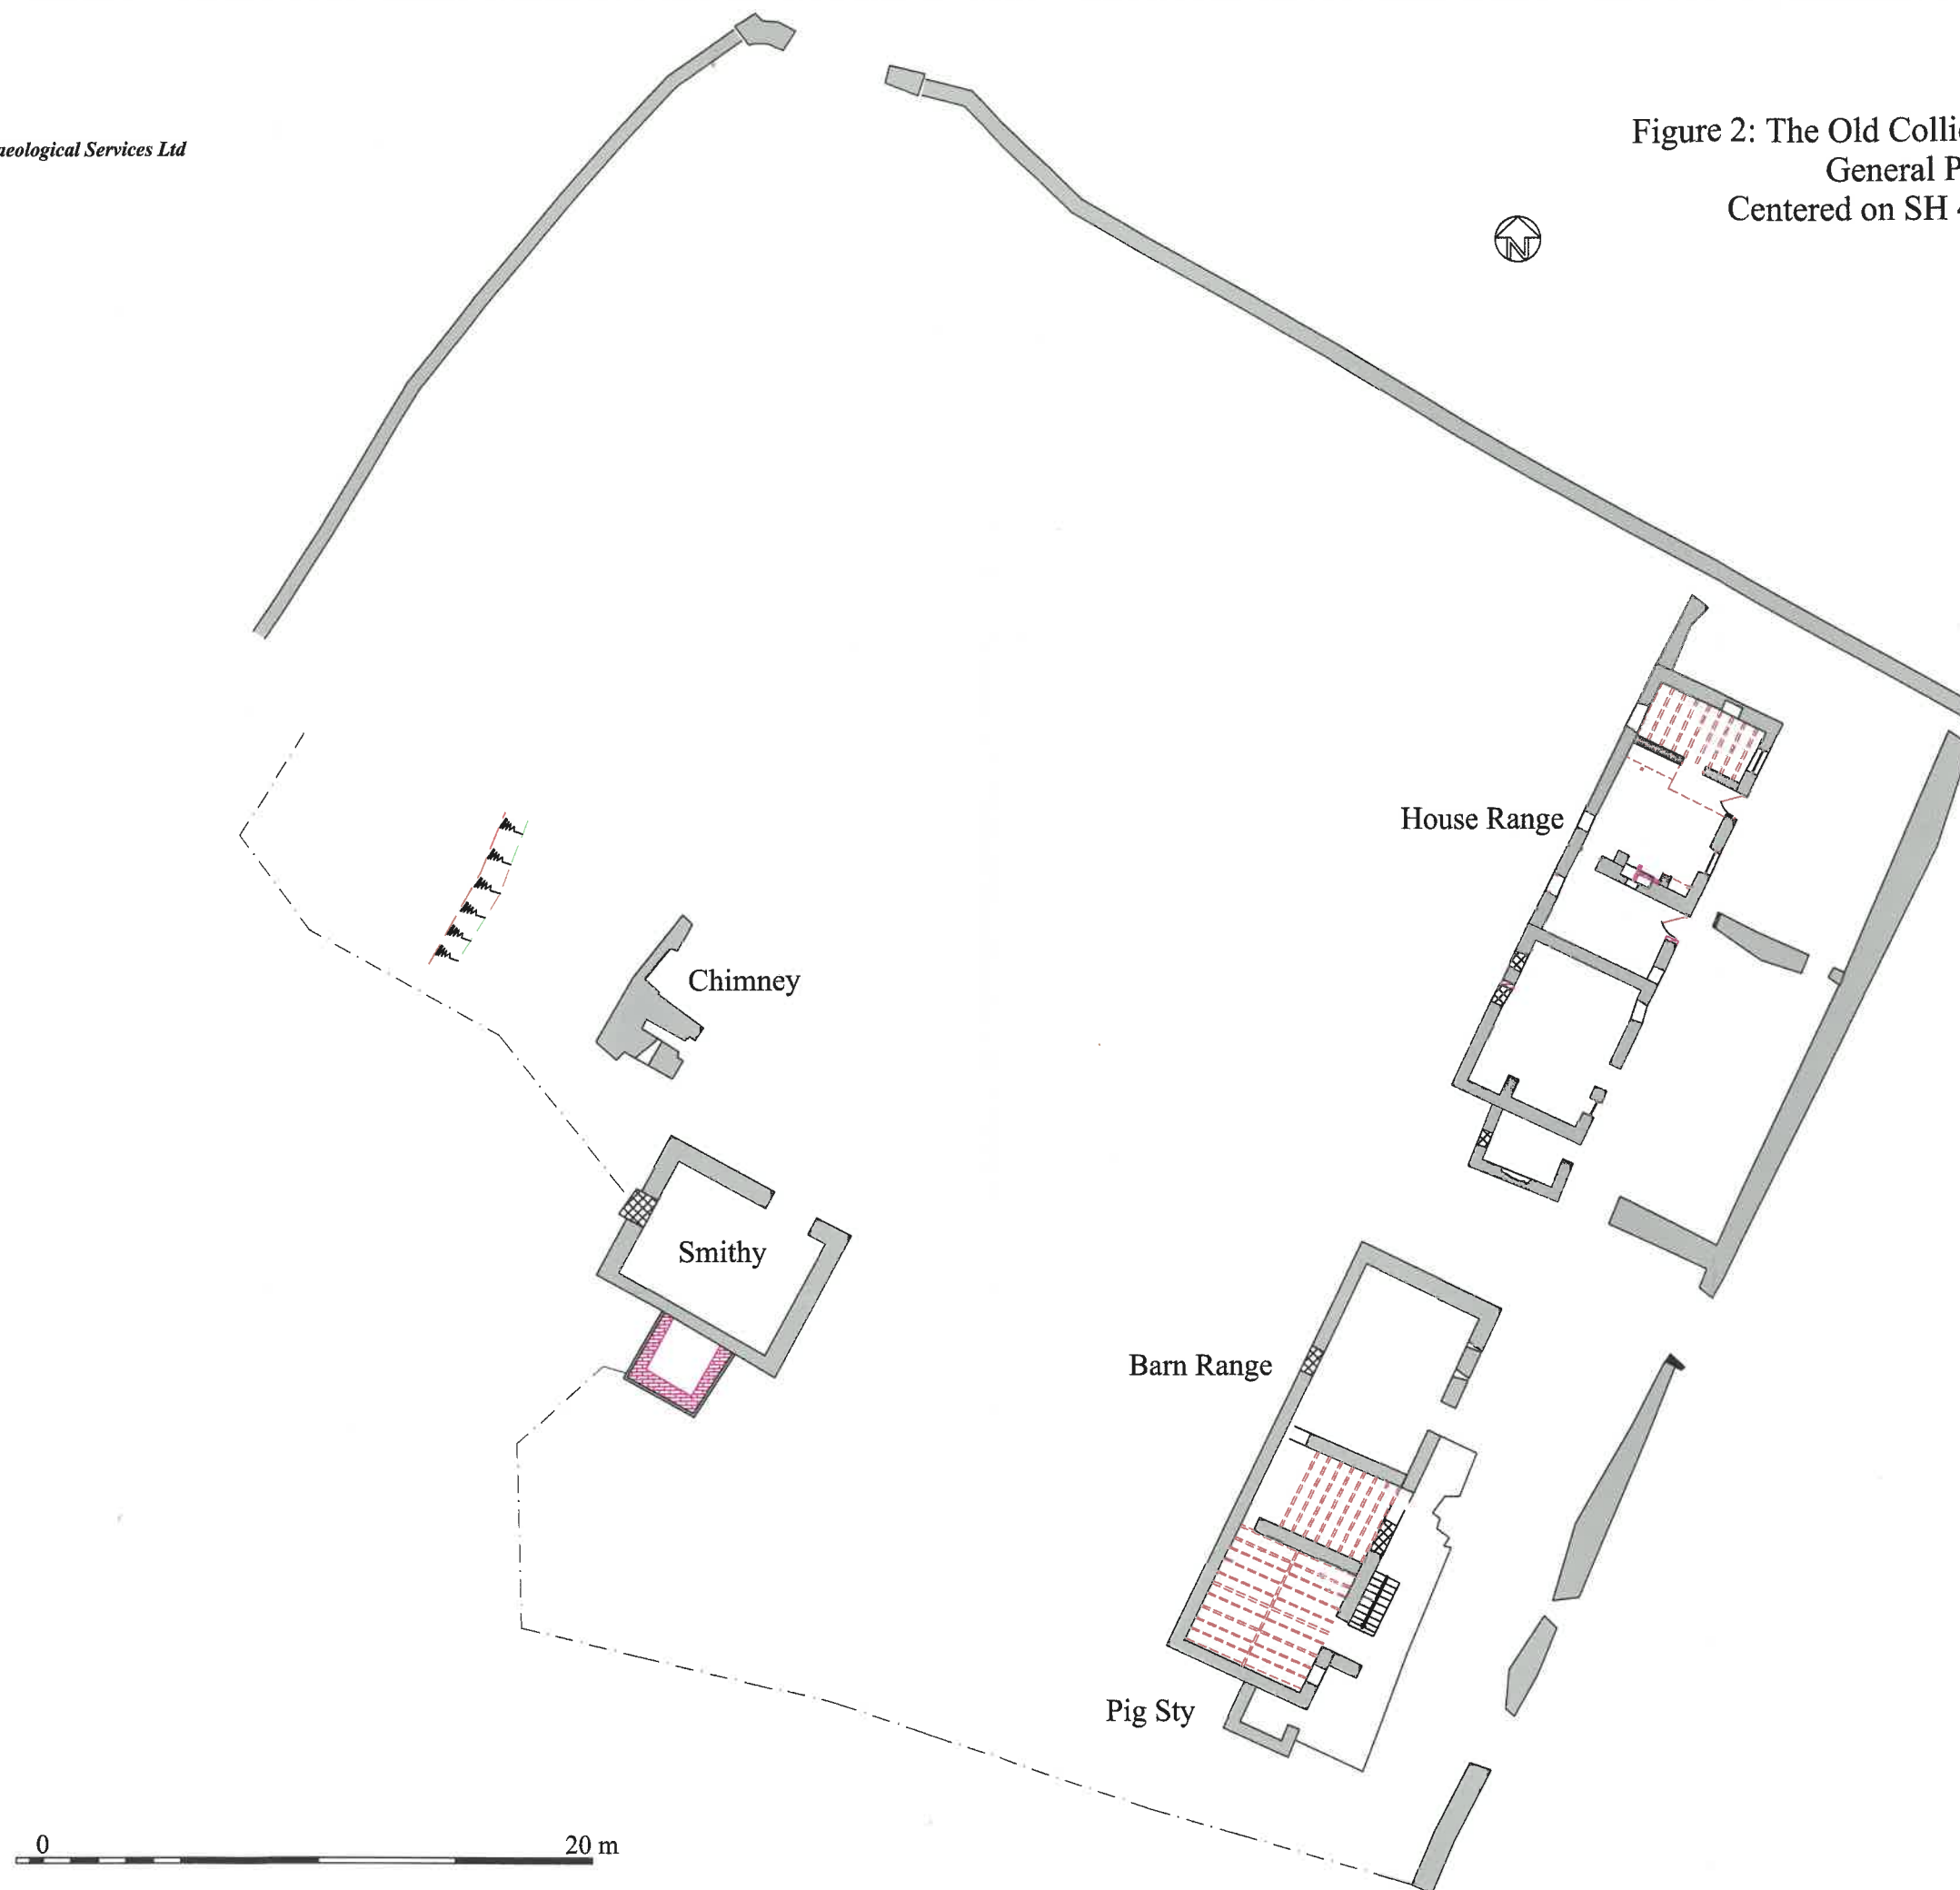
Figure 2: The Old Colliery, Pentre Berw
General Plan
Centered on SH 4636 7248

The surviving structures at The Old Colliery, Pentre Berw consist of a house range (Plate 1), barn (Plate 2), smithy (Plate 3) and colliery chimney (Plate 4) within an enclosure which is walled on three sides (Figure 2). The site of the colliery shaft was probably in the western corner of the enclosure and is now marked by a concrete block.

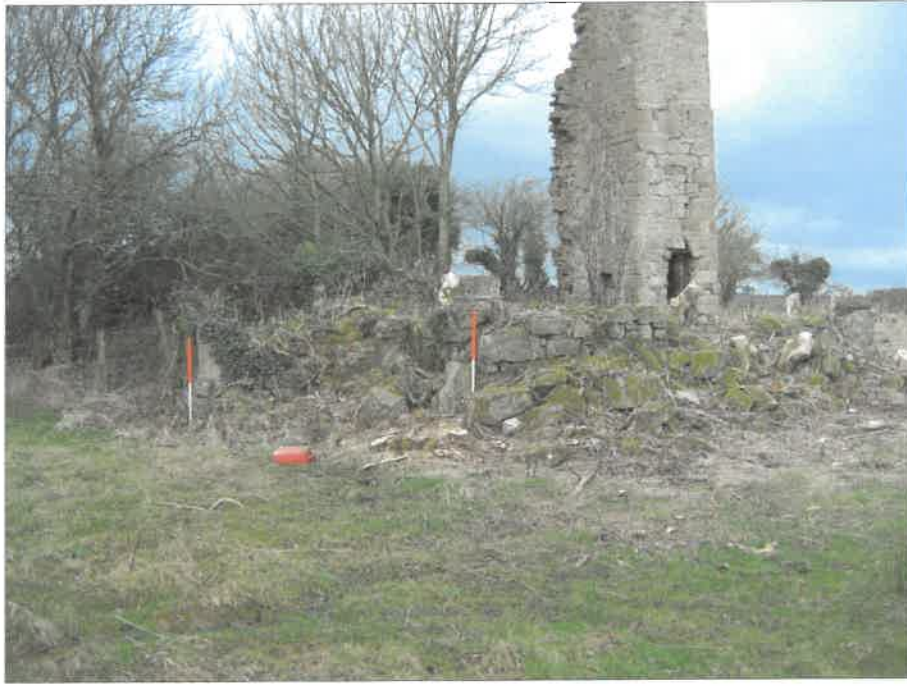
Plate 3: General view of the smithy

Now largely destroyed this building was adjacent to the colliery chimney and is likely to have been built as part of the colliery complex. This view is strengthened by the relatively large size of the building which would appear to be too large for an agricultural forge. The building was 7.48 x 5.88 m in size and had a brick extension 2.65 x 2.94 m on its south western side (Figure 7, X).

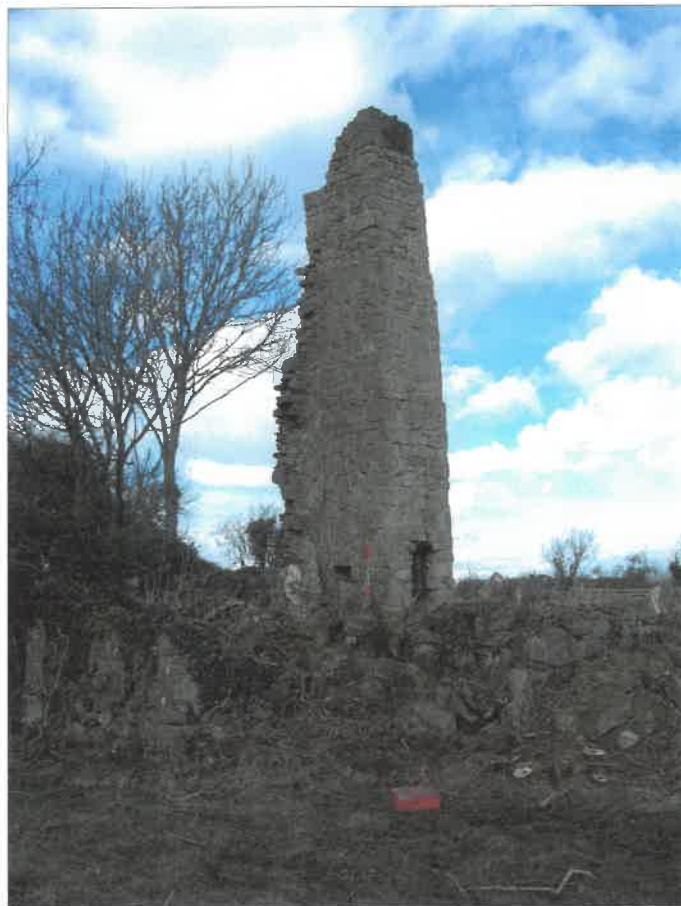
Plate 4: General view of the chimney

The colliery chimney is roughly square in plan and stands to a height of 12.18 m. There is a doorway in the south eastern face (Figure 7, Z, Plate 19) and a vent in the south western face (Figure 7, AA,

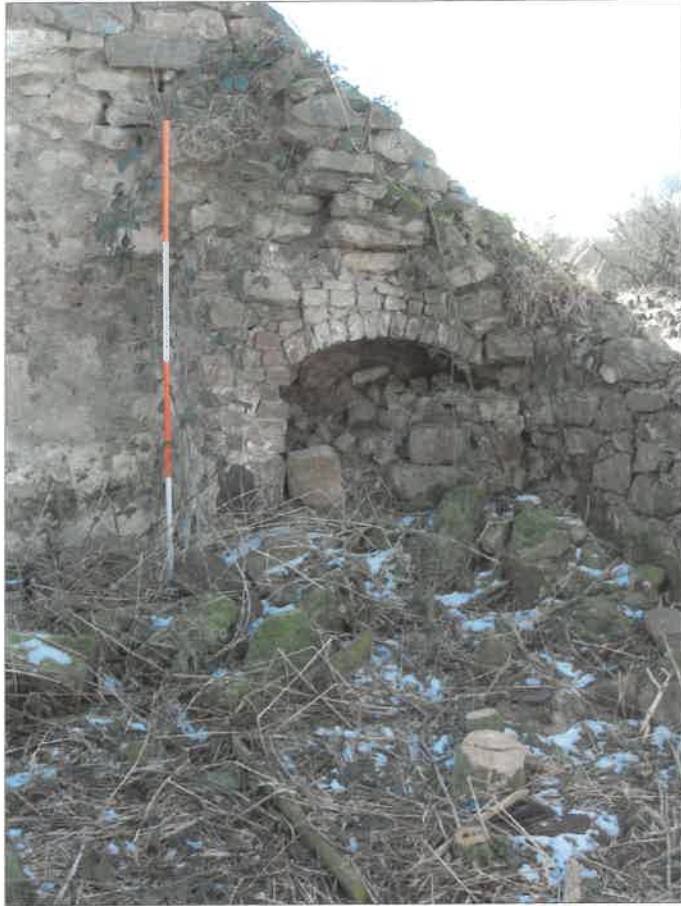
The examination of the fabric of the house range would suggest that it developed over time. The earliest part of the structure would appear to be a single storey building approximately 6.5 x 5.2 m in size (Figure 3, A). It has the remains of an oven in the south west corner of the single room (Figure 3, B, Plate 4) which was served by a chimney in the centre of the southern wall. On the western side there is a blocked window and a door in the north west corner. The eastern side contained a door and two windows. Remains of the roof found within this building would suggest that it had a slate roof with stone ridge pieces. The slates were approximately 330 x 160 mm in size and appear to have been partly held down with mortar. The ridge pieces were well made and up to 1.30 m long (Plate 6). This part of the house range was used

Plate 5: Oven in the corner of the earliest house

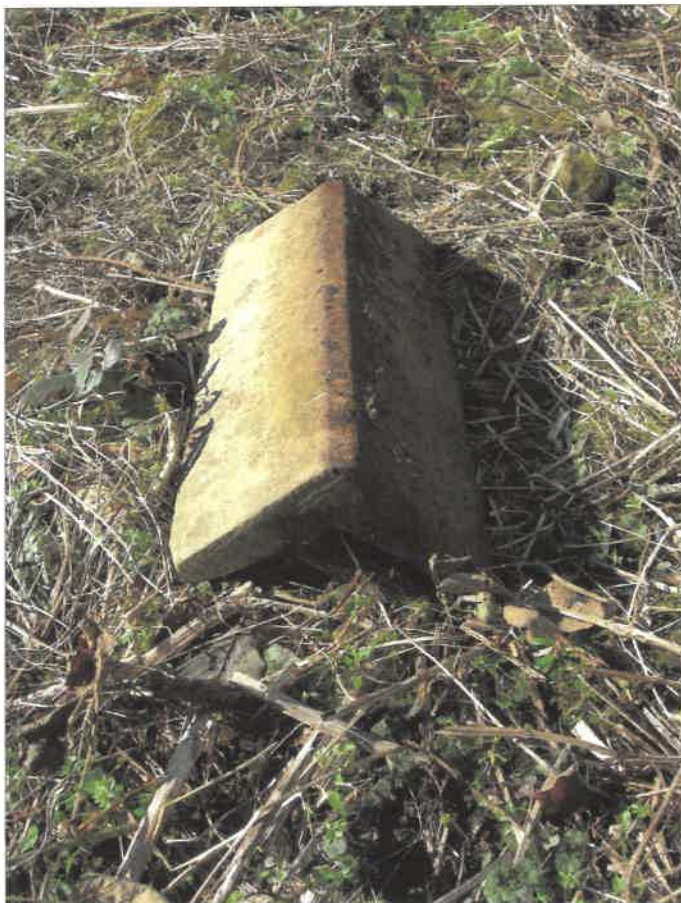
Plate 6: Stone ridge piece

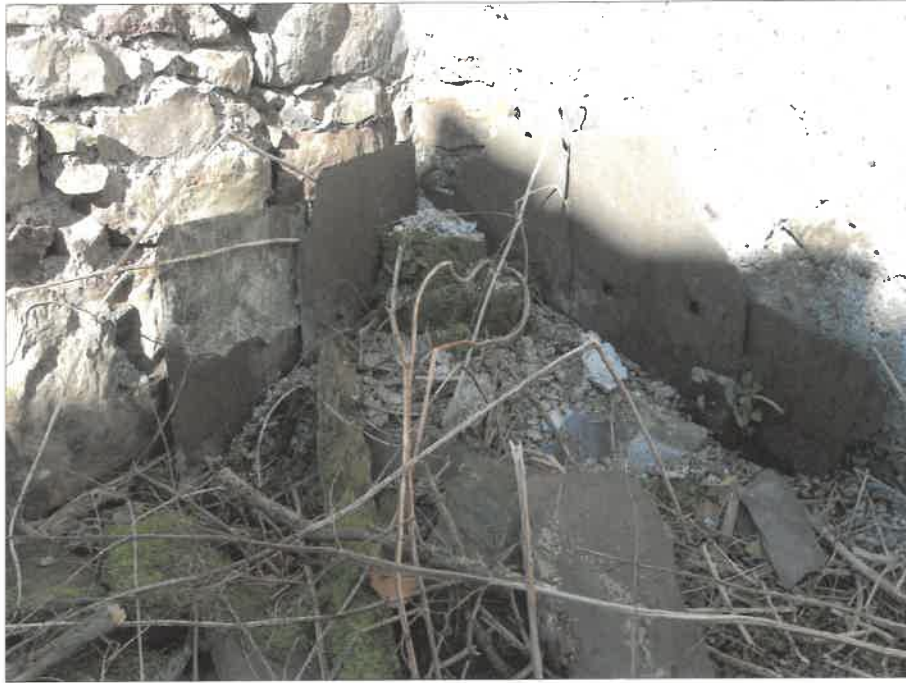
as a chicken shed and for general storage in its last phase (J. Parry pers. comm.) which probably accounts for the partial slate lining in the north west corner of the room (Plate 7). Large slates 300 x at least 500 mm were used for this lining.

Plate 7: Slate lining in corner of original house

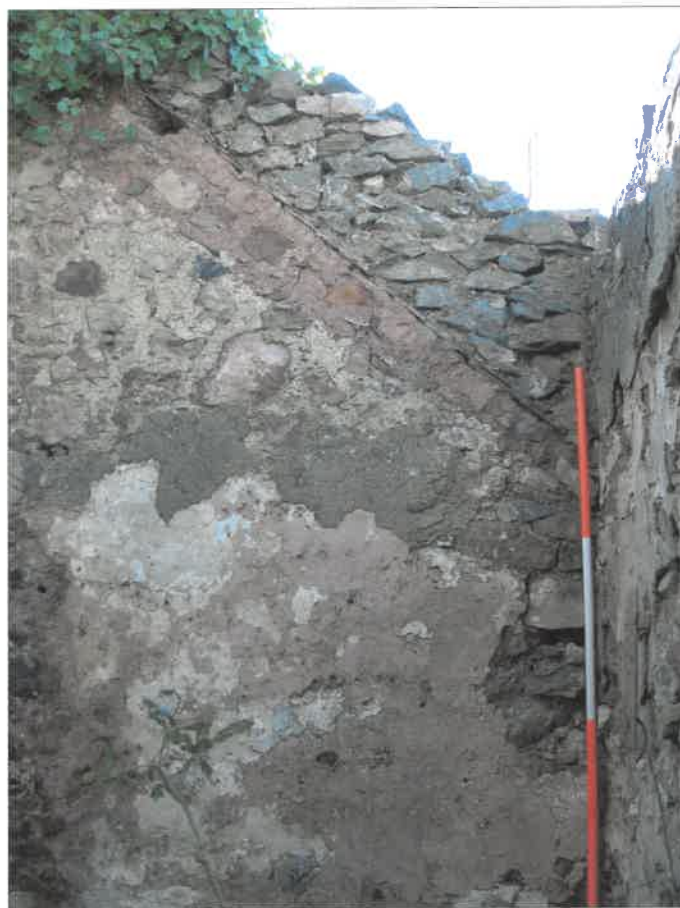
Plate 8: Gable wall of the original house showing extension

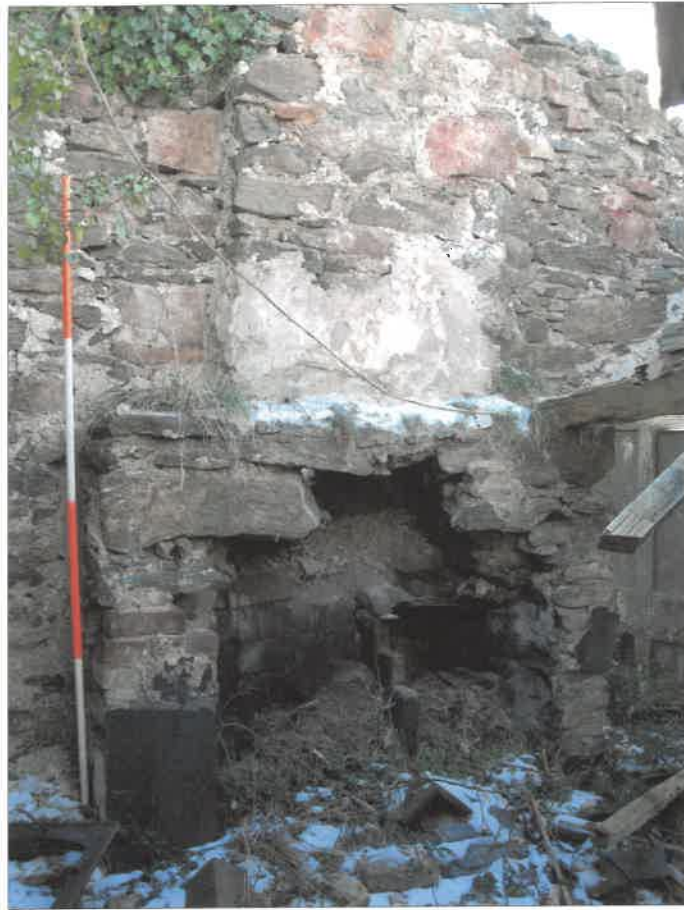
In its last phase Room F was used as a general living room (J. Parry pers. comm.), whilst it had no formal fireplace scorching to the southern wall would suggest the presence of a freestanding stove in this room. The main central room (Figure 3, G) had an oven or range within a fireplace centrally placed along the southern wall (Plate 9). The cast iron door to the oven survives in the corner of the room (Plate 10). The impression is given by the remains that this range may have been inserted into an existing fireplace. A deliberate hole in the back of the fireplace joining it to Room F (Figure 3) is difficult to explain, its appearance is similar to the ventilation slots in the barn range, but its position would suggest some sort of flue or opening into the chimney (Plate 11). Adjacent to the range there is the remains of a cupboard.

Plate 9: Oven/range in the main house

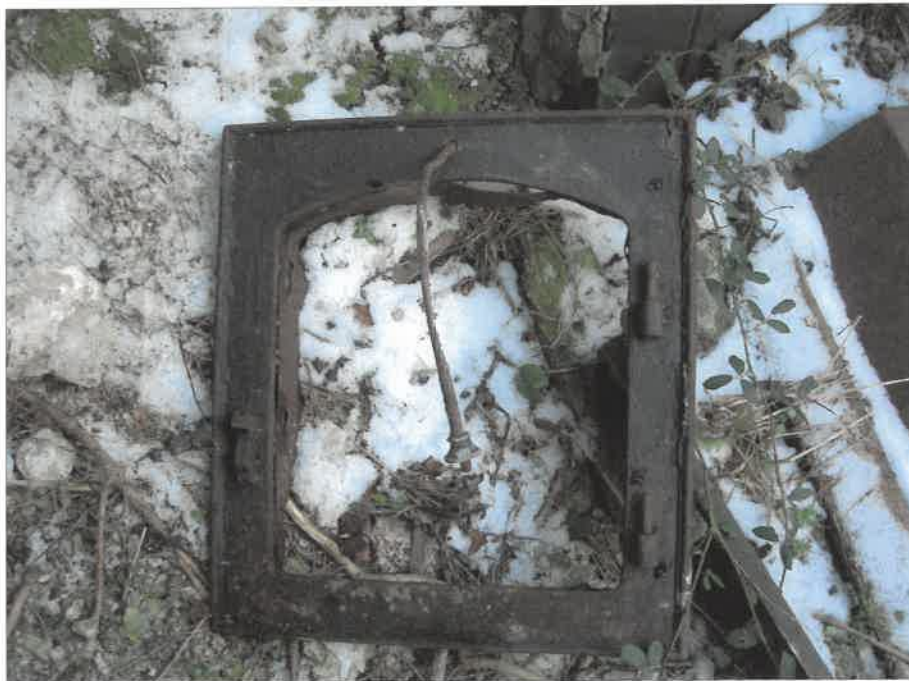
Plate10: Oven door surround in main house

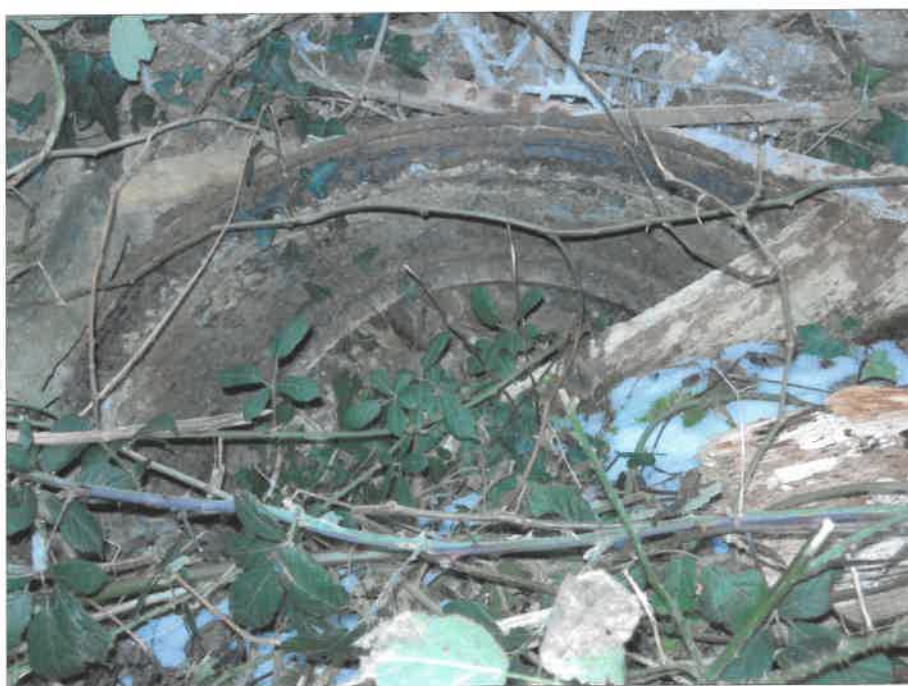
Room H (Figure 3) was used as a bedroom at one stage (J. Parry *pers. comm.*) and included a fireplace in its northern wall. The cast iron surround for this fireplace survives partly buried by the debris (Plate 12). The final phase of use, however, does not appear to have been domestic as the walls have been partly covered in corrugated iron sheets (Plate 13). Above Room H was a single, unheated bedroom (Figure 4, I).

Plate 12: Cast iron fire surround in lower bedroom

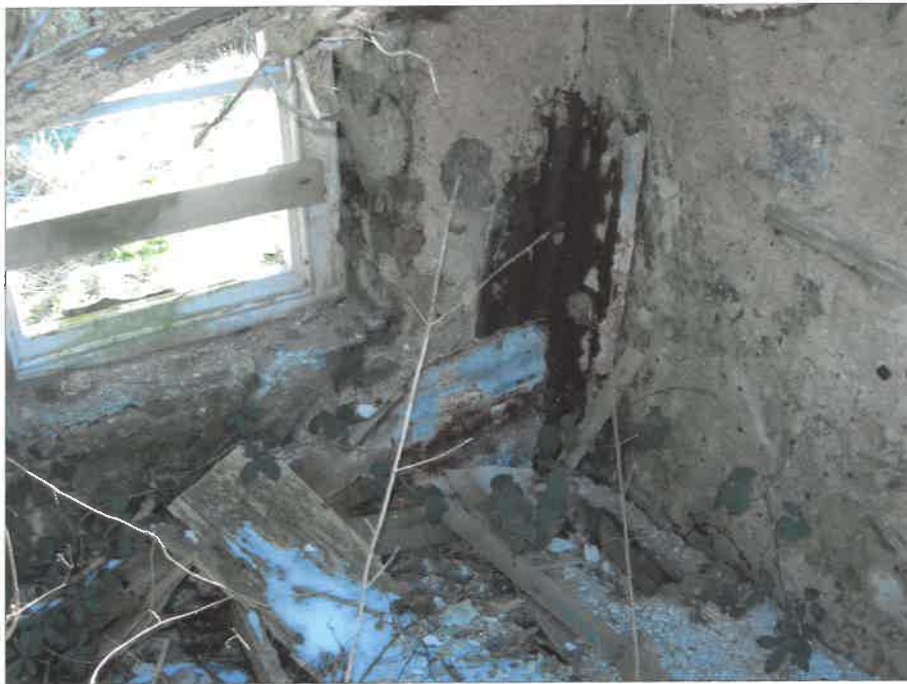
Plate 13: Corrugated iron lining to lower bedroom

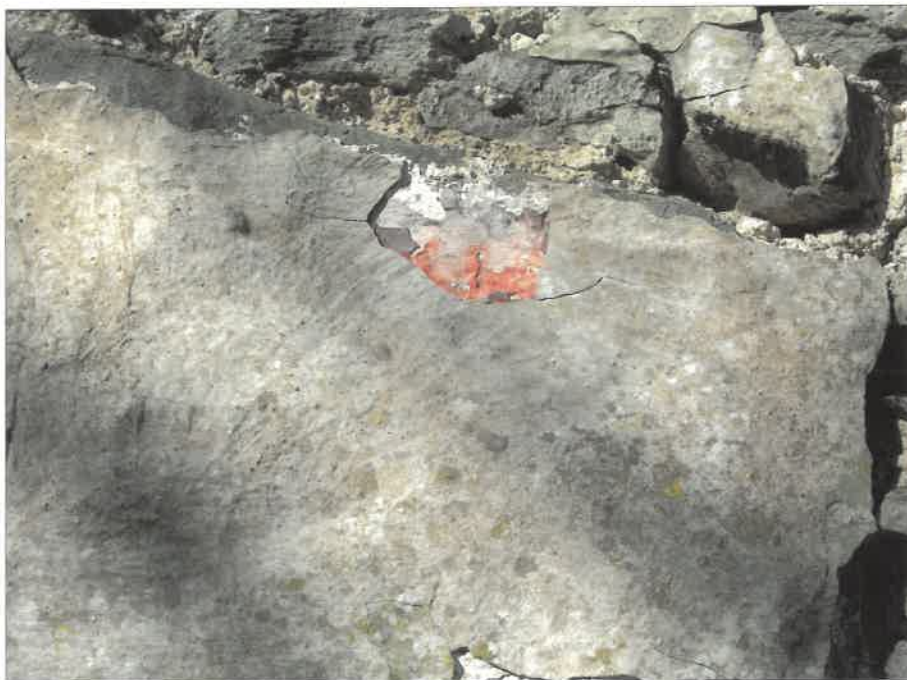
Externally it would appear that at least the front of the building had been coated with lime wash at several times in the past. At least one phase of these coating was also coloured pale pink (Plate 14). The last phase of maintenance to the property is also evident with metal plates added to the two main door frames to cover the rotting at ground level. The northern end of the house range also had iron guttering at least on the eastern side.

Plate 14: Detail of external limewash

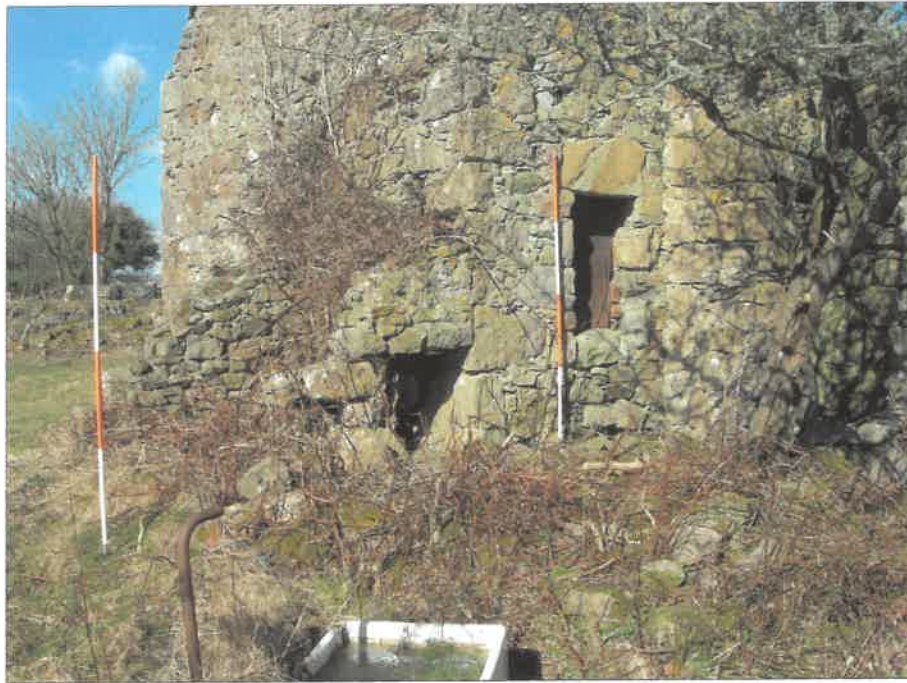
The barn covers an area of approximately 16.36 x 5.66 m and has a lean to structure 1.9 x 2.6 m, attached to its southern end. This lean to (Figure 5, P) was a pig sty (J. Parry *pers. comm.*) and is clearly a late addition to the building (Plate 15).

Plate 15: Pig sty

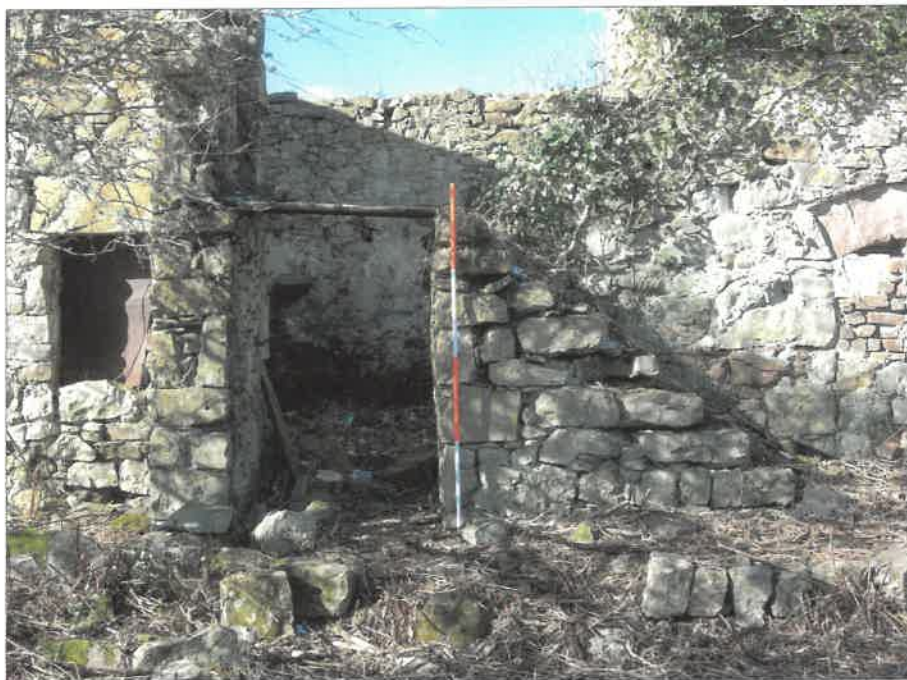
The main barn is divided into three sections (Figure 5, Q, R and S) by walls which appear to have been added to an original structure. An external stone stair (Figure 5, T, Plate 16) leads to an upper storey above Rooms Q and P. There was further access to this upper storey by means of wooden stairs in the corner of Room S leading to a

Plate 16: External stairway to barn

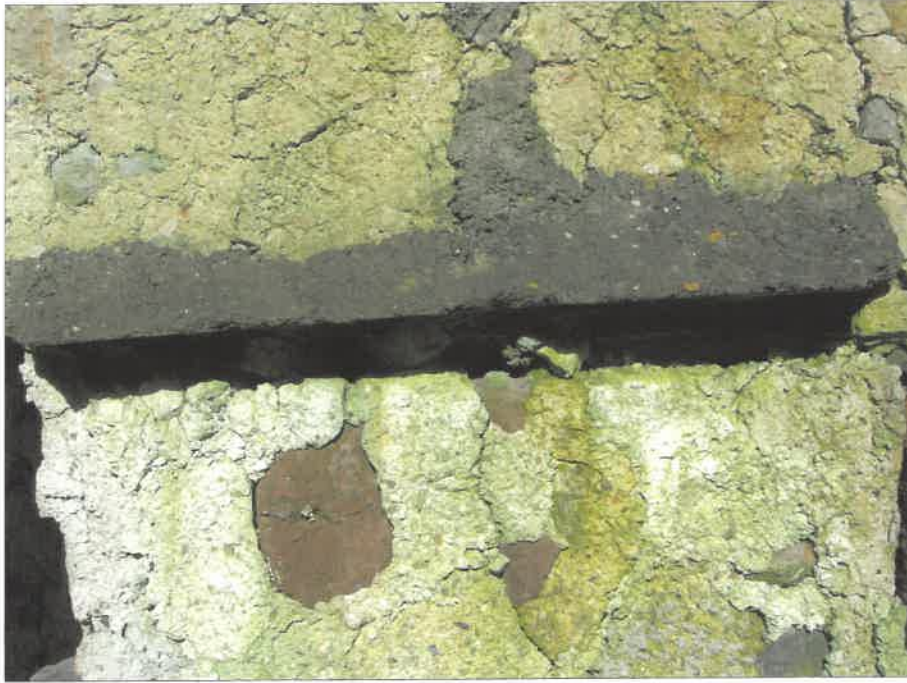
doorway (Figure 6, U). Internally the structure of the walls may suggest that this upper storey could be a later development of the barn. The floors of the upper storey appear to have been seal along the walls, presumably to prevent the loss of grain or other stored materials through the floor (Plate 17).

Plate 17: Sealing along upper floor in the barn

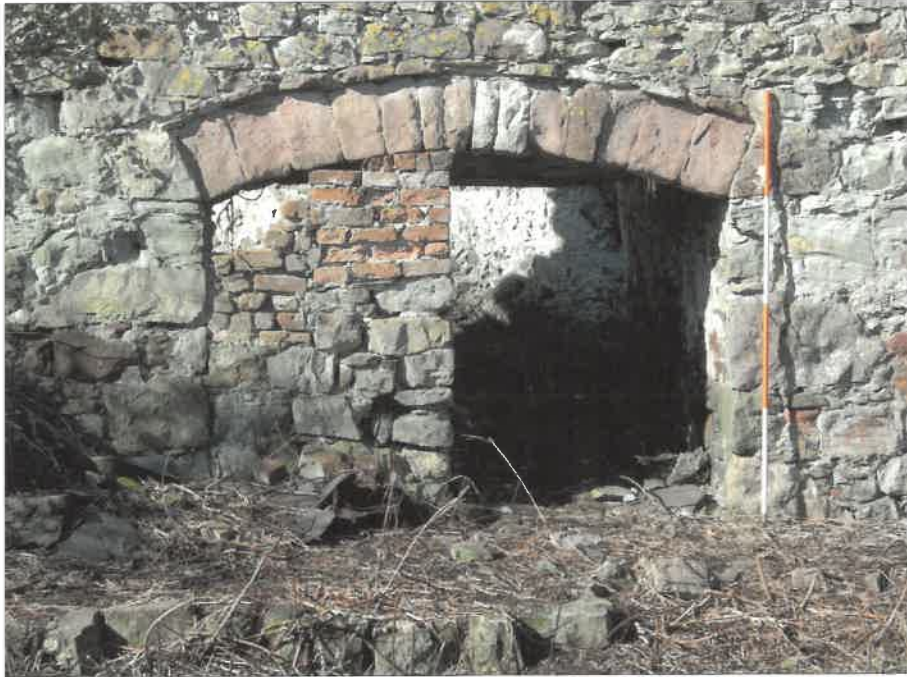
The main doorway is distinctive and has had some care in its construction. The top is a low arch, capped by voussoirs in a purple sandstone unlike the stones used for the rest of the barn construction (Plate 18). Late in the use of the barn this main doorway was partly blocked with a rough wall of stone and brick.

Plate 18: Main arched doorway to barn

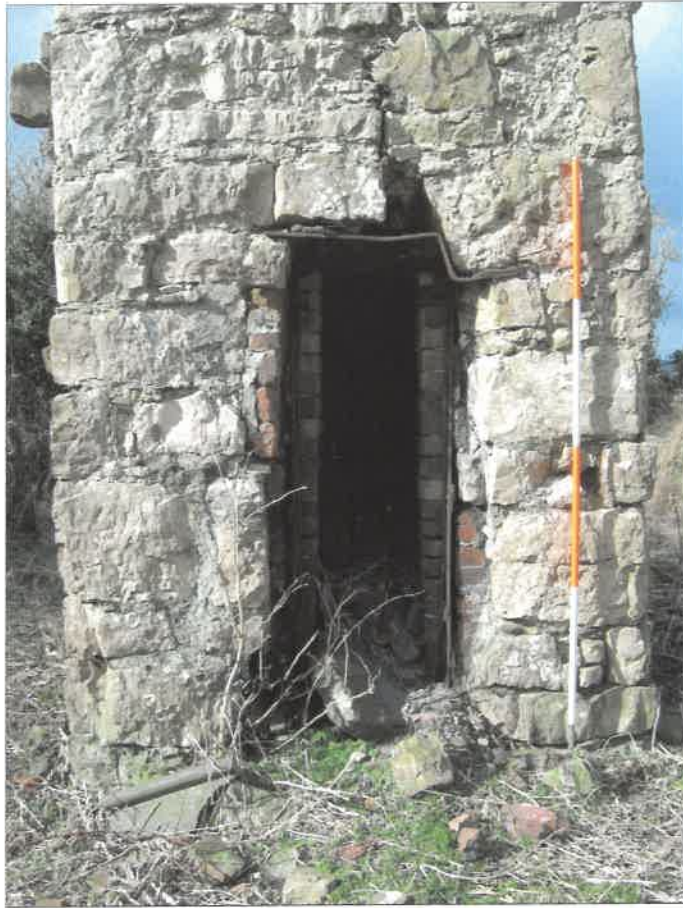
Plate 20). The door had a wrought iron frame and covered a brick lined chamber.

Plate 19: Doorway to the chimney

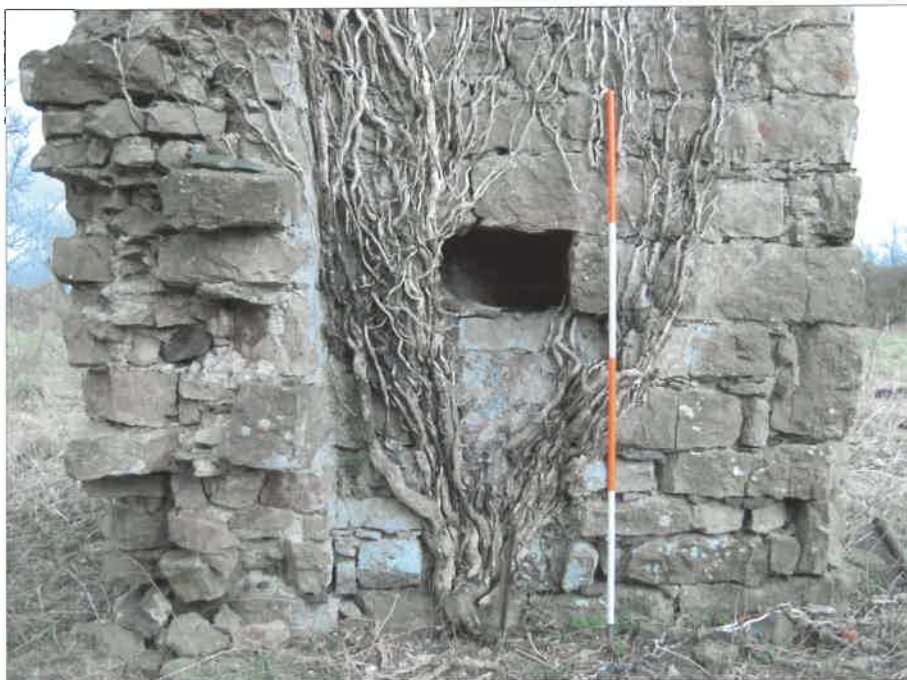
Plate 20: Vent in chimney

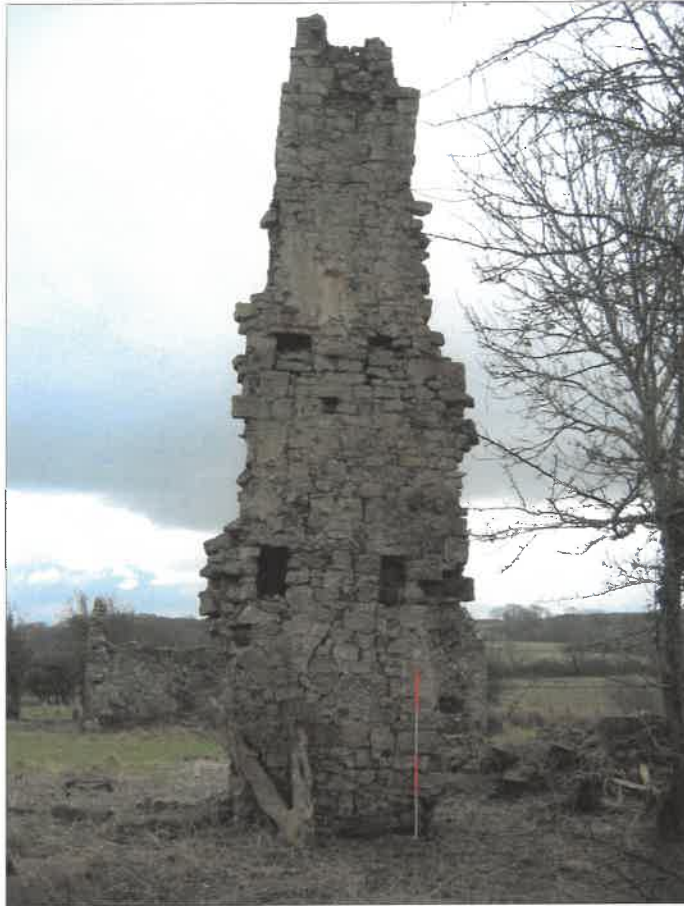
The remains of walls along the north western side of the chimney would suggest that it was originally part of a building complex, presumably housing the steam pump. Five recesses in the north western wall (Plate 21) are probably supports for parts of the steam engine and its associated machinery

Plate 21: North west face of the chimney
