**North West Wales Dendrochronology Project
Pen-y-bryn, Abergwyngregyn,
Gwynedd**

**EAS Client Report 2010/02
February 2010**

**By
I.P. Brooks and K. Laws**

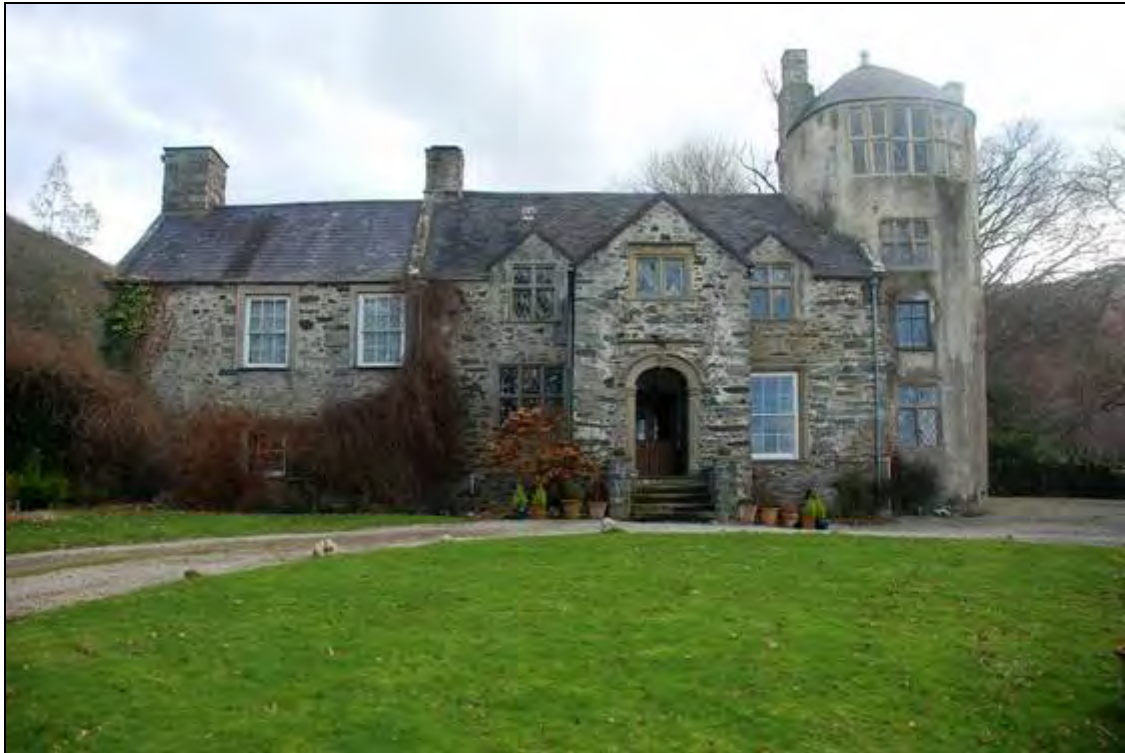
Plate 1: Front elevation

further divided into the north eastern range and central range based on changes in structure and roof line (Plates 1 and 2). There are two wings to the rear of the building; a larger southern wing and a smaller northern wing.

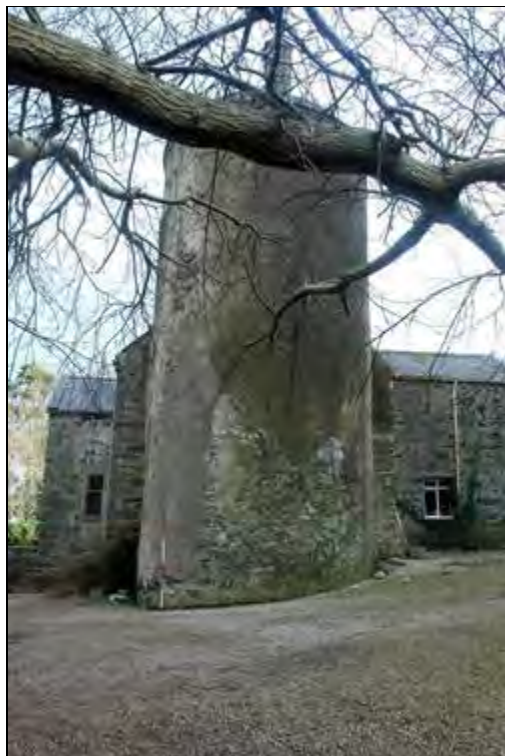
Plate 4: The tower, looking north east

The tower (Plates 3 and 4) is a four storey structure, roughly circular in plan with a conical (slightly domed) slate roof. Two chimney stacks protrude from the roof. The north east chimney serves the fireplaces in the south west gable end of the central range. The south western chimney is no longer active, but is presumably associated with the brick flue recorded on the second floor of the tower (see later). The front face is slightly flattened, presumably with the addition of the windows on this side of the structure. Each of the windows is slightly different. Those on the ground and first floors have four paned windows with mullions and transoms, although of different designs. The second floor has a six paned window with mullions and a transom, whilst the third floor window is much larger with a twelve pane window wrapped around the front face of the tower. The ground, second and third floor windows are in sandstone, whilst the first floor window is in wood.

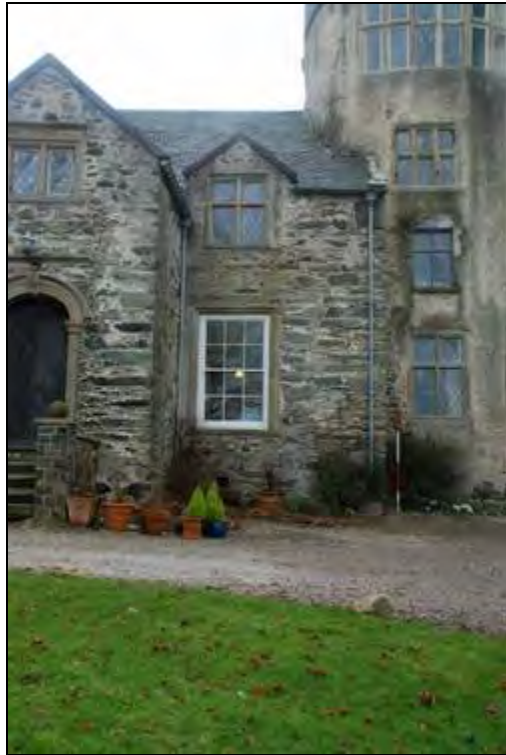
Plate 5: Central range, south west end, looking SE

The central range (Plate 5, 6 and 7) is a two storey building under a slate roof with a stone coping on the north eastern end of the range. A single "gable end" chimney is at the north eastern end, whilst the fireplace in the south western end of the range is served by a chimney on the tower. There is a porch attached centrally to the front of the range (Plates 6, 8 and 9). This is a two storey structure with a slate roof and stone coping on the gable end. It is approached by a flight of four stone steps and has a pilastered round-headed entrance arch in sandstone. This feature and the windows in the gable end and flanks of the porch appear to be later additions, possibly converting an oriel or stair turret into the porch. The gable window is a two pane window with stone mullion under a flat hoodmould. The windows in the flanking walls are two pane windows with stone transoms. The ground floor windows of the central range to the front of the property have similar sized opening, although the south western window is a twelve pane, wooden sash window, whilst the north eastern window is a six pane window with stone mullions and a transom. The windows to the first floor on the front of the building are gabled dormers containing four pane, stone mullioned and transom windows. At ground level there are also two simple rectangular slot windows giving some light to the cellar or under-croft. To the rear of the tower the gable end of the central range is partly exposed. Although obscured by render it is possible that there is a blocked opening in this corner of the range (Plate 10). A second, clearer, blocked opening can be seen in the rear wall of the central range, adjacent to the south wall of the south wing (Plate 11). This appears to be a blocked doorway, although the base of this feature is obscured by a later revetment at the base of the wall at this point. Also near to this blocking is a rectangular hole, approximately 250 mm wide and 350 mm high, at a height of approximately 2.5 m above the ground. It is filled with a block of slate and possibly marks the position of a socket for a timber structure keyed into the house wall at this point. Above the possible blocked doorway is a twelve paned, wooden sashed window with slate sill and lintel. Similar windows are in the north

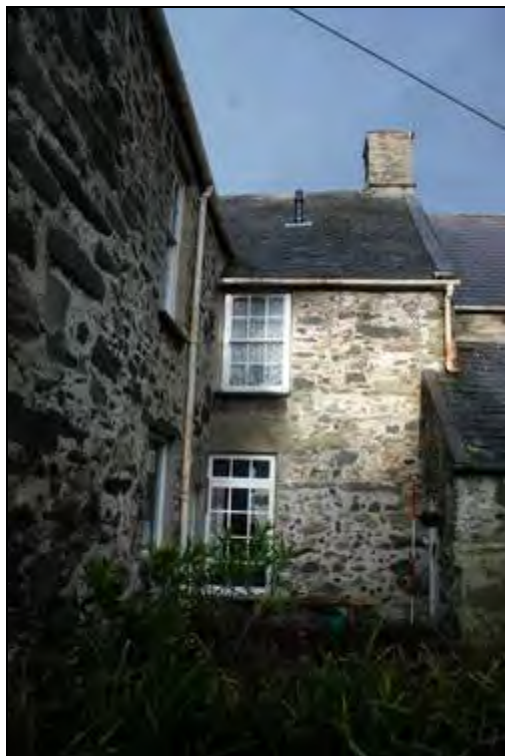
Plate 12: Possible blocked opening at northern end of the rear wall of the central range, looking NW

east, rear wall of the range as is a possible wide blocked opening adjacent to the southern wall of the northern wing (Plate 12)

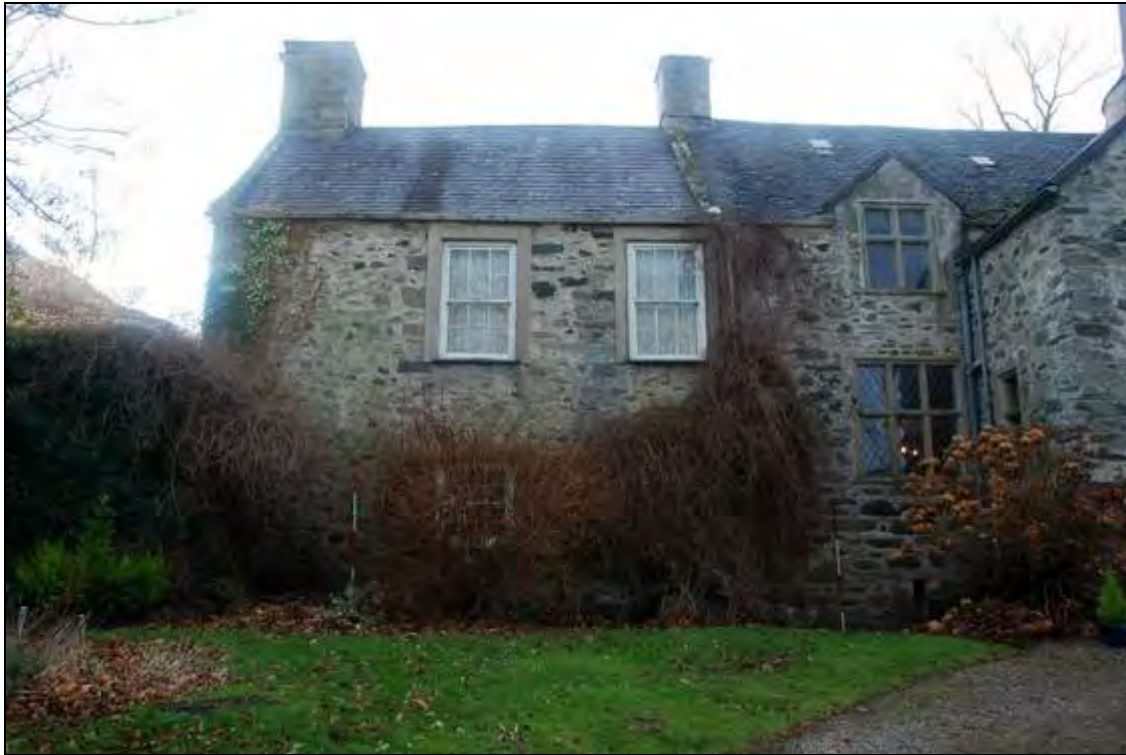
Plate 13: North east range, looking SE

The north eastern range (Plates 13, 14, 15) is a two storey construction with a slate roof with slate coping. There is a single chimney on the north eastern gable end. The ground floor windows are distinguished by having shallow segmental arched heads with long rubble voussoirs (Plates 16 and 17). The south western front window (behind the creeper on Plate 13) occupies an earlier opening which was probably a door. Together with the door linking this range to the northern wing, it is possible that these opposed doorways mark the position of a possible cross passage of an earlier structure. Only the front of the first floor has windows, these are twelve pane, wooden sash windows. There is, currently, a single door in the gable end (Plate 18) with a massive stone lintel.

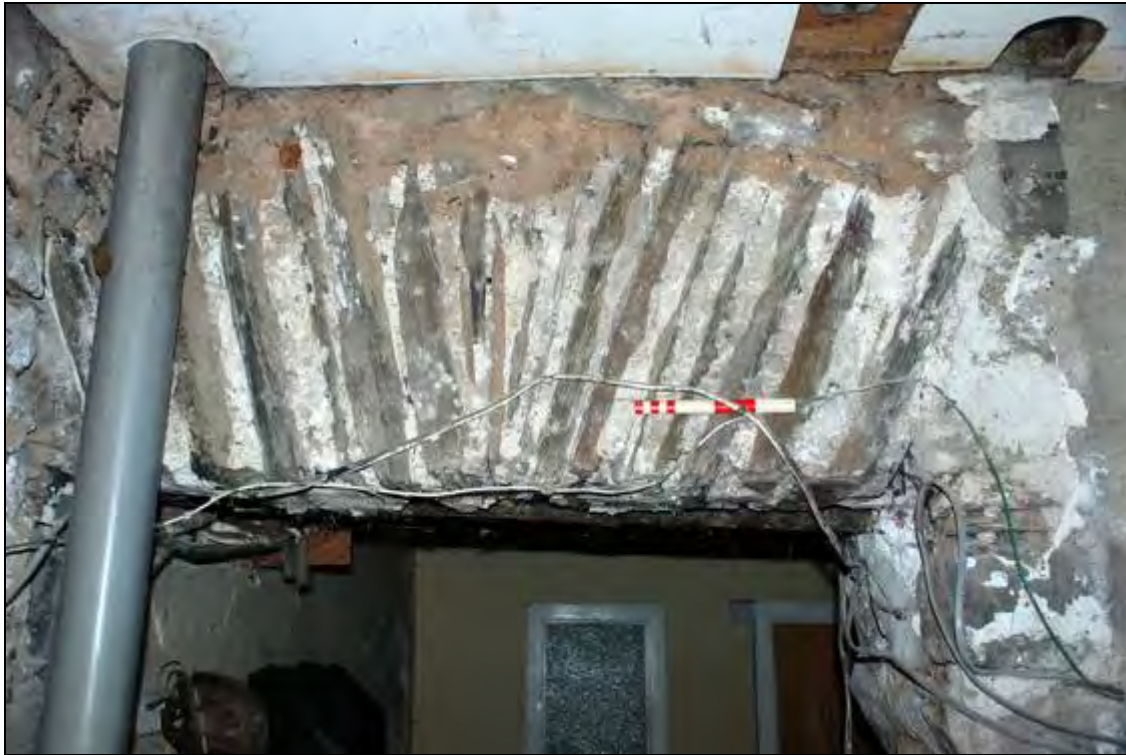
Plate 17: Voussoir head to doorway between north eastern range and north wing

The relationship between the north eastern and central ranges is evident in the doorway between the north eastern range and the north wing. Here the door head (Plate 17) can be seen to extend into the gable wall of the central range suggesting that the north eastern range is earlier. It is assumed that the two wings are later than the main range of the house. The south wing, however, has a curious angled passage between its first floor room and the central range (Plate 28). Whilst this may be to allow one of the tie beams of the central range to rest on a wall rather than above a doorway, it hints at a more complex relationship. The northern wing is clearly a late addition.

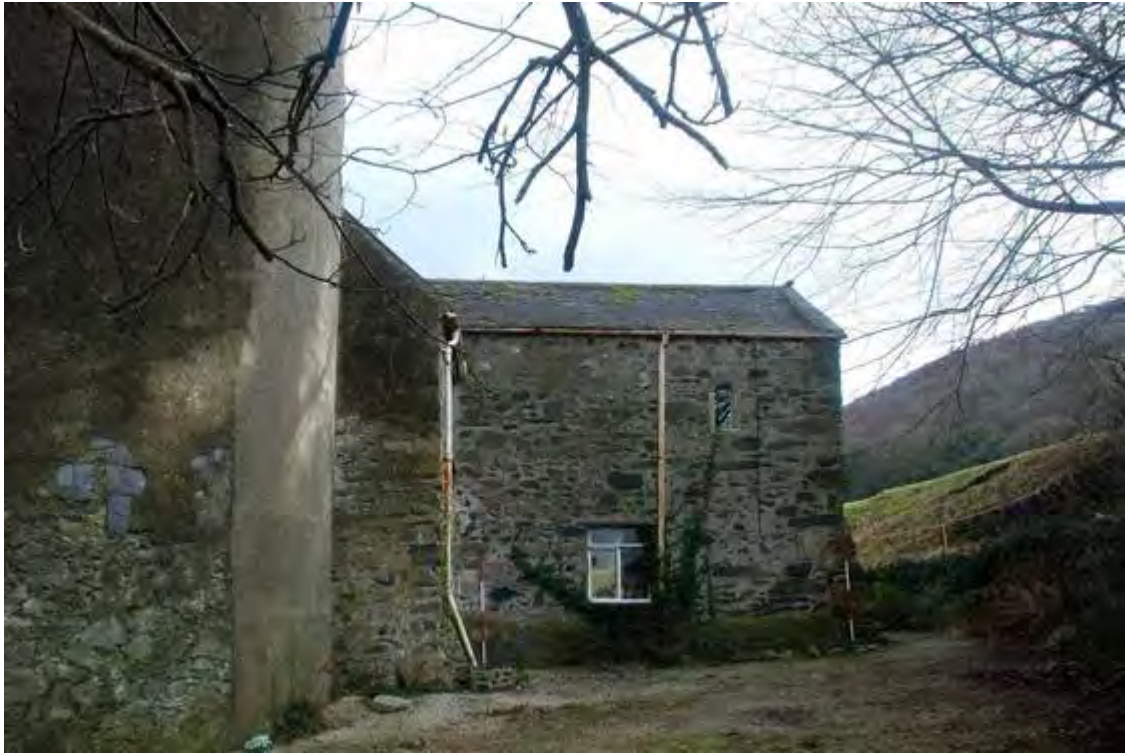
Plate 19: South wing looking NE

The southern wing runs at right angles to the central range and is a two storey construction under a slate roof (Plates 19, 20, 21). There is no chimney on this wing, although there is a fireplace and chimney breast in the ground floor kitchen which should have a chimney on the gable end. There is slight evidence on the exterior walls that the walls have been heightened and it is possible that the chimney was lost at this point. The south west and south east faces of the wing also have a later revetment along their bases. The ground floor windows are relatively modern replacements. There is however, a small window with stone semicircular arched head and monolithic jambs (Plate 22). Whilst not clear from the outside, internally this appears to have been inserted at a later date (Plate 23). The first floor window in the north eastern wall is a wooden fifteen pane sash window. The gable end of the south wing has a blocked opening which appears to be a blocked doorway, its position, however, is problematical. The opening, set at first floor level, would appear to be into the chimney breast in the gable end of the south wing (Plate 20). There is also some suggestion that there was a structure below this opening, with a line of protruding stones in the gable end.

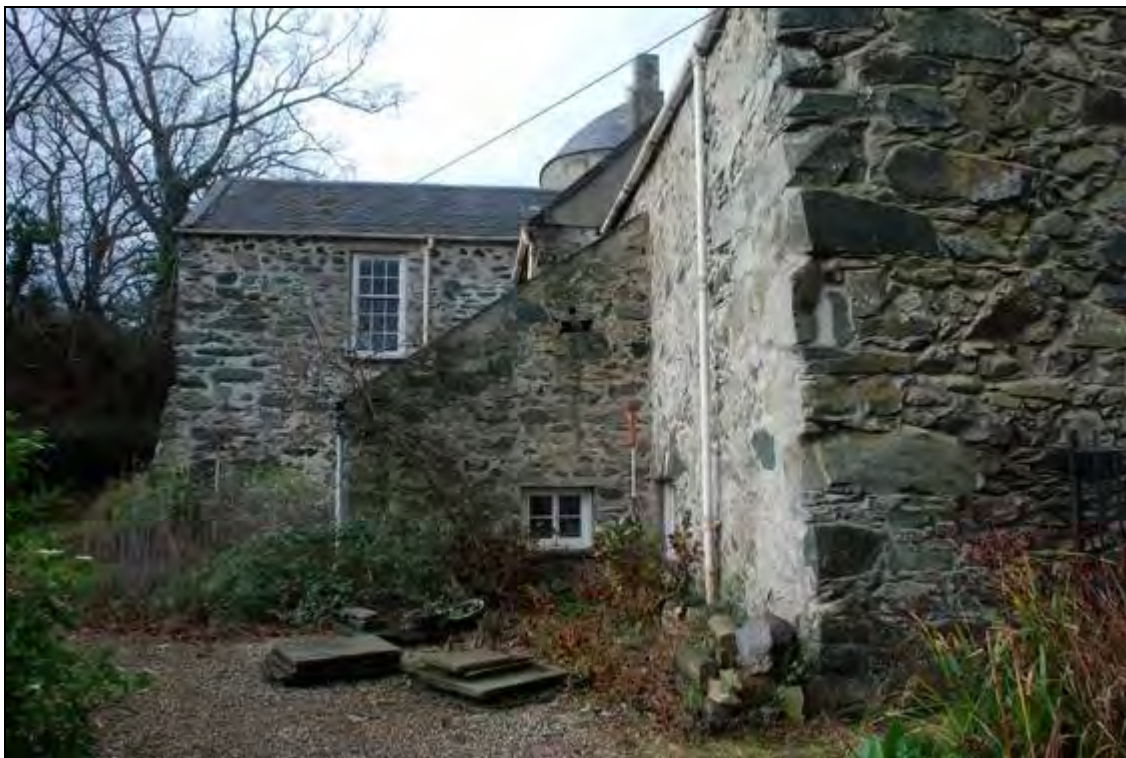
Plate 24: North wing, looking SW

The northern wing is set at right angles to the north eastern range, is single storey, lean-to structure with a slate roof (Plate 24, 25, 26) and is clearly a late addition. Whilst the existing door way is in the south western wall there is a blocked opening in the south eastern wall of the wing. This doorway must predate the corner fireplace in this wing.

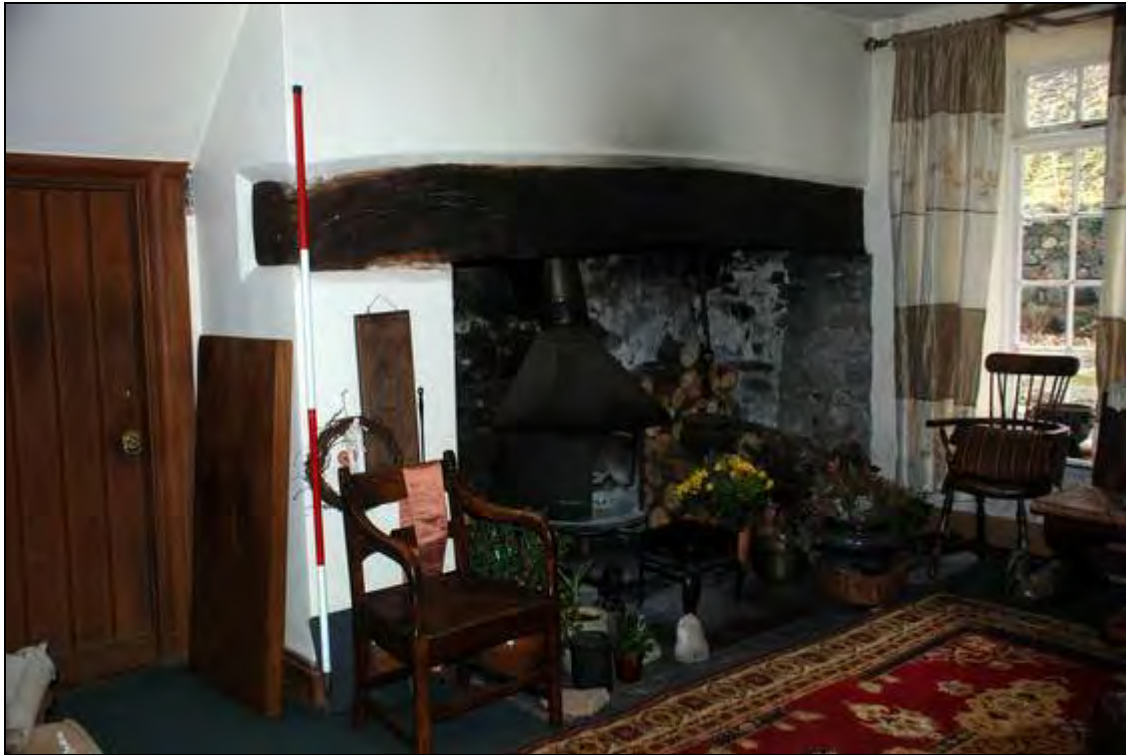
Plate 35: Central range fireplace, looking SE

On the ground floor the central range has a large fireplace with a wooden bressumer on what would be its north eastern gable wall (Plate 35). Adjacent to this is the main staircase with massive moulded and swept handrail, turned balusters to lower flight, and double-square newels with capping (Plate 36). Room for the staircase was provided by replacing the dividing wall between the Central and North Eastern ranges with a thin, timber and brick wall (Plate 37 and 38). This wall was constructed of a timber frame with rails and studs with some diagonal bracing filled with hand made brick of eighteenth century type. There are three tie beams visible on the first floor, the two outer of which have the feet of trusses 5 and 6 adjacent (Figure 5, Plate 39). The exposed tie beams have been roughened to take a plaster coat, however they were originally chamfered with straight stops (Plate 40). The trusses for this range are largely hidden as they are used as the dividing walls between the rooms on the second floor. The

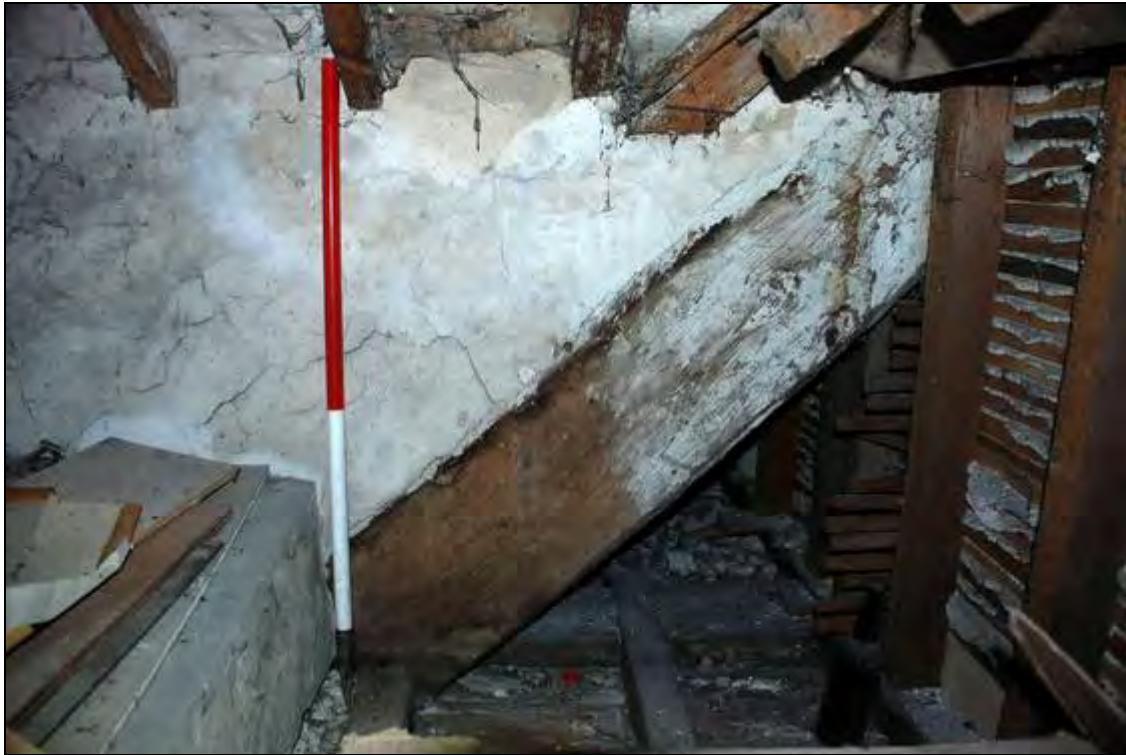
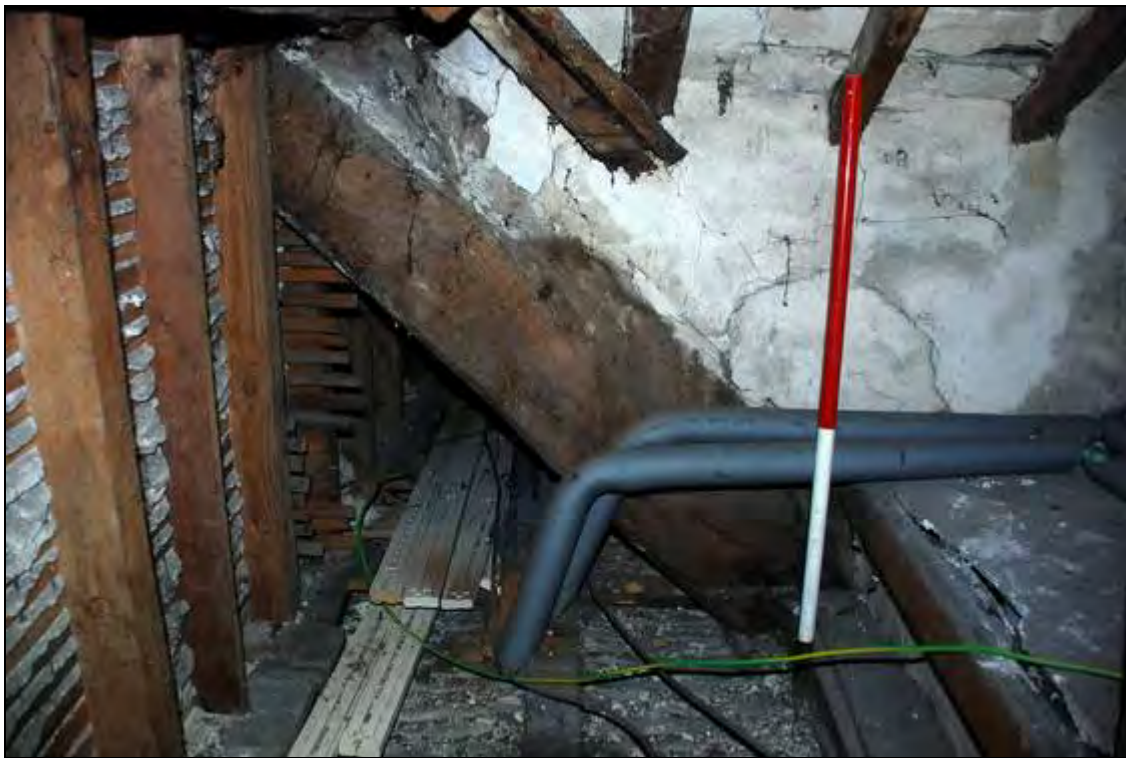
bases of the trusses are exposed in the attic space between the walls of the second floor rooms and the roof structures (Plates 41 and 42), unfortunately any collars or other reinforcement are hidden. Truss 4 survives only on the north western side of the chimney breast. A raking strut runs from the principal rafter to the chimney breast and two purlins are trenched into the principal rafter (Figure 8, Plate 43).

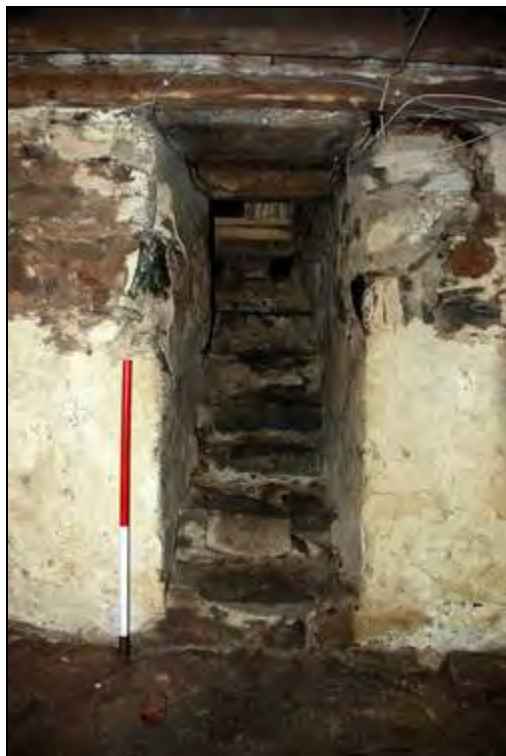
Plate 44: Stone stairs between the cellar and the tower

Below the front section of the central range is the cellar or undercroft (Figure 4). Access is via a flight of stone steps from beneath the tower (Plate 44). This relationship would suggest that the cellar predates the central range. There has been a link between the central range and the cellar with the remains of a dog-legged staircase (Plate 45) which would have exited in the space now occupied by the main staircase. There are a series of small niches cut into the cellar wall (Plates 46 – 50), one of which extends behind the dividing wall of the cellar (Plate 47) possibly suggesting this wall was from a secondary phase. To the north east of the dividing wall is an area of cobbling (Plate 52) which leads to a door frame and head of late sixteenth or early seventeenth century type (Alcock and Hall 1994, 20) (Figure 10, Plate 51). The door frame and head would appear to be of relatively high quality work, possibly suggesting that they have been moved from elsewhere in the house. The doorway leads to a short passage below the current porch; some work has broken through the end wall of the passage revealing the northern wall of the passage extending beyond its current extent.

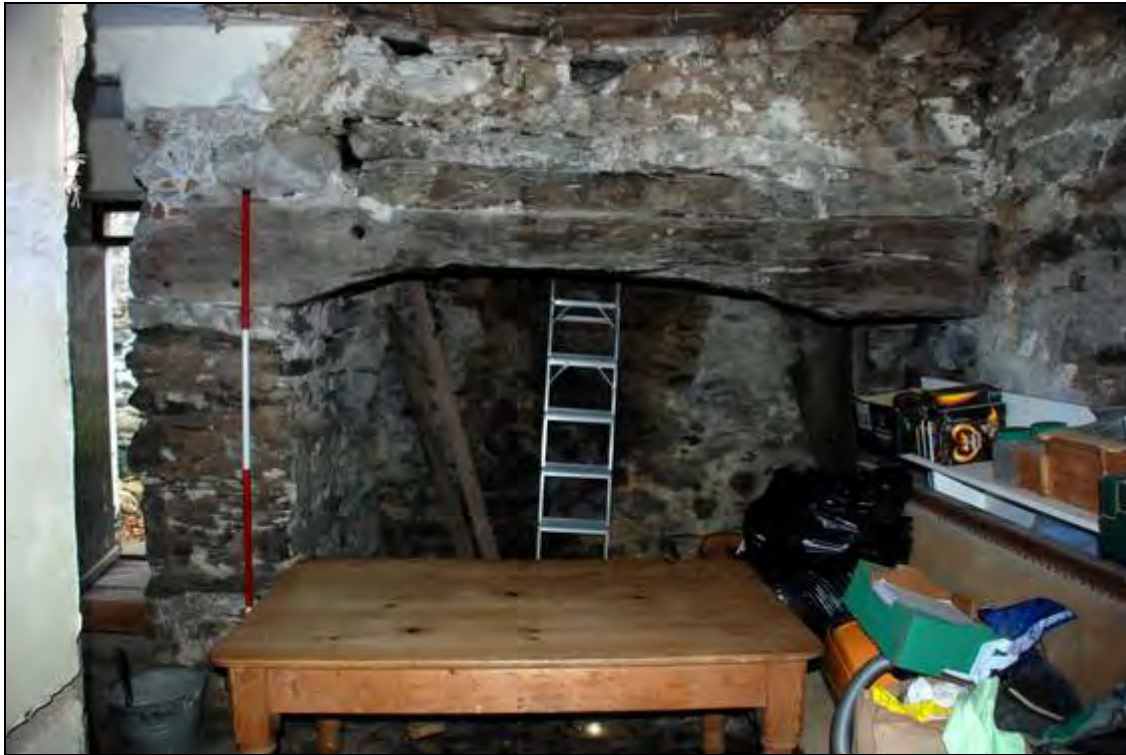
Plate 53: Fireplace in north eastern range, looking NE

The north eastern range has a large fireplace at the north eastern end (Plate 53) with a wooden bressumer and recesses on each side suggesting the possible locations of ovens. Truss 1 is disrupted by the chimney breast (Figure 9, Plate 52) with only a short length of principal rafter surviving on the north western side running between the eaves and the chimney breast. The purlins sit on the principal rafter and are supported by cleats both on this truss and Truss 2. Truss 2 is the most exposed truss in the house. It has a slightly curved collar with dove tailed lap joints linking it to the principal rafters (Figure 9.2, Plate 54). At the north eastern end of the collar is a clear carpenter's mark of "VIII" in chisel mark. There is also the same number in scratch marks slightly above the chisel marks in larger figures (Plate 55). Below the collar are two mortice holes in the principal rafters suggesting the position of a lower collar, now lost. The principal rafters are crossed, with a notched joint, to house the ridge purlin.

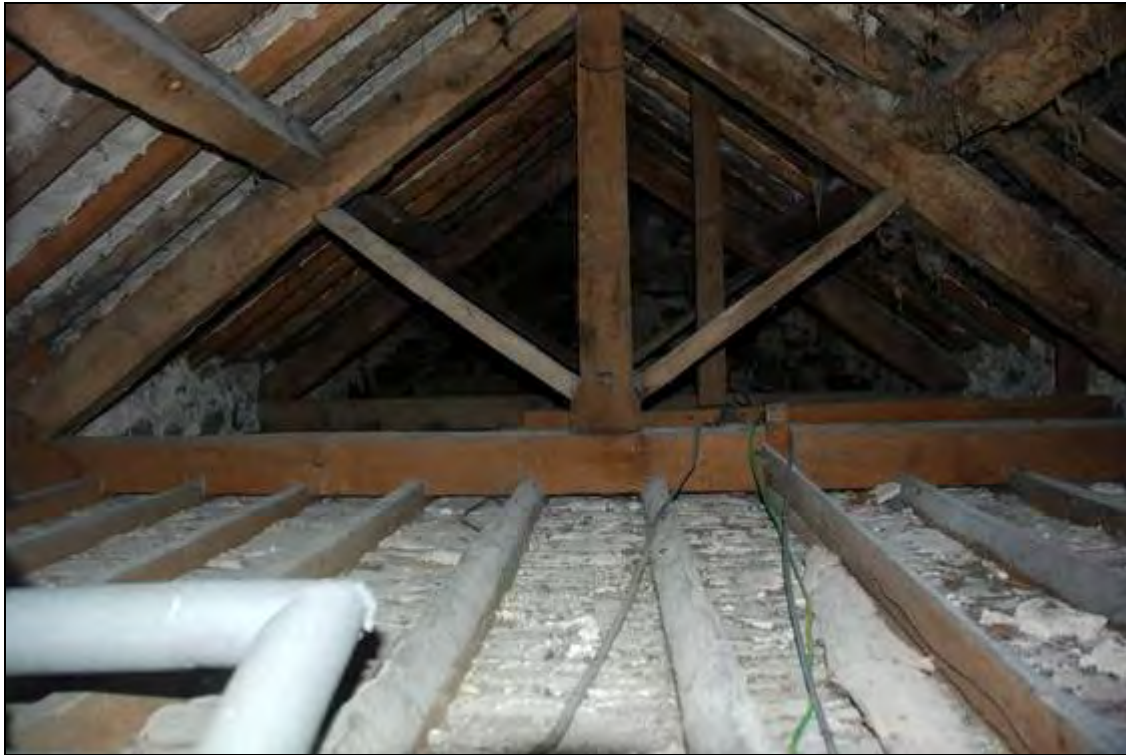
Plate 56: The roof structure for the south wing, looking SE

The south wing has a modern replacement roof structure (Plate 56) with a king post and racking struts. On the first floor the plaster has been removed from the south western wall, revealing the heightening of the wing observed on the outside wall (Plate 57). The removal of the plaster also revealed a niche cut into the wall (Plate 58).

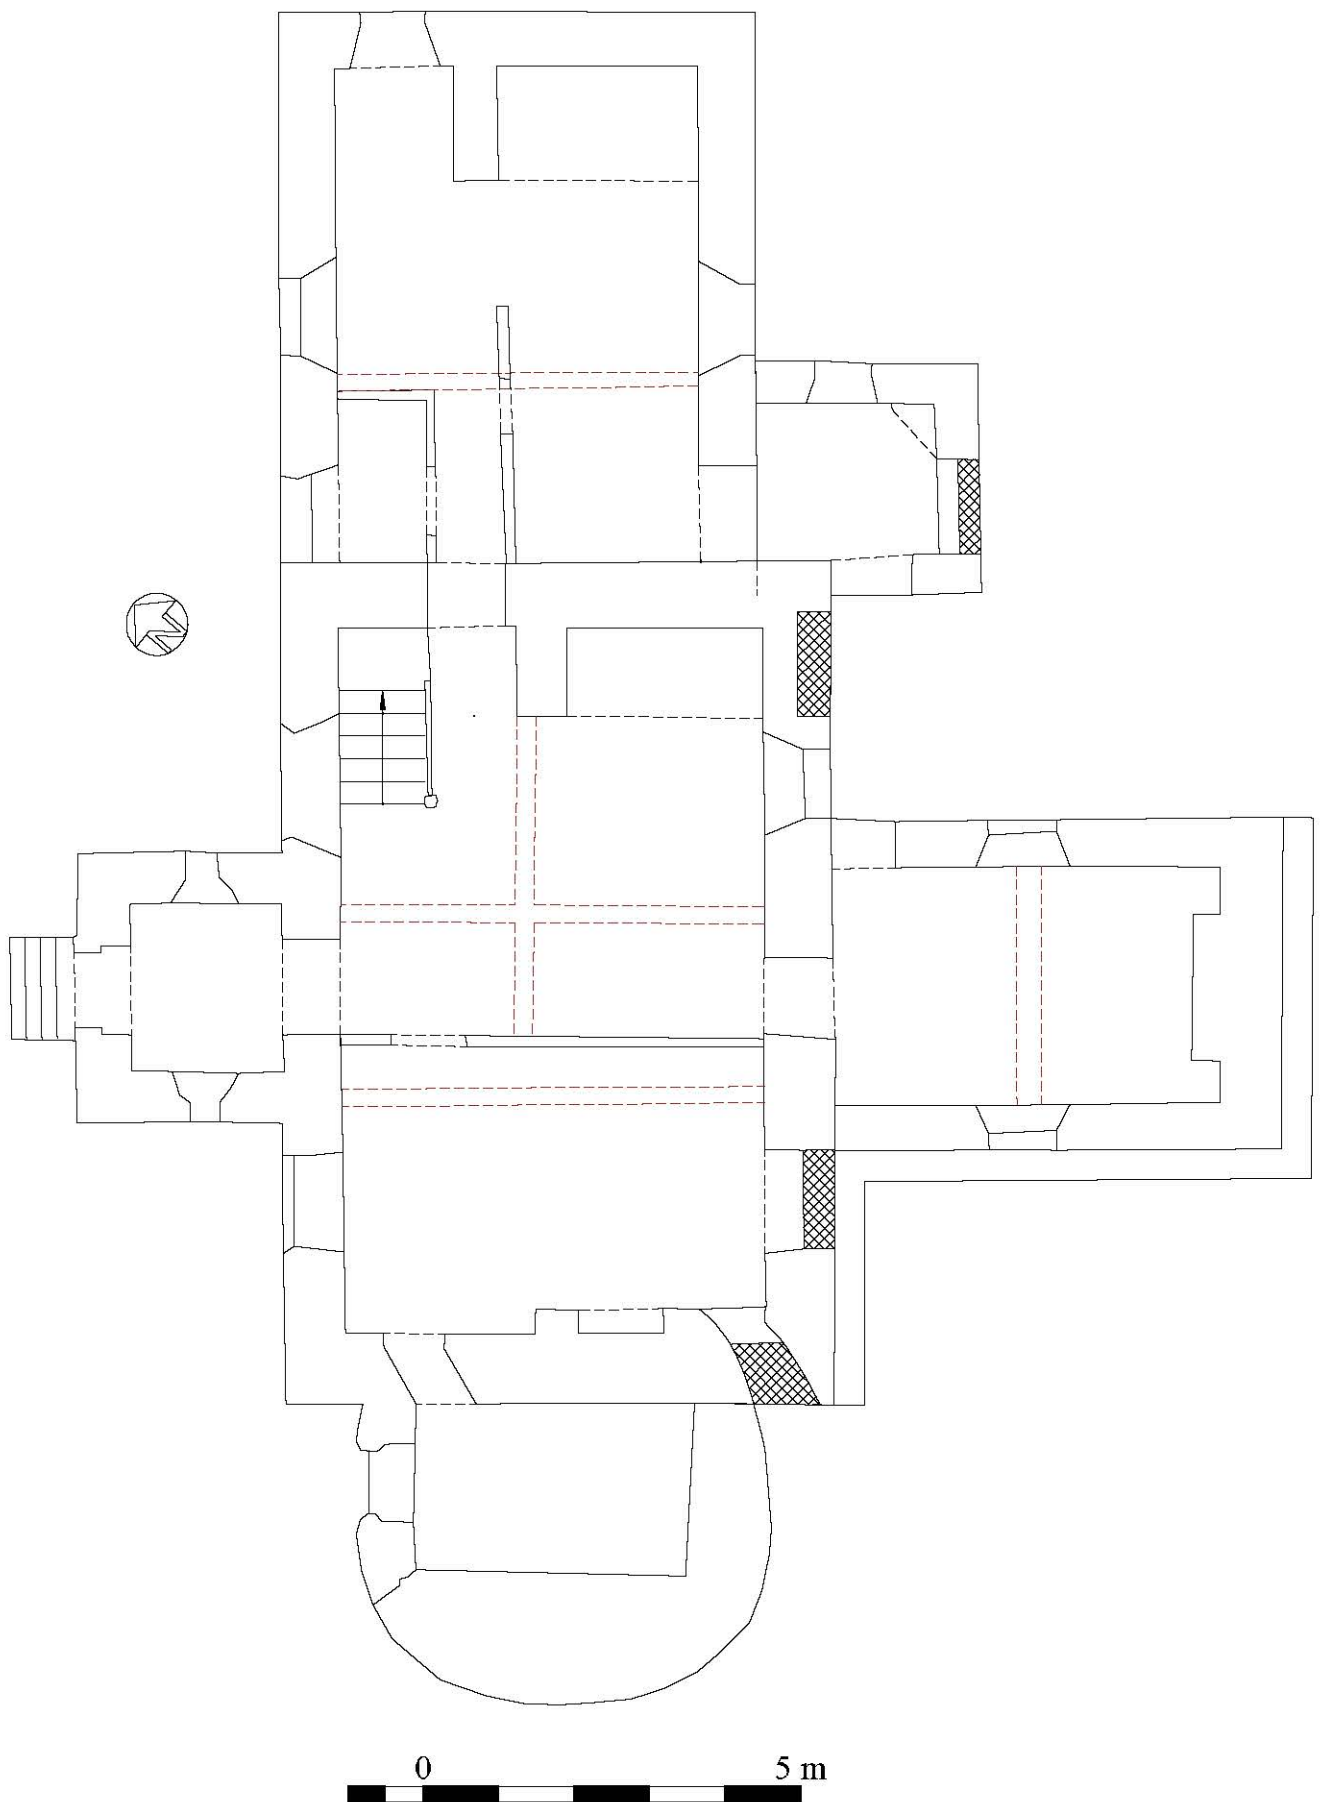
Figure 3: Pen-y-bryn Ground Floor Plan
Scale 1:100

Pen-y-bryn consists of a main range aligned approximately north east to south west with a circular tower on its south western end (Figure 3). The range can be
